REPORT NO. 710/380

METALLURGICAL EXAMINATION OF

GERMAN AIRCRAFT ARMOR

WATERTOWN ARSENAL
WATERTOWN, MASS.

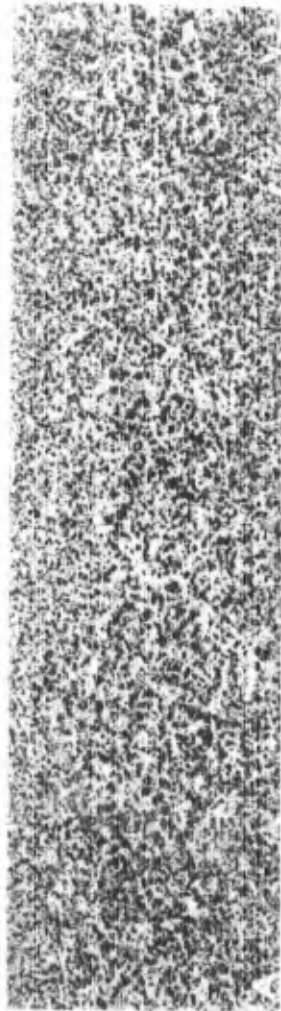
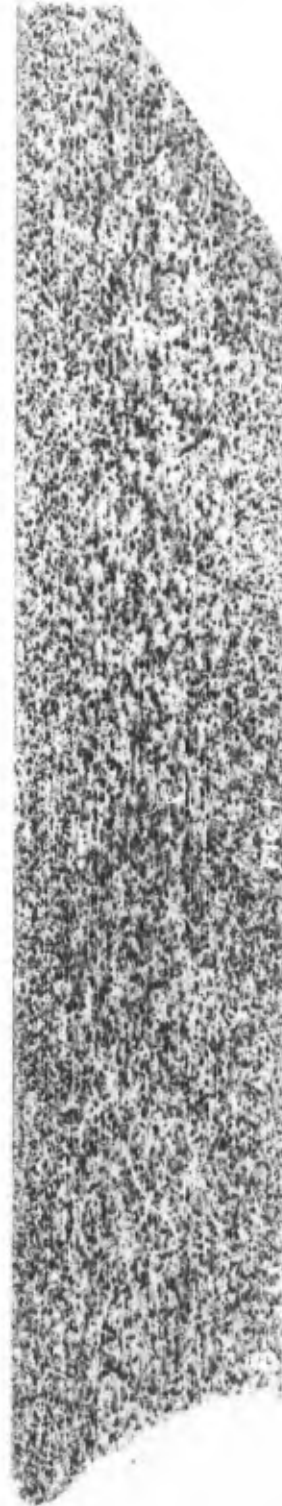
Figure 1

Macroscopic Examination - Deep Etch

Section "A"

This section shows a rather uniform condition throughout with practically no dendritic structure. The partially etched-out nonmetallics are well distributed.

Section "B"

This section was cut at right angles to section "A". Macrostructure same as section "A".

The etched sections show a rather uniform condition throughout with practically no dendritic structure indicating thorough working. The partially etched out nonmetallics are well distributed. (See, Figure 1).

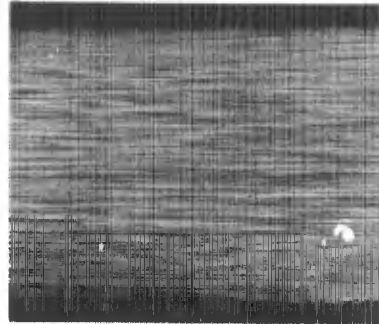
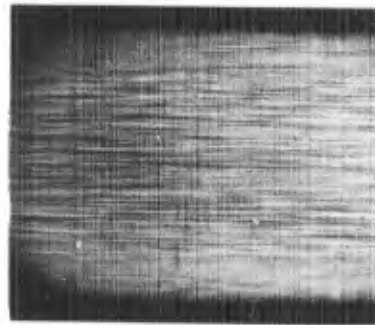
Figure 2

Macroscopic Examination - Oberhoffer's Etch

This section shows a fine uniform banded structure.

This section was cut at right angles to section "A".
Macrostructure same as section "A".

There is a slight amount of uniform fine banding present in sections cut at right angles to each other. (See Figure 2). This is considered reasonably good quality material.

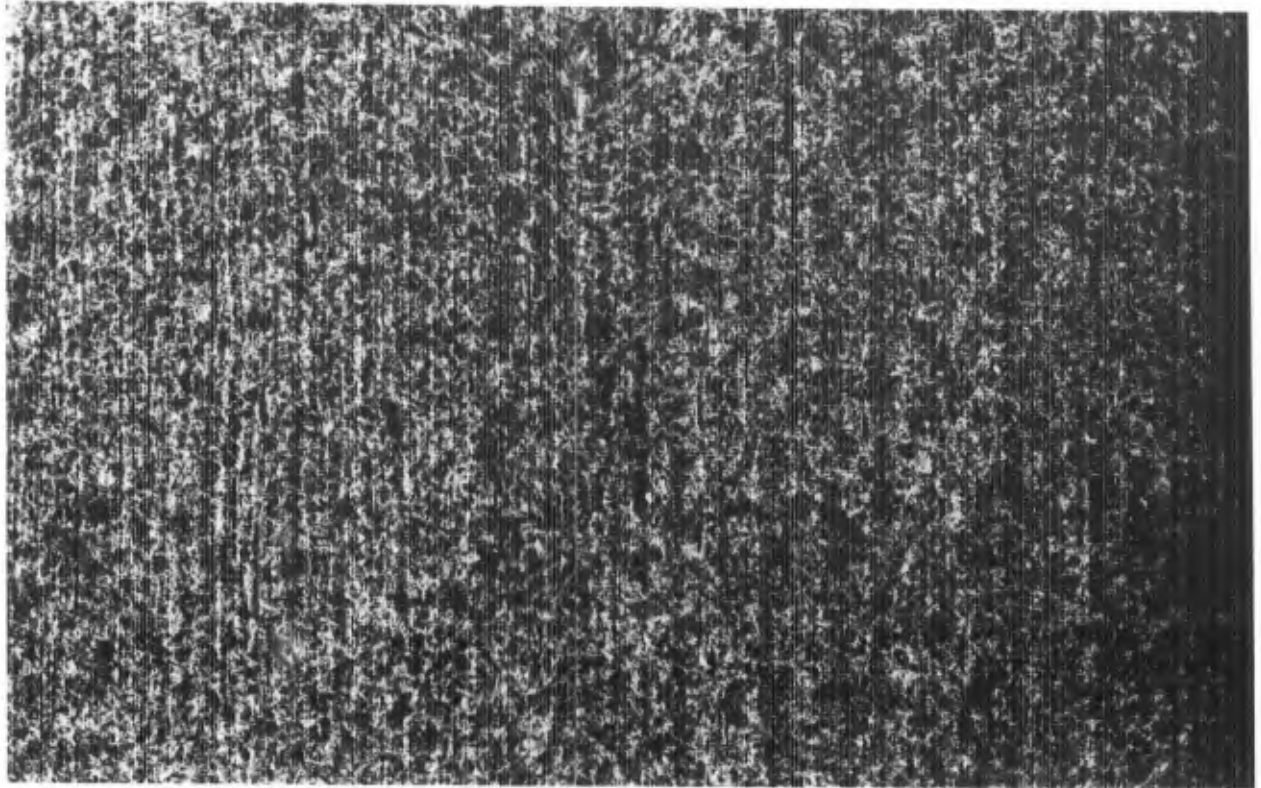
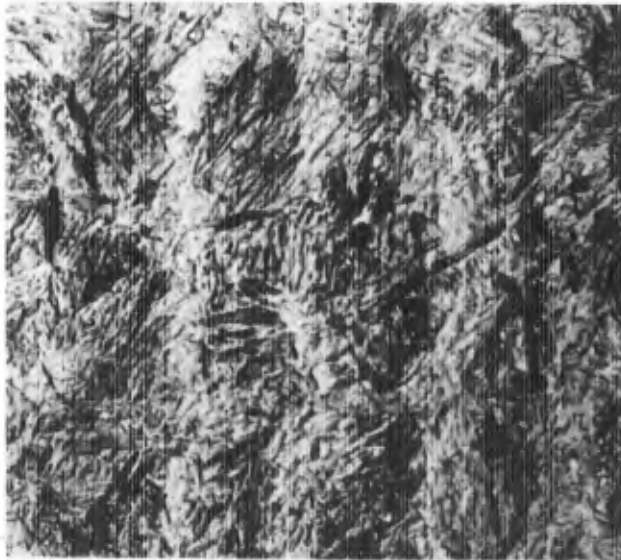
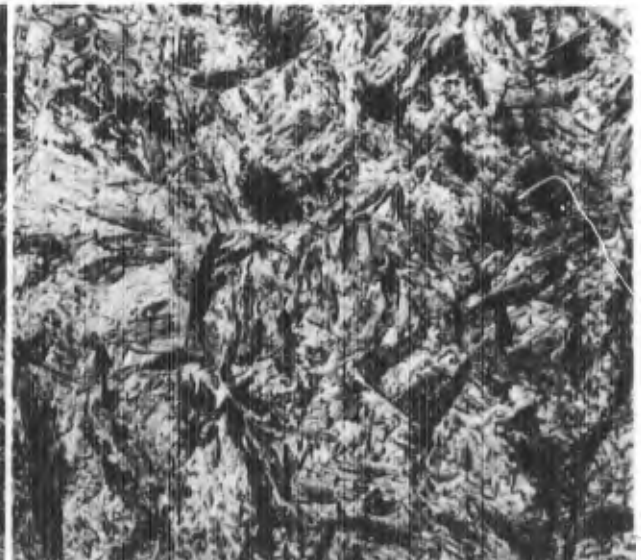
Figure 4

Typical microstructure near the surface of the plate.
Slight banding in the interior layers.

Microstructure of internal section of plate. White
bands - martensitic areas.

Microstructure near the surface. Fairly coarse
martensite.

Banding is evident in the central portions of the cross section while near the surface the structure is uniform. The material had a fairly coarse martensitic structure. (See, Figure 4).

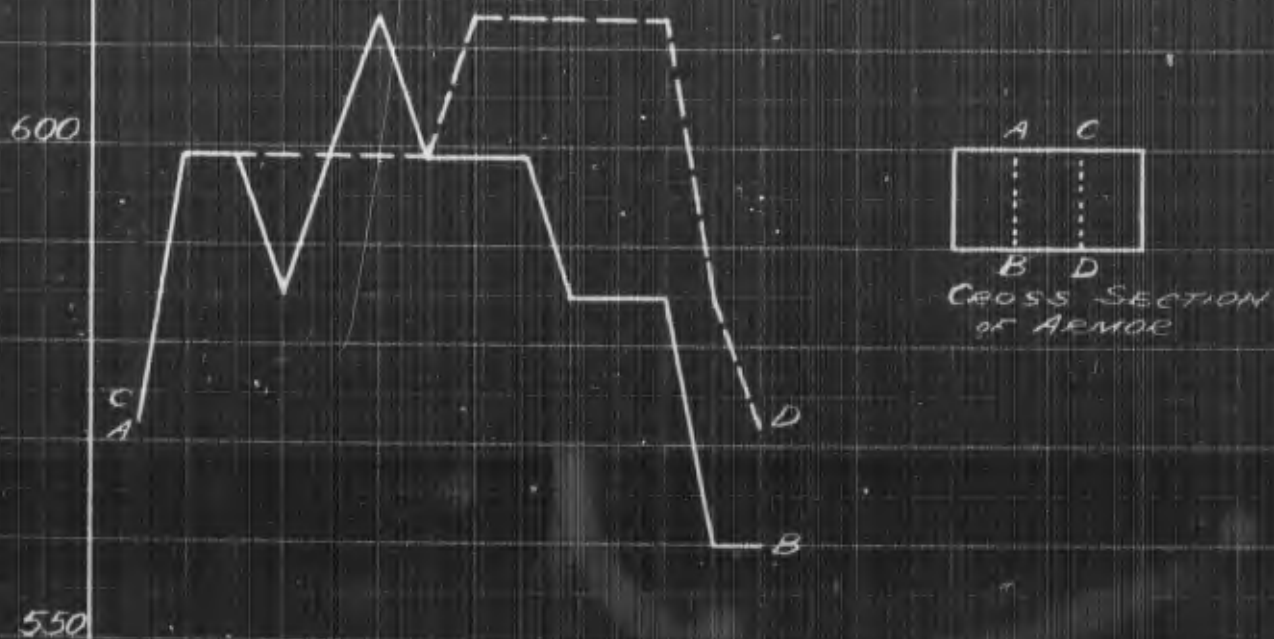
FIG 6

VARIATION IN HARDNESS
ON CROSS SECTION OF
HOMOGENEOUS GERMAN AIRCRAFT ARMOR
SPECIMEN NO. GA
290" THICK

Figure 6 illustrates this hardness survey. A hardness survey made across a cross section of the plate indicated that there was some evidence of decarburization at both surfaces.
