WT-825 (EX)
EXTRACTED VERSION

OPERATION UPSHOT-KNOTHOLE

Report to the Test Director Aircraft Participation

Nevada Proving Grounds
March-June 1953 *et seq*

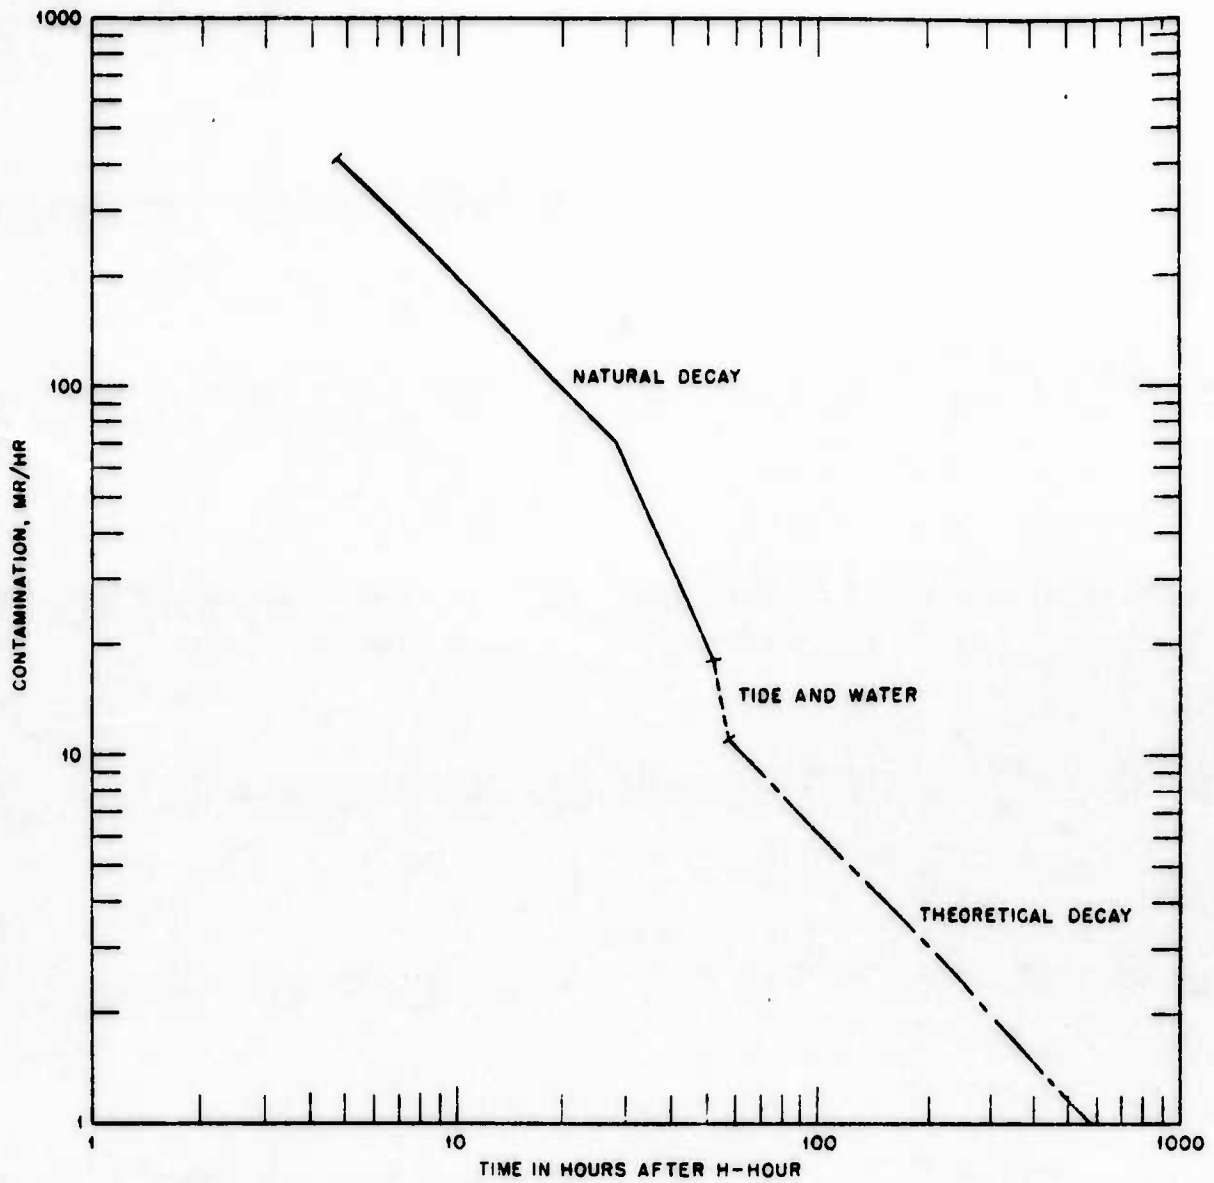
Fig. B.5—F-84G aircraft contamination; Shot ANNIE, 17 March 1953; aircraft No. 51-1051-A. Time of first survey, 1005 PST. Values plotted are average over-all aircraft contamination.

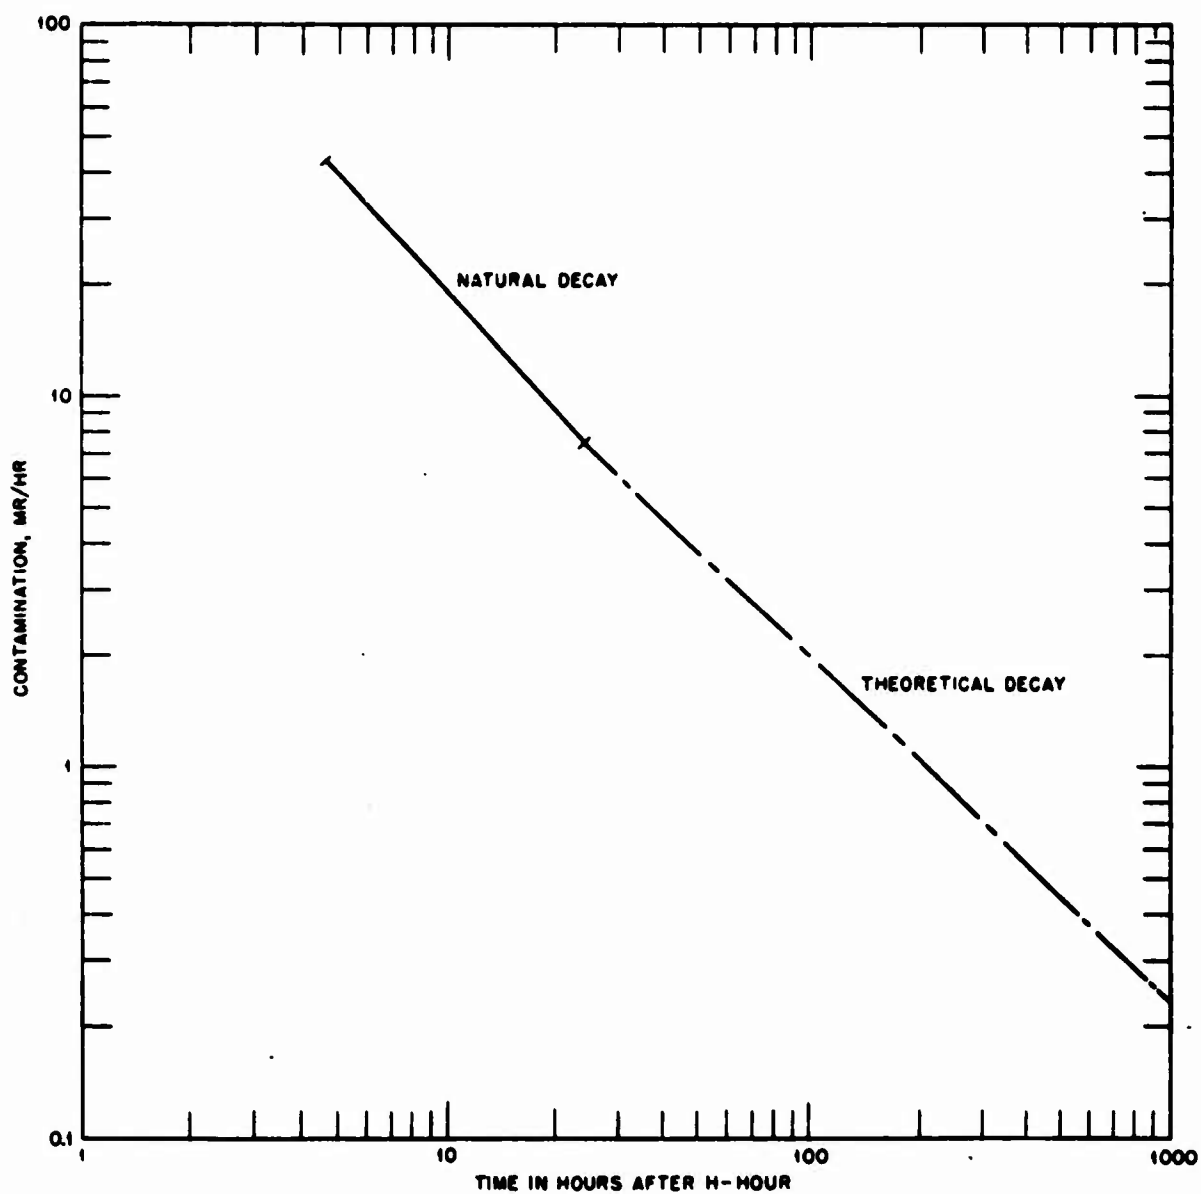
Fig. E.5— F-84G aircraft contamination; Shot DAVE, 6 April 1953; aircraft No. 51-1038-A. Time of first survey, 12:10 PST. Values plotted are average over-all aircraft contamination.
