OPERATION SNAPPER

Project 8.5

# INCENDIARY EFFECTS OF ATOMIC BOMB TESTS ON BUILDING SECTIONS AT YUCCA FLAT

*REPORT TO THE TEST DIRECTOR*

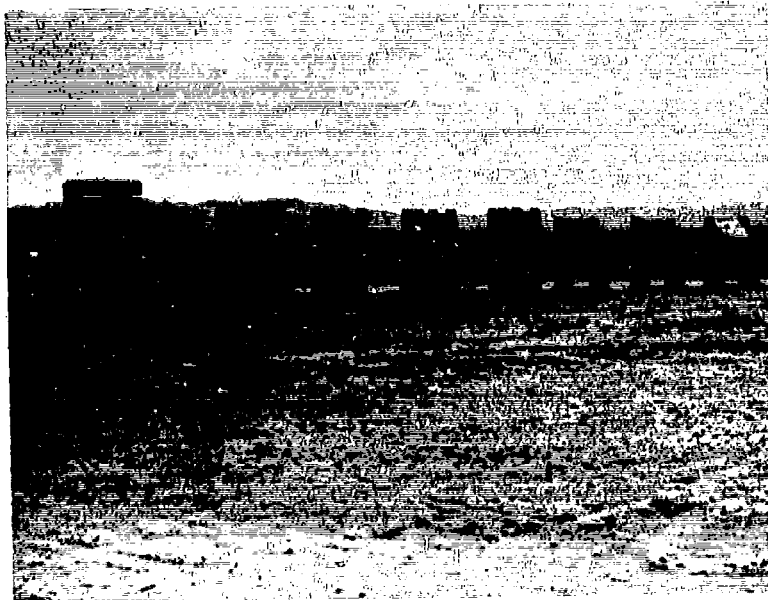
Fig. A.1. The Several Types of Test Structure (room; wall-corner and cornice-corner with and without excelsior; three roof sections) installed for TUMBLER Shots 3 and 4.

The four types of test specimens exposed to Shots 3 and 4 are shown in Figure A.1. They represented: (1) a cubicle room, (2) right-angle corner between walls, (3) right-angle corner with cornice, and (4) roof. Structure 1 included several combustible materials placed to receive radiant energy through a glass window. Structures 2 and 3 were exposed with and without excelsior at the base to serve as a "fuse" fuel. All wood was seasoned and all materials were new, except as otherwise stated.

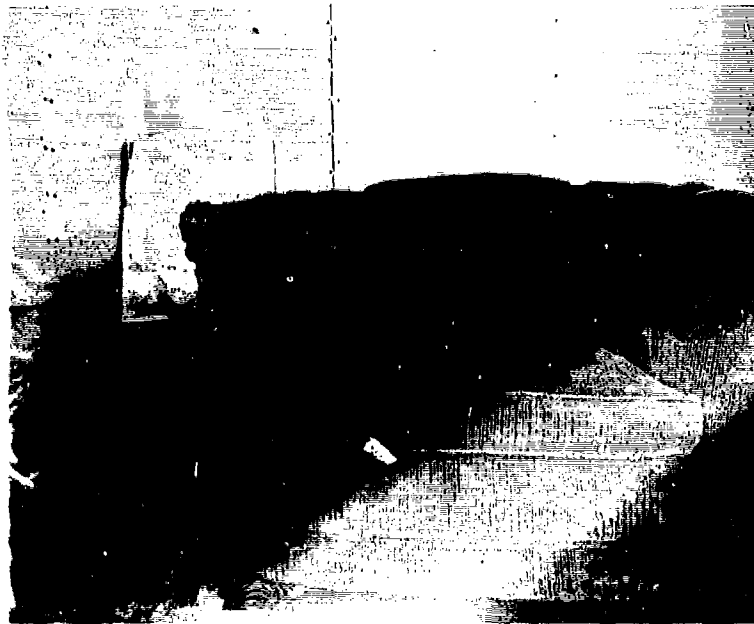
Fig. A.3. Red Pile Overstuffed Chair Exposed to Shot 4 in Room at 10,000-ft Station.

For Shot 4, an old overstuffed chair covered with red or brown pile upholstery was added to the furnishings in three of the rooms (Fig. A.3), a white cotton tablecloth and newspapers were placed upon each table, and a piece of old quilt or sheeting was hung on the back of each wood chair to simulate clothing. A paper carton containing wastepaper to serve as a wastebasket was on the floor. Also a strip of old woolen rug was laid on the floor in back of the front window. Dark green, heavy rayon drapery was used in place of the white cheesecloth curtains used in Shot 3. The arrangement was such that the shade, draperies, overstuffed chair, and rug received radiation through the front window at the 7000-, 8000-, and 10,000-foot stations and shade,

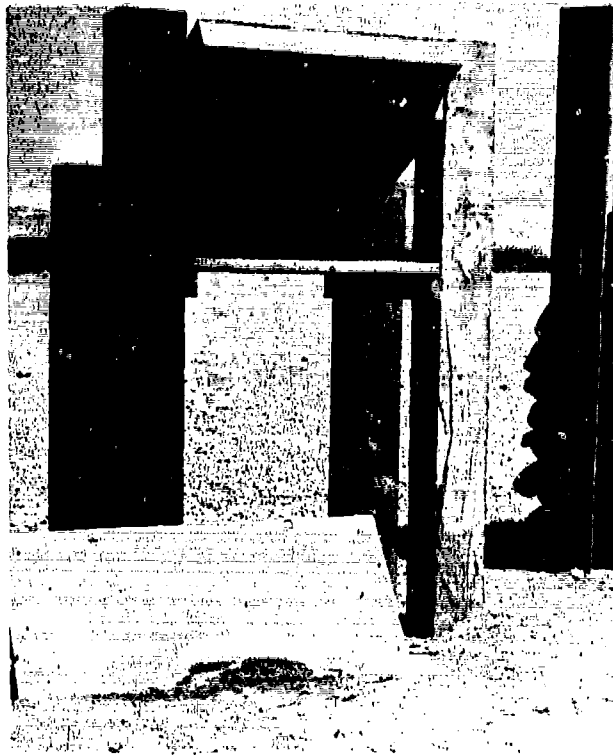
Fig. A.13. Spot Fire at 7000-ft Station in a Sheet of Douglas-fir Plywood Set Ablaze by a Firebrand of Sheeting Ignited by Shot 3.

At the 7000-foot station a piece of ignited sheeting was carried 30 to 40 feet, landing at the base of a sheet of plywood that had been blown from the back of a roof section. A spot fire resulted in which an appreciable area of the plywood was burned (Fig. A.13).

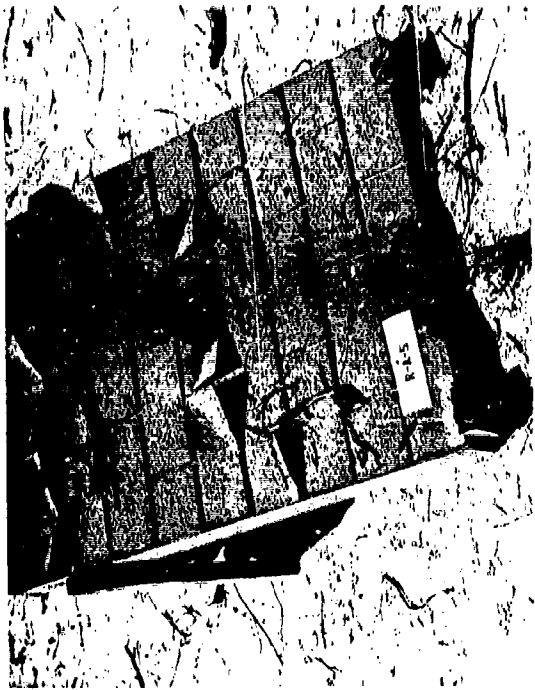
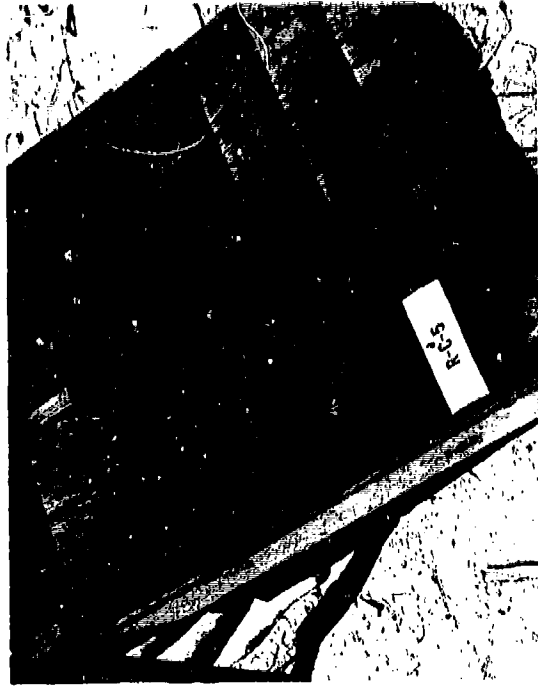
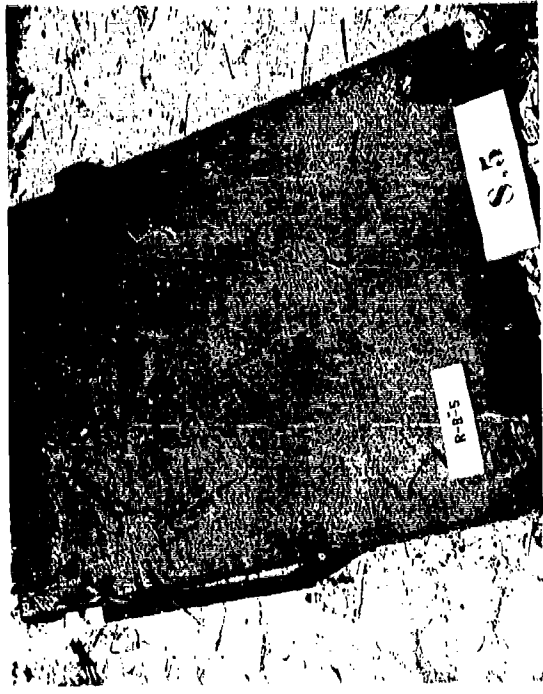
Fig. A.14. Three Roof Sections at 4000-ft, Before (top left) and After Exposure to Shot 4.

None of the roof sections were badly damaged either by radiation or blast. At 4000 and 5000 feet there was surface carbonization of the cedar shingles to a depth of a few tenths of a millimeter, but progressively less at greater distances. At 4000 and 5000 feet the asphalt composition shingles became hot enough to discolor and lose much of the bright green color, but would still be serviceable as a roof. There was evidence that the asphalt of the built-up roofing melted at all distances out to 10,000 feet.

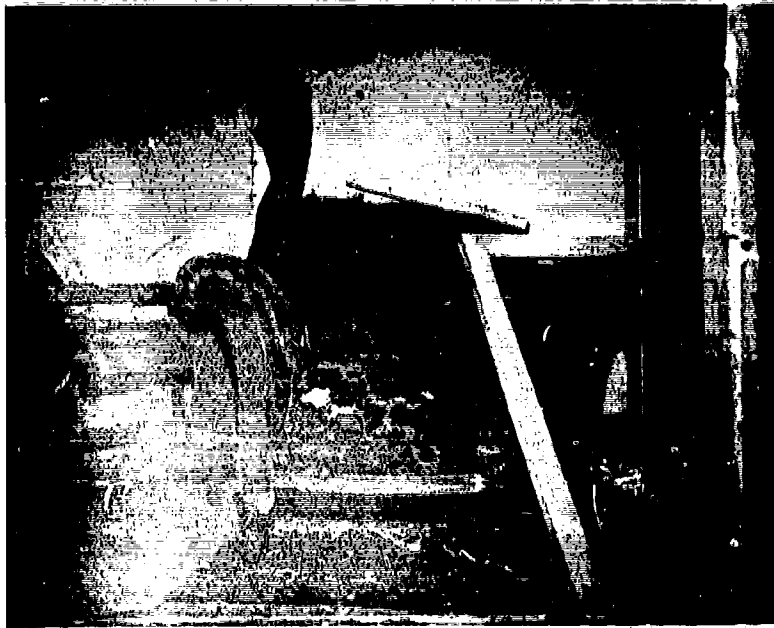
Fig. A.15. Interior of Room at 7000-ft After Shot 4. Sash, shade, and drapery blown in; upholstery torn by flying glass; part of chair upholstery pile darkened by carbonization.

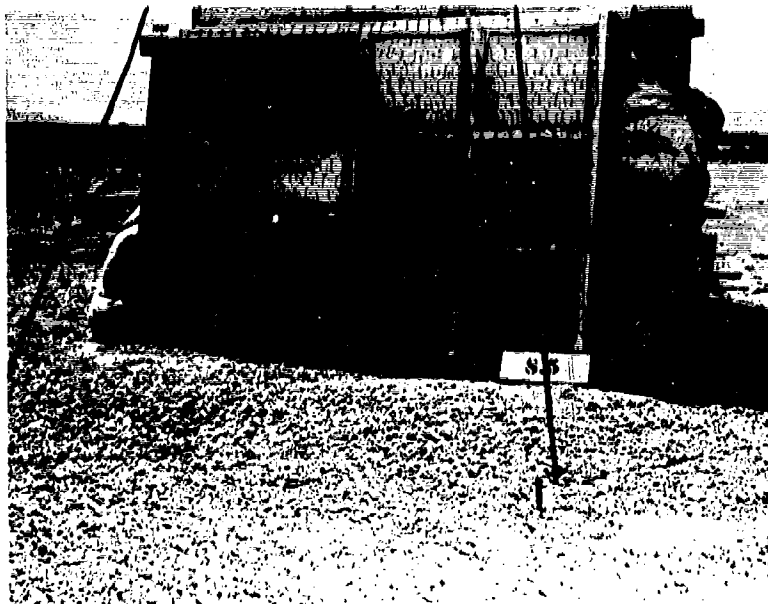
Fig. A.16. Panel of Fabrics at 7000-ft, Before and After Shot 4. Wood singed; glass shattered; rayon drapery burned; cotton sheeting burned; cheesecloth slightly browned; red cotton cloth burned; frieze charred; wool rug fused and charred.

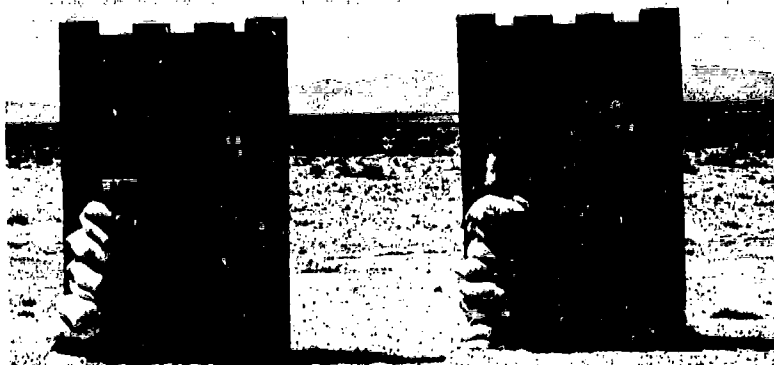
Fig. A.19. Cornice-corner at 8000-ft After Shot 4.  
Plywood singed; excelsior tips burned;  
two brief spot fires in the excelsior.

At 7000 feet the excelsior was ignited and consumed (Fig. A.18). At 8000 feet fine tips of the excelsior were charred and two spot fires were started, but the excelsior did not burn completely (Fig. A.19). At 10,000 feet only a few fine tips were discolored.

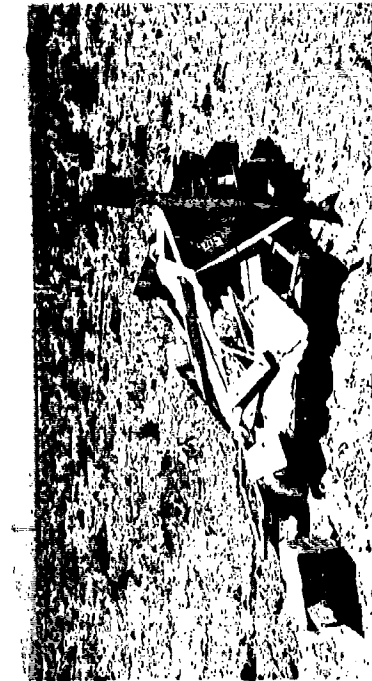
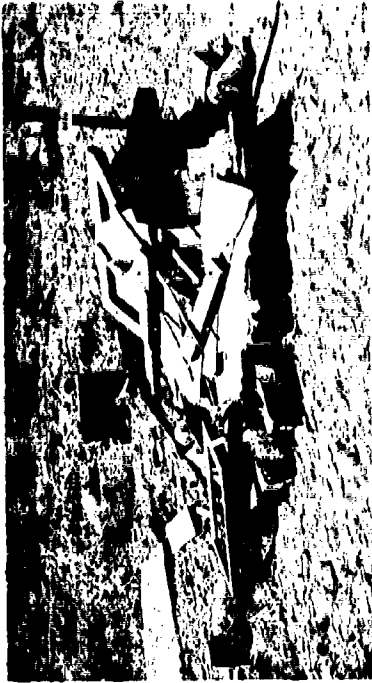
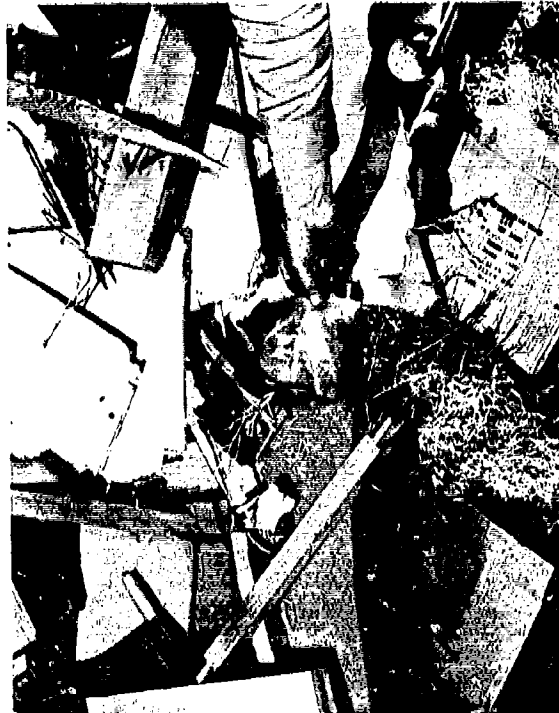
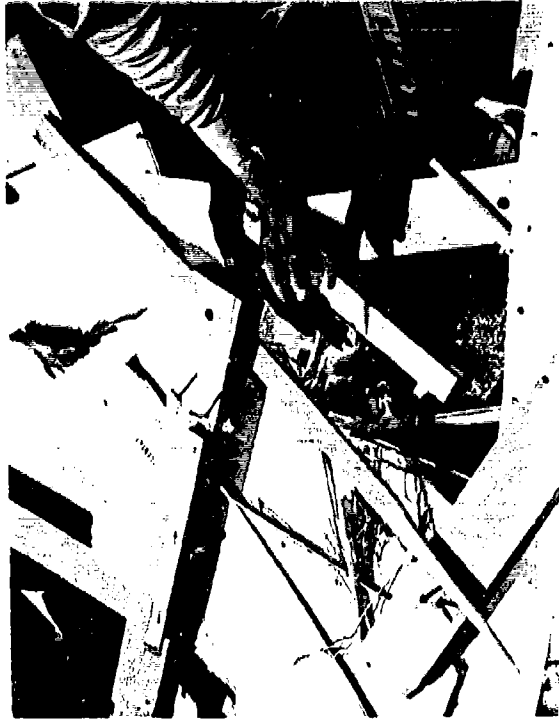
Fig. A.21. Scrap Pile at 10,000-ft Before (top left) and After Shot 4. Pile disarranged but not set afire. Soot on under side of plaster board from spot fire in excelsior or brush (bottom left). Pencil (bottom right) points to partly burned newspaper.

At 7000 and 10,000 feet there were scrap piles of waste plywood and lumber. The one at 10,000 feet also contained paper, excelsior, and cartons. At 7000 feet there was some charring of the wood but no evidence of burning. At 10,000 feet the excelsior and the paper caught fire and burned appreciably at three or four spots, depositing soot on pieces of wallboard, but the fires soon went out (Fig. A.21).
