Project 8.1a

UNCLASSIFIED 7/9935
WT-766
Copy No. 188

Operation UPSHOT-KNOTHOLE NEVADA PROVING GROUNDS

Project 8.1a
EFFECTS OF THERMAL AND BLAST FORCES FROM
NUCLEAR DETONATIONS ON BASIC AIRCRAFT
STRUCTURES AND COMPONENTS

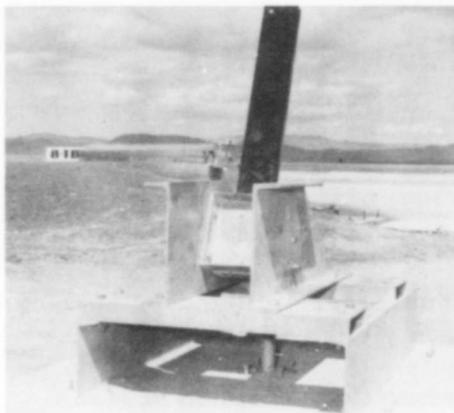
Fig. 2.1 Box Beam and Mount

The thermoelastic response of simple aircraft type structures was studied using specimens called box beams, which were long, slender structures consisting of two faces and two webs fastened together with screws and dowel pins, and tension ties, which were thin bars of rectangular cross-section stressed in tension. The specimens were made of aluminum and magnesium materials and each was mounted with its longitudinal axis in a vertical plane and with its front face normal to the intended burst point. The beams, rigidly clamped at one end, were exposed as cantilevers, as shown in Fig. 2.1; and the ties were loaded by leaf springs, such that the material stress at the peak of the thermal phase would be between yield and ultimate. A tension tie and its loading device are shown in Fig. 2.2.

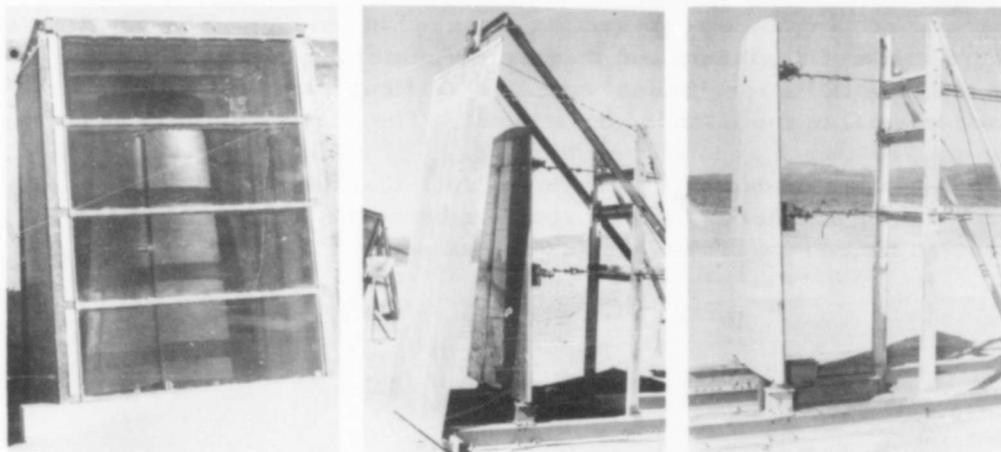
Fig. 2.3 One Set of T-28 Stabilizers. Left to Right; Shielded from Blast, Shielded from Thermal, and Unshielded.

The response of preloaded aircraft components to separate and coupled inputs was determined using horizontal stabilizer and elevator assemblies from T-28 aircraft. These specimens, representative of thin-skin, all-metal construction, were mounted vertically, with the chord oriented normal to blast incidence and with the control surface locked. A bending preload was applied to each stabilizer to simulate in-flight conditions. At each of three ranges, one assembly was exposed to thermal energy but shielded from blast, a second assembly was shielded from thermal but exposed to blast, and a third was exposed to both thermal and blast inputs, as shown in Fig. 2.3. Three

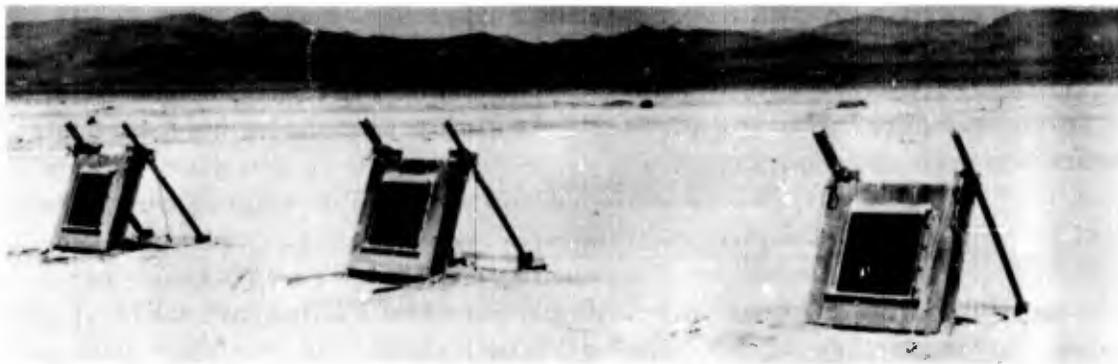
Fig. 2.5 Typical Bonded Metal Panel Blast Shield Array

thermoelastic buckling characteristics was accomplished by exposing the panels to the thermal energy while shielding them from the blast. Three bonded metal panels enclosed in blast shields are shown in Fig. 2.5. All panels were instrumented for peak skin temperature determination to facilitate correlation of buckling with skin temperature. In

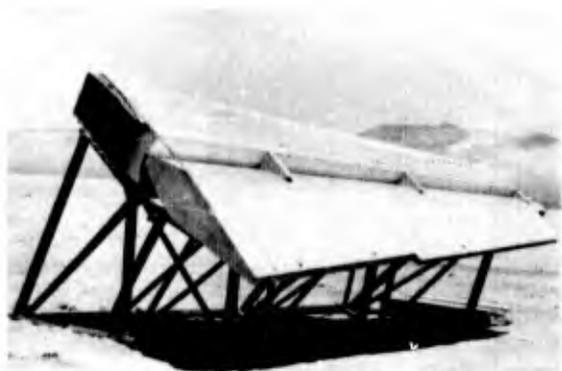
Fig. 2.6 The B-36 Stabilizer and Elevator Assembly

The horizontal stabilizer and elevator assembly was supported on a tubular steel framework, as shown in Fig. 2.6, in such a position

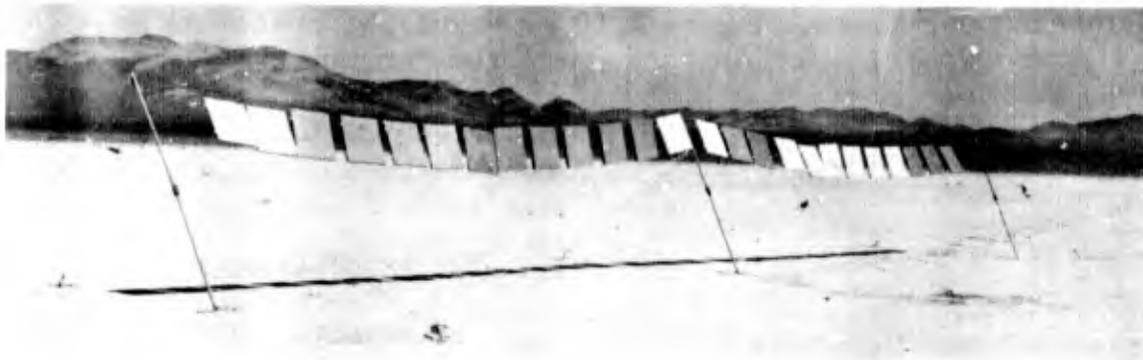
Fig. 2.8 Control Surface Covering Test Panels

Panels, consisting of a light metallic frame covered with fabric or thin gage metal to represent aircraft control surfaces, were tested to determine what protection against thermal radiation was afforded these materials by dope, enamel, or a foil covering. The thin gage metal covering was bare magnesium alloy to test its effectiveness as a replacement for fabric. A variety of panels and exposure levels were used to provide a large amount of visual inspection data. A set of panels, displayed for exposure, is shown in Fig. 2.8.

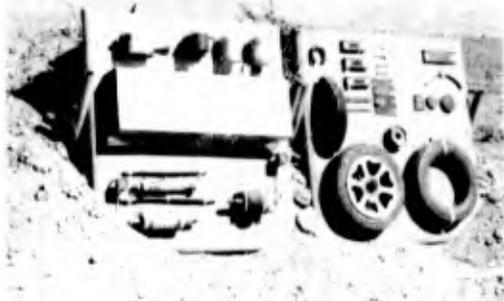
Fig. 2.9 Aircraft Undercarriage Components

Parts of aircraft undercarriages including tires, wheels, brakes, and actuators were exposed at relatively high levels of thermal energy to obtain visual damage data in an attempt to determine the exposure limits of the metallic and rubber materials used in their construction. The information could aid in the establishment of protective and maintenance measures for the prolongation of the service life of the components. One set of equipment in exposure position is shown in Fig. 2.9.

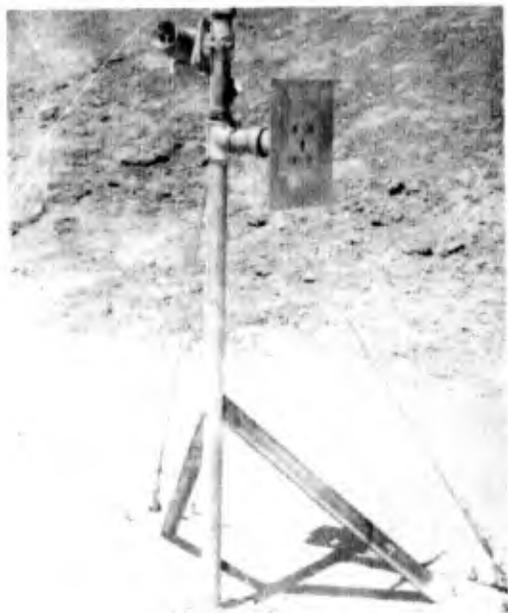
Fig. 2.10 Pressure Gage, Calorimeter and Mounting Assembly

measured by openly exposed calorimeters. In addition, calorimeters were mounted behind the glass panels of the stabilizer blast shields to measure the energy incident at the stabilizer and indirectly giving the thermal attenuation of the glass. Overpressure was measured by Statham and Consolidated gages with one of each type gage located at each station. Each gage was mounted in a hole at the center of a square plate which was oriented vertically in a plane passing through intended ground zero. Figure 2.10 shows a typical pressure gage, calorimeter, and mounting assembly.

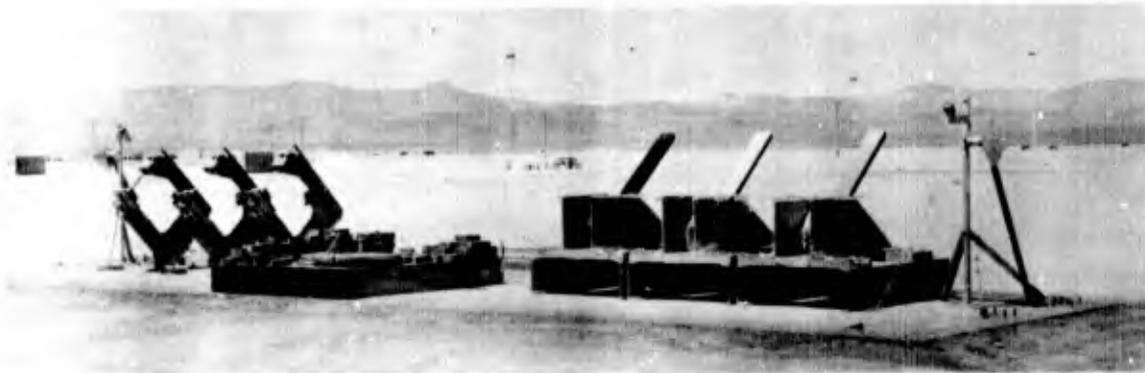
Fig. 2.12 Test Array at Station 2300, Shot 9

The high temperature requirement of the beam and tie specimens indicated the need for Station 2300. The construction consisted of one large concrete base on which the specimens and instruments were mounted relatively close to each other. The instrument shelter was completely underground at the center of the base. The specimen display consisted of three box beams, three tension ties, and two sets of total thermal energy and overpressure measuring instruments, as shown in Fig. 2.12. All the beams and ties were made of 3/16 in.

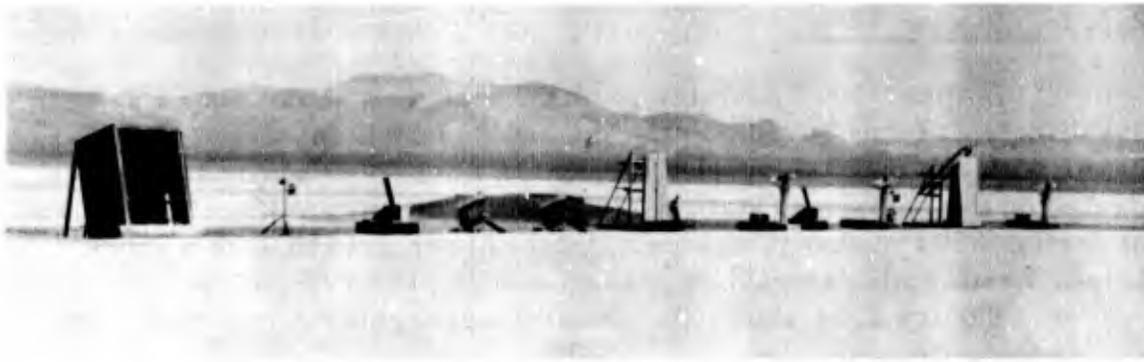
Fig. 2.13 Display at Station 6500, Shot 9

Station 6500 was the closest position to ground zero at which it was desirable to display a set of T-28 stabilizer assemblies. The construction consisted of a line of concrete bases which supported the specimens and their mounts or frames. The instrument shelter, of semi-buried, reinforced concrete design, was located at the center of, but behind the line of specimens with that portion above ground protected by earth fill. The detailed arrangement of the station, as shown in

1. A T-28 stabilizer, painted black and shielded from blast by a structural steel shelter but exposed to the thermal energy by means of the glass-paneled forward face of the enclosure. Also, inside the blast shield was a calorimeter.

Motion picture coverage of the response of the test specimens to thermal and blast inputs was accomplished by means of one each GSAP (Gun Sight Aiming Point) camera and High-speed Eastman Camera trained on each item to be photographed. The GSAP camera was used to record the response of the specimen during the thermal phase and the High-speed Eastman for specimen response during the blast phase. The cameras were mounted about 5 1/2 ft above the ground on pedestals as can be seen in Fig. 2.13.

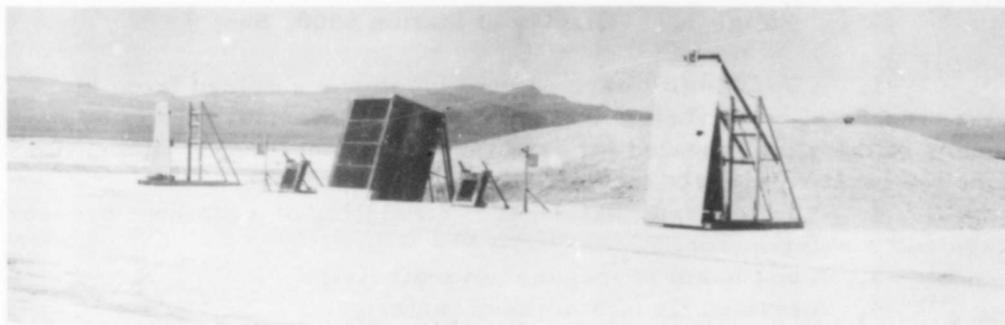
Fig. 2.14 Display at Station 7200, Shot 9

Station 7200 consisted primarily of the second set of T-28 stabilizers. As at Station 6500, the construction consisted of a line of bases with the instrument shelter behind the center of the line. The design of the shelter at Station 7200, however, was different from that at Station 6500 in that it was completely above ground with a much larger earth embankment for protection.

Figure 2.14 shows the detailed arrangement; reading from

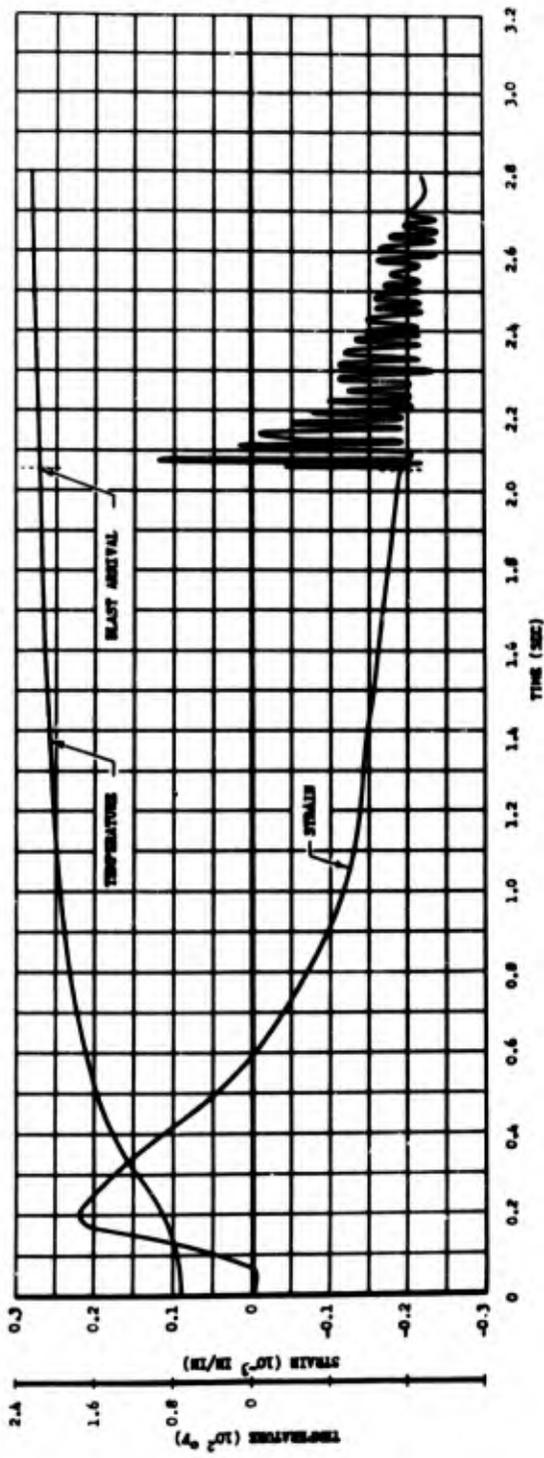
Fig. 3.1 Typical Box Beam Time-Histories of Strain and Temperature

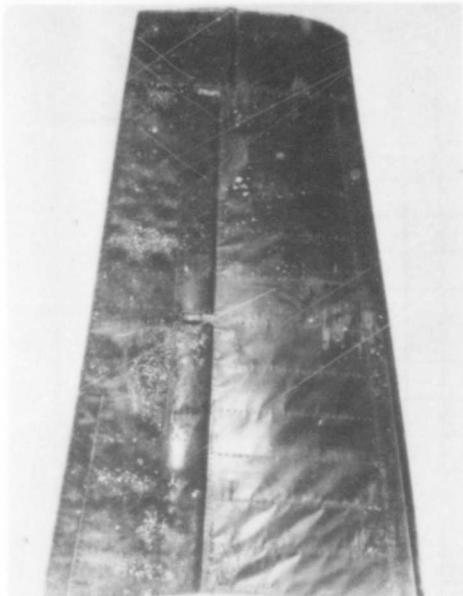
Fig. 3.3 Thermal Damage To Stabilizer at Range 3500, Shot 10

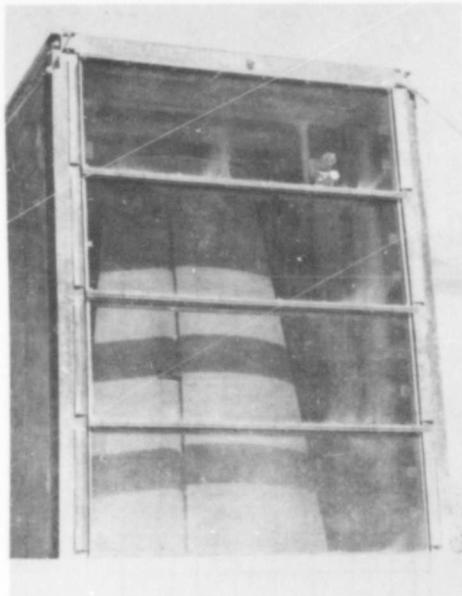
Fig. 3.4a Stabilizer Shield From Blast Station 6500, Shot 9

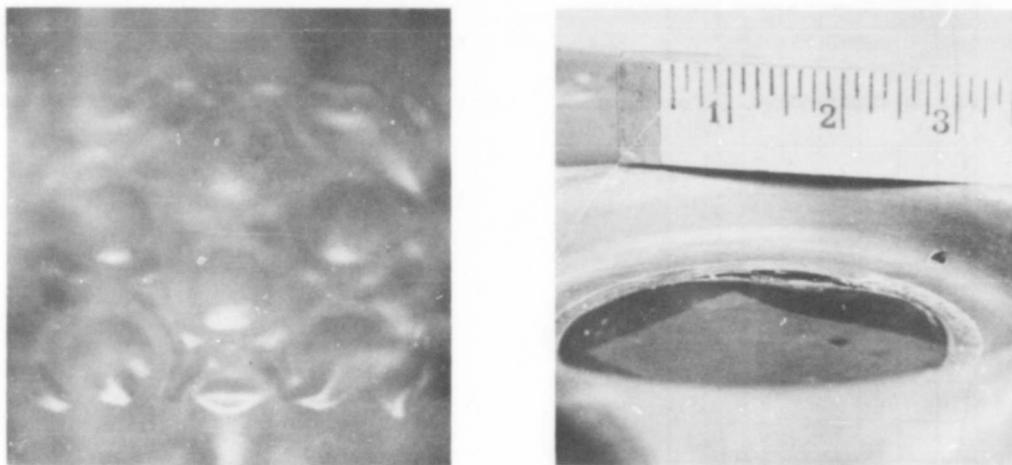
Fig. 3.7 Typical Damage to Waffle Panel

Seven waffle panels were exposed. An example of damage to this type panel is shown in Fig. 3.7. Panel No. 5 sustained a maximum

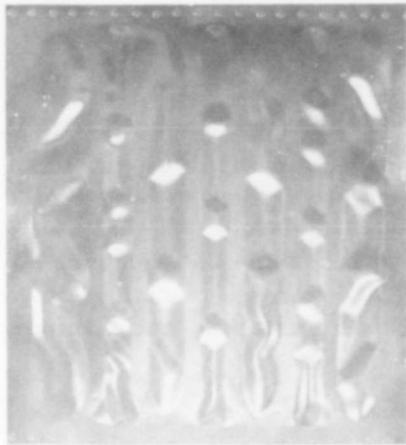
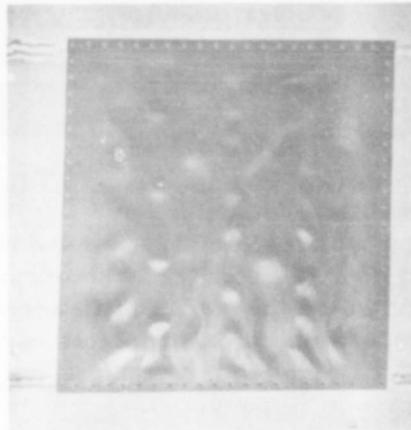
(a) 0.020" Skin, Free Edges

(d) 0.025" Skin Fixed Edges

Fig. 3.8 Damage of One Set of Hat Panels

Twenty-four hat panels were exposed. Figure 3.8 shows the damage inflicted on one of each of the four hat panel configurations tested. These four panels were located at Range 4800 during Shot 10. The two panels with 0.020 in. skin and free edges, the one completely and the other partially irradiated, were subjected to temperature rises between 430°F and 524°F, whereas the temperatures of the two panels with 0.025 in. skin, one with free edges and the other with fixed edges, were raised between 378°F and 404°F. On all four panels the maximum

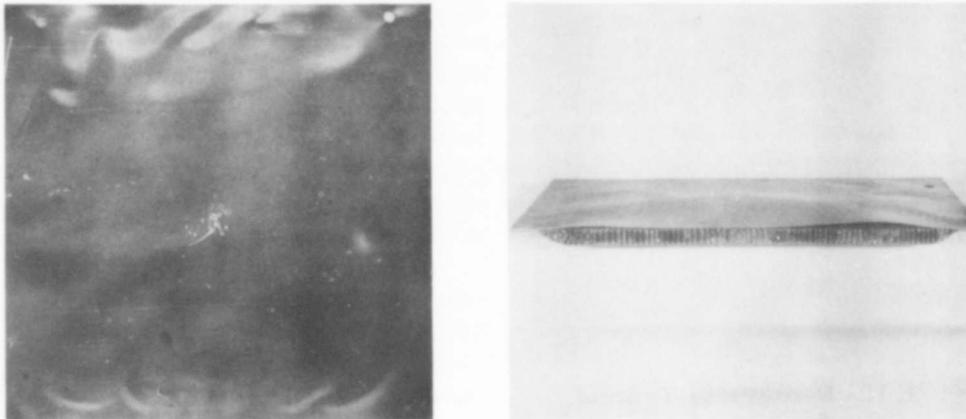
Fig. 3.9 Typical Damage to Honeycomb Core Panel

Five honeycomb core panels were exposed. The damage shown in Fig. 3.9 is representative of the reaction of honeycomb core panels

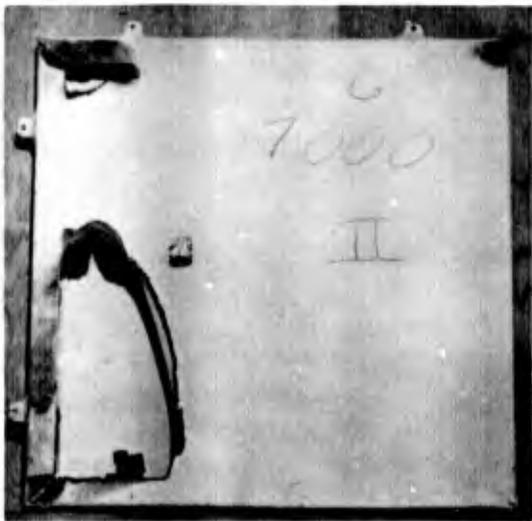
Fig. 3.10 Damage to Typical Control Surface Covering Panel

shows the damage inflicted on a typical specimen. This panel of type "G" (see Table D.3a) was covered with cotton cloth treated with two brush coats of clear dope, four spray coats of aluminizing dope, and one coat of white enamel. It was exposed during Shot 10 at Range 7000 ft, where the thermal input level was 8.4 cal/sq cm. Details of the thermal damage sustained by each type of panel tested are given in Appendix D.

A total of 213 test panels representing various control surface coverings were exposed during Shots 9 and 10 and were damaged within the range of negligible effect to complete destruction. Figure 3.10

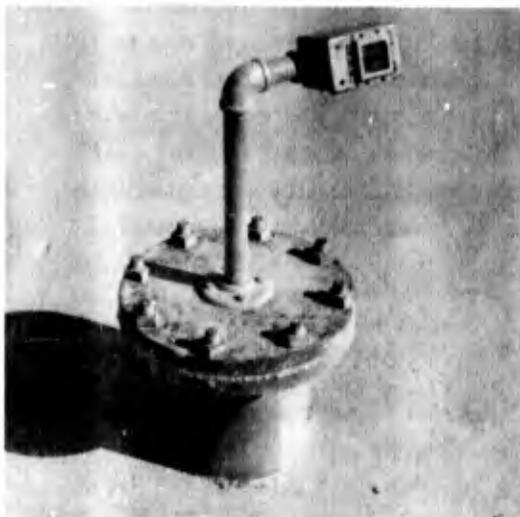
Fig. A.1 Typical Phototube Installation for Blue Box

outside the shelter. A typical installation of the conduit box with phototube inside is shown in Fig. A.1.

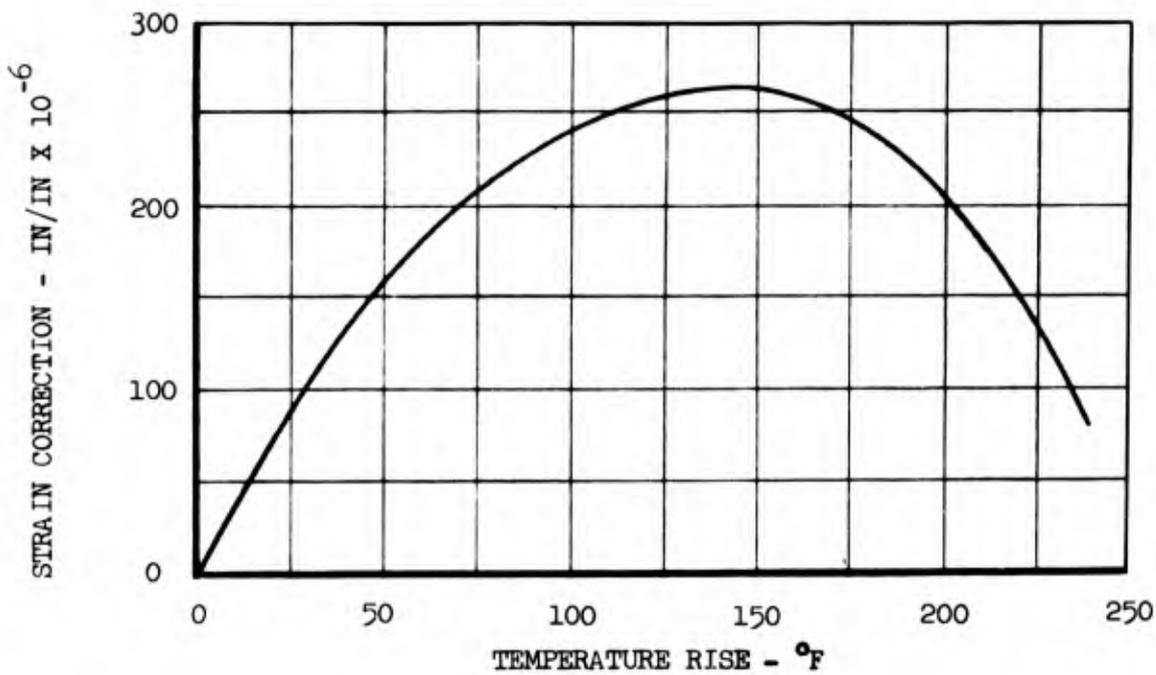
Fig. A.4 Typical Strain Gage Correction Curve

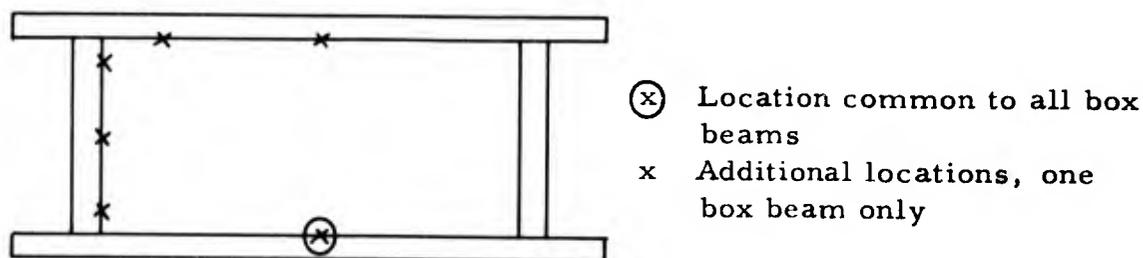
Fig. B.5 Instrumentation Locations on Cross Section of Box Beam

Time-history instrumentation on the box beams consisted of two strain gages and one thermocouple on the inside of the front surface, 1 ft above the attachment fitting. In addition, one box beam had similar installations at three locations on one web and at two locations on the rear surface, as shown in Fig. B.5. The two strain gages at each

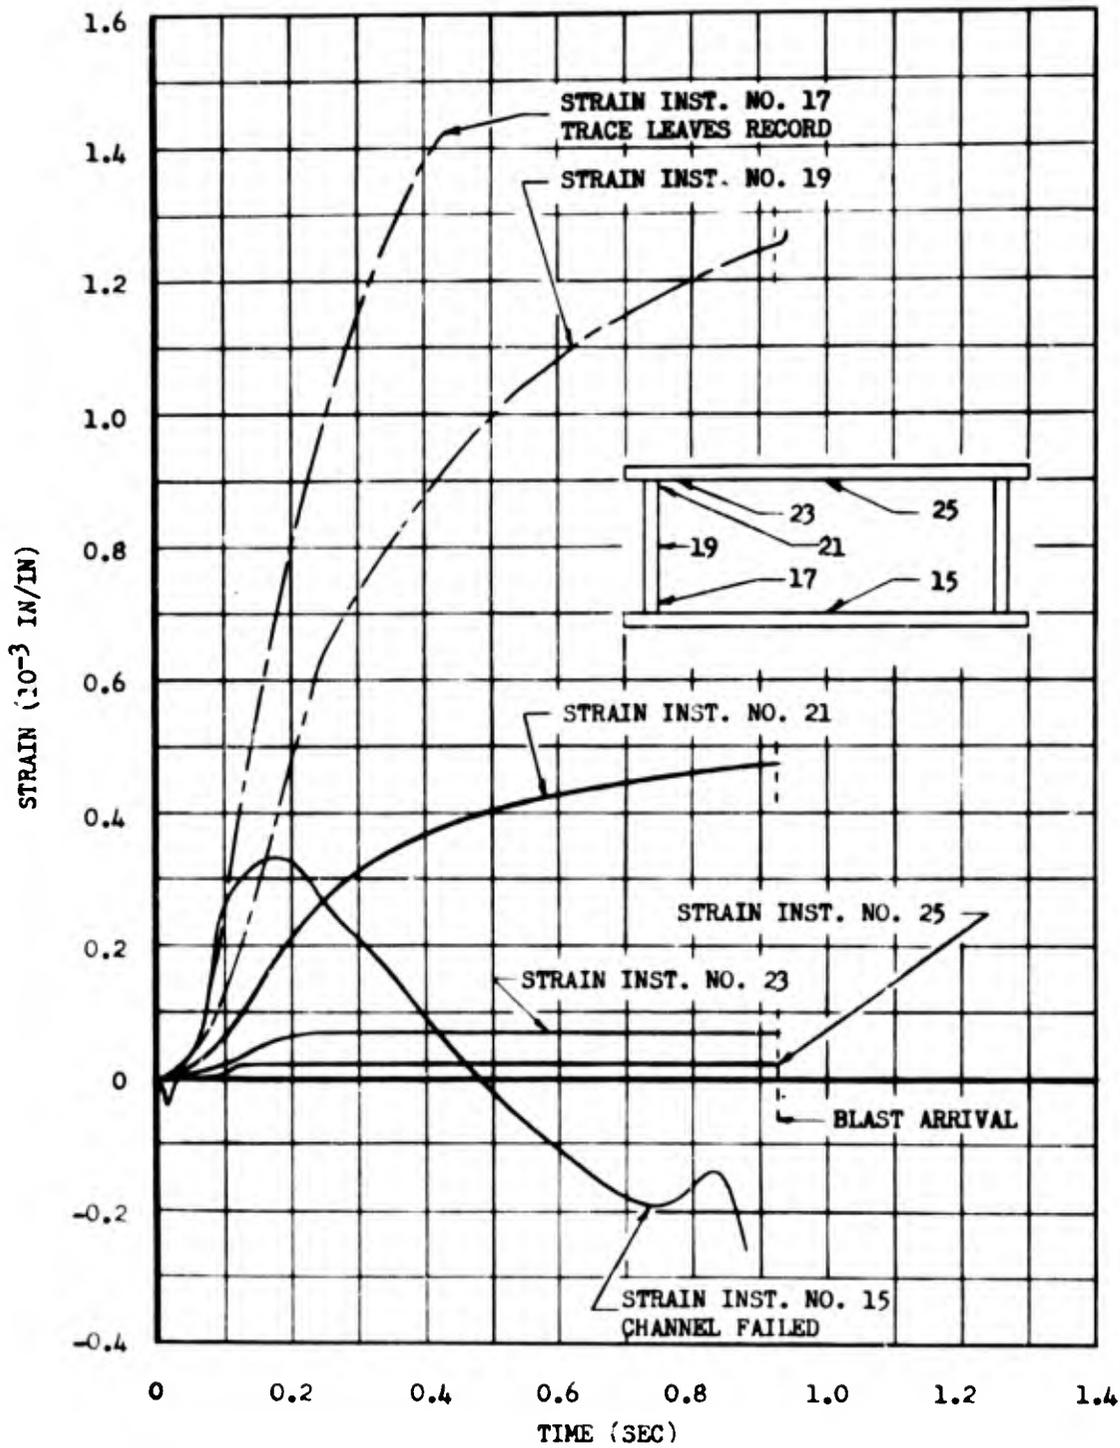
Fig. B.21 Strains as a Function of Time of 3/16 in. Al Box Beam, (Absorptivity 0.96), Before Blast Arrival, Station 2300, Shot 10

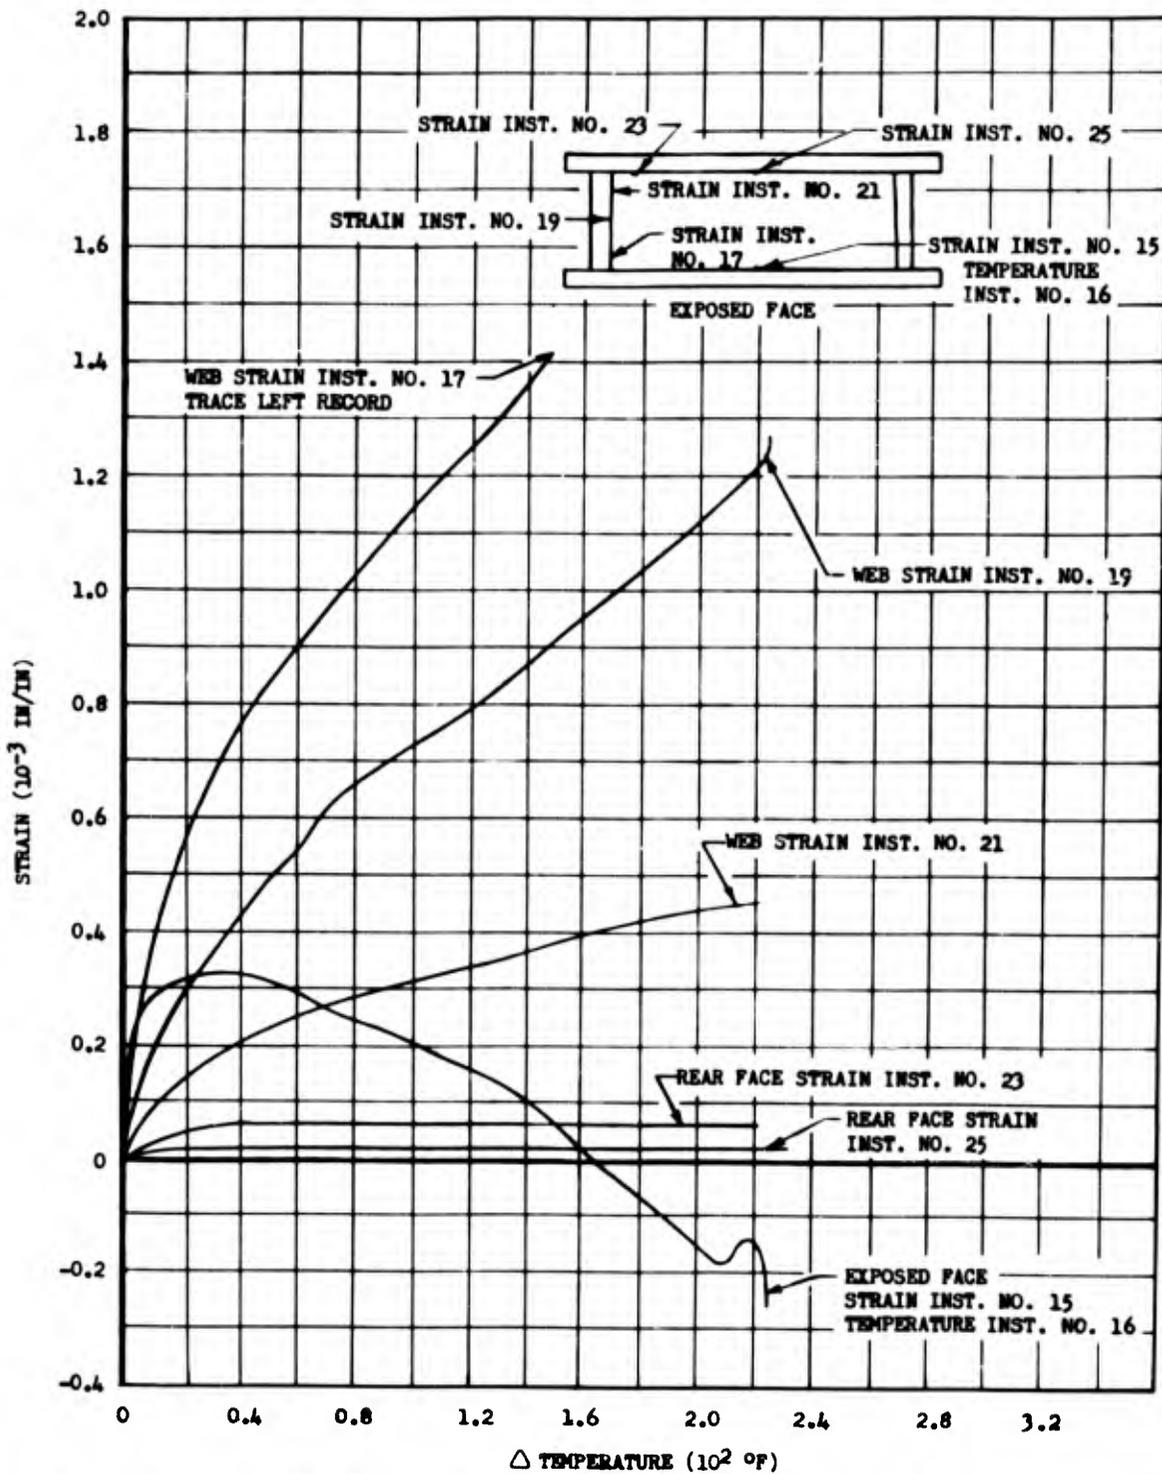
Fig. B.48 Comparison of Exposed Face, Web, and Rear Face Strains as a Function of Exposed Face Temperature Rise of 3/16 in. Al Box Beam (Absorptivity 0.96), Station 2300, Shot 10

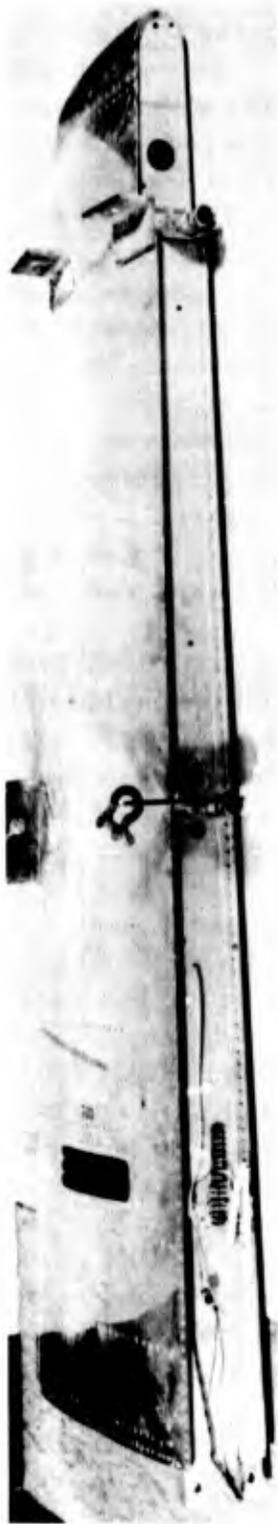
Fig. C.3 Stabilizer Loading Attachments and Access Panel

the unexposed side, consisted of mounting steel clips on the front and rear spars at stabilizer Stations 47.75 and 83.5 so that preloads could be applied. The addition of an access panel in the skin next to the in-board front spar load attachment was required for access to fastenings which secured the load attachment fitting. All other clips were riveted to the structure. Existing holes were used for all bolts and rivets.

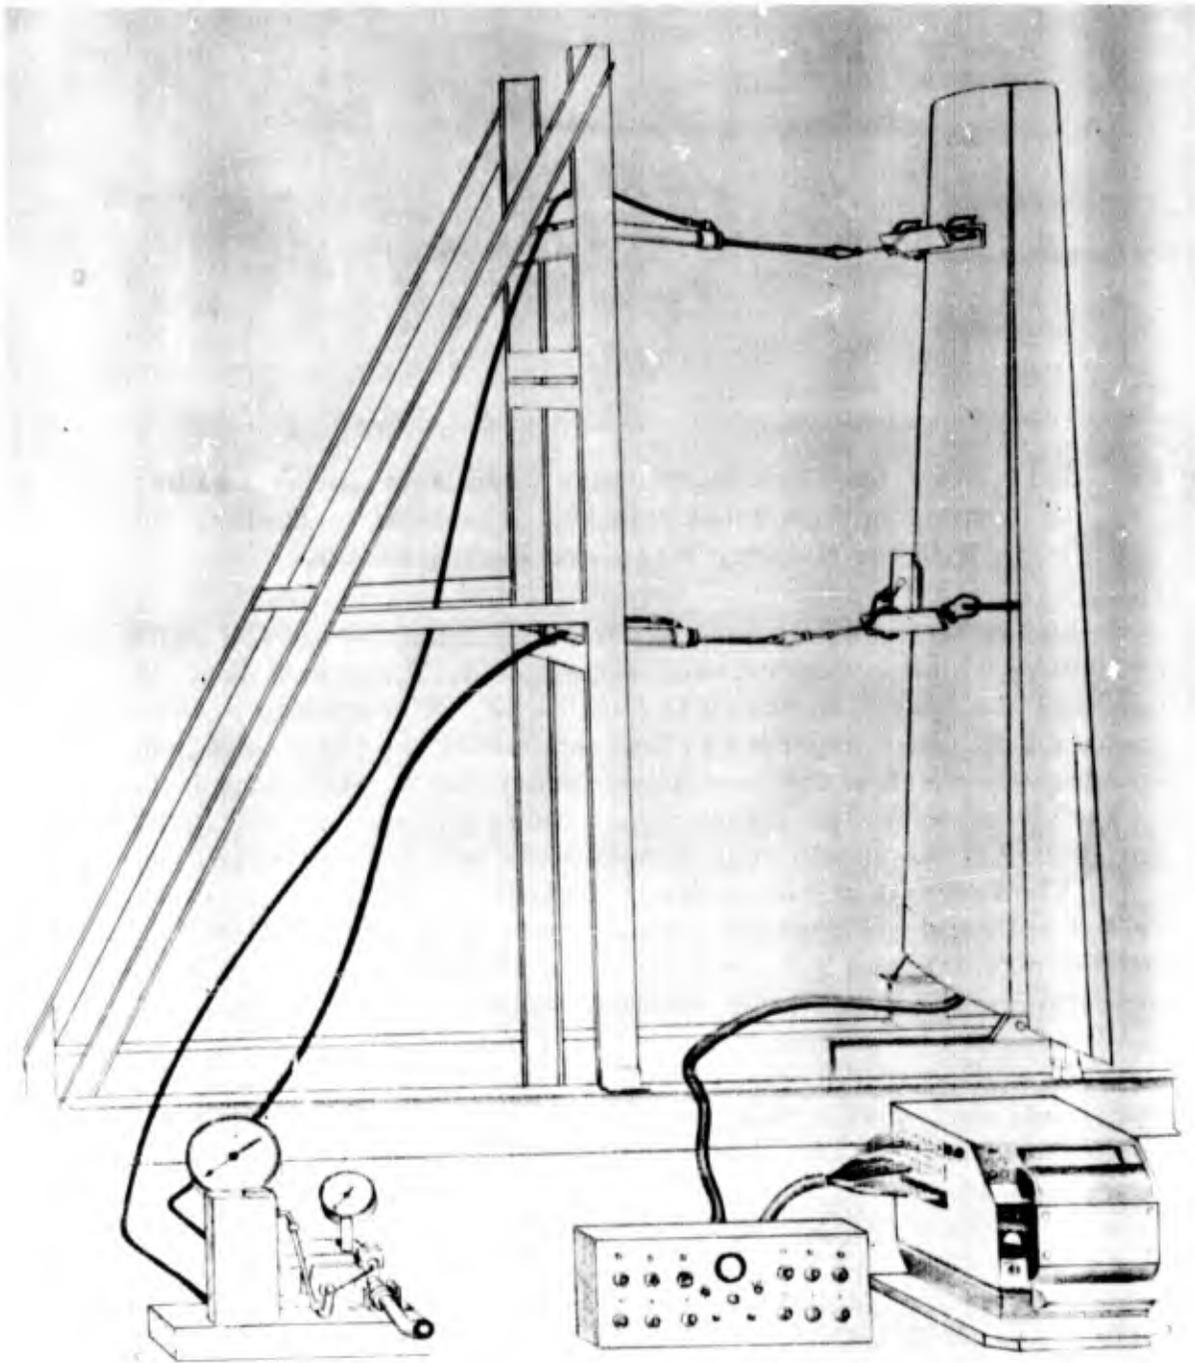
Fig. C.12 Calibration Apparatus for T-28 Stabilizer Calibration

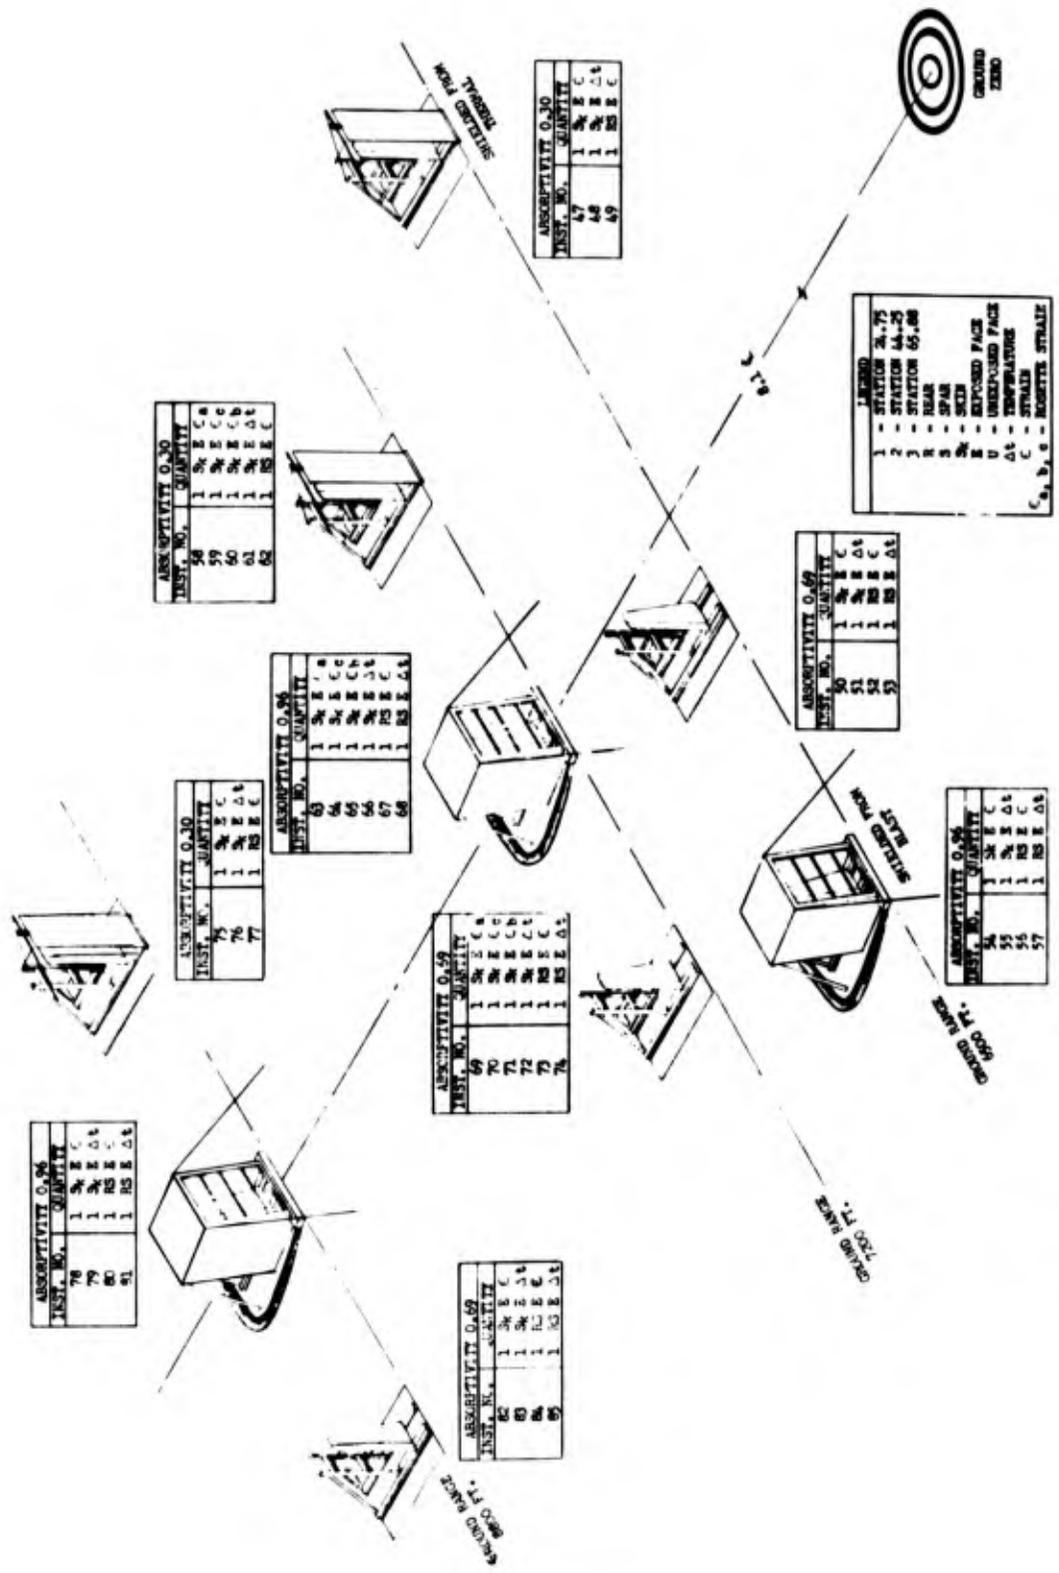
Fig. C. 15 Schematic of T-28 Stabilizer Program for Shot 9

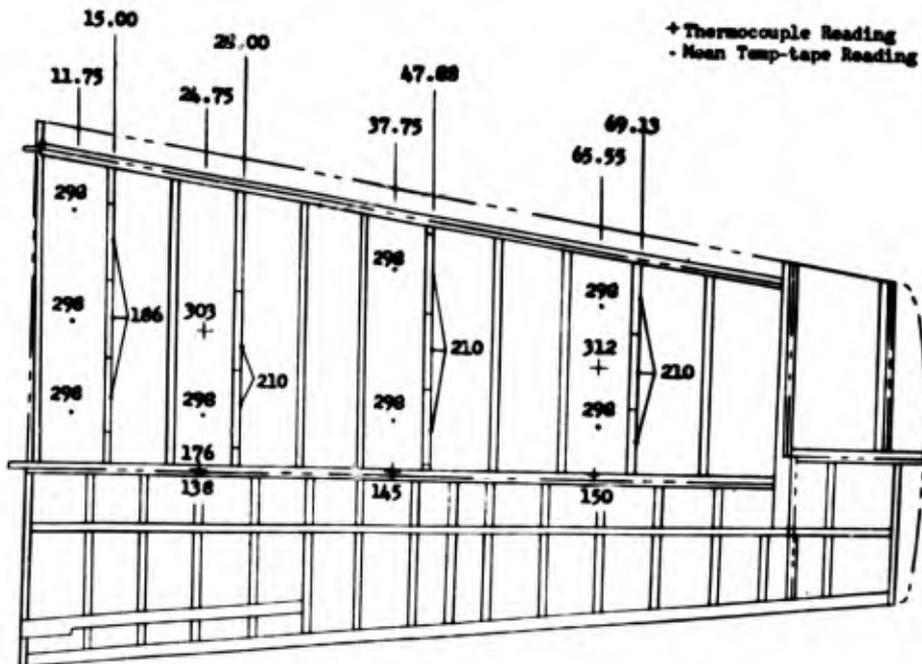
Fig. C.20 Peak Temperature Distribution for the Stabilizer Exposed to Thermal and Blast Inputs at Station 6500, Shot 10

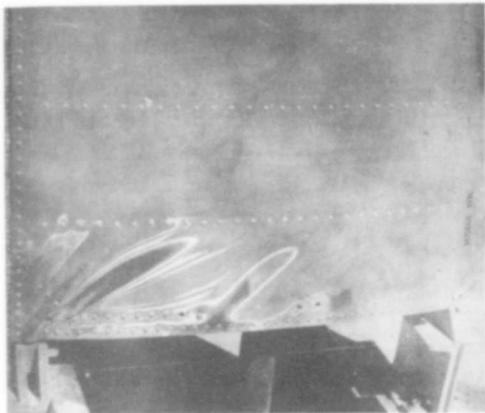
Fig. C.21 Typical Skin Buckle on Irradiated Surface at Intersection of Rear Spar and Root Rib

inspected for damage. Damage in the form of spar buckling and skin wrinkling was predominant. A diagonal wrinkle, shown in Fig. C.21, starting at the intersection of the rear spar and the station 7.5 rib (exposed side) was detected on nearly all installations exposed to blast. The structure was reinforced by a doubler at this point. Another typical failure, shown in Fig. C.22, consisted of a skin buckle on the

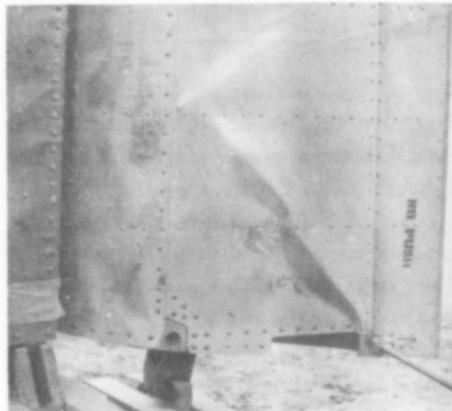
Fig. C.22 Typical Root Buckle on Unexposed Side of Elevator

unexposed side of the elevator at the intersection of the root elevator rib and the elevator trim tab. A failure evident on all stabilizers exposed to blast was a series of parallel, diagonal buckles in the rear spar web beginning at the reinforced root web section and extending outboard to station 40. No similar effects on the rear spar web of stabilizers exposed only to thermal energy were discovered. As a result of the spar web buckles, permanent set in the affected stabilizers was observed both from the postshot inspection and from the difference in the preload strains measured before and after the shot. A typical web buckle is presented in Fig. C.23.

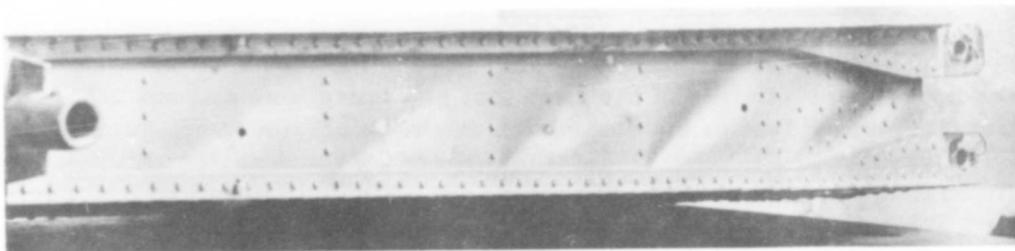
Fig. C.23 Typical Rear Spar Web Buckles

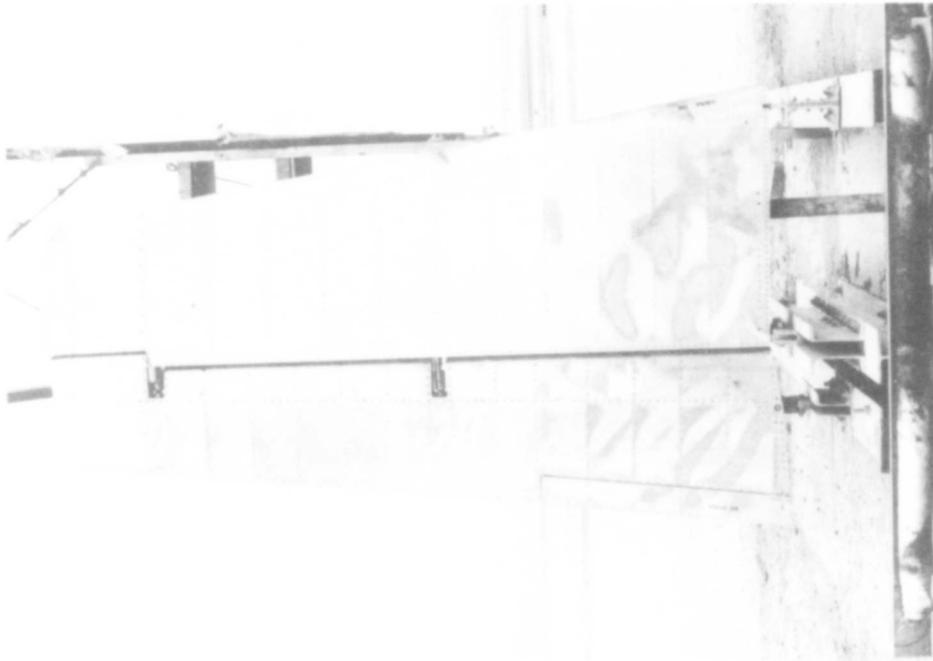
Fig. C. 24 Over-all Damage Sustained by Stabilizer Exposed to Blast Only, Station 6500, Shot 9

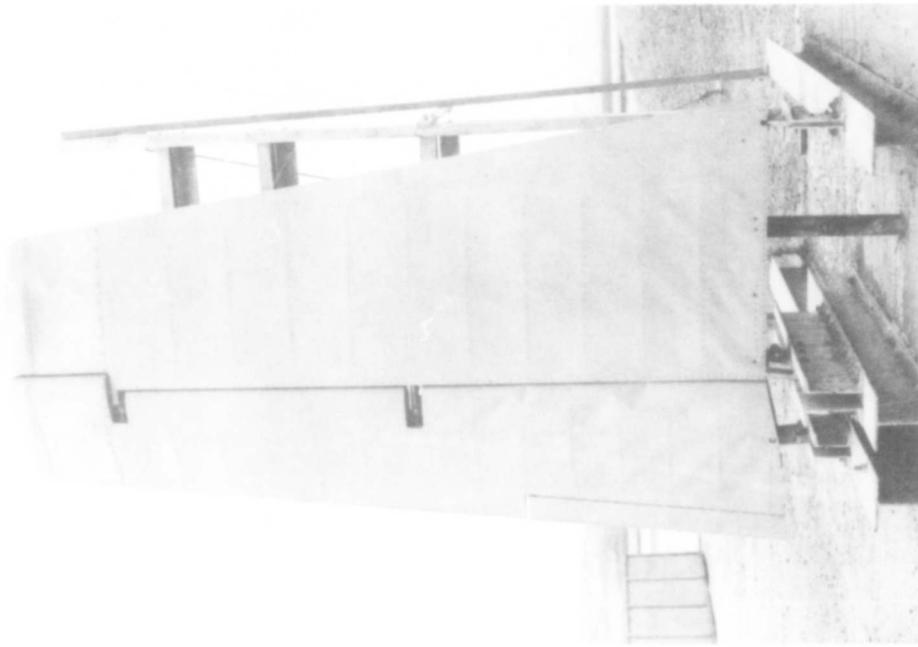
Fig. C. 25 Over-all Damage Sustained by Stabilizer Exposed to Both Thermal and Blast Inputs, Station 6500, Shot 9

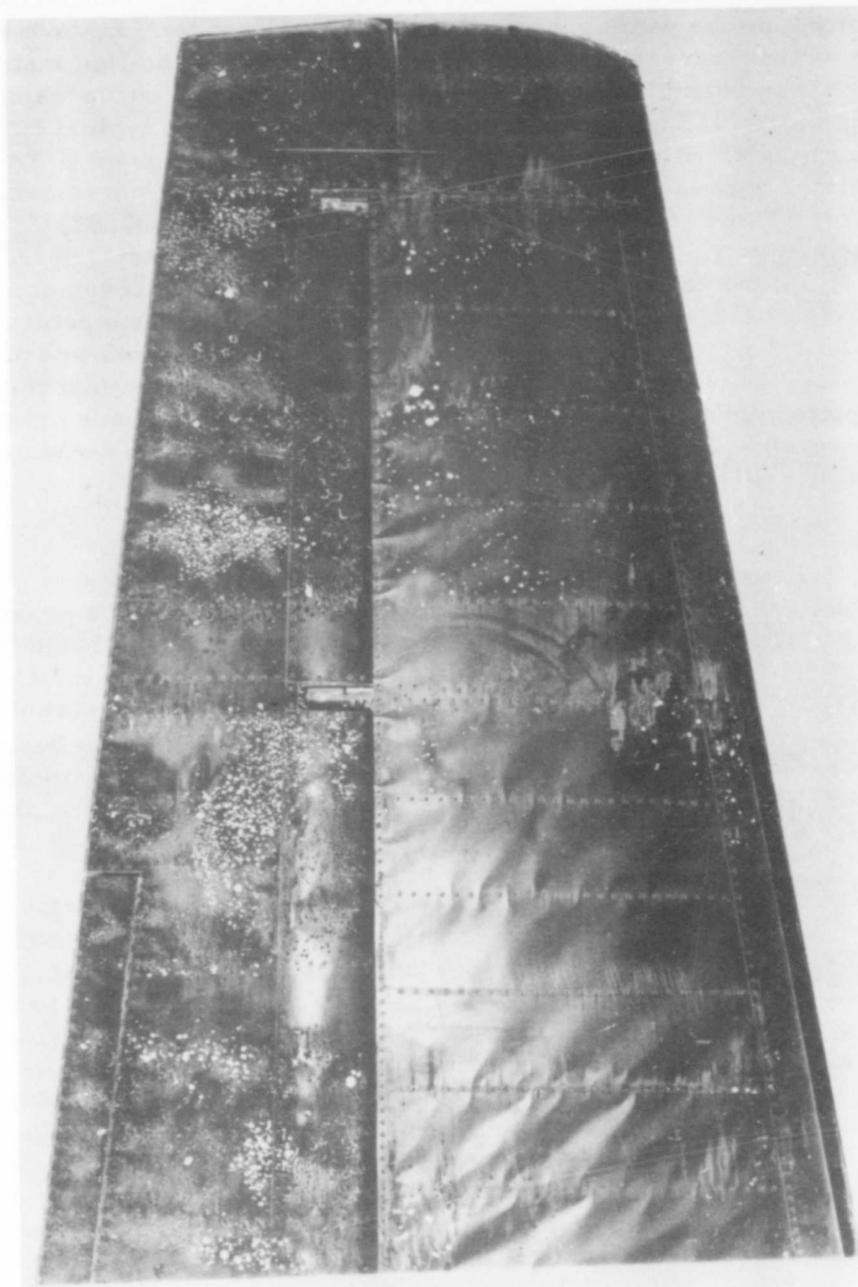
Fig. C.26 Over-all Damage Sustained by Stabilizer Exposed to Thermal Radiation Only, Station 3500, Shot 10

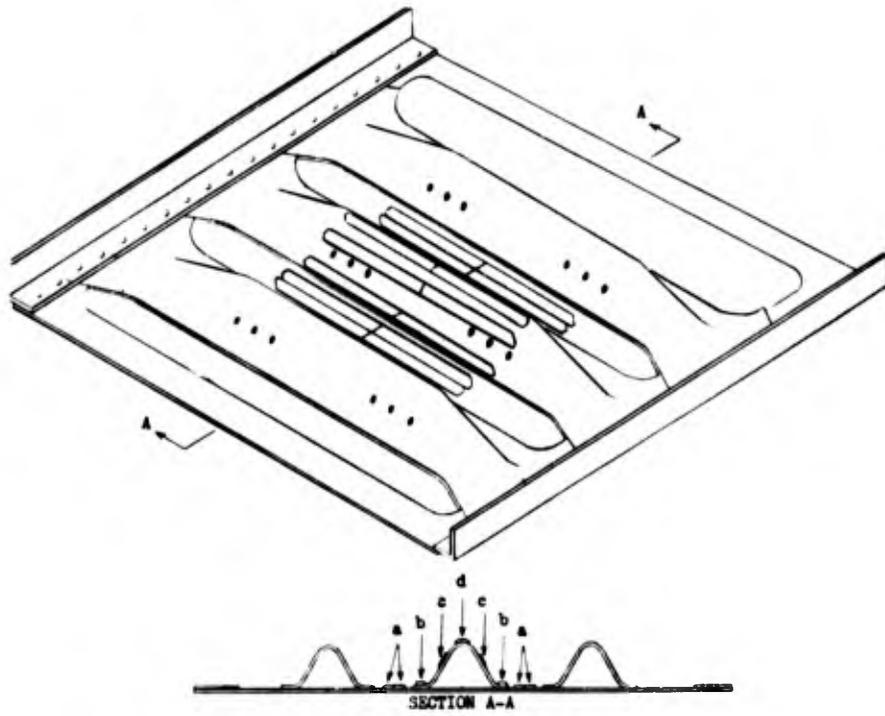
Fig. D. 7 Temp-tape Installations on Hat Panel. Letters Indicate Location Code.

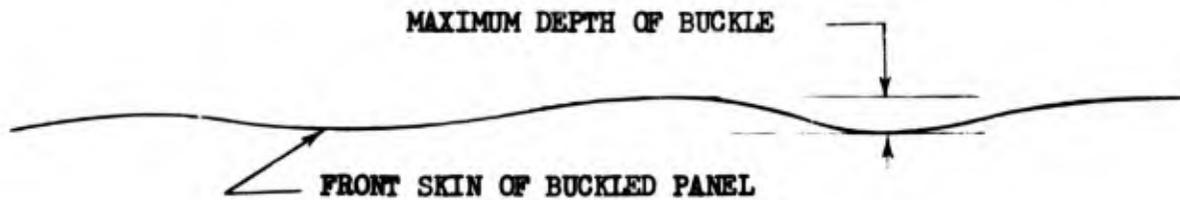
Fig. D. 13 Illustration of Maximum Depth of Buckle

Buckling damage reported herein is a measured value of the maximum depth of buckle, defined as the greatest vertical distance from any one trough of a buckle to the adjacent crest as shown in Fig. D. 13. The measurements of buckle depth for free edge hat and waffle

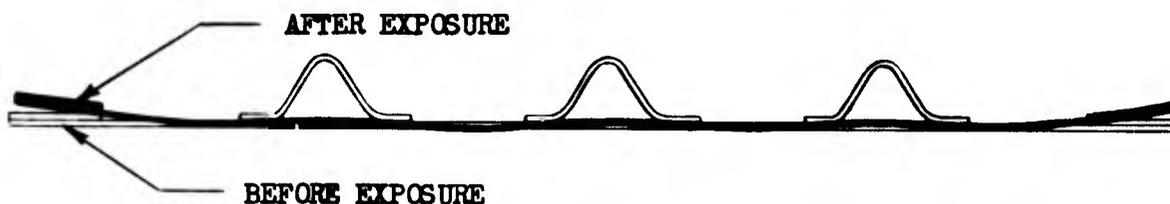
Fig. D. 32 Typical Deformation of Hat Panels, Free Edge

Waffle panel deformation was characterized by an outward buckling of the circular skin areas not enclosed by the stiffener and a general inward bowing of the entire panel. Hat panel buckling was somewhat similar to that of the waffle panels. Sketches of typical panel deformations are presented in Figs. D. 32 and D. 33 for free edge and fixed edge hat panels, respectively. On those hat panels which exper-

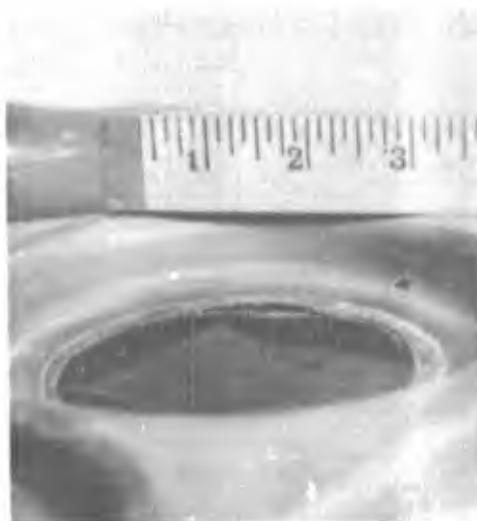
Fig. D.14 Typical Thermal Damage to Waffle Panels

1/32" Buckle Depth, Panel No. 2

1/4" Buckle Depth, Panel No. 5

Bond Release, Panel No. 5
