Project 8.1a

UNCLASSIFIED 7/9935
WT-766
Copy No. 188

Operation UPSHOT-KNOTHOLE NEVADA PROVING GROUNDS

Project 8.1a
EFFECTS OF THERMAL AND BLAST FORCES FROM
NUCLEAR DETONATIONS ON BASIC AIRCRAFT
STRUCTURES AND COMPONENTS

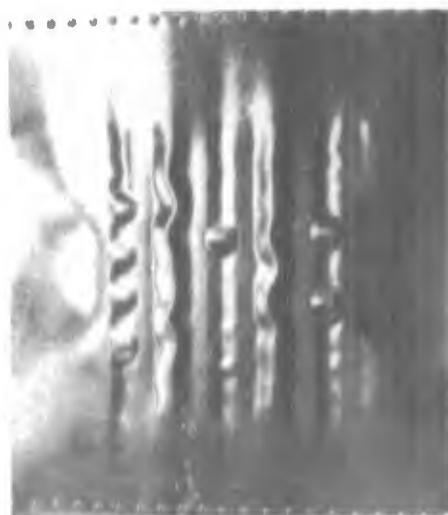
Fig. D.17 Typical Thermal Damage to 0.020 in. Hat Panels, Free Edges, Partially Irradiated

1/32" Buckle Depth, Panel No. 15 3/32" Buckle Depth, Panel No. 17

7/64" Buckle Depth, Panel No. 16

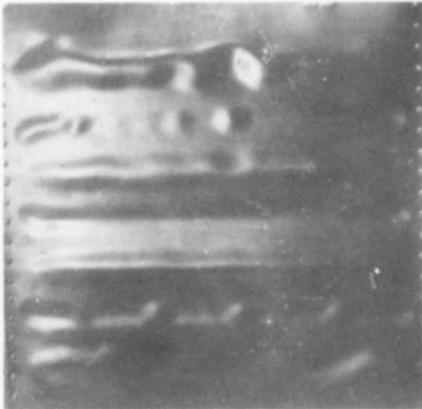
3/64" Buckle Depth, Panel No. 18
(Typical of Panels No. 18 and 19)

7/64" Buckle Depth, Panel No. 23

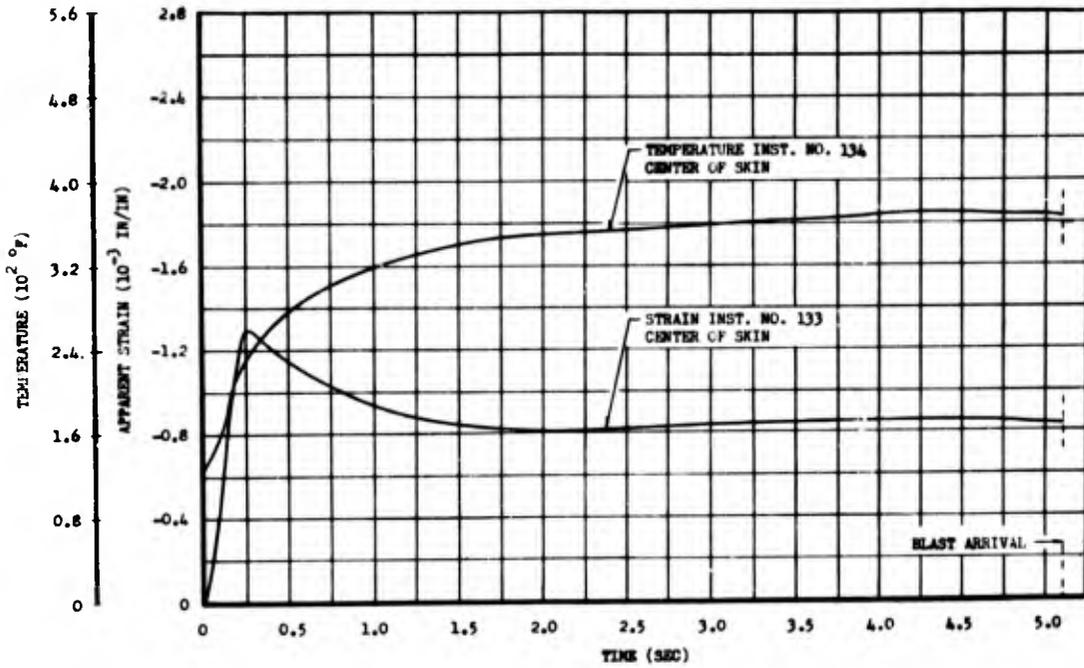
Fig. D.20 Comparison of the Strain-time and Temperature-time Data for the Center of the Skin of Waffle Panel No. 1, Station 6500, Shot 9 (See Fig. D.9)

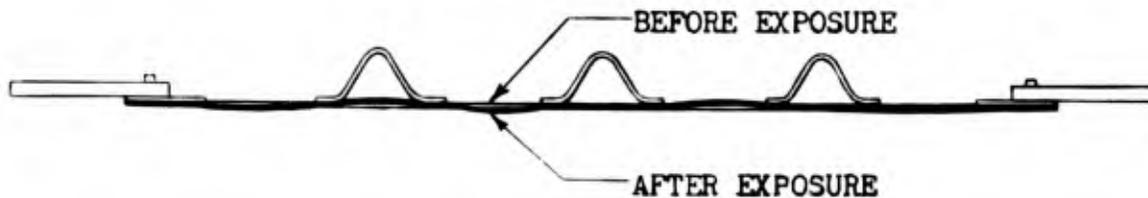
Fig. D. 33 Typical Deformation of Hat Panels, Fixed Edge

Graphs of maximum depth of buckle versus skin temperature rise for the four parameters of panel type, skin thickness, edge condition, and area of irradiation are presented in Figs. D. 34, D. 35, D. 36, and D. 37, respectively. The point of inflection on the curves for hat panels may indicate a temperature rise beyond which the smaller secondary "ripples" were formed on top of the larger primary buckles.

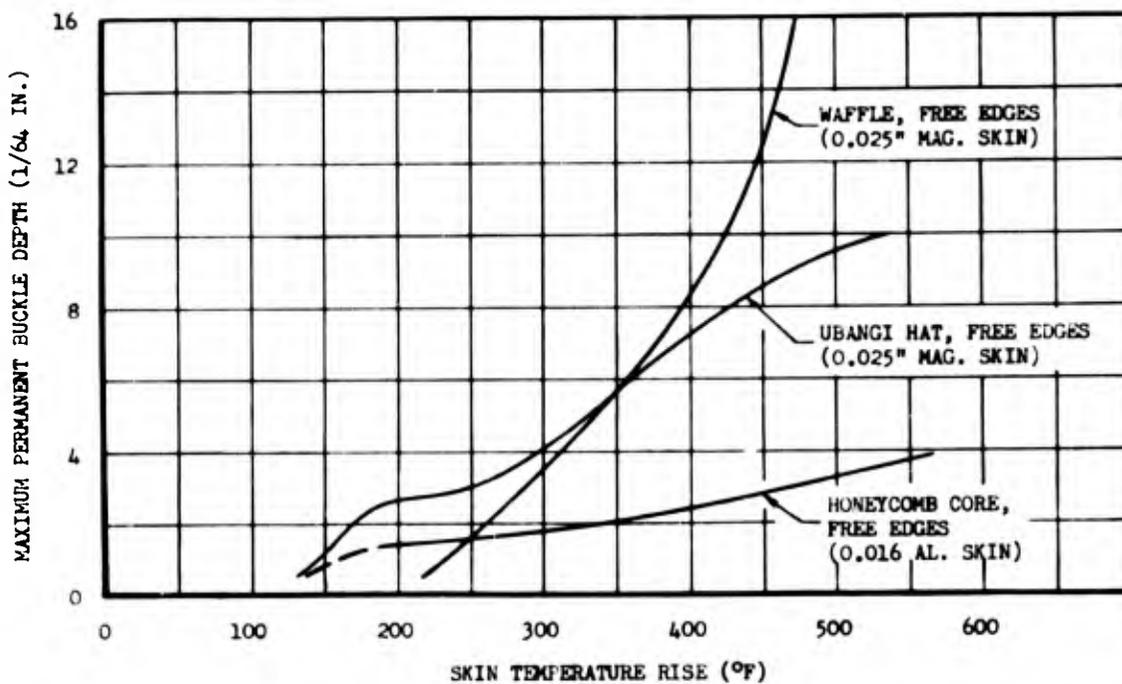
Fig. D. 34 Vulnerability of Bonded Metal Aircraft Panels to Permanent Skin Buckling as a Function of Skin Temperature Rise for the "Panel Type" Parameter

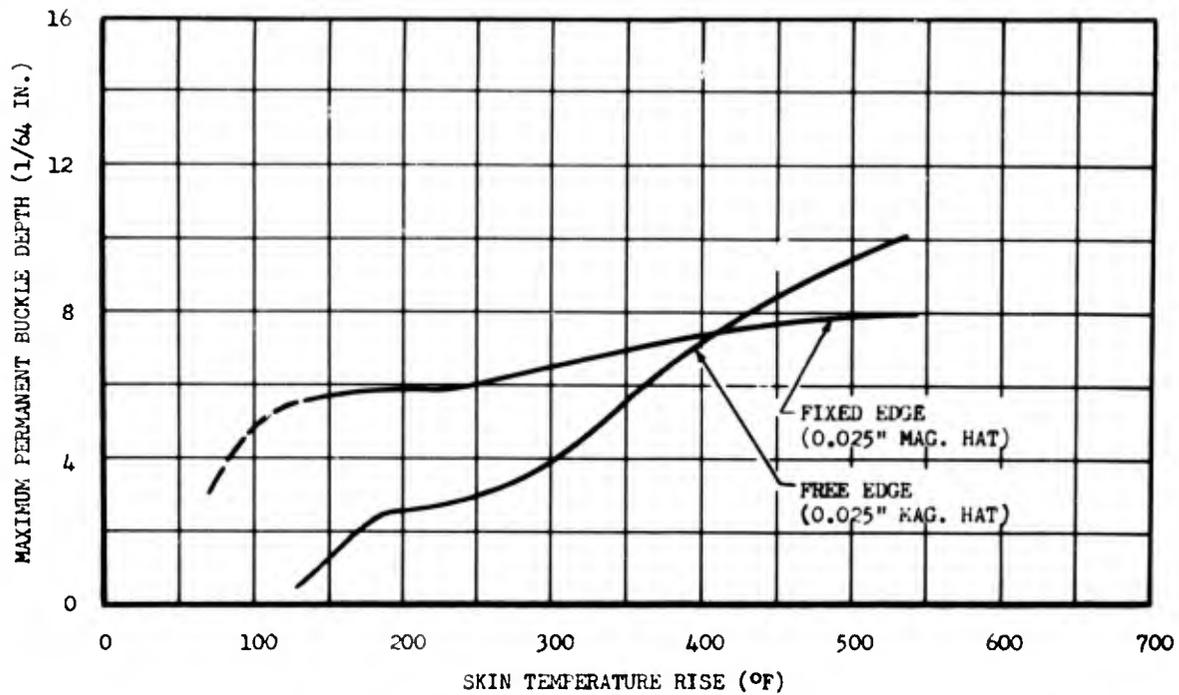
Fig. D. 36 Vulnerability of Bonded Metal Aircraft Panels to Permanent Skin Buckling as a Function of Skin Temperature Rise for the "Edge Condition" Parameter

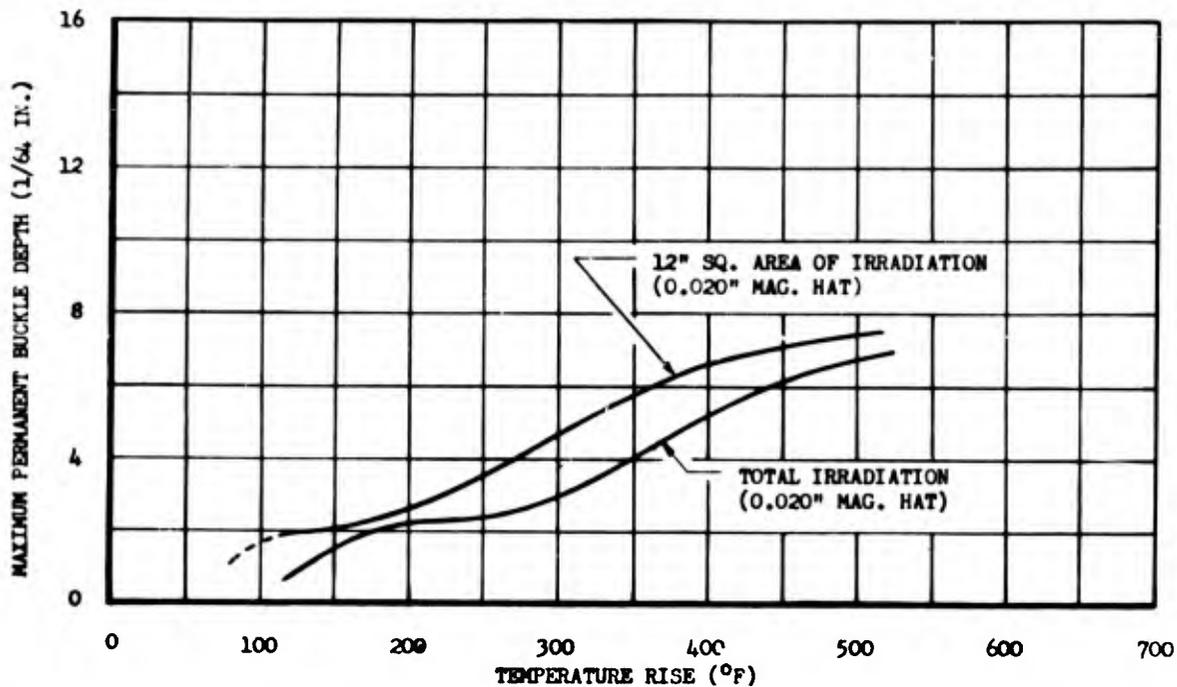
Fig. D. 37 Vulnerability of Bonded Metal Aircraft Panels to Permanent Skin Buckling as a Function of Skin Temperature Rise for the "Area of Irradiation" Parameter

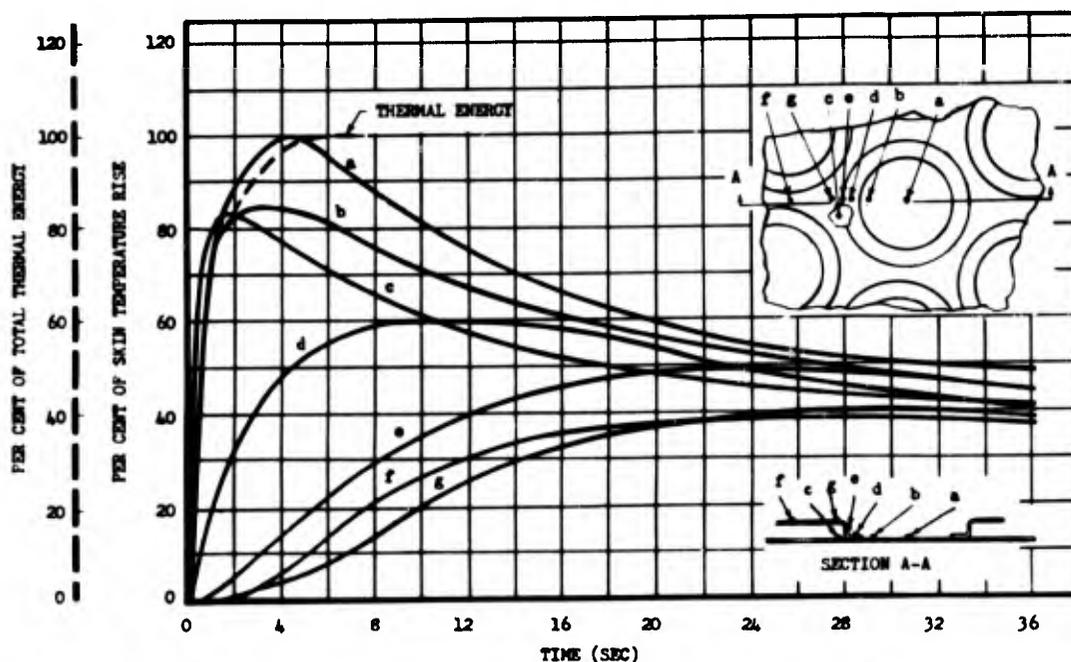
Fig. D. 38 Relative Temperature Rise Distribution as a Function of Time for Various Locations on Waffle Type Aircraft Panels

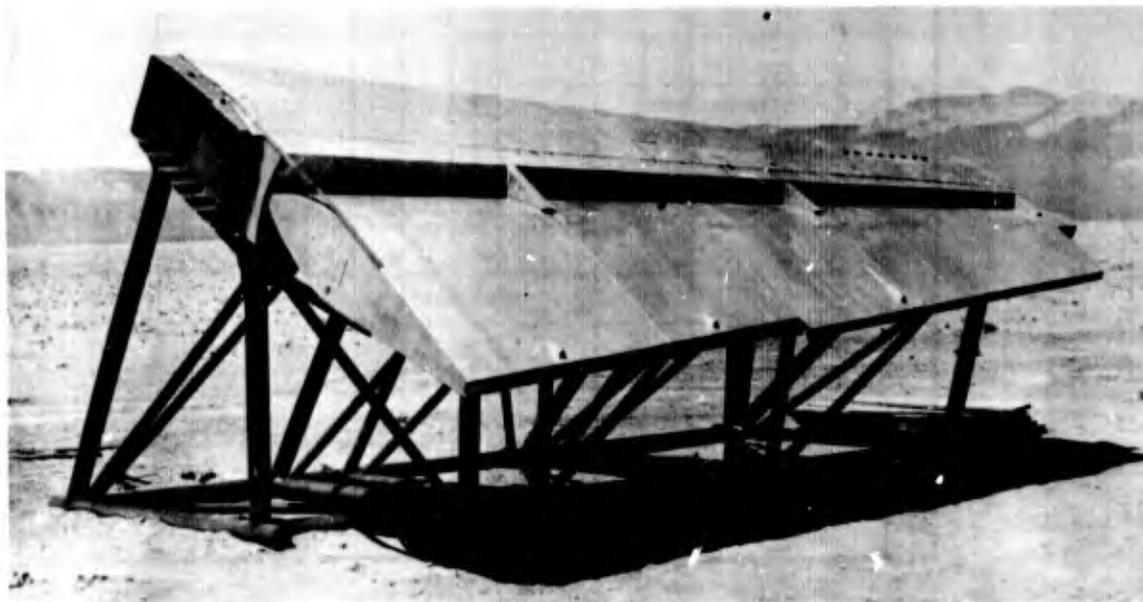
Fig. D.41 B-36 Stabilizer and Elevator Assembly Prior to Shot 9, Range 13,000 ft

The stabilizer and elevator specimen, Fig. D.41 consisted of

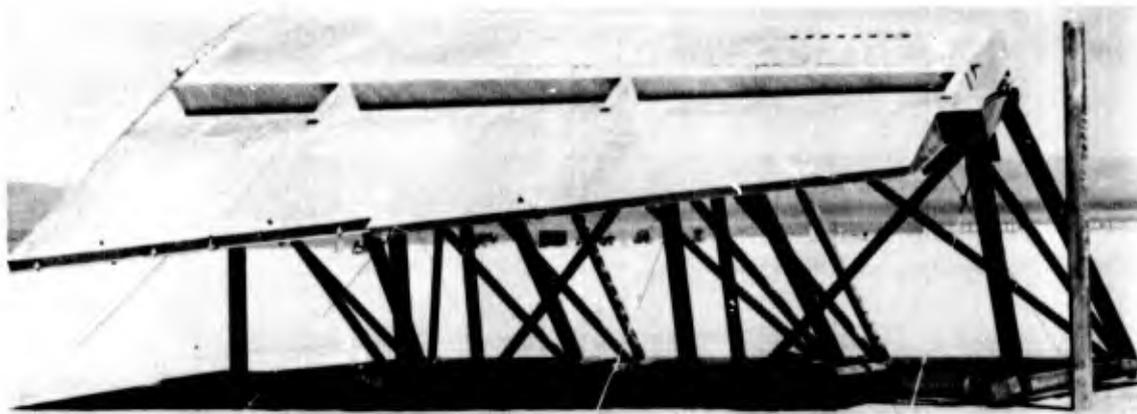
Fig. D.45 B-36 Stabilizer and Elevator Assembly Prior to Shot 10, Range 5300 ft

region of higher overpressure for Shot 10. The stabilized area at ground range 5300 ft was chosen for its location on Shot 10, since it offered a predicted overpressure of approximately 2.9 psi, as well as the camera coverage originally set up for other test articles on Shot 9. Immobility at this location was achieved by the use of four tie-downs consisting of 3/8 in. steel cable anchored to poured concrete deadmen as shown in Fig. D.45.

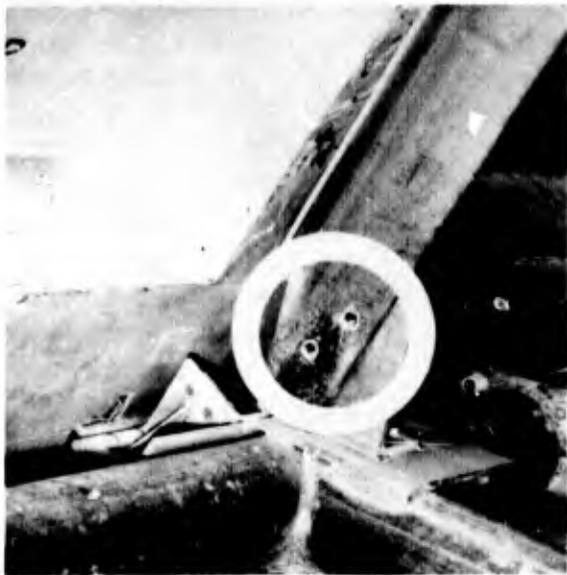
Fig. D.47 B-36 Stabilizer Assembly, Range 5300 ft (3.2 psi), Shot 10, Showing Sheared Bolts on Mounting Jig

f. The two 1/2 in. bolts which attached the stiffening angle on the elevator to the jig, Station 133, were sheared as shown in Fig. D.47.

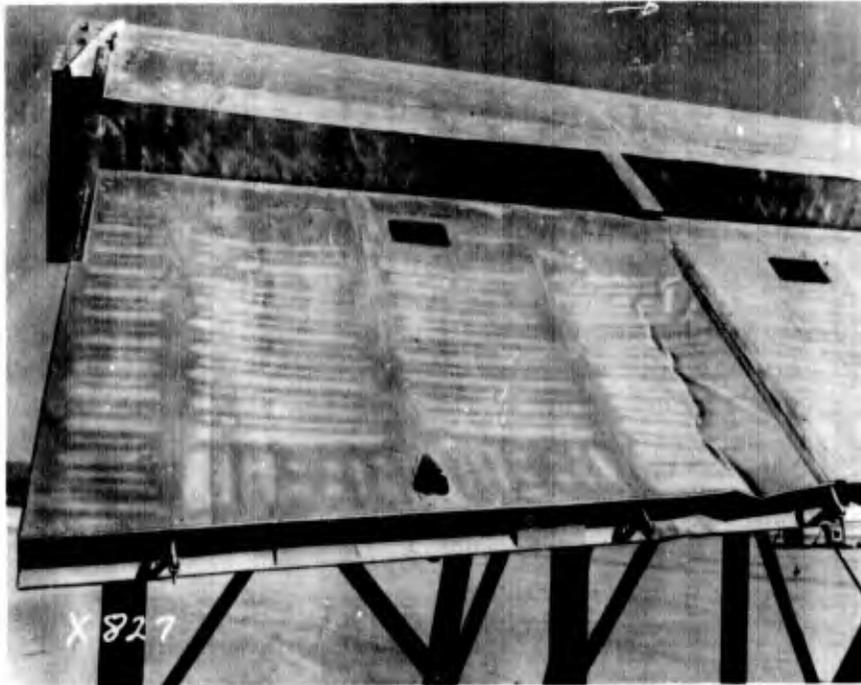
Fig. D. 50 B-36 Stabilizer Assembly, Range 5300 ft (3.2 psi), Shot 10, Showing Elevator Skin Damage, Station 133 to Station 252

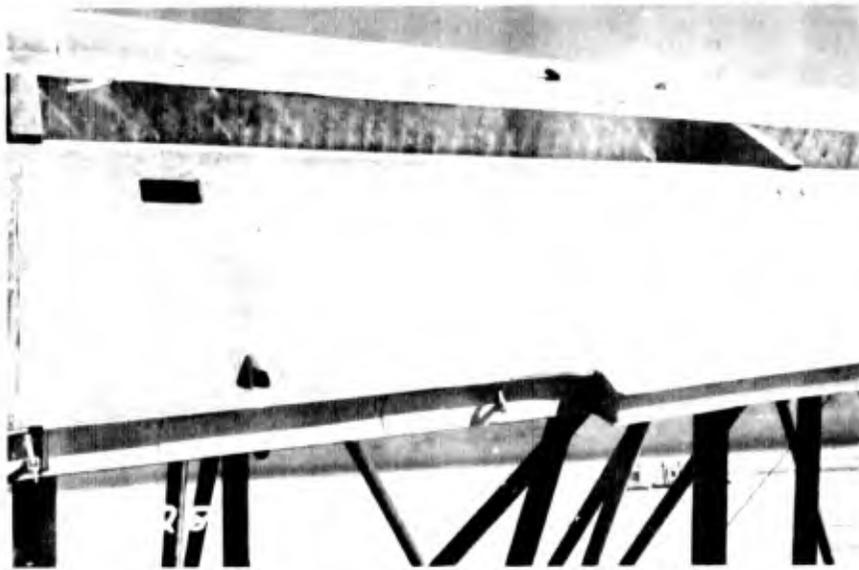
Fig. D. 51 B-36 Stabilizer Assembly, Range 5300 ft (3.2 psi), Shot 10, Showing Elevator Skin Damage, Station 252 to Station 372

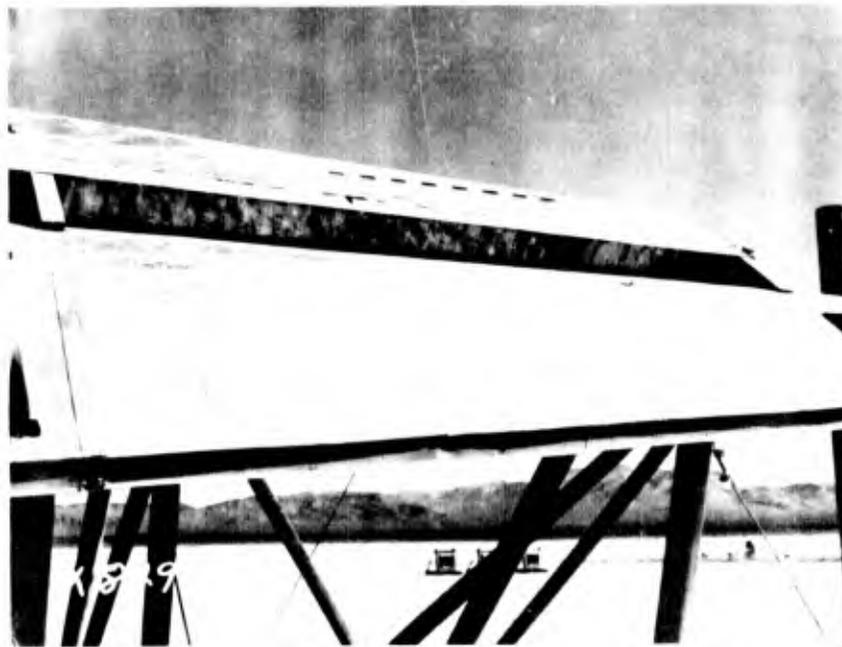
Fig. D.52 B-36 Stabilizer Assembly, Range 5300 ft (3.2 psi), Shot 10, Showing Typical Skin Buckling on Stabilizer Looking Inboard Toward Station 50

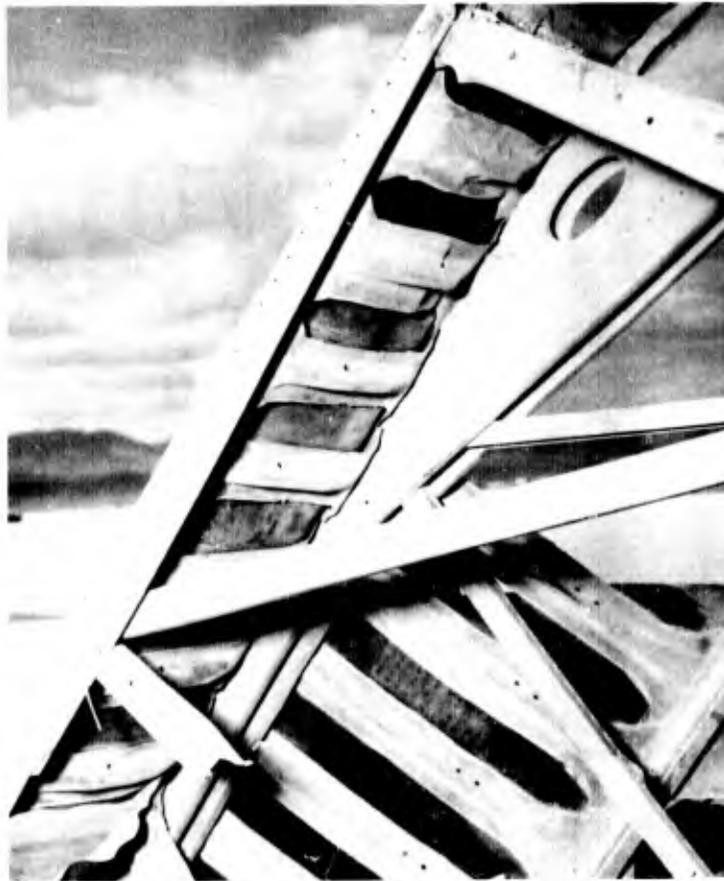
Fig. D. 55 B-36 Wing Section, Range 4800 ft (5.7 psi), Shot 9, Close-up View of Hat Panels Along Inboard End. Note bond failures.

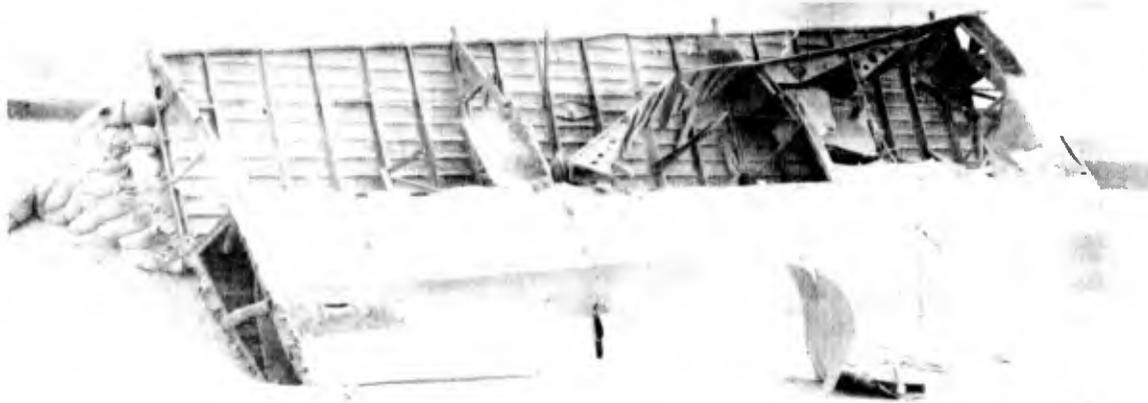
Fig. D. 56 B-36 Wing Section Range 4800 ft (5.7 psi), Shot 9, Showing General Damage

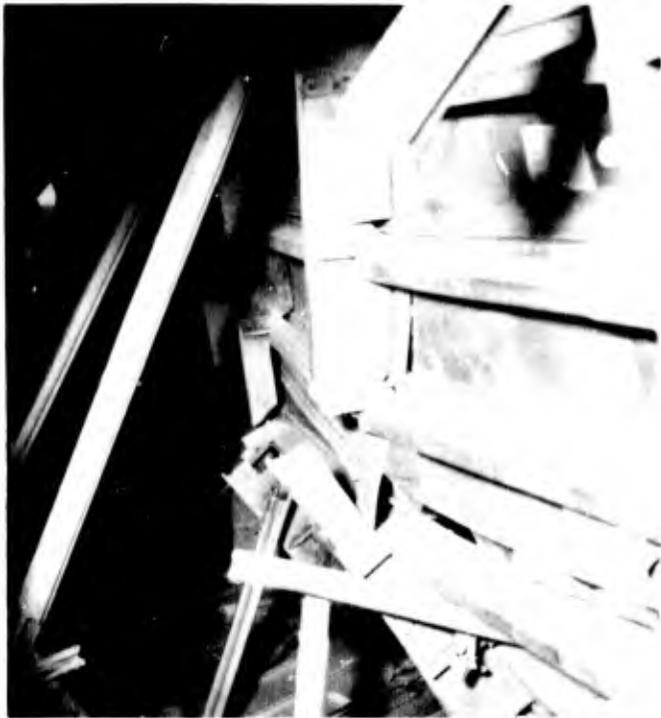
Fig. D. 58 B-36 Wing Section Range 4800 ft (5.7 psi), Shot 9, Close-up View of Interior of Wing at Outboard Extremity

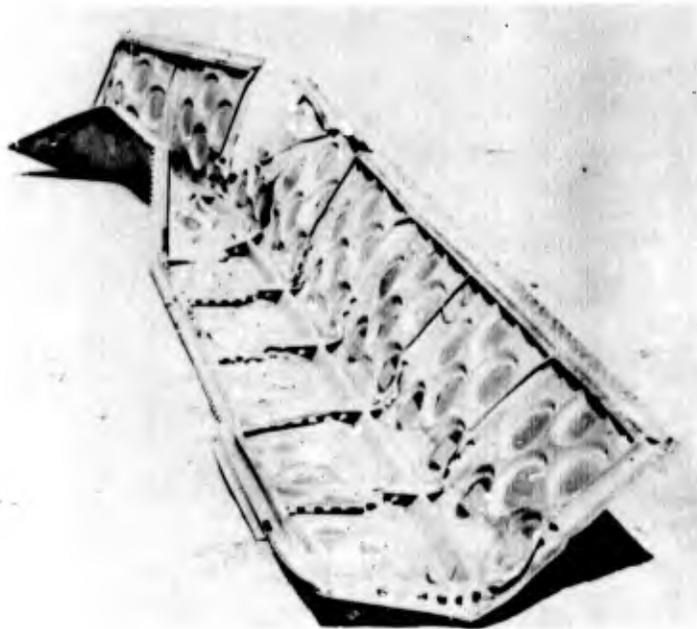
Fig. D.59 B-36 Wing Section, Range 4800 ft (5.7 psi), Shot 9, View of Under Side of Aileron Hinge Access Door

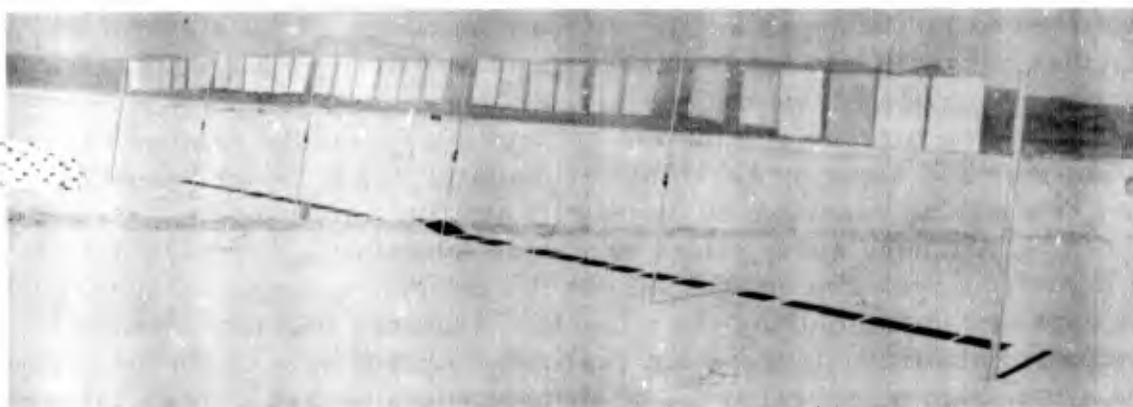
Fig. D. 60 Typical Display of Control Surface Covering Panels

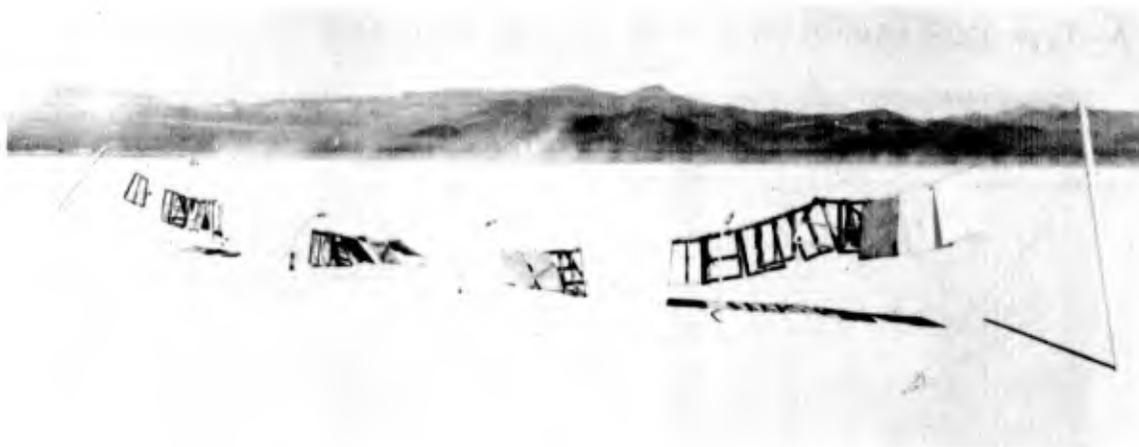
Fig. D. 61 Typical Postshot Condition of Control Surface Covering Test Panel Array

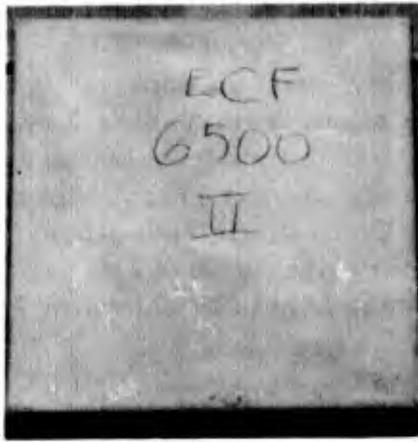
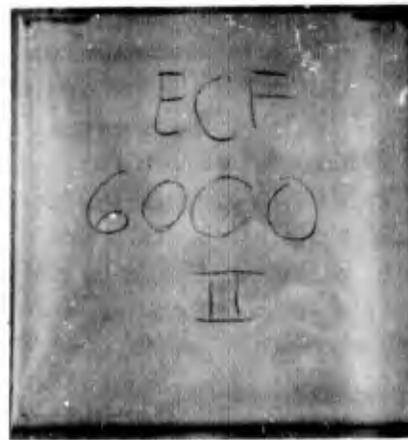
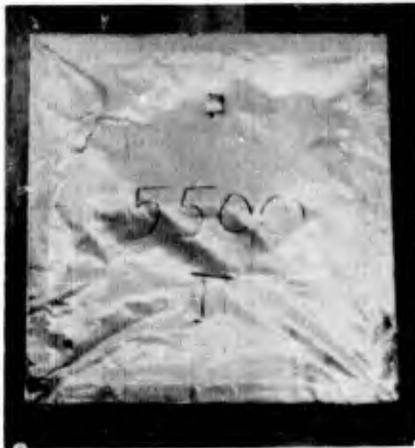
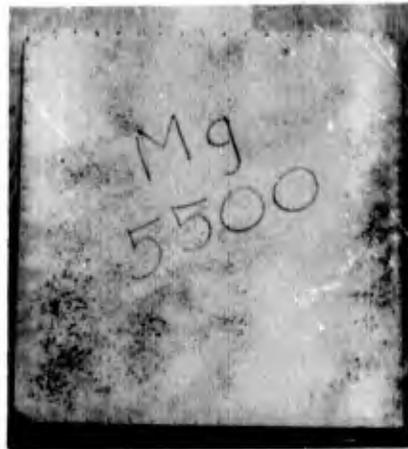
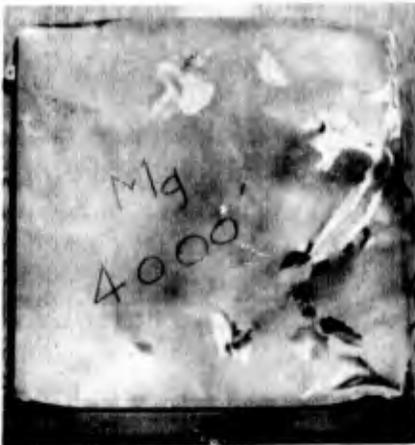
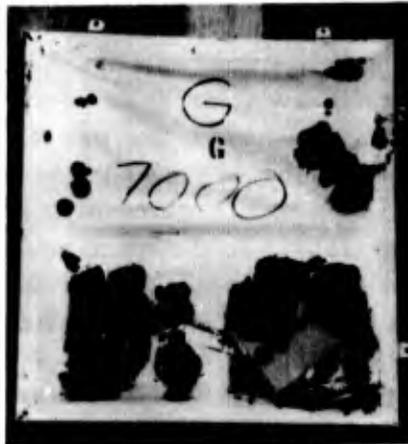
Fig. D.62 Typical Damage to Control Surface Covering Panels Giving Type of Panel, Range, Shot, and Per Cent Destruction

A Type ECF 6500 ft Shot 10 0%

B Type ECF 6000 ft Shot 10 10%

C Type F 5500 ft Shot 10 20%

D Type Mg 5500 ft Shot 9 30%

E Type Mg 4000 ft Shot 9 60%

F Type G 7000 ft Shot 9 70%

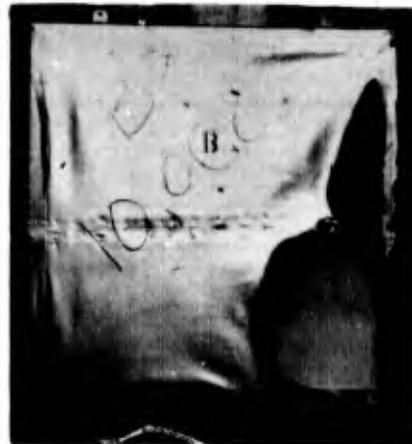
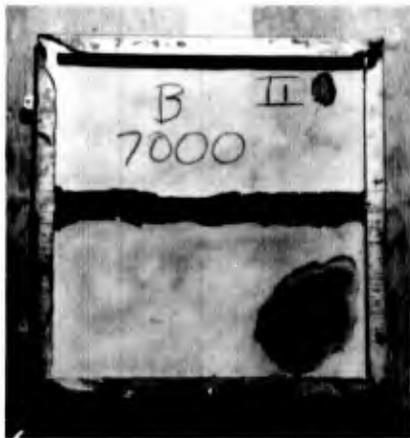
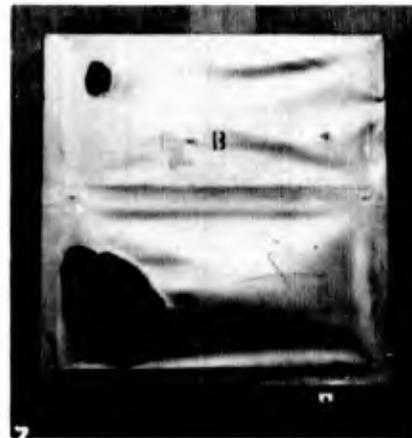
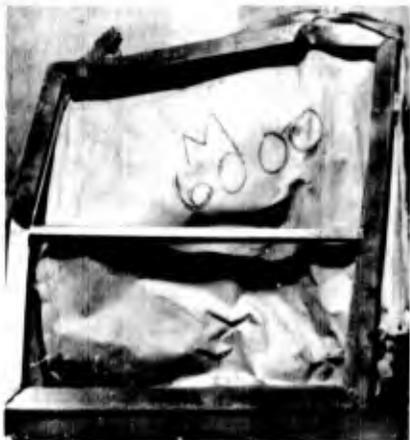
B Type B 10,000 ft Shot 9 80%

C Type B 7000 ft Shot 10 90% (Front)

D Type B 7000 ft Shot 10 90% (Rear)

E Type M 6000 ft Shot 10 100%

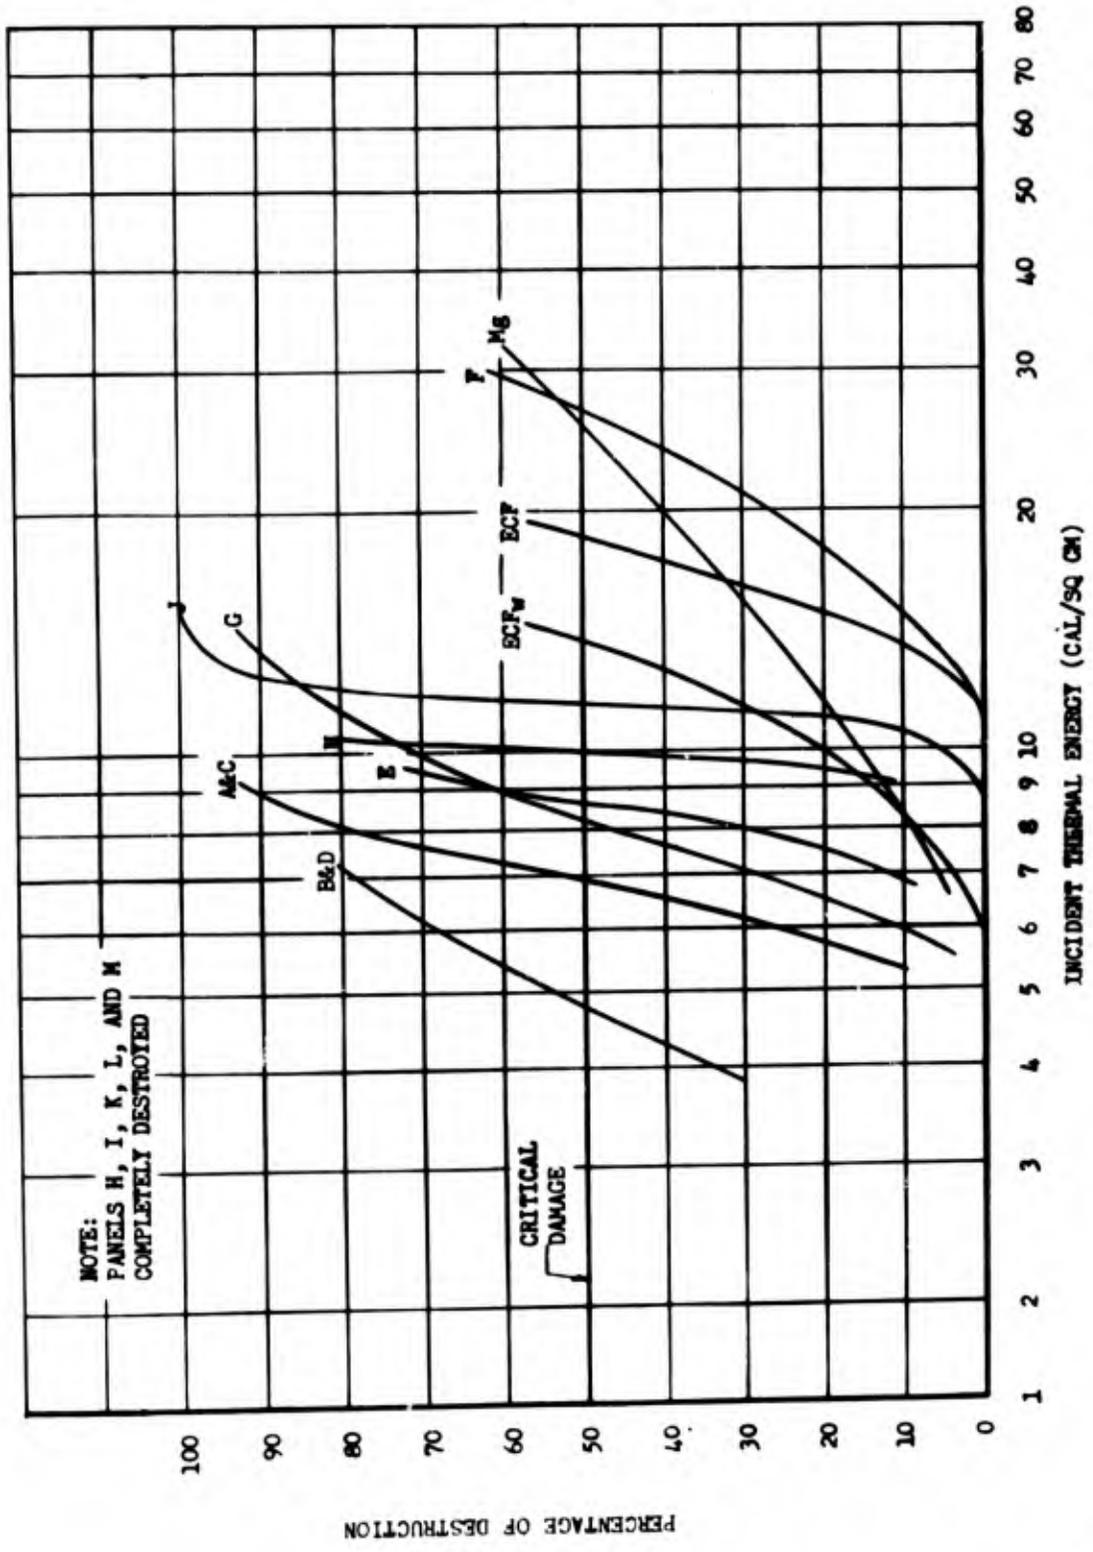
Fig. D.64 Percentage of Destruction Versus Thermal Input Plotted from Data Contained in Table D.10

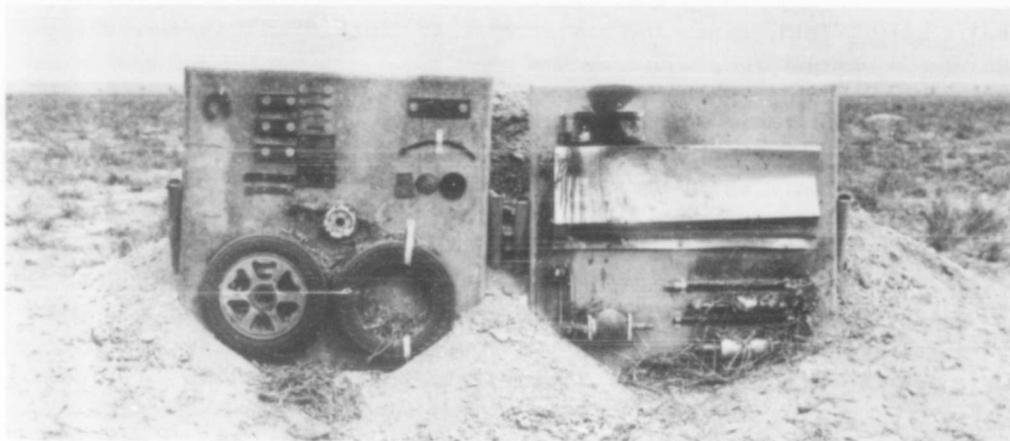
Fig. D. 69 Aircraft Undercarriage Component Panels, Range 3460 ft,
Shot 7

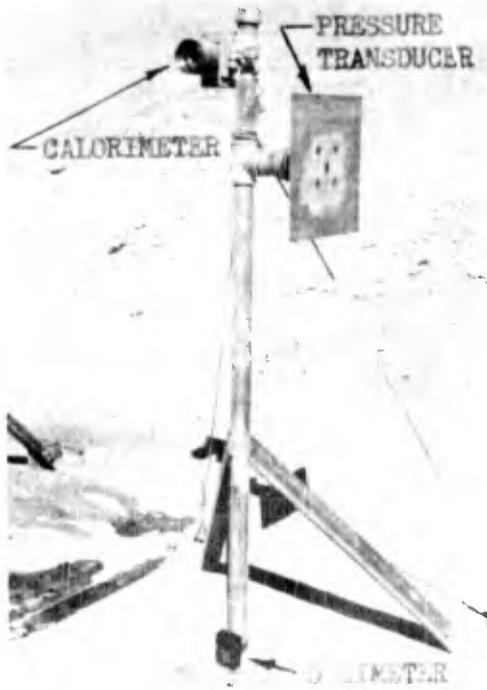
Fig. E.3 Typical Pressure Transducer, Calorimeter, and Dosimeter Installation

Total thermal energy measurements were made using two NRDL disc type calorimeters at each of the four Project 8.1 instrumentation stations during Shots 9 and 10, except at Station 8800 during Shot 9 where only one was used. In addition to this, one calorimeter was placed inside the stabilizer at Station 6500, 7200, and 8800 during Shot 9 and at Station 6500 during Shot 10 in order to measure the total thermal energy received by the stabilizers shielded from the blast, and to determine the transmission characteristics of the "Herculite" plate glass. The calorimeters were mounted 5 ft above the ground on the same pipe used for mounting the pressure transducers as shown in Fig. E.3. The calorimeters were oriented toward intended air zero. Details of the NRDL calorimeter are given in Appendix A.

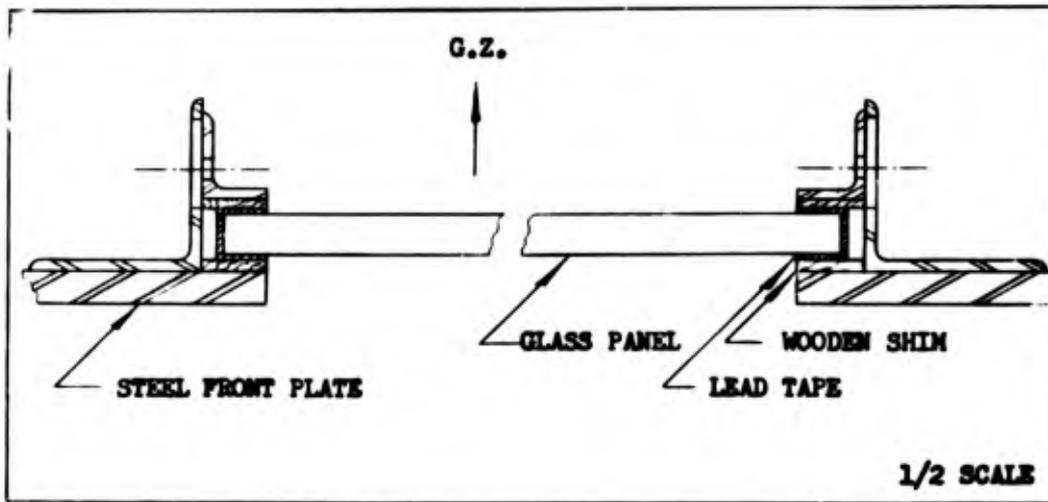
Fig. F.1 Glass Clamps for Bonded Metal Panel Blast Shield

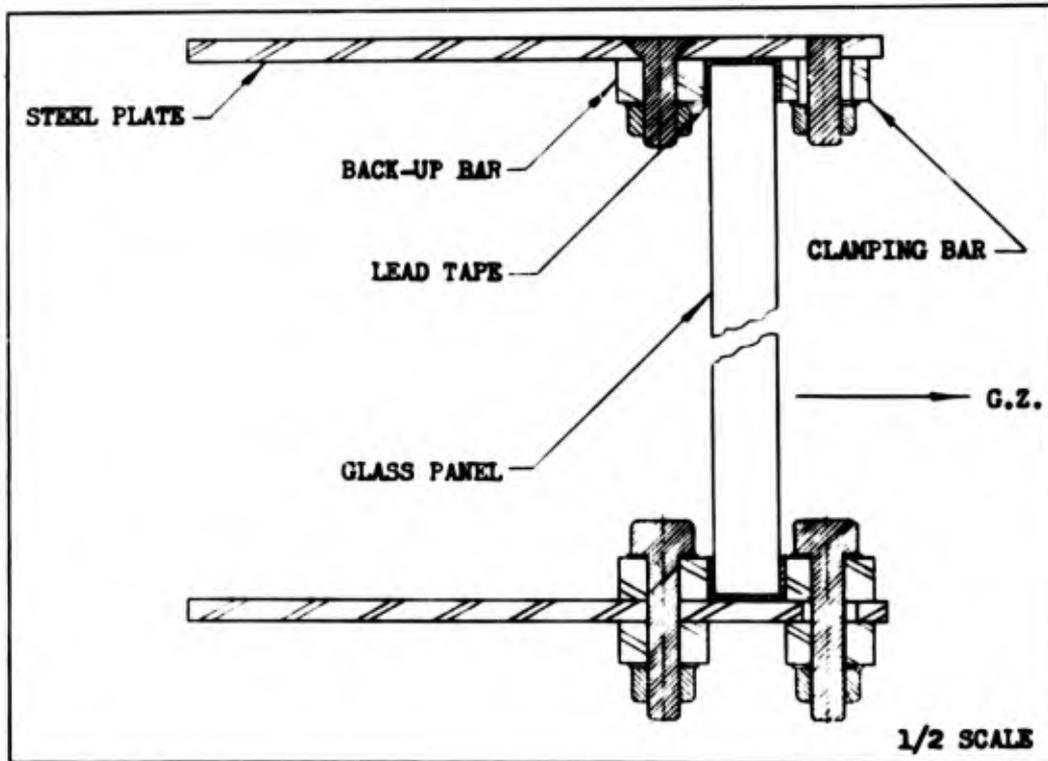
Fig. F.2 Glass Clamps for Stabilizer Blast Shield

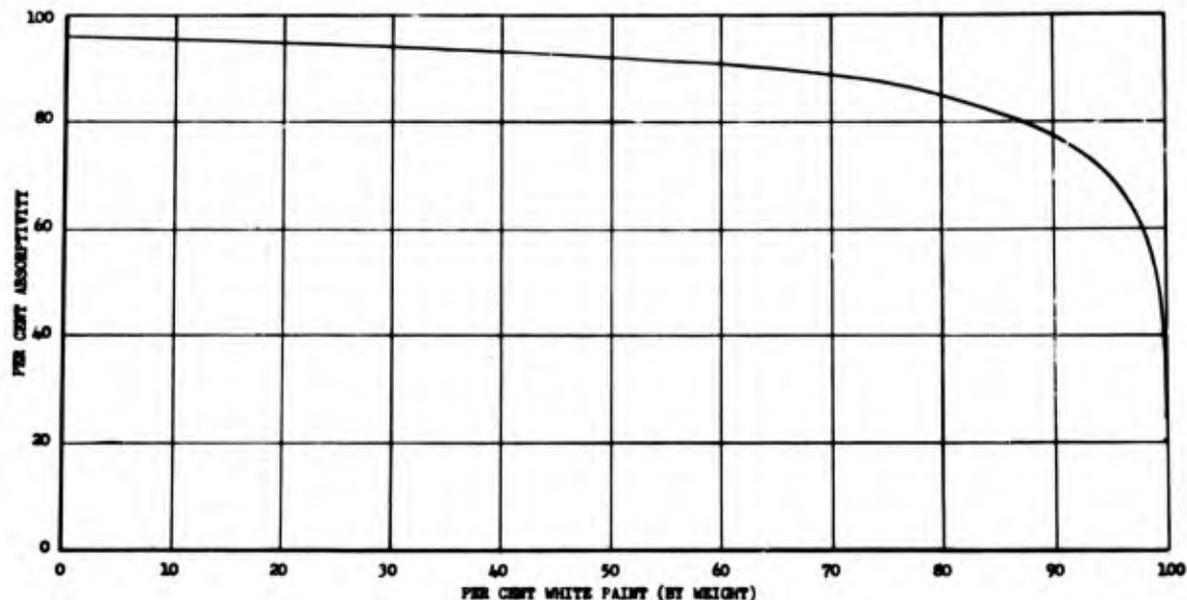
Fig. F.3 Curve Showing Variation of Absorptivity with Per Cent of White Paint in a Mixture of Black and White Silicone Base Paints
