SIMULATED AIR LAUNCH ENVIRONMENT  
FINAL REPORT FOR PERIOD SEPT. 72 THROUGH MAY 74

THIOL CORPORATION  
HUNTSVILLE DIVISION  
HUNTSVILLE, ALABAMA 35807

OCTOBER 1974

VOLUME I: TECHNICAL REPORT

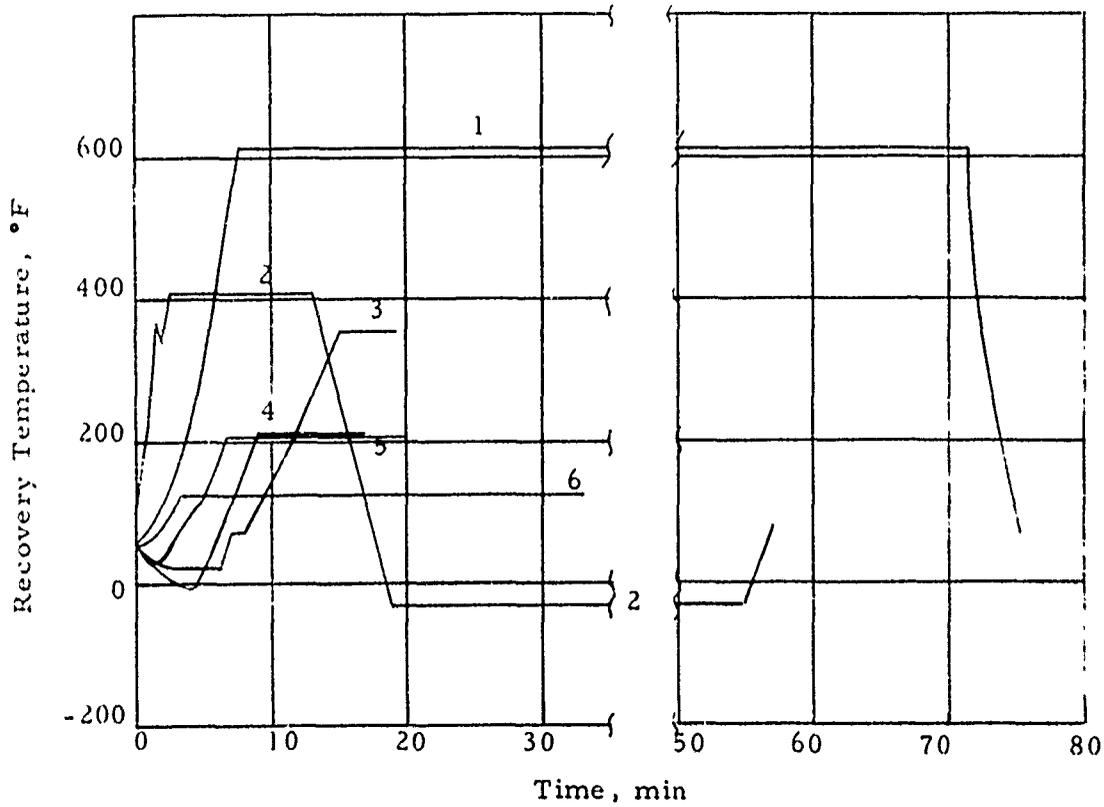
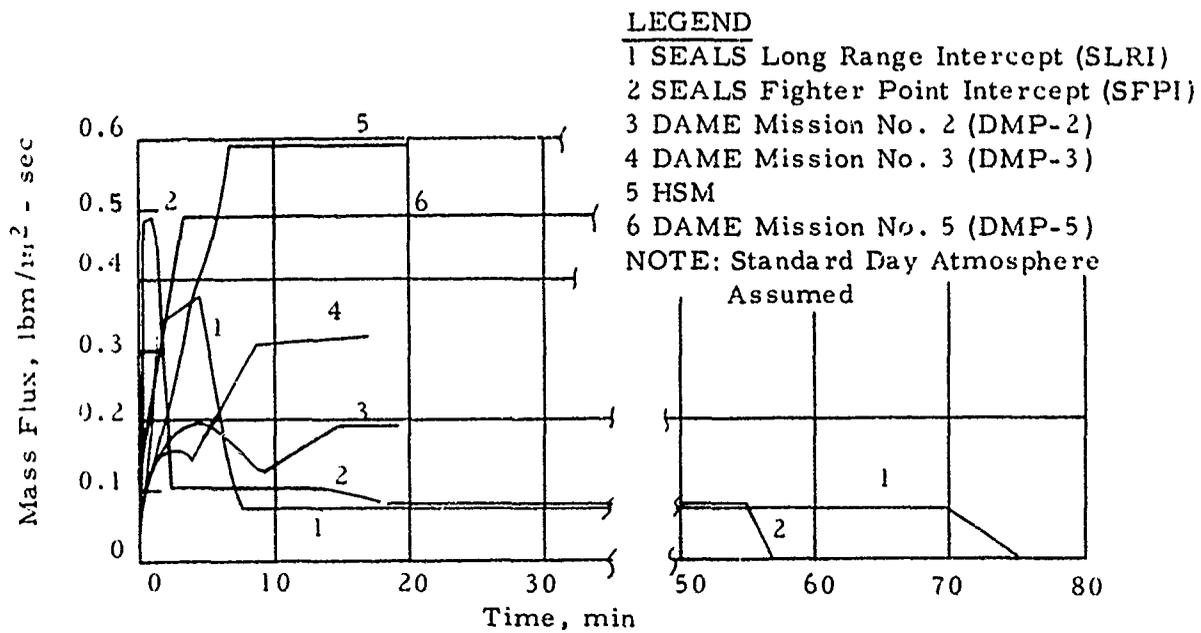
Figure 2. Typical Mass Flux and Recovery Temperature Schedules

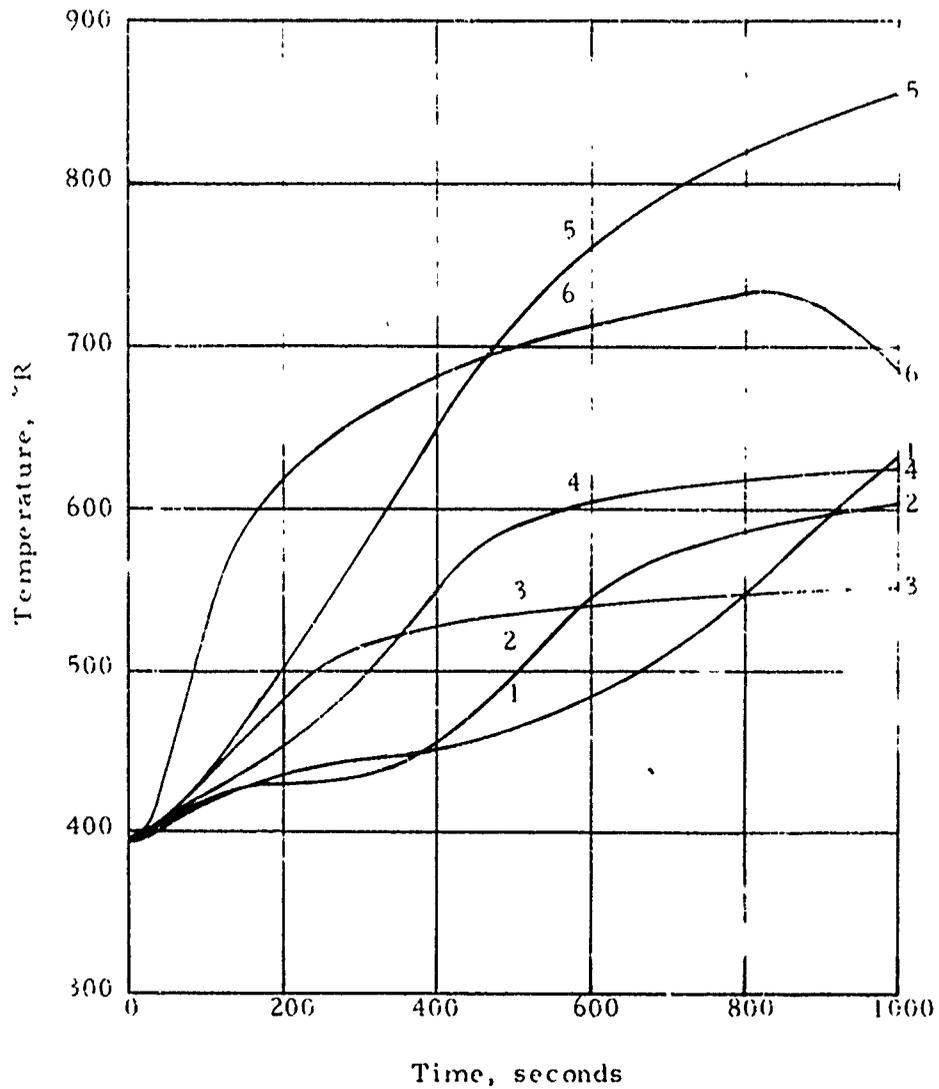
Figure 3. Results of THVINC Analysis of Selected Mission Profiles, Temperature at Propellant Bond Line

Perhaps the most informative aspects of these results are found by comparing the tangential or hoop stress time histories at the inner bore and the radial or normal stress time histories at the bond line with time for the mission profiles. These comparisons along with comparisons of bond line temperature-time histories and both inner bore hoop and bond line radial strain time histories are presented on Figure 3 through 7. Because of the rapid rate of increase of temperature at the bond line with time, one might expect high values of radial stress and strain to be induced at the bond line. Inspection of Figures 4 and 5 refute this expectation. Because the motor has been cooled to a temperature below cure temperature, a negative or compressive strain is induced in the radial direction. Although aeroheating has induced a tensile stress (Figure 4) which is relatively small, we find that the effect is one of strain relief. Therefore, it would appear that the effects of aeroheat are relatively mild from a structural standpoint at the bond line; however, such a conclusion would be premature since a large degradation in propellant capability may be exhibited if the propellant were repeatedly cycled through this high temperature range.

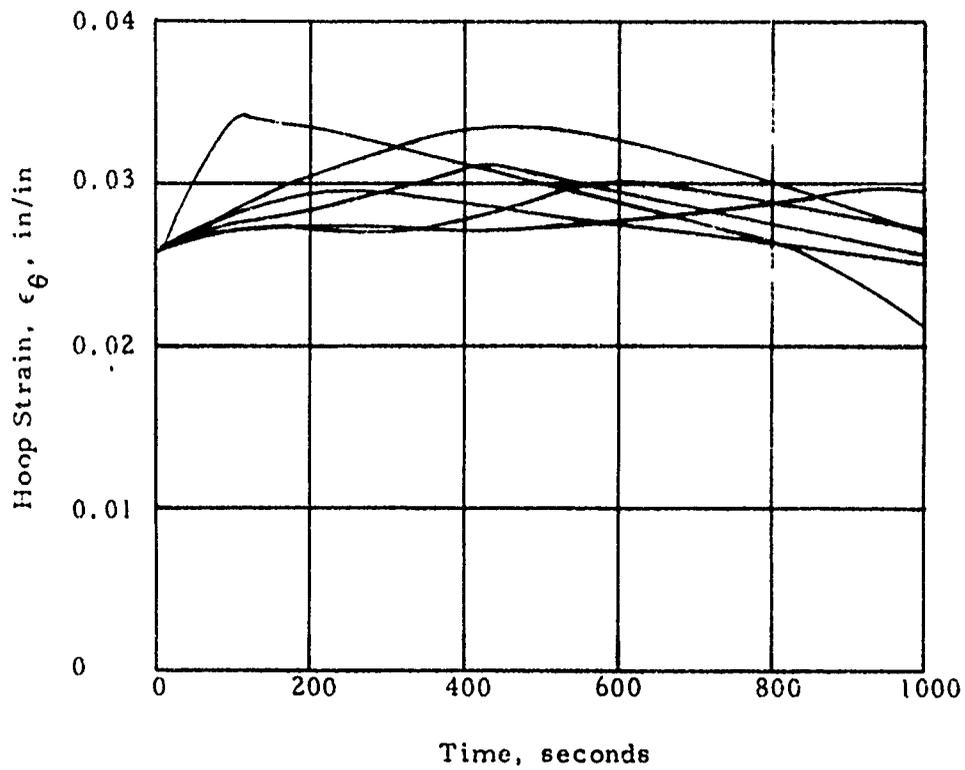
Figure 7. Results of THVINC Analysis of Selected Mission Profiles, Hoop Strain at Inner Bore

The hoop stresses and strains at the inner bore (Figures 6 and 7) do show a considerable effect from aeroheating. Although these values do not seem large, they do represent a relatively severe stress condition when a stress concentration factor of three is introduced. This factor represents the relationship between the cylindrical core case and a star point design of the Maverick type. Therefore, increasing the values of hoop stress and strain in the figures by a factor of three, does represent a relatively severe

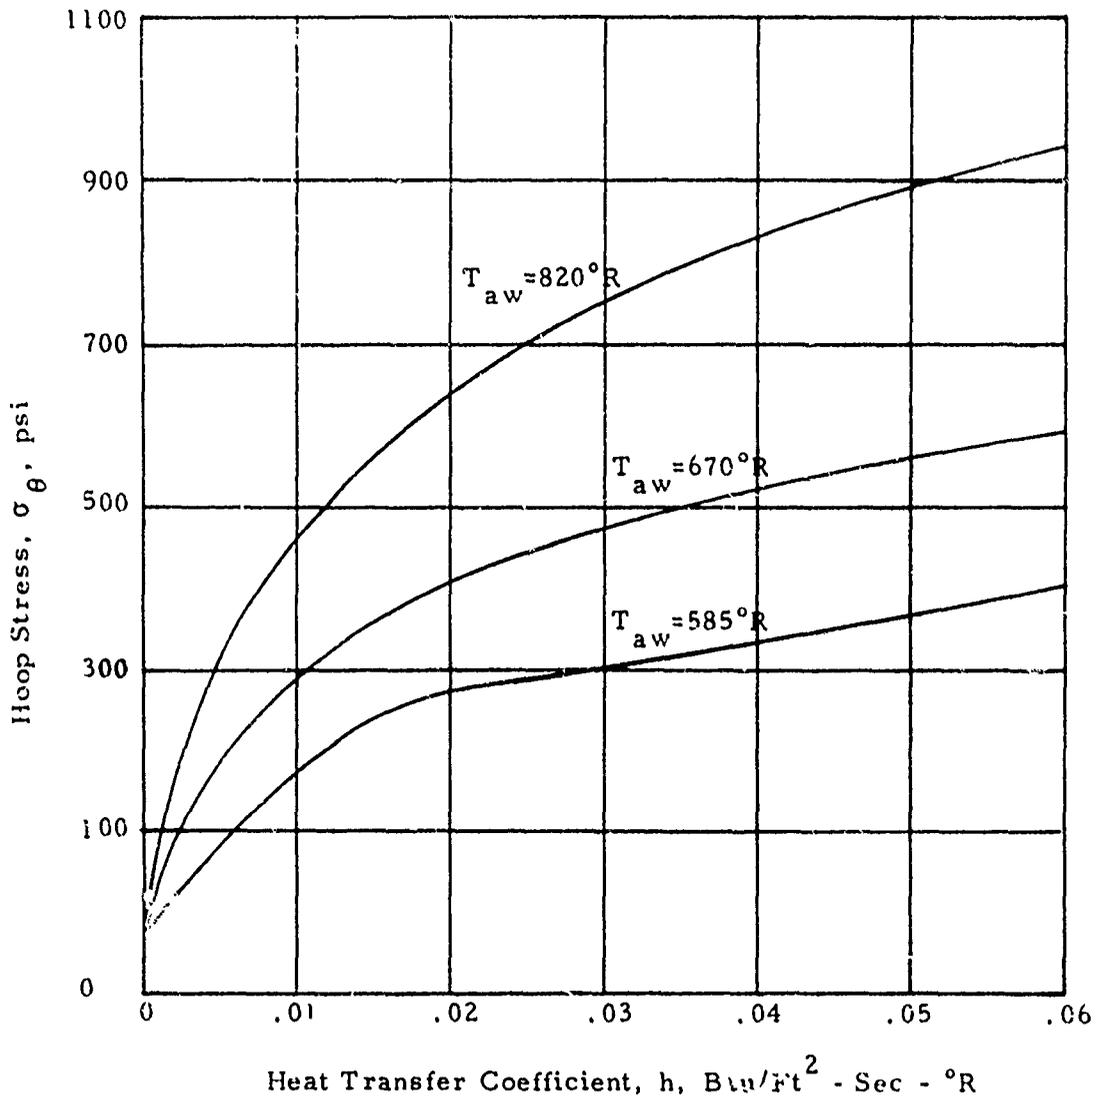
Figure 8. Hoop Stress at Inner Bore as Function of Heat Transfer Coefficient and Adiabatic Wall Temperature

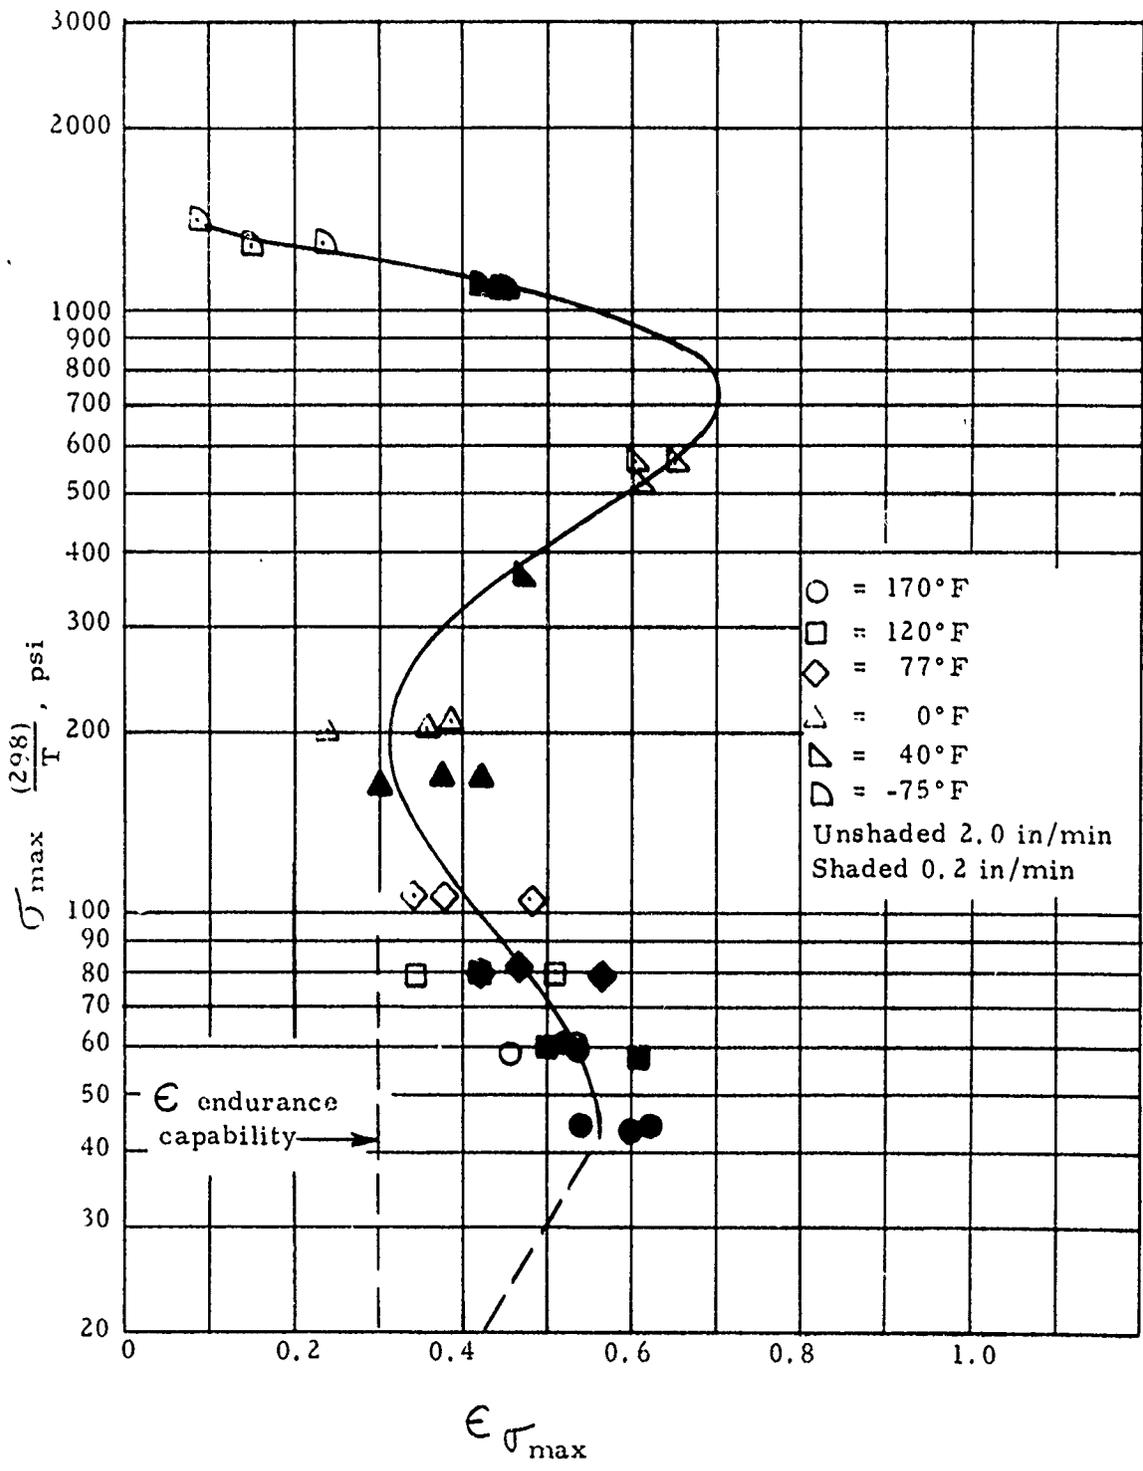
Figure 10 . Failure Boundary for UM #1 Propellant (Mix L158-54)

To assure failure, the failure schedule should transgress beyond the failure boundary curve such as "Case 11" as shown on Figure 10. Based on the results shown on Figure 9, it would appear that either the DMP-2, DMP-3, or both missions could be selected as a schedule comparable to the DAME environment. The HSM mission could be used as the second schedule, the SLRI as the third, the SFPI as the fourth, and the "Case 11" or equivalent as the fifth schedule. This selection assumes that little damage is accumulated through each of the schedules and that the fifth schedule must be capable of causing immediate failure, even if tested as the initial schedule.

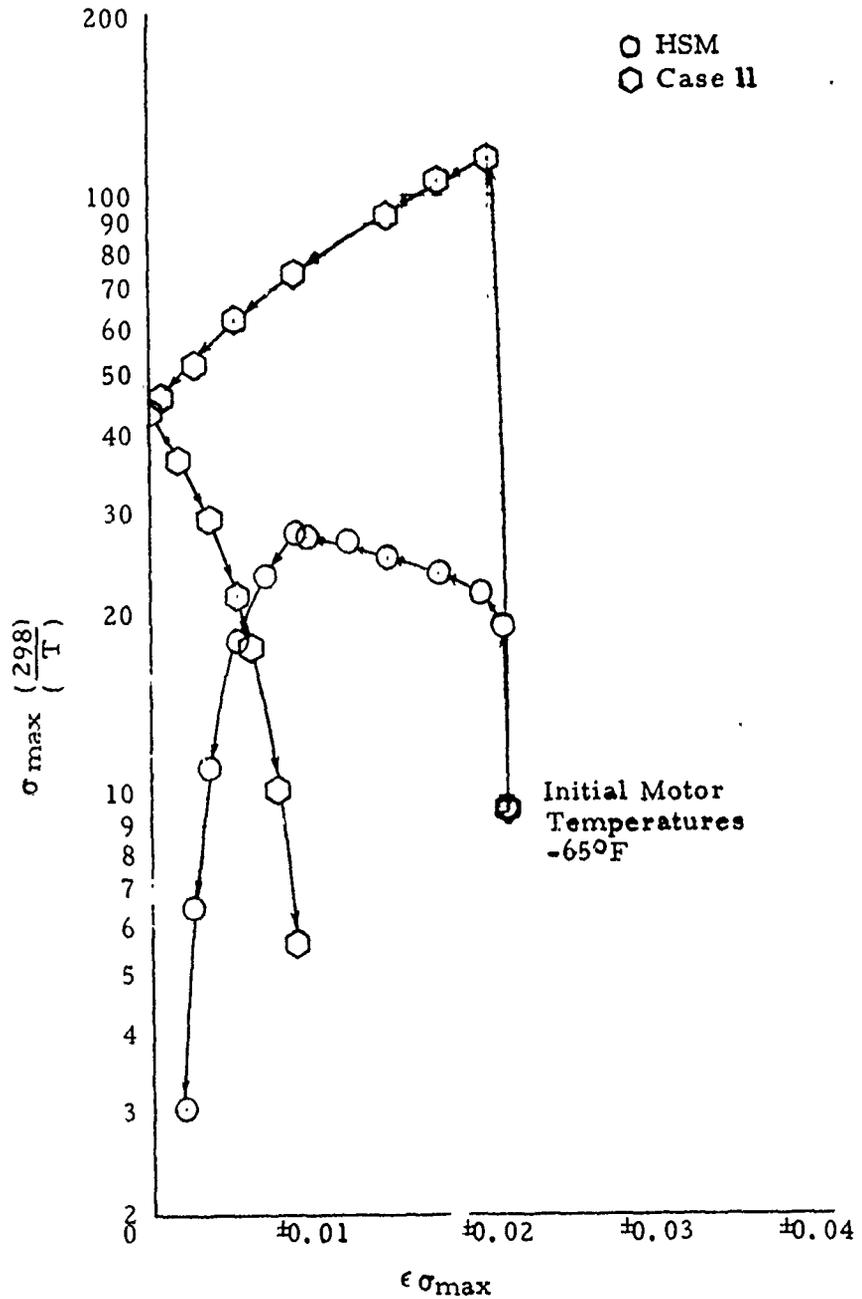
Figure 11. Typical Radial Stress and Strain Relationships at Propellant Bond Line

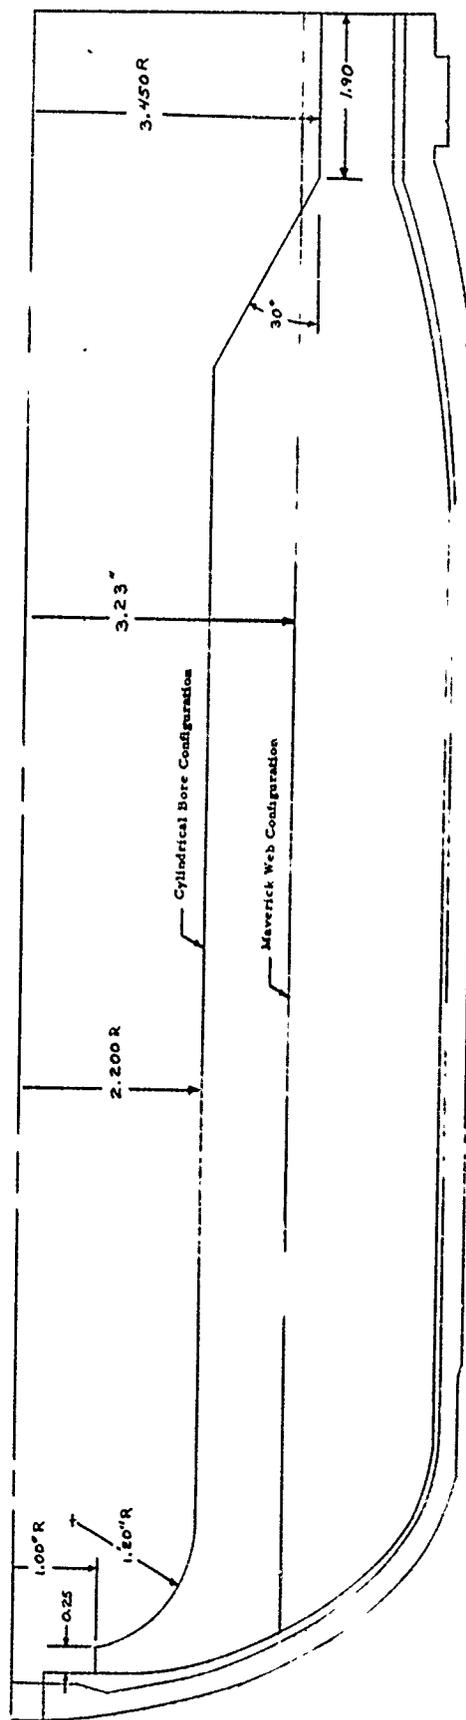
Figure 13. Sketch of Selected Cylindrical Bore Configuration and Maverick Web Configuration

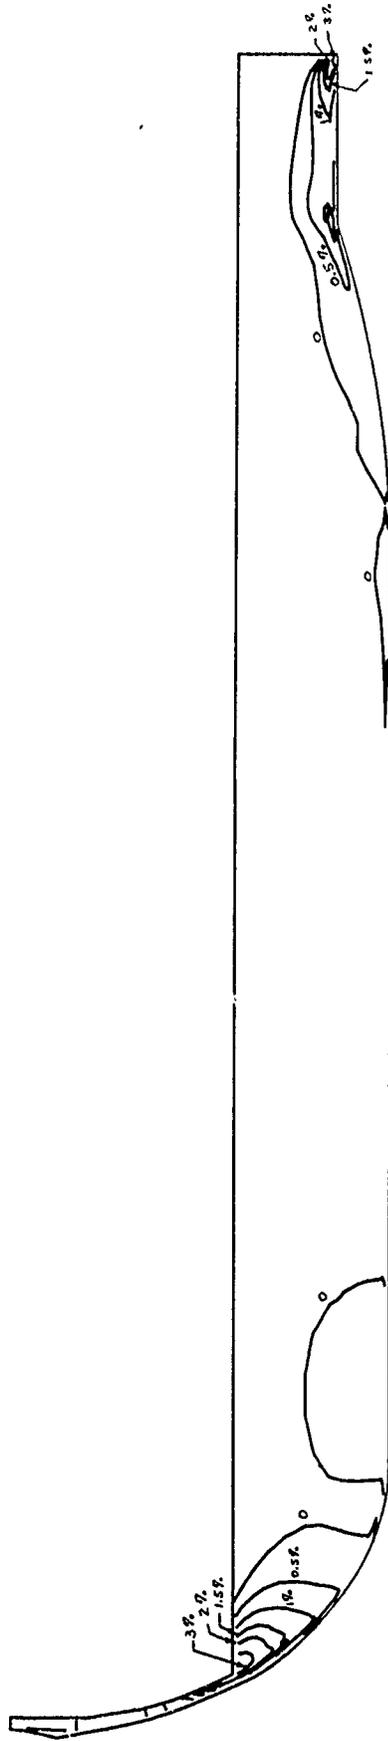
Figure 18. Maximum Strain Contours in Maverick Web Configuration at  $-75^{\circ}\text{F}$

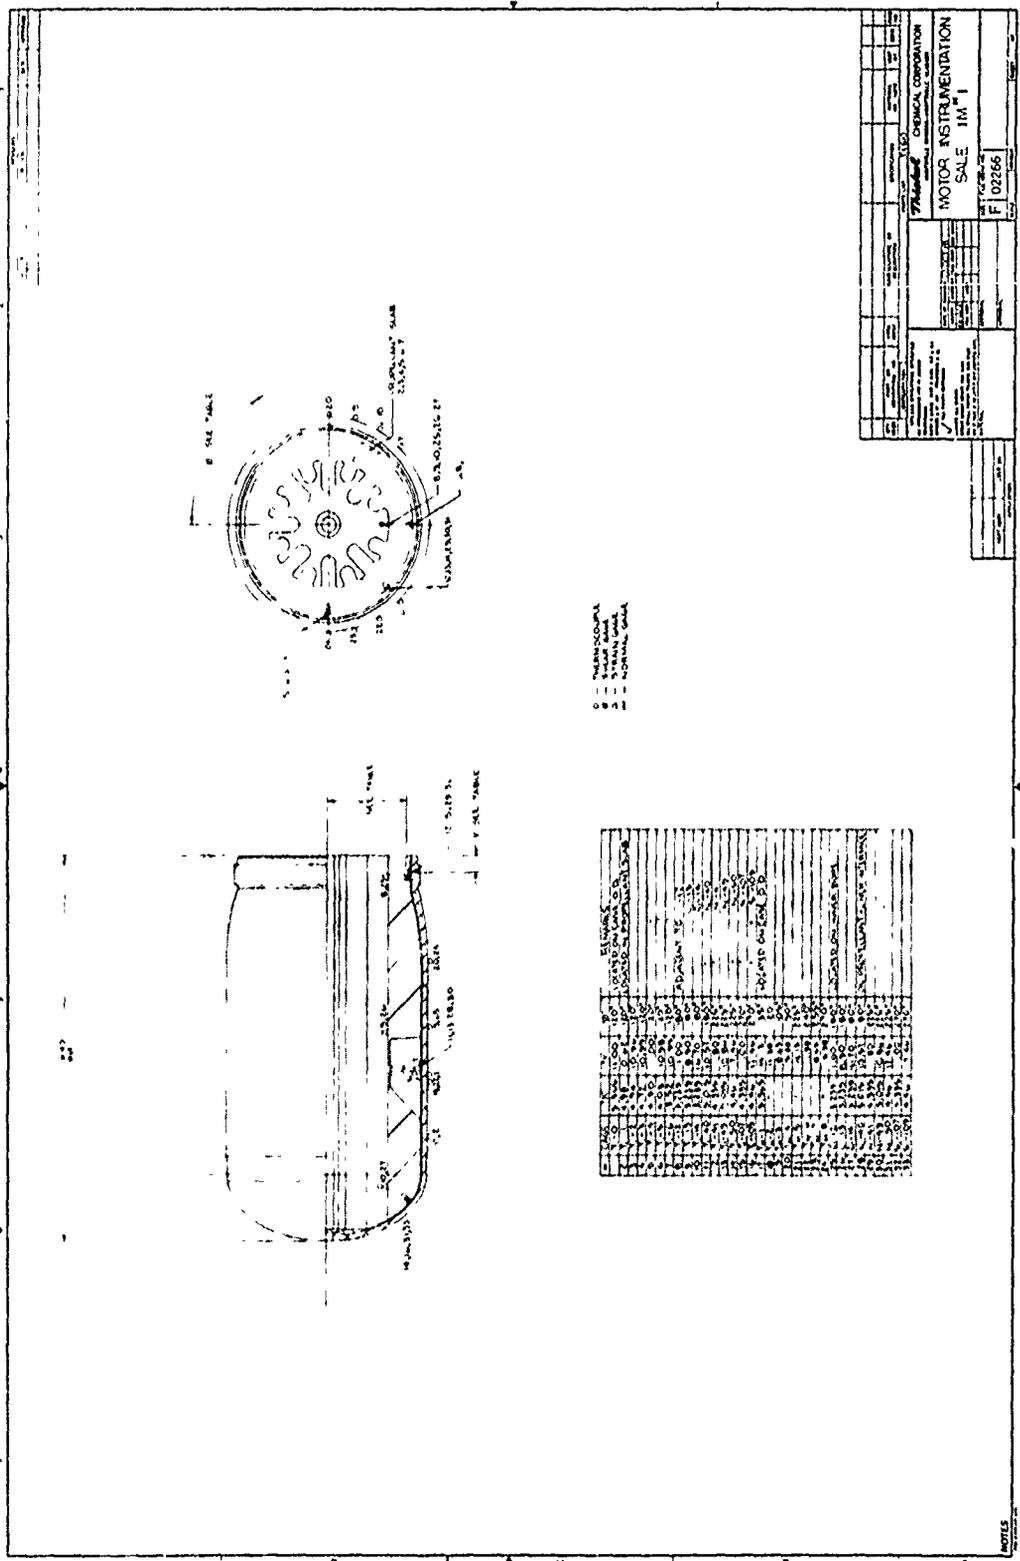
Figure 30. IM #1 Gage Locations

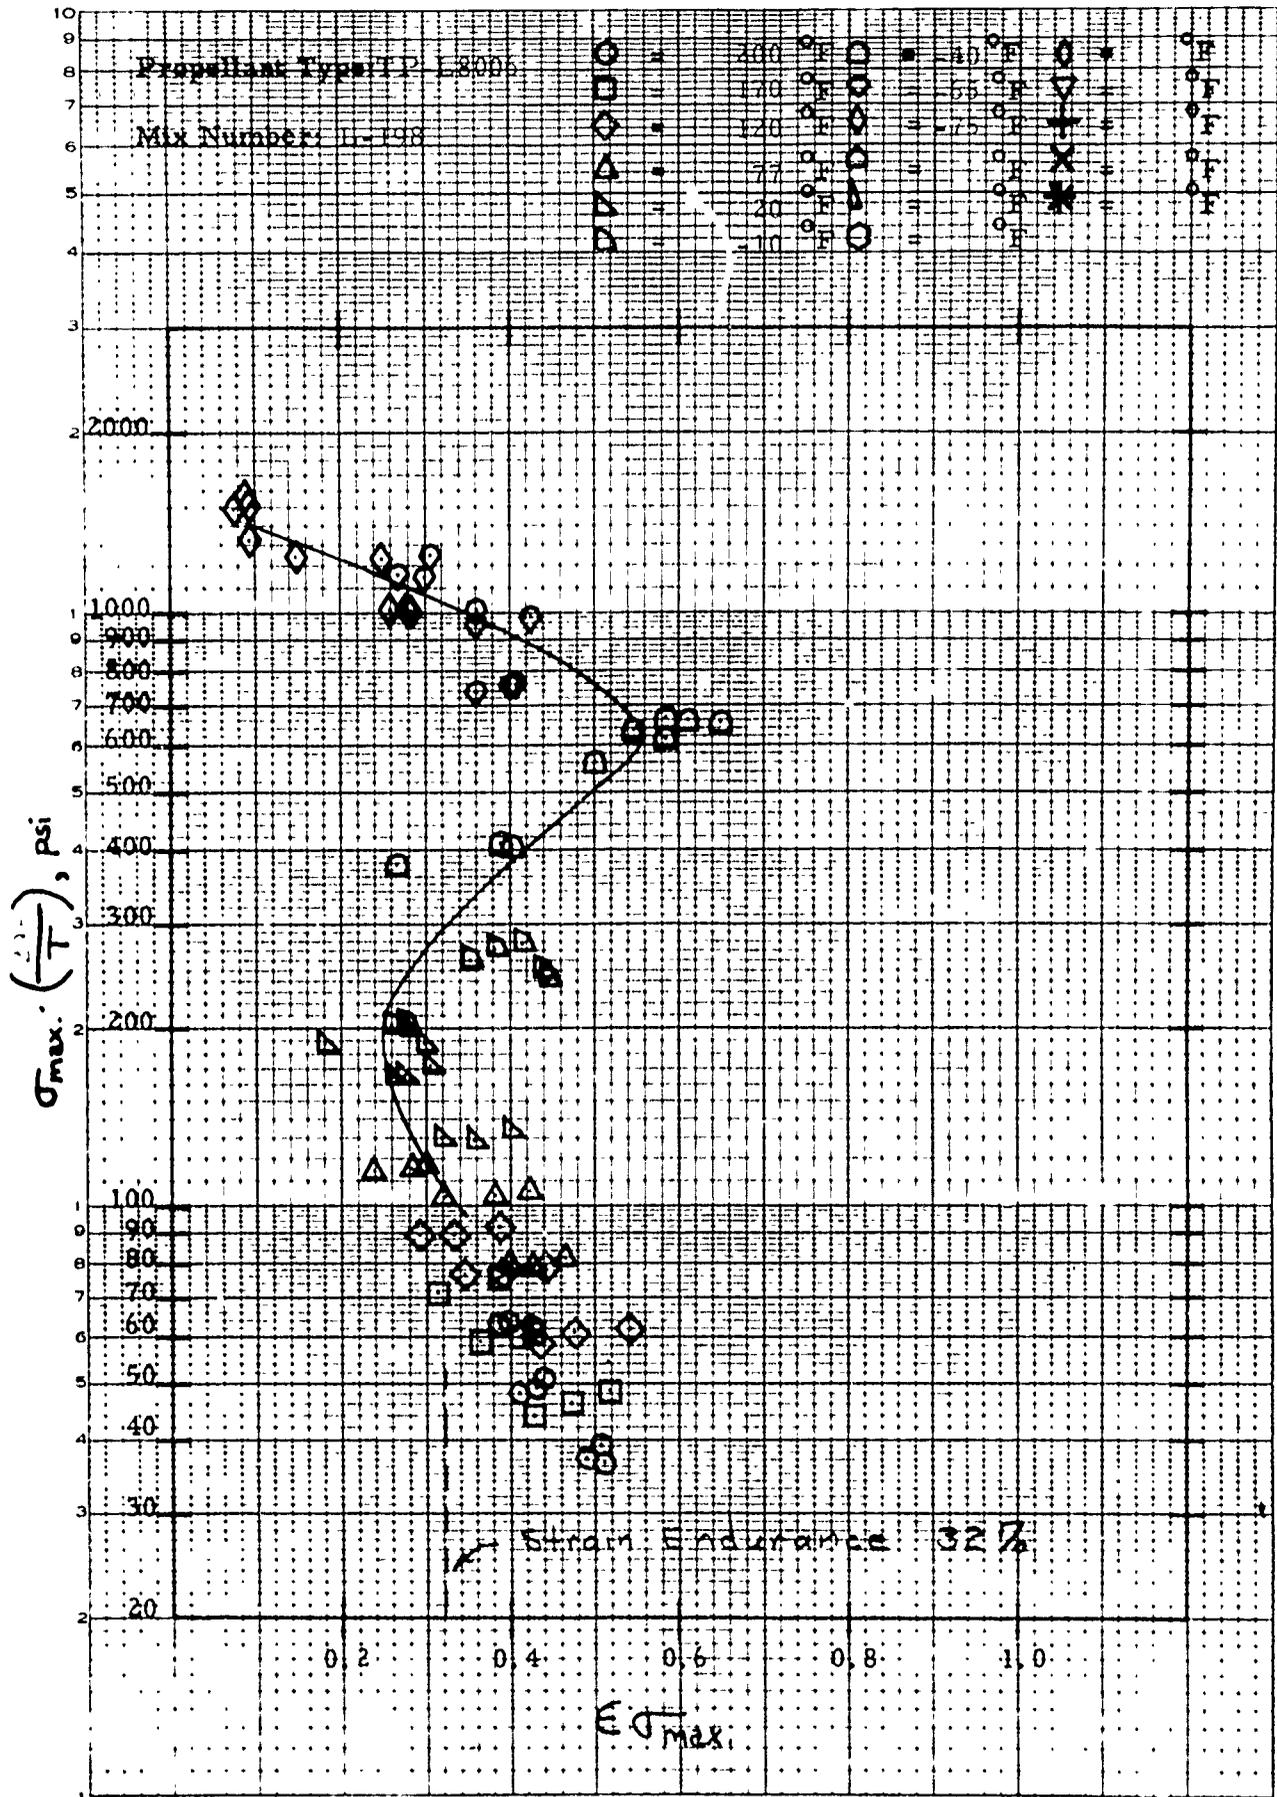
Figure 33. Failure Boundary for Mix 1-198

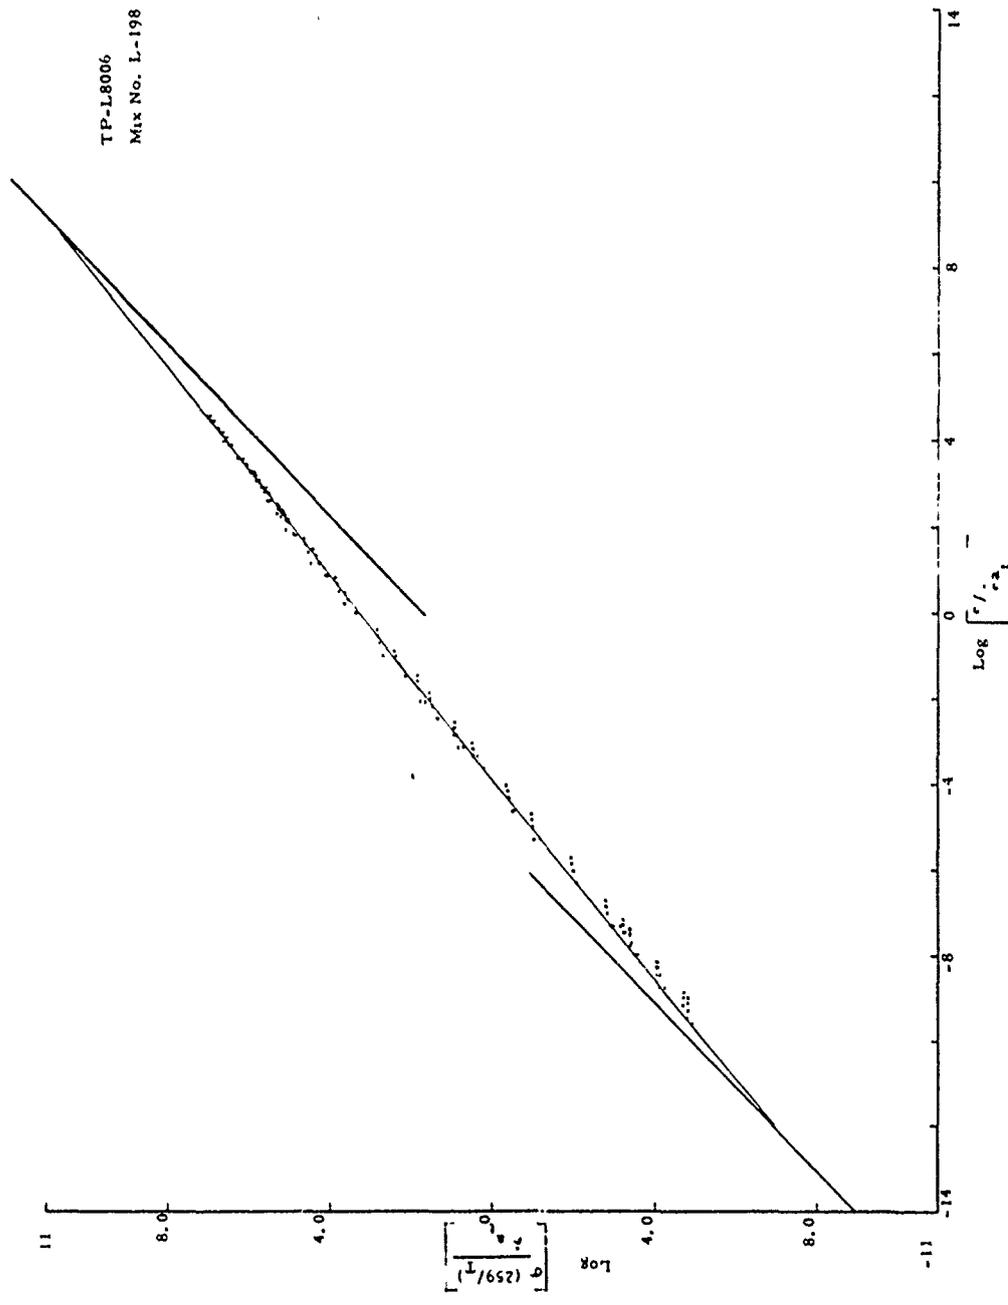
Figure 34. Temperature and Strain Rate Reduce Master Stress - Strain Curve for TP-L8006 Propellant (Mix L-198)

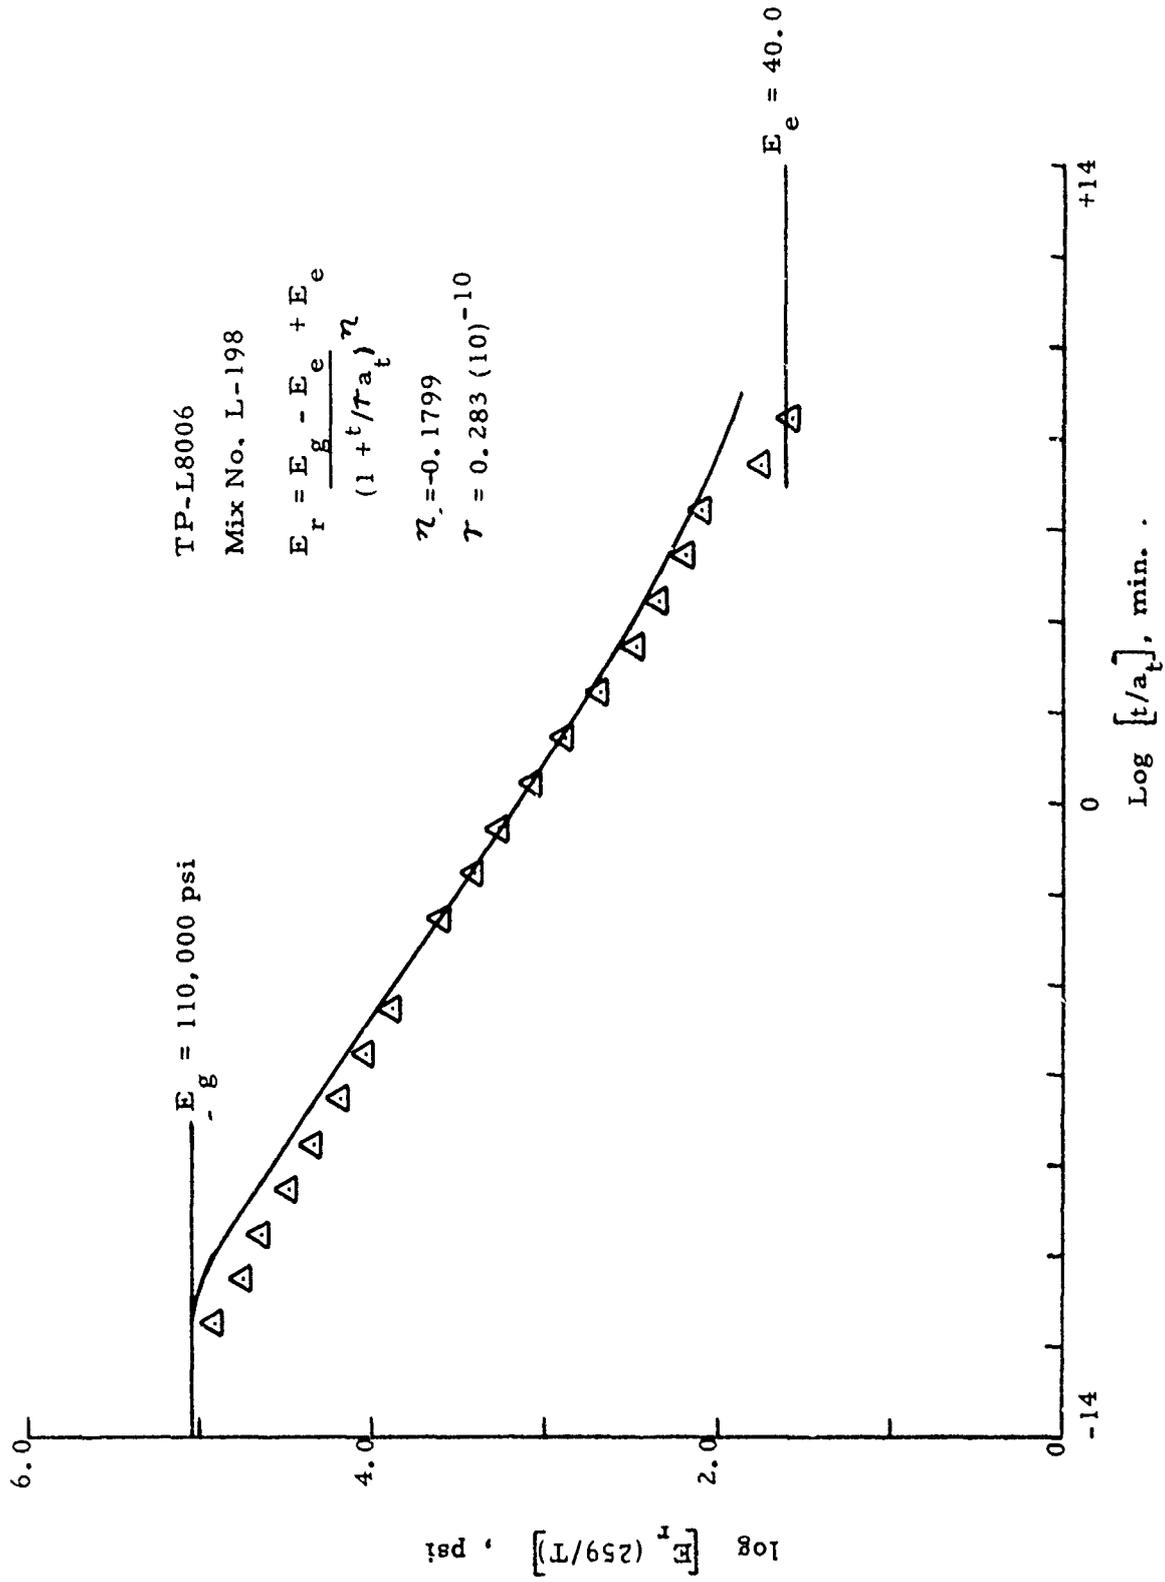
Figure 35. Relaxation Modulus for TP-L8006 Propellant

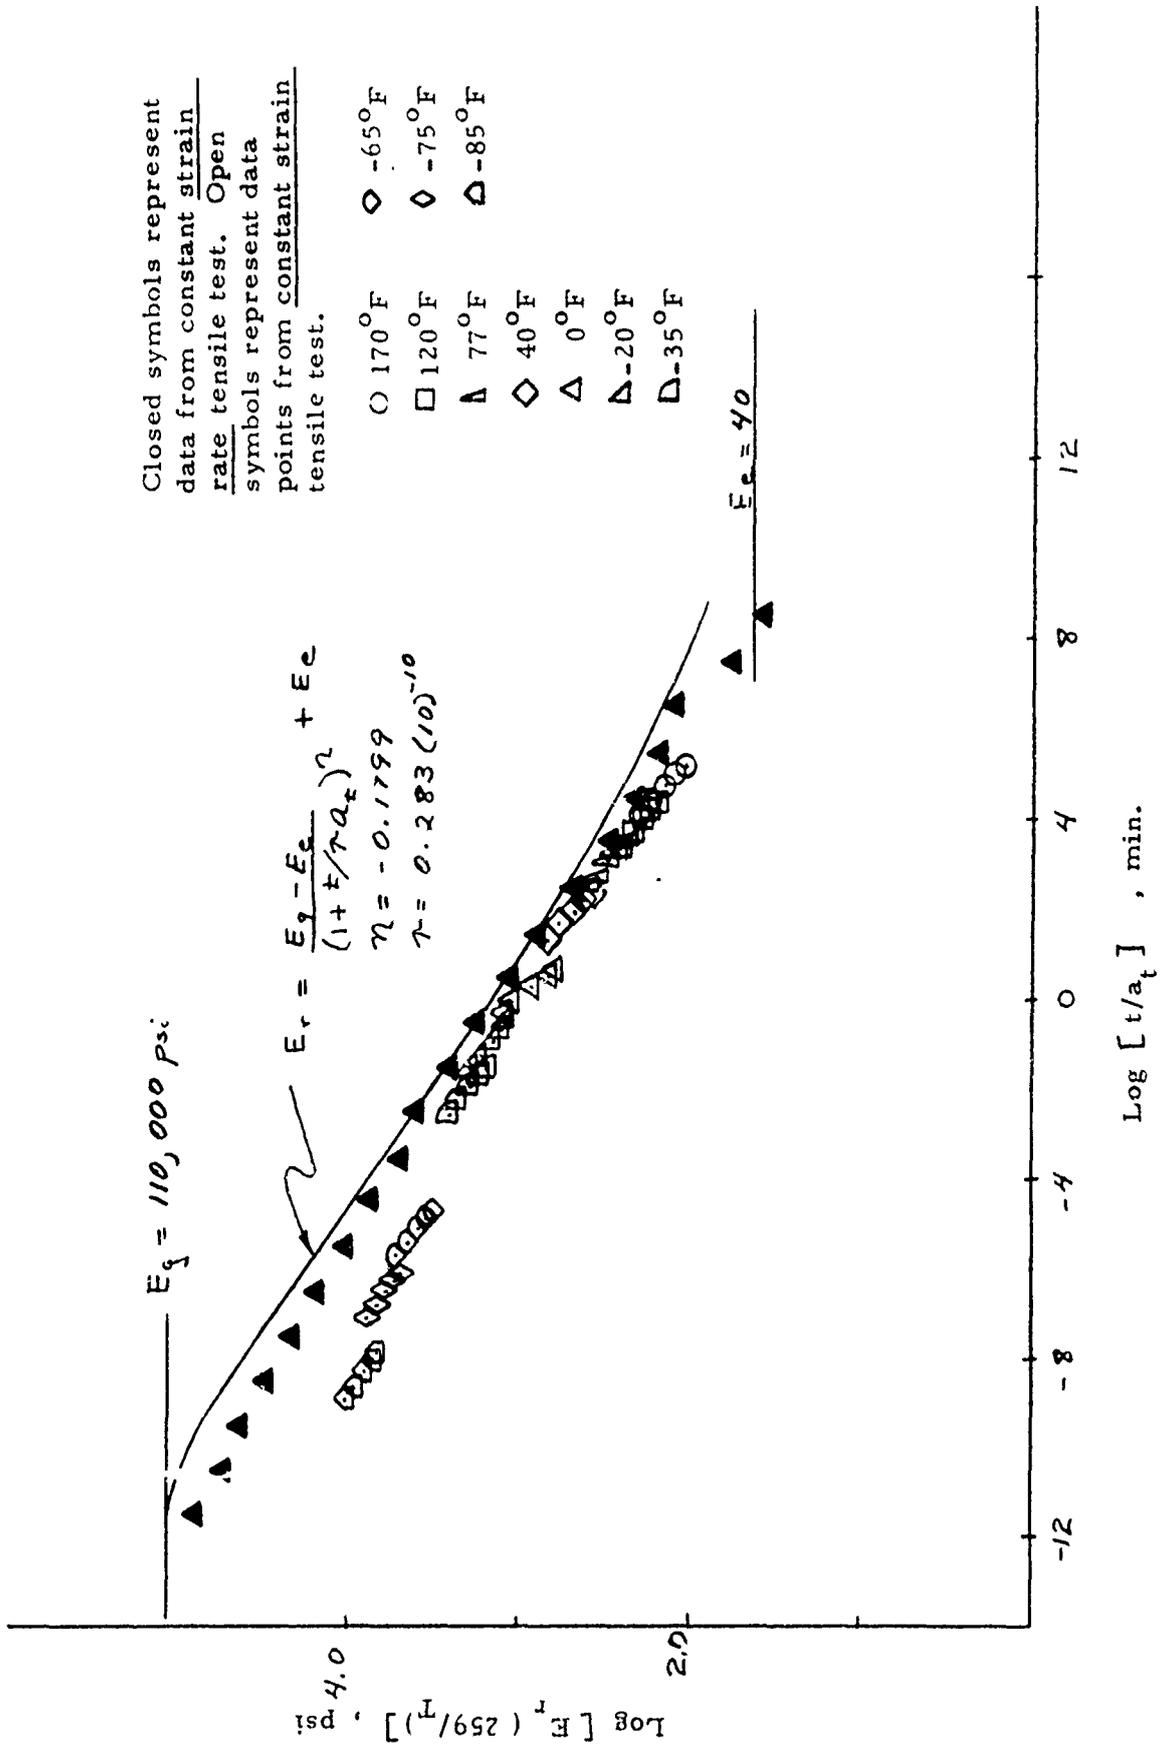
Figure 36. Comparison of Calibration Modulus Data From Mix L-198

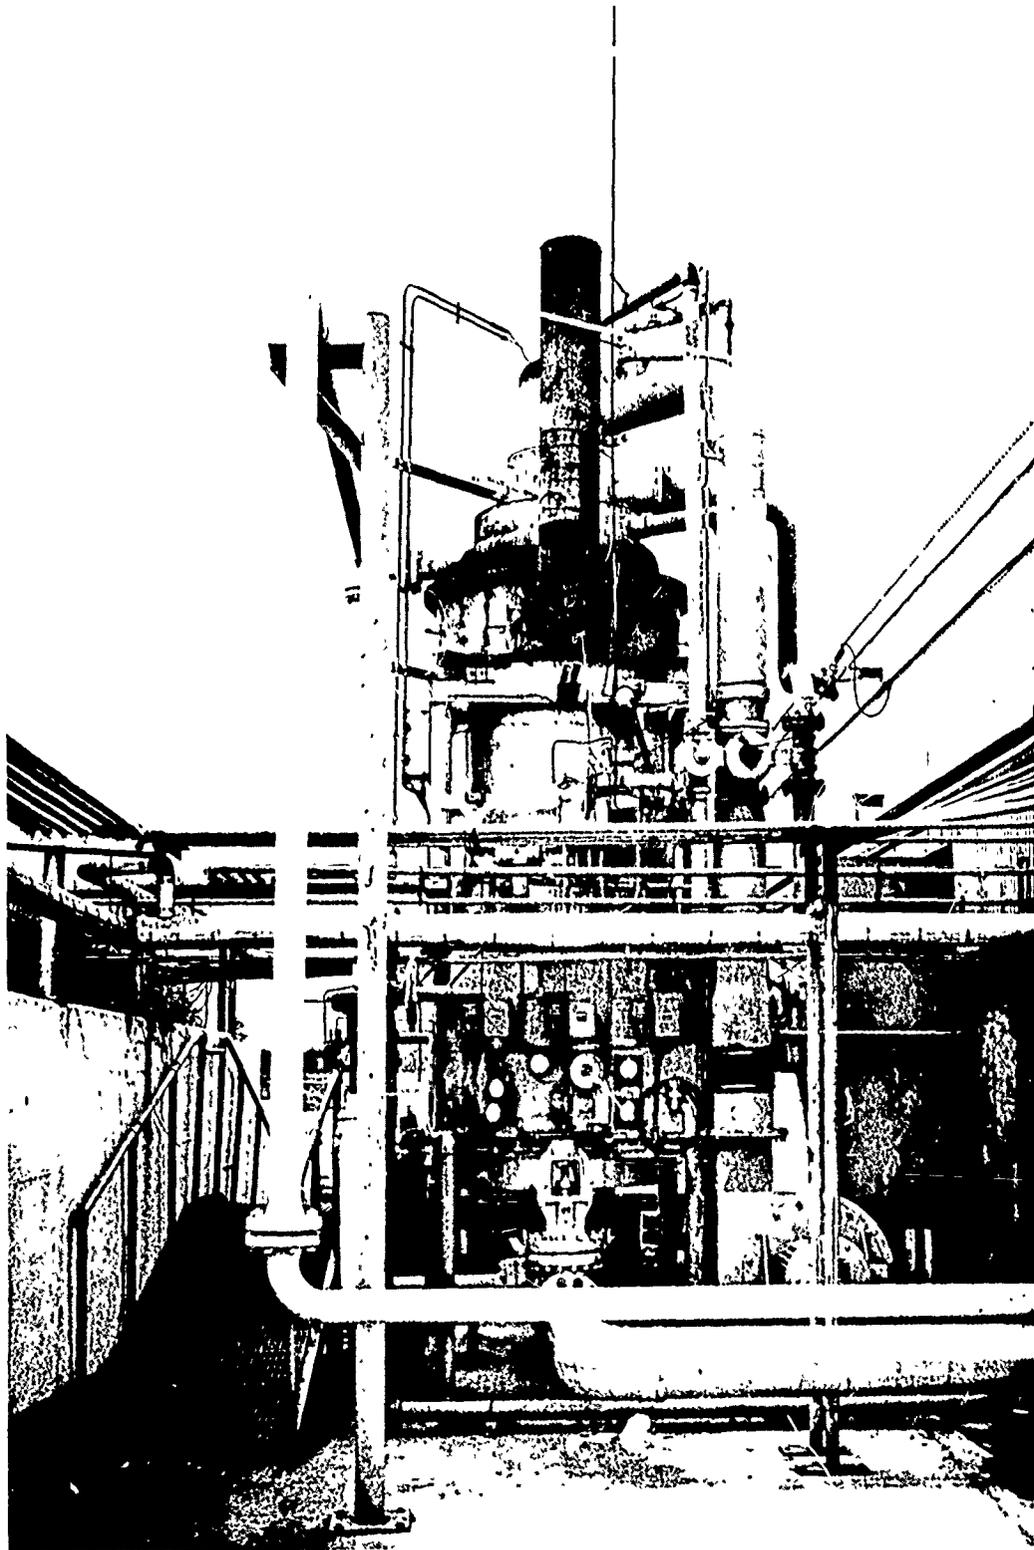
Figure 42. Capacitance Heater

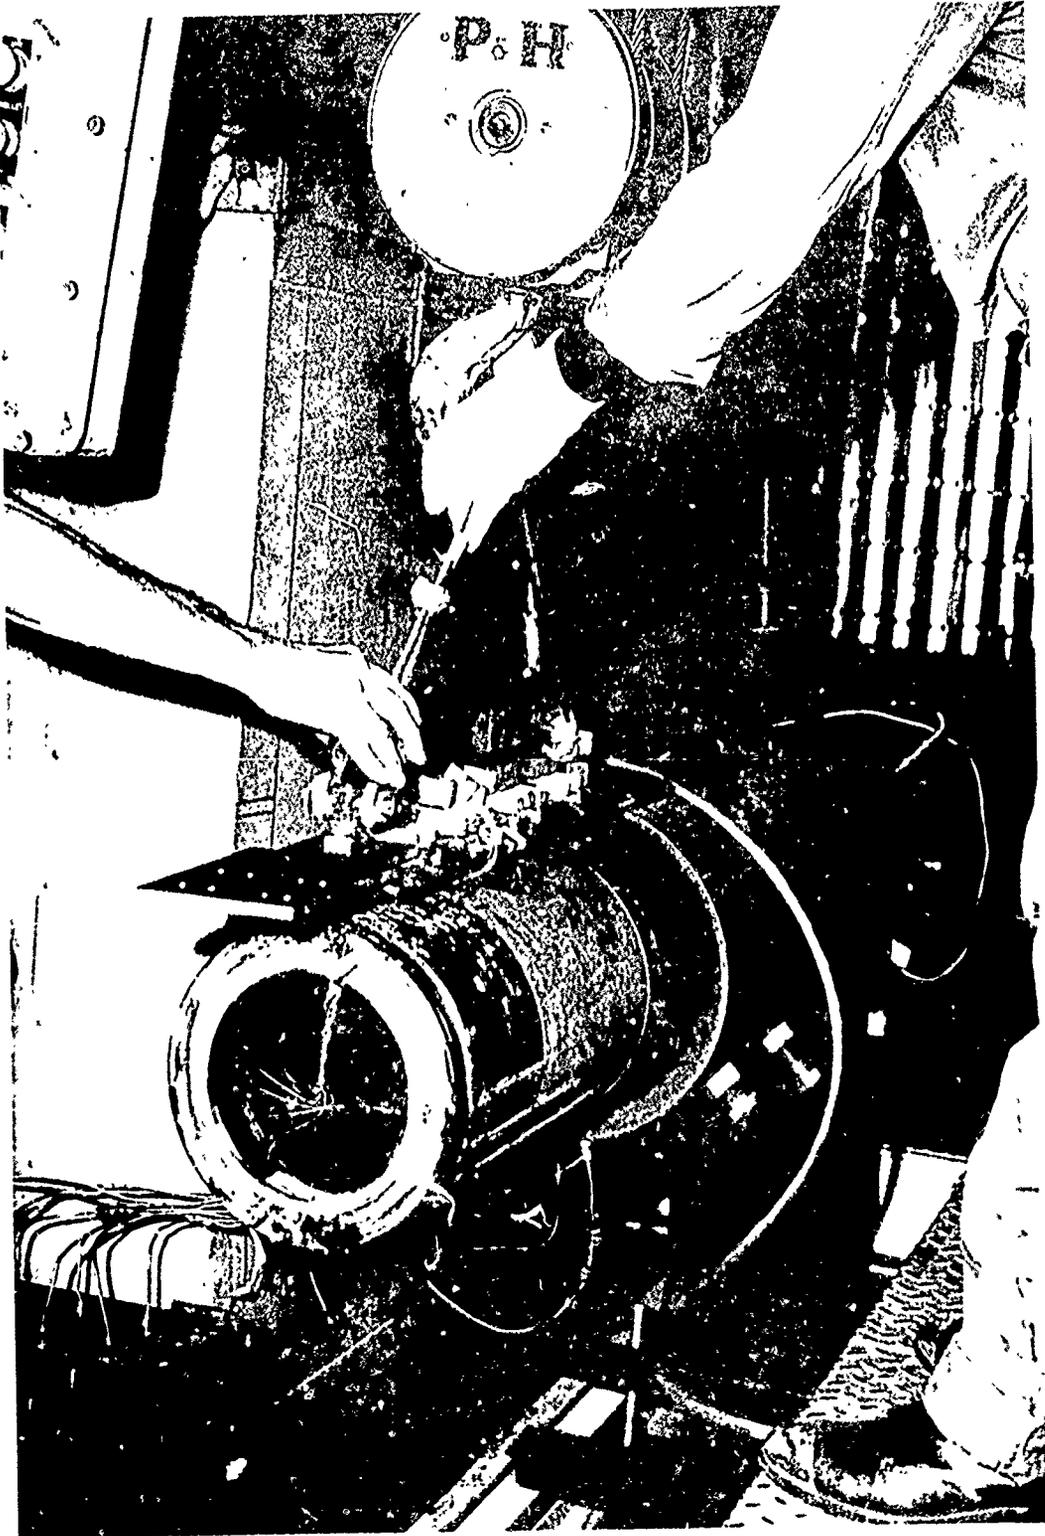
Figure 39. U.M. 1 Being Stalled in Test Chamber
