SIMULATED AIR LAUNCH ENVIRONMENT  
FINAL REPORT FOR PERIOD SEPT. 72 THROUGH MAY 74

THIOL CORPORATION  
HUNTSVILLE DIVISION  
HUNTSVILLE, ALABAMA 35807

OCTOBER 1974

VOLUME I: TECHNICAL REPORT

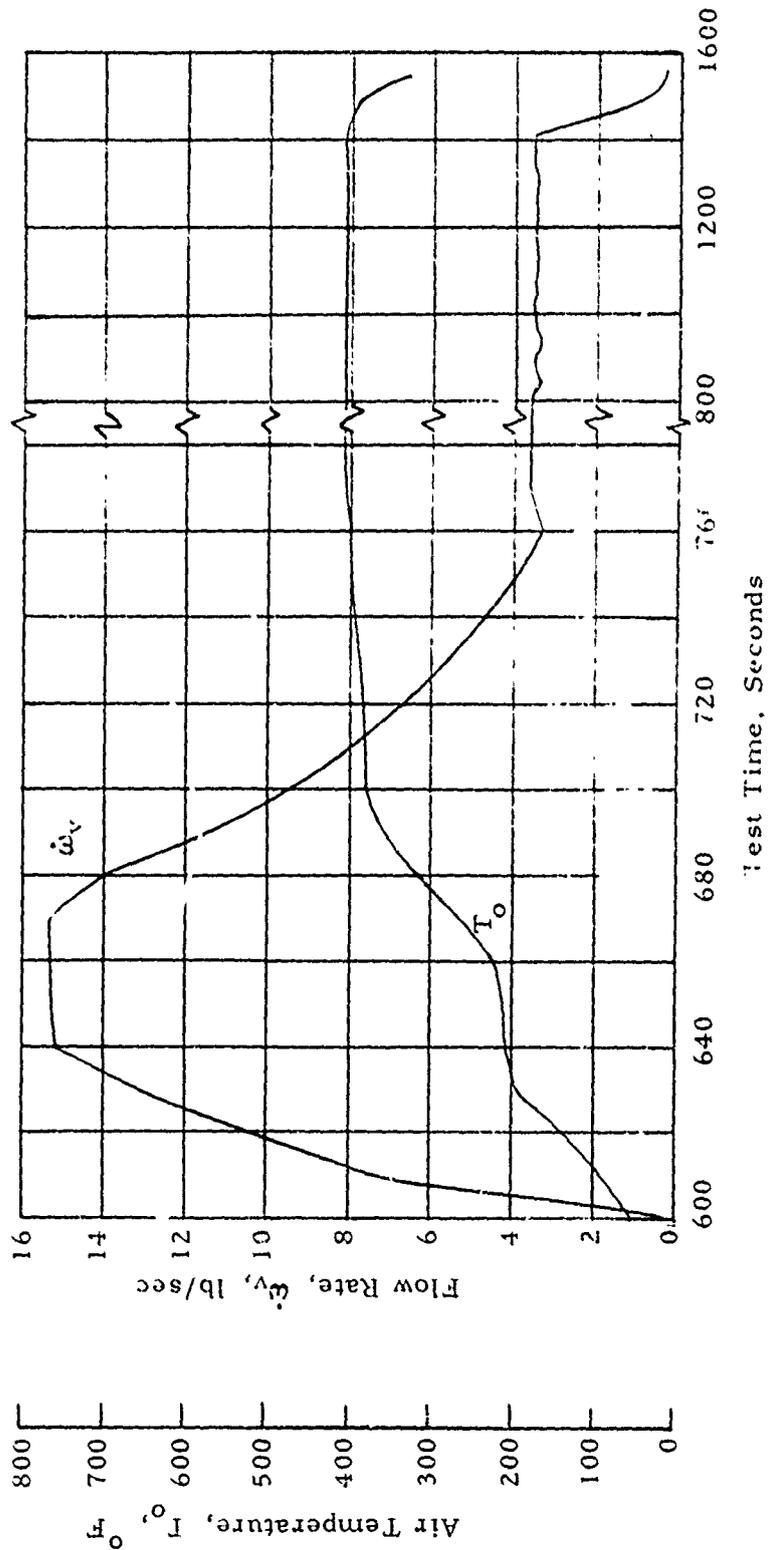
Figure 48. Typical Test Schedule for a SFPI Mission - Source Test No. 7

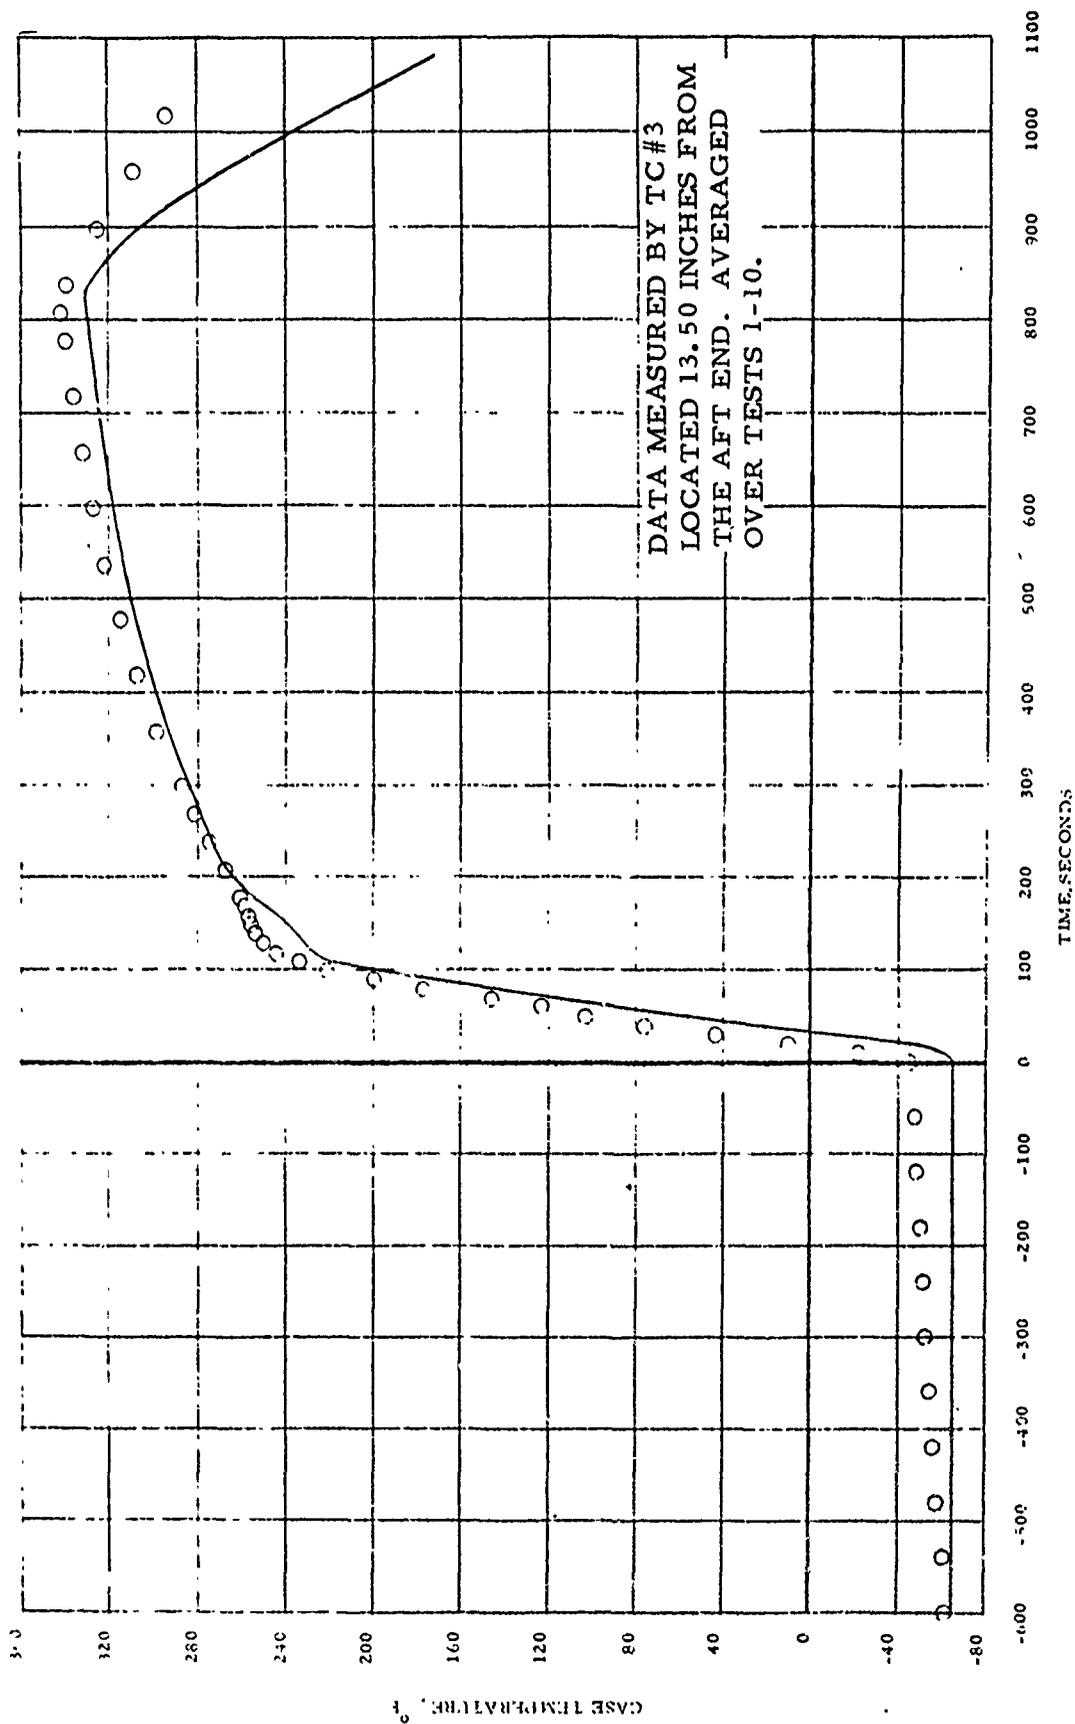
Figure 49. Comparison of Predicted and Measured Motor Case Temperatures

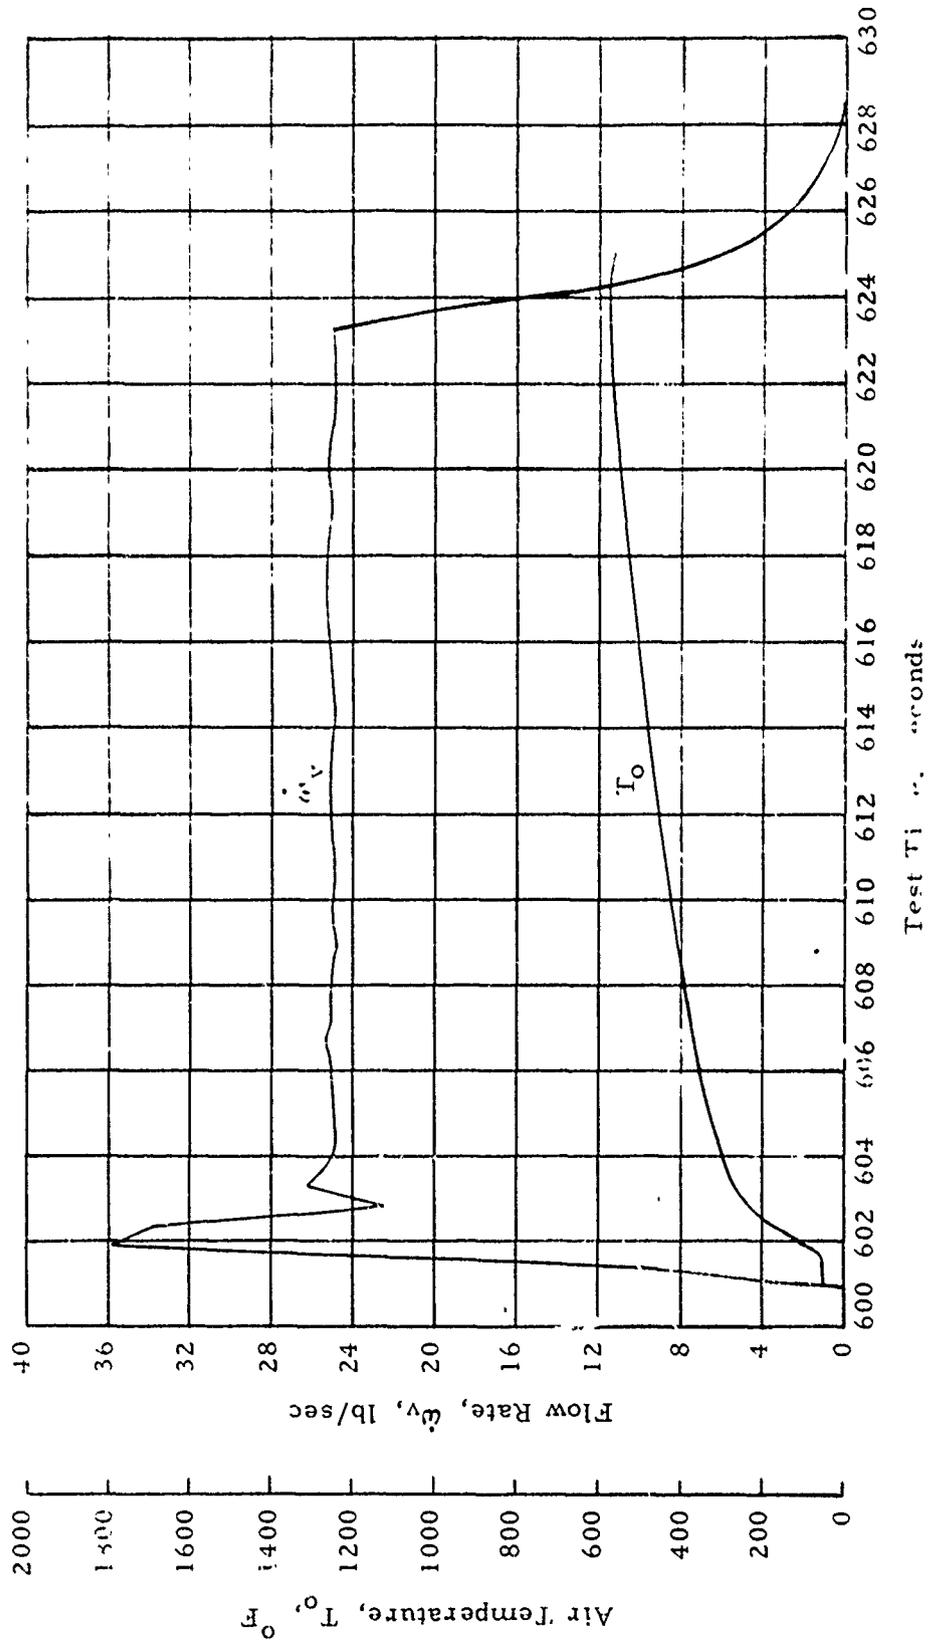
Figure 51. Typical Test Conditions for TS Mission Test 12

Three of the TS designated tests were conducted using this cycle and the bore was visually inspected after each test. The test conditions typical of the TS cycle are illustrated in terms of flow rate and air temperature on Figure 51. The extremely expanded time scale should be noted when comparing these conditions with the SFPI test conditions. Results of these tests in

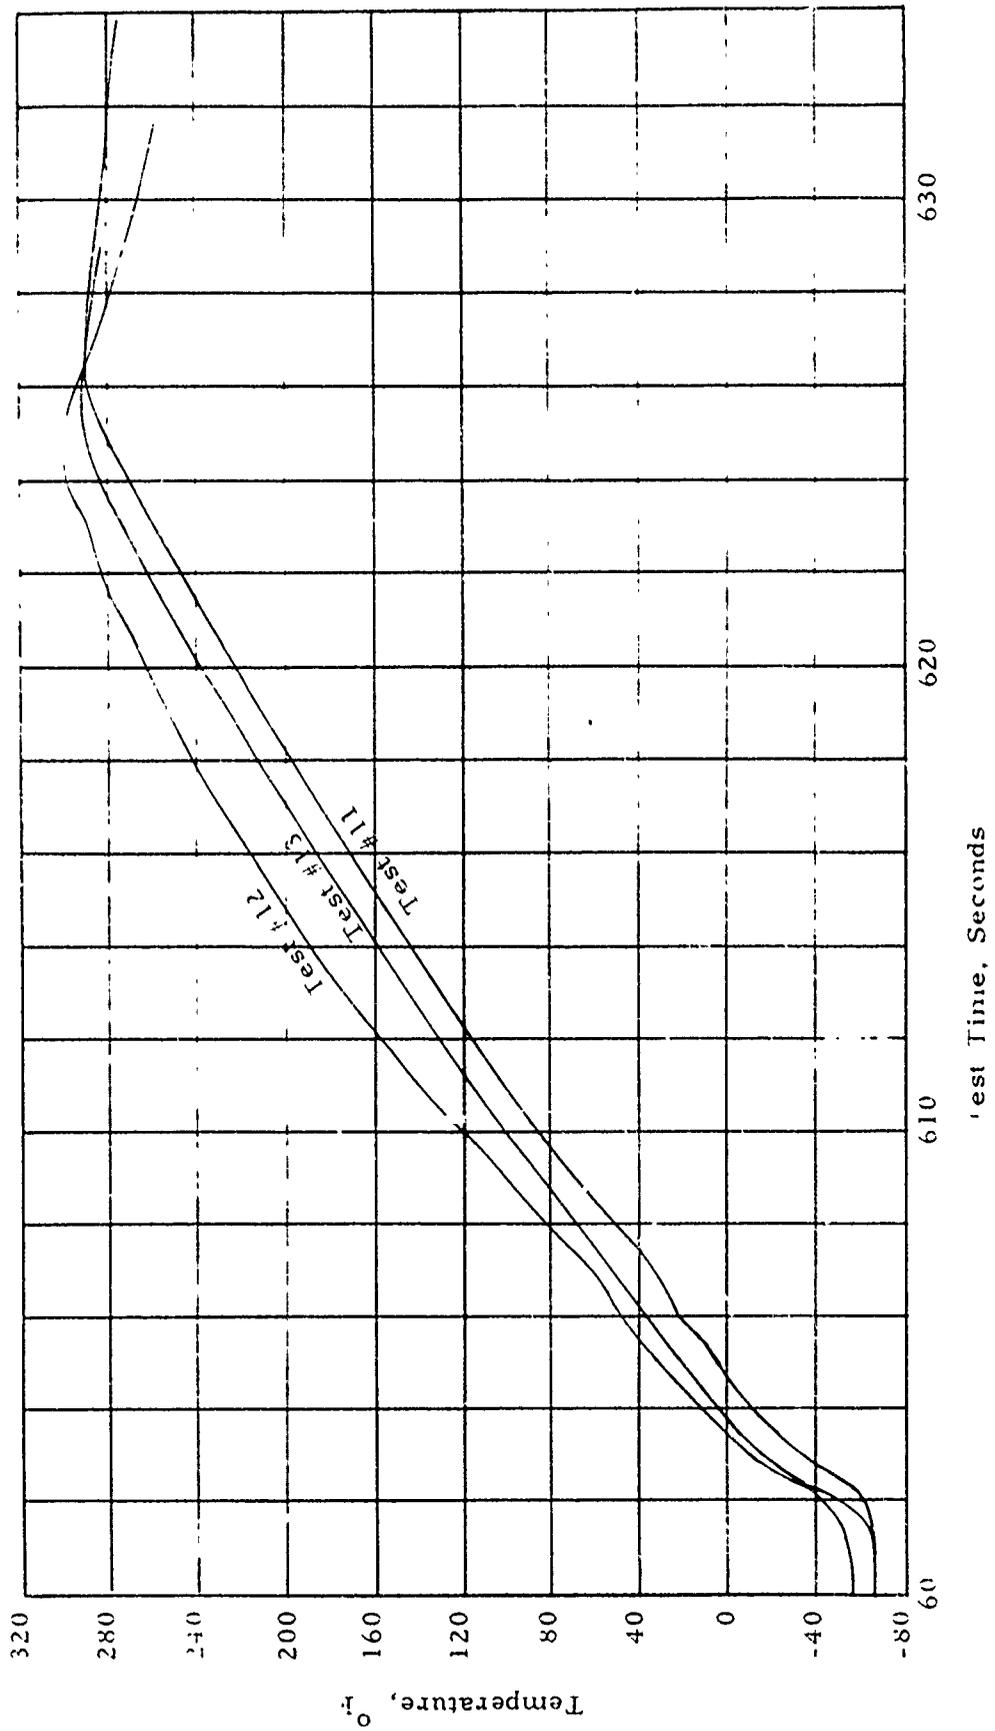
Figure 52. Motor Case Temperature Histories for the IS Series

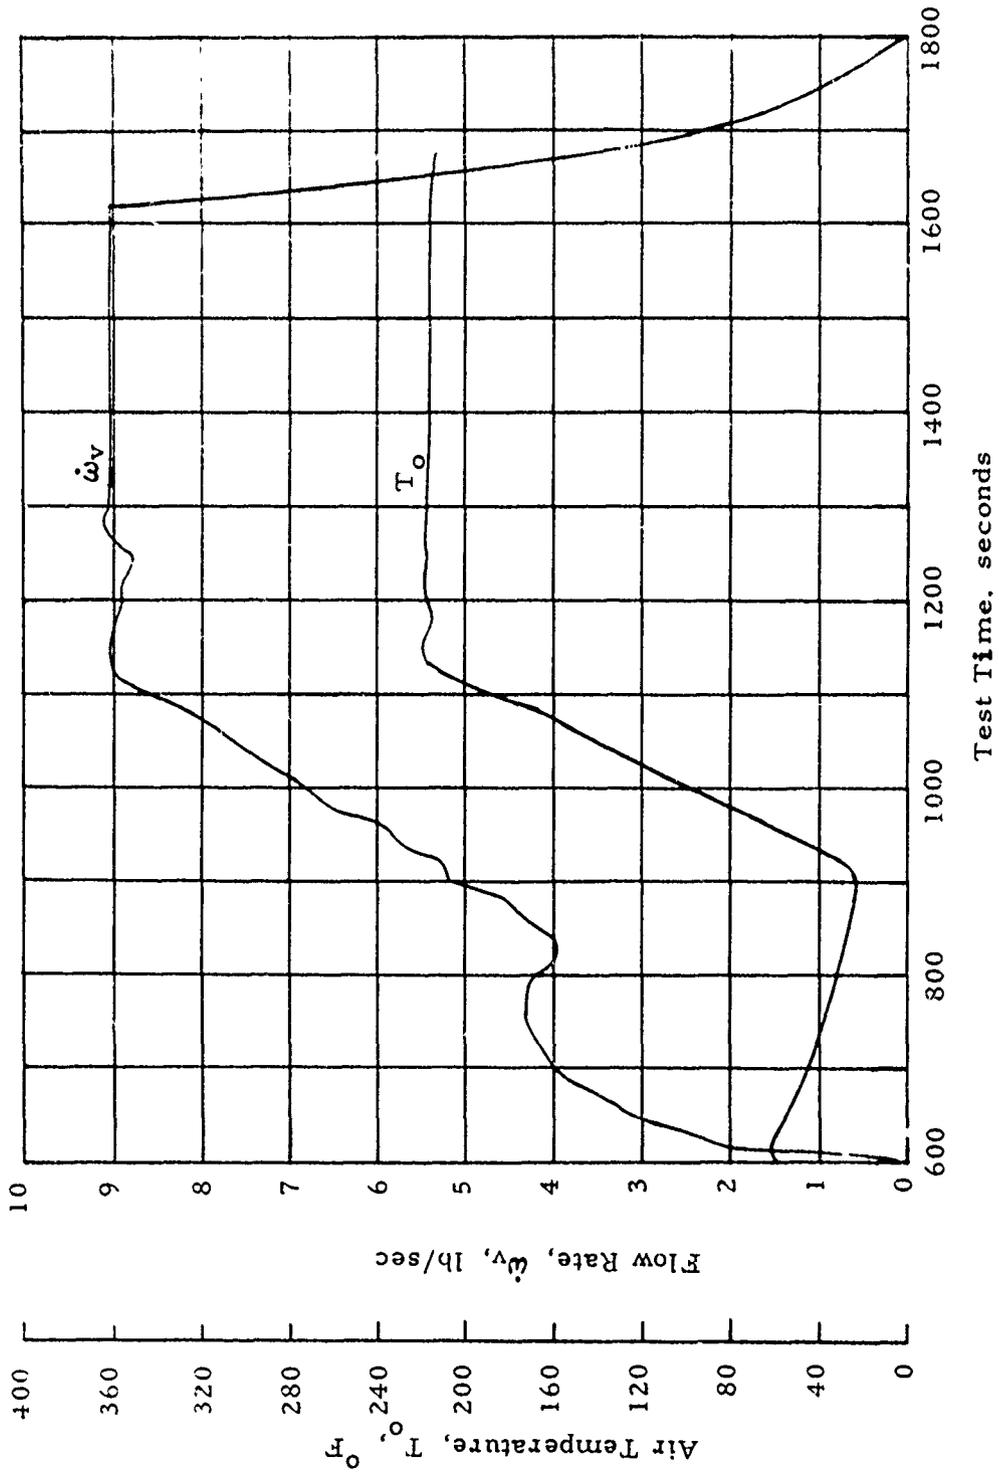
Figure 53. Typical Test Conditions for DMP-3 Mission - Test 17

Testing of UM #2, as shown on Table 7 began with the DMP-3 mission schedule. The corresponding test conditions in terms of flow rate and air temperature are shown on Figure 53. It is of interest to compare the actual case temperature histories with that predicted by THVINC for UM #2. Such a comparison is shown on Figure 54. Inasmuch as the comparison appears rather poor, we have taken the liberty to also show the cause on the same figure by presenting a comparison between actual and desired test air temperatures. The heat transfer coefficients have been matched very closely (i. e.  $h_{flight} \approx h_{test}$ ) and it is obvious that the case wall temperature mismatch corresponds very closely to the air temperature mismatch. The reason that

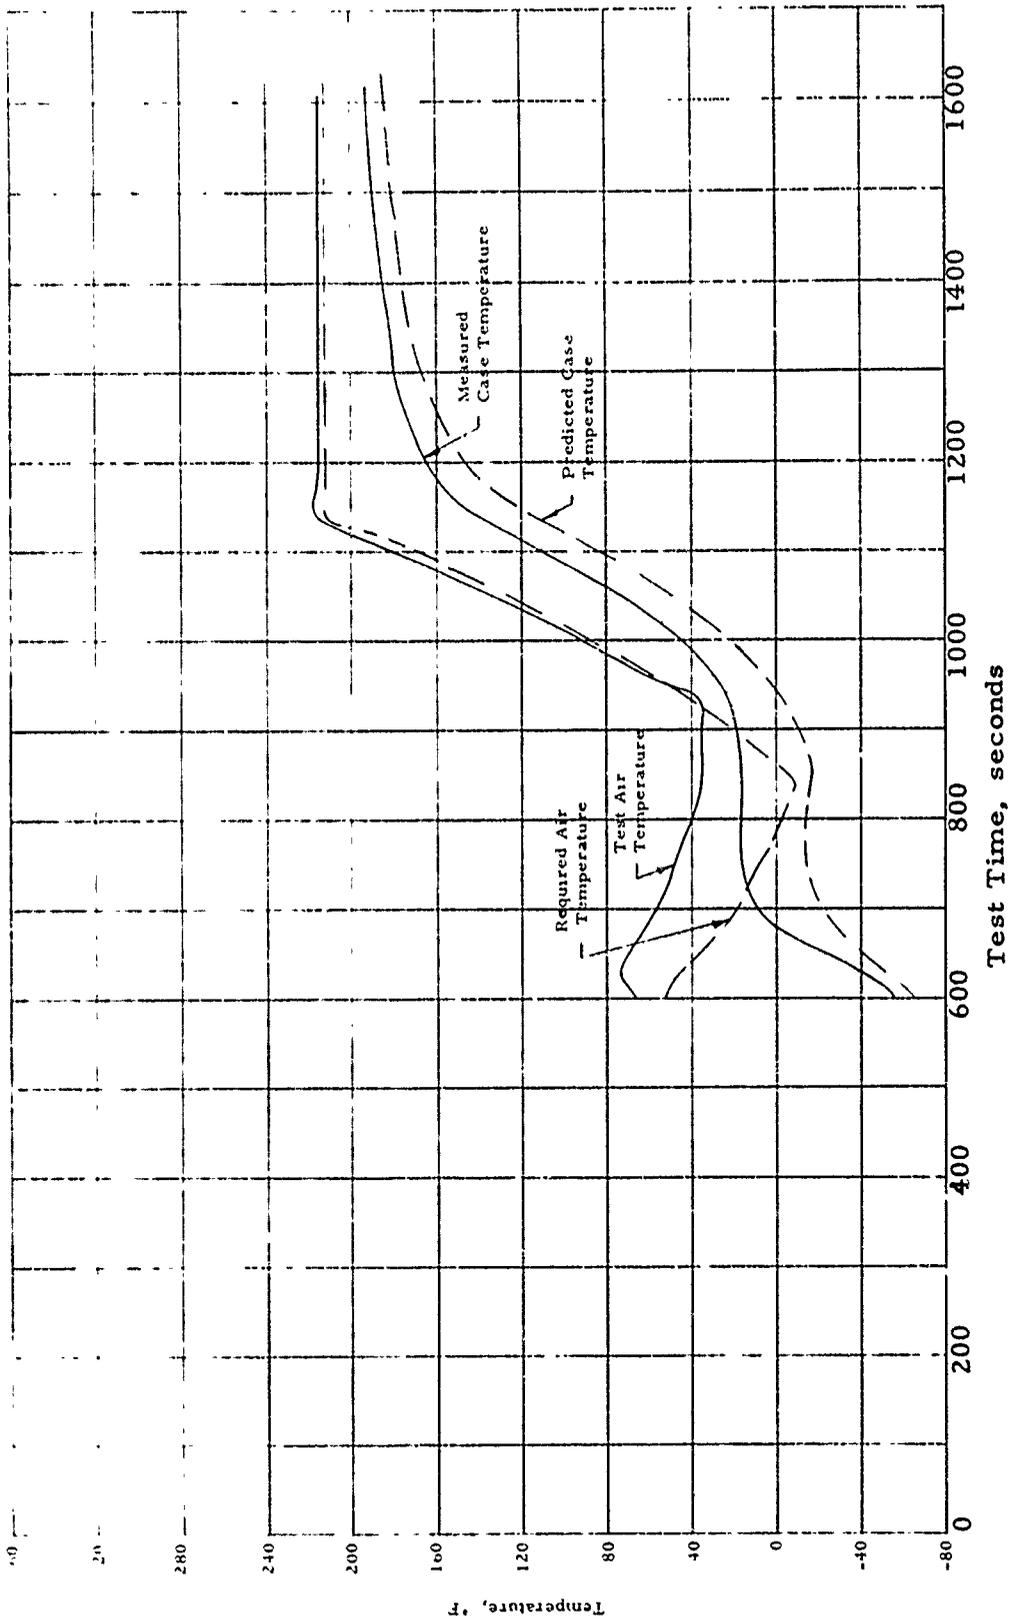
Figure 54. Comparison of Predicted and Measured Motor Case Temperature for the DMP-3 Mission Test No. 14, JM #2

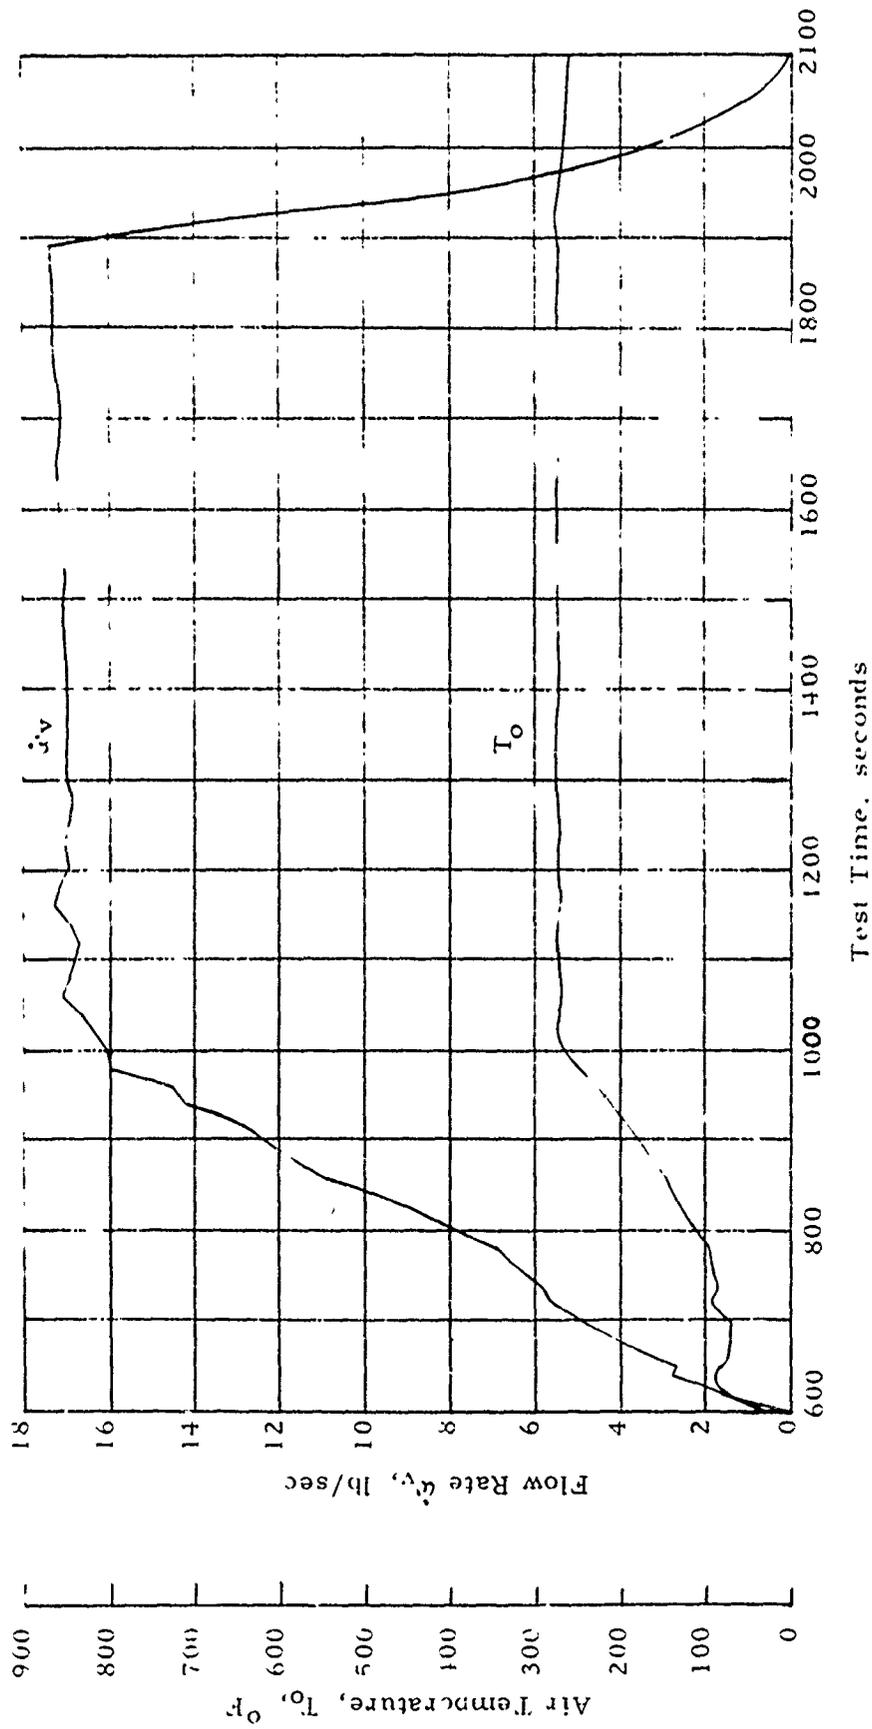
Figure 54A. Typical Test Conditions for HSMH Test Mission

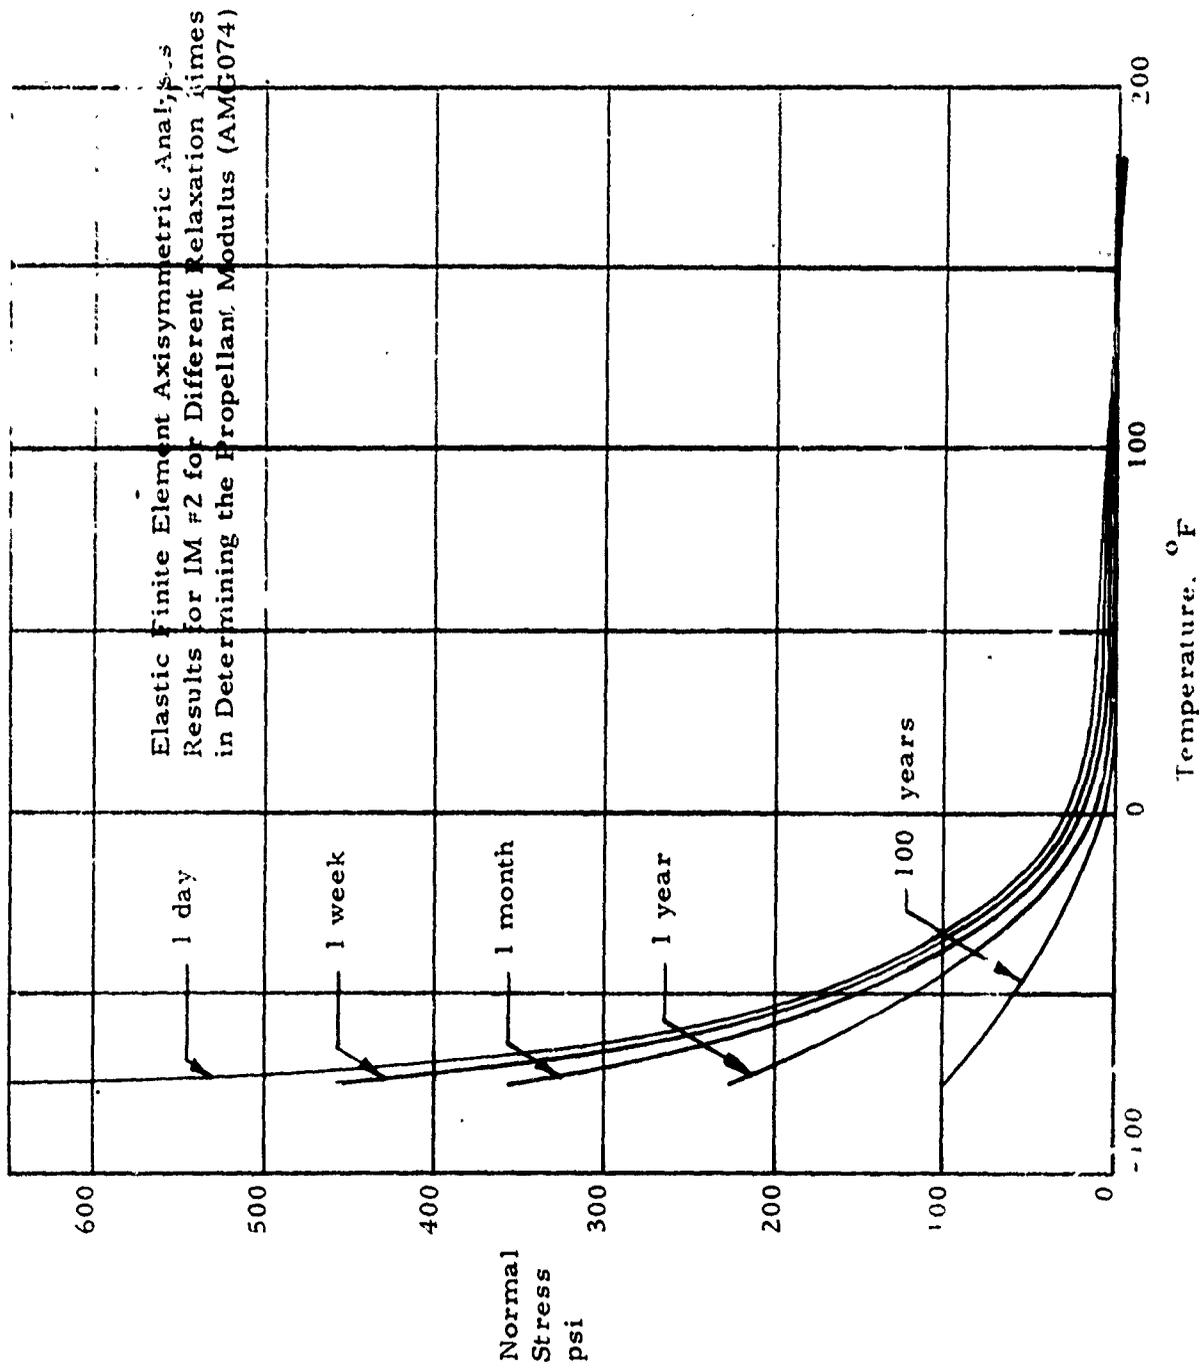
Figure 60. Normal Stress Elastic Analysis results

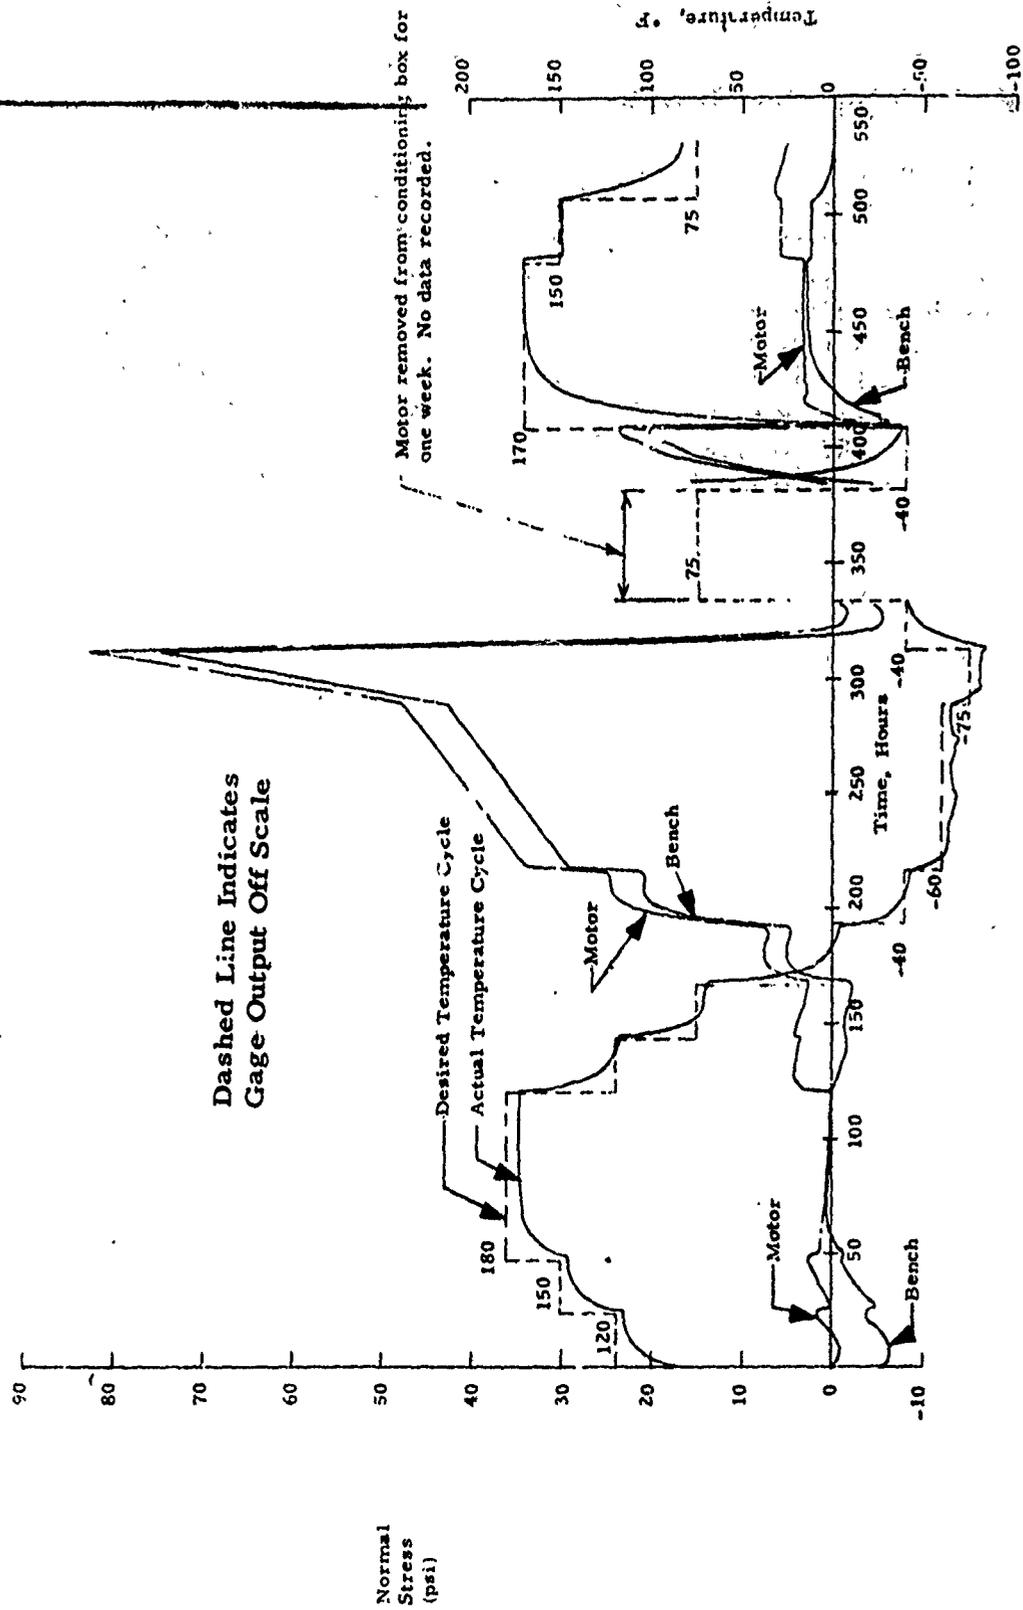
Figure 61. Measured Normal Stress Results for Motor and Bench Calibration of Gage N2-51

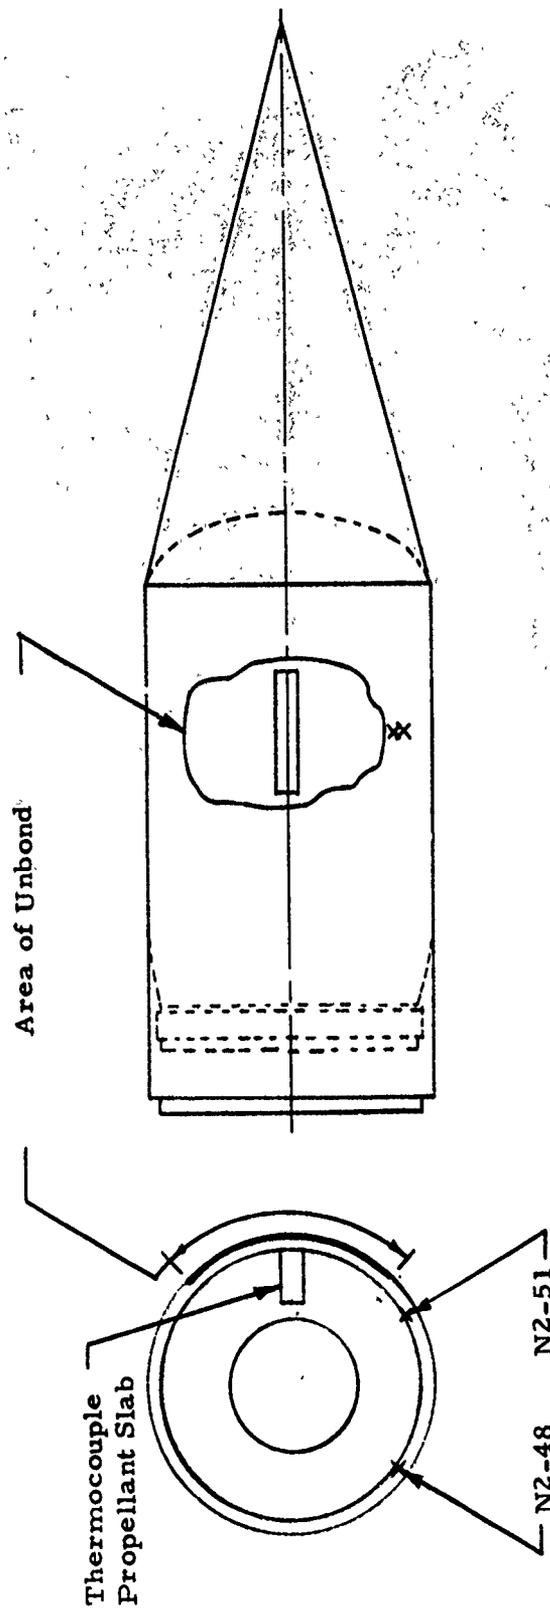
Figure 63. Schematic Showing Location of Failure

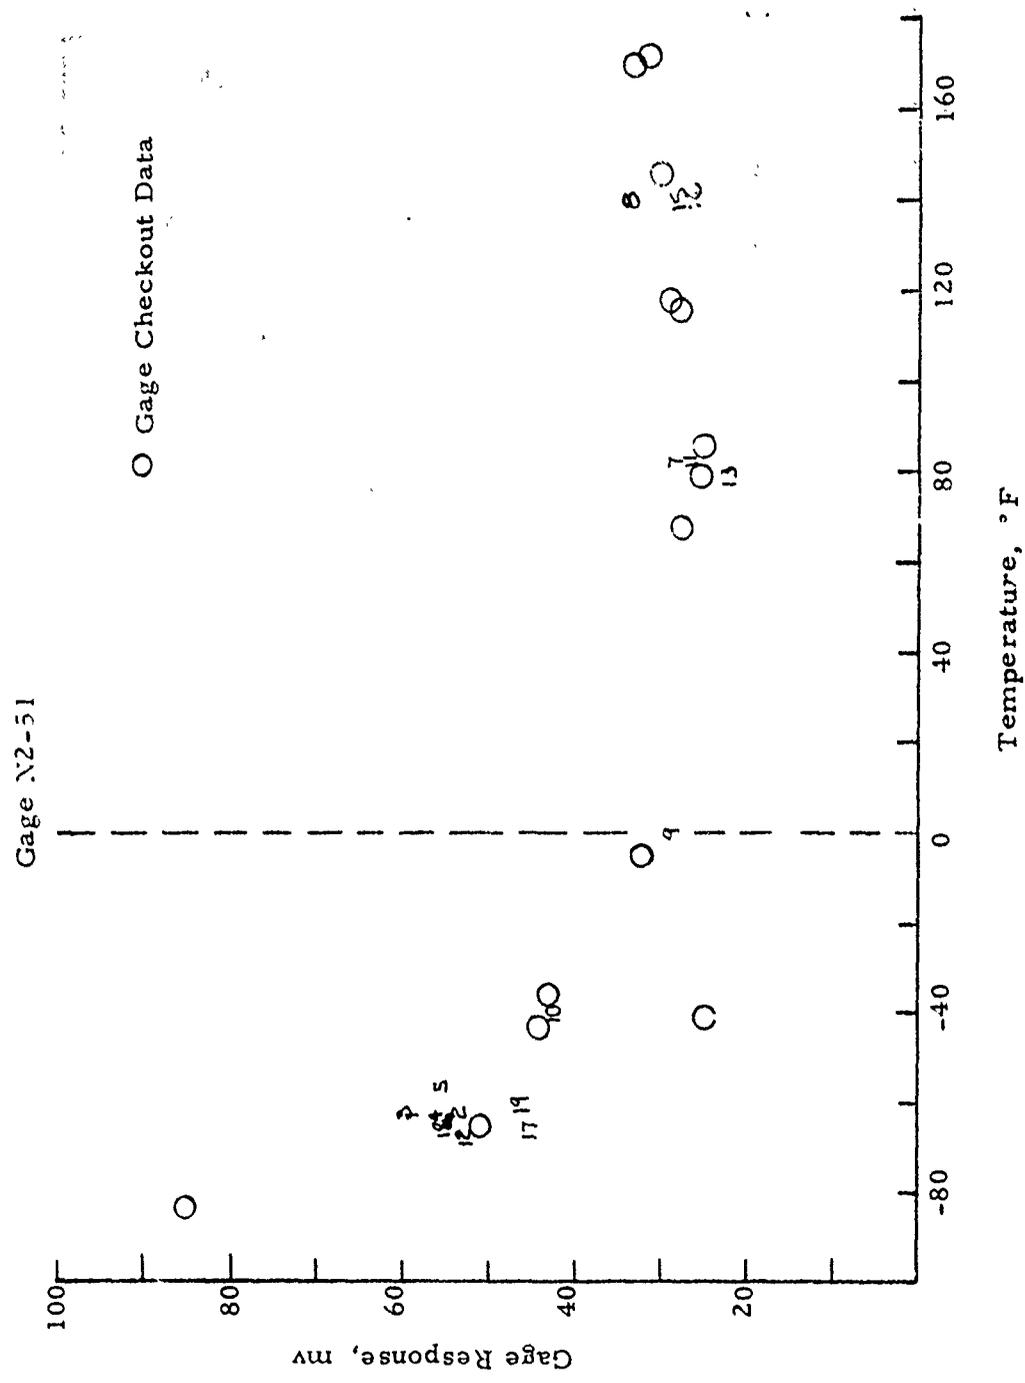
Figure 64. Gage N2-51 Output as a Function of Motor Temperature

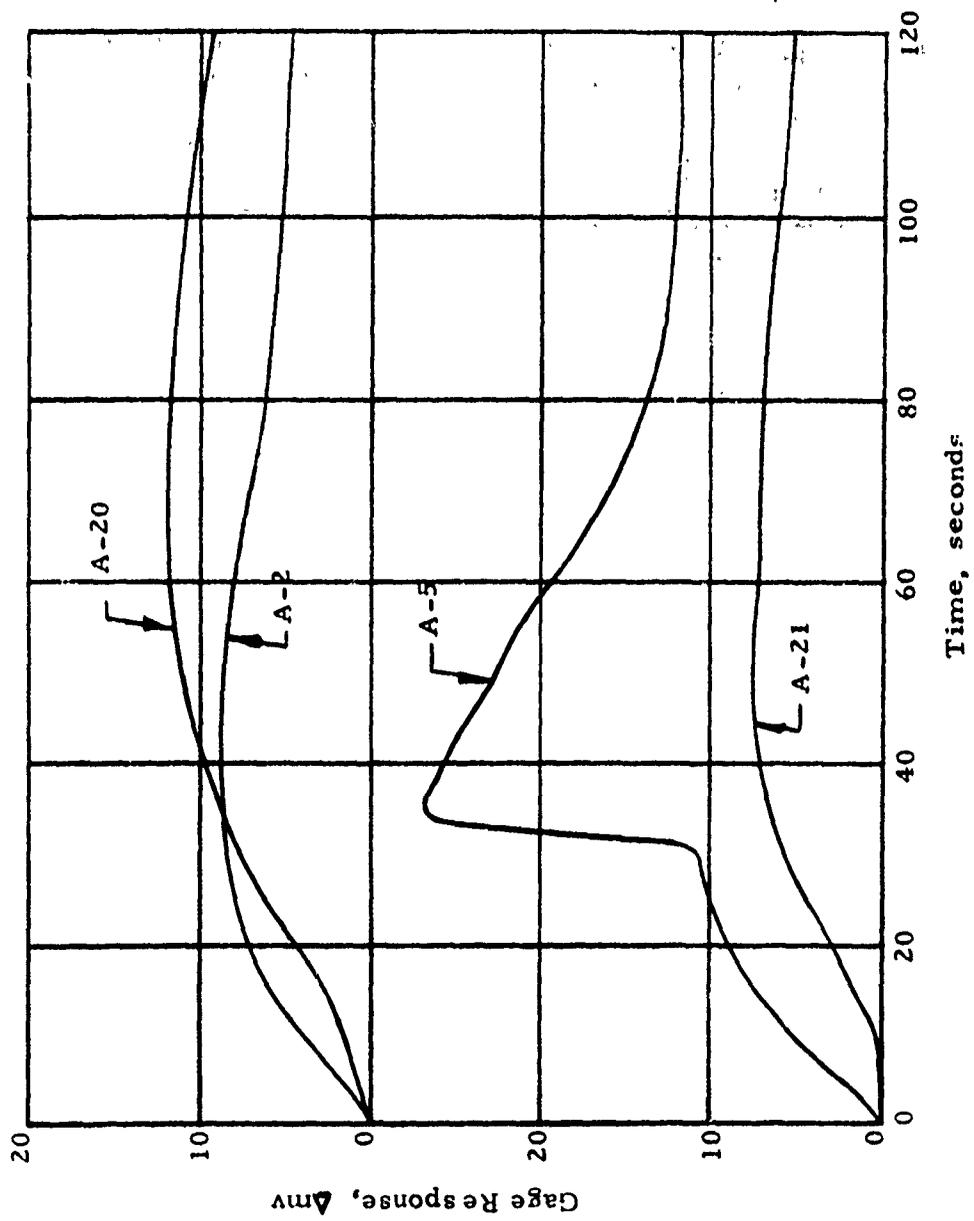
Figure 68. Comparison of Gage N2-51 Response for Tests A-2 and A-20 and Tests A-5 and A-21.

The results of these two tests as compared to their appropriate counterparts are shown on Figure 68. These data offer no conclusive proof that failure occurred or did not occur on the initial SFPI tests. Certainly there are no significant difference between the two DMP-3 tests. Somewhat faster response is found on Test 2; however, this is offset by the higher output levels induced in Test 20. On the other hand, Test 21 (HSMH) shows essentially little response as compared to Test 5 and even more surprising less response than Test 20. It almost appears that the motor had reached a point

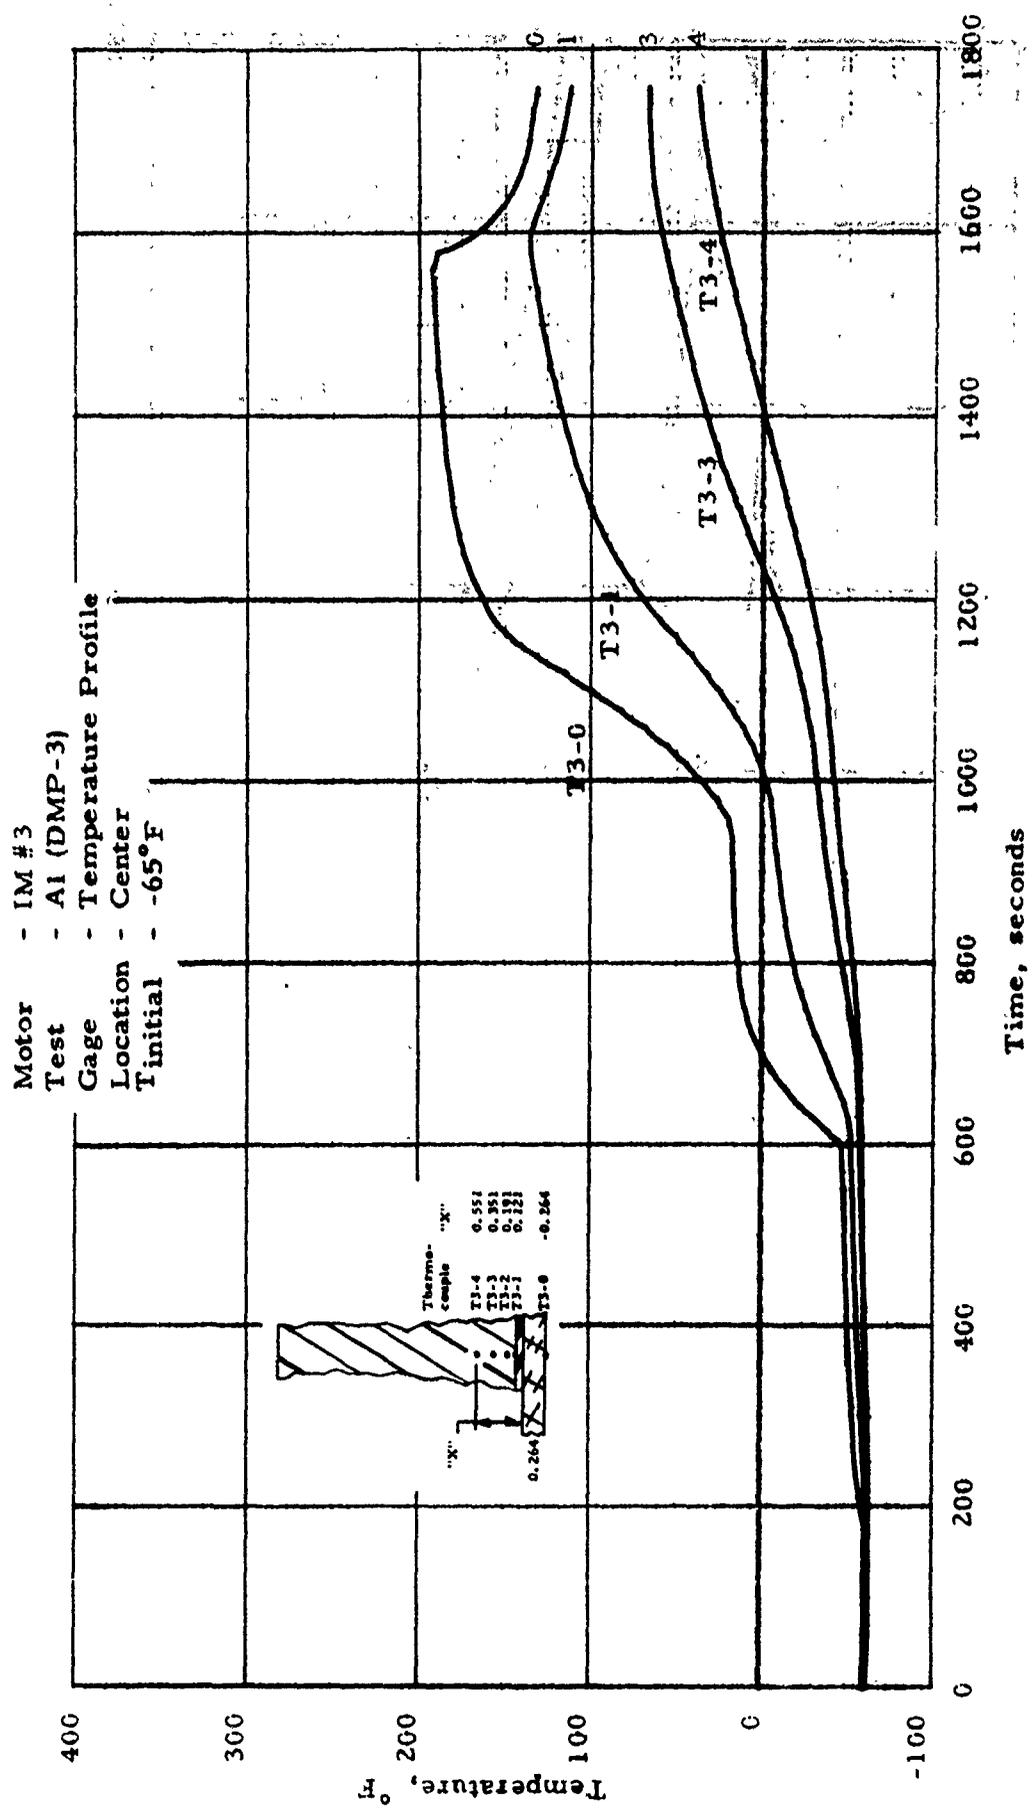
Figure 75 Temperature Profile Histories for Various Aeroheat Loads (Test No. A-1)

Typical temperature profile histories for each test condition (i. e. Tests 1, 4-9, 12) are presented on Figures 75-81. These data provide an assessment of the severity of the aeroheat tests. Severity can be examined in two ways. First, the rate of the temperature rise on the case can be interpreted as an indication of induced stress rise. Second, the overall temperature levels reached at the case, liner interface (basically Thermocouple T3-0) and at the propellant-liner interface (Thermocouple T3-1) provide an assessment of potential thermally induced bond system damage. Both of these aspects are important in a review of the data. Another important facet is the excellent repeatability on Tests 3, 11 and 17 as well as Tests 12-16. Since these tests were conducted to examine repeatability of gage output and to provide baseline data, that purpose was well satisfied. Of course, the temperature data show how well the test conditions and thus the induced loads were duplicated.

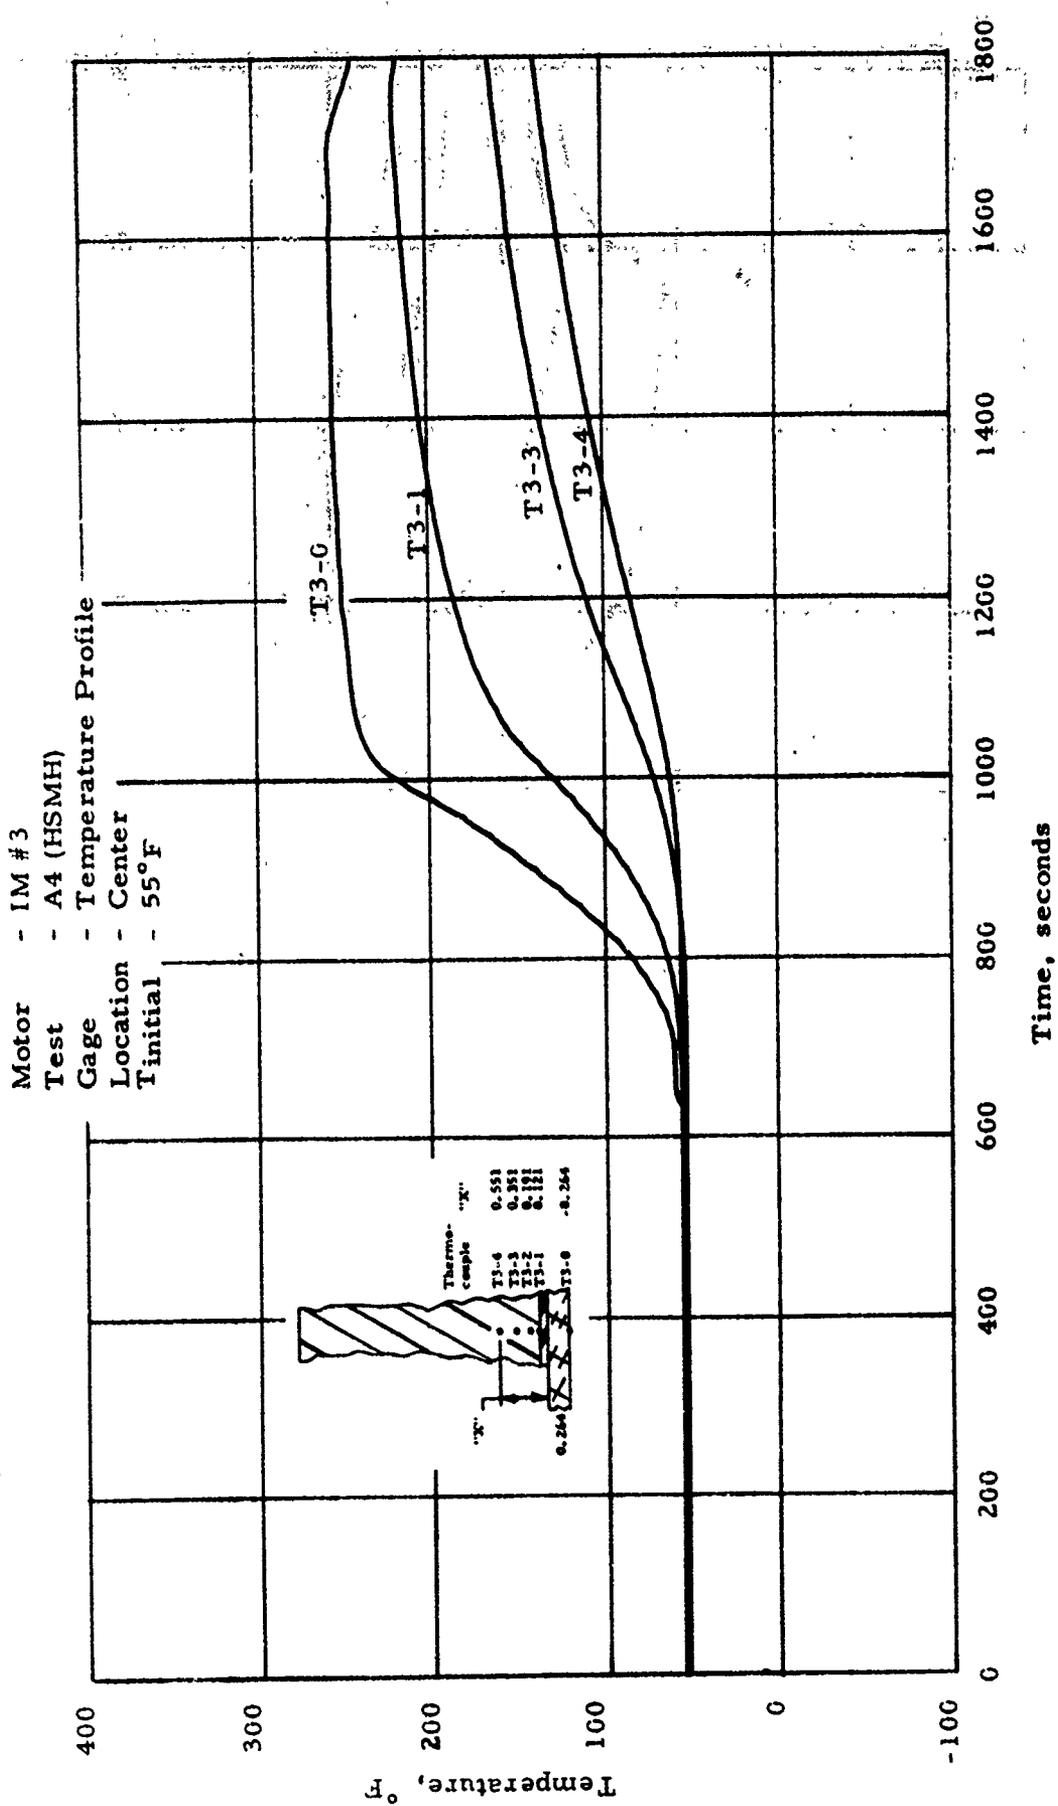
Figure 76 Temperature Profile Histories for Various Aeroheat Loads (Test No. A-4)
