SIMULATED AIR LAUNCH ENVIRONMENT  
FINAL REPORT FOR PERIOD SEPT. 72 THROUGH MAY 74

THIOL CORPORATION  
HUNTSVILLE DIVISION  
HUNTSVILLE, ALABAMA 35807

OCTOBER 1974

VOLUME I: TECHNICAL REPORT

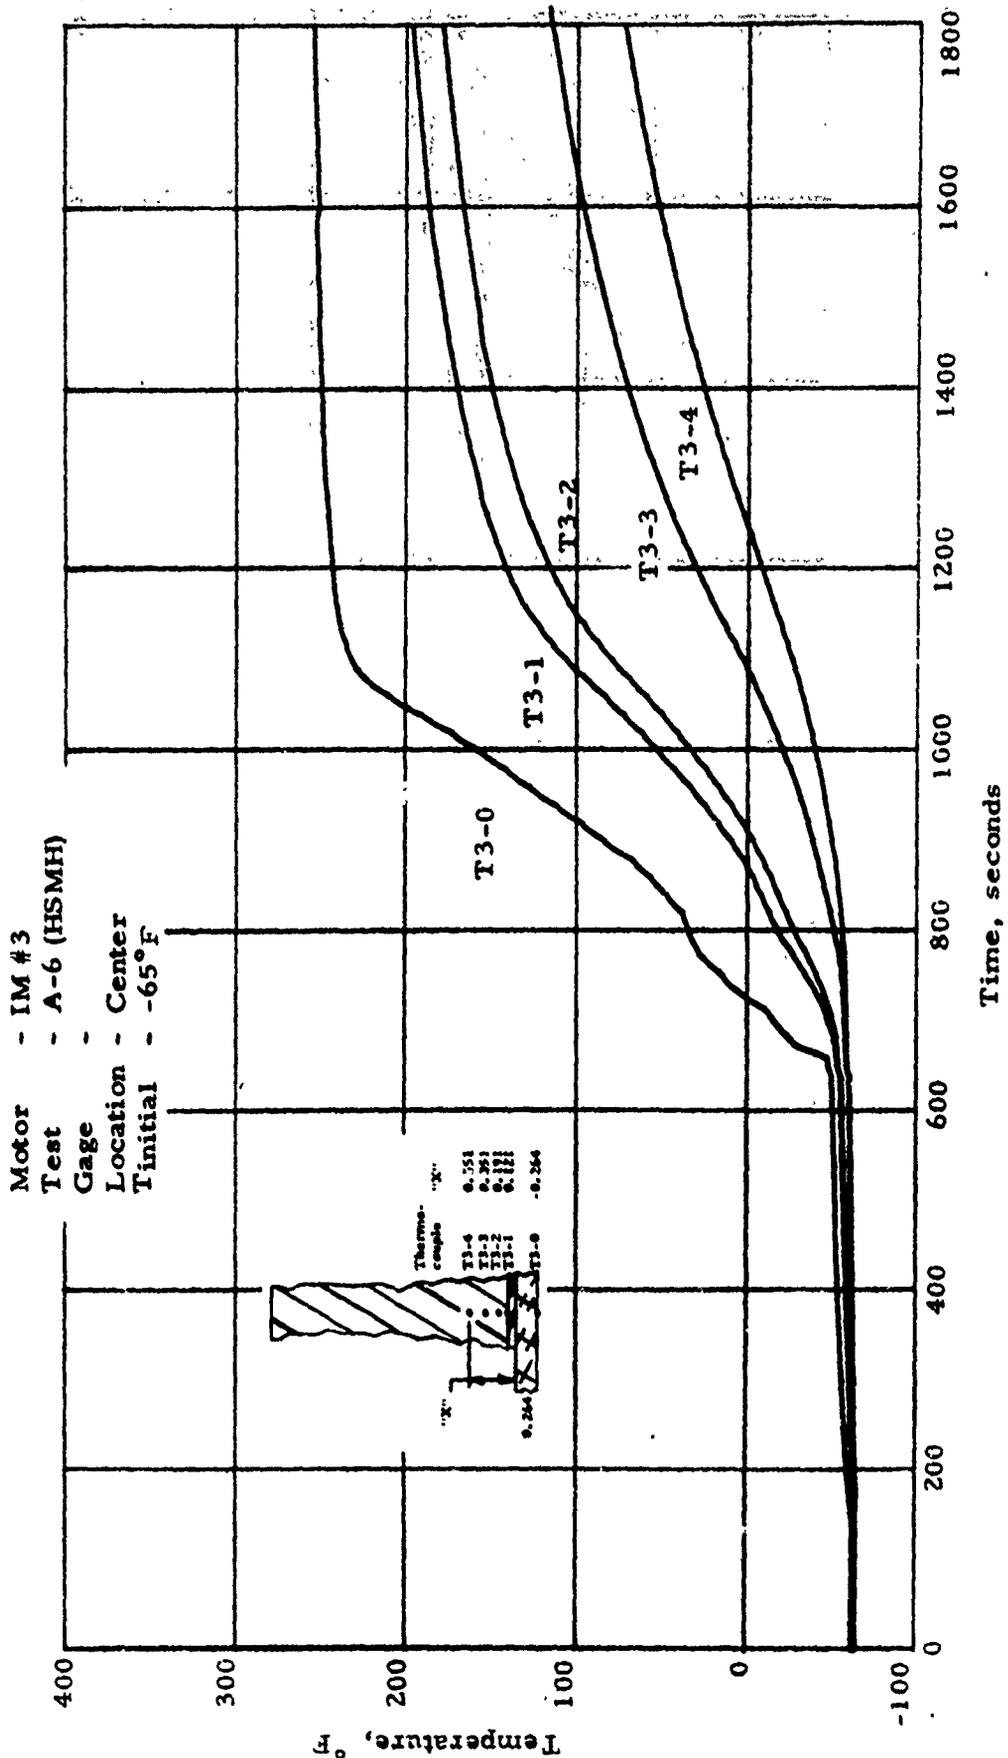
Figure 77 Temperature Profile Histories for Various Aeroheat Loads (Test No. A-6)

Typical temperature profile histories for each test condition (i. e. Tests 1, 4-9, 12) are presented on Figures 75-81. These data provide an assessment of the severity of the aeroheat tests. Severity can be examined in two ways. First, the rate of the temperature rise on the case can be interpreted as an indication of induced stress rise. Second, the overall temperature levels reached at the case, liner interface (basically Thermocouple T3-0) and at the propellant-liner interface (Thermocouple T3-1) provide an assessment of potential thermally induced bond system damage. Both of these aspects are important in a review of the data. Another important facet is the excellent repeatability on Tests 3, 11 and 17 as well as Tests 12-16. Since these tests were conducted to examine repeatability of gage output and to provide baseline data, that purpose was well satisfied. Of course, the temperature data show how well the test conditions and thus the induced loads were duplicated.

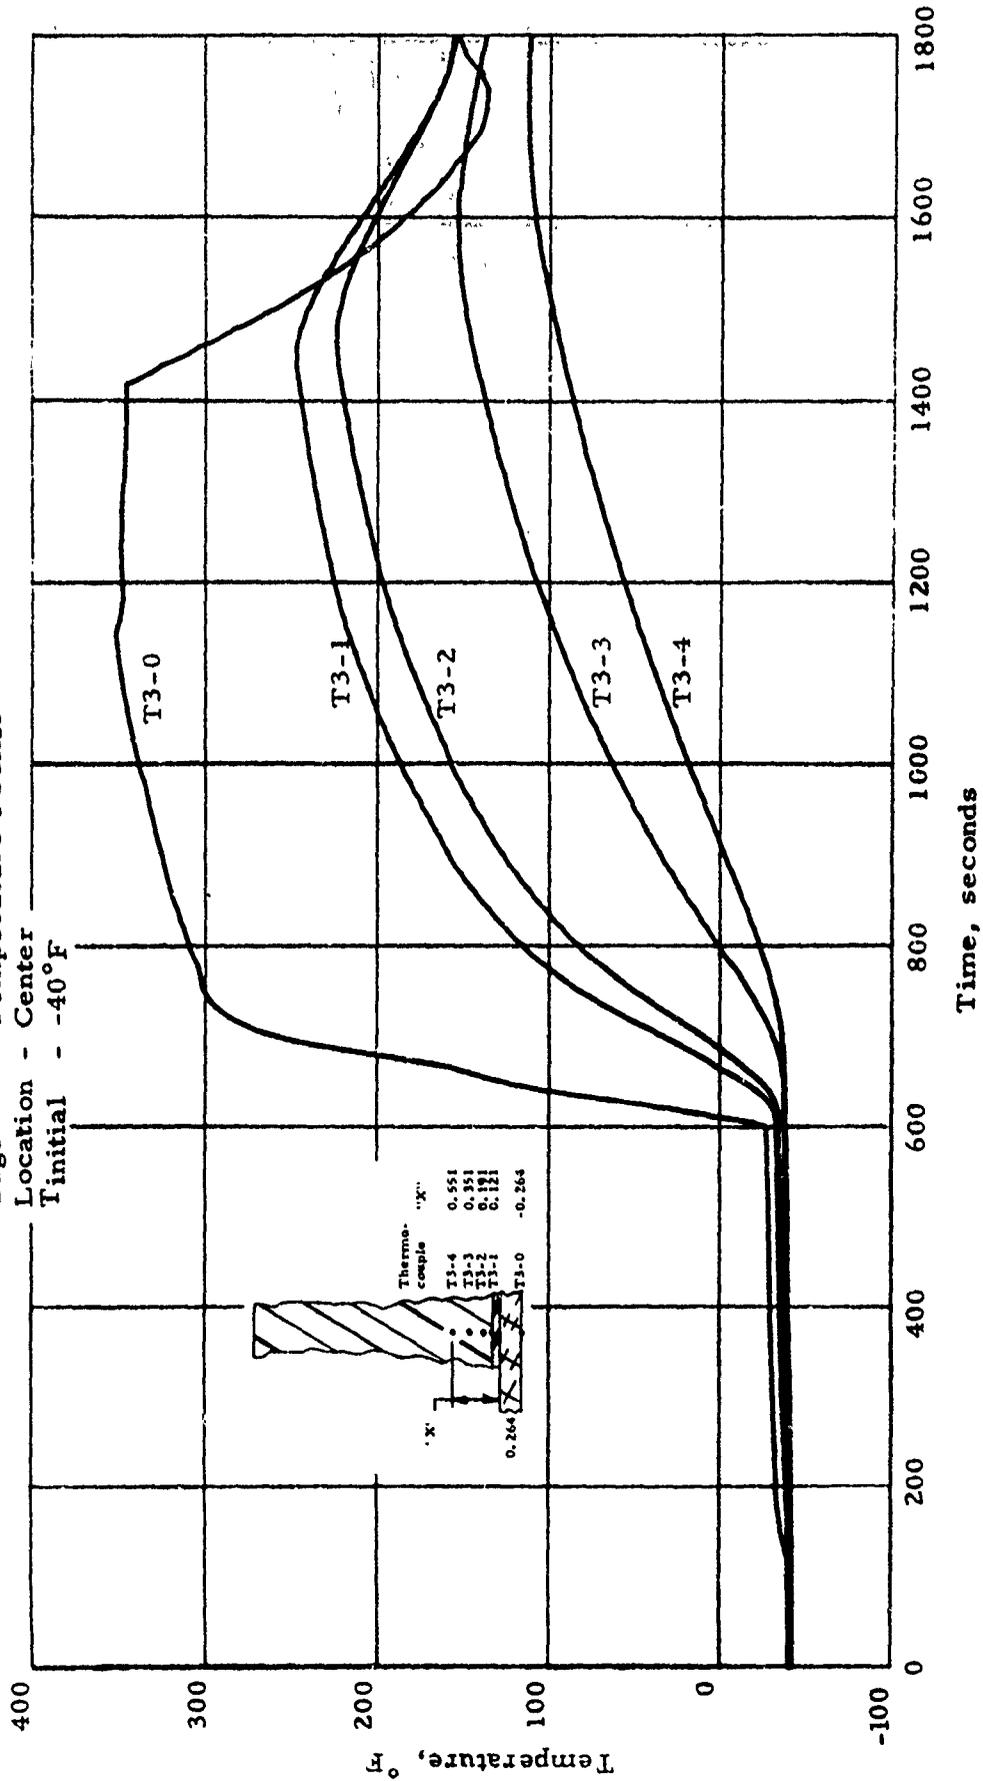
Figure 80 Temperature Profile Histories for Various Aeroheat Loads

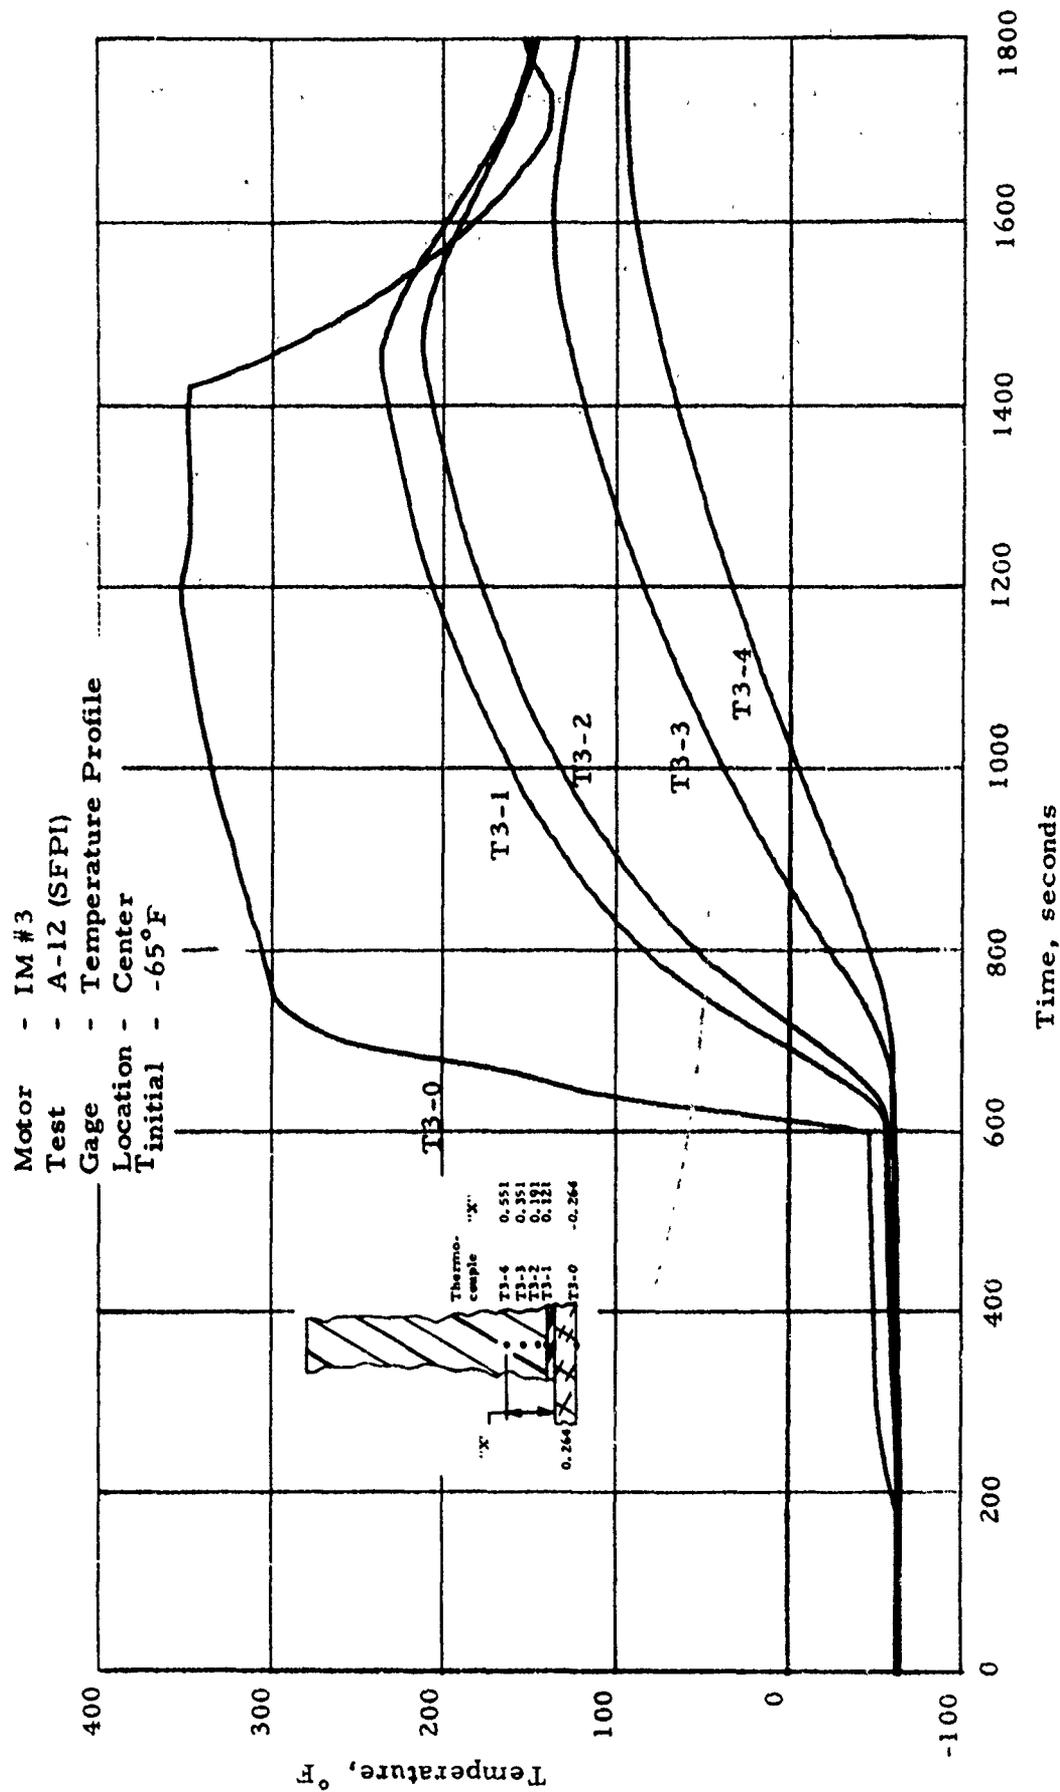
Figure 81 Temperature Profile Histories for Various Aeroheat Loads

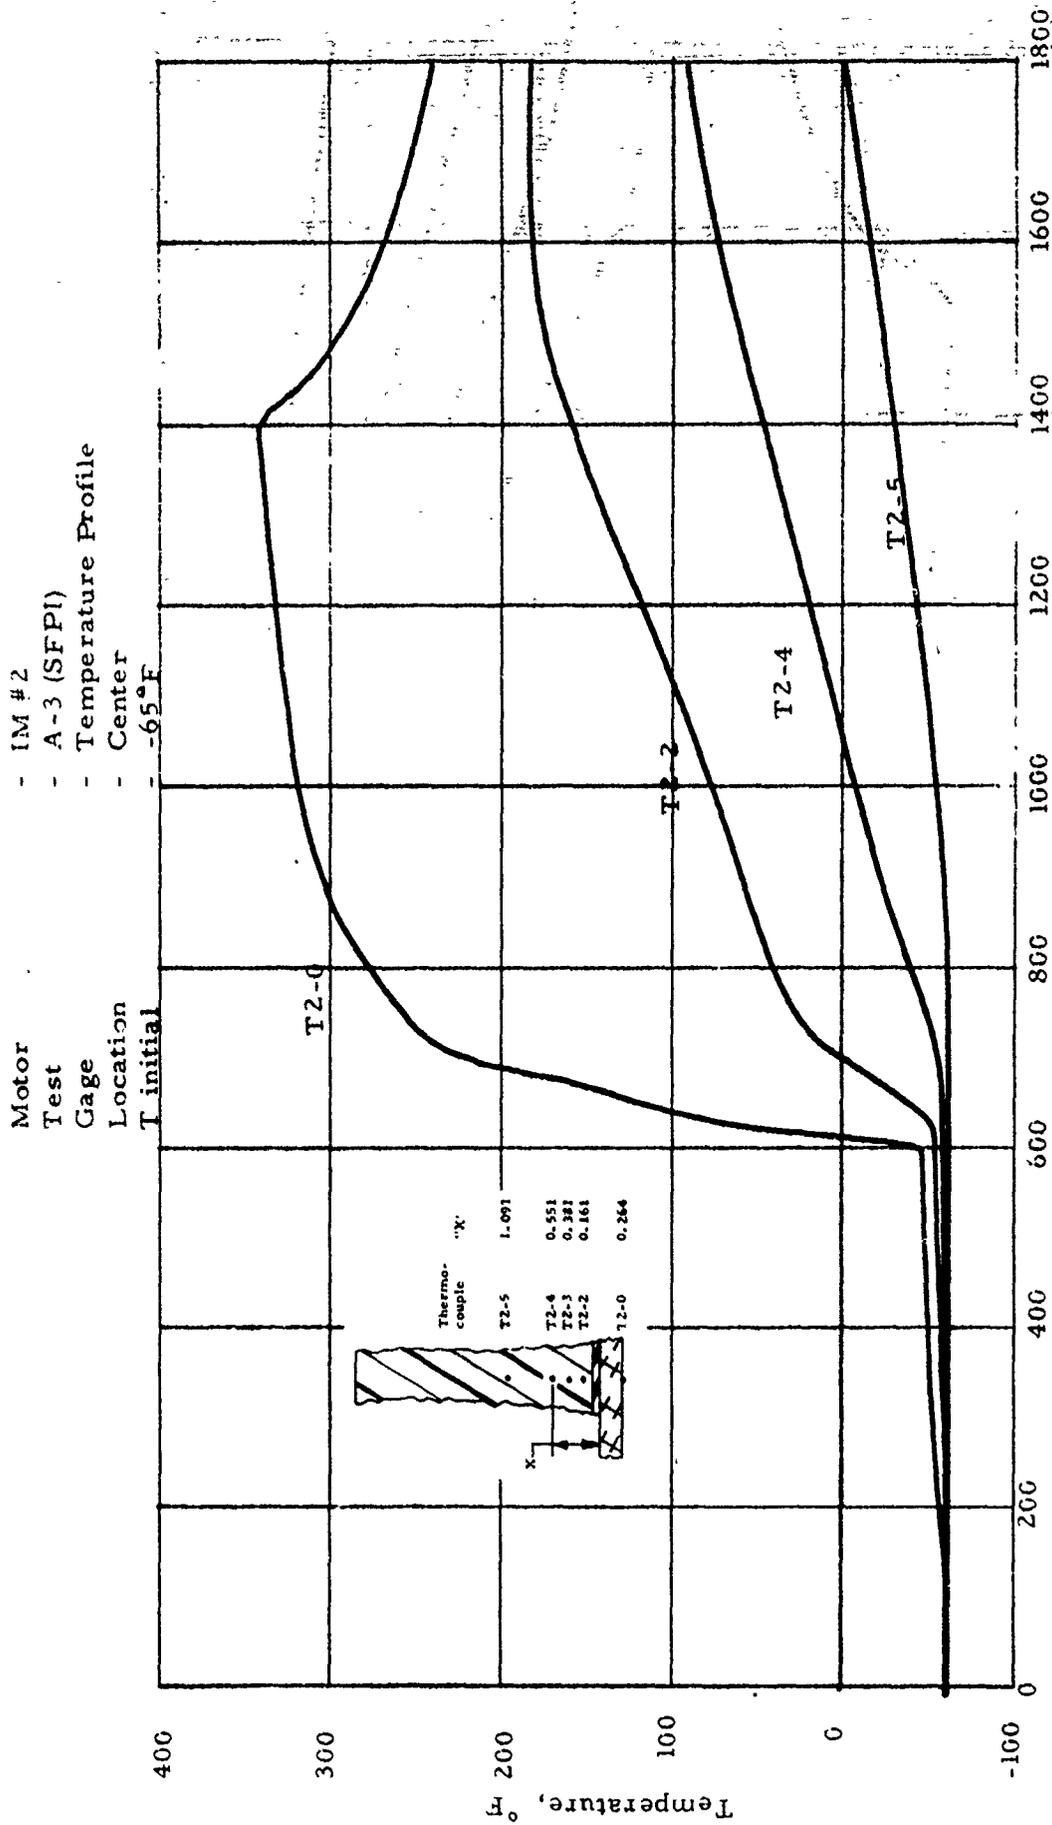
Figure 82 Temperature Profile Histories for Various Aeroheat Loads. Test A-3

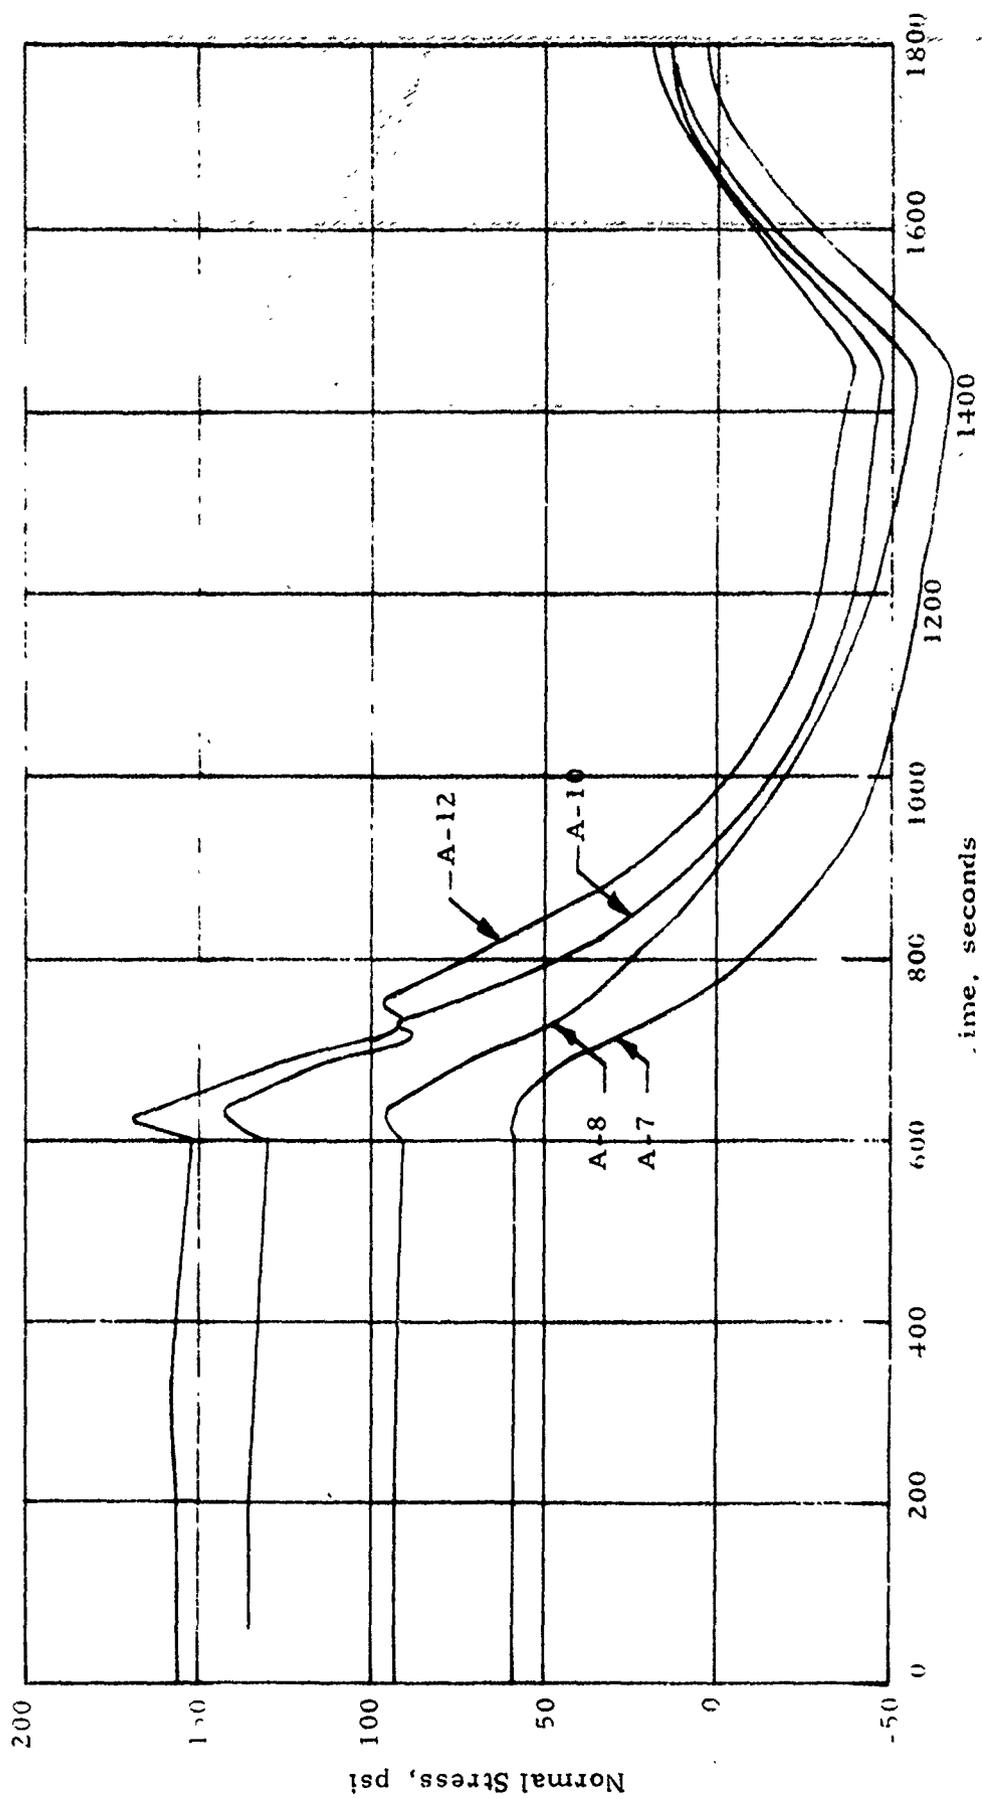
Figure 86. Effect of Decreasing Initial Motor Temperature. --Cage 3-43, SFPI Profile

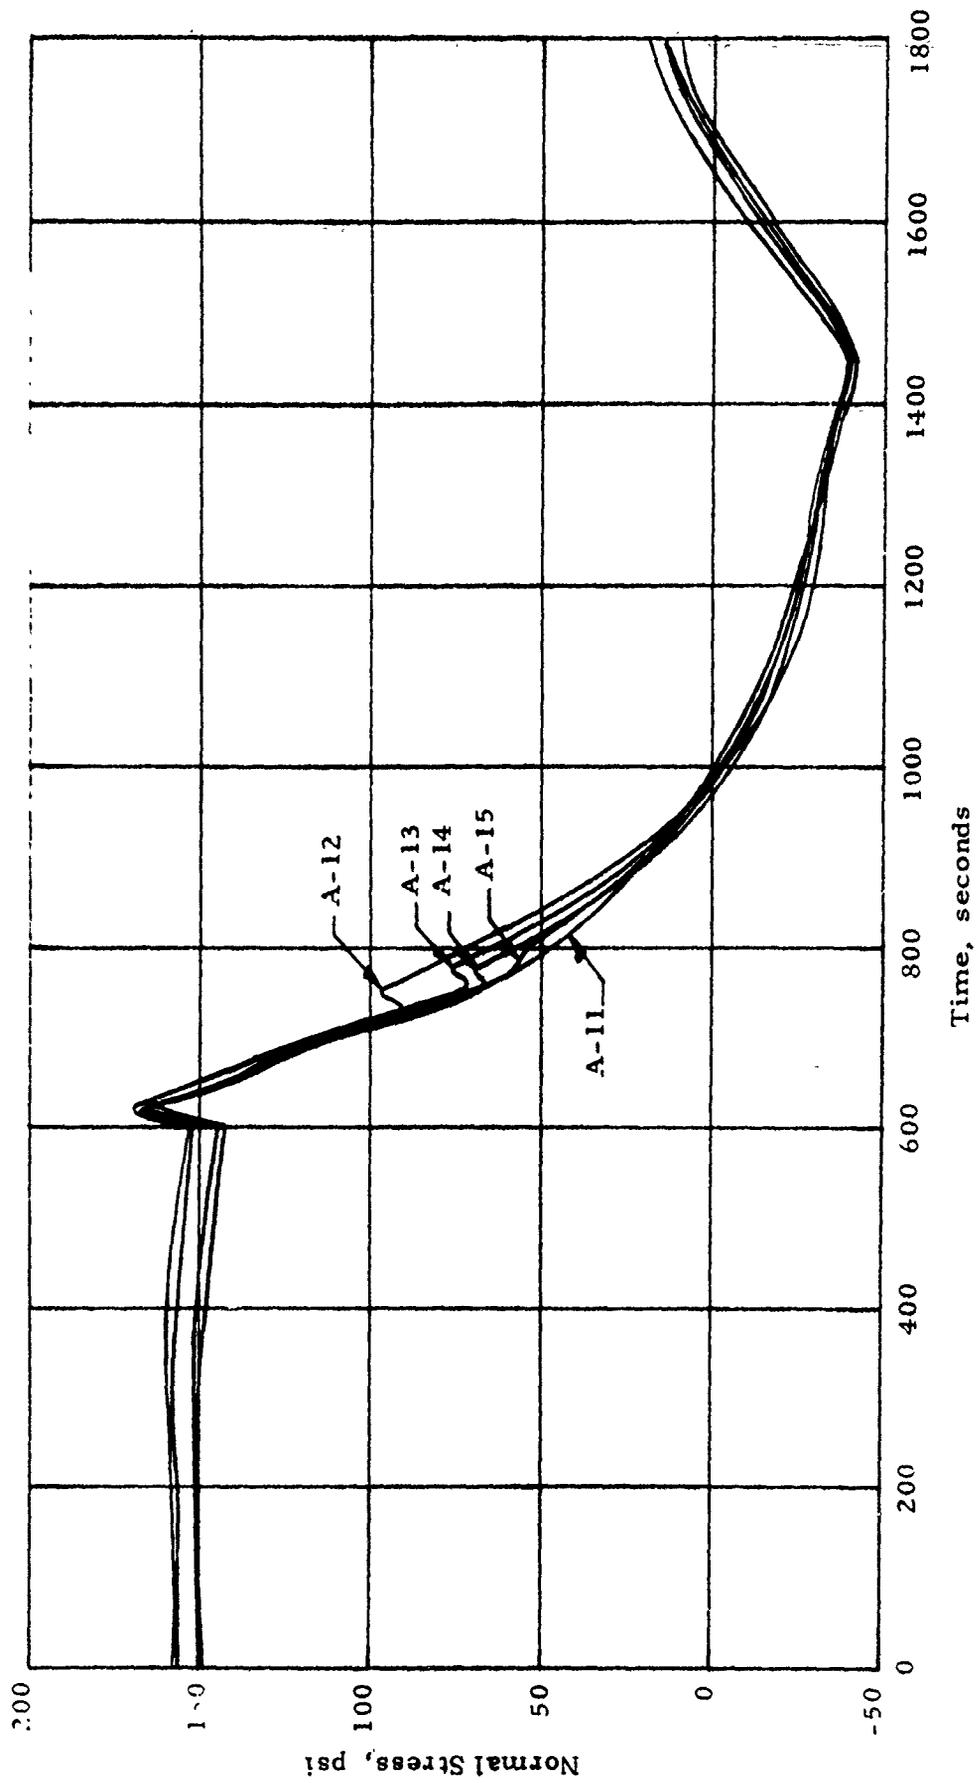
Figure 87. Comparison of Results from Successive SFPI Tests--Gage N3-43

Typical results from the two normal gages located in the center section of the motors are presented on Figures 84-89. Since both gages (N3-43 and N3-47) are located at the same radial and longitudinal positions (differ only in circumferential location) similar results would be expected. This similarity does exist throughout these tests. Upon examination of Figure 84, we can see that these gages compare well over the first three tests (repeatability of each gage is excellent), although there is a tendency of Gage N3-43 to measure a higher stress on the secondary peak than Gage N3-47. This could have been caused by one of a number of reasons from a poor gage to different local

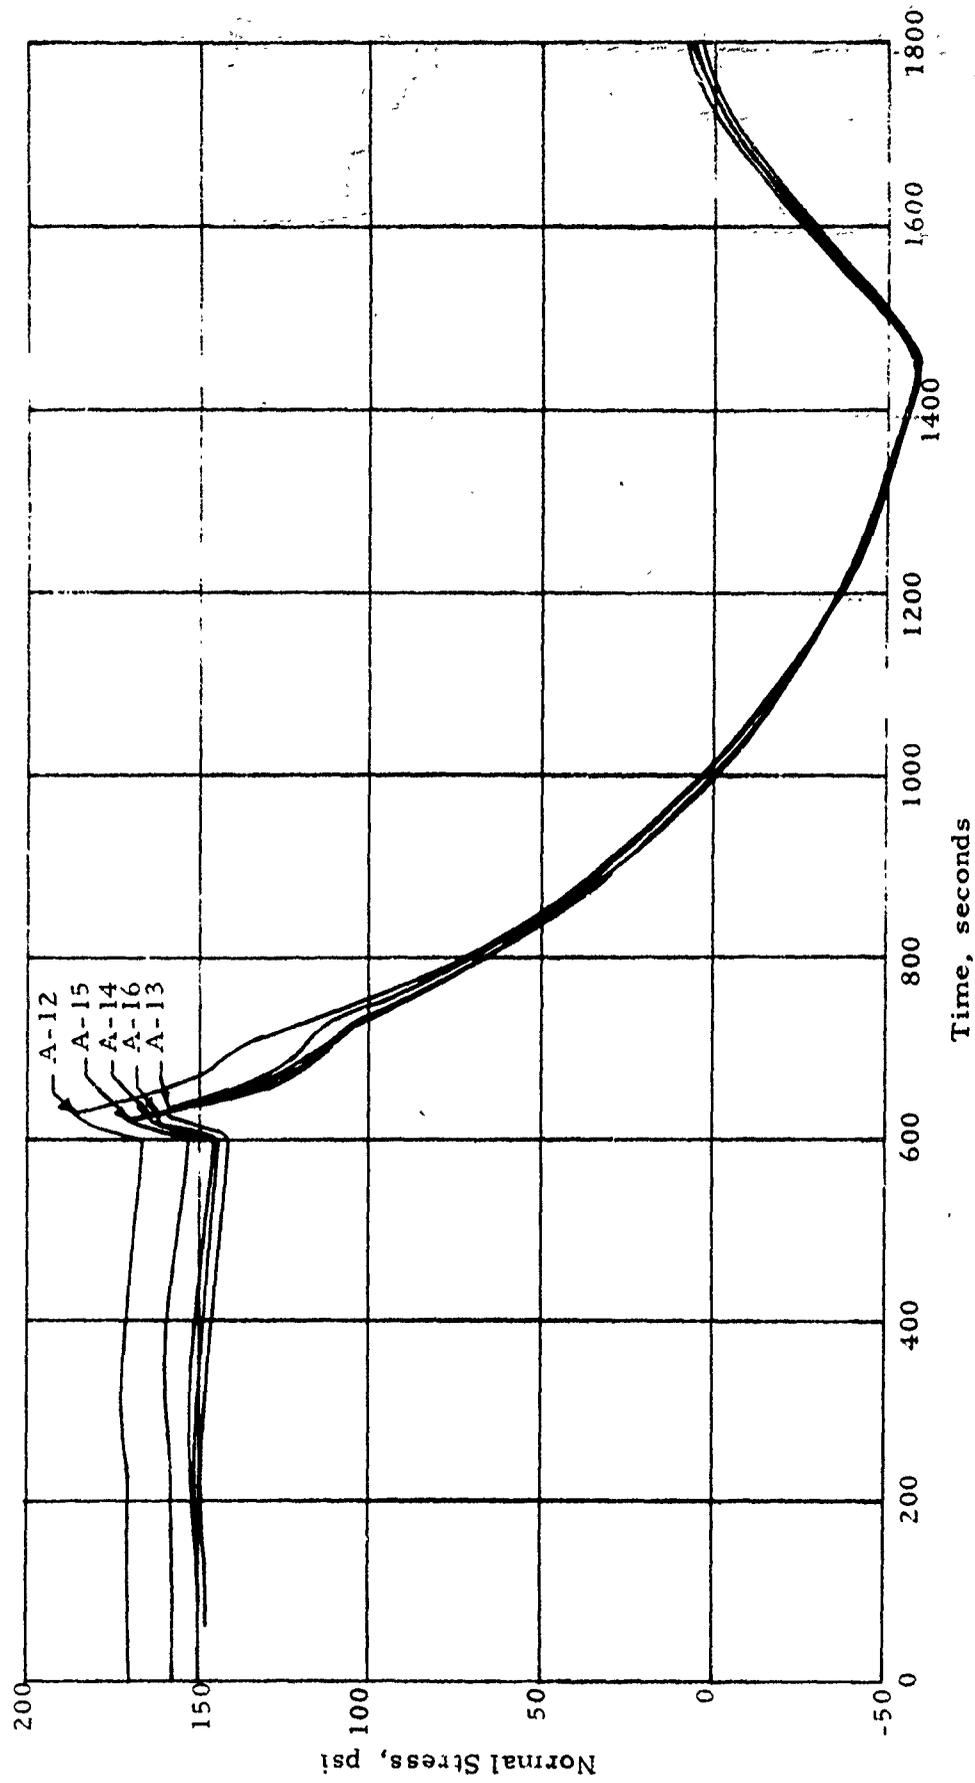
Figure 88. Comparison of Results from Successive SFPI Test--Gage N3-47

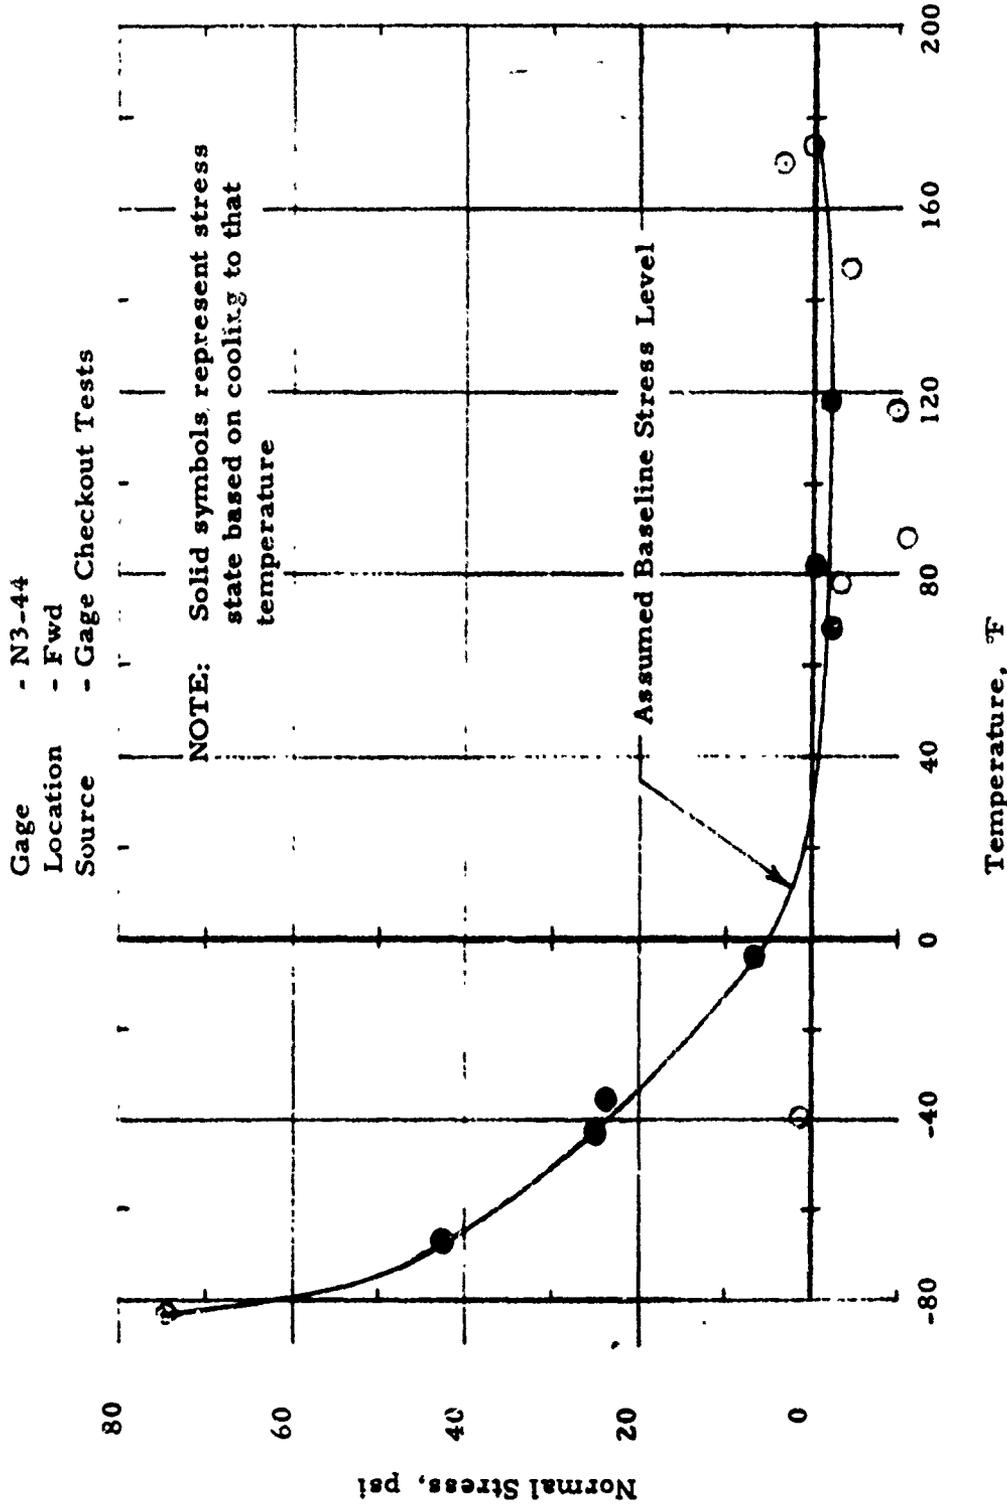
Figure 90. Baseline Stress Data For Gage N3-44

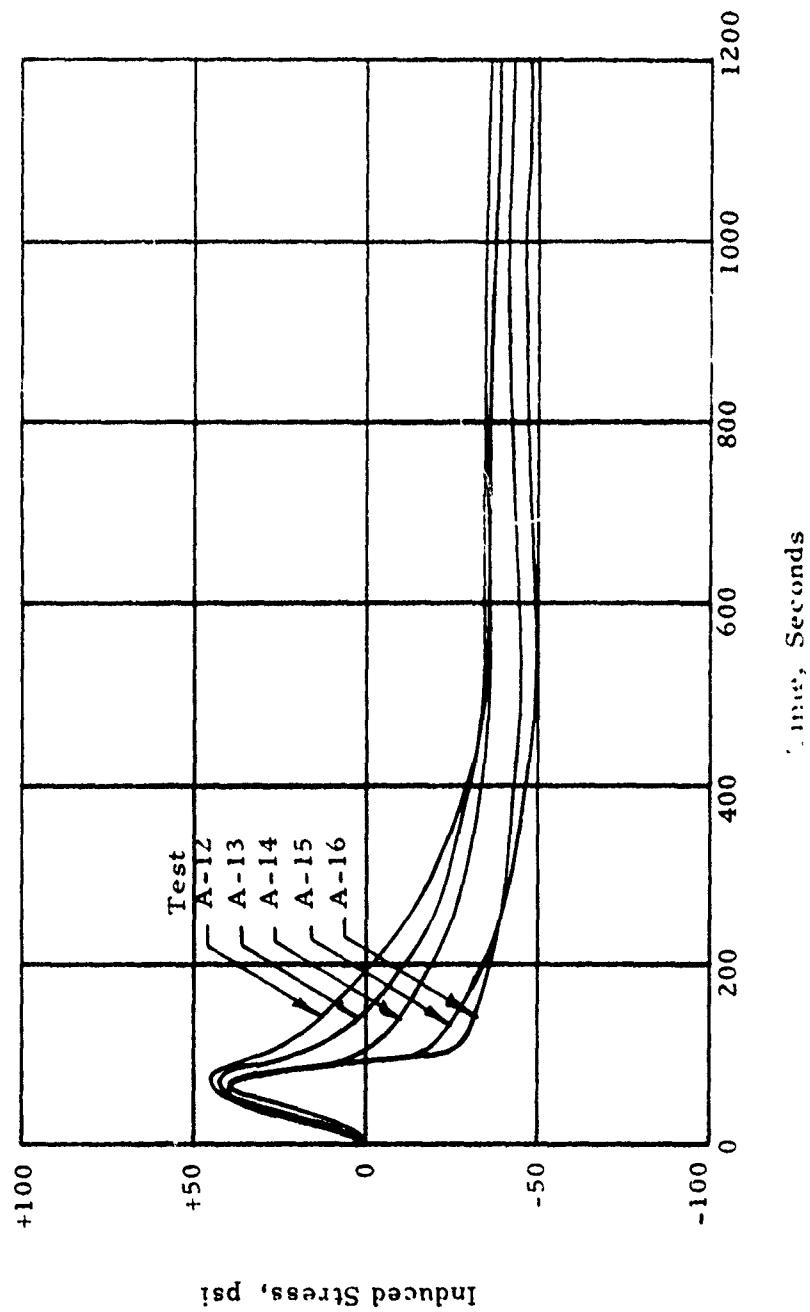
Figure 95. Aft End Motor Stress Relaxation Rate Increase Observed by Gage N3-45

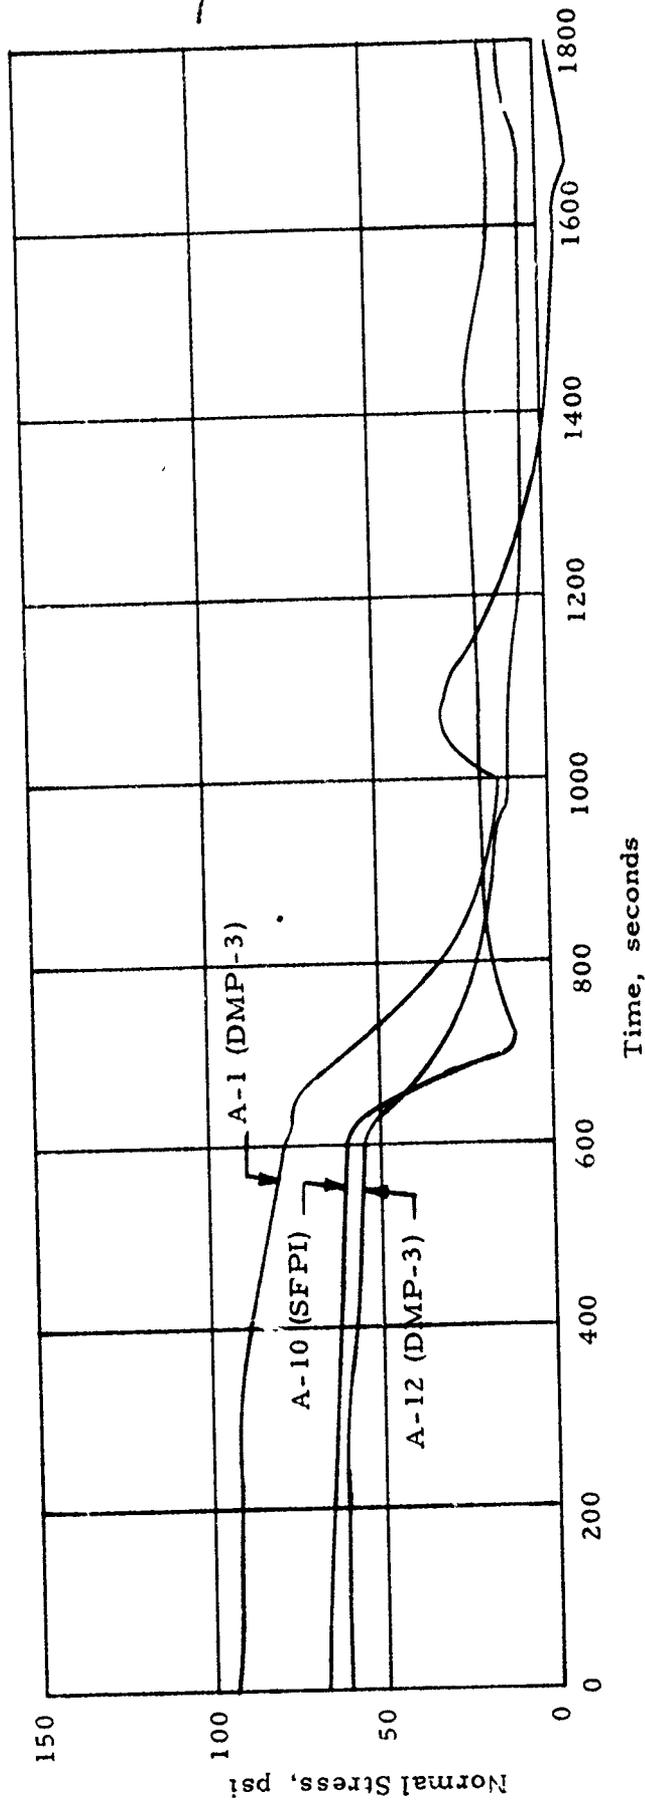
Figure 103. Change in Gage NI-49 Response for Various Tests

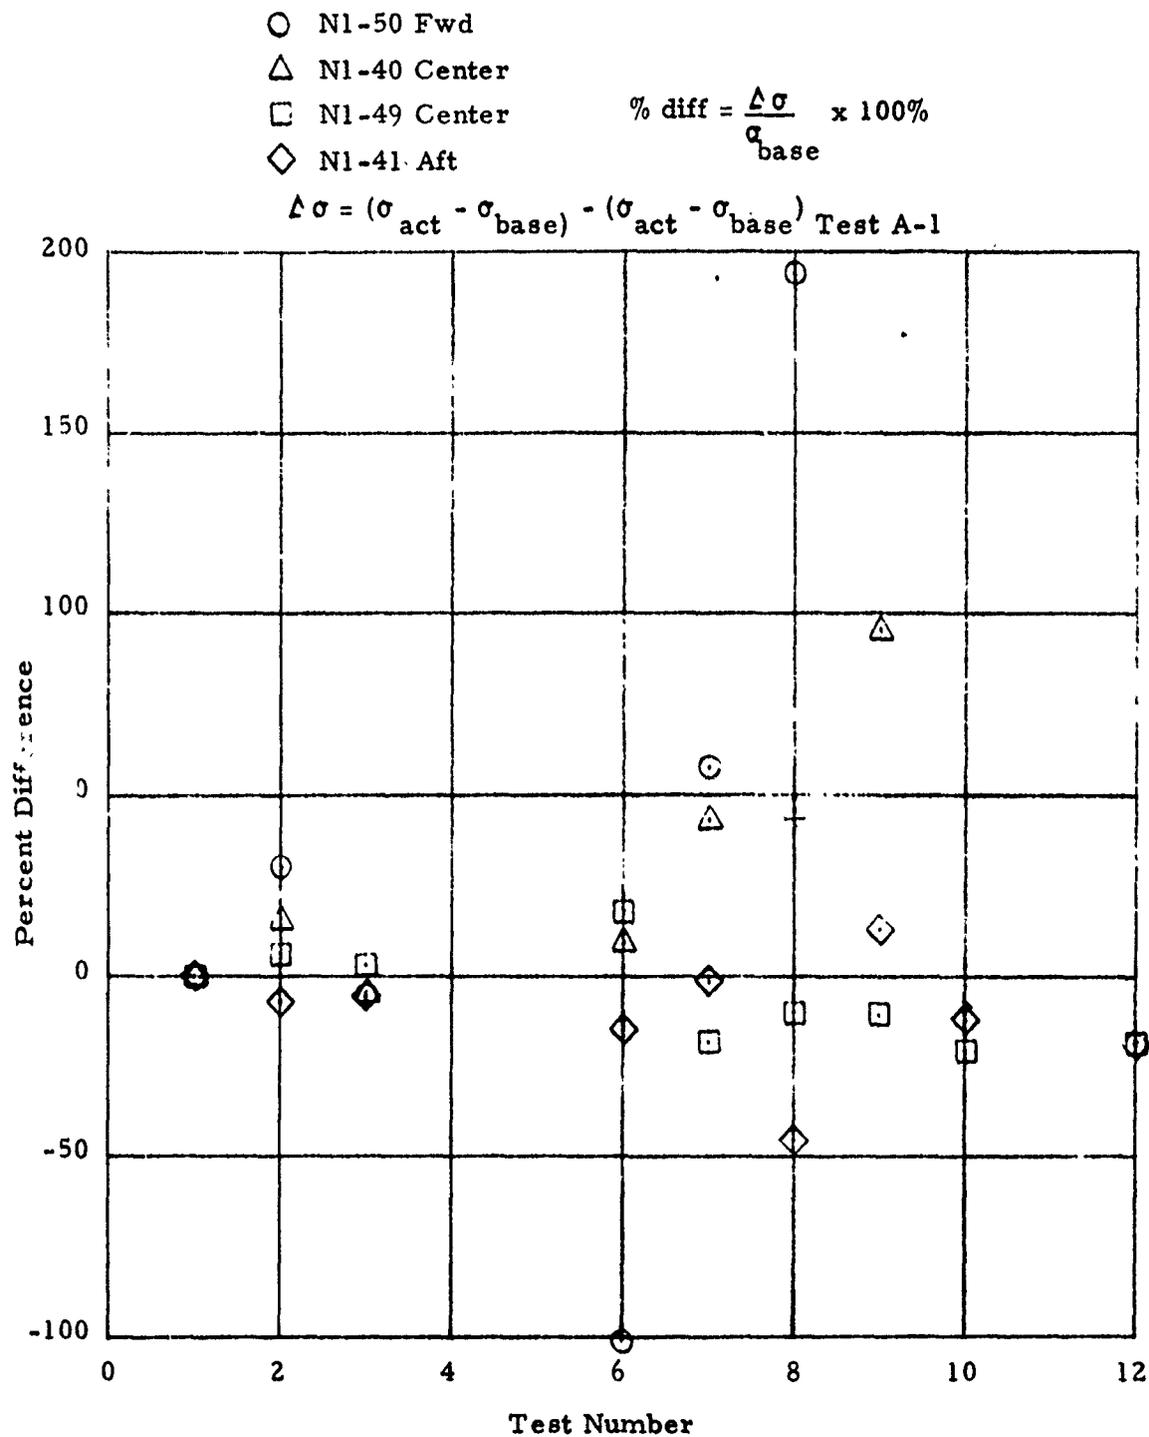
Figure 105. Change in Measured Stress in IM #1 at -65°F Due to Aeroheating Cycling

The changes in measured level for each normal gage as the testing progressed are presented on Figure 105. As shown, some deviations are found. Two gages, N1-40 (as mentioned above) and N1-50, went off scale. The last on-scale measurement made with these gages are shown. That is, N1-50 was completely off scale in the positive direction after Test 8. Gage N1-40 was off scale in the positive direction after Test 9. These data seem to be completely reversed from those measured on IM #3. That is, the head-end gage increased output in this motor whereas it decreased in the IM #3 tests. The aft-end gage is completely reversed also. The center gages in IM #3 compared well with each other as they both increased. Here we see N1-49 decrease while N1-40 increases to such a point that it went off scale.

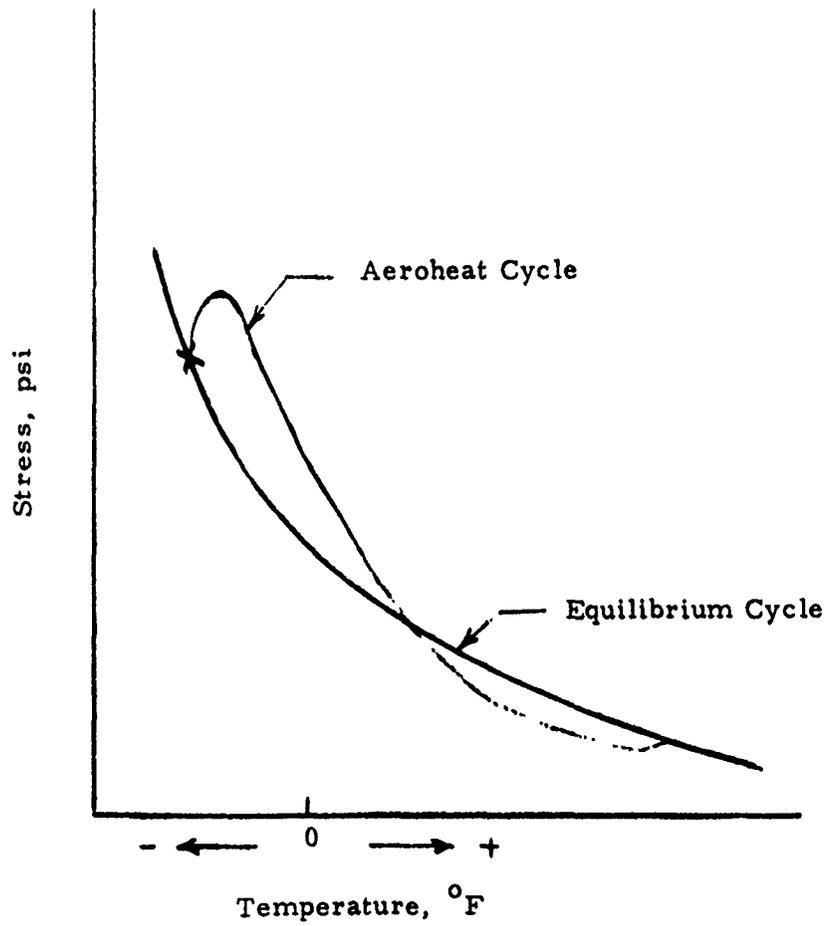
Figure 106. Difference in Stress Levels Between Aeroheat and Equilibrium Cycles

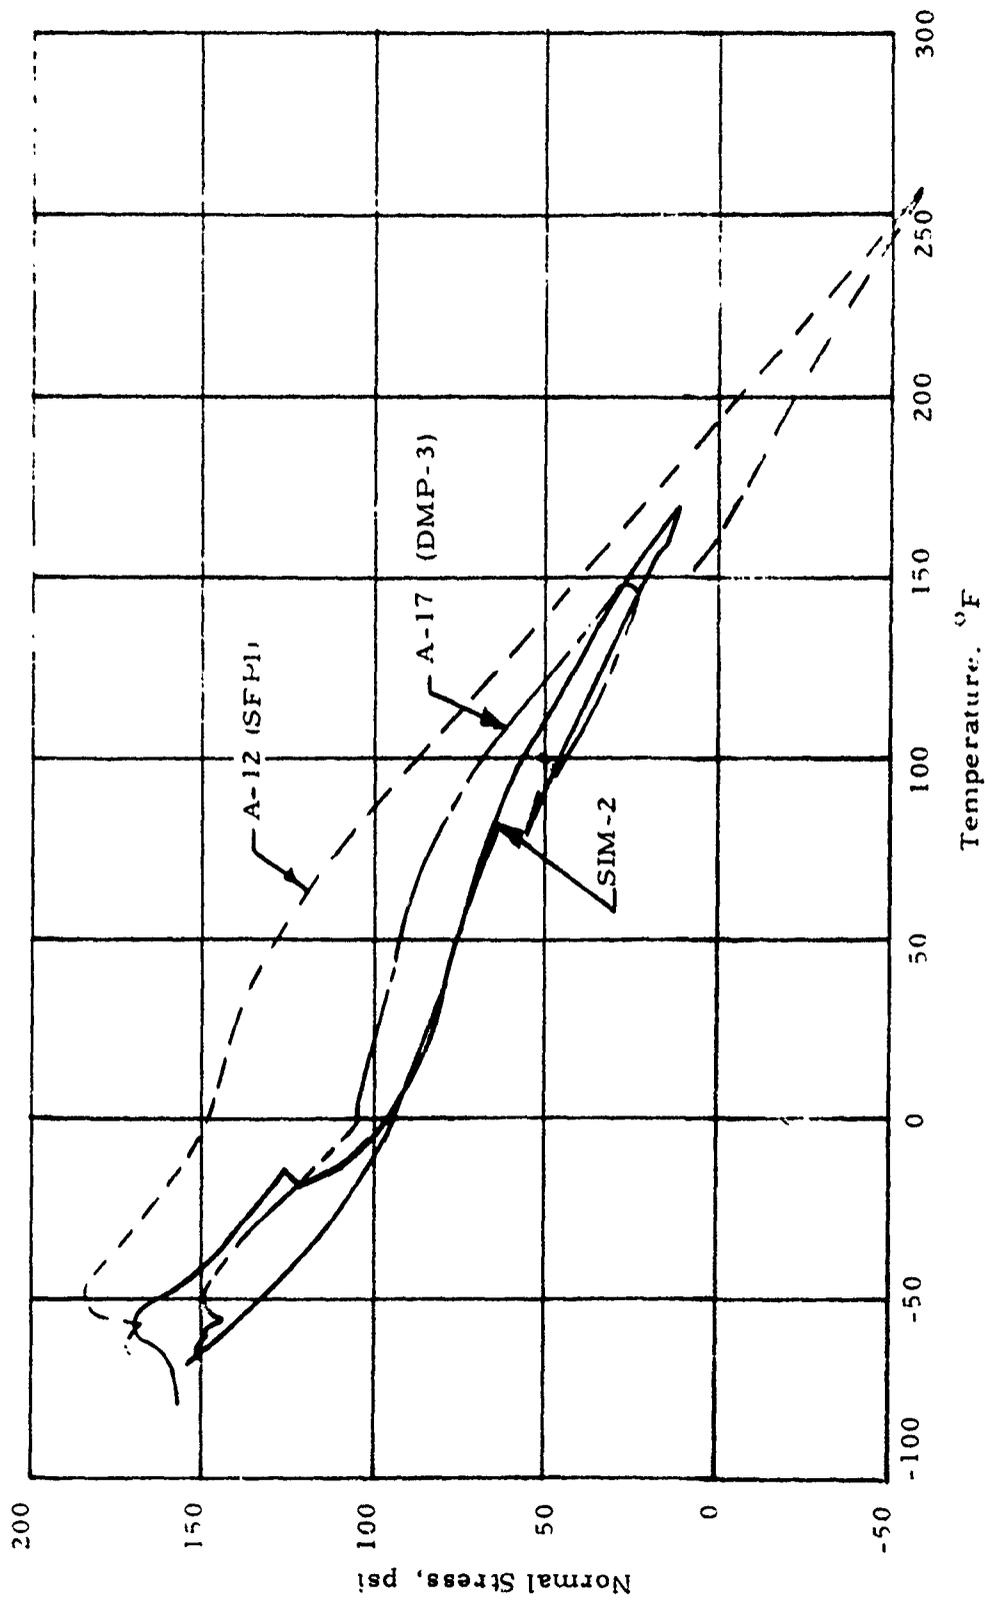
Figure 107. Comparison Between Aeroheat and Simulation Cycle for Gage N3-47.

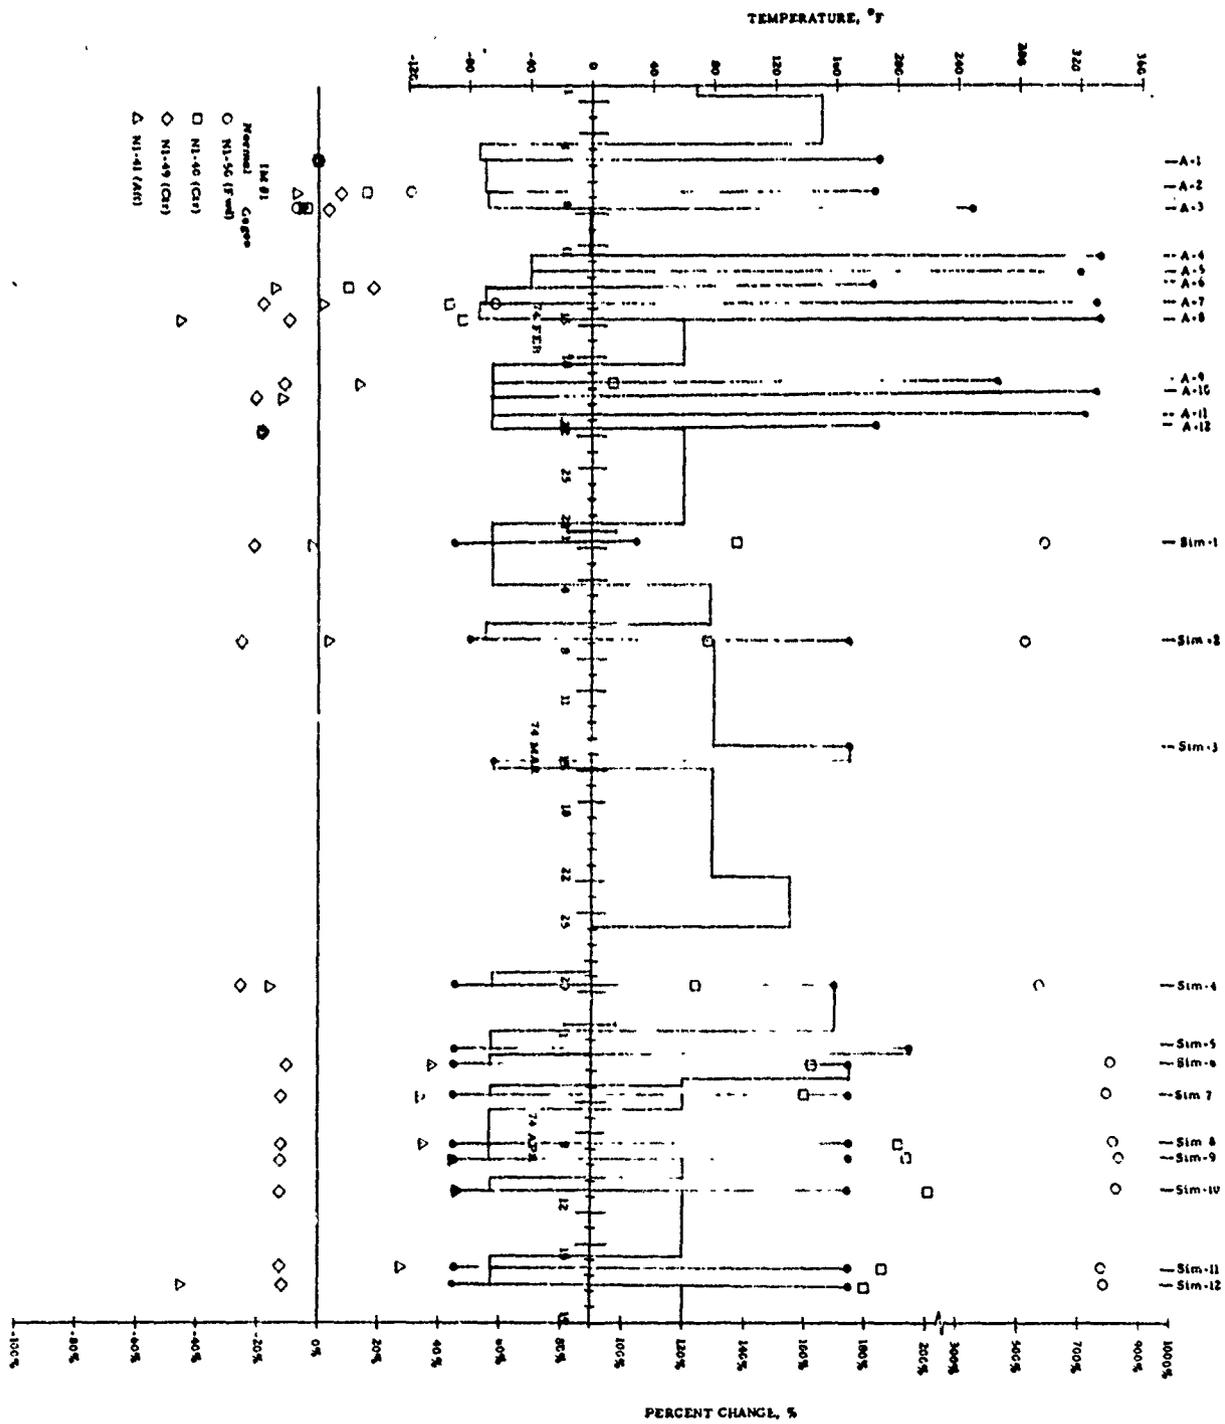
Figure 110. History of IM#1 Normal Gage Response Changes at -65°F.
