SIMULATED AIR LAUNCH ENVIRONMENT  
FINAL REPORT FOR PERIOD SEPT. 72 THROUGH MAY 74

THIOL CORPORATION  
HUNTSVILLE DIVISION  
HUNTSVILLE, ALABAMA 35807

OCTOBER 1974

VOLUME I: TECHNICAL REPORT

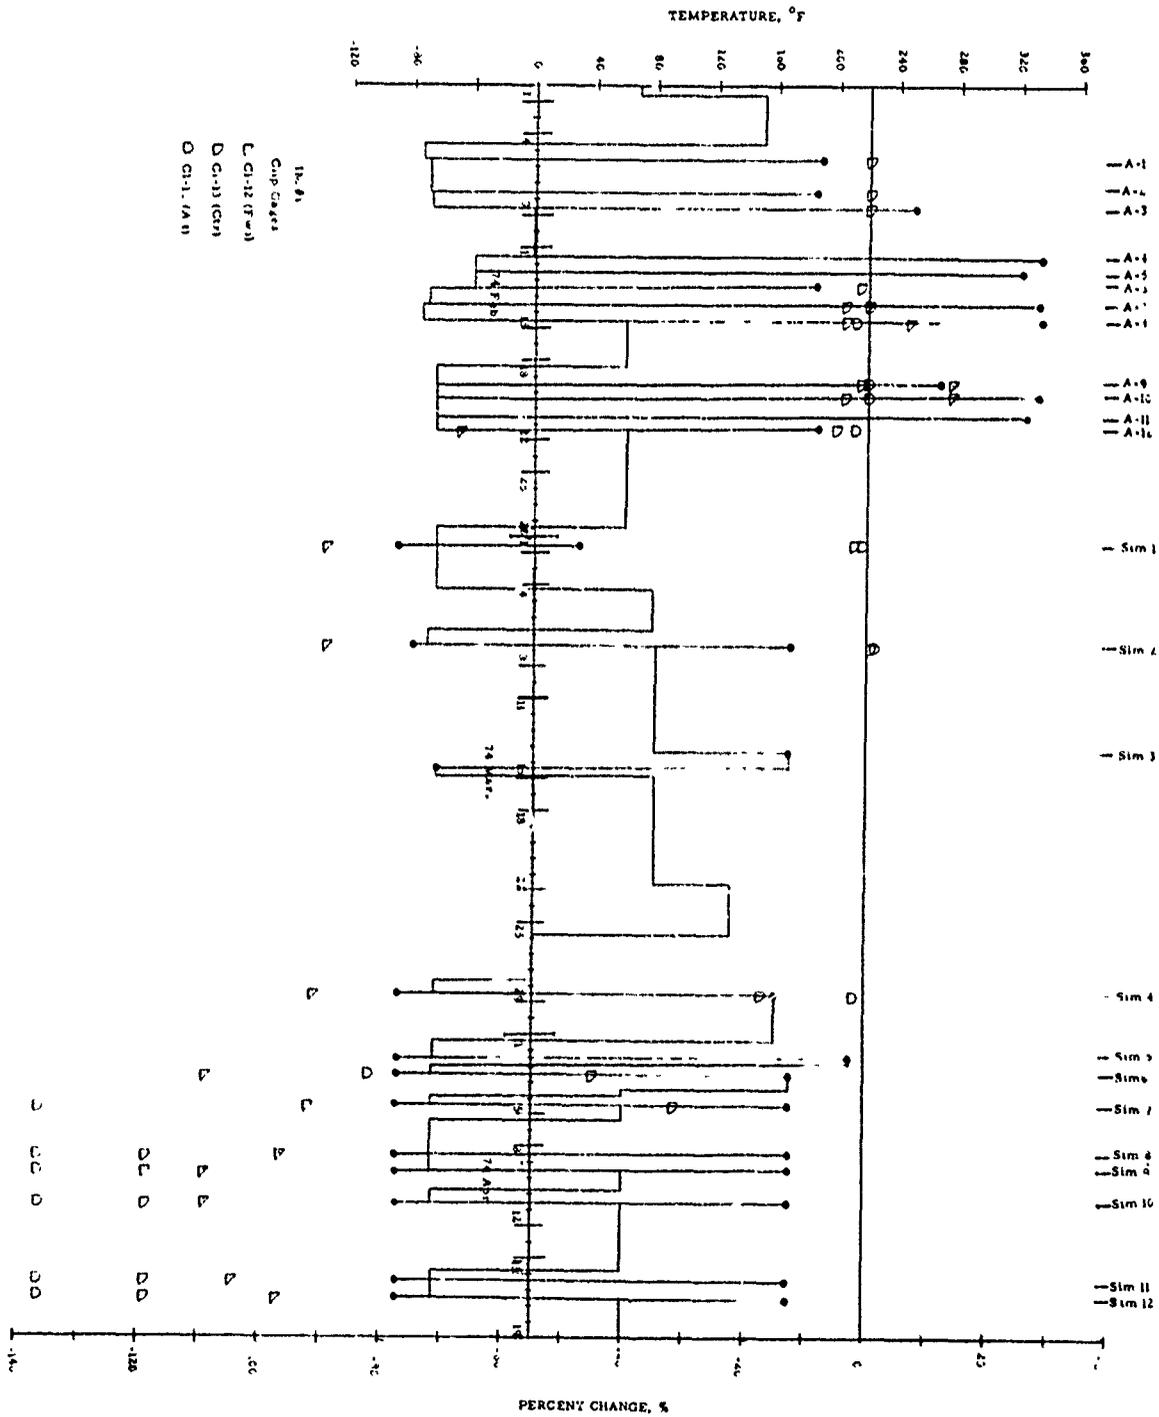
Figure 111. History of IM#1 Clip Gage Response Changes at -65°F.

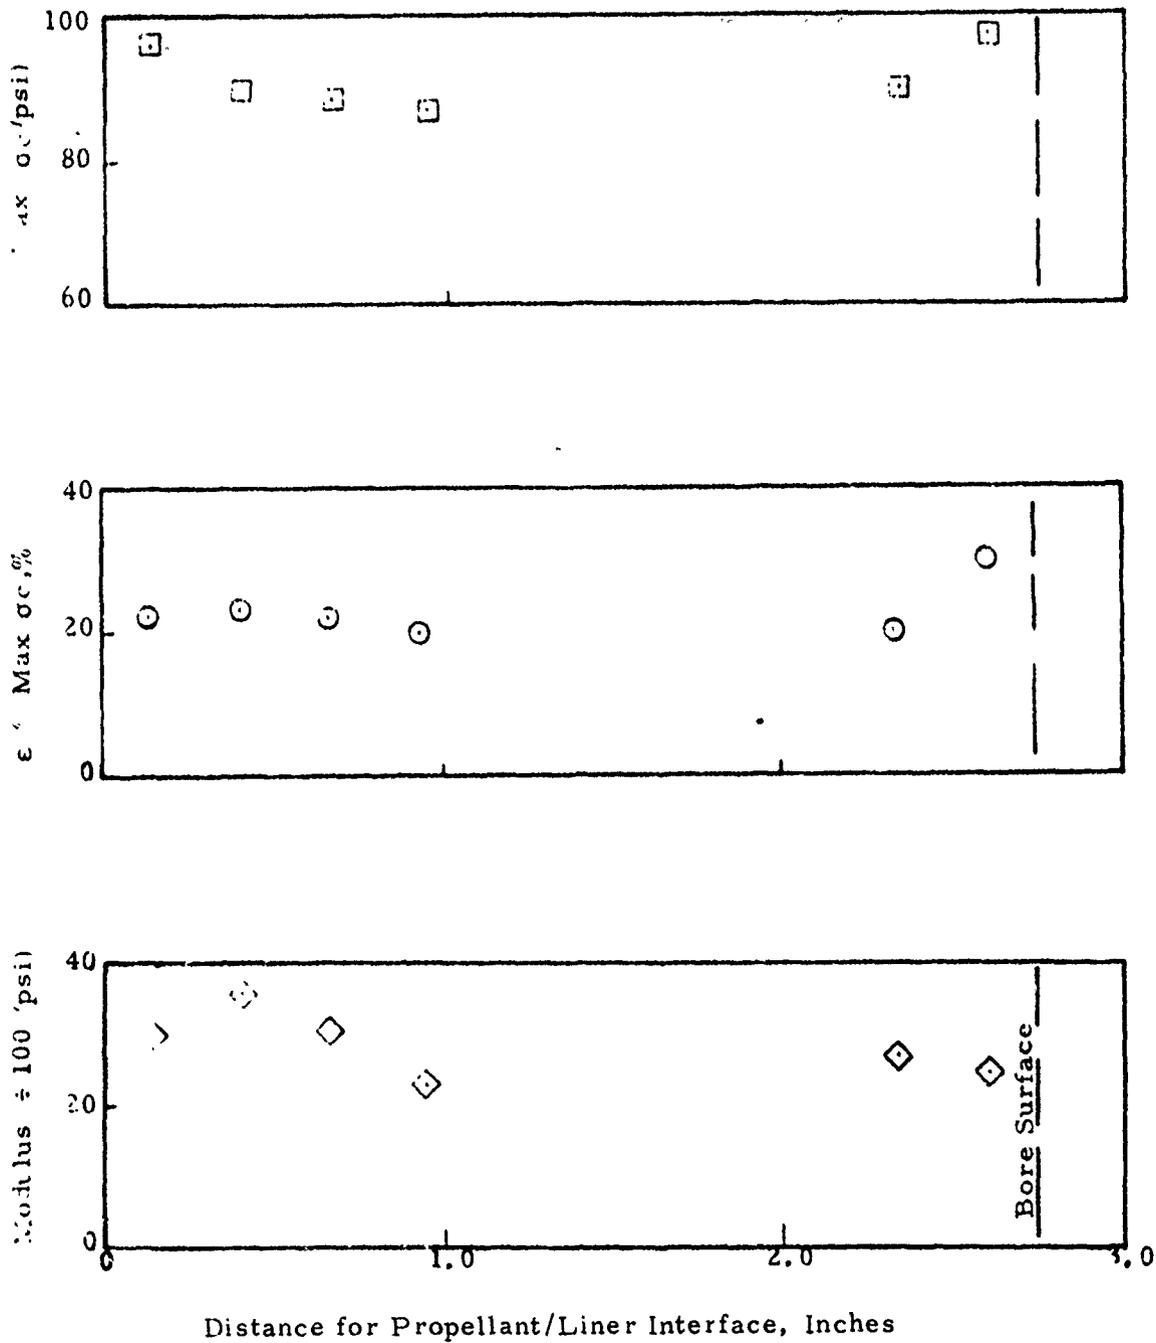
Figure 117. TP-L8006 Propellant Removed from SALE IM #2, Segment 2

Comparing these properties with those obtained from the samples removed from the motor shows that the thermal conditioning caused a decrease in strain, an increase in modulus, and little or no change in stress.

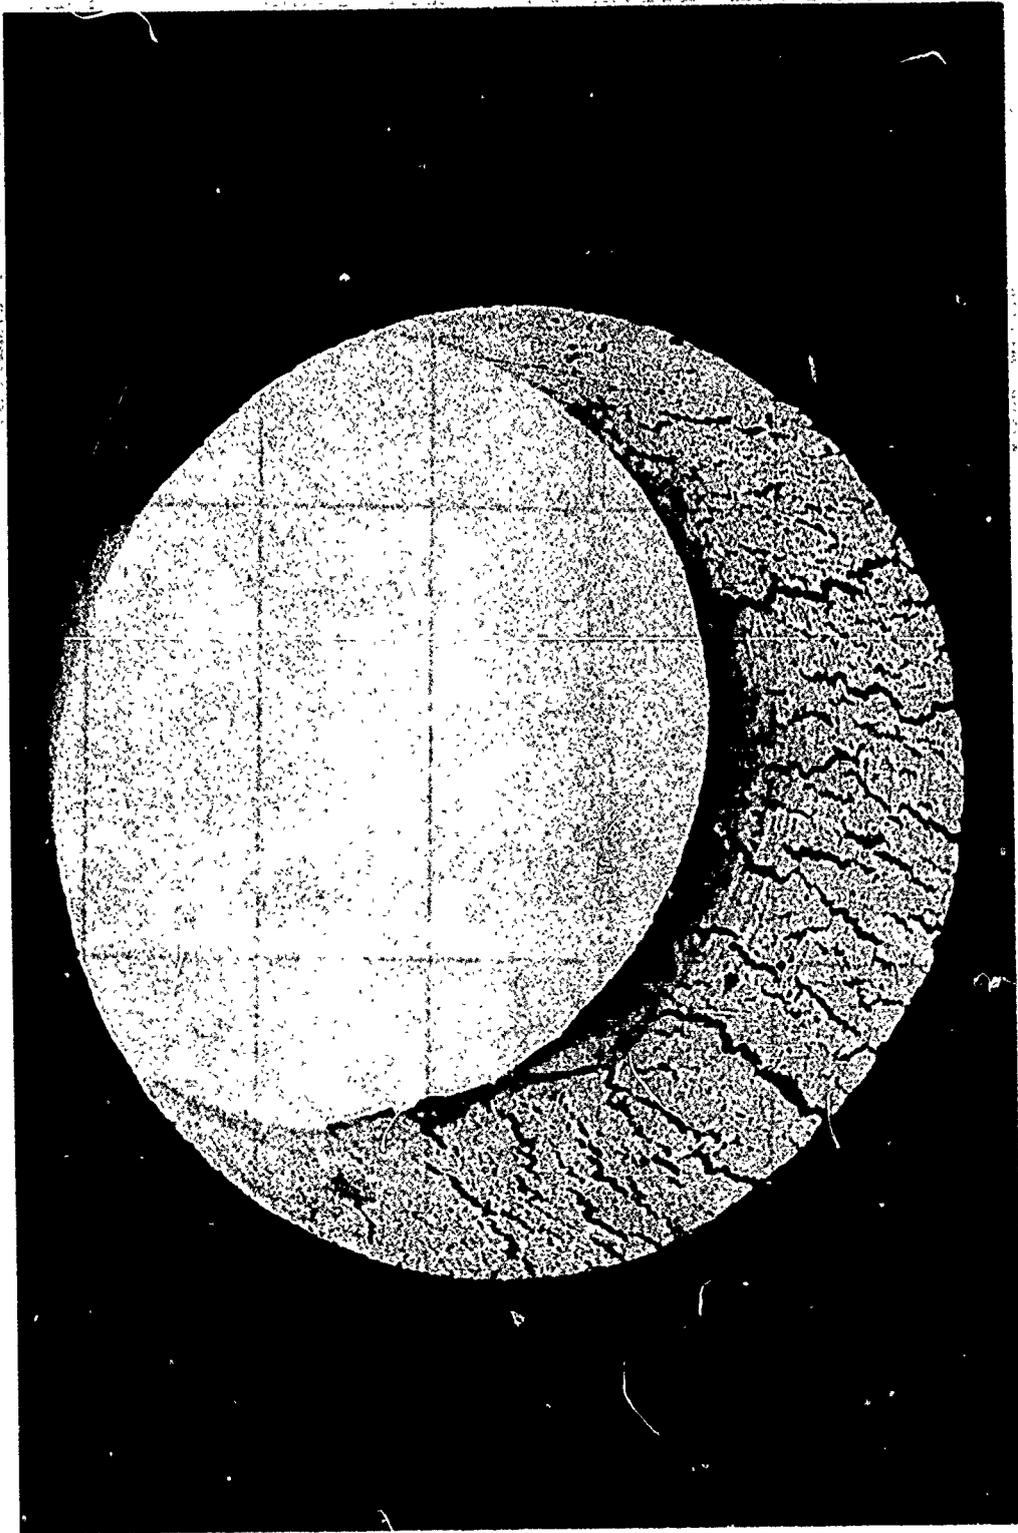
Figure 121. Cracking in IM #3

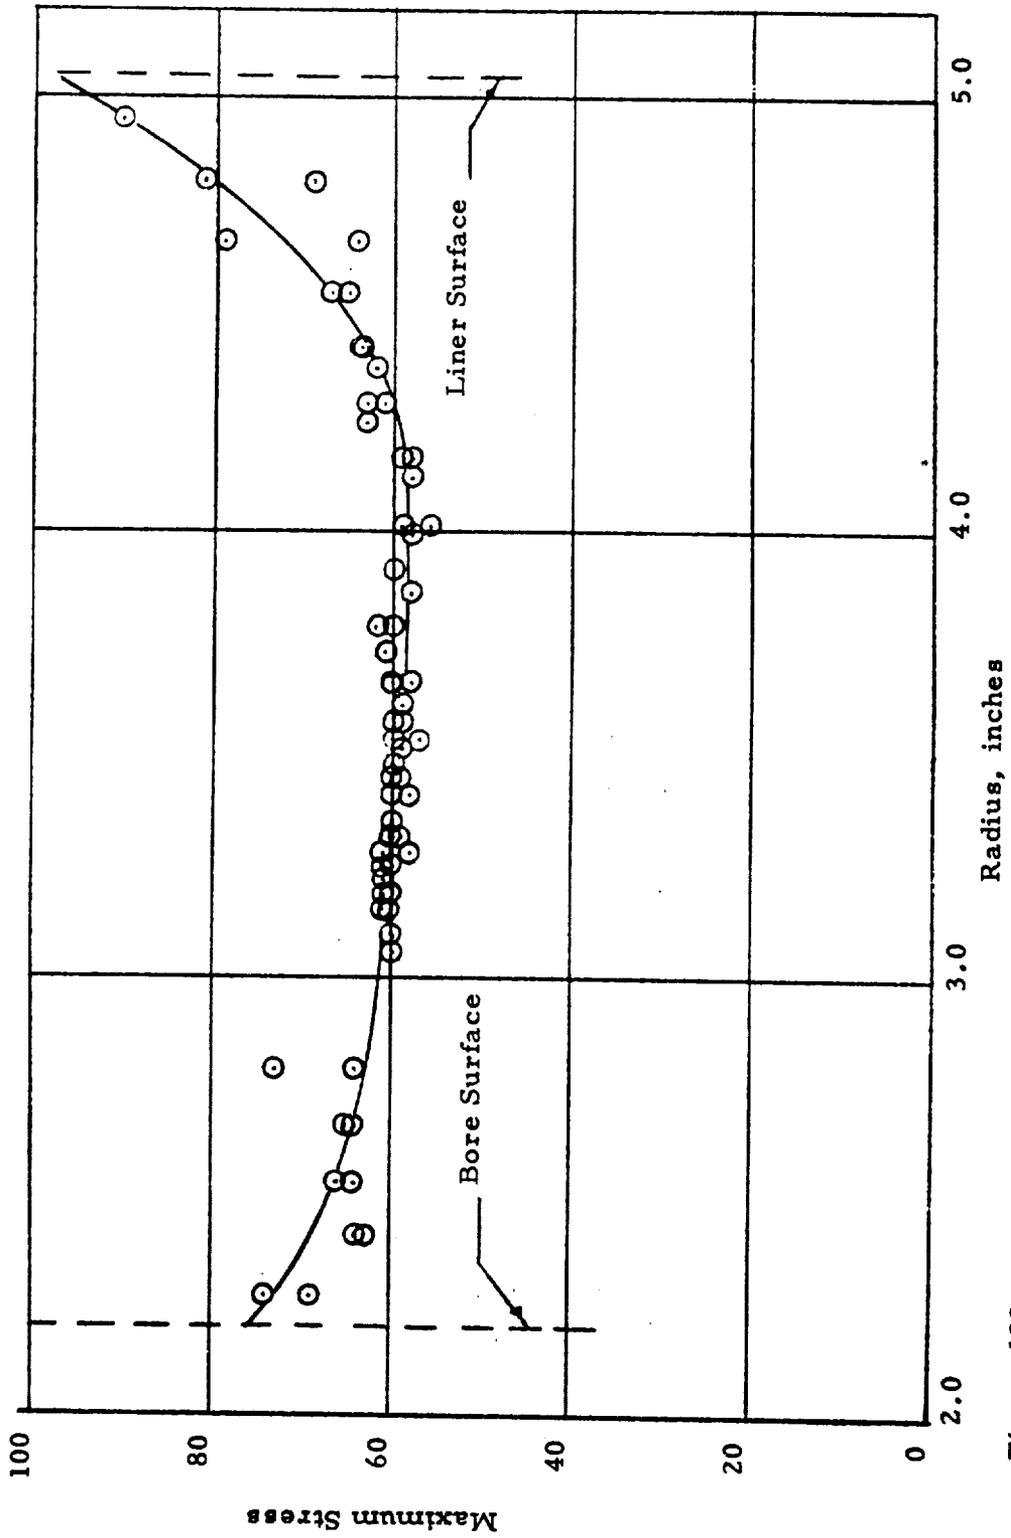
Figure 122. Maximum Stress Versus Radius, Motor IM #3

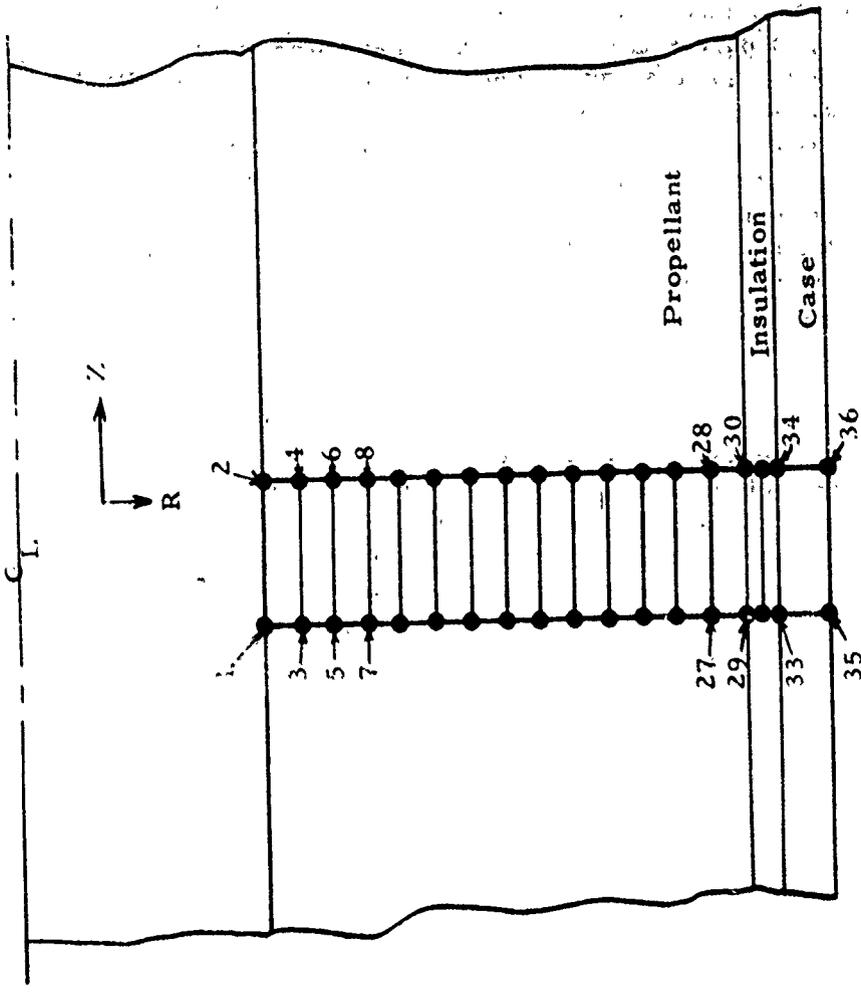
Figure 124. Nodal Point Modeling of Problem (one dimensional) THVINC

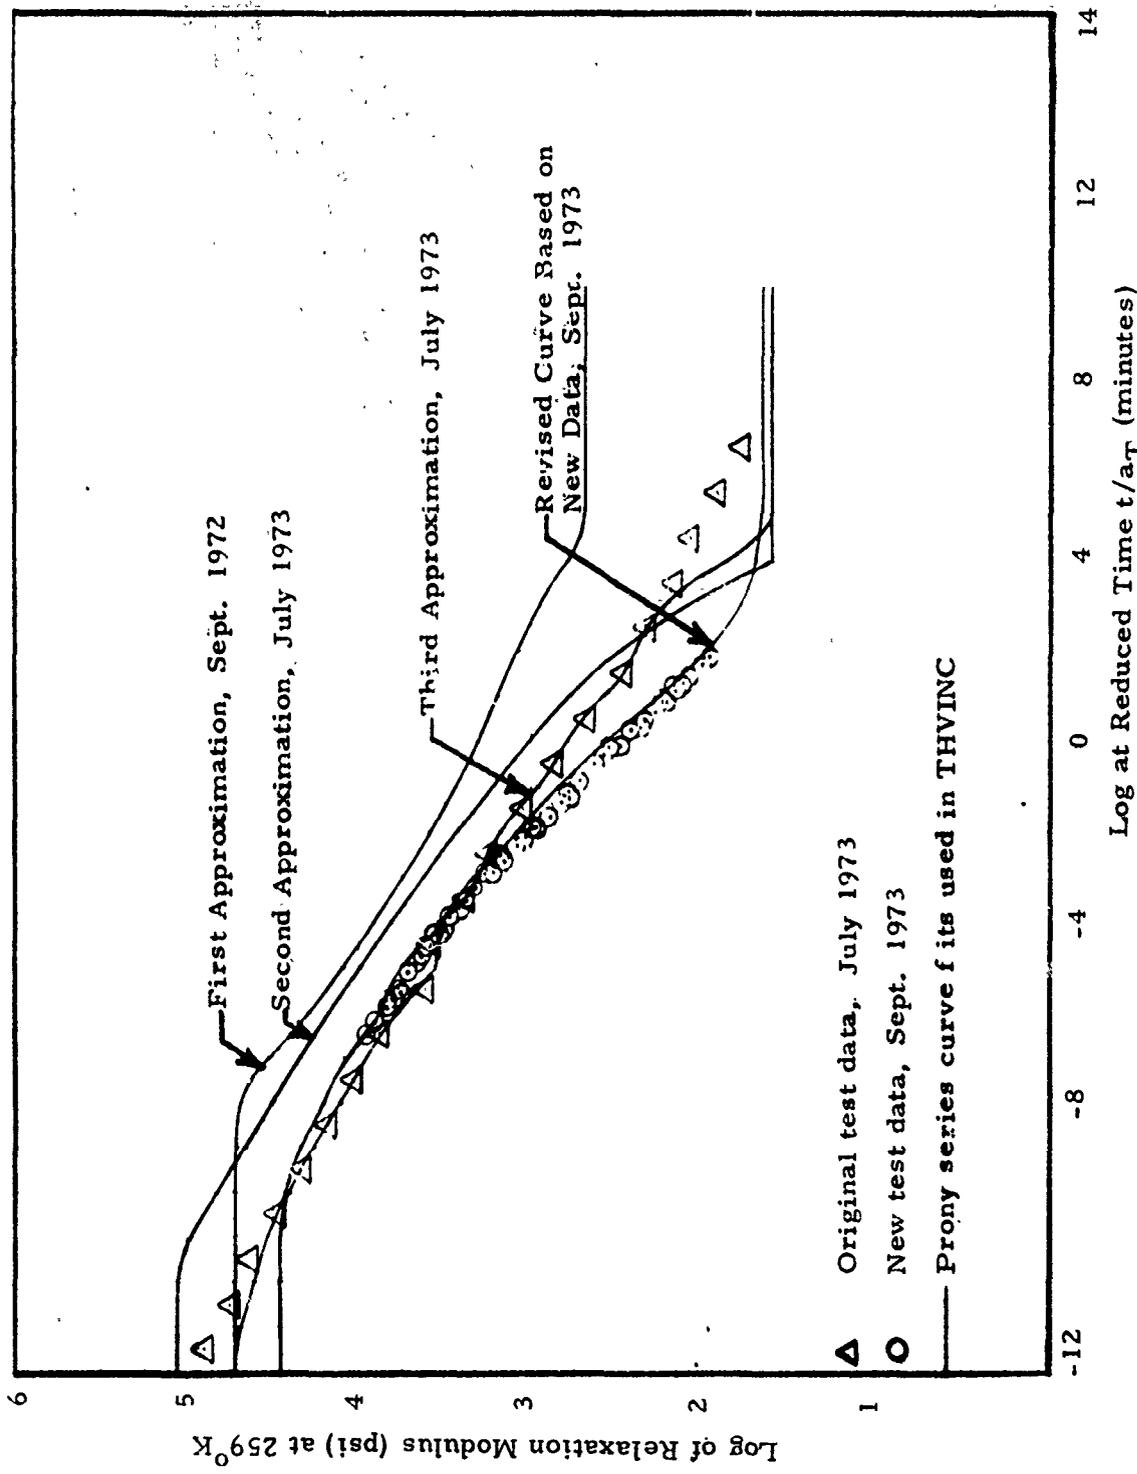
Figure 126. Relaxation Modulus Curve, TP-L8006 Propellant

Later in the program the instrumented motors were dissected and the aged propellant relaxation modulus was determined. The aged and unaged modulus curves are presented in Figure 129. As is evident the propellant modulus has changed after experiencing the aeroheat cycles. It appears that the propellant has become softer at the longer times or higher temperature and somewhat harder at short time and low temperature. A comparison between the effects on radial stress at the bondline and the hoop stress at the

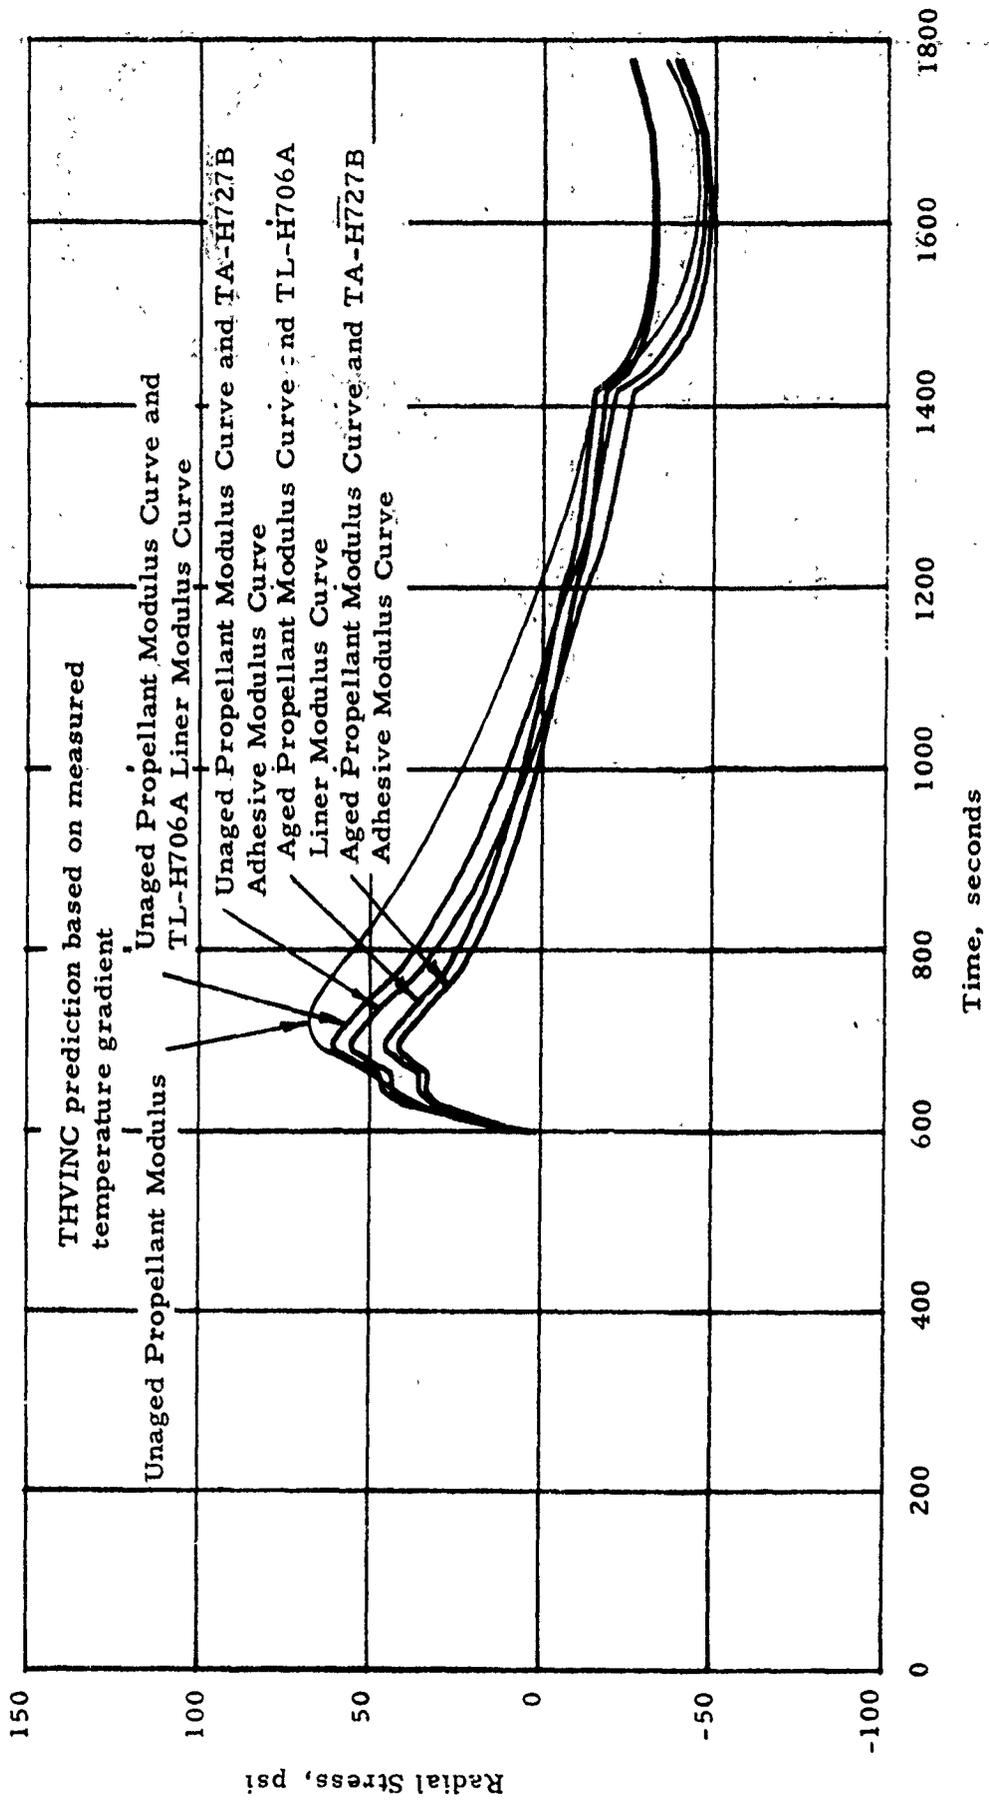
Figure 133. THVINC Prediction of Radial Stress at the Bondline for the SFPI Aeroheat Mission Using Different Modulus Curves

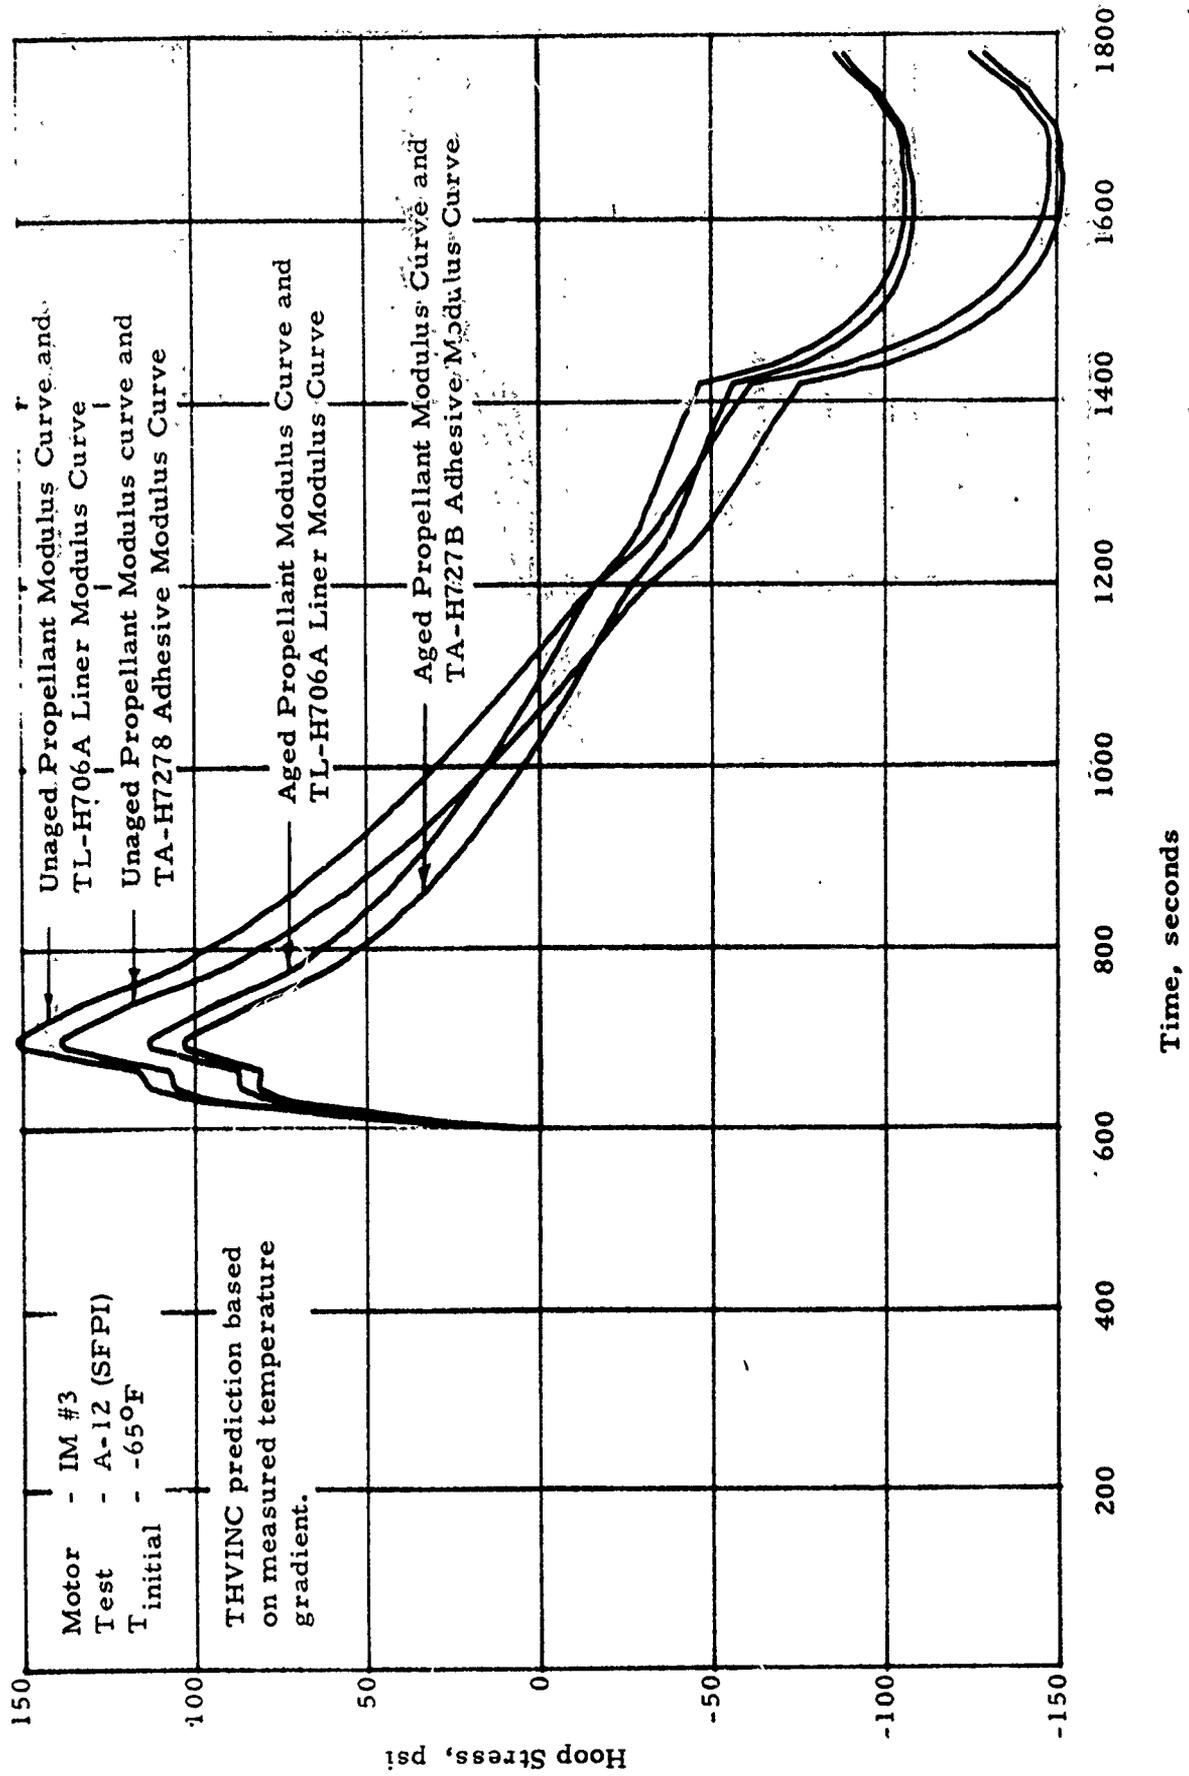
Figure 134. THVINC Prediction of Hoop Stress at the Inner Bore for the SFPI Aeroheat Mission Using Different Modulus Curves

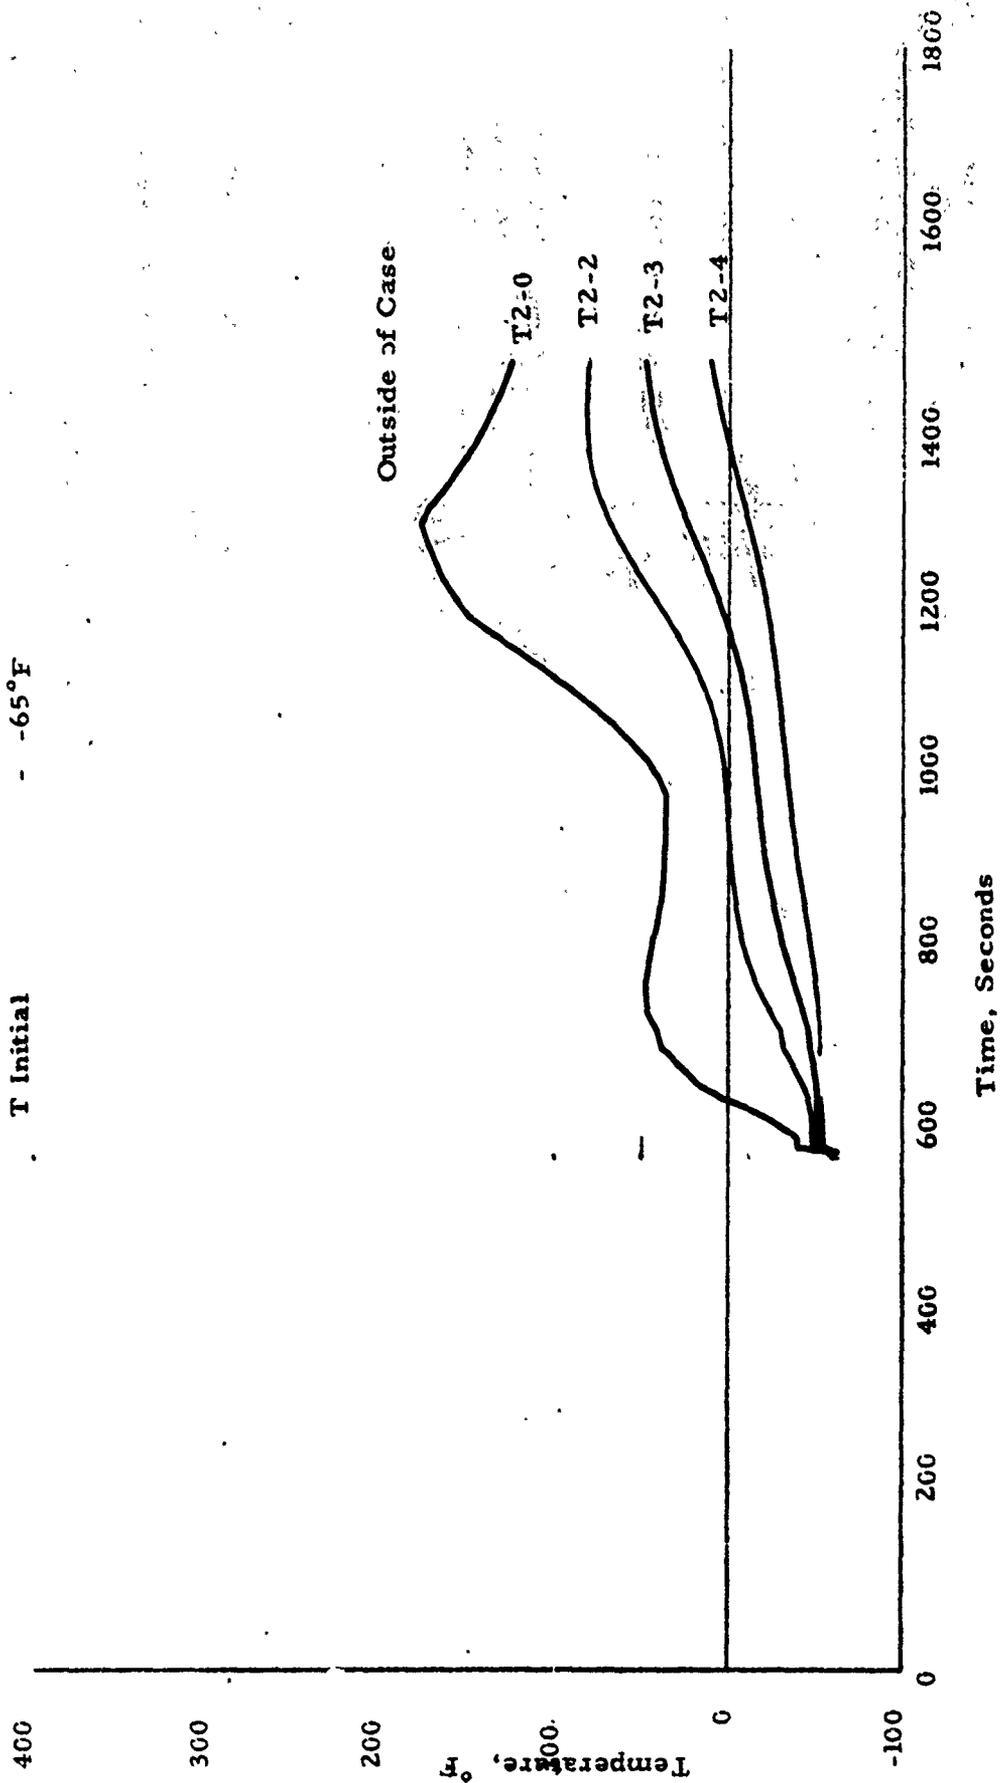
Figure 138. Temperature Profile Histories for Various Aeroheat Loads. Test A-1

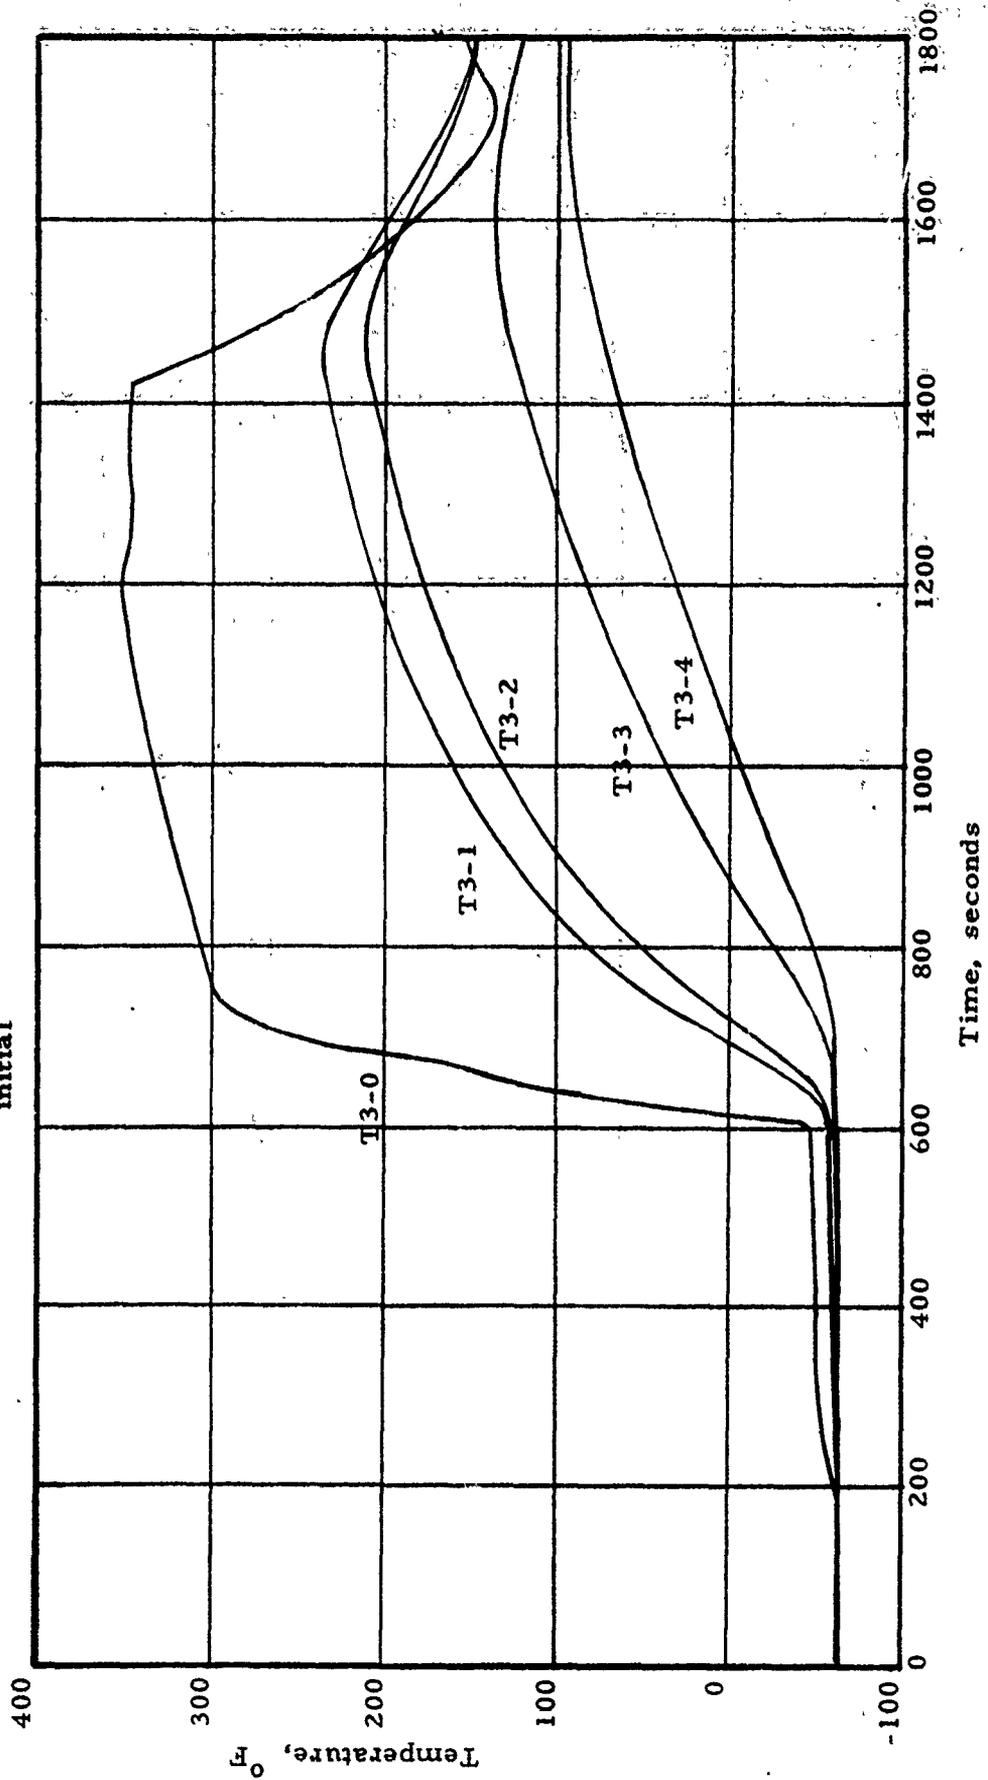
Figure 140. Temperature Profile Histories for Various Aeroheat Loads

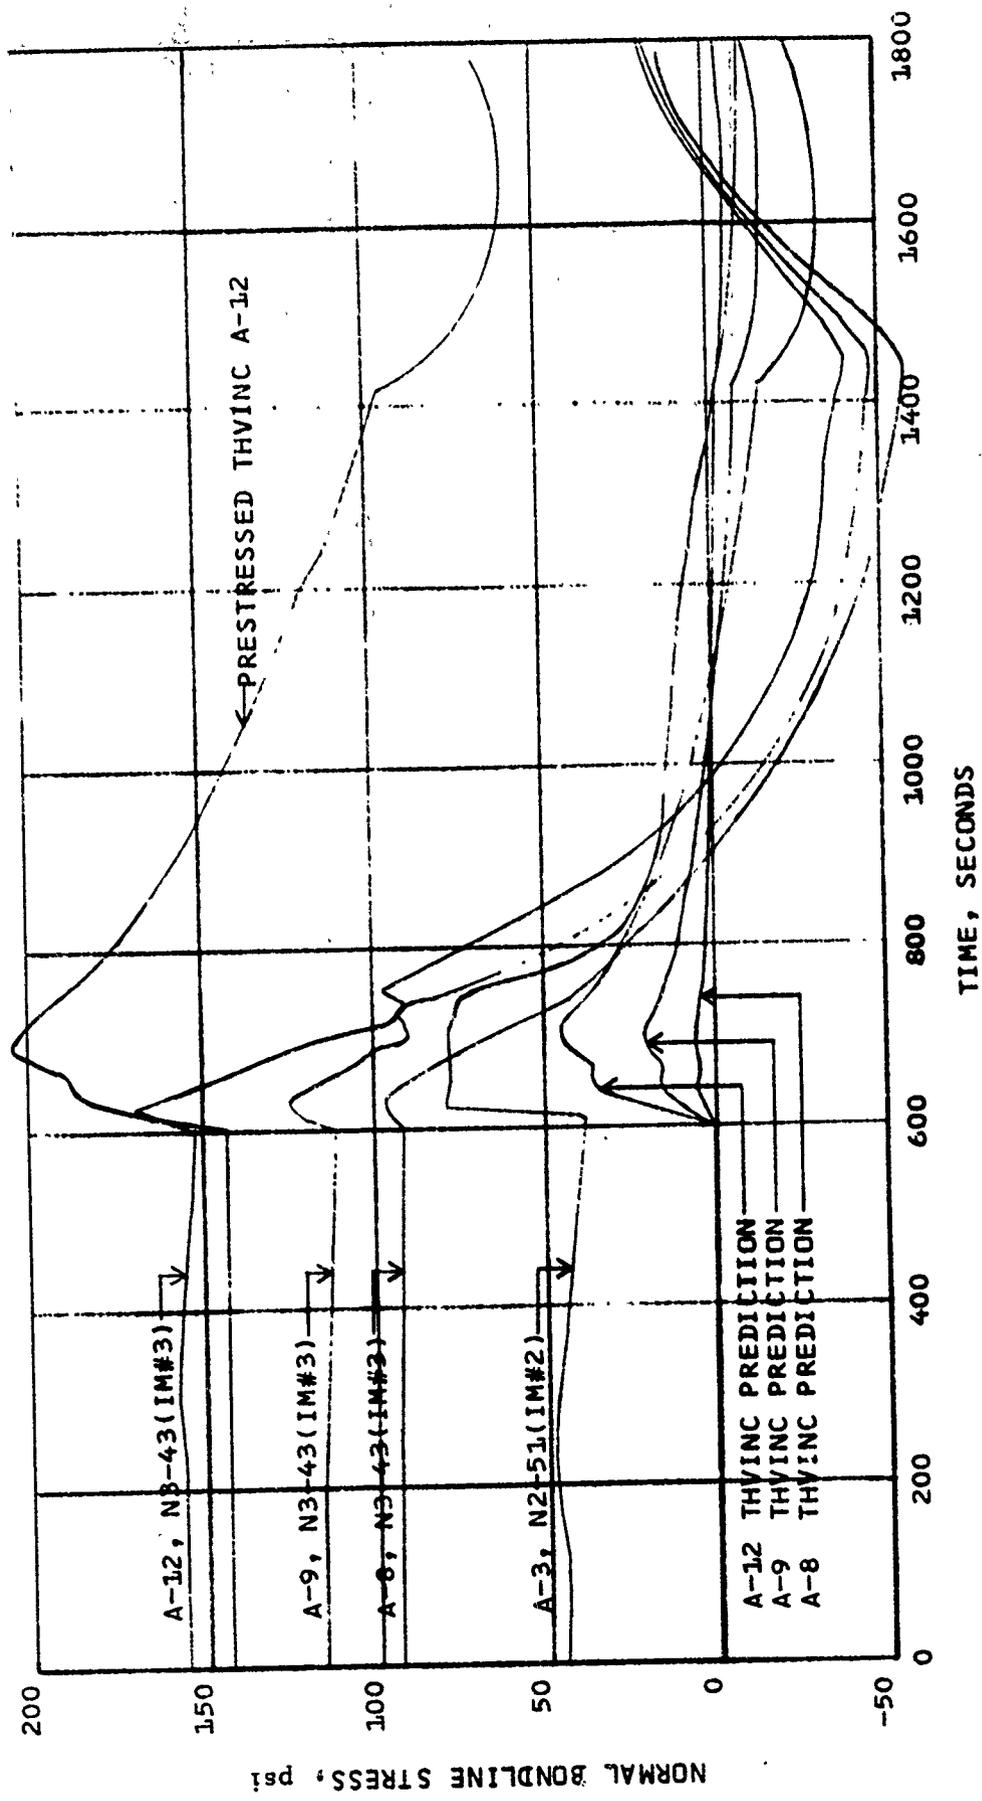
COMPARISON BETWEEN NORMAL GAGE DATA AND THVINC PREDICTION  
 FOR A SFPI AEROHEAT MISSION WITH IM#2 AND IM#3
