INITIAL PROTOTYPE EVALUATION OF EXPANDABLE CARCASS-REPLACEABLE TREAD TIRE FOR C-130 AIRCRAFT

THE B.F. GOODRICH COMPANY
AKRON, OHIO 44318

JANUARY 1975

TECHNICAL REPORT AFFDL-TR-74-131

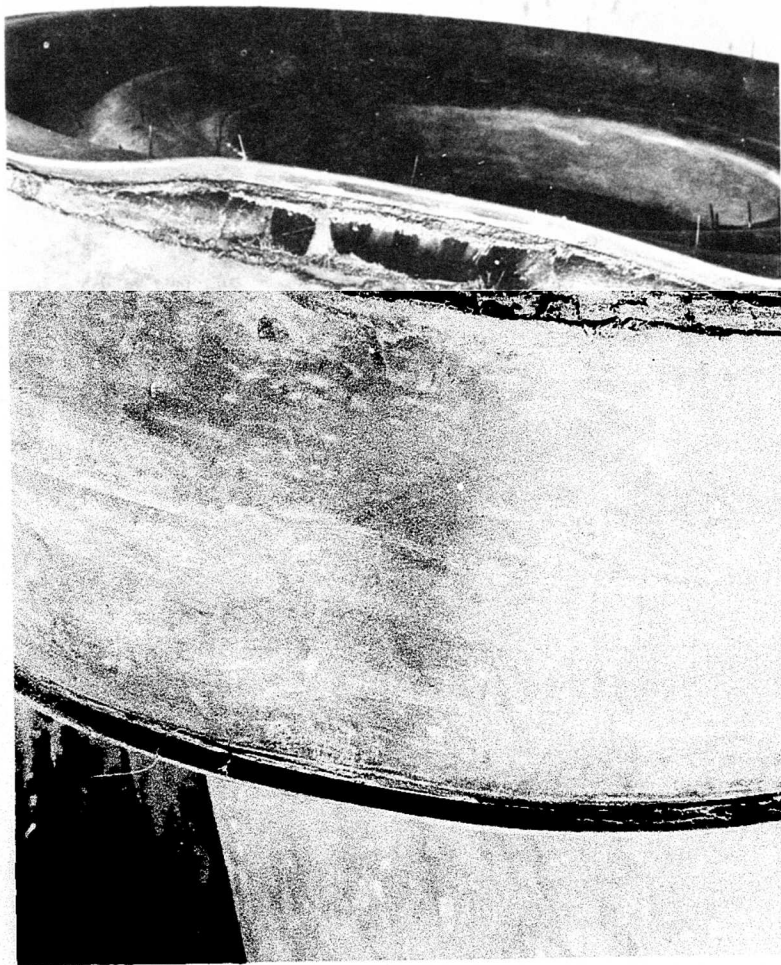
It was at this stage of the program that the chafing problem was discovered. During one of the first dynamometer tests of the redesigned tread band with the 90° cords at the innermost ply, the carcass exploded during the 10th taxi-take-off cycle. Examination of the carcass disclosed the failure region to be in the shoulder area as shown in Figures 7 and 8. Both shoulders of the carcass had two plies of cord abraded away around the entire circumference. The inside of the tread band disclosed damage at both edges

Figure 7. Photograph of Carcass After Rupture Caused by Chafing.

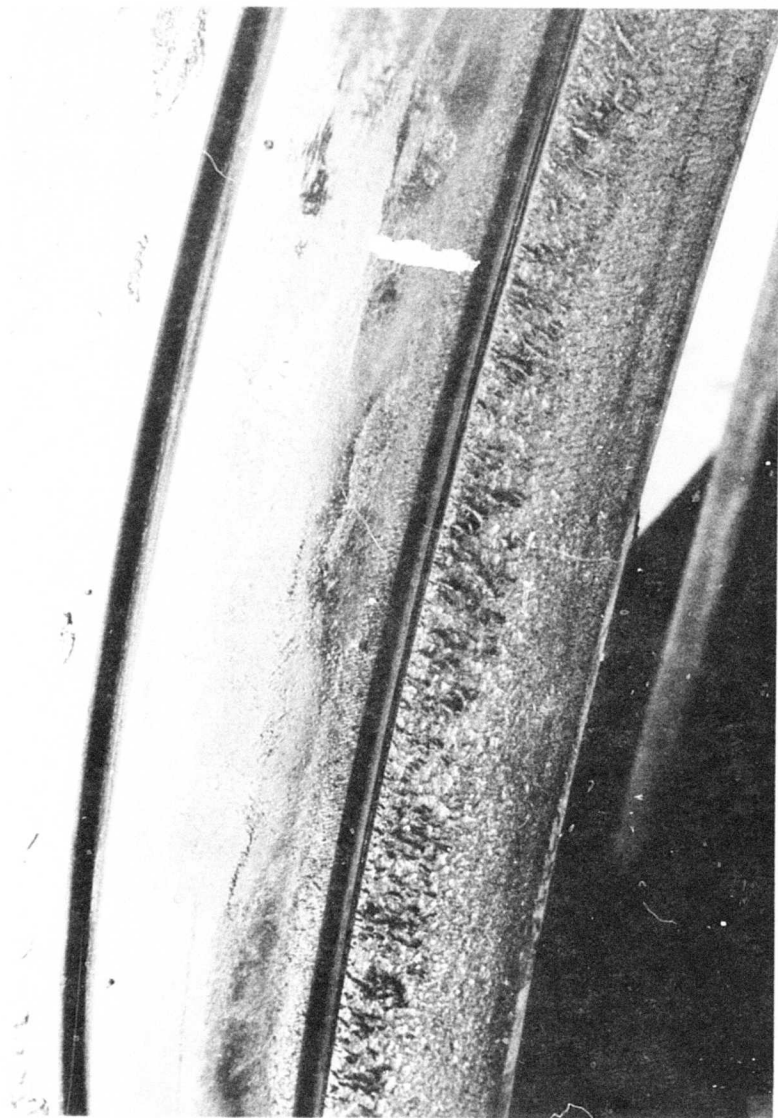
Figure 10. Photograph of Outside of 20.00-20/26 PR Tread Band Showing Abrasion Along One Edge.

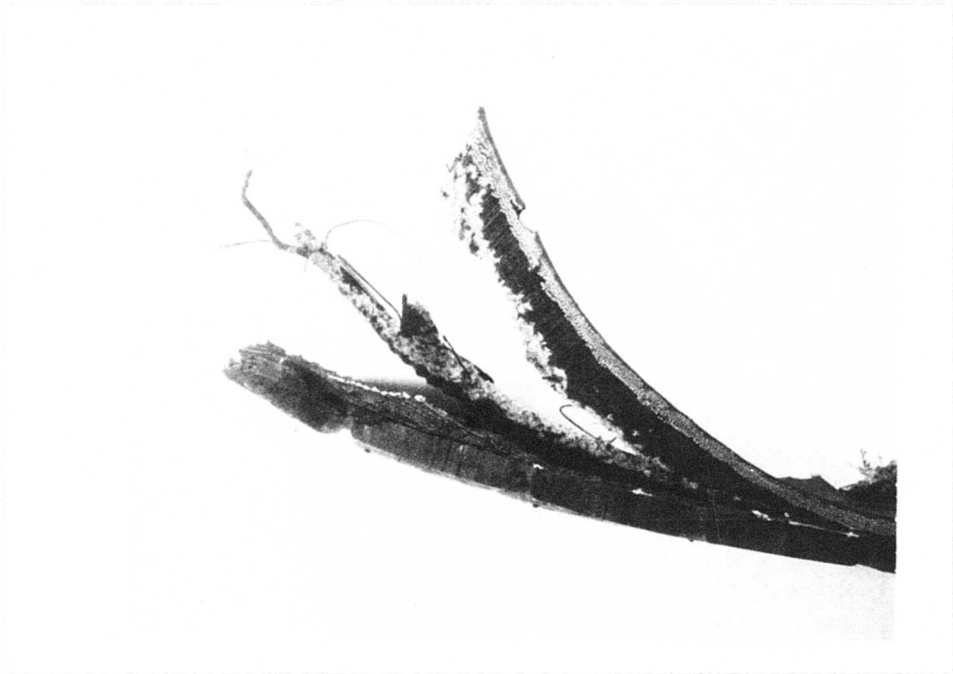
One of the failure modes of the newly modified smaller and narrower tread band was cord breaks, See Figure 13. Observations made throughout the test and prior to gross failure showed many small, local failures were occurring at the edges of the belt. As testing progressed, the existing local failures became more severe and new ones appeared around the circumference. Continued testing apparently weakened the belt sufficiently to cause gross failure. Figures 14 and 15 show additional views of the failed belt. Similar observations were made at AFFDL by the project engineer on a modified 20.00-20 replaceable tread band. He reported, "Examination of the primary failure shows that the cord ends are highly frayed at the edges of the belt with a considerable mass of cord debris deposited between the 0 and 90 degree plies. The cords are less frayed as one moves toward the belt center and seem to have a much cleaner break. This suggests that the failure initiated at the belt edges and progressed toward the center at a fairly low rate, until the belt was critically weakened. This conclusion is born out by small failures which were initiated at two other points on the tread belt edges." Figures 16 and 17 are photographs supplied by the AFFDL project engineer of the failures.

Figure 13. Photograph of a Tread Band Break in a Modified Tread Band.

Figure 14. Closeup Photograph of Tensile Failure in a Modified Tread Band.

Figure 15. Closeup Photograph of a Cross-Section in a Modified Tread Band After Tensile Failure.

Figure 16. AFFDL Photograph of the Gross Failure of a Modified 20.00-20 Replaceable Tread Band.

Figure 17. AFFDL Photograph of the Initiation of Failure at the Edge of a Modified 20.00-20 Replaceable Tread Band.

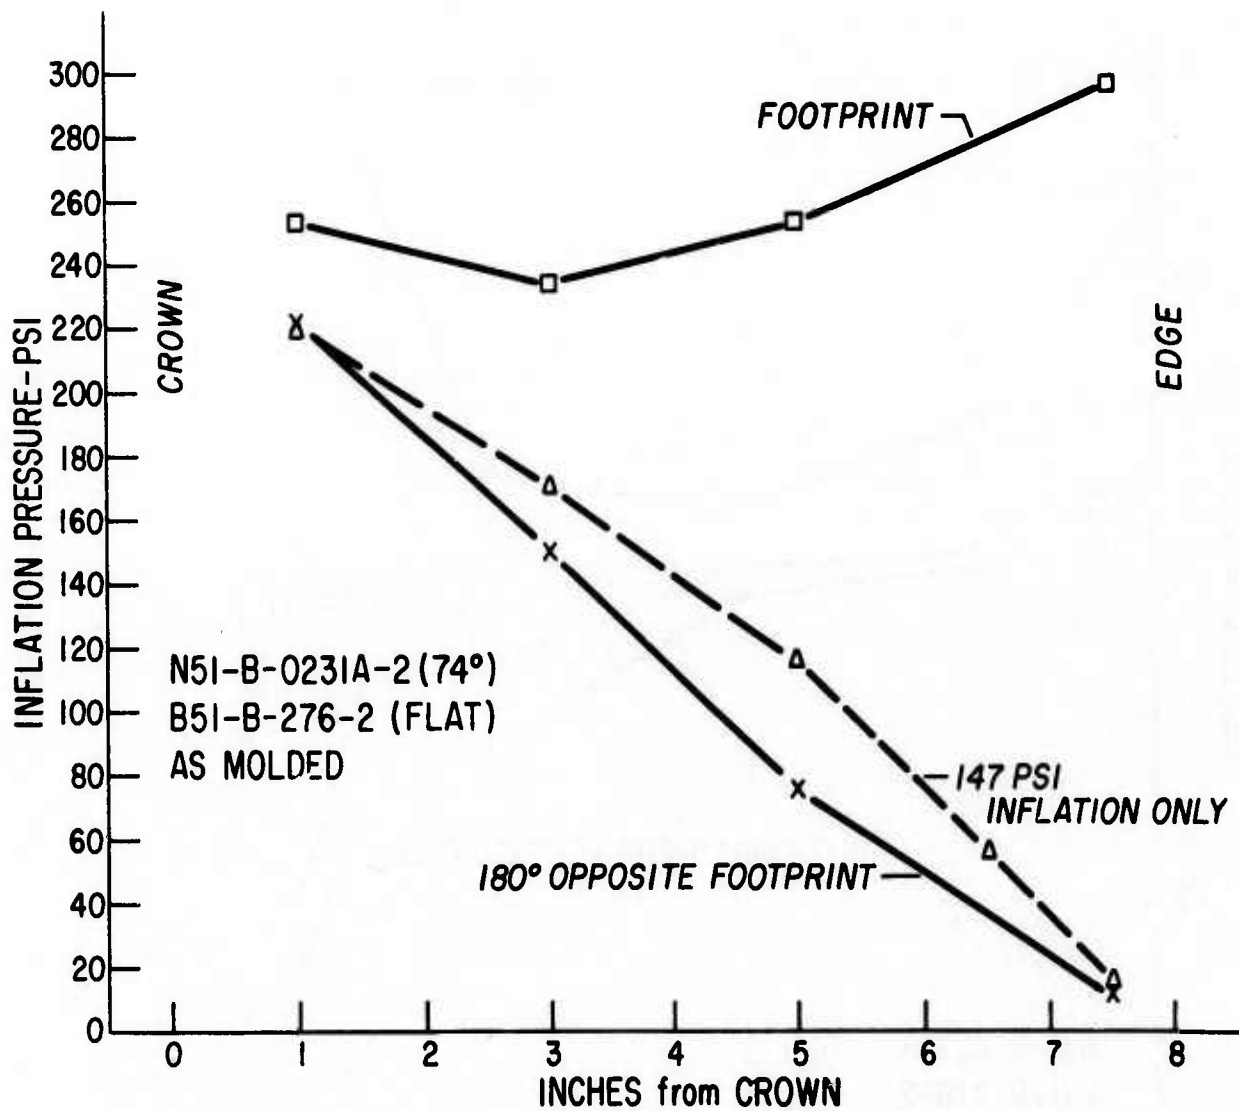
- 1) Load has little effect on interface pressure at the crown.
- 2) At the belt edge interface pressure undergoes a range of 280 psi during any one roll cycle.
- 3) Narrowing the tread band has a direct effect on interface pressure. During a roll at the edge of belt the interface pressure range increases from 280 psi (wide belt) to 340 psi (intermediate) to 530 psi (narrow).

Figure 32. EFFECT of LOAD on INTERFACE PRESSURE DISTRIBUTION of a 20.00-20 REPLACEABLE TREAD TIRE

Figure 33. EFFECT of LOAD on INTERFACE PRESSURE DISTRIBUTION of a 20.00-20 REPLACEABLE TREAD TIRE - BELT TRIMMED ONE INCH

Figure 34. EFFECT of LOAD on INTERFACE PRESSURE DISTRIBUTION of a 2000-20 REPLACEABLE TREAD TIRE - BELT TRIMMED TWO INCHES
