AMMRC CTR 75-28

BRITTLE MATERIALS DESIGN,  
HIGH TEMPERATURE GAS TURBINE

Interim Report Number 8, January 1, 1975 to June 30, 1975

Contract Number DAAO 46-71-C-0162

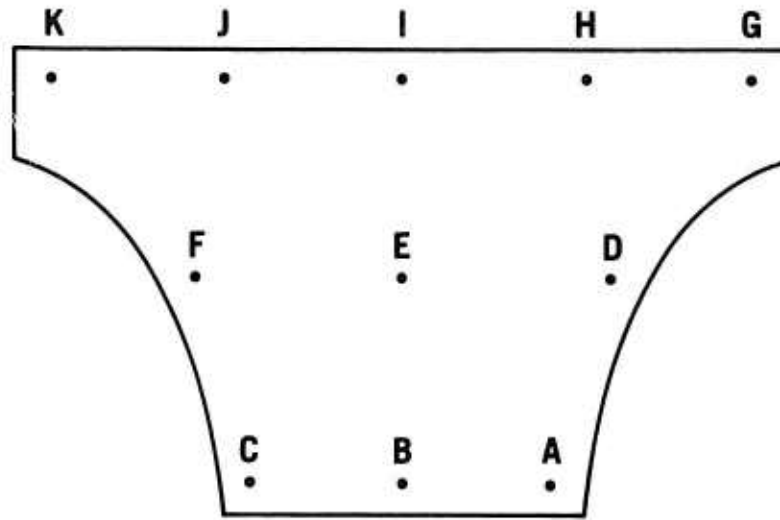
LOCATION	A	B	C	D	E	F	G	H	I	J	K
SAP III; 3D, (KSI)	21.79	15.99	22.98	15.59	15.10	15.87	8.77	10.01	14.40	10.38	8.61
AXISYMMETRIC; 2D, (KSI)	20.41	17.32	22.12	14.91	14.71	15.56	7.61	7.84	7.75	7.71	8.10

Figure 3.9 Comparison of Maximum Stresses as a Result of Centrifugal Loading at 110% Speed From Both SAP III and Axisymmetric Analyses at Various Rotor Disk Locations
