BRITTLE MATERIALS DESIGN, HIGH TEMPERATURE GAS TURBINE

Arthur F. McLean, Ford Motor Company, Dearborn, Michigan 48121
Robert R. Baker, Ford Motor Company, Dearborn, Michigan 48121

Interim Report Number 10, January, 1976 to June 30, 1976

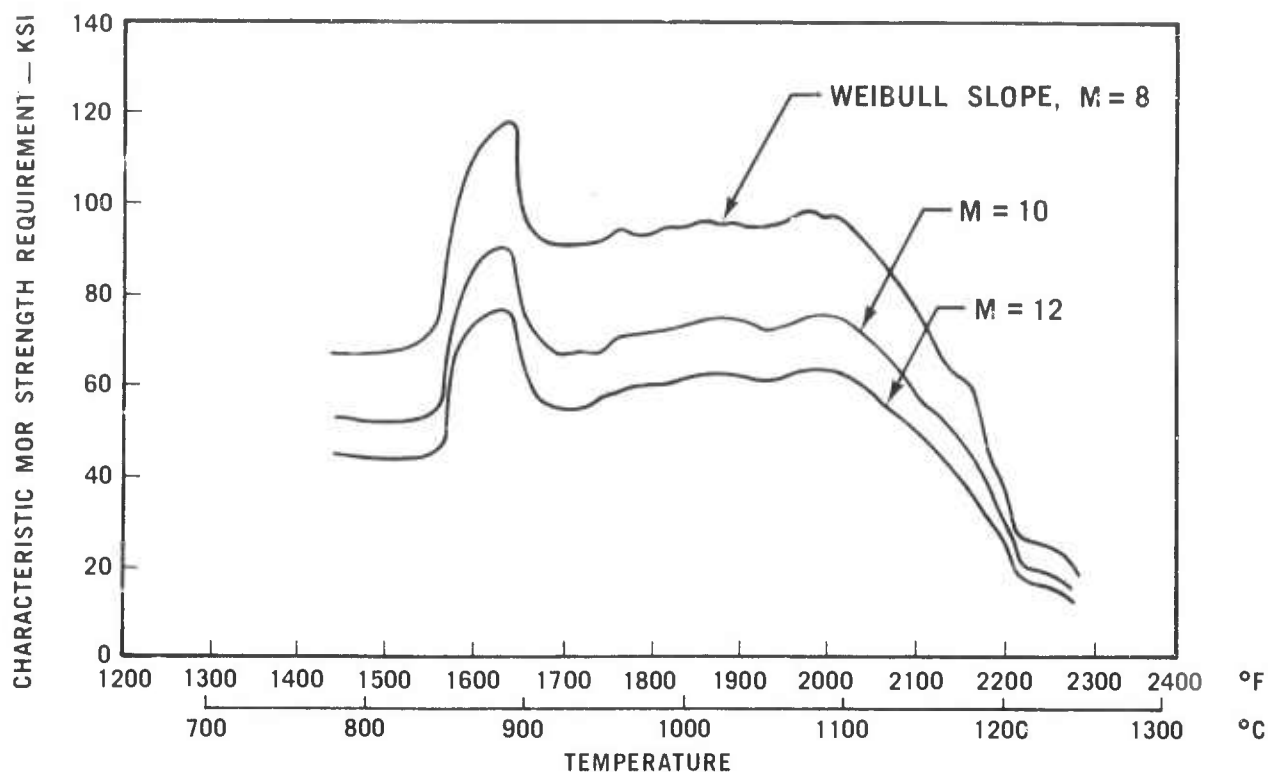
Figure 3.11 Envelope of Characteristic MOR Strength Requirements Versus Temperature for the First Stage Turbine Rotor Disk at 2500°F T.I.T. and 100% Speed for 90% Reliability.

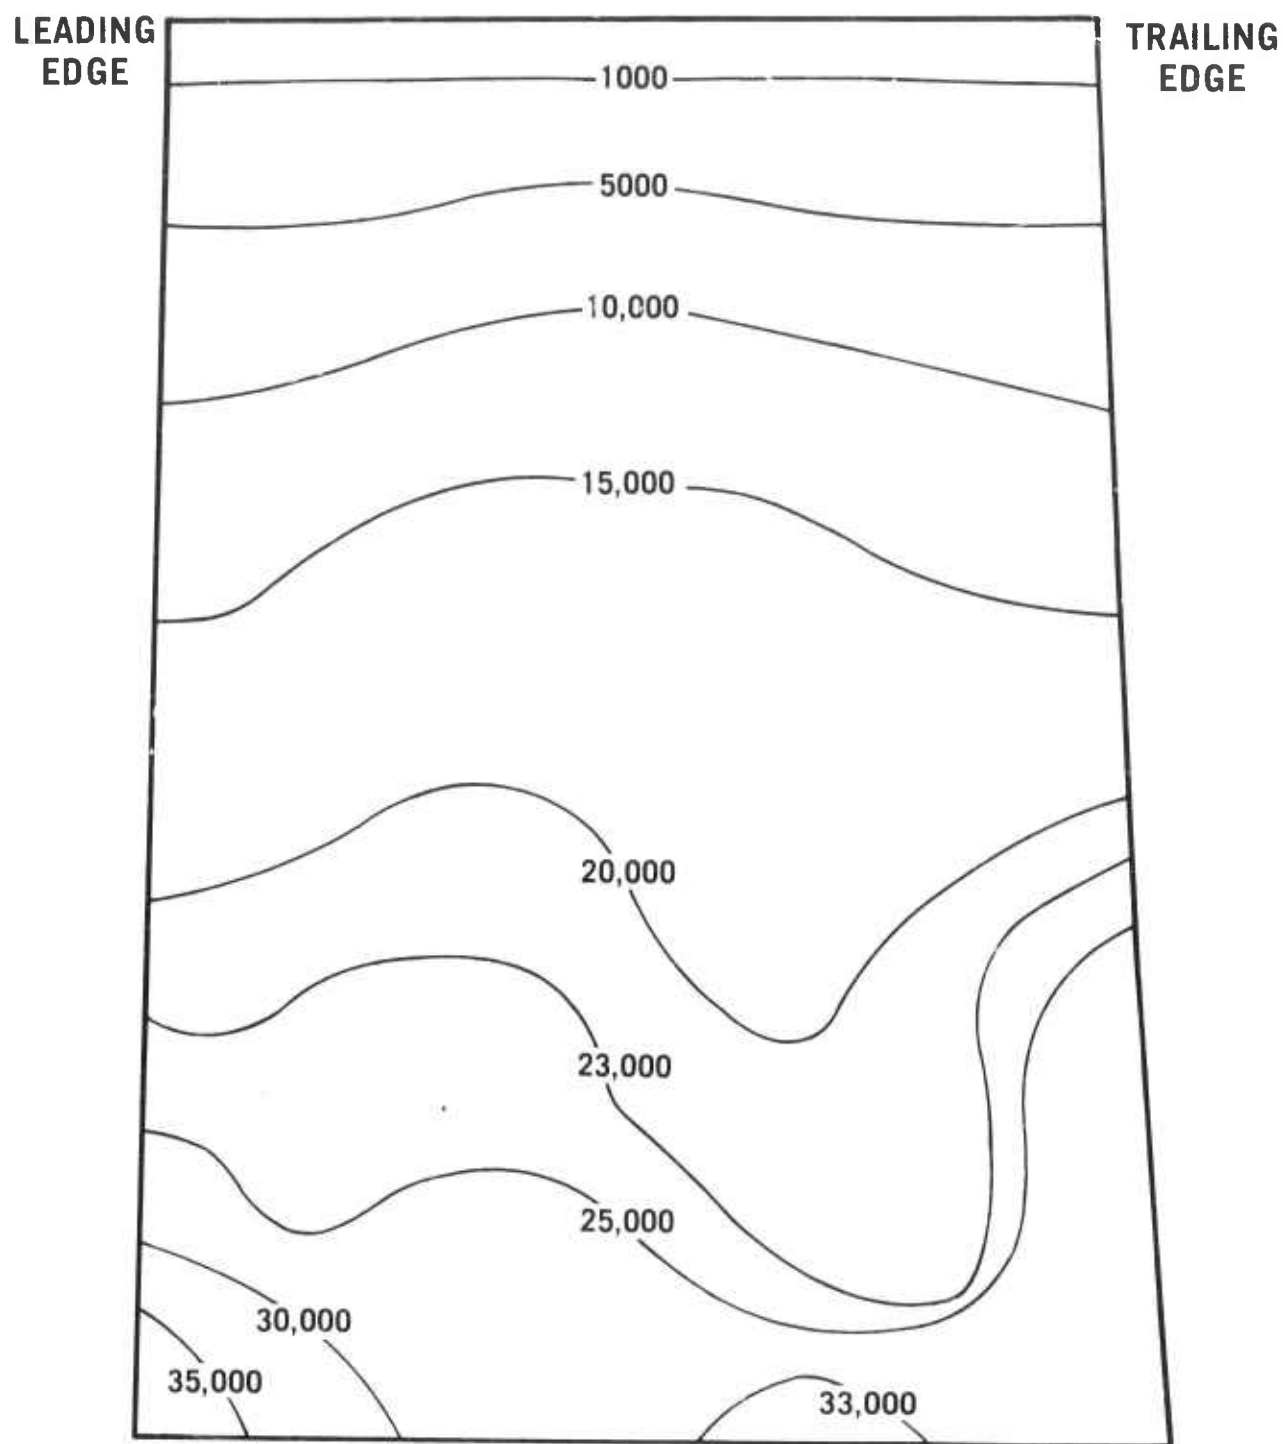
Figure 3.13 Contour Map of Characteristic MOR Strength Requirements for the First Stage Turbine Rotor Blade at 2500°F T.I.T. and 100% Speed for $m = 10$ and $R = 90\%$.

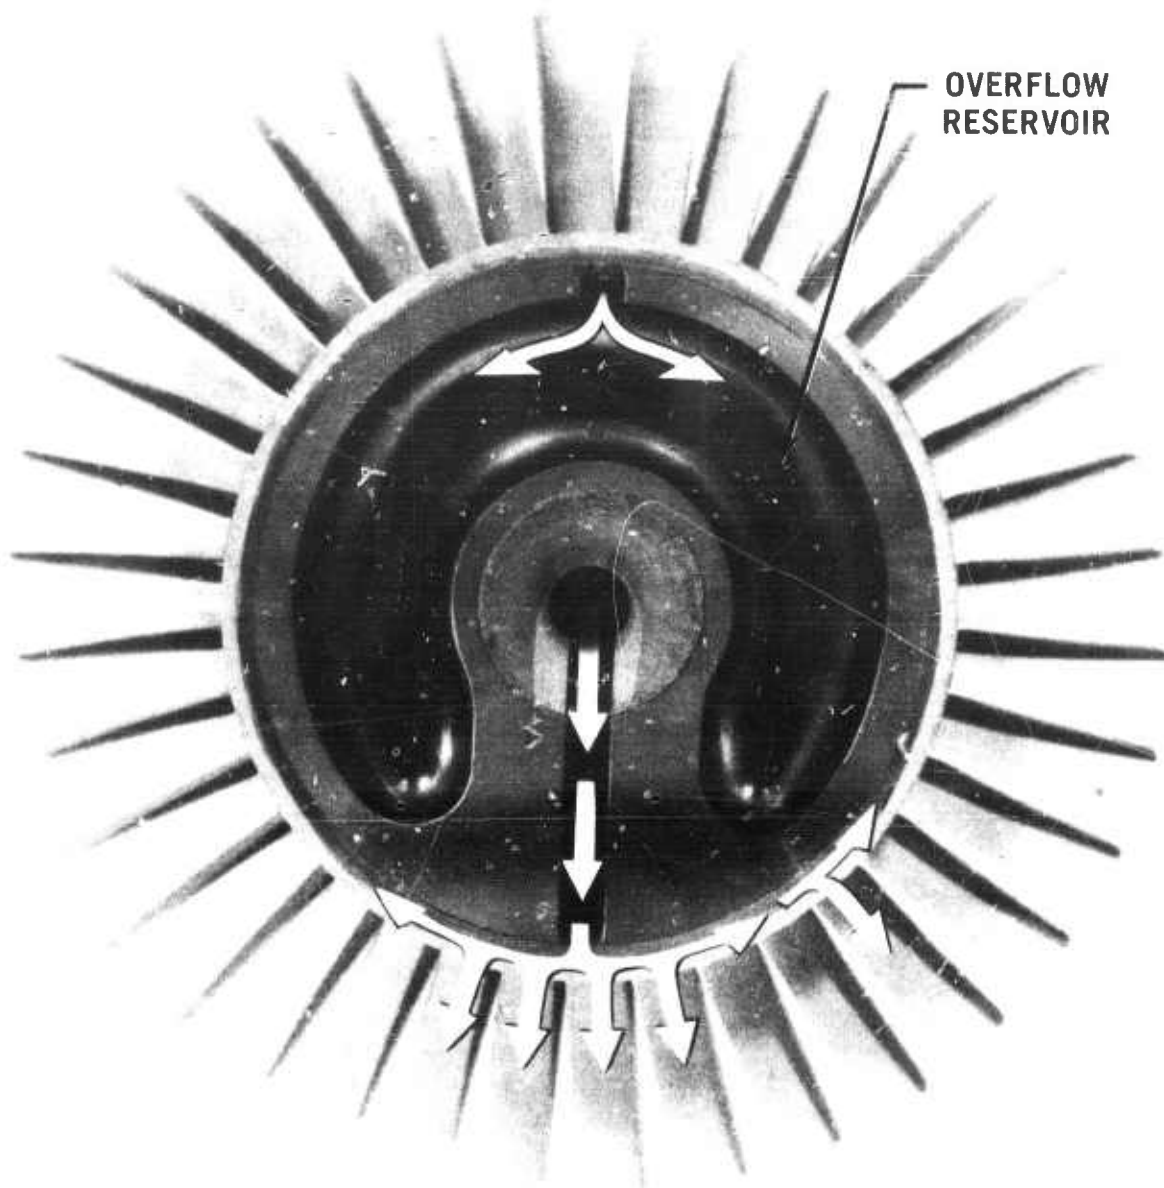
Figure 3.18 Overflow Reservoir on D' Rotor Tooling.
