MTMC REPORT OA 7T-16 ✓

**AN ANALYSIS  
OF MTMC PARTICIPATION  
IN THE  
REFORGER 76 EXERCISE**

MARCH 1977

**MILITARY TRAFFIC MANAGEMENT COMMAND  
TRANSPORTATION ENGINEERING AGENCY  
NEWPORT NEWS, VIRGINIA 23606**

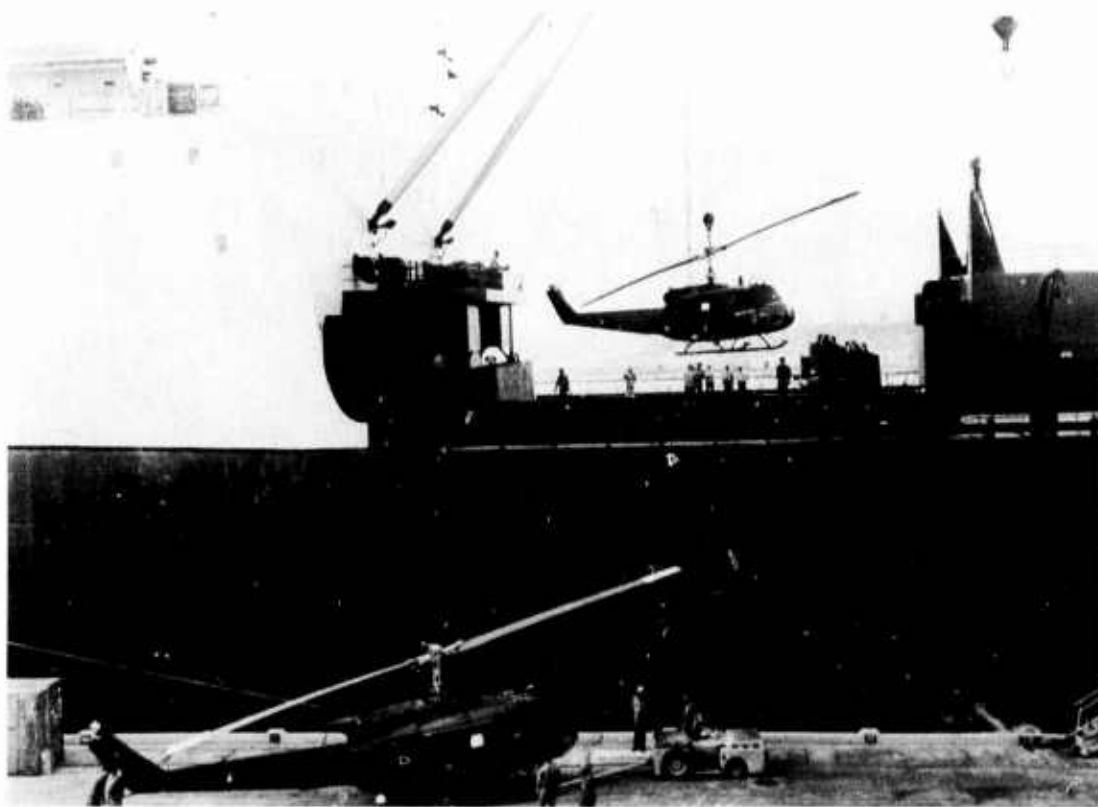
Figure 4-10. Helicopter Positioned for Lowering Through the Hatch.

(3) The REFORGER Pretest proved to be most valuable to the successful execution of the actual exercise. Based on the pretest, the conceptual helicopter loading plans were confirmed with minor changes, and a technique for below deck loading of helicopters with blades installed was developed (Figures 4-9 to 4-14). Deficiencies in special equipment, such as helicopter positioning devices and redi-covers, were identified and improvements recommended. The overall height of the CH-47 spreader bar and the variety of lifting eyes associated with the CH-47 were identified as potential problem areas. Perhaps the most important aspect of the pretest was the confidence gained in the sealift concept.

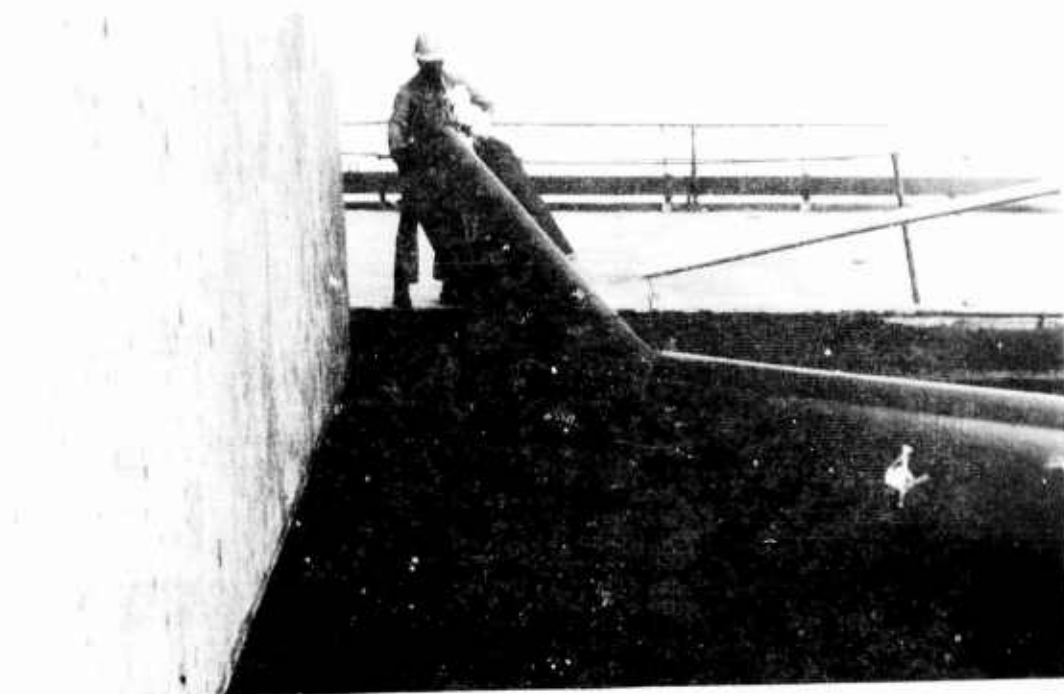
Figure 4-11. The Tail of the Helicopter is Lowered Carefully Through the Hatch.

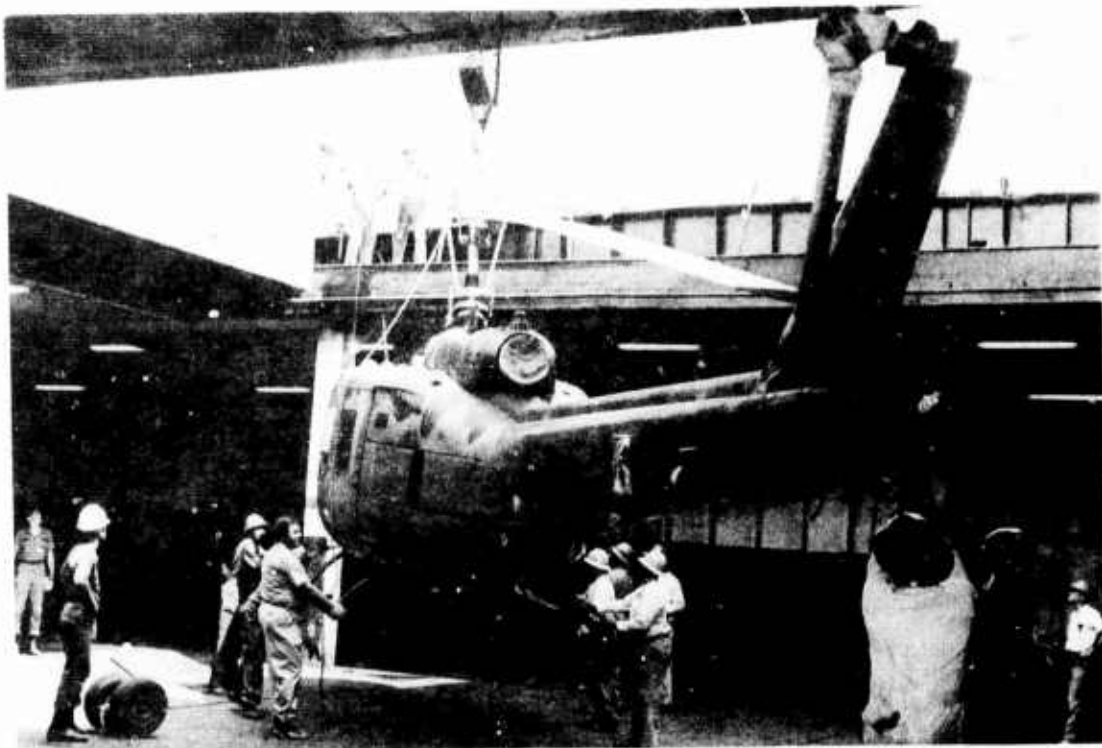
Figure 4-13. The Tail is Moved Backwards so the Front Blade can Safely Clear the Hatch Opening.

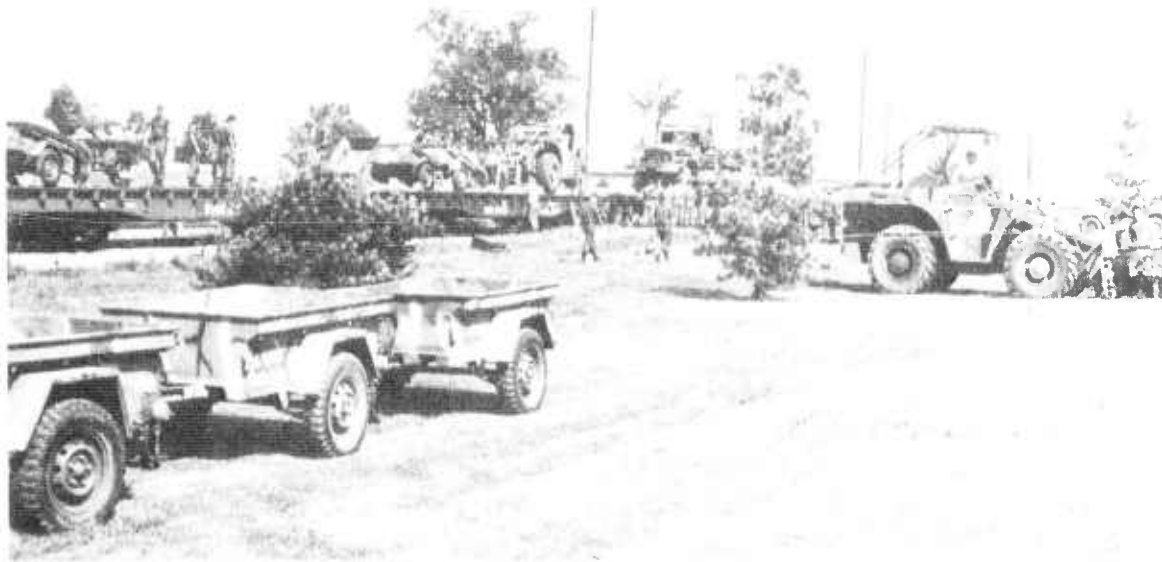
Figure 6-2. MHE Loading Railcars.

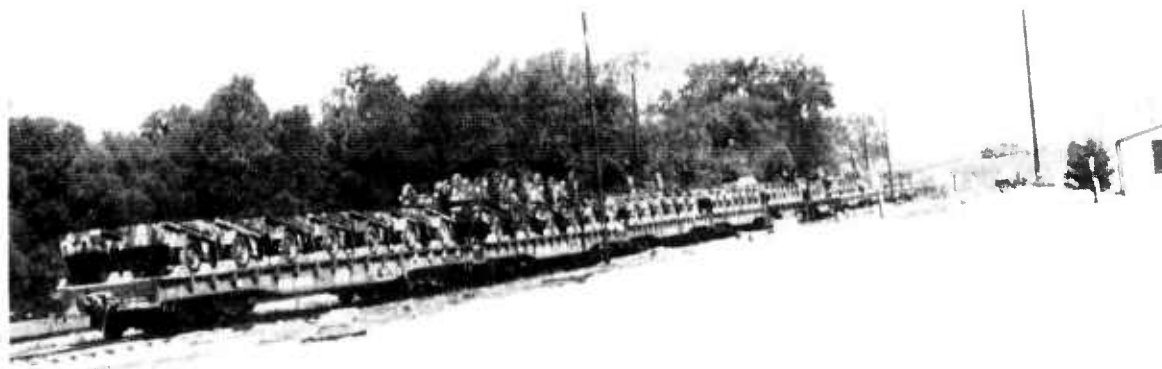
Figure 6-3. 1/4-Ton Trailers Loaded Without Being Banded.

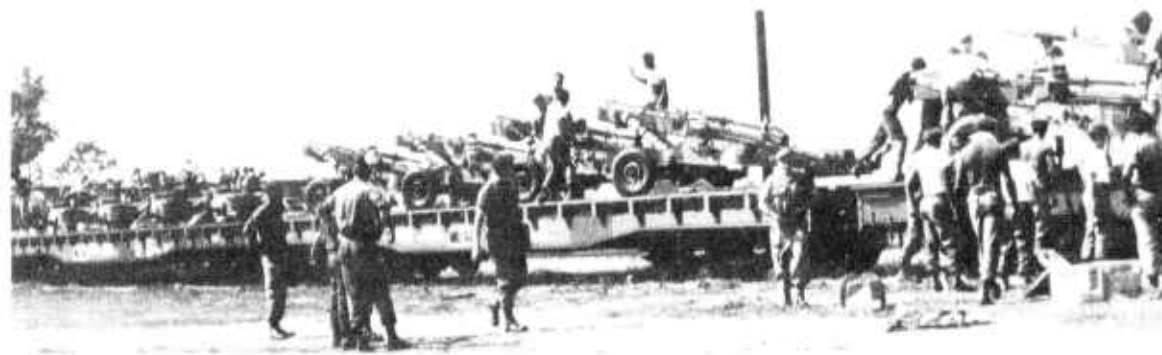
Figure 6-4. M102A1 Howitzer Blocking and Bracing  
Developed by MTMC.

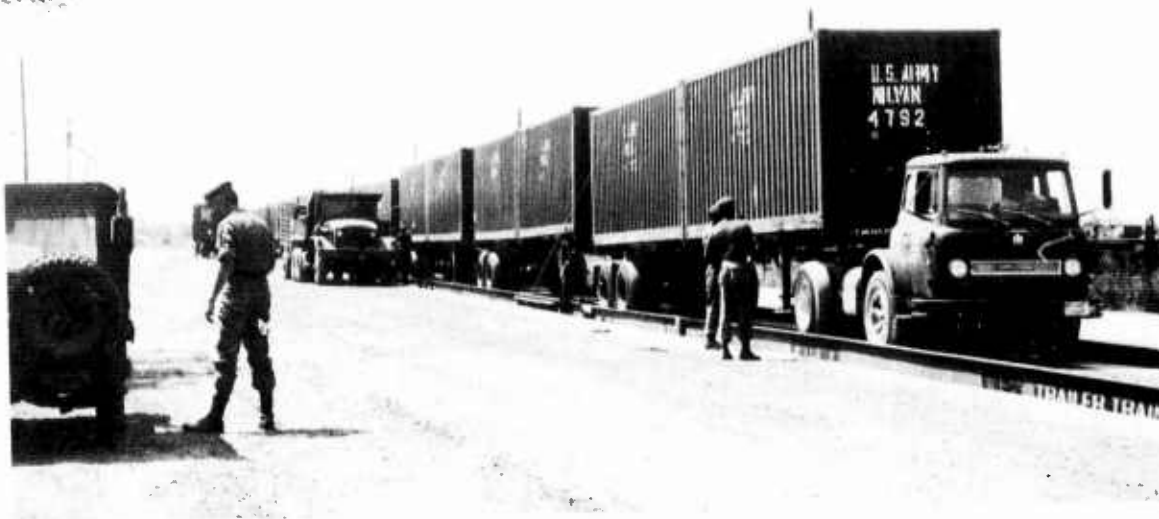
Figure 6-7. MILVANS and Chassis Loaded on Trailer-on-Flatcars.

(4) Operations at Sites A-6 and A-5, where large vehicles were being loaded on 60-foot (chain tiedown) flatcars (Figure 6-5), went very smoothly and quickly. These railcars were completed and accepted for shipment by 1330 hours (Figure 6-6). MILVANS loaded at site B-1 were backed down the string of trailer-on-flatcars (TOFC) and positioned with the average string of cars, taking approximately four to complete (Figure 6-7). The container-on-flatcar (COFC) loading at Clarksville Base spur did not proceed as smoothly as this, since the crane used for loading the containers was stationary, and the railcars had to be repositioned each time a container was loaded. The use of COFC to ship 51 MILVANS was recommended by MTMC representatives in lieu of the planned use of 26 conventional noncushioned flatcars. Conventional flatcars would have required considerable blocking and bracing material, as well as labor time. In place of the 26 conventional cars, 13 container cars were used (4 containers per car). These special-purpose railcars greatly simplify rail movement, reduce loading/unloading time and loading cost, and most important, reduce the potential for damage to cargo. As only 13 container cars were required, the slow loading operation did not adversely affect the overall movement. Site A-12 was used to load bilevel flatcars (Figure 6-8) with smaller vehicles. The earth ramp at the site was removed to permit a mobile bilevel ramp to be positioned (Figure 6-9). Bilevel chain tiedown cars (Figure 6-10) had not been inspected to insure that the railcars were of the type that could be used to secure the vehicles scheduled for shipment. Upon railcar examination, MTMC representatives recommended the purchase of 700 adapters for use with the M880-series trucks. These adapters are U-shaped connectors that attach to holes in the vehicles frame and provide the only hardpoint on the vehicle for securement. Serious consideration should be given to modifying the tiedown points on the M880-series vehicles to permit them to be secured with any conventional tiedown device. Present tiedown points consist of holes in the frame.

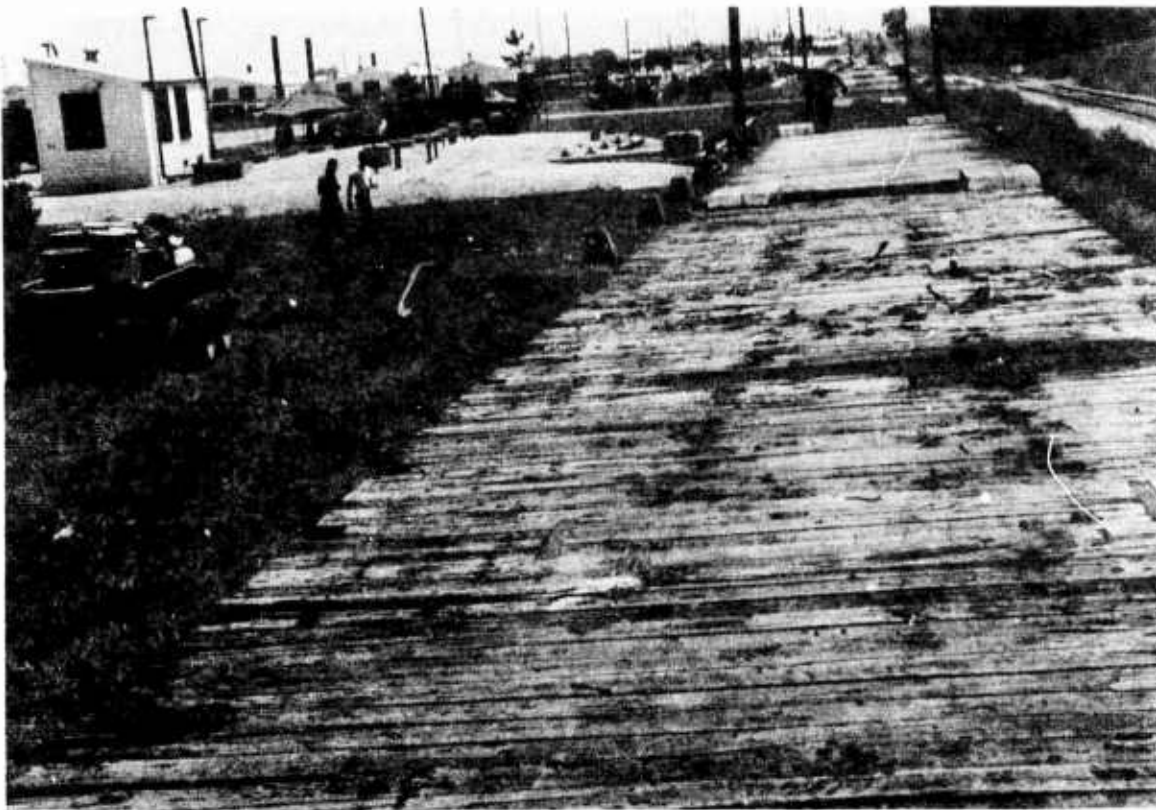
Figure 6-11. Wooden Spanners Joining DODX Flatcars.

(5) Wooden spanners (Figure 6-11) were used between railcars at all sites. Problems were encountered at A-12 due to the thickness of the spanners. Readjustments were required periodically. This temporarily delayed operations. MTMC representatives recommended a temporary modification to enable the spanners to remain in place. However, all the spanners had been fabricated in advance, and once the outloading commenced it was impossible to make the required modification. It is recommended that the wooden spanners in the AAR loading rules be modified in the future to correct the deficiency noted at Fort Campbell.

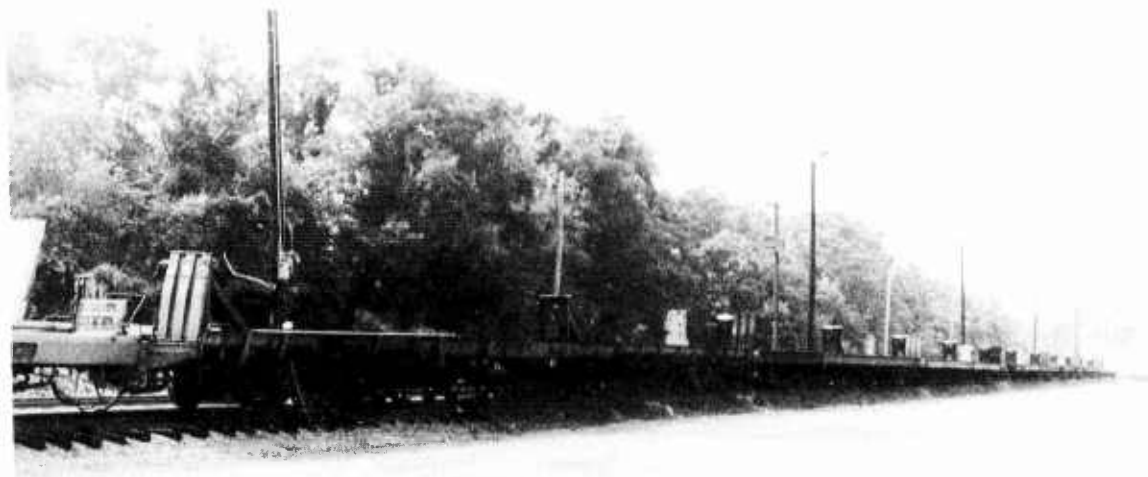
Figure 7-2. 89-Foot Trailer-on-Flatcars.

f. A special operation for the offloading of military-owned demountable containers (MILVANS) on chassis was arranged early in the planning stages of REFORGER 76. MTMCEA was informed by NSC Norfolk that, due to the curvature of the trackage on Pier 4, 89-foot railcars could not be offloaded. The use of the NSC "circus" ramps was considered. However, the addition of this requirement to the already congested operation would have unduly tasked NSC's capability to provide the necessary level of support. To overcome these constraints and still utilize cost-effective 89-foot railcars (Figure 7-2), it was planned that the TOFC MILVANS on 89-foot cars be offloaded at the N&W TOFC Yard at Portlock (23 highway miles from the Norfolk Naval Station). A local drayage company drayed the MILVANS to the Naval Station. The Portlock container facility opened at 0700 hours, and the MILVANS were given top priority as the trains

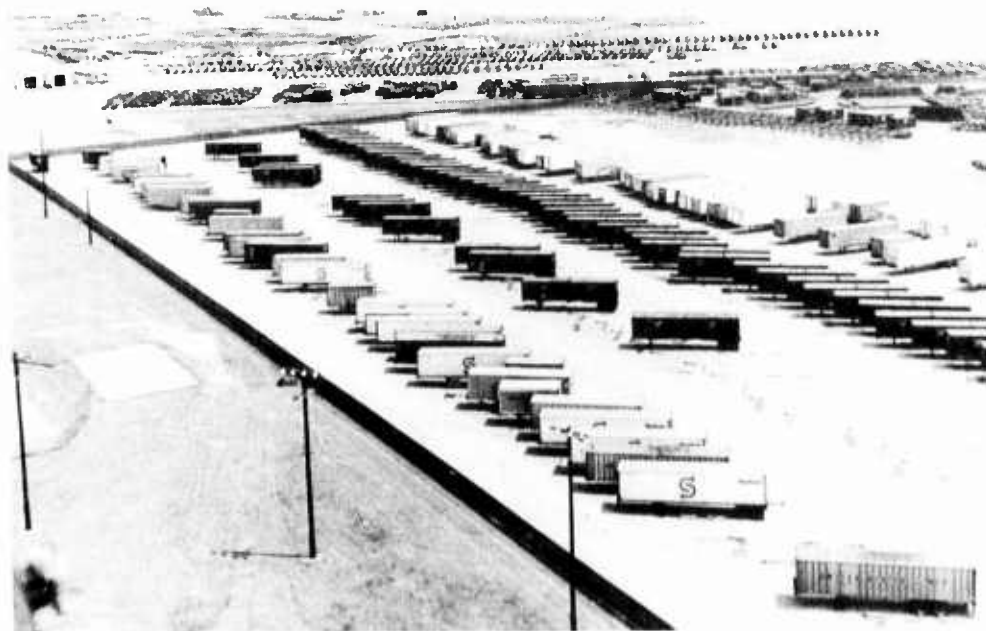
Figure 7-3. Container Staging Area at the Norfolk Naval Station.

arrived. Commercial armed guards were provided for drayage security. Security for the Portlock area was provided by three military policemen from the 101st Airborne Division. During this operation 190 MILVANs and 4 semitrailers were delivered from Portlock to the Naval Station (Figure 7-3). A few minor problems were encountered:

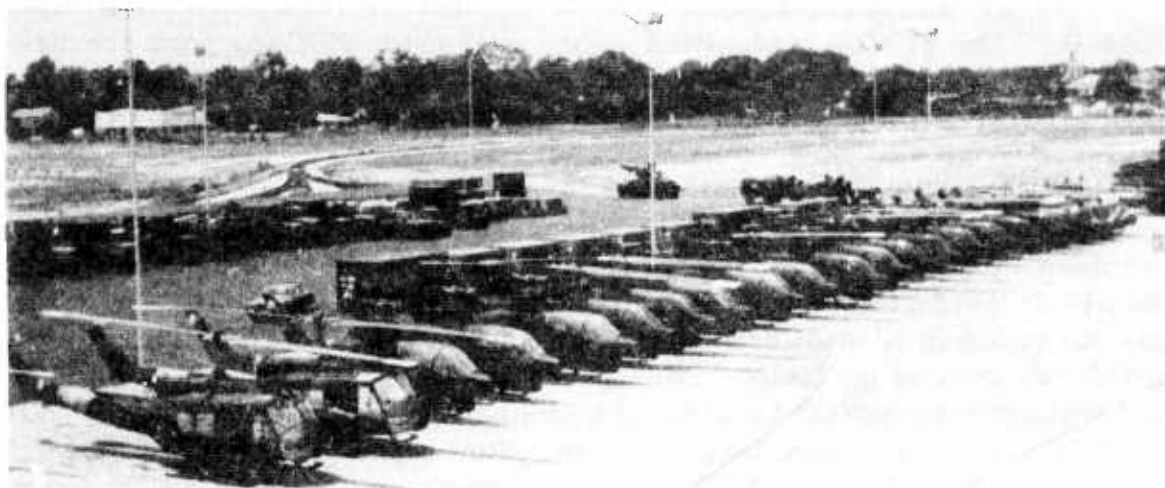
Figure 8-16. Beaumont, TX, Staging Area.

(1) The receipt, staging, and loading of Fort Hood REFORGER 76 equipment was conducted without major complications (Figures 8-16 and 8-17). Helicopters were self-deployed to the port, and other equipment was moved via commercial highway.

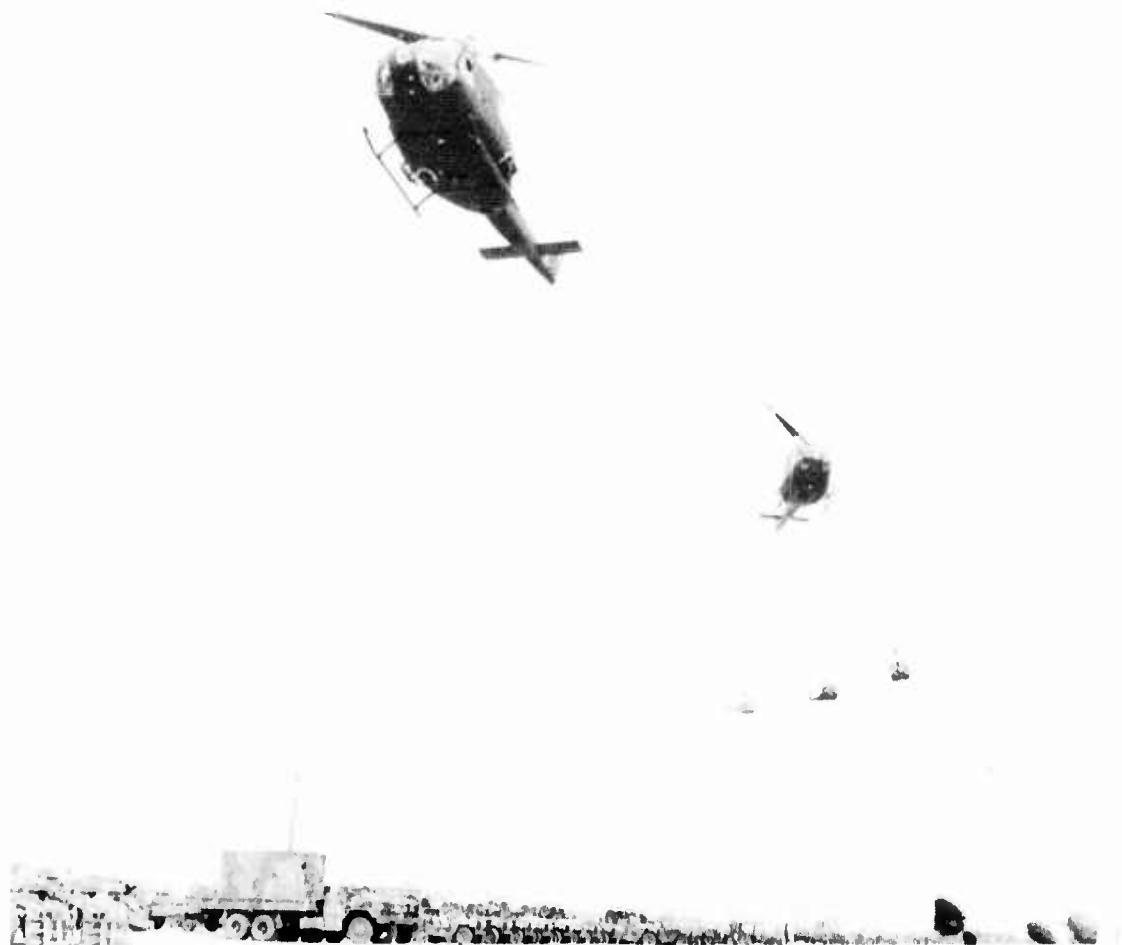
Figure 8-19. Helicopter Fly-In at Norfolk Naval Station.

(b) Aircraft arrived in flights of five every 30 minutes (Figure 8-19) and were directed to their disassembly area (Figure 8-20).

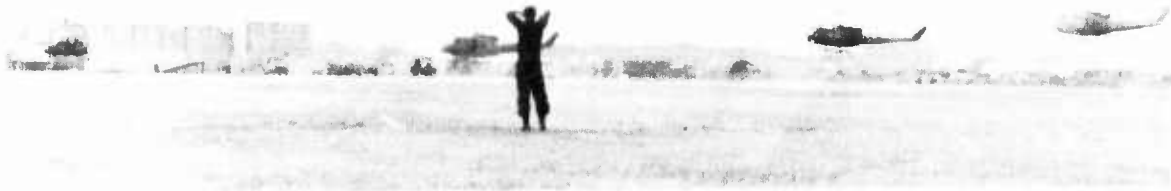
Figure 8-20. Helicopters Directed to Staging and Preparation Area.

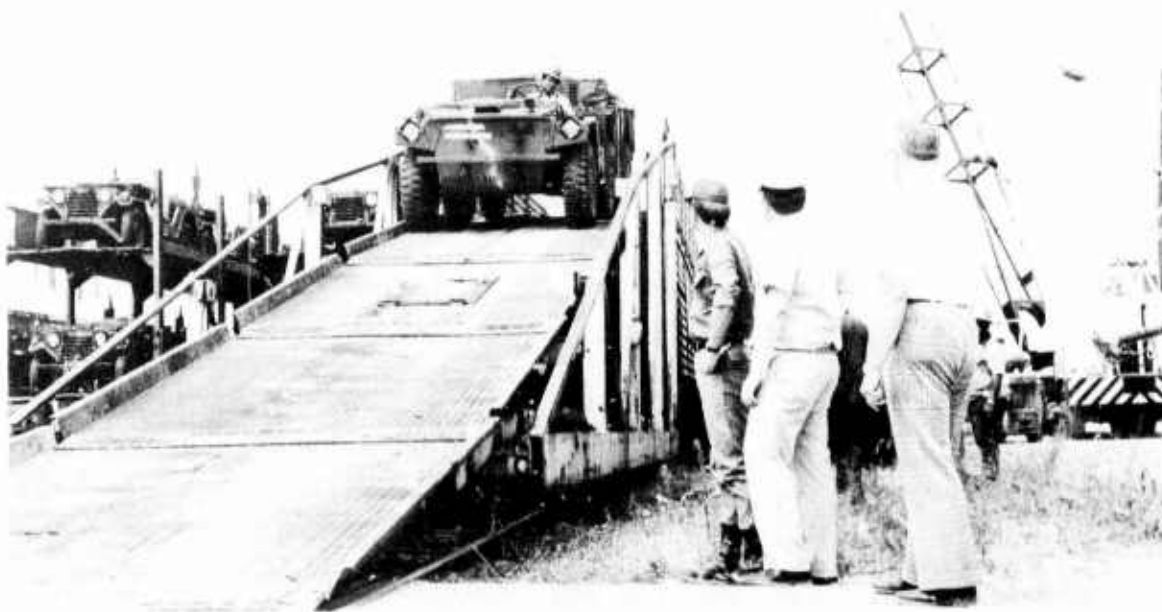
Figure 8-21. Bilevel Railcars Unloading Utilizing Mobile Ramp Provided by the Norfolk & Western RR.

2. Bilevel cars were offloaded at the Naval Supply Center open storage area with the use of a mobile bilevel ramp rented from the Norfolk and Western Railroad (Figure 8-21).

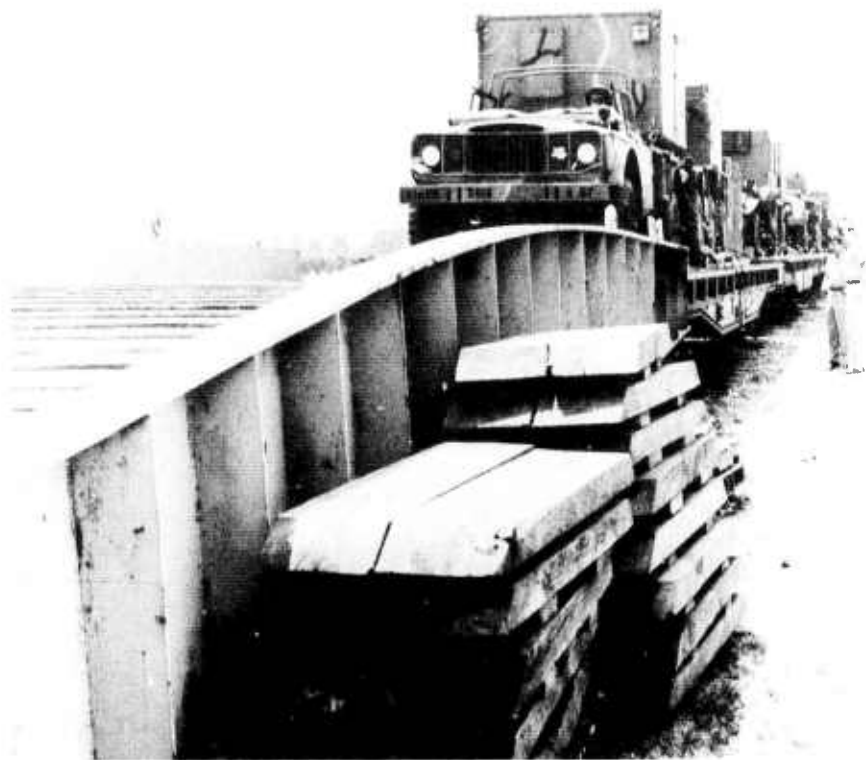
Figure 8-24. Vehicles Driven Off Flatcars at the Norfolk Naval Station Railhead.

4. Dunnage-free railcars were discharged at the permanent naval station roll-off ramps (Figure 8-24).

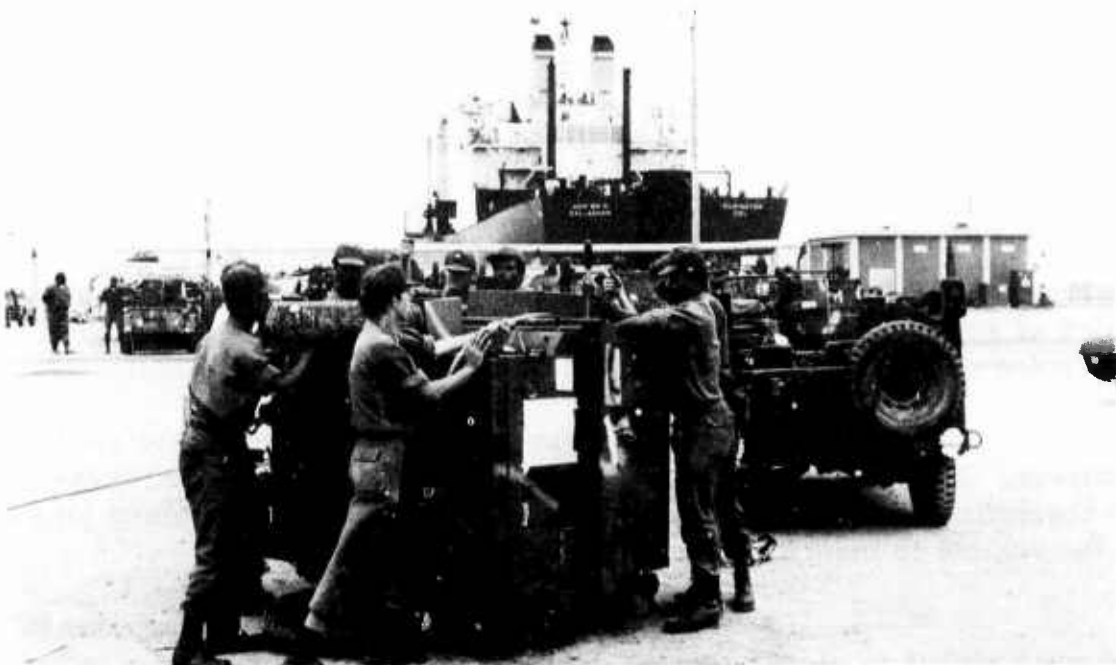
Figure 8-26. Trailers Were Nested at Norfolk.

2. Approximately 50 percent of the cargo stowage space in vehicles such as cargo trucks, gamma goats, and trailers was not used for storing break-bulk cargo (Figure 8-25). Army regulation 220-10, para 7-6, and FORSCOM Regulation 55-1 require that the moving unit use vehicle cargo space to the maximum for storing miscellaneous organization equipment and supplies. The moving unit's noncompliance with these regulations required substantial manpower at the SPOE to consolidate equipment and make better use of vessel stowage space (Figures 8-26 and 8-27). It also increased the number of MILVANS needed to transport the miscellaneous break-bulk cargo. It is estimated that, if vehicle cargo stowage space had been fully utilized, the number of MILVANS could have been reduced by 25 percent and over \$50,000 of line haul and port handling

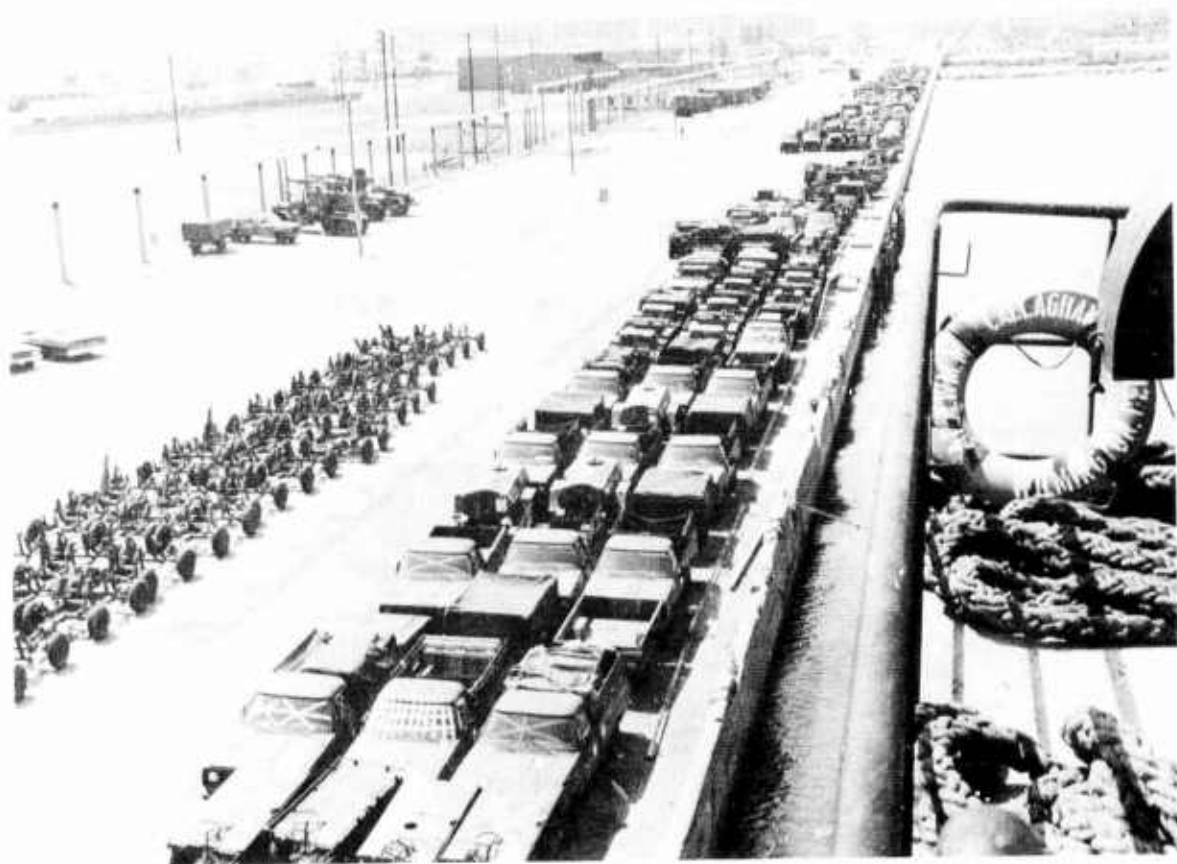
Figure 8-30. Staging Area Callaghan.

(2) Vehicles and other equipment were staged by vessel and stow location (Figures 8-29 and 8-30). The staging areas, assigned by NSC, proved sufficient. Although extra effort was required to stage vehicles in such precise locations, this staging method facilitated the call forward of the cargo of the vessel.

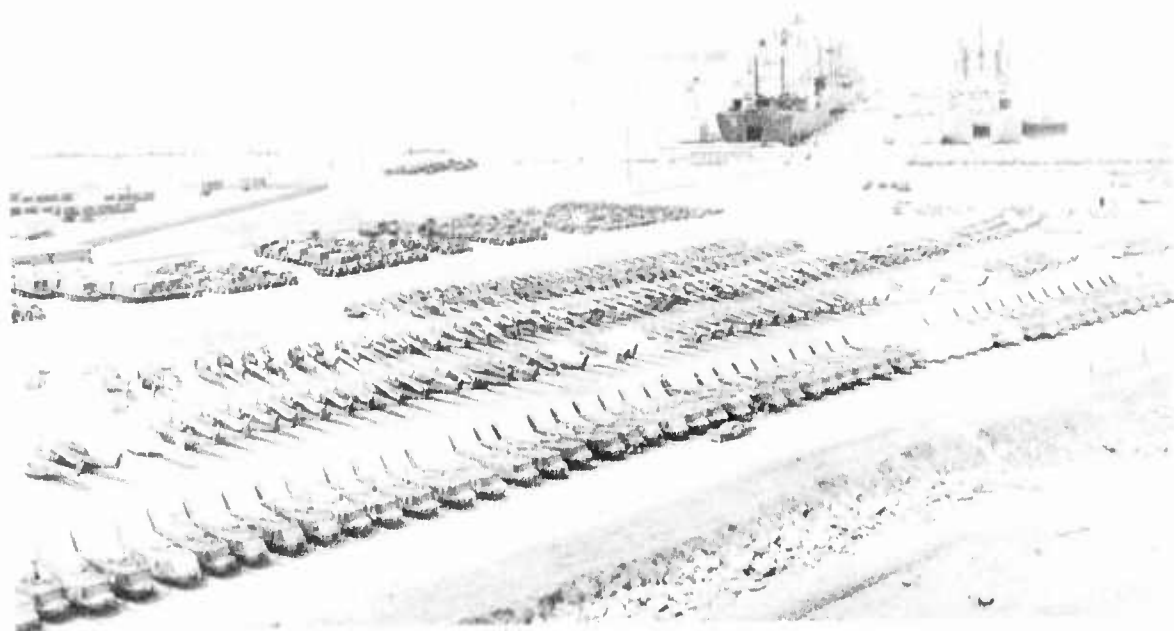
Figure 8-31. Helicopter Staging Area.

(3) The area that was provided for helicopter preservation, disassembly, and staging was adequate (Figure 8-31). Its proximity to the pier facilitated bringing the aircraft pierside, and the sodded surface maintained its firmness despite heavy rains. Helicopter preservation and disassembly times were less than pretest REFORGER times, due to the systematic production line used by the 101st Airborne Division personnel. (Figures 8-32 to 8-35).

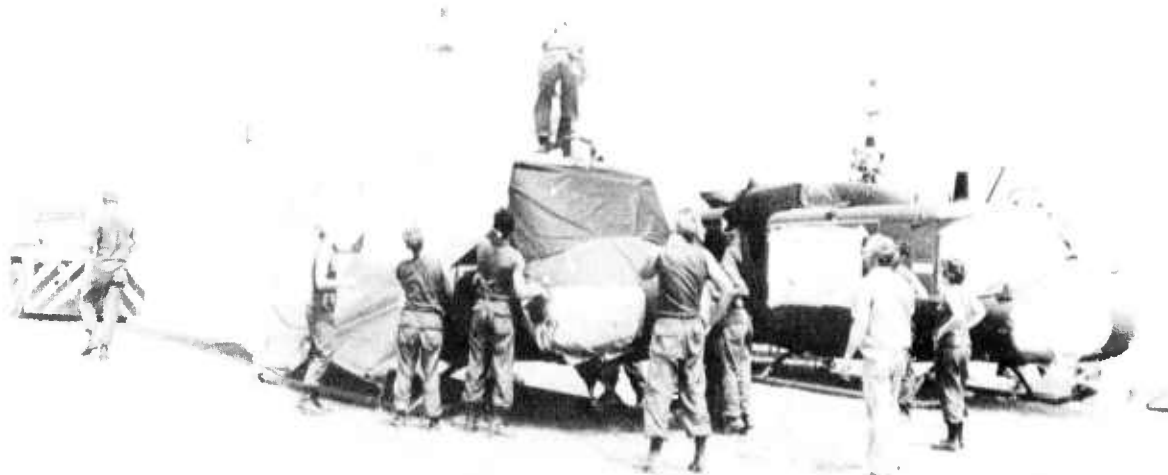
Figure 8-33. Installing Redi-Covers on the UH-1.

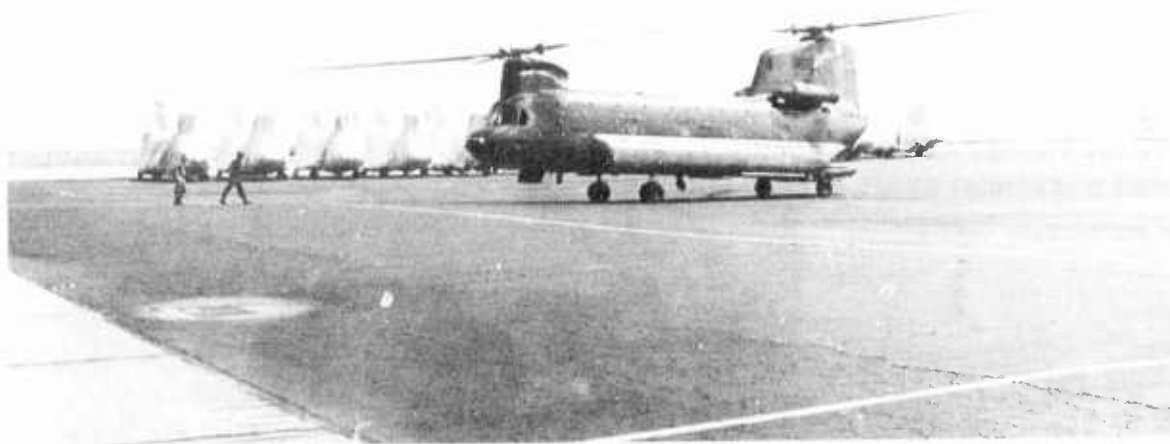
Figure 8-34. CH-47 Landing and Preparation Area.

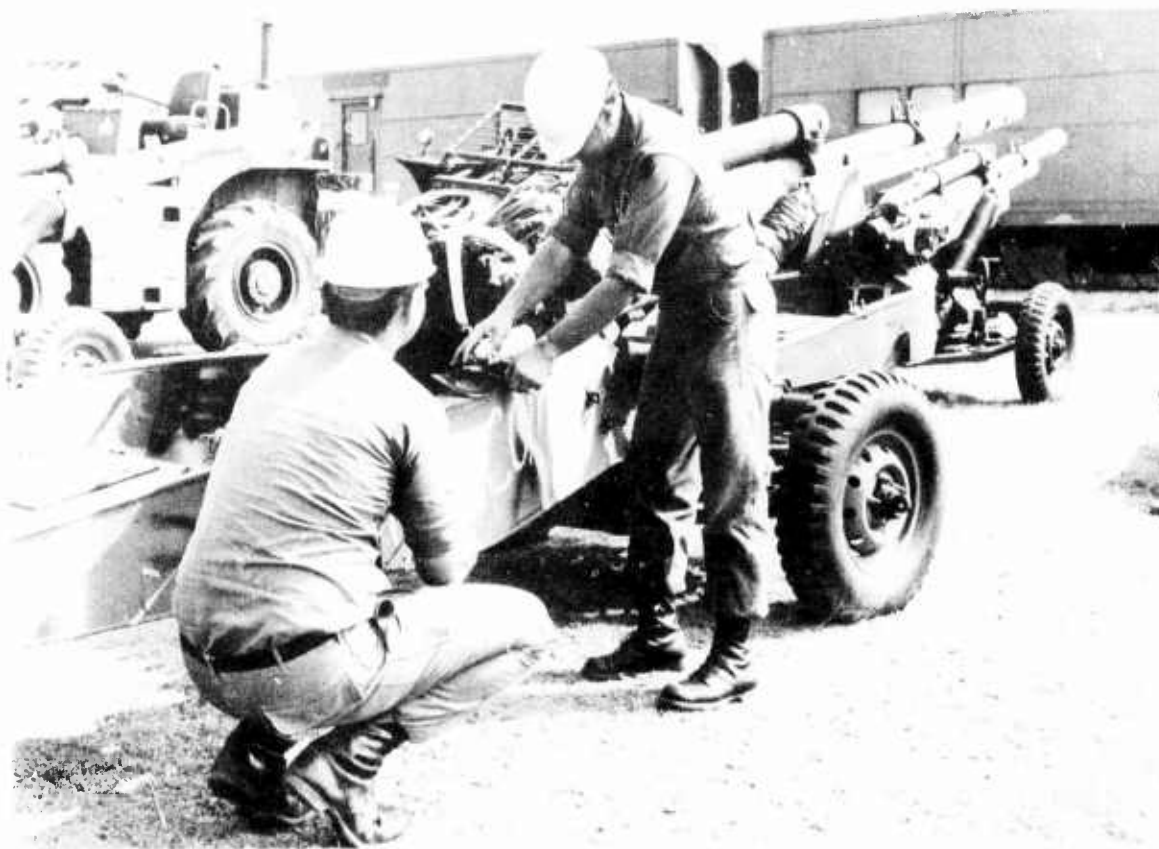
Figure 8-36. MTMC Personnel Mark Equipment With Correct Vessel and Stow Location.

(a) Since the moving unit failed to comply with the port call message, MTMC personnel had to mark the arriving equipment with correct vessel and stow locations (Figure 8-36). This task required additional personnel at all vessel staging areas.

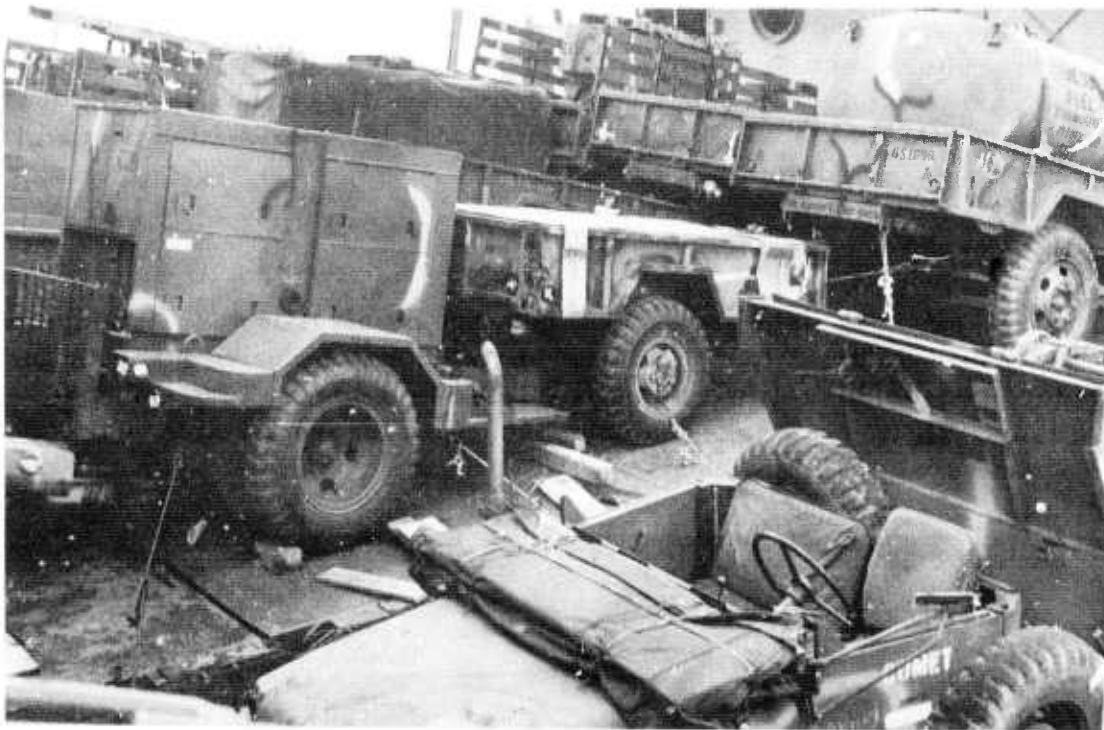
Figure 8-38. Typical Tight Stow of Trailers on Comet.

(1) A very tight stow was necessary on all four vessels (Figures 8-37 to 8-40). Normal RORO loading was modified by using forklifts and stevedore personnel to lift and push vehicles into spaces impossible to drive into. All tiedowns were doublechecked to insure a stable, damage-free ocean voyage (Figure 8-41).

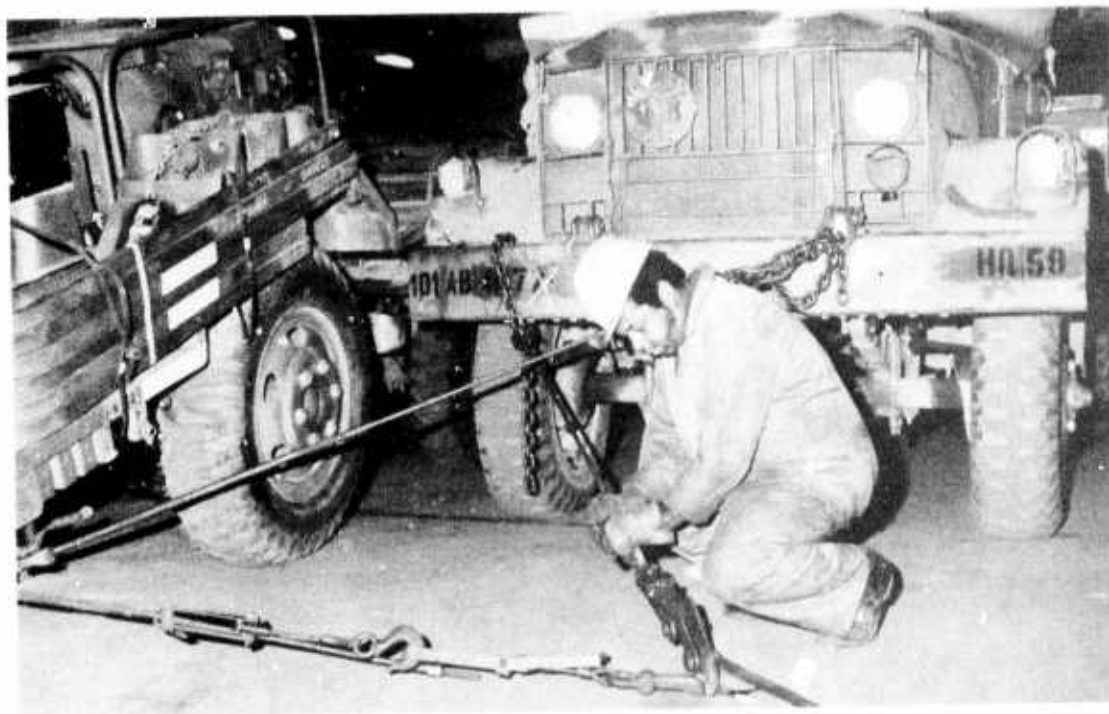
Figure 8-41. Tiedown Restraints Were Carefully Checked.

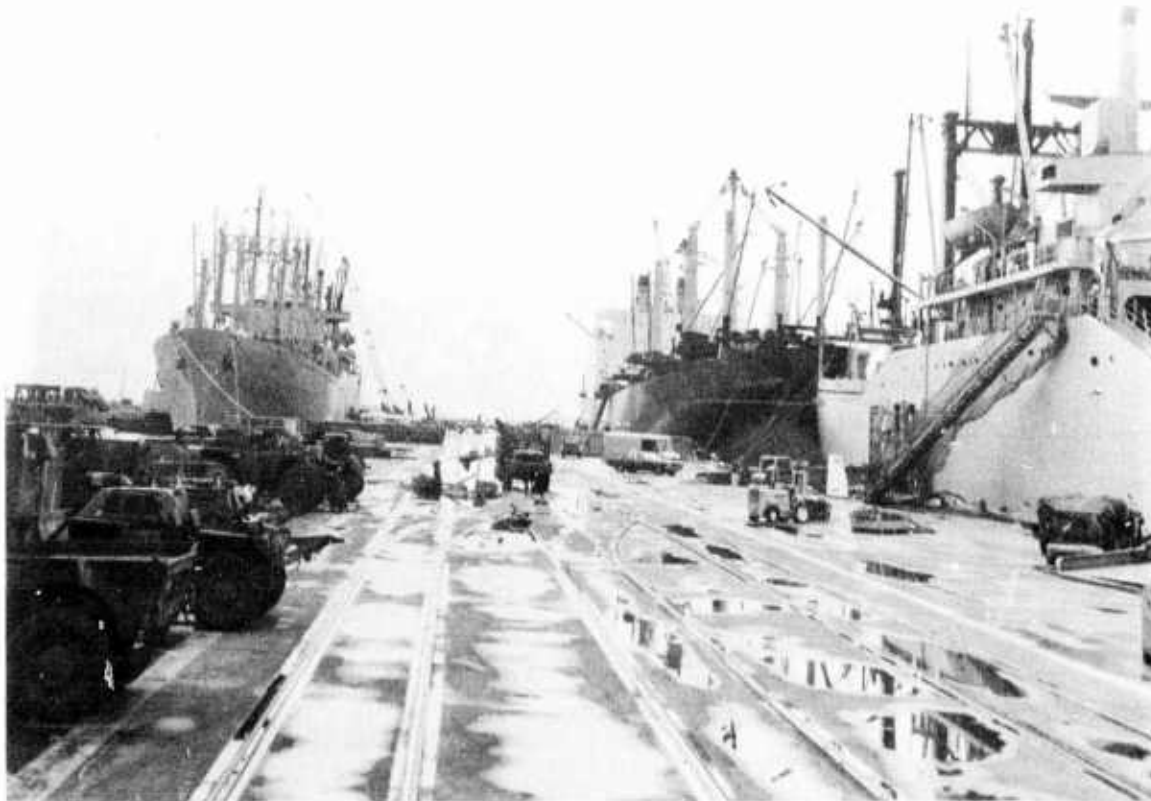
Figure 8-42. Pier 12 With Three Berthed RORO Vessels.

(4) The three RORO ships were berthed on Pier 12. This pier proved to be very efficient for RORO operations. It was large enough to work three vessels simultaneously without interference (Figures 8-42 to 8-48). The proximity of the three vessels provided the port operators with easy control. The American Ranger was berthed at Pier 4, where the gantry crane was used along with ship's gear to load MILVANS (Figures 8-49 to 8-52 and break-bulk cargo.

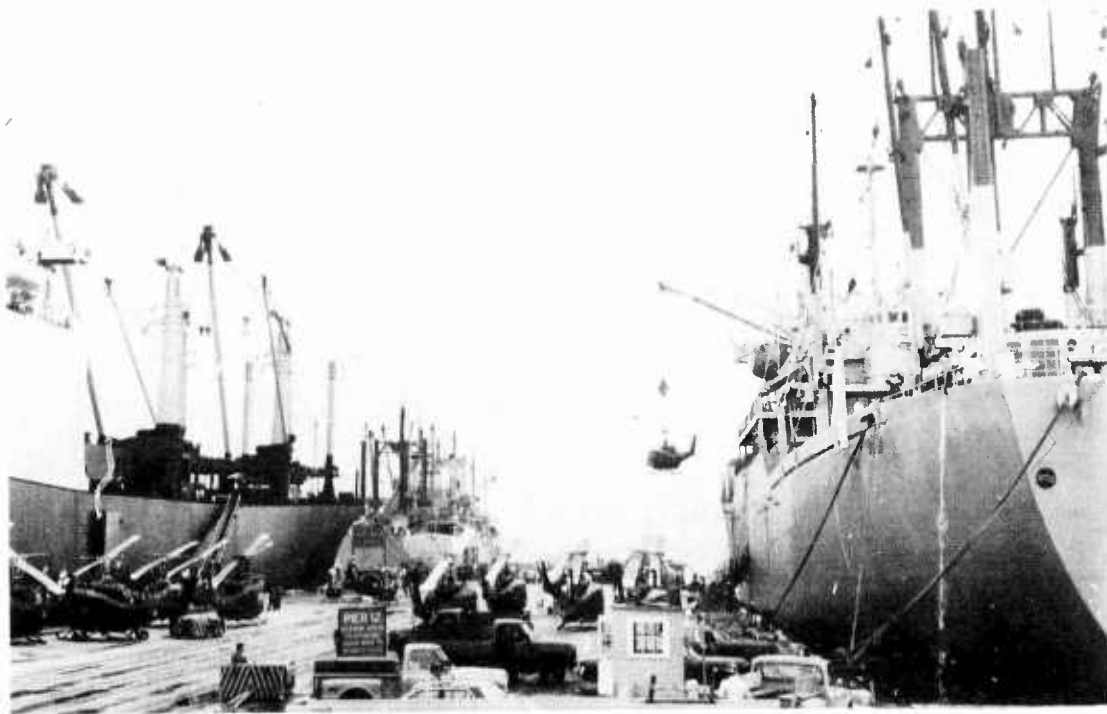
Figure 8-43. Pier 12 was Sufficiently Wide to Provide for the Simultaneous Loading of Three REFORGER Vessels.

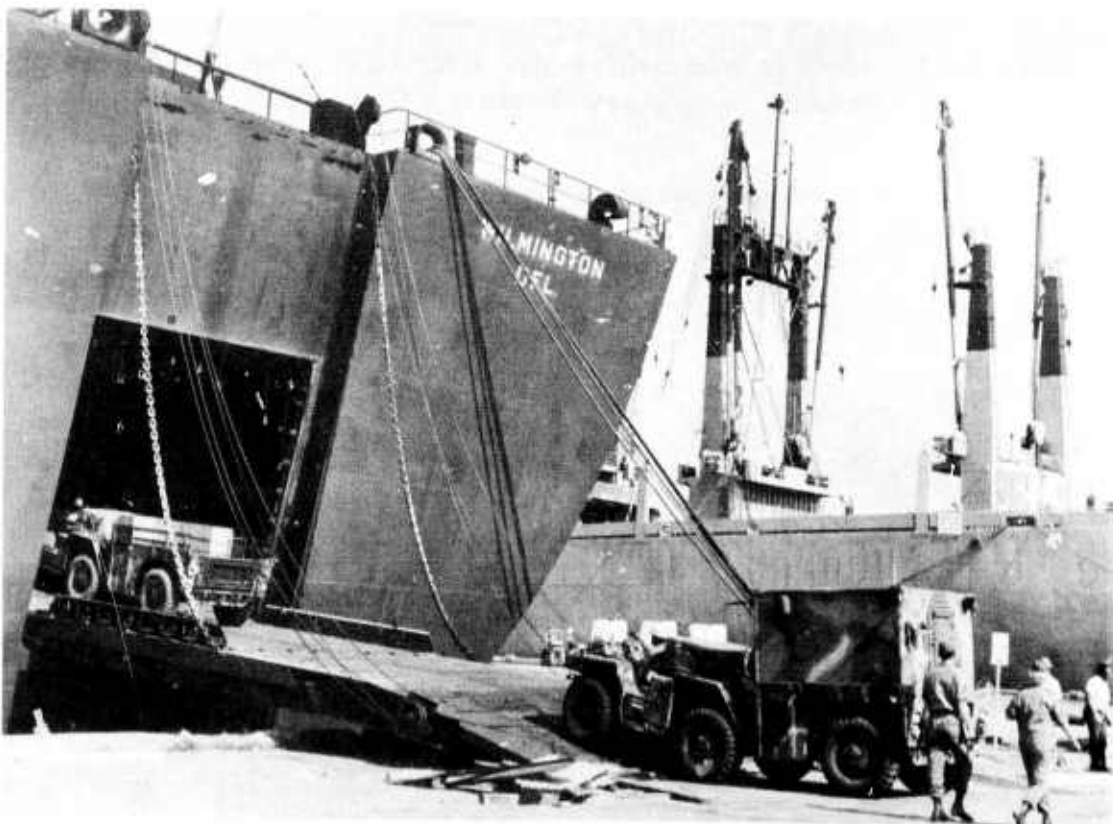
Figure 8-46. RORO Operations GTS Callaghan.

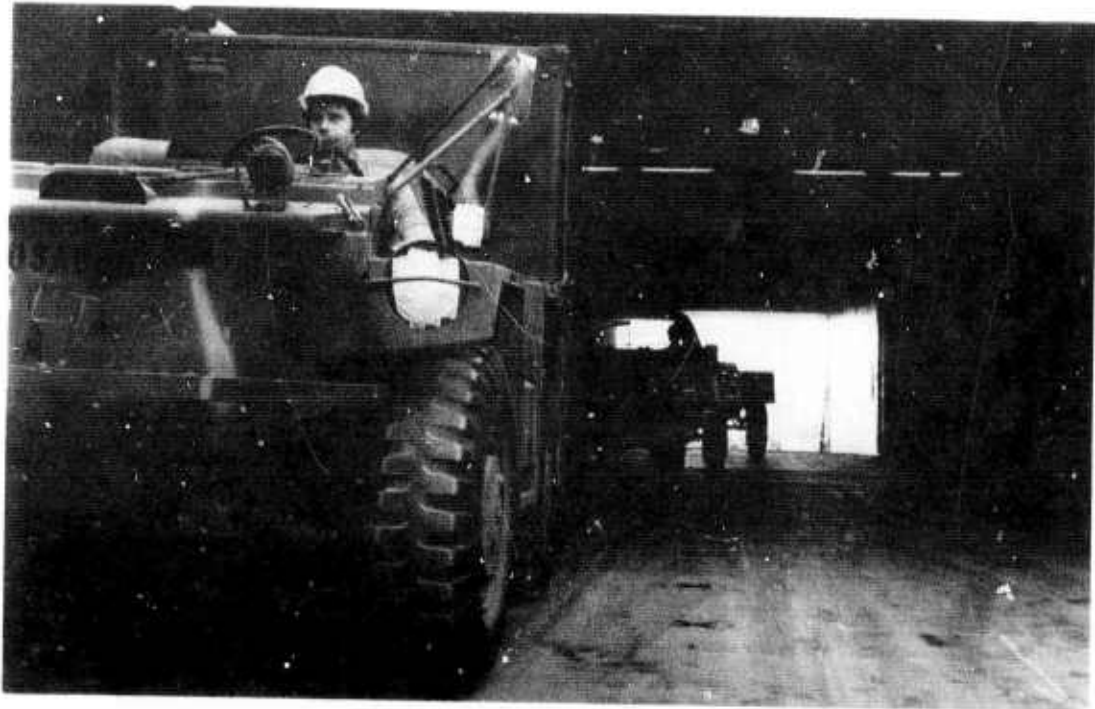
Figure 8-47. Vehicles Driven Through the Upper Tween Deck USNS Meteor.

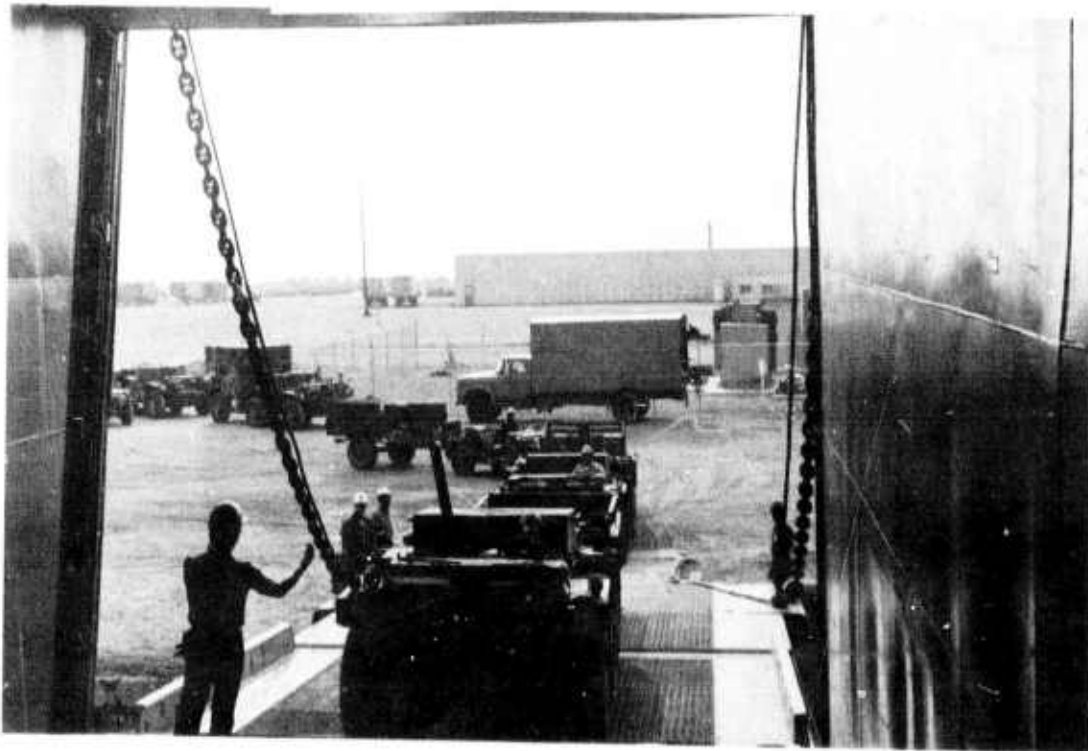
Figure 8-48. RORO Operations USNS Meteor.
