MTMC REPORT OA 7T-16 ✓

**AN ANALYSIS  
OF MTMC PARTICIPATION  
IN THE  
REFORGER 76 EXERCISE**

MARCH 1977

**MILITARY TRAFFIC MANAGEMENT COMMAND  
TRANSPORTATION ENGINEERING AGENCY  
NEWPORT NEWS, VIRGINIA 23606**

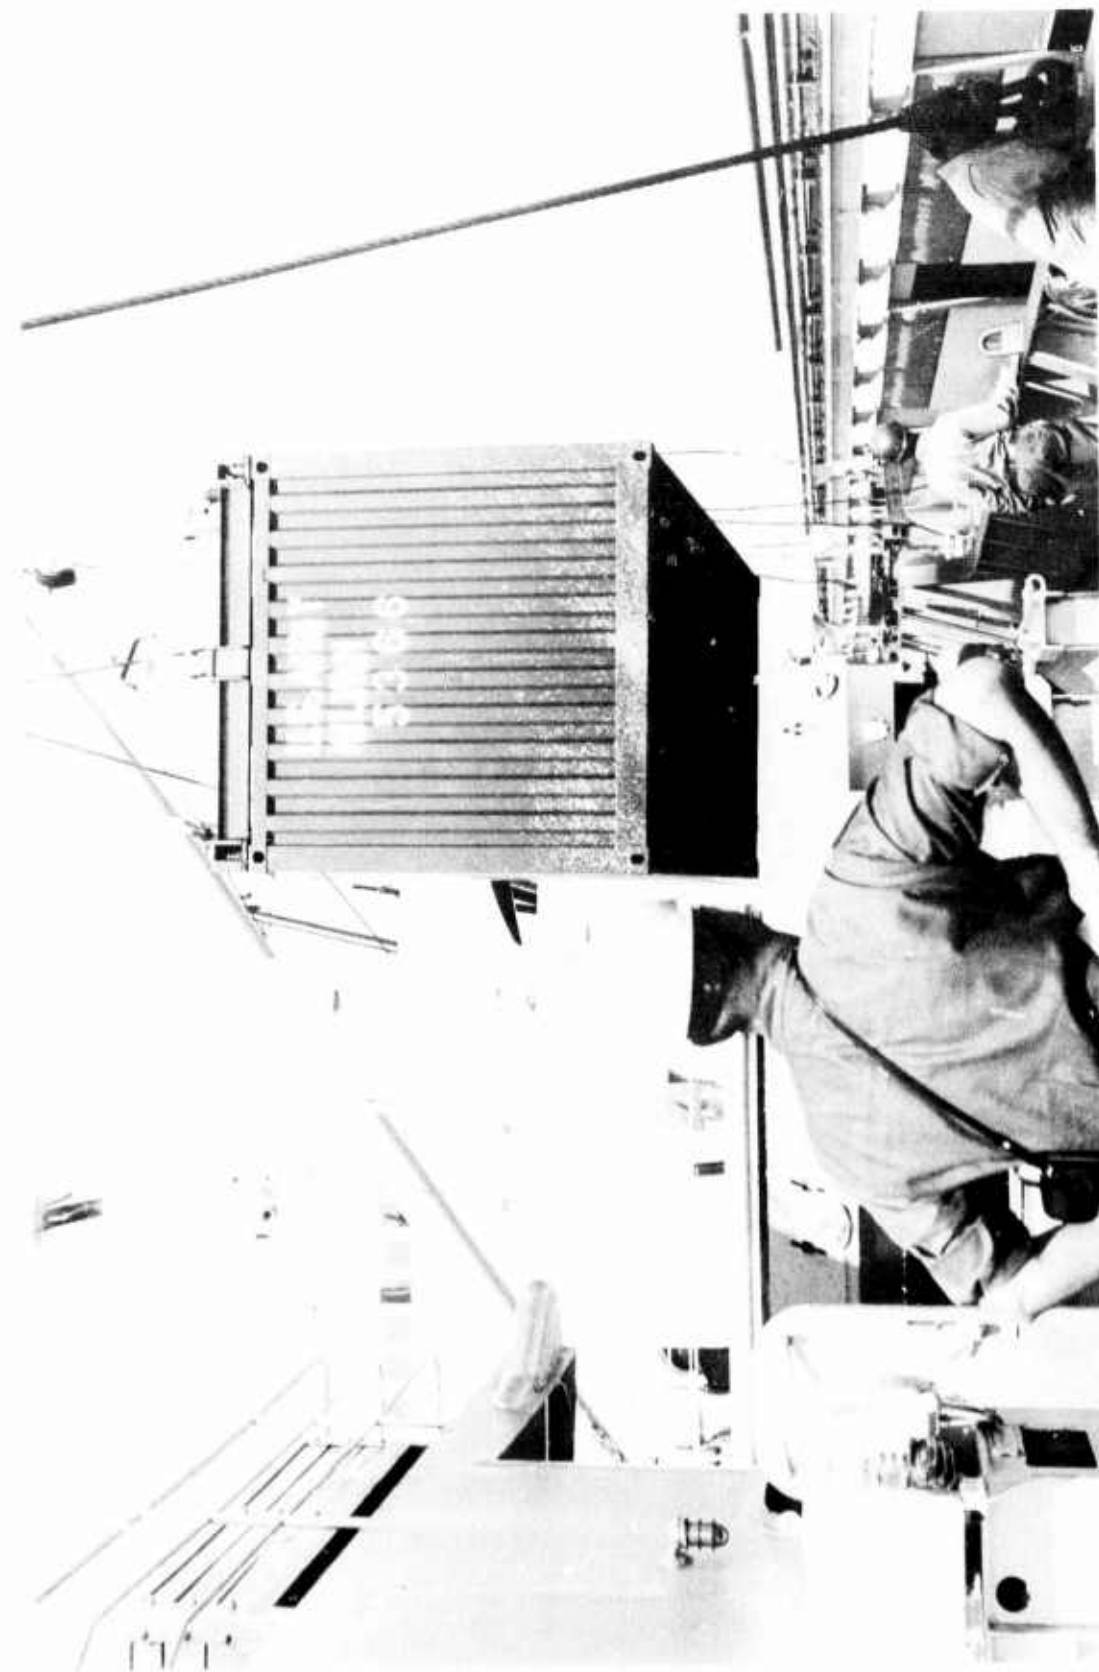
Figure 8-50. MILVAN Loaded on American Ranger Using the Manually Locked Container Top Lifting Device.

(4) The three RORO ships were berthed on Pier 12. This pier proved to be very efficient for RORO operations. It was large enough to work three vessels simultaneously without interference (Figures 8-42 to 8-48). The proximity of the three vessels provided the port operators with easy control. The American Ranger was berthed at Pier 4, where the gantry crane was used along with ship's gear to load MILVANS (Figures 8-49 to 8-52 and break-bulk cargo.

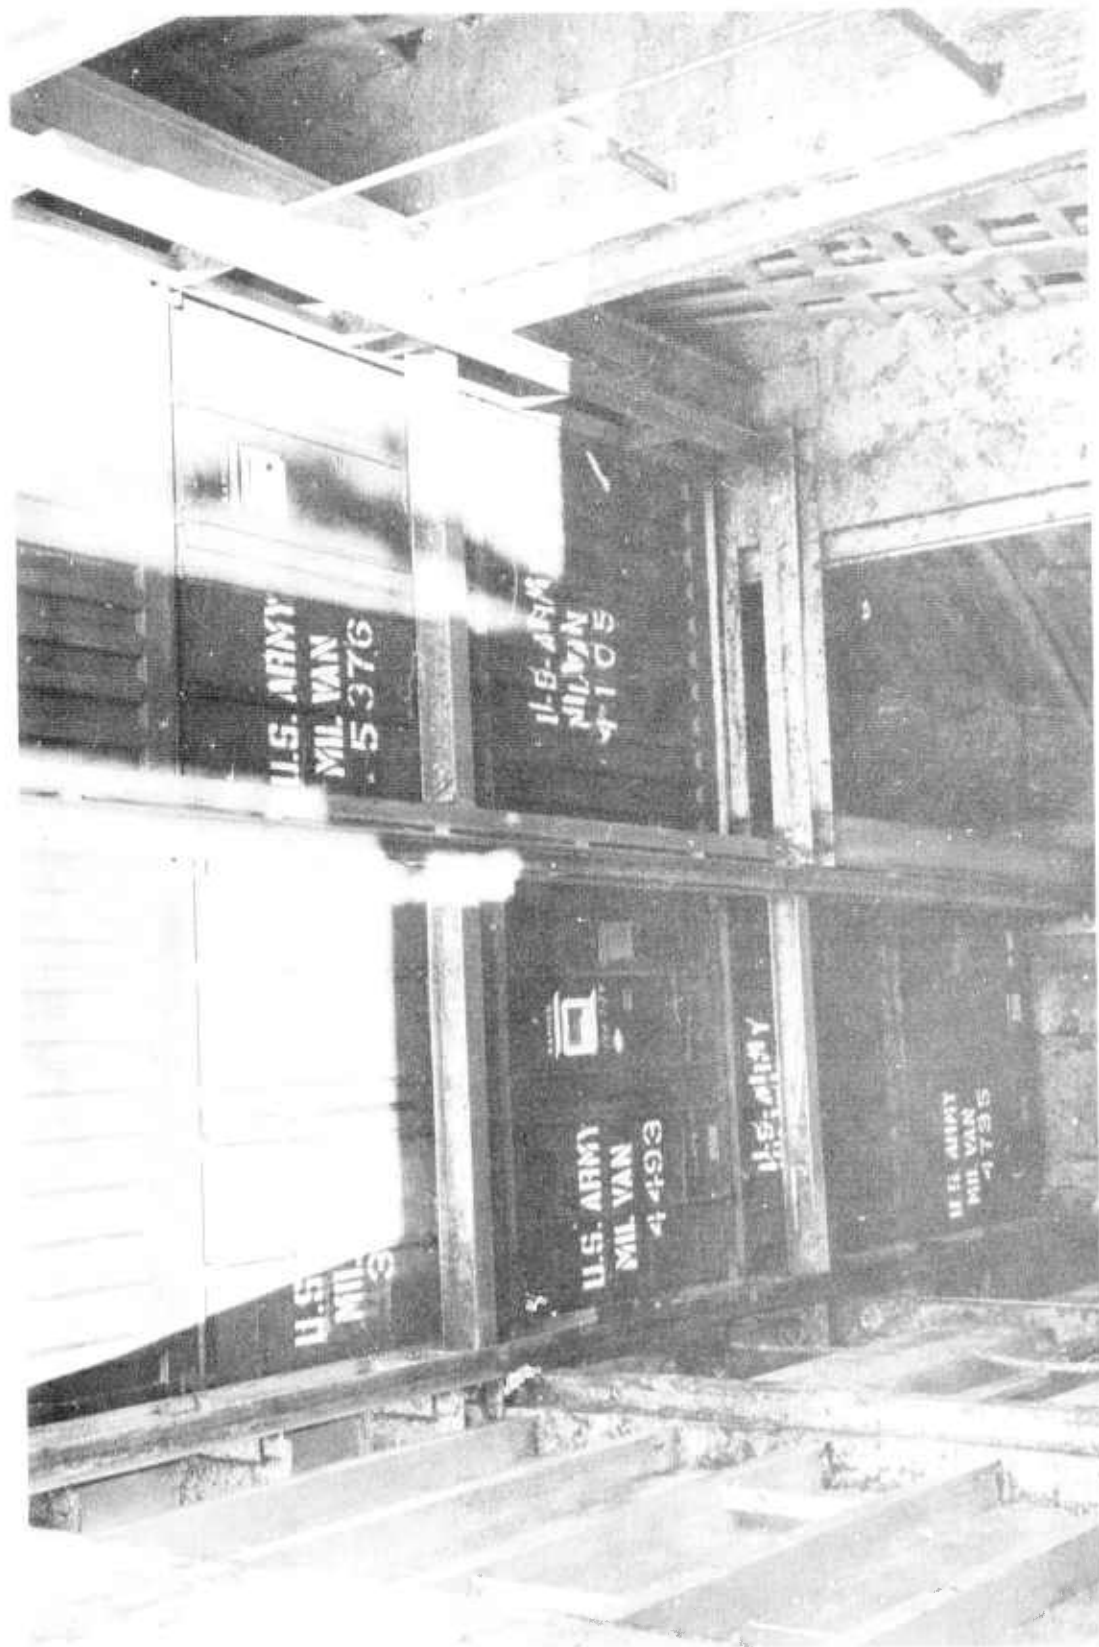
Figure 8-51. MILVAN Container Cells Hatch Number 3 USS American Ranger.

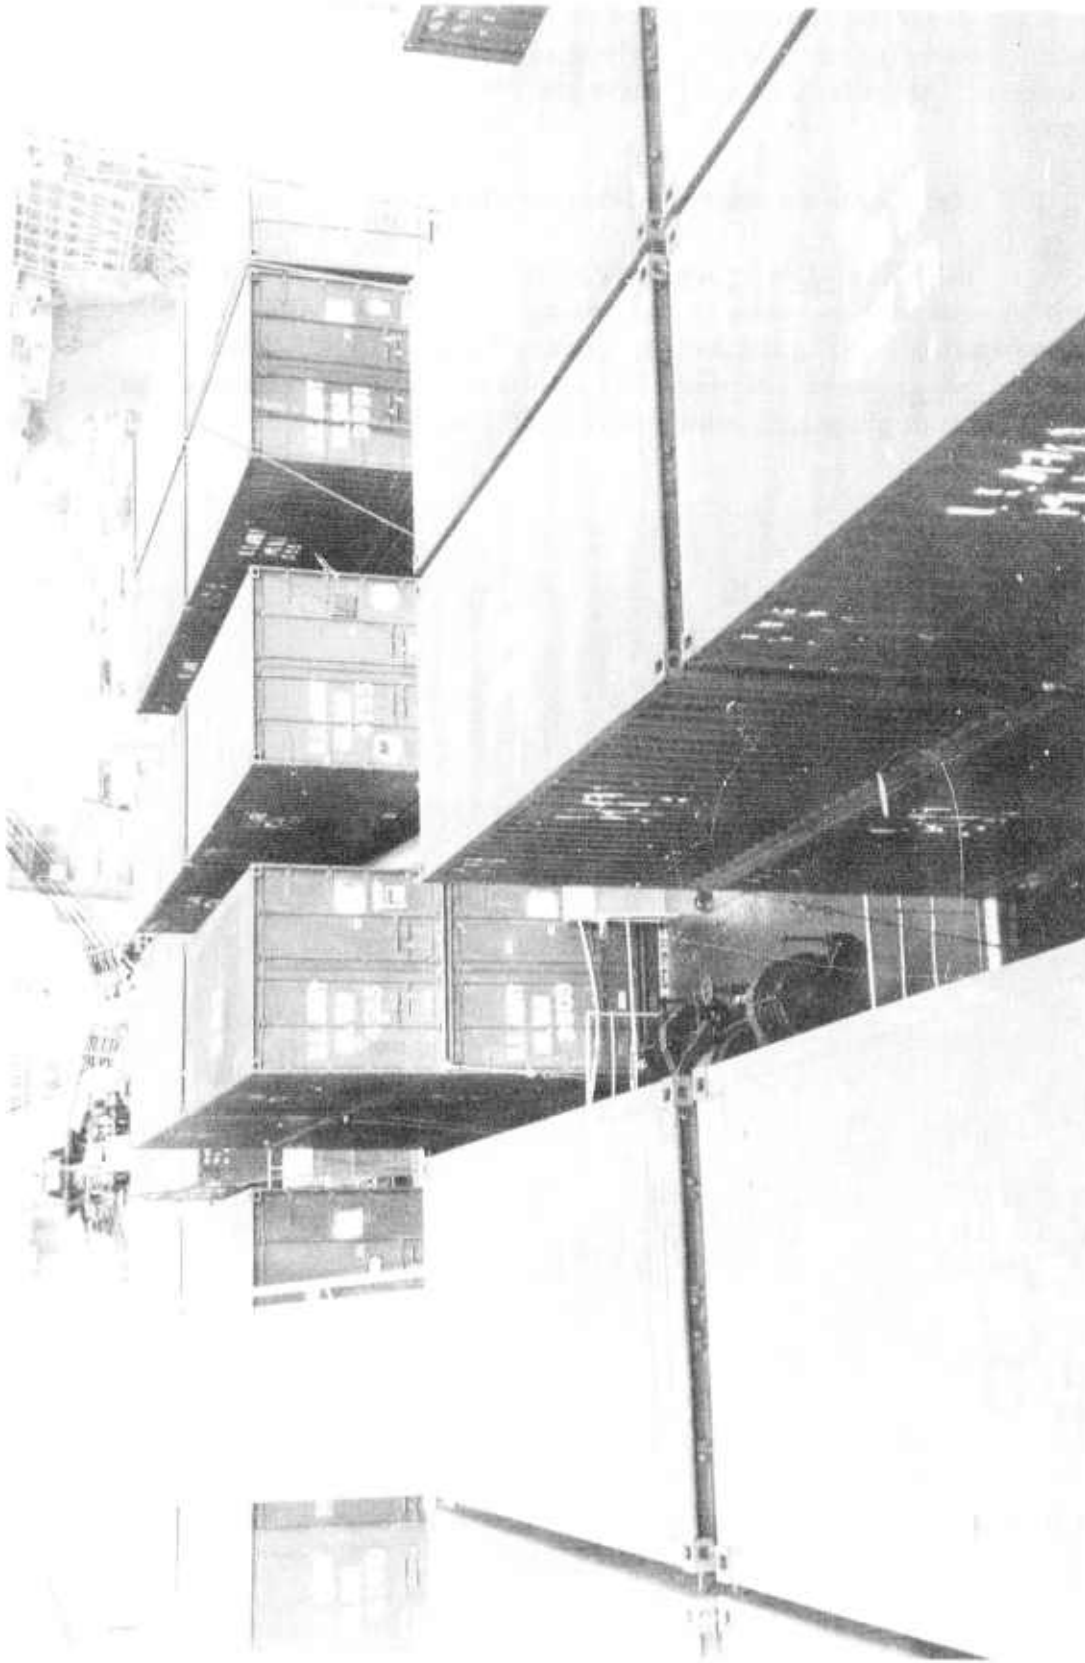
Figure 8-52. MILVANs Stowed Three High on Deck USS American Ranger.

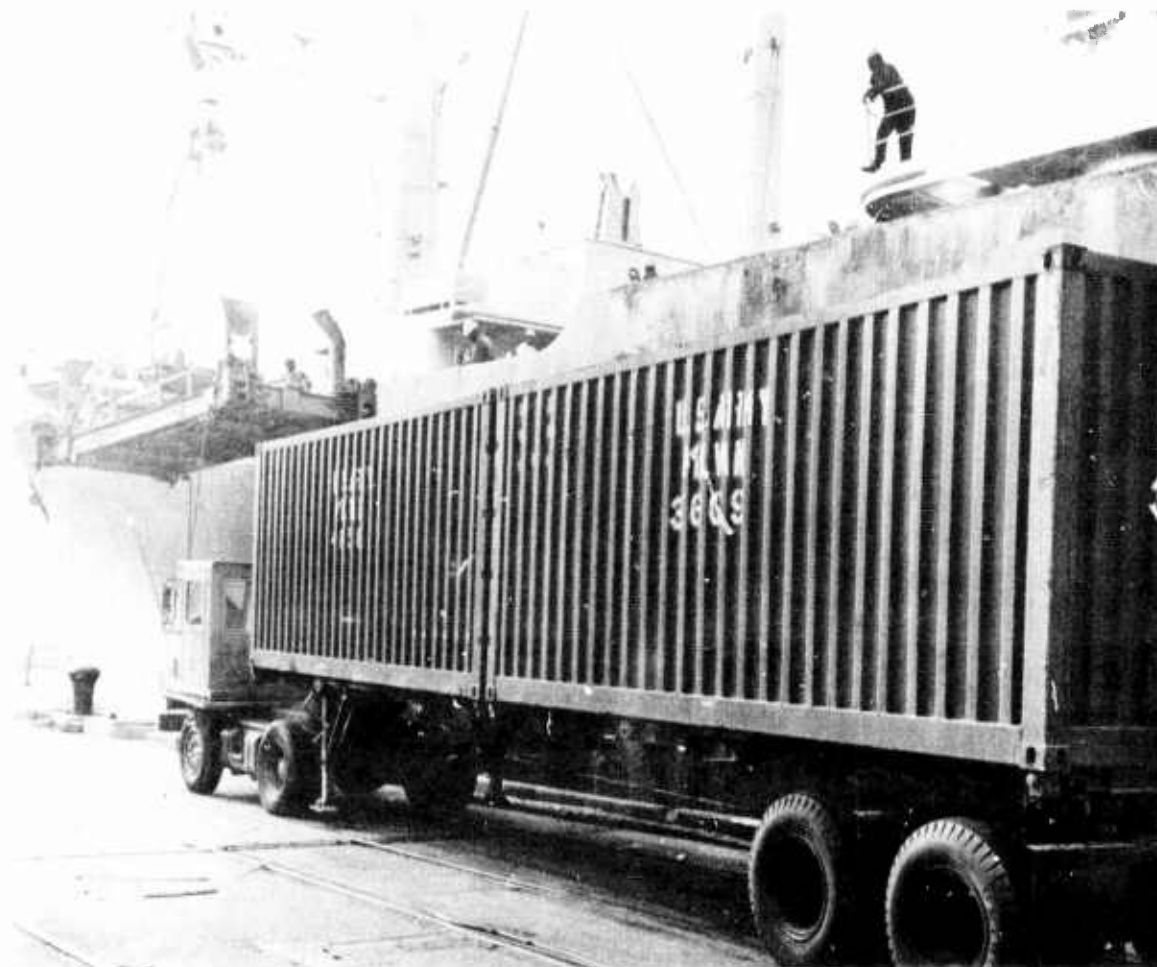
Figure 8-54. MILVANs on Double Bogie Chassis Moved Pierside by Tractor.

(b) Because of improper unloading techniques, eight coupled MILVAN chassis received minor damage during vessel loading operations.

When the forward MILVAN was removed from the coupled MILVAN chassis the landing gear on the rear chassis was not lowered, which caused the coupled MILVAN chassis to bow in the middle (Figures 8-54 to 8-56). Subsequently, the landing gear on the MILVAN chassis were lowered to preclude further damage.

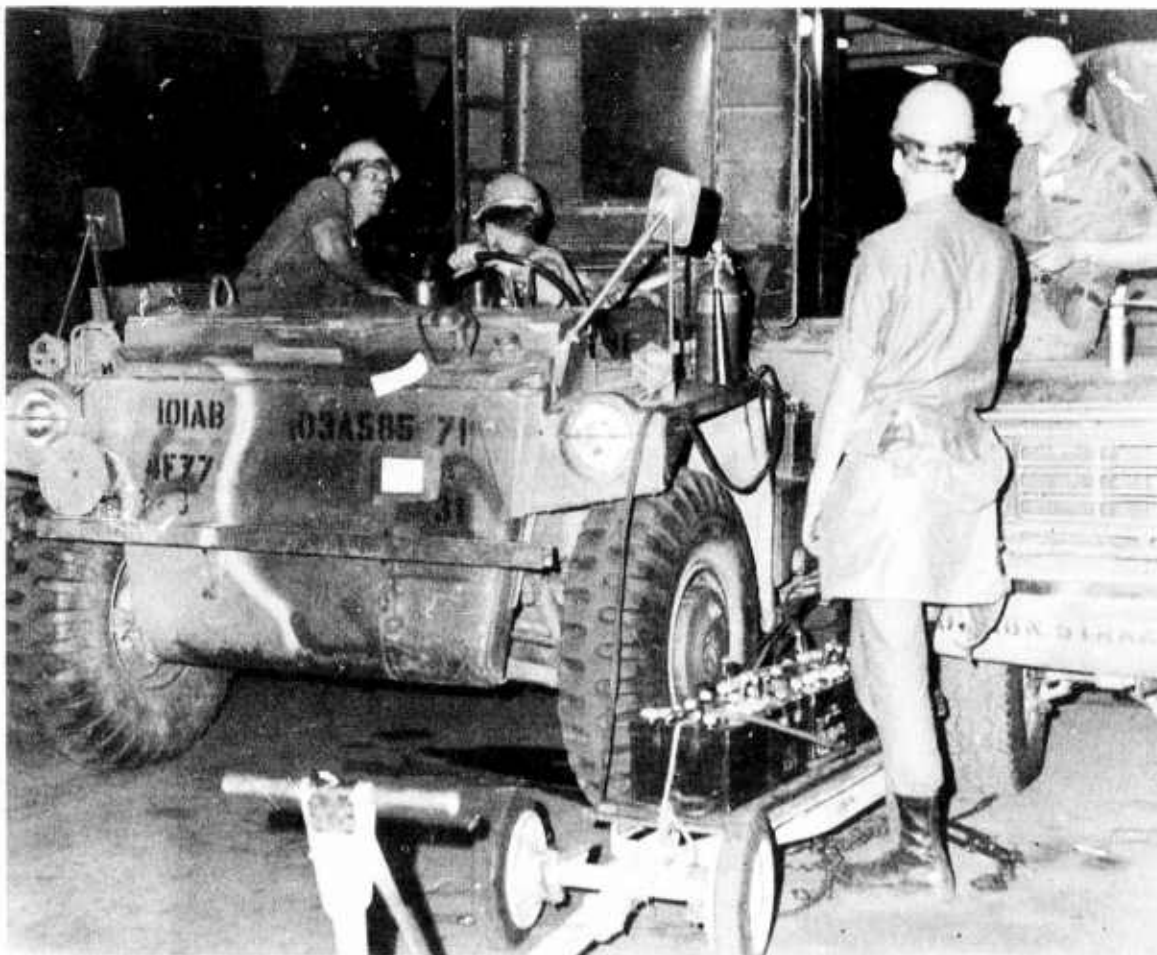
Figure 8-58. Vehicle Maintenance Teams on the REFORGER Vessels.

(g) Vehicles that would not start and those with flat tires caused delays in loading operations. Hence, a maintenance contact team (Figures 8-58 and 8-59), consisting of a minimum of six personnel per vessel, should be readily available to correct maintenance problems.

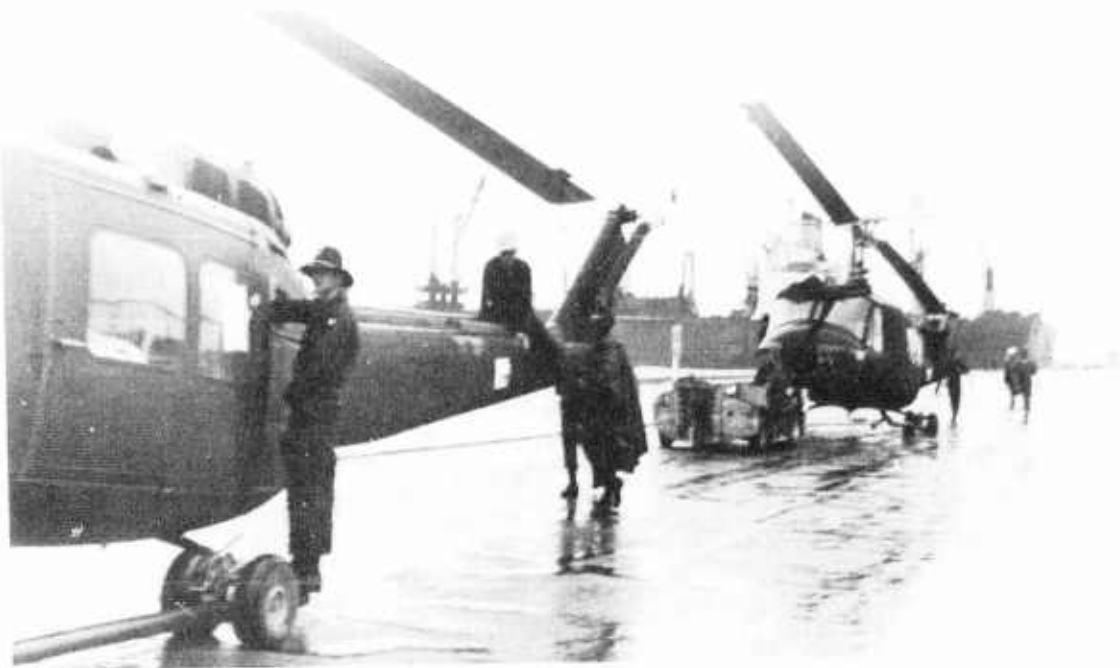
Figure 8-60. Hurricane Belle Delayed Vessel Loading Operations by 24 Hours.

(j) A 20-hour delay in vessel loading was caused by weather. With hurricane Belle expected to hit Norfolk on the afternoon of 9 August, around-the-clock vessel loading was effected on 8 August to load as much cargo as possible before the storm; 113 helicopters had to be moved from the staging area into hangars to preclude storm damage (Figures 8-60 and 8-61). Winds in excess of 30 mph and rain forced helicopter loading to cease at 091000 August; loading resumed at 0700 the next day.

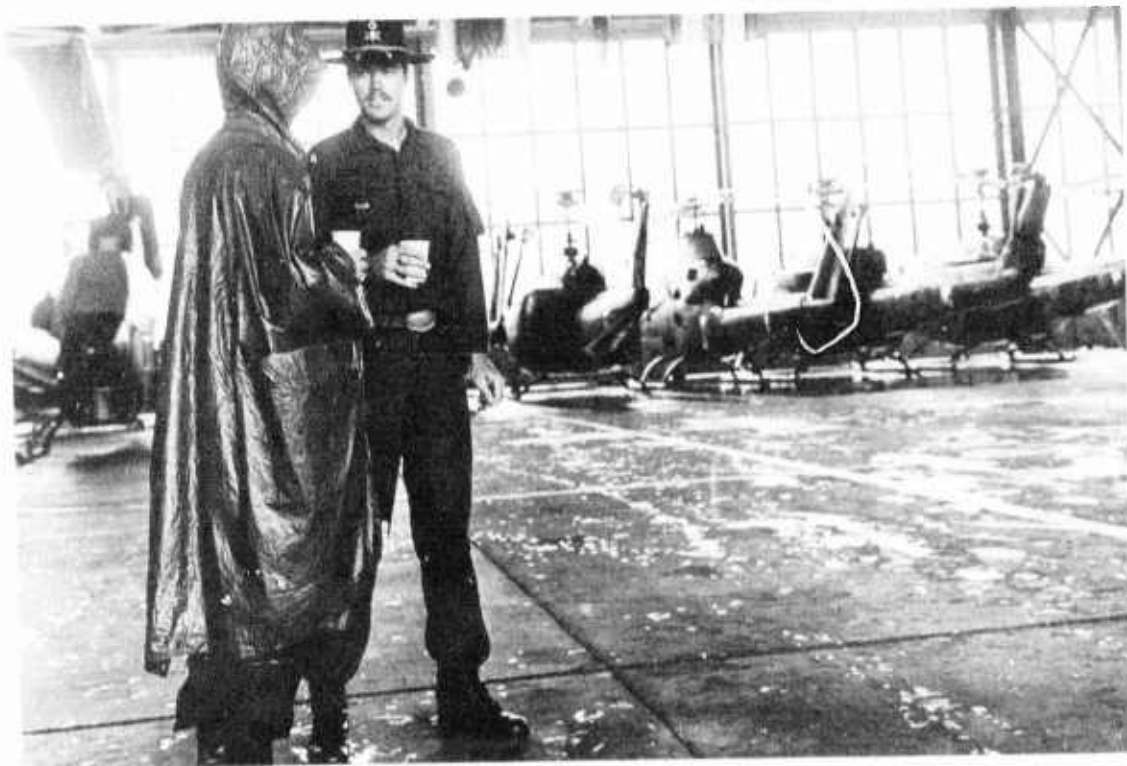
Figure 8-61. One Hundred and Thirteen Helicopters Were Moved to Covered Storage for Protection From the Storm.

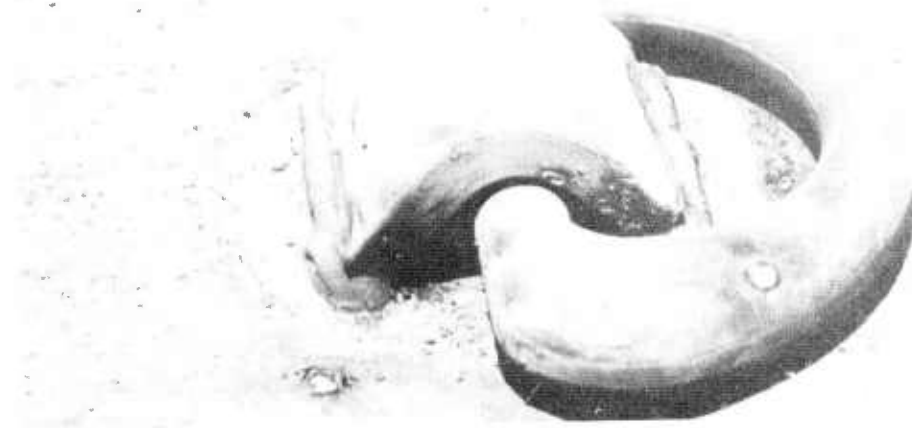
Figure 8-62. Extra "D" Rings Were Installed for REFORGER to Provide Needed Securing Points for MILVANS and Helicopters.

(k) Tiedown points on the American Ranger were inadequate to secure MILVANS stacked three-high on the main deck, so extra D-rings and securing points were welded onto the main deck and hatch covers (Figure 8-62).

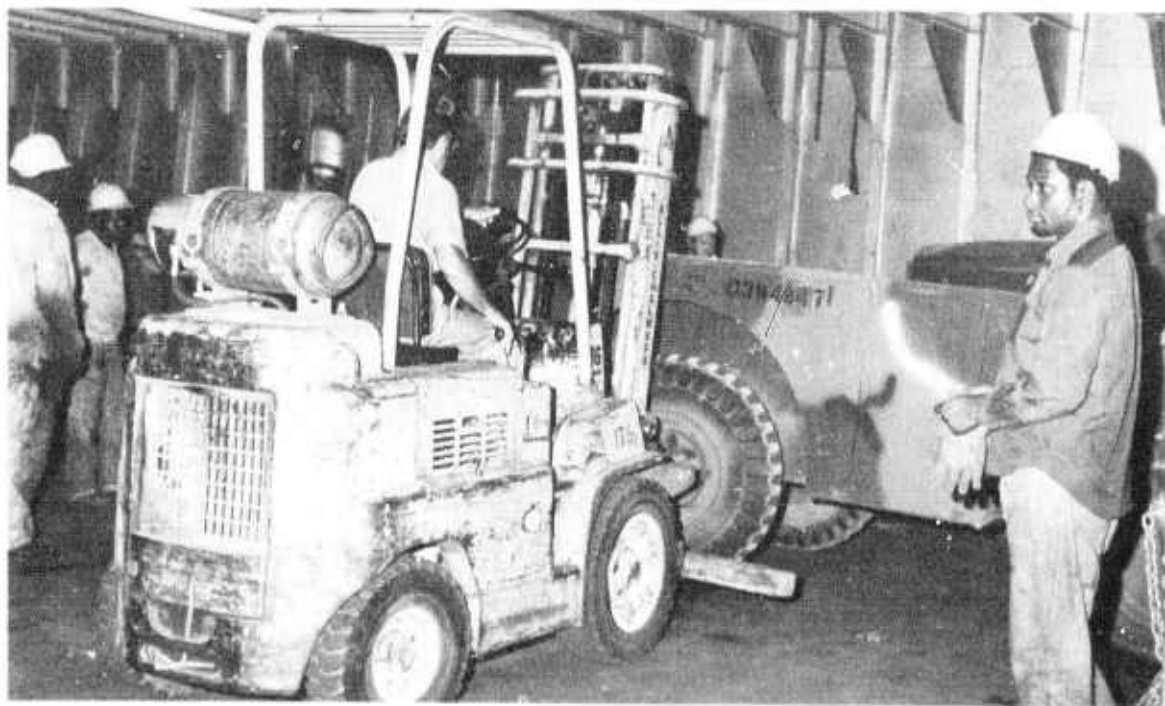
Figure 8-67. Typical Tight Stow of Vehicles.

(5) The tight stow of vehicles restricted immediate drive-off access on the RORO vessels. Some vehicles had to be moved into position for drive-off discharge (Figures 8-66 through 8-69). When a tight stow is used on RORO vessels, SPOD stevedore gangs should be notified in advance so that appropriate special equipment (forklifts and tow tractors) will be on hand.

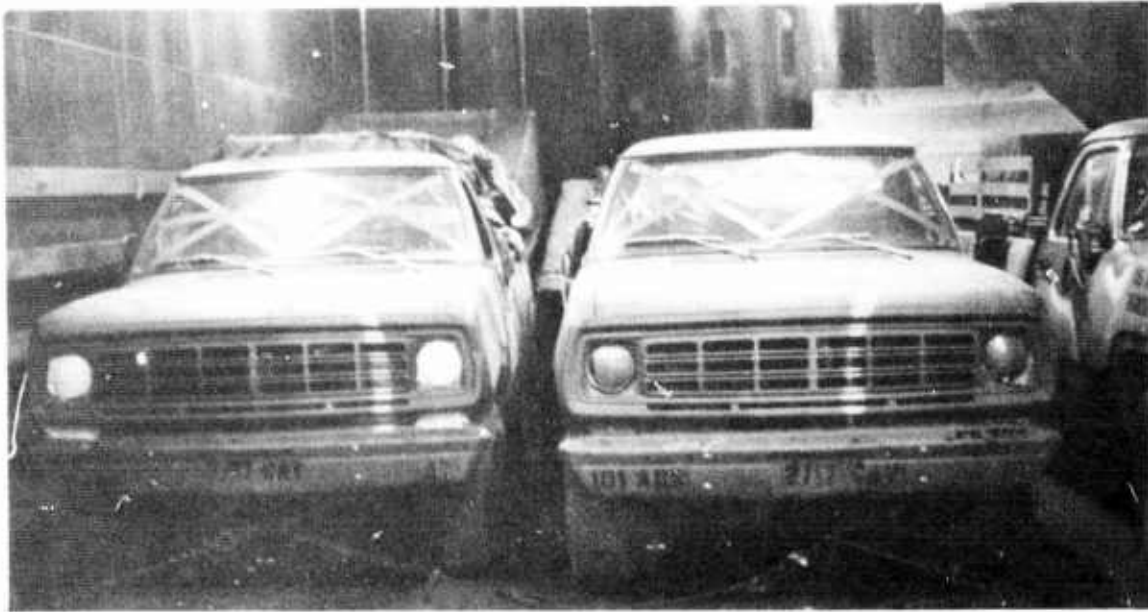
Figure 8-68. Typical Tight Stow of Vehicles.

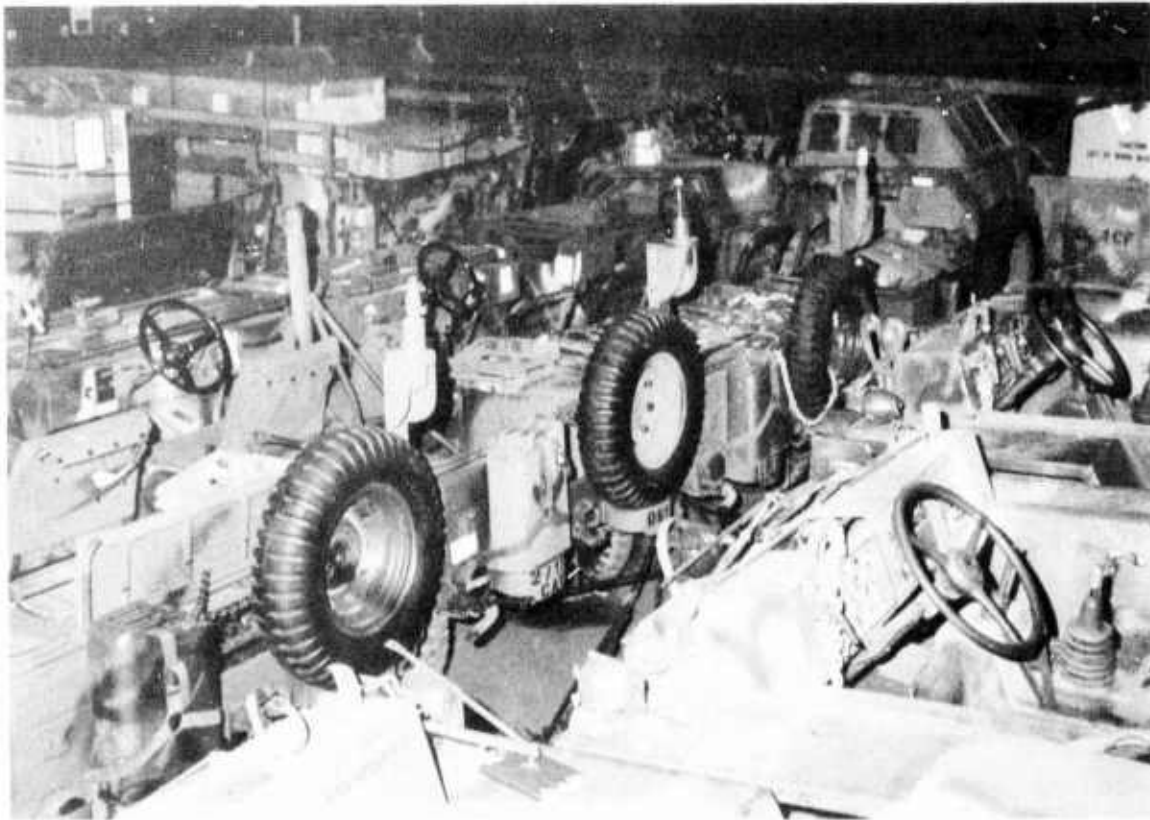
Figure 8-69. Typical Tight Stow of Vehicles.

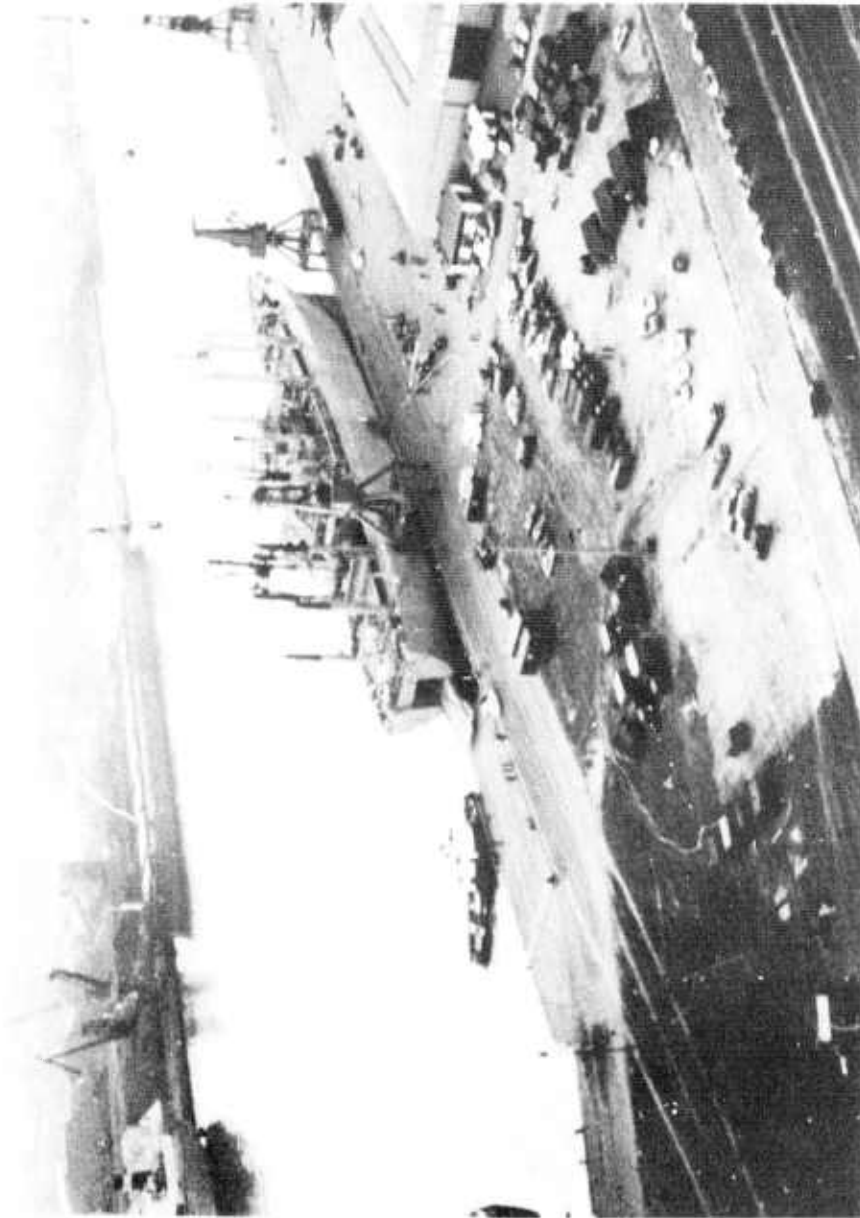
Figure 8-70. Ghent Port Facilities (Meteor).

(1) Port facilities at Ghent were well suited for the simultaneous discharge of the Callaghan and the Meteor (Figure 8-70 and 8-71).

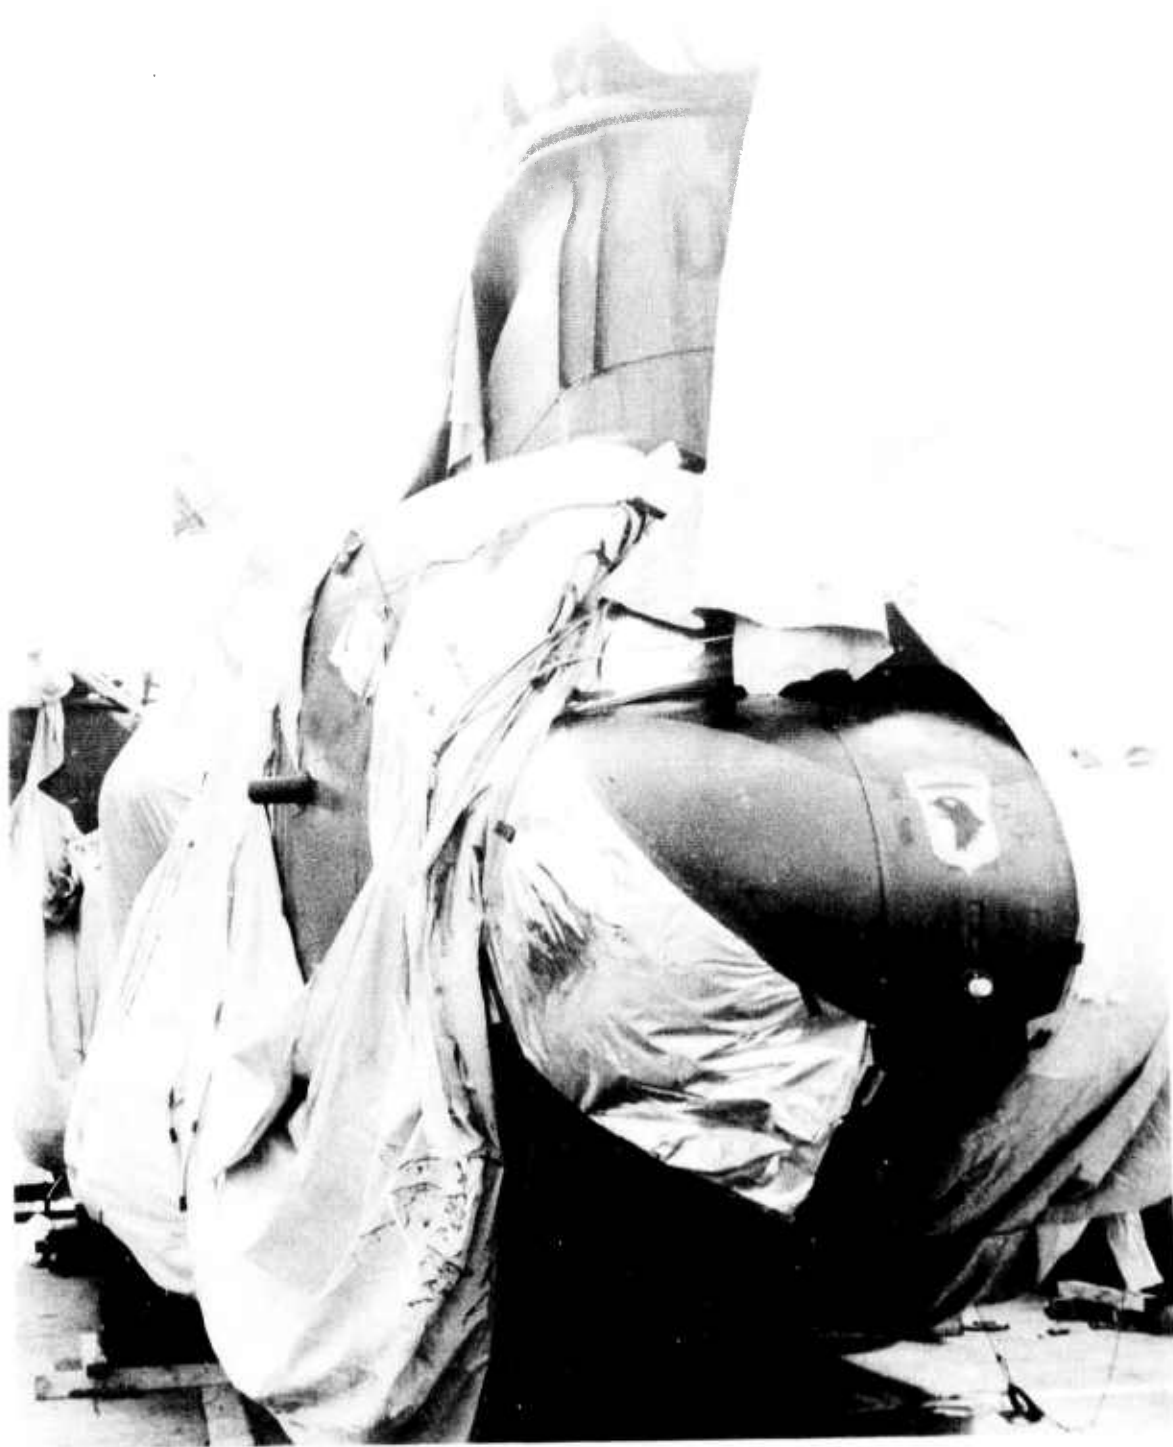
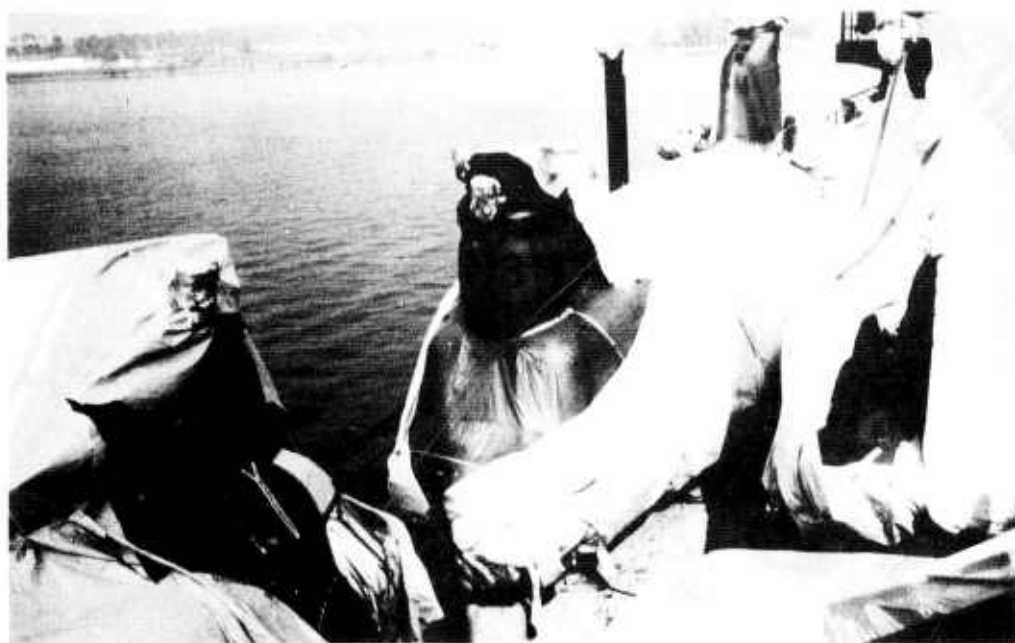
Figure 8-73. Damaged CH-47 Redi-Covers.

Figure 8-74. Damaged CH-47 Redi-Covers.

Figure 8-75. Damaged CH-47 Redi-Covers.

Figure 8-76. Damaged CH-47 Redi-Covers

(d) The zippers on the helicopter redi-covers provided by AVSCOM came open while subjected to normal winds, and modifications were recommended.

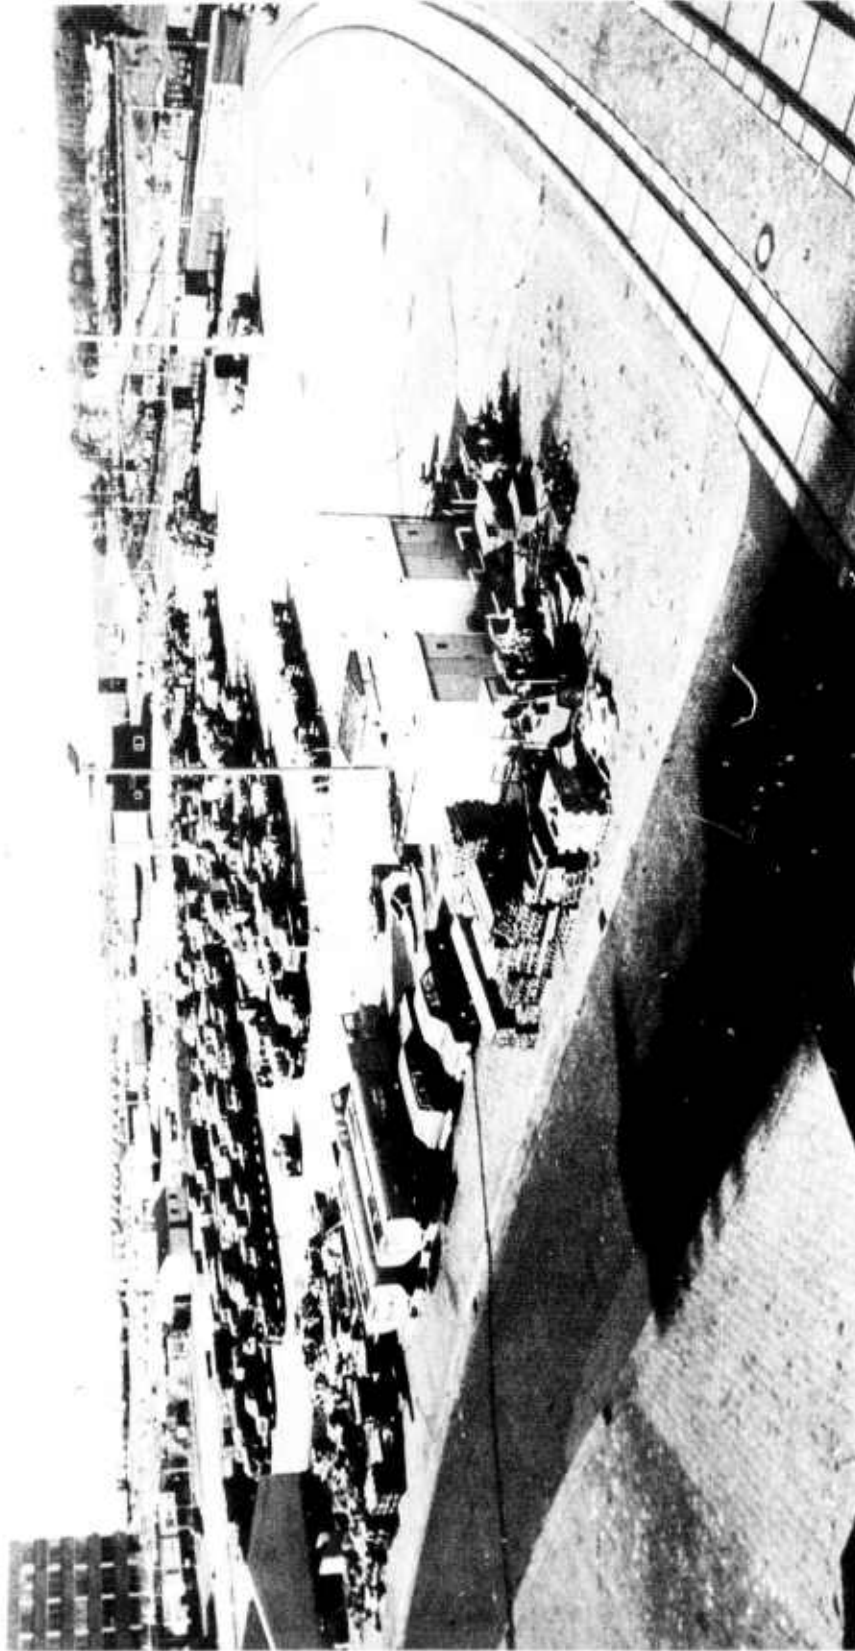
Figure 8-80. Bremerhaven Vehicle Staging Area.

(1) The redeployment phase of REFORGER 76 was planned by MTMC-TTGE. The receipt and loading of all 101st Airborne Division cargo was accomplished at Bremerhaven Terminal (Figures 8-79 through 8-81). The cargo was loaded aboard the GTS Admiral Wm. M. Callaghan, USNS Meteor, USNS Comet, and the USS American Ranger, between 24 September and 6 October 1976, using Bremer Lagerhaus Gesellschaft (BLG) stevedore contractors.

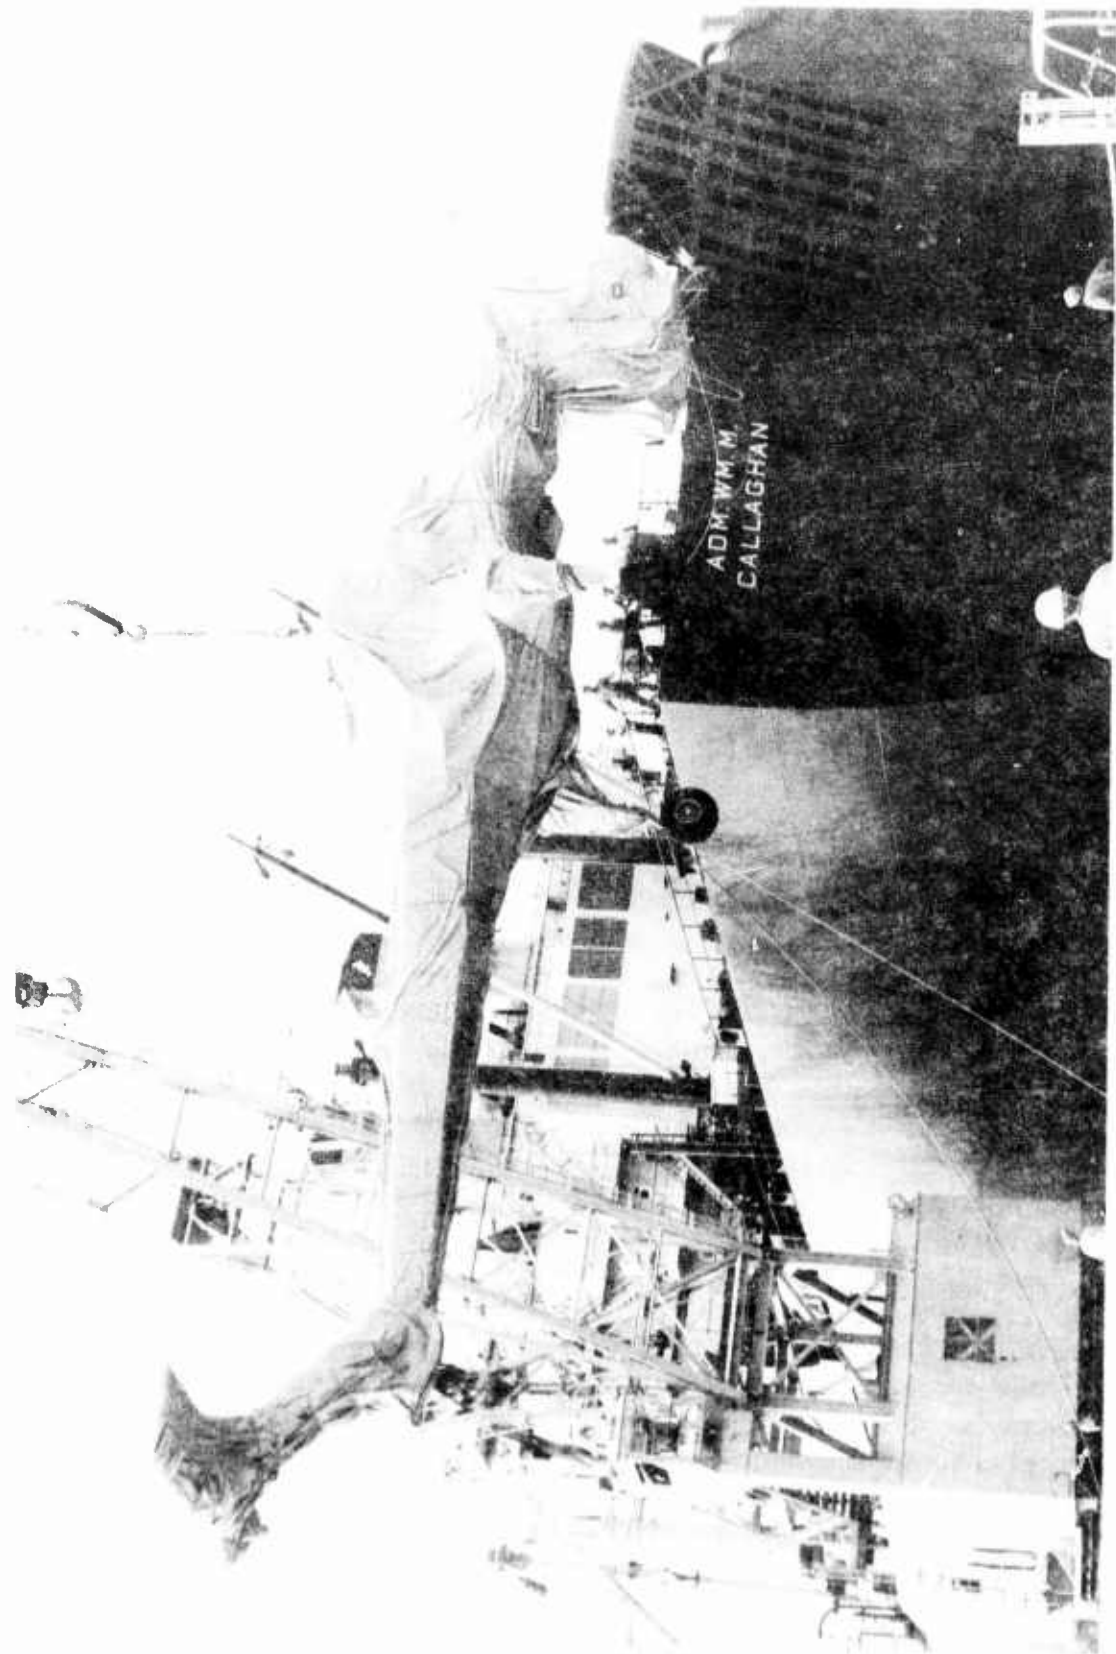
Figure 8-84. CH-54 Helicopter Discharge from GTS Callaghan.

(1) Norfolk discharge operations were successfully accomplished with minimal complications (Figure 8-82 through 8-85). Damage to equipment was minimal and operations were smoothly conducted. The expertise gained in the deployment outloading was evident in the redeployment phase.

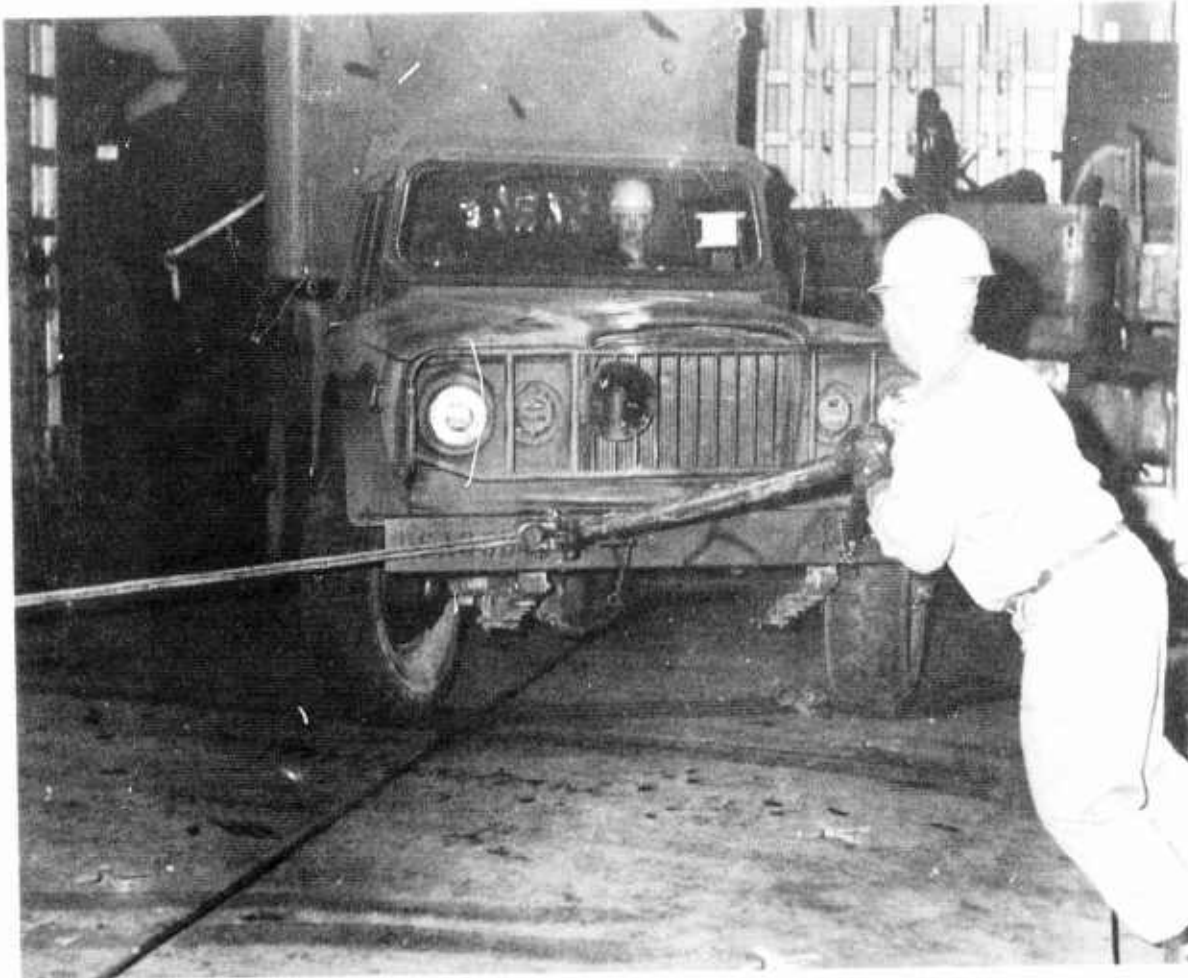
Figure 8-86. Vehicle Maintenance Team During Discharge Operations.

(5) The discharge of vehicles was adversely affected by vehicle maintenance problems. Maintenance assistance requirements at Norfolk during redeployment were greater than at any other time during the exercise. Many vehicles had dead batteries and missing or defective parts. Fortunately, the maintenance teams provided by the COSCOM were properly equipped, manned, and supervised to provide the necessary support (Figure 8-86).

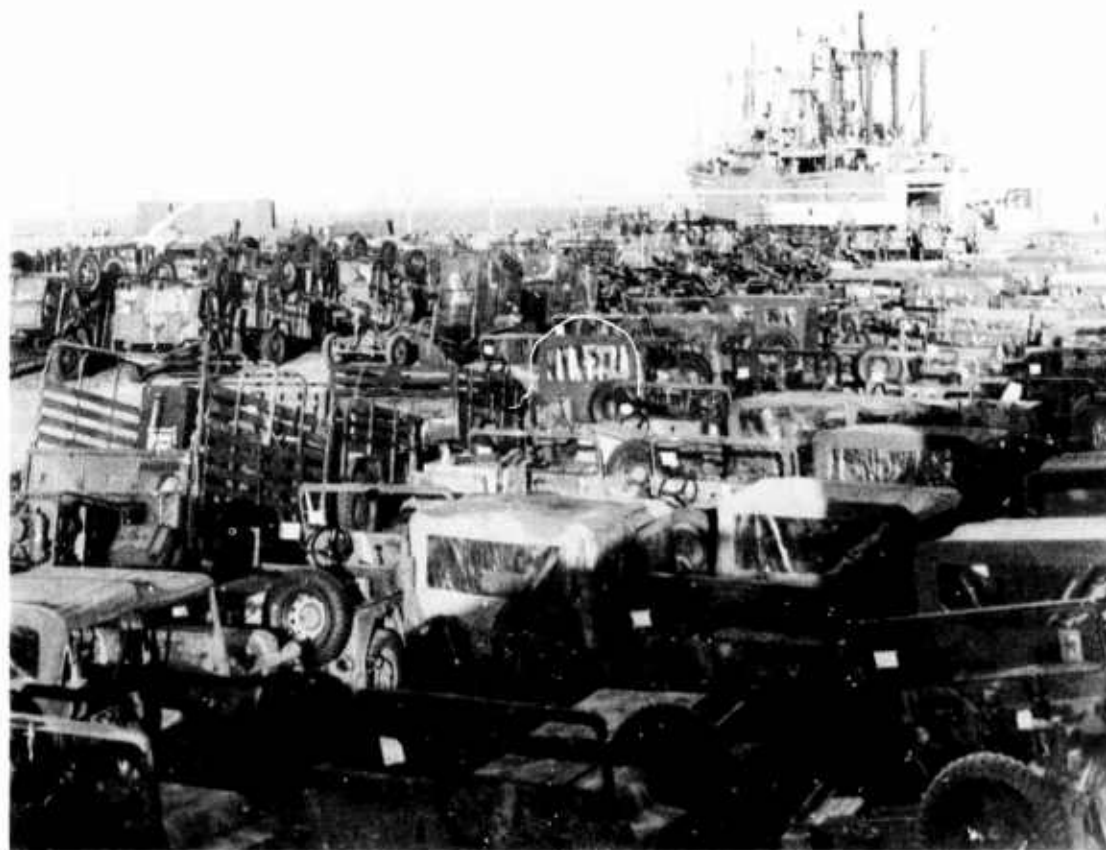
Figure 9-1. Equipment Staged by Type for Redeployment Rail Load-out at Norfolk.

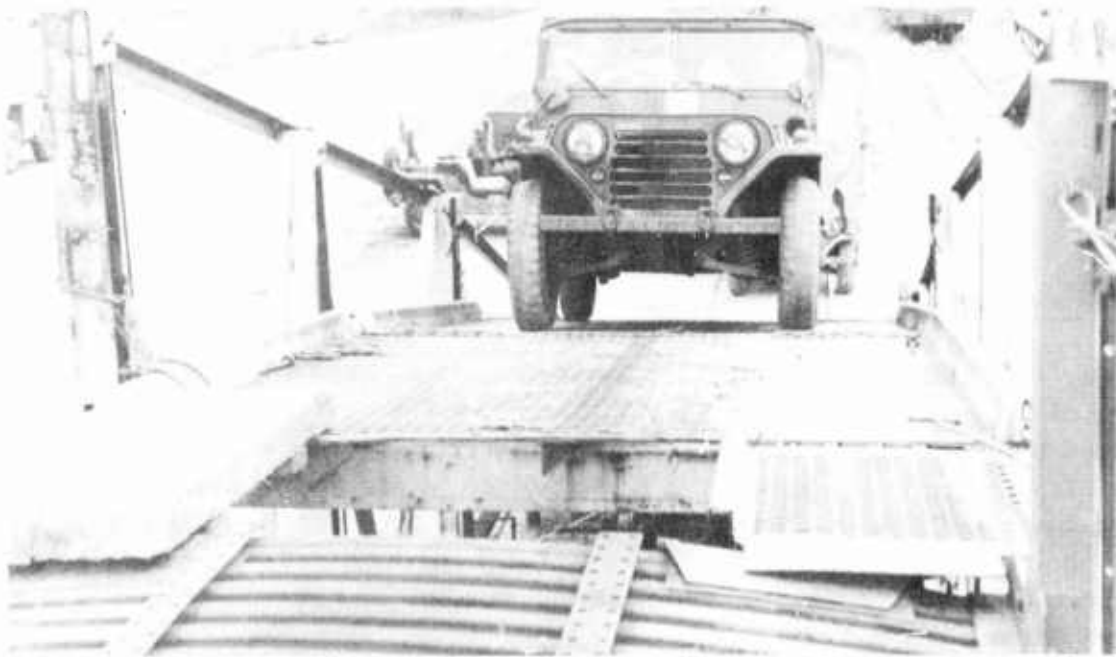
Figure 9-2. Mobile Ramp Used to Load the Bilevel Railcars.
