MTMC REPORT OA 7T-16 ✓

**AN ANALYSIS  
OF MTMC PARTICIPATION  
IN THE  
REFORGER 76 EXERCISE**

MARCH 1977

**MILITARY TRAFFIC MANAGEMENT COMMAND  
TRANSPORTATION ENGINEERING AGENCY  
NEWPORT NEWS, VIRGINIA 23606**

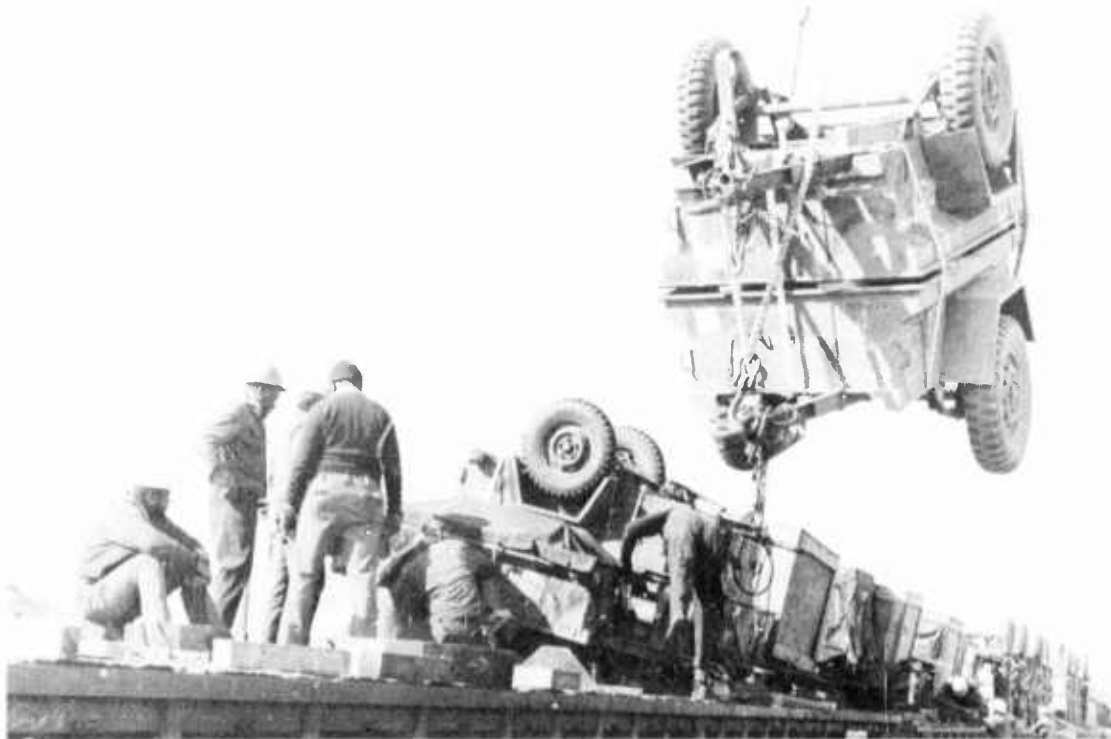
Figure 9-3. Equipment Loaded and Secured by ILA Contract Labor.

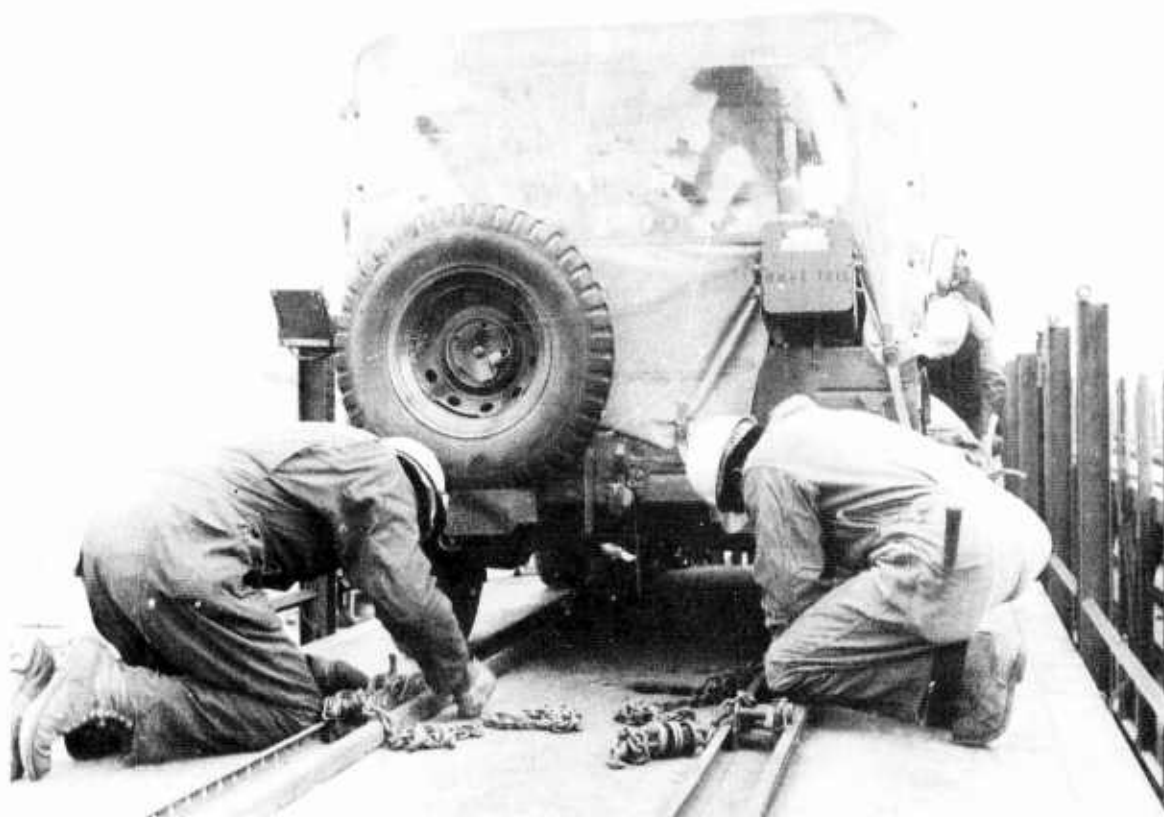
Figure 9-4. Vehicles Loaded and Secured by ILA Contract Labor.
