A RELIABILITY STUDY AND INVESTIGATION OF COMPLEMENTARY MOS/SOS INTEGRATED-CIRCUIT TECHNOLOGY

RADC-TR-77-111  
Final Technical Report  
March 1977

RCA Solid State Technology Center

ROME AIR DEVELOPMENT CENTER  
AIR FORCE SYSTEMS COMMAND  
GRIFFISS AIR FORCE BASE, NEW YORK 13441

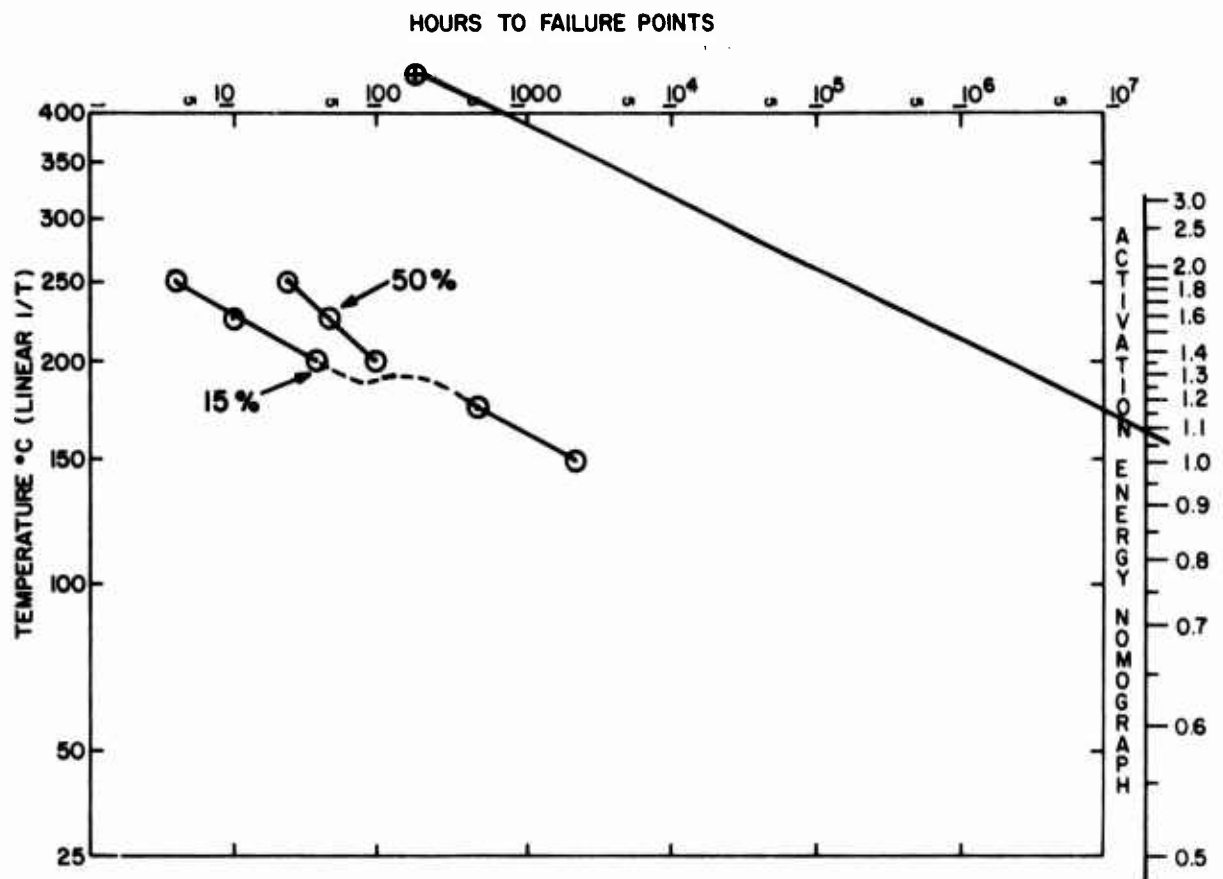
Figure 19. Si-gate TC1092 15% and 50% failure points.

The failures resulting from the 50-kHz operational life-testing at 125°C exhibited characteristics similar to those observed during the static-bias and bias-power stress tests. However, the median failure time of 4000 h for the life test is lower for the Al-gate devices than that predicted by the static stresses. The Si-gate devices had no failures prior to the 3000-h test point, and 8% failed during the next 2000h. The reliability of the

TC1092 in this test is considerably greater than that projected from the static-bias stress test. At the 125°C test temperature the differences in the protective network designs of the two Si-gate array types had no effect on the device reliability. The Weibull Probability Chart shown in Fig. 20 plots the results obtained for this test. Since no failures occurred during the initial 2000h of test, the 168-h bias burn-in performed during the screening procedure appears to be an effective screen for eliminating "early life" failures.

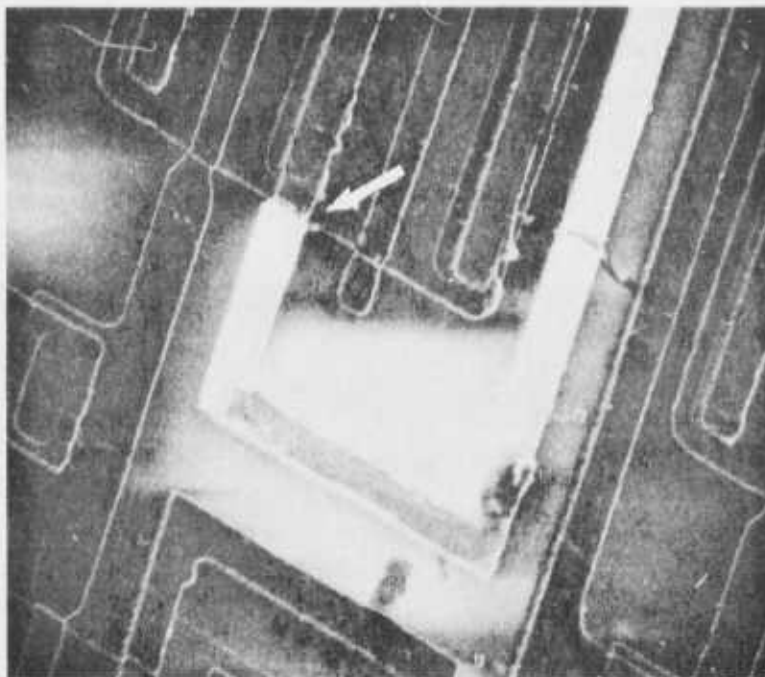
Figure 54. SEM voltage contrast mode (TC1092, #51). Pin 1 - drain terminal, open at epi-island edge.

1. Serial #51 (TC1092) Si-Gate. This unit failed the thermal shock test at 10 cycles. Its failure mode was an open N3-P3 inverter. To verify the failure, the unit was tested for hermeticity (MIL-STD-883, Method 1014 A, C<sub>1</sub>, C<sub>2</sub>) and found to be satisfactory. It was then "delidded" and examined on the SEM using the voltage contrast mode. Figure 54 shows the voltage on the drain terminal stopping at the epi-island edge. Figure 55 shows the cracked metal condition observed at the failure site. The failure mechanism was due to poor metal coverage over the island edge step.
2. Serial #98 (TC1092) Si-Gate. This unit failed the temperature cycling with intermittent bias test at 10 cycles. The failure mode was a gate-to-source breakdown of the P1 transistor at 8 V. In the failure verification, the unit was tested for hermeticity and found to be satisfactory. The unit
