AFML-TR-77-212

CHARACTERIZATION OF REACTION SINTERED SILICON NITRIDE RADOMES

TECHNICAL REPORT AFML-TR-77-212
Final Report for Period 1 January 1977 - 1 September 1977

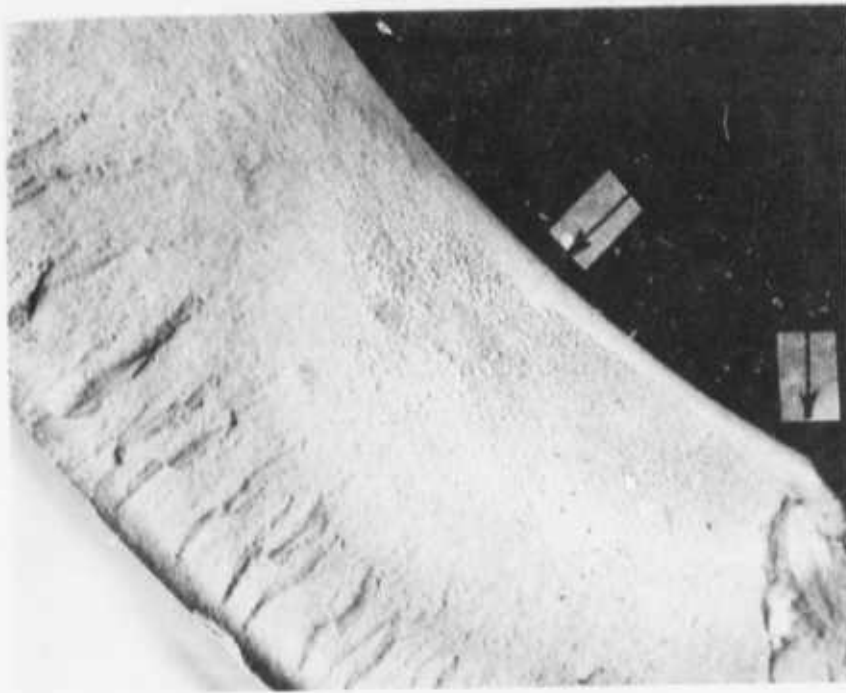
Figure 1. The fracture surface of Radome 1. (a) 4X. (b) 0.5X. The arrows indicate flaws that could have initiated fracture.

Figures 1 through 5 show views of the upper portion of five fractured radomes. On each fracture surface there are flaws which are large compared to the 100 to 200 micron flaws which were the sites of initial fracture in flexure bars used to measure the strength of the radome material. These large flaws, which could have initiated fracture, include internal voids and inclusions, extended regions where the prefracture bond strength across the fractured surface was apparently weaker than in the bulk, and large chips, cracks and laminations on the inner surface.

The origins of fracture are not clear since fracture mirrors and associated features which often permit unequivocal identification of a fracture origin were not observed. There are, however, ridges radiating to the outer surface from flawed areas which may be an indication that fracture initiated at the neighboring flawed area. The small pieces of material recovered from the wind tunnel were inspected for fracture mirrors and other markings, but nothing significant was found.

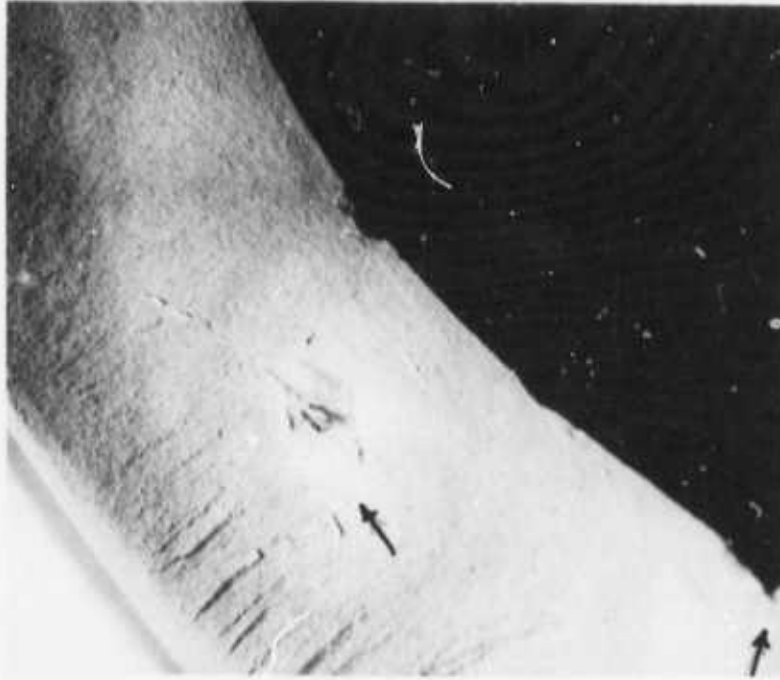
Figure 2. The fracture surface of Radome 2. (a) 3.5X. (b) 0.4X. The arrows indicate flaws that could have initiated fracture.

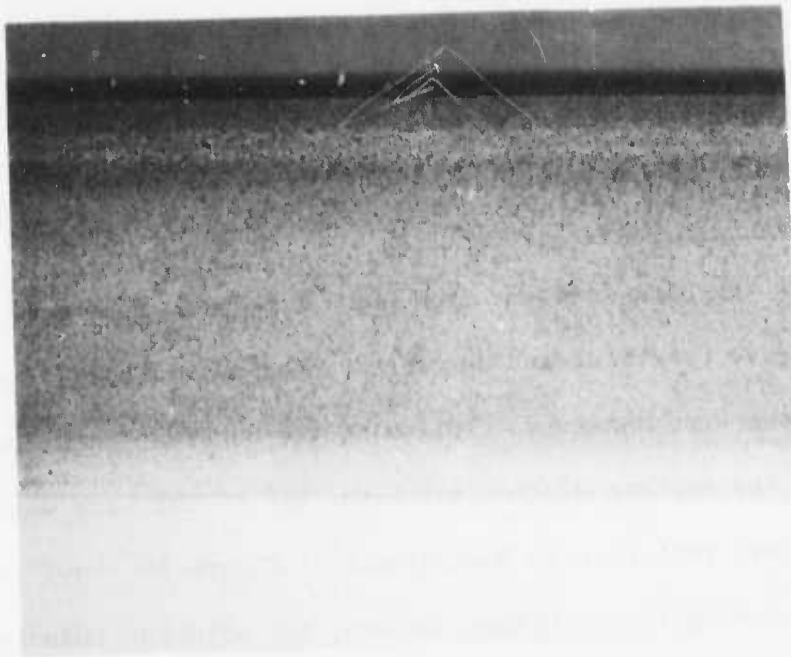
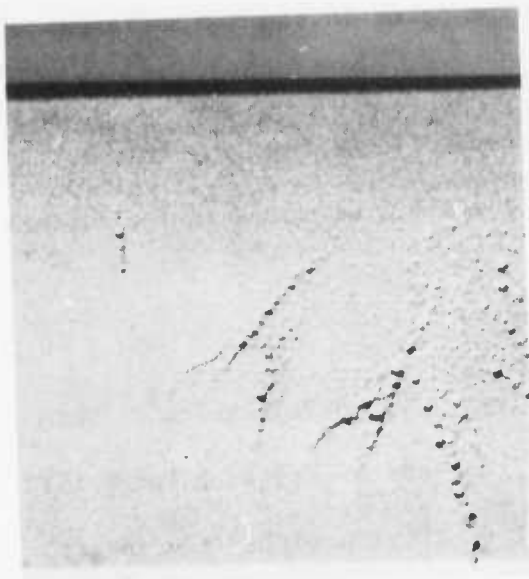
After the bars were cut to 1/4 in. sq. cross section size, it was observed that both radomes had a zone of porosity just beneath the surface. This can be seen in Figure 7a. In addition, an area of Radome 3 contained extended flaws which were revealed as 0.1 mm size pores in the sectioned pieces. This can be seen in Figure 7b and c. The worst flaws occurred in Sections 2, 4 and 5 of Radome 3. The three-dimensional continuity of the flaws is illustrated by an edge view of sample 3-4B, (Figure 7c). The fracture surface of 3-4A, Figure 11, shows a hump and valley where the fracture passes through a weak zone. The hump and depression have pullouts and matching voids which are about the same size as the 0.1mm pores in the surface of the bars. This suggests that some of the exposed pores were not initially void, but that poorly bonded material was detached during the cutting operation.

Figure 7. (a) A side view of a typical flexure bar from Radome 5. (b) A flawed area of the tensile surface of sample 3-4B. (c) A scanning electron micrograph of the edge of sample 3-4B showing that the flaw is three dimensional.

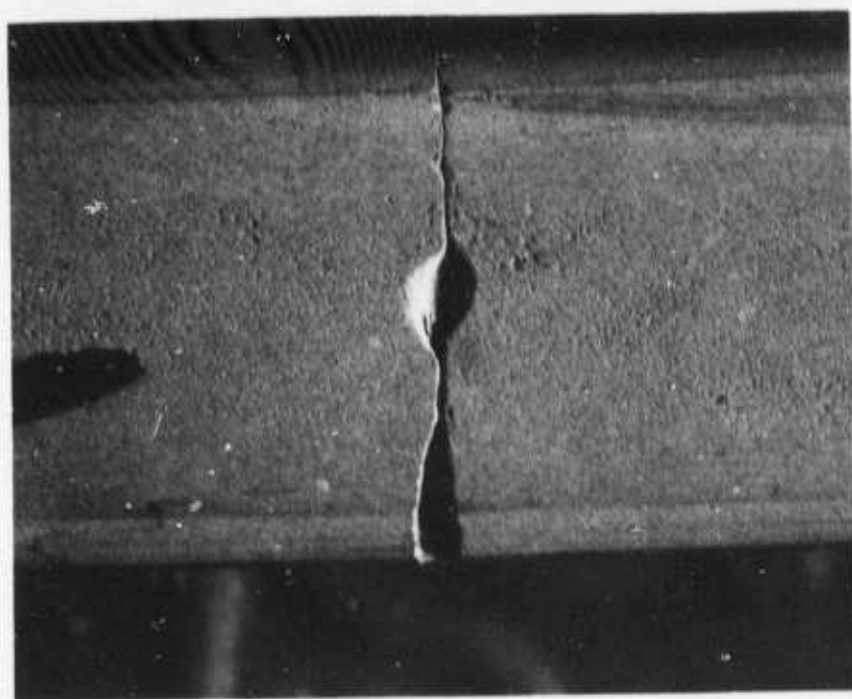
Figure 10. Fracture surface (a) and tensile surface (b) of flexure bar 3-3B.

Table I summarizes the observations of fracture surfaces. Figure 9-16 show the fracture surfaces and the flaws causing failure in those cases where the fracture origin is clearly indicated by the features of the fracture surface, i.e., by ridges radiating from the flaw and increasing smoothness near the flaw. The following statements are derived from observations of the fracture surfaces: (a) There are damaged regions near the center of the fractured tensile surface which are a result of post-fracture damage caused by the impact of the broken bar with a cylindrical part of the bend fixture. (b) Most of the identifiable fracture sources are pores in a zone of many 0.1mm pores. Two flaws, those in 3-4A (Fig. 11) and 5-1A, (Fig 15) may be a result of damage by cutting or grinding. (c) A large-scale pullout occurred in the fracture surface of 3-4A, Figure 11a, and within this region are small-scale pullout features which are comparable in size to the pores in the surfaces of the bend bars, ($\approx 0.1\text{mm}$). The pullouts are a result of below-average cohesion, and the region where they occur might be expected to yield a flawed surface if a diamond saw cut were made there. (d) The fracture surfaces of 5-3A and 5-3B, which were not photographed, are smoother than most others. This feature is indicative of low fracture energy and these were the bars with the lowest strength values.

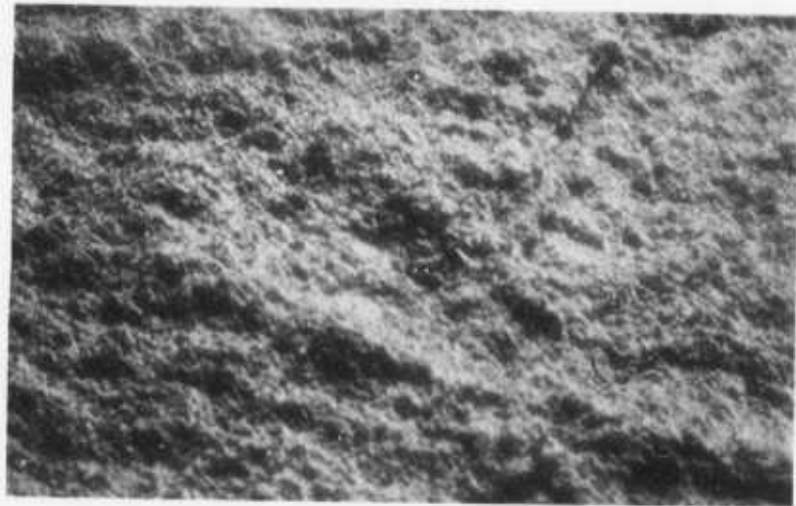
Figure 17. Secondary emission scanning electron micrographs of a sample from Radome 3. (a) 2000 X, (b) 500X, (c) 15 X. Circled areas EDAX alike.

Since the radomes varied in grayness and density through the thickness and since reaction-sintered Si_3N_4 frequently fails to nitride completely in the interior, evidence for variations in Si concentration and other microstructural features was sought. The SEM micrographs of a fracture surface, Figure 17, and a polished section, Figure 18a, from Radome 3 contain no bright spots characteristic of elemental silicon. Figure 18a shows the band of porosity near the outer radome wall (top of picture). An EDAX scan of the polished sample, Figure 18b, indicates no significant difference in Si concentration with depth. An EDAX scan for impurities, Figure 19, indicates some iron, and a substantial amount of Al replacing Si, which was incorporated while the powders were milled with Al_2O_3 .

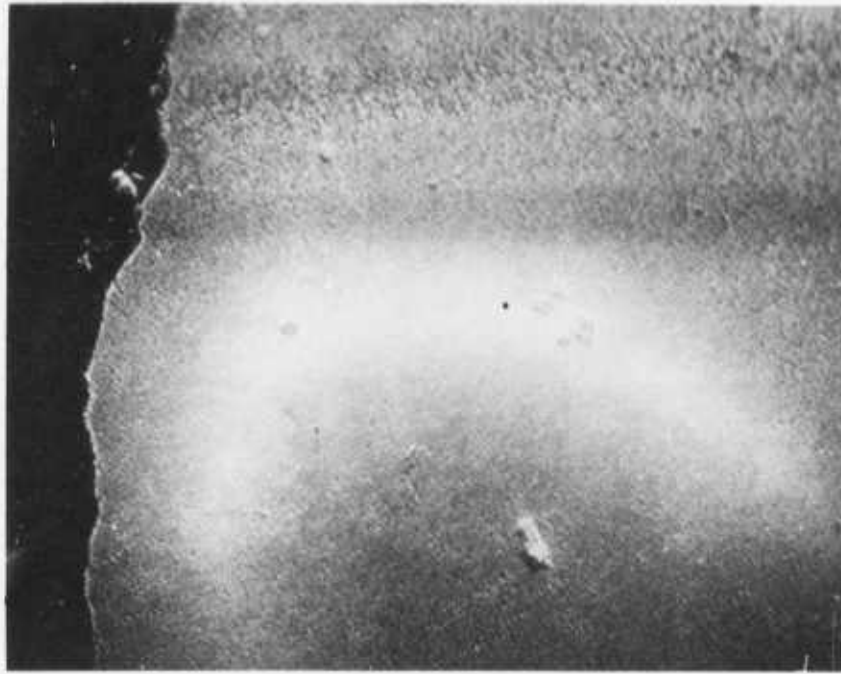
Figure 18. (a) Secondary emission scanning electron micrograph of a polished sample from Radome 3 at 20X. (b) An EDAX scan for silicon concentration in the same area.

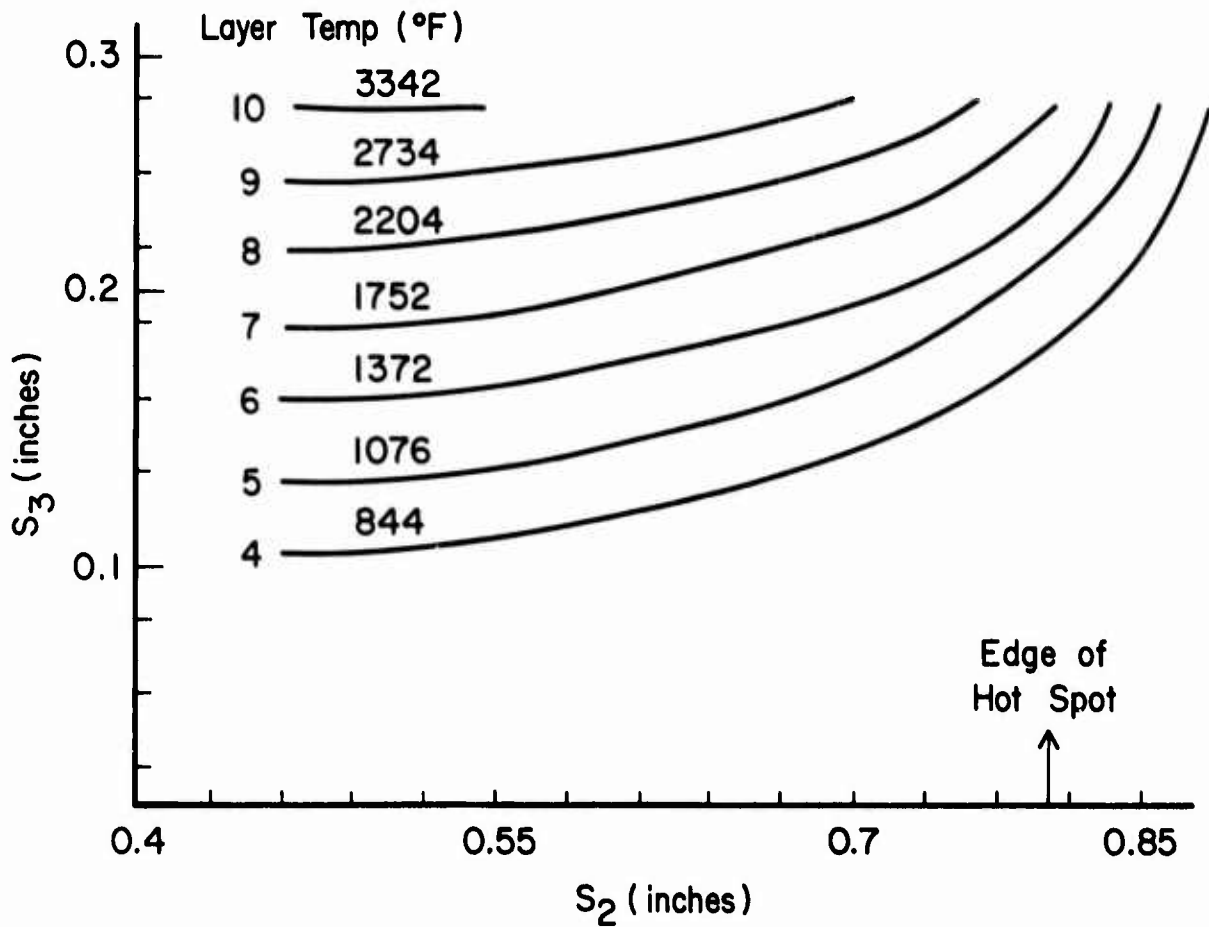
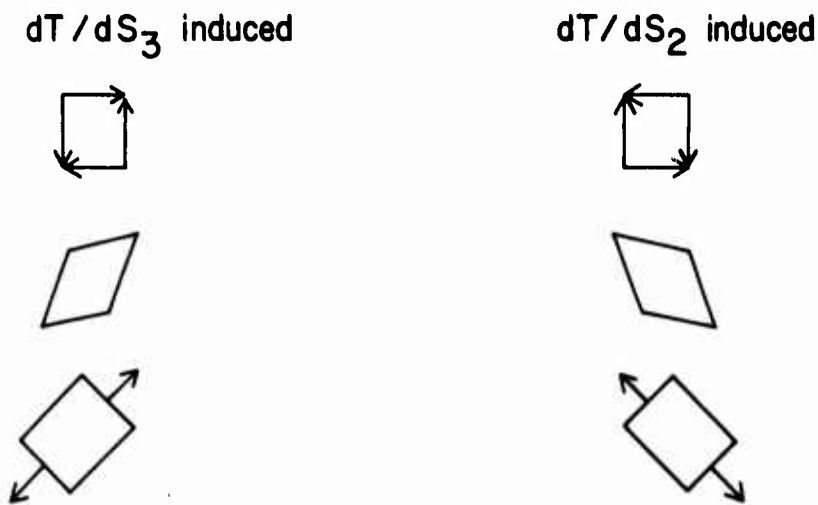
Figure A-2. (a) The isotherms for a 0.3 inch thick disc of Si_3N_4 with a 1.56 inch diameter hot spot applied for 2.0 seconds as calculated from MM Figure 35. (b) The limits of locally induced shear stress and shear strain for the above figure and the equivalent tensile stress-strain.

The Martin Marietta curves for shear versus S_2 are positive everywhere. Since there are regions outside the heated spot where $dT/dS_2 > dT/dS_3$, as shown in Figure A-2, it is presumed that remotely generated stress accounts for the shear being positive near and outside the boundary of the heated region. The consequences of the shear stress being positive everywhere is that the principal tensile stress in any volume element has S_2 and S_3 components with the same sign. Fracture resulting from this tensile stress would initiate on an orthogonal surface having a "negative" inclination. This does not account for fragmentation momentum in the S_3 direction.
