NWC TP 7098

Rain Erosion Studies of Sapphire, Aluminum Oxynitride, Spinel, Lanthana-Doped Ytria and TAF Glass

13. ABSTRACT (Maximum 200 words) (U) This report describes the results of testing six potential missile dome materials in simulated rain fields in whirling-arm facilities. Visual damage and changes of optical scatter are described.

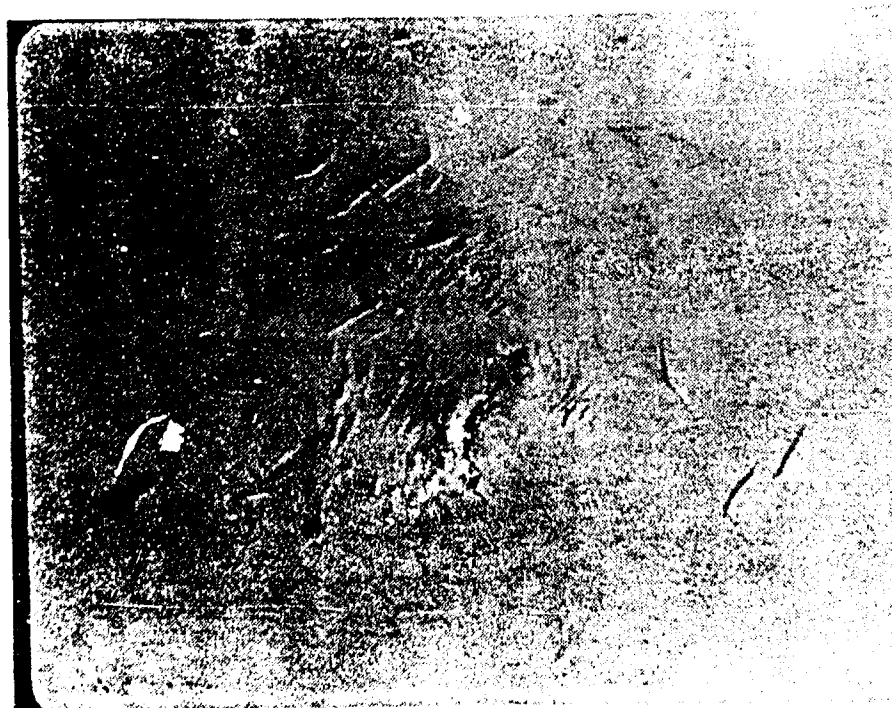
FIGURE 9. Photomicrograph of Damage on GTE Lanthana-Doped Ytria Specimen No. 27242 Run at UDRI for 20 min. Micrograph was taken in reflected Nomarski (differential interference contrast) at 160x.

FIGURE 10. Photomicrograph of Damage on GTE Lanthana-Doped Ytria Specimen No. 27242 Run at UDRI for 20 min. Micrograph was taken in reflected Nomarski (differential interference contrast) at 160x.

A number of the eroded specimens were examined with light microscopy at the Naval Weapons Center (NWC). Five of the Coors spinel samples run at NADC were examined by eye and the most damaged one had three obvious nicks in it. Figure 1 is a photograph of the disk at very low magnification; two damage sites are visible. It is noteworthy that the vast majority of the surface of this disk is undamaged. A photomicrograph of the largest flaw in Figure 1 is shown in Figure 2. Figure 3 shows the flaw near the center of the disk in Figure 1. Photographs of Coors spinel and sapphire run at UDRI are shown in Figures 4 through 7. Although the current production-quality ALON from Raytheon was not damaged in the rain field, the high scatter ALON was damaged; a photomicrograph of a flaw is shown in Figure 8. Figures 9 and 10 show two different damage sites on a lanthana-doped yttria disk run at UDRI.

The fracture origins of several lanthana-doped yttria samples were examined. In one case, the fracture origin was found to be on the back face suggesting an unusual stress pattern perhaps related to the method of holding the test specimen. Also edge fractures were noted which probably were caused in the same manner. Upon closer examination of a sample in Table 3 showing "backface crazing," the defect was found to be a partial delamination. The supplier later informed us that this same defect had been observed in fabricating this series of specimens. The delamination phenomena was triggered by the rain erosion test in these specific specimens, but may not be a characteristic of production quality lanthana-doped yttria.

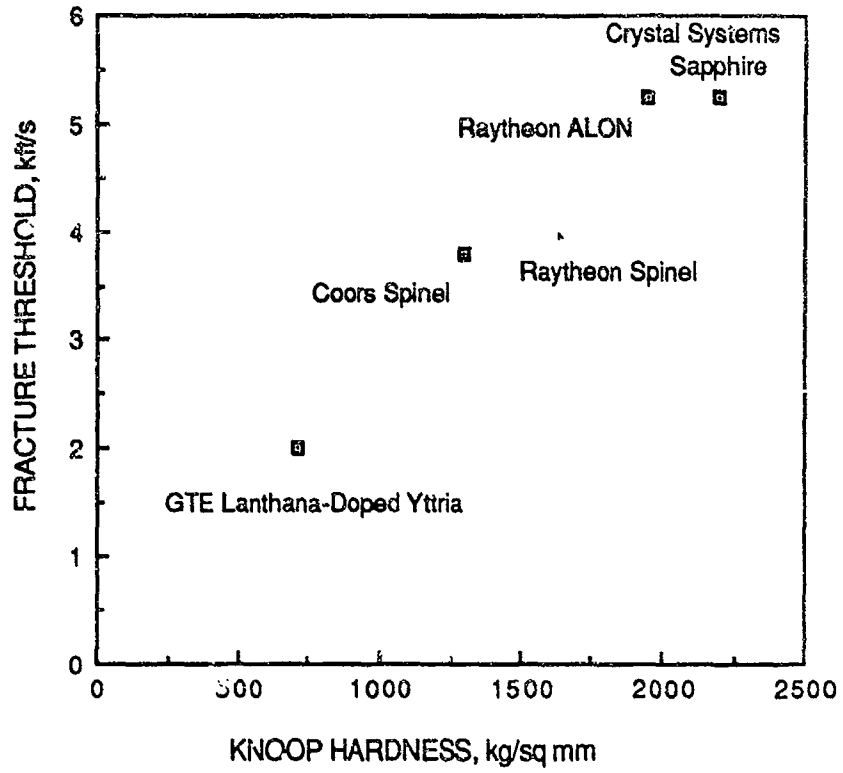
FIGURE 11. Fracture Threshold for Damage by 1.2-mm-Diameter Nylon Bead as a Function of Material Hardness (Reference 4).

The resistance to rain erosion that we observed in the present study is qualitatively consistent with that of a previous study whose results are displayed in Figure 11 (Reference 4). The data in the figure were derived from an experiment in which a 1.2-mm-diameter nylon bead was projected at each specimen at an impact angle of 30 degrees from perpendicular. The damage threshold is the speed at which surface damage first appeared. Consistent with the present study, sapphire, ALON, and Raytheon spinel have high-threshold velocities for impact damage, and lanthana-doped yttria has a lower-threshold velocity. Coors spinel withstood damage better in the previous tests than it did in our studies.
