ACCELERATIONS MEASURED AT CENTER OF GRAVITY

AND ALONG SPAN OF THE WING OF A B-24D

ATRPLANE IN LANDING IMPACTS

By John R. Westfall

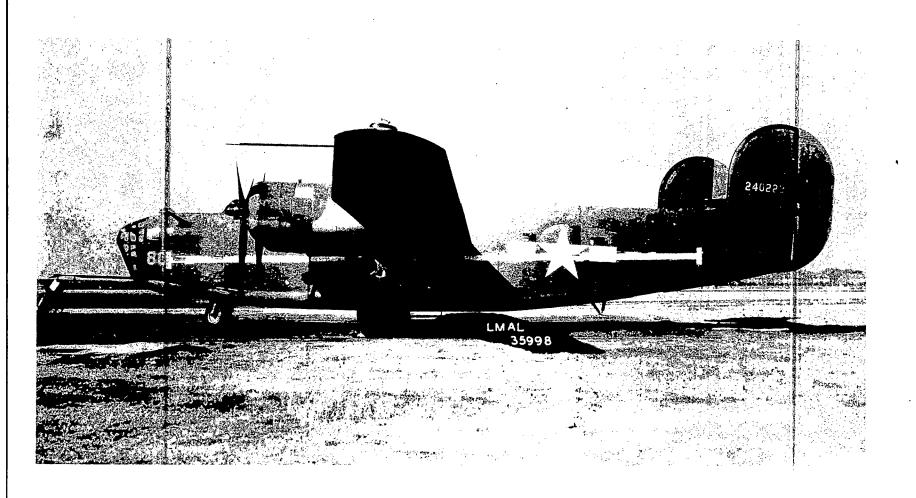
Figure 1.- Side view of the B-24D airplane.

The airplane on which the tests were conducted was a four-engine bomber, the Consolidated B-24D. Its general specifications are given in table I, and two views of its external appearance are shown in figures 1 and 2.

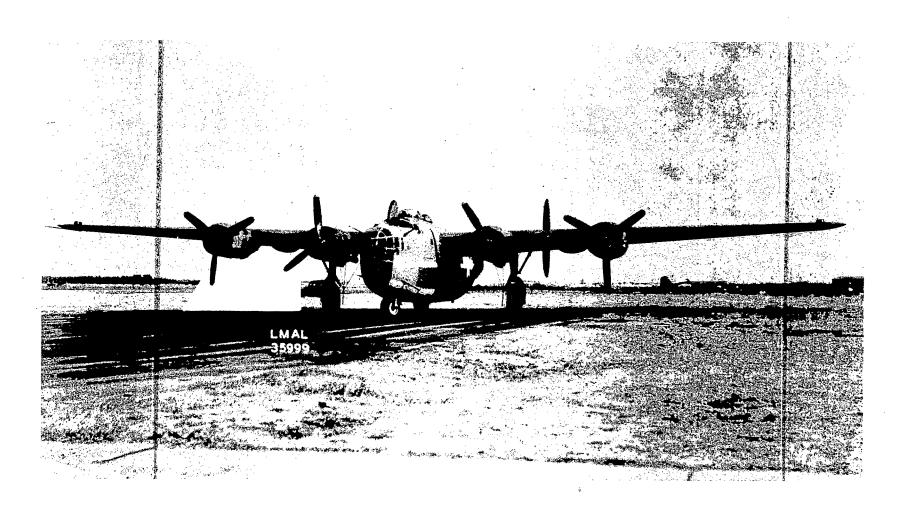
Figure 2.- Three-quarters front view of the B-24D airplane.

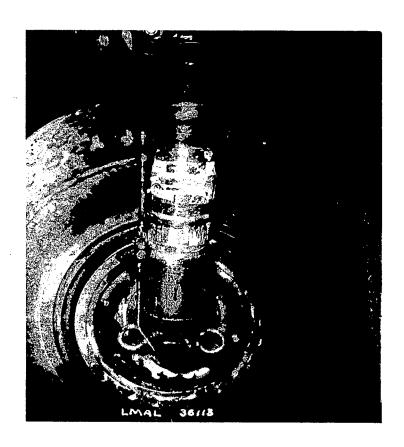
Figure 3.- Strain gage installation on left main landing-gear strut of B-24D airplane.
Protective covering of tape and wax removed.

For determining the horizontal-tail loads, the airplane was instrumented with electrical strain gages and accelerometers. The strain gages were attached to the front and rear spars of the horizontal stabilizer to determine the tail bending moments, and to the main landing-gear struts and nose-wheel strut to determine the vertical and drag components of the ground re-Standard NACA three-component accelerometers actions. were installed near the center of gravity of the airplane, at the center of the fuselage, and the center of the stabilizer. Before the landing tests began, it was decided to install two more accelerometers, one near the tip of each wing. After about half of the landings had been made, two more accelerometers were installed in the left wing, one near the attachment of the main landinggear strut to the wing and the other in the wheel well near the outboard engine nacelle. Figures 3 and 4 show the attachment of the strain gages to the landing-gear struts, and figures 5 through 8 show installation of the accelerometers at the center of gravity, the center of the stabilizer, the outboard nacelle, and the wing tips. Figure 9 is a sketch of the airplane showing the accelerometer locations in the airplane.

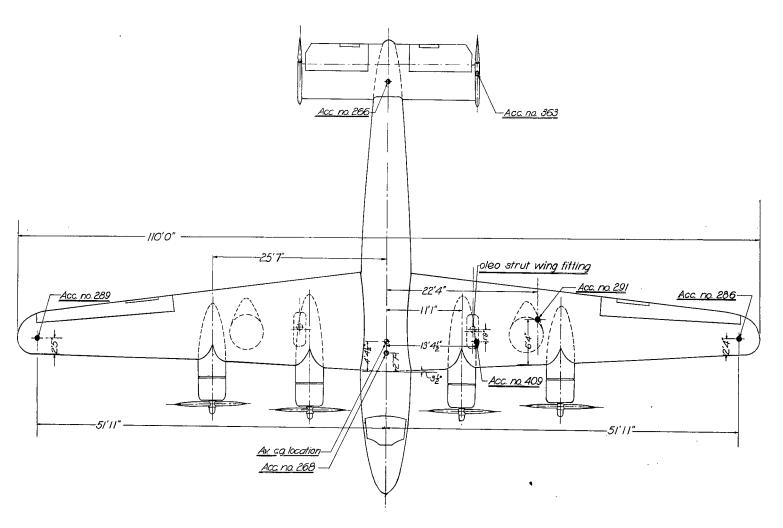
Figure 9.-Installation of accelerometers in the B-24D airplane

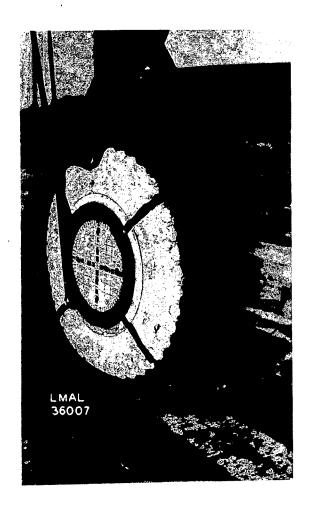
Figure 11.- Two views of the left main landing wheel of the B-24D airplane, showing wheel markings and reference target. Inboard face of wheel shown.

A photographic record of the behavior of the main landing gear during impact was obtained by two 35-millimeter cameras having speeds of about 60 frames per second, mounted beneath the fuselage of the airplane. Stationary targets, attached to the lower end of a tripod-supported boom whose upper end was secured to the wing structure, were installed in the fields of view of the cameras to serve as reference points in determining the movement of the gear. Camera and target installations are shown in figures 10 and 11. All of the instruments in the airplane were synchronized by means of an NACA timer.
