November 1944 as  
Advance Confidential Report E4KO2

EXPERIMENTAL STUDY OF THE COATING FOUND ON SCUFFED CAST-IRON  
PISTON RINGS DURING OPERATION IN NITRIDED-STEEL CYLINDERS

By J. Howard Kittel and Walter A. Vierthaler

Aircraft Engine Research Laboratory  
Cleveland, Ohio

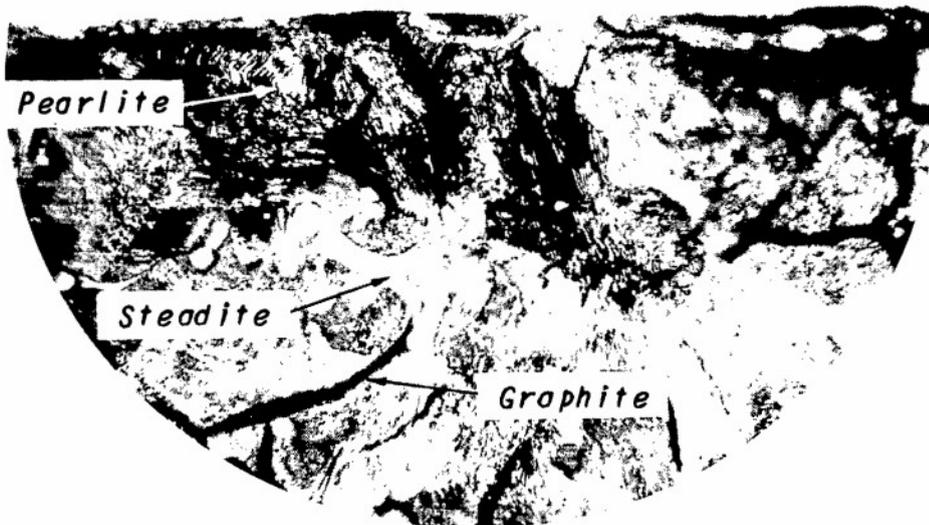
*Figure 1. - Transverse section of the running face of a new cast-iron piston ring. Etched in nital. X1500.*

A photomicrograph of a transverse section of a new cast-iron piston ring is presented, for convenience of reference, in figure 1. The structure consists of a number of constituents randomly distributed over the cross section. The cross section shows the presence of graphite, pearlite, and steadite.

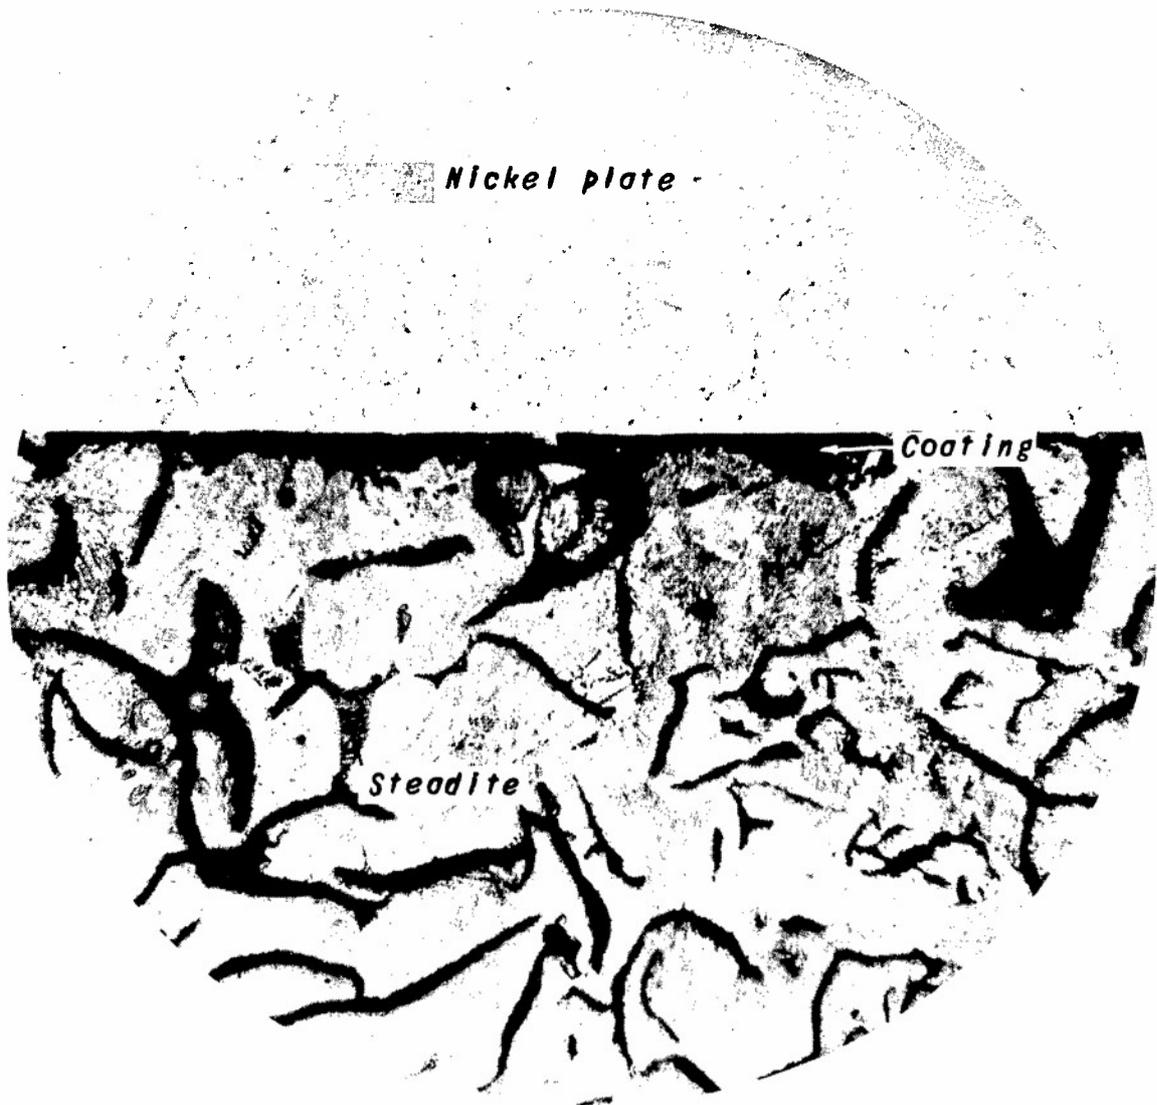
Figure 4. - Transverse section through scuffed portion of the running face of a cast-iron piston ring showing coating material after test. Same area as figure 3. Etched in hot concentrated potassium hydroxide. X1500.

Figure 4 is a photomicrograph of the same area as shown in figure 3 but the etching reagent employed in this case was potassium hydroxide, which chiefly attacked the coating material and the steadite. The uppermost surface of the coating, despite its appearance in figure 2, was fairly smooth. The surface finish of the

scuffed areas ranged from 20 to 30 microinches, rms as compared with a surface finish of from 6 to 10 microinches, rms on a normally operated unscuffed ring. The maximum thickness of coating observed to date in transverse sections is about 0.0001 inch.

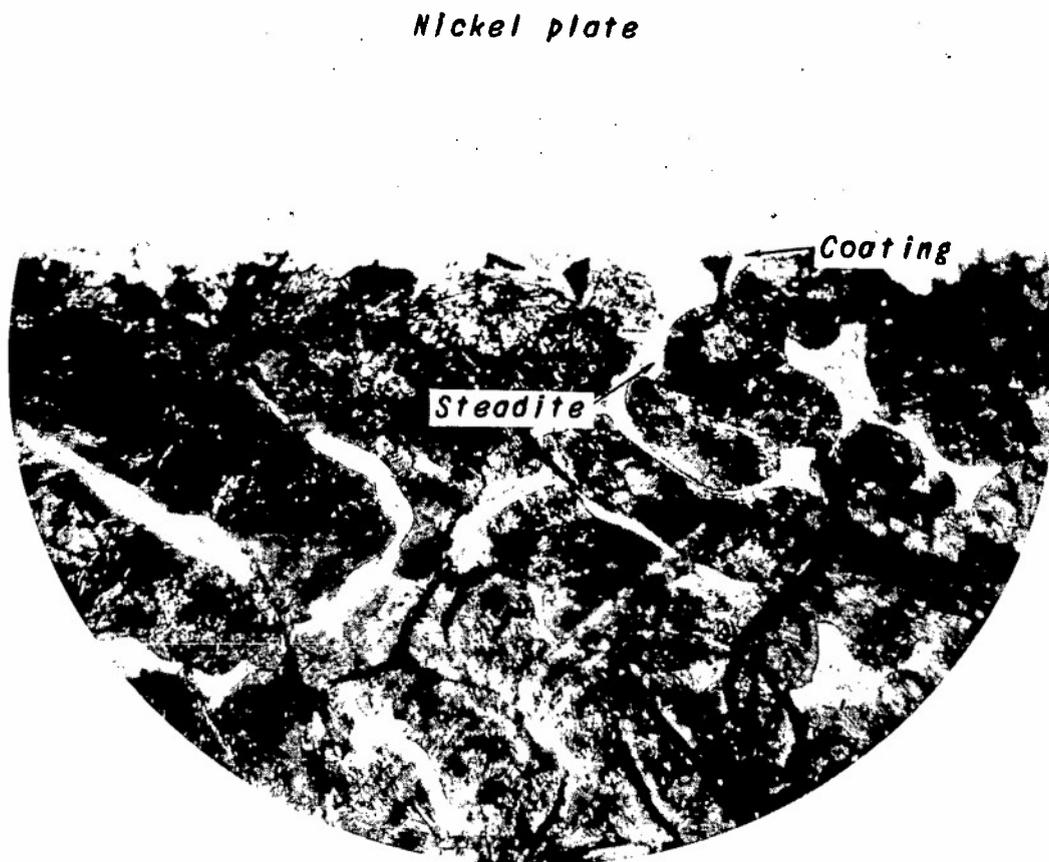
*Figure 7. - Transverse section through scuffed portion of the running face of a cast-iron piston ring showing coating material after test. Etched in nital. X1500.*

The thin coatings observed on portions of scuffed cast-iron piston rings were not easily attacked by dilute nitric acid but were visible attacked by hot concentrated potassium hydroxide. Steadite showed approximately the same chemical behavior. A transverse section of a coated cast-iron piston ring etched with nital (fig. 7) shows steadite apparently merging into the coating. Figure 8 shows the same area as figure 7, but in this case the section has been etched with hot concentrated potassium hydroxide. The apparent merging of the steadite into the coating is shown here even more clearly; it appears possible, therefore, that steadite is associated with the formation of the coating on scuffed cast iron.

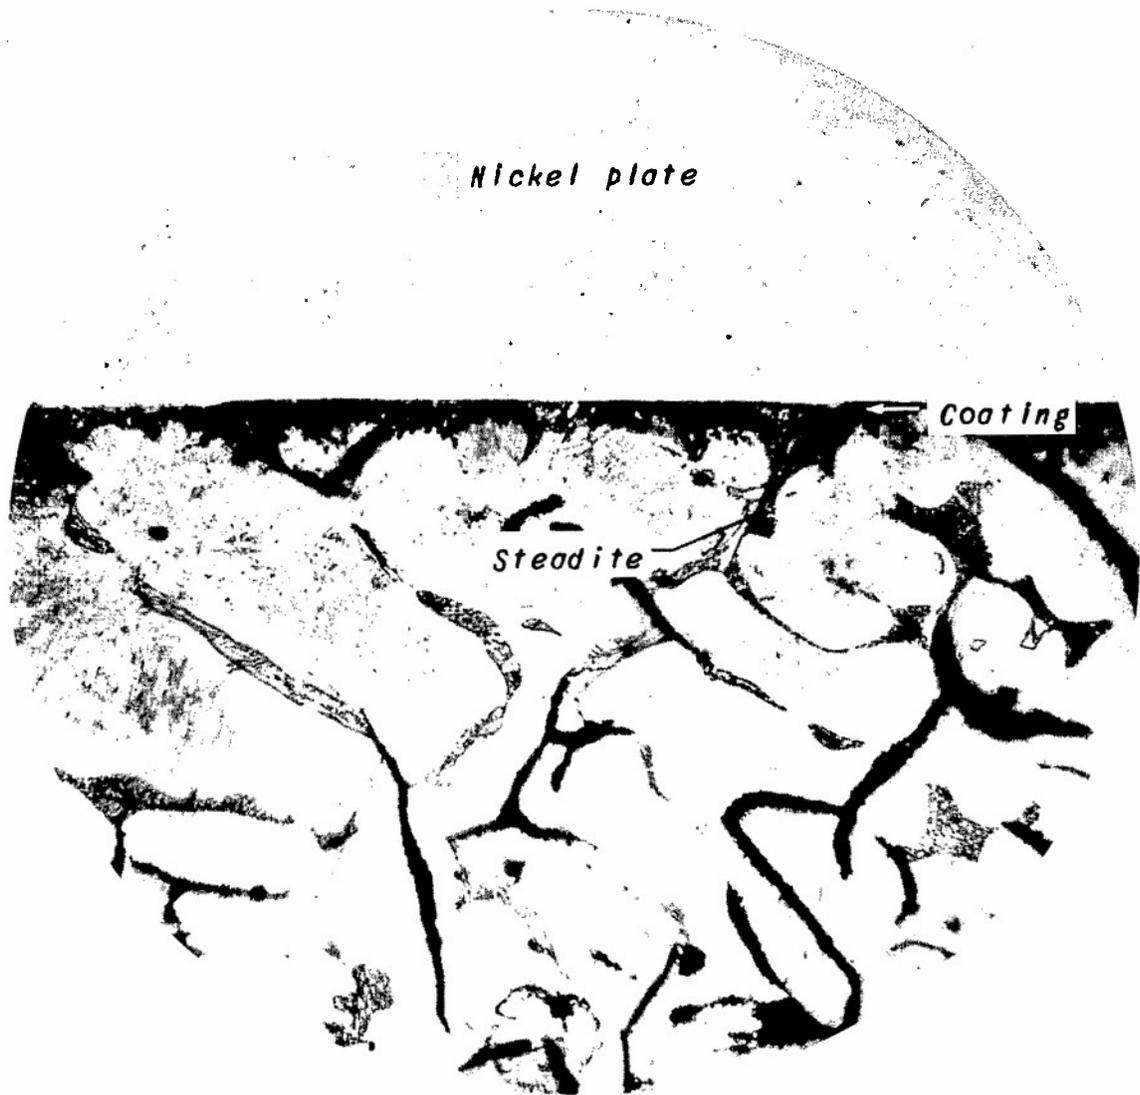
Figure 8. - Transverse section through scuffed portion of a cast-iron piston ring showing coating material after test. Same area as figure 7. Etched in hot concentrated potassium hydroxide. X1500.

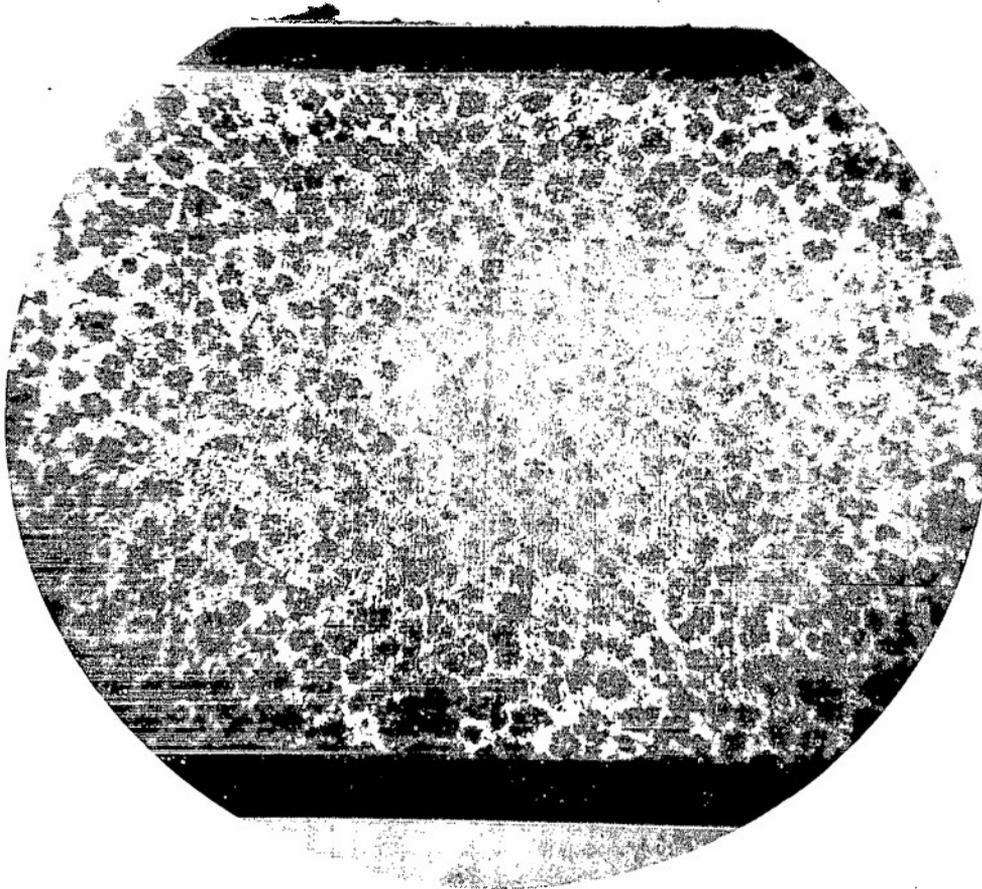
*Figure 10. - Running face of a normally operated, unscuffed cast-iron piston ring. The light reflective areas are steadite. Etched with Stead's reagent. X35.*

Figure 9 presents a plan view of a new cast-iron ring face that has been etched with Stead's reagent. On the basis of results obtained from the use of Stead's reagent, it appears that a large part of the face area is composed of steadite (which is the reflective or light portion of the surface). It seems likely then, that the machining of the piston ring may cause some steadite to flow over the surface. Figure 10 shows a piston ring that has been run but has not scuffed. There is more steadite in evidence on this ring than on the new ring in figure 9. The scuffed section of ring shown in figure 11 shows more steadite than either figures 9 or 10. This evidence, also, indicates that the coating is at least partly steadite.
