# NATIONAL ADVISORY COMMITTEE FOR AERONAUTICS

TECHNICAL NOTE

No. 1186

REVIEW OF AN INVESTIGATION OF CERAMIC COATINGS FOR  
METALLIC TURBINE PARTS AND OTHER  
HIGH-TEMPERATURE APPLICATIONS

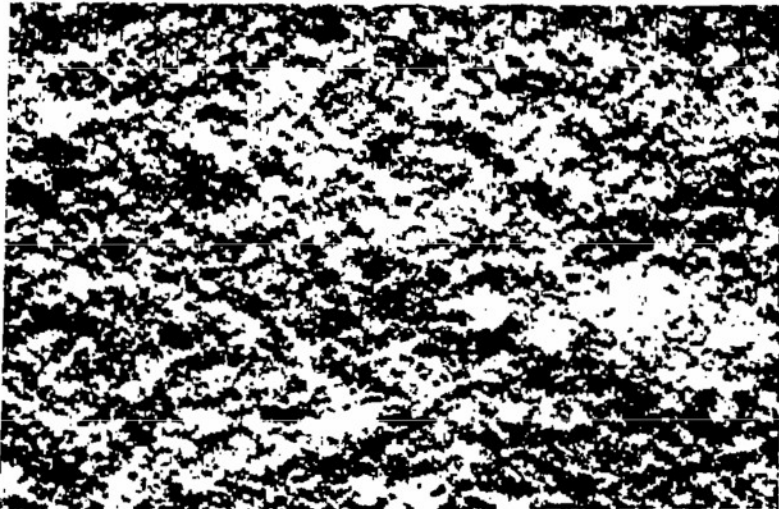
(a) Before heating.

(b) After 200 hours.

(c) After 500 hours.

Figure 5.- Photomicrographs at 120X of coating L-5A0 on alloy S-816, showing a gradual healing of discontinuities initially present as the specimen was heated in air at 1500°F.

During the 500 hours of heating there were considerable changes in microstructure of some of the coatings, whereas others showed little or no change. Photomicrographs of the same field on selected specimens were taken at 120 magnification before treatment and after 200 and 500 hours, respectively. Figure 3 shows three such views of coating L-6A on alloy S-590, which is an example of a type of coating that showed considerable deterioration during heating in air at 1500° F. Figure 4 is a series of photomicrographs of coating A-309 applied on alloy S-816, which is an example of a coating type that showed no appreciable change in the microstructure during the 500-hour heating treatment in air. The only visible change that occurred with this specimen was a small decrease in glossiness from a slightly glossy original condition. Figure 5 represents coating L-5ACas applied on alloy S-816, and illustrates the unusual property of self-sealing of discontinuities that were initially present.

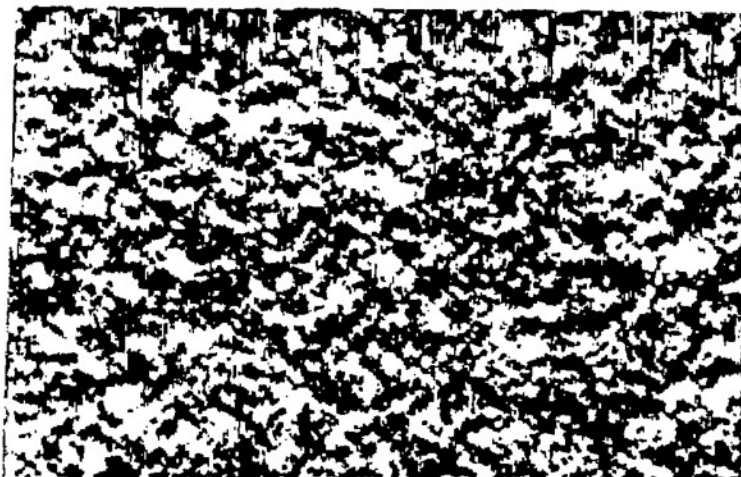
(a) Condition of coating before tubercules had begun to form. Note discontinuities in the coating (probably caused largely by gas evolution from the metal during the firing process).

(b) Early stage of tubercule formation.

(c) Advanced stage of tubercule formation.

Figure 11.- Photomicrographs at 30X, showing development of tubercules. Areas shown are from specimen with coating A-305 (see fig. 10), which was treated at 1350°F in H<sub>2</sub>S for 189 hours. Locations of the tubercules are controlled by the locations of the original discontinuities.

The attack through coatings A-189 and A-305 took the form of tubercles, consisting probably of sulfides of the alloying elements, and these are apparent in figure 10 as white specks. Very few of them, if any, are visible on coating L-2A. The specimens with coating A-305 shown in figure 11 offer a favorable opportunity for a study of the mechanism of the attack. The locations of the tubercles on these specimens correspond to the locations of discontinuities in the coating, which were visible under the microscope before the  $H_2S$  treatment and which appeared to result from gas evolution during firing of the coating. Figure 11(a) shows the appearance of coating A-305 at a magnification of 30X before the tubercles had begun to form; 11(b) shows the early stages of tubercle formation and 11(c) a more advanced stage. With continued treatment, growth of the nodules continues. The selective attack on the metal is illustrated in figures 12(a) and 12(b), which are photographs taken at 30X after the coating was removed by sandblasting. Figure 12(a) corresponds to 11(a), and 12(b) to 11(c). Figure 12(b) shows cavities resulting from selective attack where discontinuities occurred in the coating. Figure 12(c), which is a photomicrograph of coating L-2A as shown in figure 10, illustrates the appearance of a coating that gave successful protection of the alloy against the attack by  $H_2S$  at  $1350^\circ F$ . Figure 12(c) should be contrasted with figure 11(c).

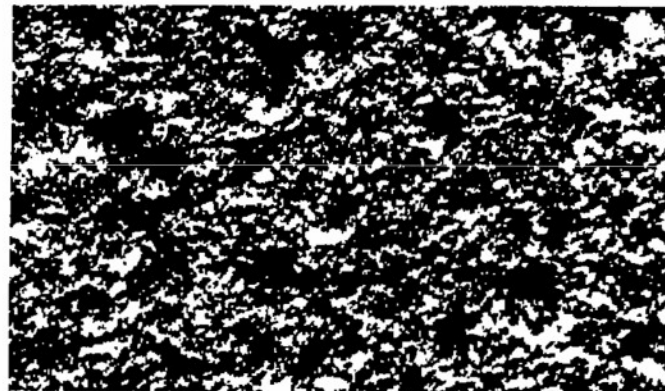
(a) No tubercules yet formed; corresponds to figure 11a.

(b) Cavities in the alloy beneath the tubercules caused by attack of the  $H_2S$  atmosphere at  $1350^{\circ}F$ ; corresponds to figure 11c.

(c) 30X magnified view of coating L-3A (see fig. 10) which withstood treatment with little or no formation of tubercules. This photomicrograph should be contrasted with figure 11c, which is a magnified view of coating A-305 (see fig. 10) after formation of tubercules.

Figure 12.- Photomicrographs at 30X, showing appearance of specimens shown in figure 11 after removal of coating by sand-blasting.
