WADC TECHNICAL REPORT 54-492

# **OXIDATION-RESISTANT COATINGS FOR MOLYBDENUM**

*CLIMAX MOLYBDENUM COMPANY OF MICHIGAN*

*DECEMBER 1954*

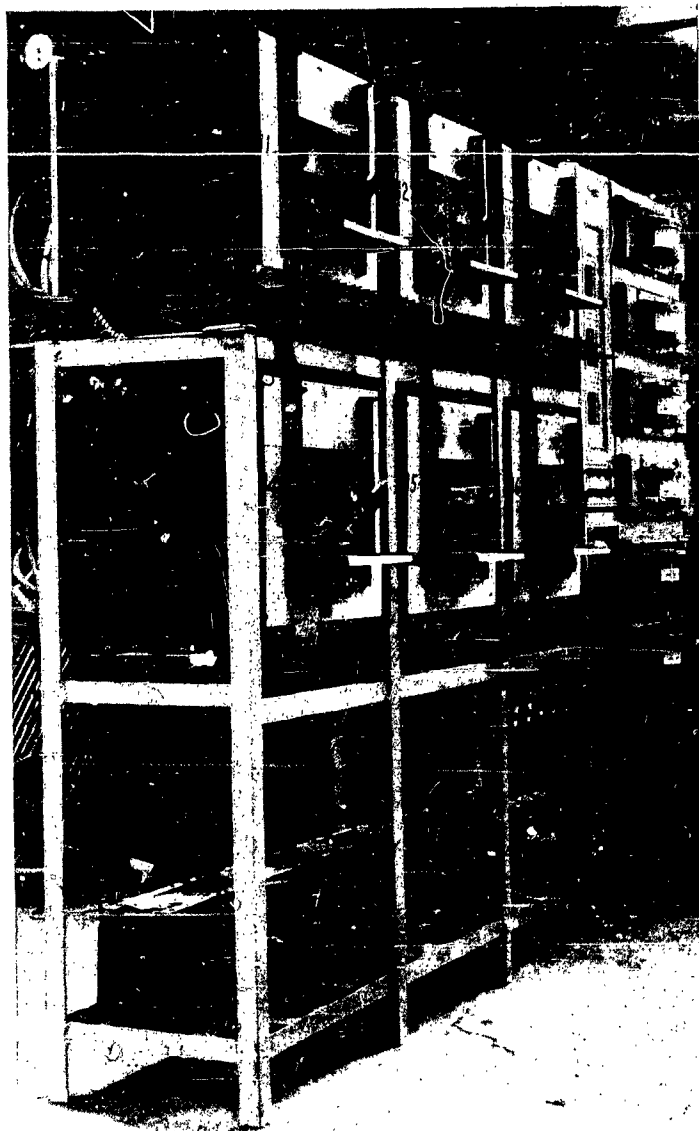
FIG 4 (P1142) - FRONT VIEW OF SIX FURNACES FOR  
CONDUCTING OXIDATION TESTS IN  
AIR AT 1800°F

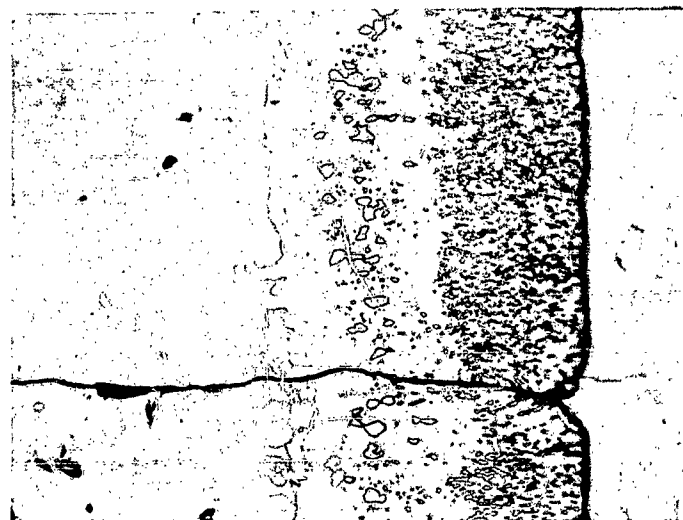
A. Oxidation Tested 50 Hours in  
Air at 1800°F

FIG 14 - MICROSTRUCTURES OF Al-Cr-Si COATINGS ON MOLYBDENUM  
AFTER OXIDATION TESTING IN AIR FOR 50 AND  
100 HOURS AT 1800°F

The irregularity of the interface at the base of the crack in Figure 14B was caused by the presence of a small molybdenum carbide which interfered with the interdiffusion of the coating and molybdenum. This effect is illustrated more clearly with another specimen in Figure 16.

Coating cracks were purposely included in each of the photomicrographs of Figures 13-15 to show that within the 500-hour period of testing at 1800°F the molybdenum was not oxidized at the base of the cracks. Evidently the coating expands sufficiently upon heating to 1800°F that the cracks are closed, and thus air is prevented from gaining access to the molybdenum at 1800°F.

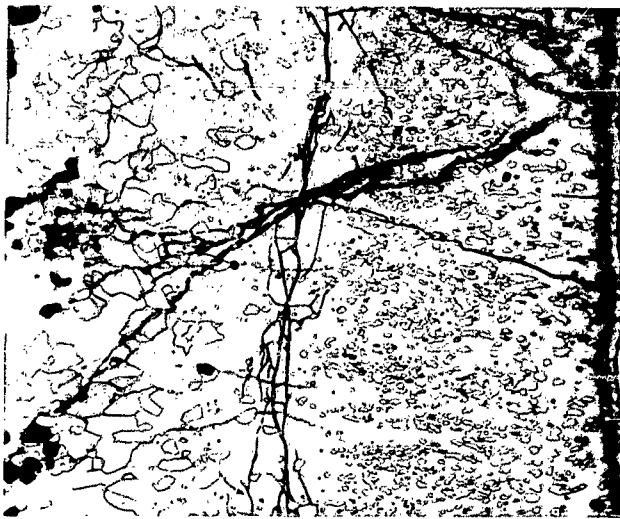
A. Oxidation Tested 200 Hours in  
Air at 1800°F

B. Oxidation Tested 500 Hours in  
Air at 1800°F

FIG 15 - MICROSTRUCTURES OF Al-Cr-Si COATINGS ON MOLYBDENUM  
AFTER OXIDATION TESTING IN AIR FOR 200 AND  
500 HOURS AT 1800°F

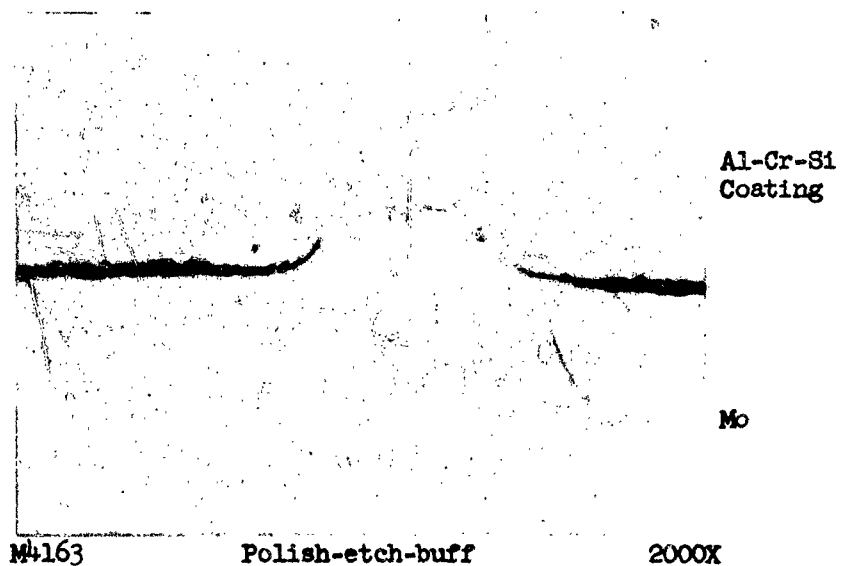
FIG 16 - MICROSTRUCTURE OF Al-Cr-Si COATING ON MOLYBDENUM  
DIFFUSION TREATED TWO HOURS IN PURIFIED HYDROGEN  
AT 2000°F, SHOWING MOLYBDENUM CARBIDE  
INTERFERENCE WITH INTERDIFFUSION OF  
COATING AND MOLYBDENUM

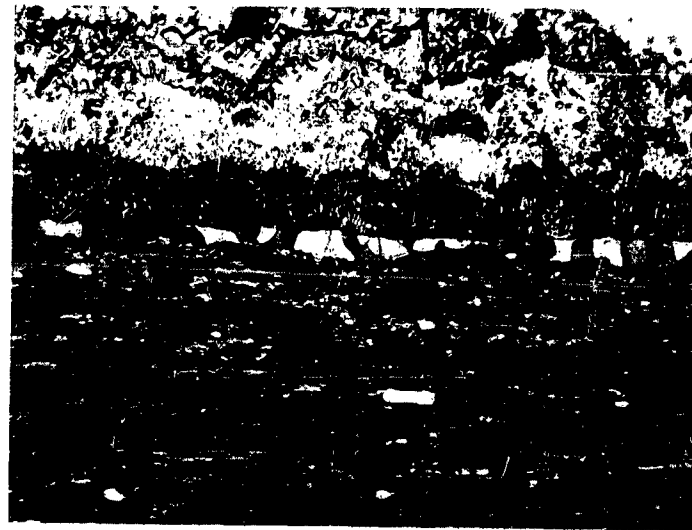
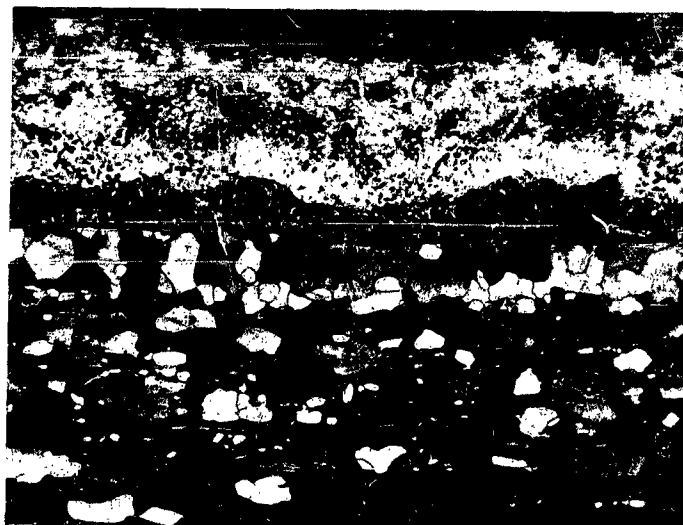
A. Diffusion Treated Two Hours in  
Purified Hydrogen at 2000°F

B. Stressed for 27 Hours in Air  
at 1800°F

FIG 19 - MICROSTRUCTURES AT GAGE SECTIONS OF COATED DUCTILITY  
TEST SPECIMENS AS DIFFUSION TREATED AND AFTER  
STRESSING FOR 27 HOURS IN AIR AT 1800°F

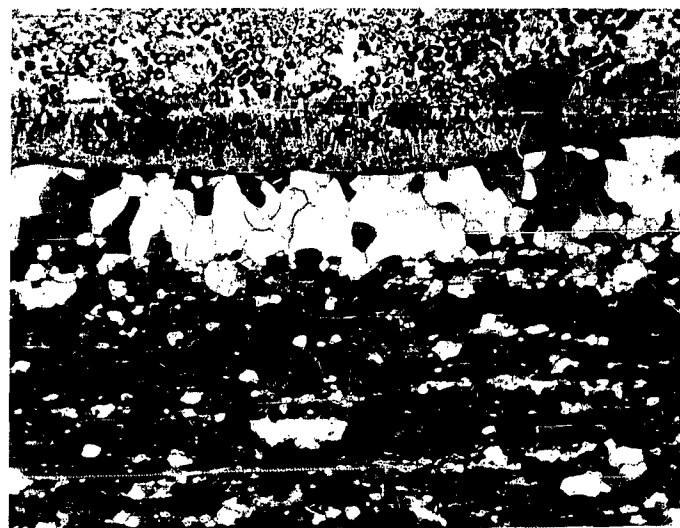
A. Stressed for 136 Hours in Air at  
1800°F. Colmonoy No. 6 Coating
