Project NY 450 030  
Technical Memorandum M-109

THE ROLE OF *Limnoria tripunctata* IN PROMOTING  
EARLY FAILURE OF CREOSOTED PILING

6 April 1956

U. S.  
naval  
civil  
engineering  
research  
and  
evaluation  
laboratory

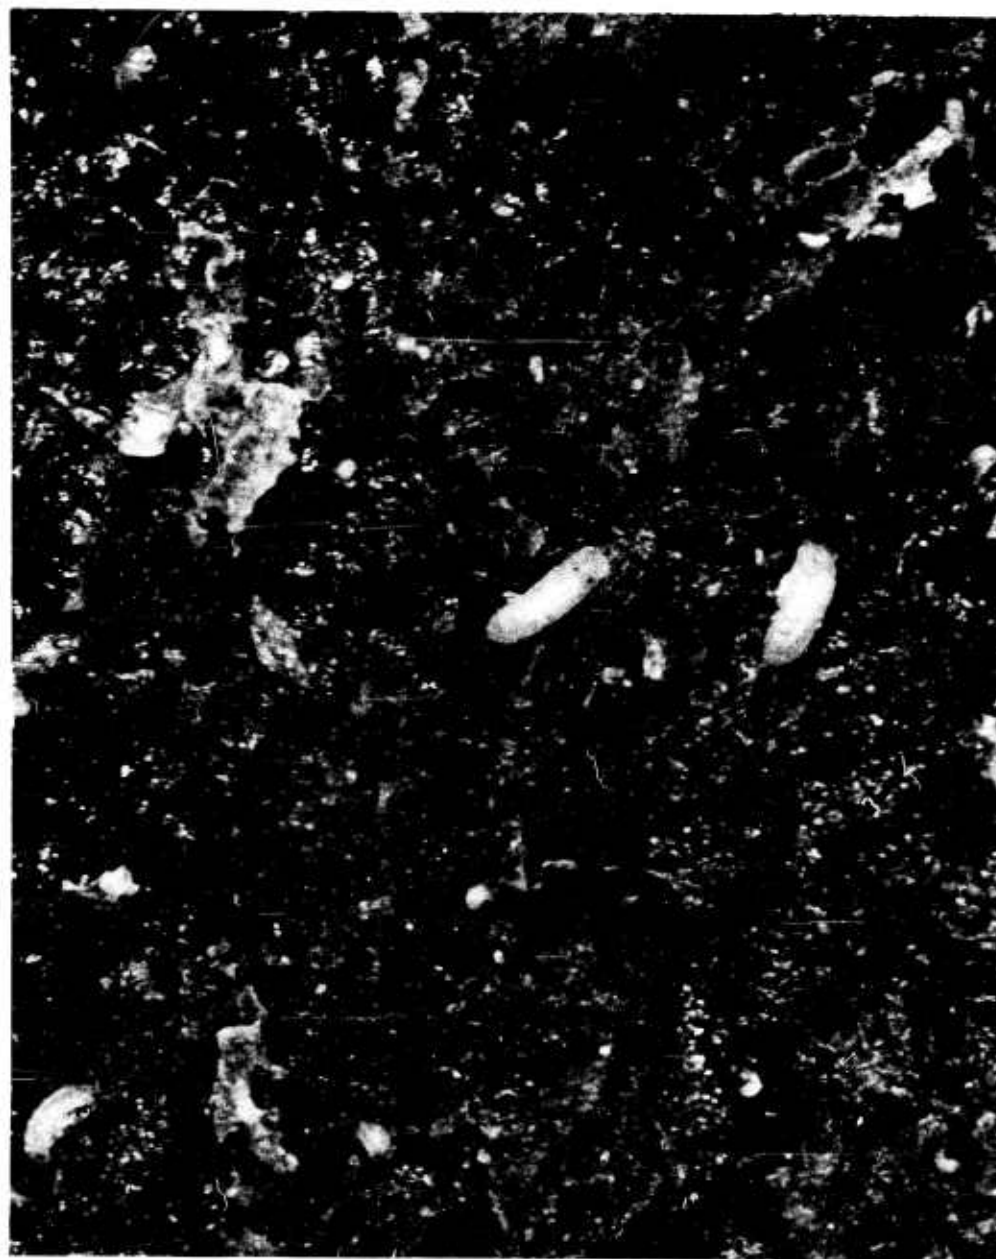
There appeared to be much greater activity in the movement of the *Limnoria* from their burrows to the surface of the wood and back again into the burrows than had been previously noted for *Limnoria* attacking untreated wood. This behavior may be necessary for survival of *Limnoria* in the presence of creosote.

Figure 4. *Linnoria* crawling and burrowing on the surface of creosoted piling.
