TECHNICAL REPORT  
EP-108

DESERT FLOOD CONDITIONS IN THE WHITE MOUNTAINS  
OF CALIFORNIA AND NEVADA

QUARTERMASTER RESEARCH & ENGINEERING CENTER  
ENVIRONMENTAL PROTECTION RESEARCH DIVISION

APRIL 1959

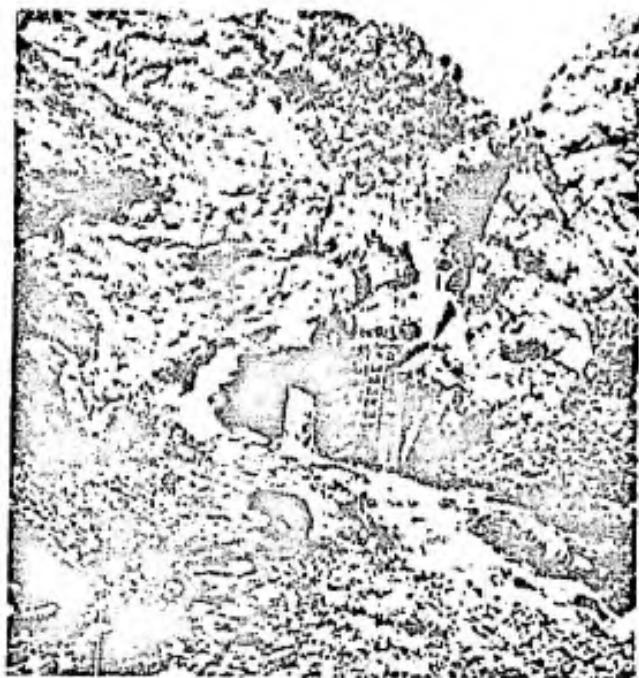
Figure 19. Milner Creek bedrock narrows and dam at foot of lower falls. Men on dam give scale.

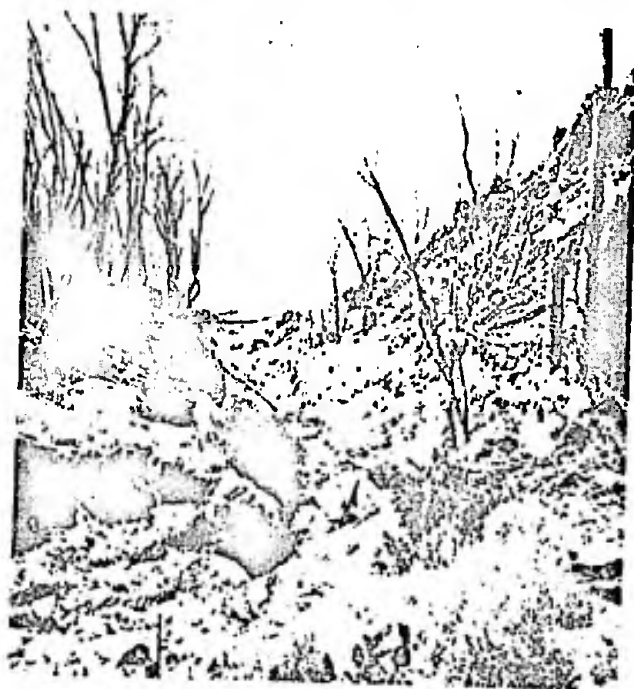
Figure 20. View looking downstream just above mouth of Cottonwood Canyon showing dead trees on terrace formed by 1952 flood. Depth of cut at this point is about 15 feet.

There is excellent evidence of the removal of debris from the floor of the lower canyon of one of the drainage systems, Cottonwood Canyon. Today, a stand of dead cottonwood trees occupies matched narrow terraces of alluvial fill about 15 to 20 feet above the creek bottom in the lower half-mile of canyon (Fig. 20). Prior to 1952, these trees were green and were growing on a flat extending completely across the lower canyon; the creek then occupied a shallow channel in the approximate center of the flat (Springer, R., Personal Communication, 1957). During the flood of 1952, a body of material roughly 20 to 30 feet wide, 20 feet deep, and about 1,500 to 2,000 feet long was removed and added to that brought down from higher in the basin. The lowering of the

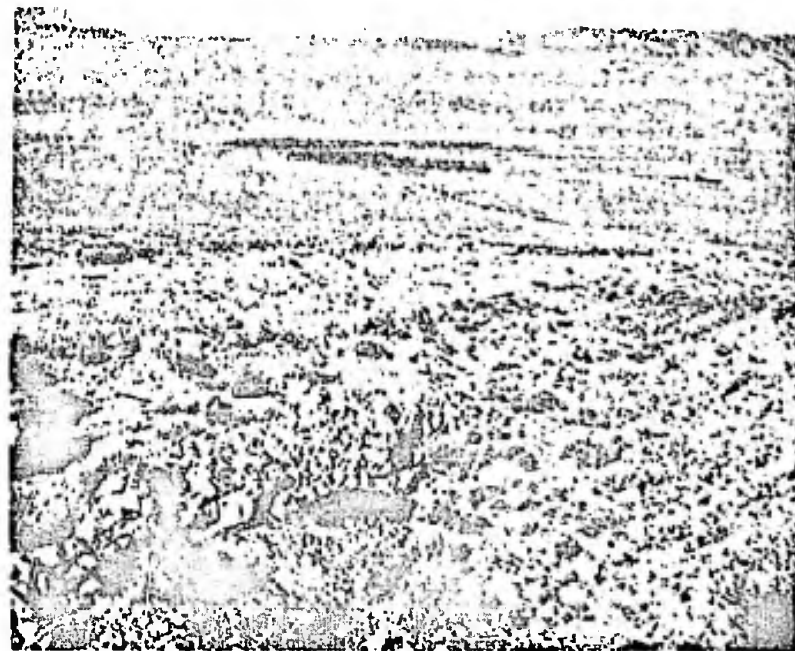
Figure 24. Lateral ridges along edge of 1952 debris flow near apex of Cottonwood Canyon fan. One ridge extends diagonally across picture from lower left corner and is about 3 feet high and 5 feet wide at the base. A second ridge can be seen on opposite side of fresh deposits. Cultivated fields in background are Symons ranch, near which the lower end of the debris flow is visible.

The appearance of the debris flows today, several years after the event, is quite distinctive. In cross section they are concave upward, with well-defined lateral ridges 3 to 6 feet wide and 2 to 4 feet high along parts of their margins (Fig. 24). Evidently the central part of these debris flows had greater fluidity than the margins, and material gradually was left stranded along the edges. Subsequent water runoff followed the centers of the flows and removed a certain amount of material, tending to accentuate the ridge-like characteristics of the margins.

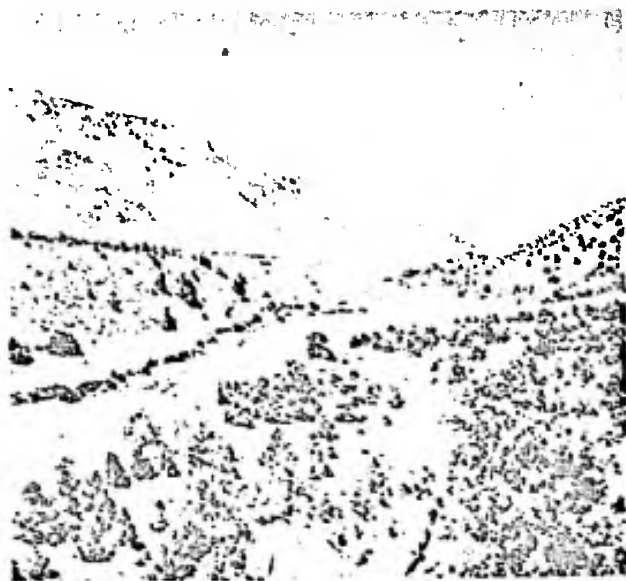
Figure 28. Looking downstream in lower Leidy Canyon from a point about one-half mile above mouth. The row of trees to the right of the stream cut marks the approximate margin of the 1952 debris flow, which spread to cover most of the canyon floor in the middle-ground of the photograph. Note well-defined, sloping terrace at left of stream channel, which supports a thrifty growth of pinyon pine.

Morphologic evidence and effects in canyon. The heavy rains of July 1952 produced considerable debris movement on the floor of the trunk canyon within the mountains; the large debris flow came to a halt about one-quarter of a mile above the canyon mouth (Fig. 27). The lower portion of the main canyon floor, which widens markedly about one mile above the canyon mouth, was covered with coarse, blocky debris to a depth of 2 to 3 feet (Fig. 28).

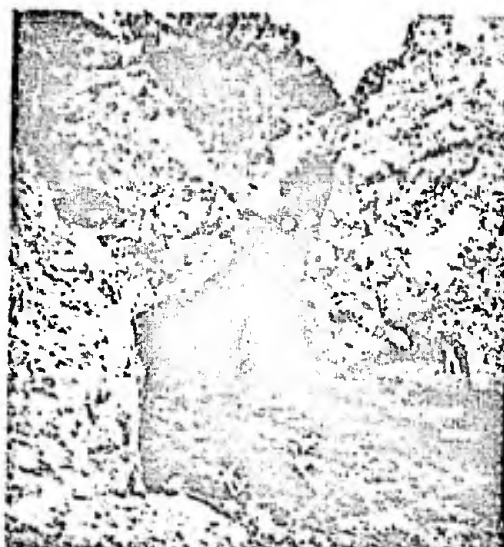
Figure 31. Flow over Milner Creek intake box during the period of snowmelt flooding of June 1957. Compare with Figure 19.

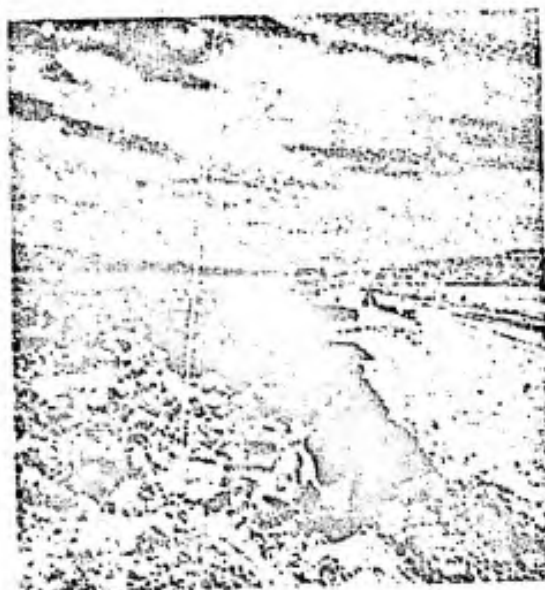
Figure 38. Damage to U.S. 6 at west end of Columbus Salt Marsh, Nevada. This was caused by the cloudburst flooding of 21 August 1957. The amount of uncovered culvert, about 15 feet, indicates the width of road and shoulder removed by the overflow.

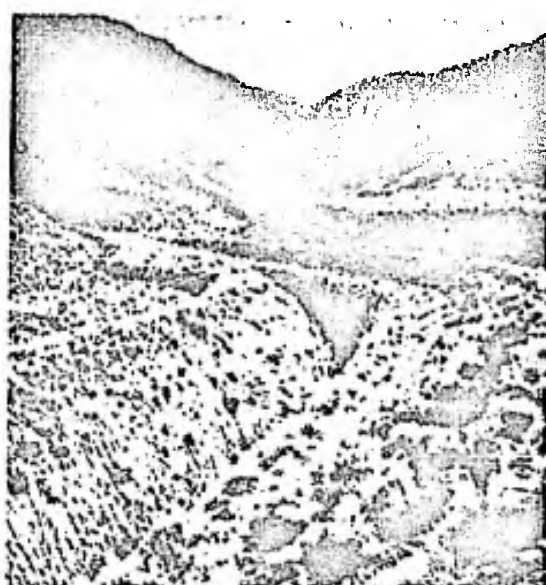
Figure 40. Lateral ridges along active channel in lower Straight Canyon deposited by flood of 1918. The channel is about 10 feet deep and 20 feet wide. Despite its artificial appearance, it is a natural feature. One lateral debris ridge appears in the right foreground near the right edge of the photograph and can be followed upstream beyond the prominent terrace in the middle distance. The lateral ridge in the left half of the picture is on the upper edge of the channel and appears especially clearly at the first upstream bend. The lateral ridges are about three to four feet high and four to eight feet wide at their bases.
