ESWC-TN-60-25

THE FEASIBILITY OF USING REMOTELY CONTROLLED
VEHICLES TO DECONTAMINATE LARGE PAVED AREAS

Clayton L. Schlemm
Captain USAF
Project Officer

Research Directorate
AIR FORCE SPECIAL WEAPONS CENTER
Air Research and Development Command
Kirtland Air Force Base, New Mexico

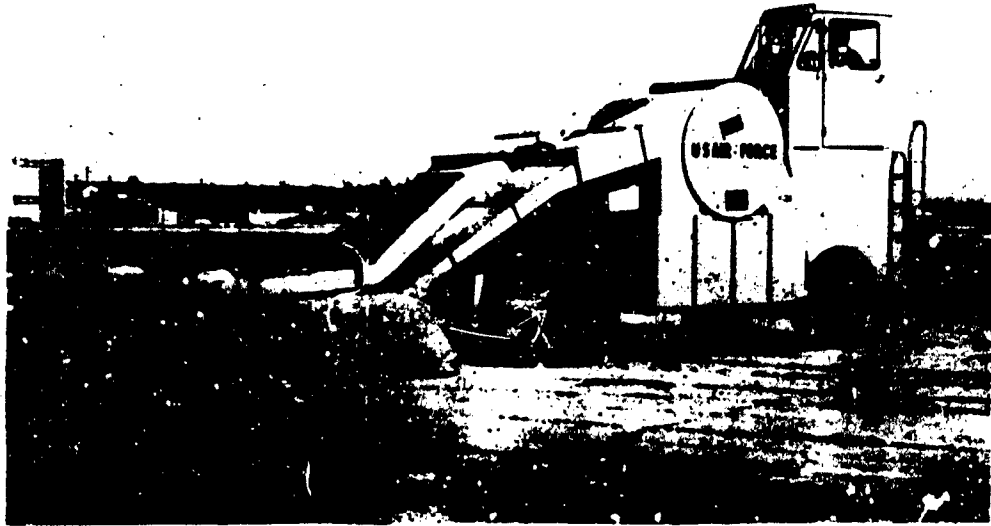
Figure 3. Coleman runway vacuum sweeper.

The requirements from ARDC closely paralleled the specifications of the Coleman Runway Vacuum Sweeper developed by the Coleman Engineering Company, Inc. of Los Angeles, California (see figure 3). The feasibility of shielding the operator's cab had already been studied and found impractical. Depending upon material used and space required for the operator, an added weight of 6,000 to 20,000 pounds would be required. This might be used in some instances on heavy equipment, but would seriously impair the operation of a relatively light vehicle.

Investigation of the Coleman sweeper indicated that extensive modification to the unit would be necessary to make it suitable for decontamination purposes. The US Naval Civil Engineering and Research Evaluation Laboratory at Port Hueneme, California, had initiated a study contract with the Coleman Engineering Company to determine the feasibility of adapting the Coleman-designed airfield vacuum cleaner for use in effectively decontaminating paved areas.
