Air force surveys in geophysics

Investigations of ice-free sites for aircraft landings
in East Greenland, 1959

September 1961

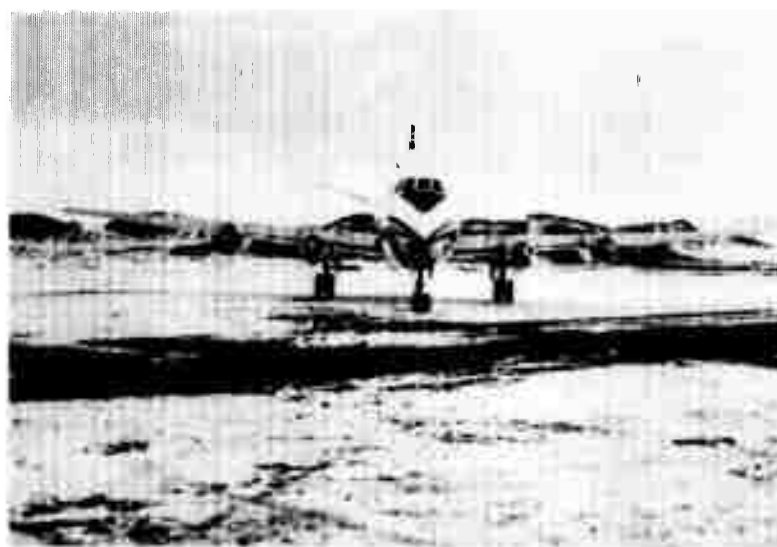
Photograph 1. Aircraft operations in East Greenland and North Greenland are exemplified by this view of a commercial prop-jet Viscount on a snow-covered, unsurfaced airstrip at Mesters Vig. Increasing use of the northern airways by commercial and military aircraft and the abrupt and severe changes in weather common in this area have created a need for emergency landing areas to supplement existing airfields. Date: 9 September 1959.

Both American and Danish authorities have noted the need for additional emergency landing fields in northern and eastern Greenland to supplement existing airfields at Nord, Mesters Vig, and elsewhere (Photograph 1). Groundhog III (1959), in addition to advancing general objectives set by previous Groundhog operations, had been asked by the

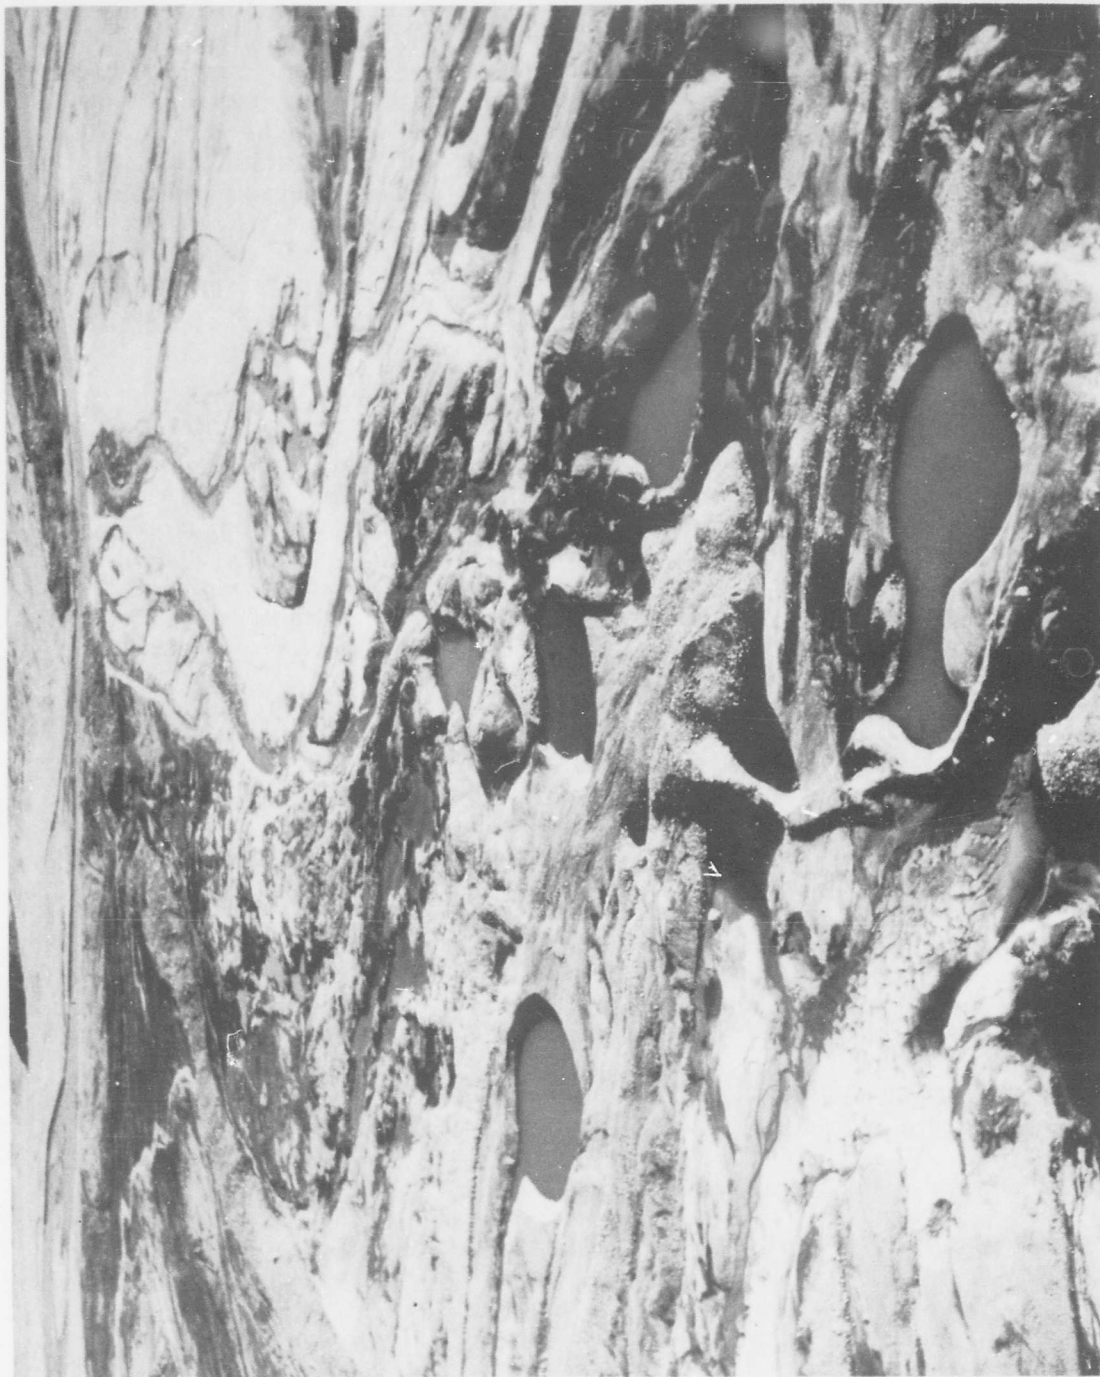
Photograph 2. View near Charcot Glacier. Slumped and pitted older outwash in foreground, deposited on and around blocks of stagnant ice; younger outwash in right background. End moraine runs diagonally across picture in left background, Charcot Glacier off to right. Elevation approximately 600 feet. Date: 20 August 1959.

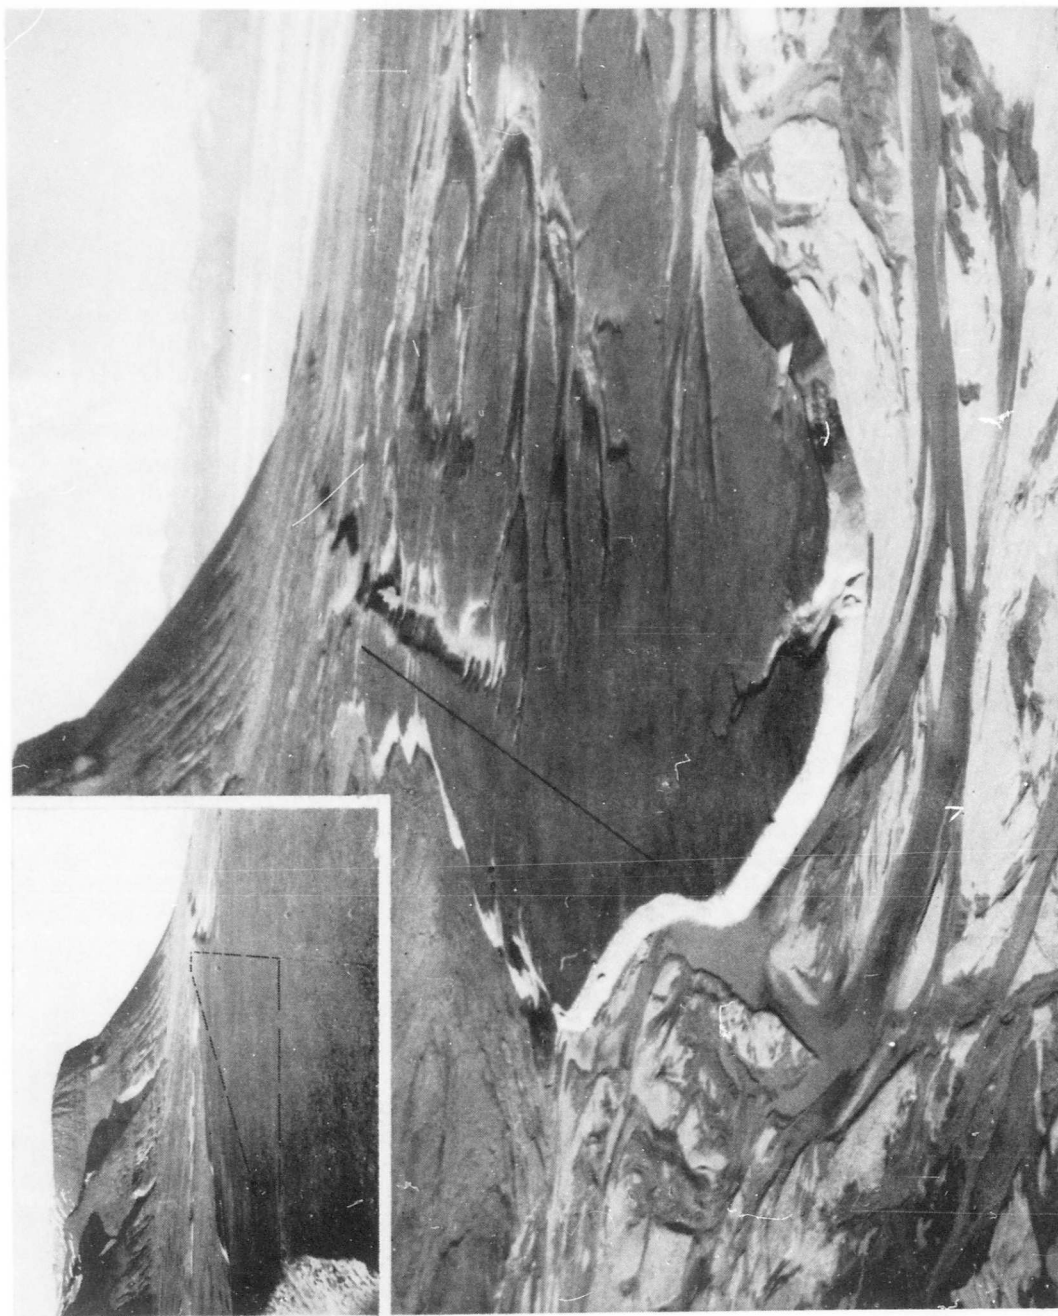
Photograph 5. Aerial views of the Carlsberg Fjord Site (#10), looking northward along a ridge of dissected valley fill, perhaps outwash gravel, located in valley on west side of Carlsberg Fjord. Centerline and outline of a potential 4000-foot runway are shown, oriented approximately N30° E. Date: 27 August 1959.

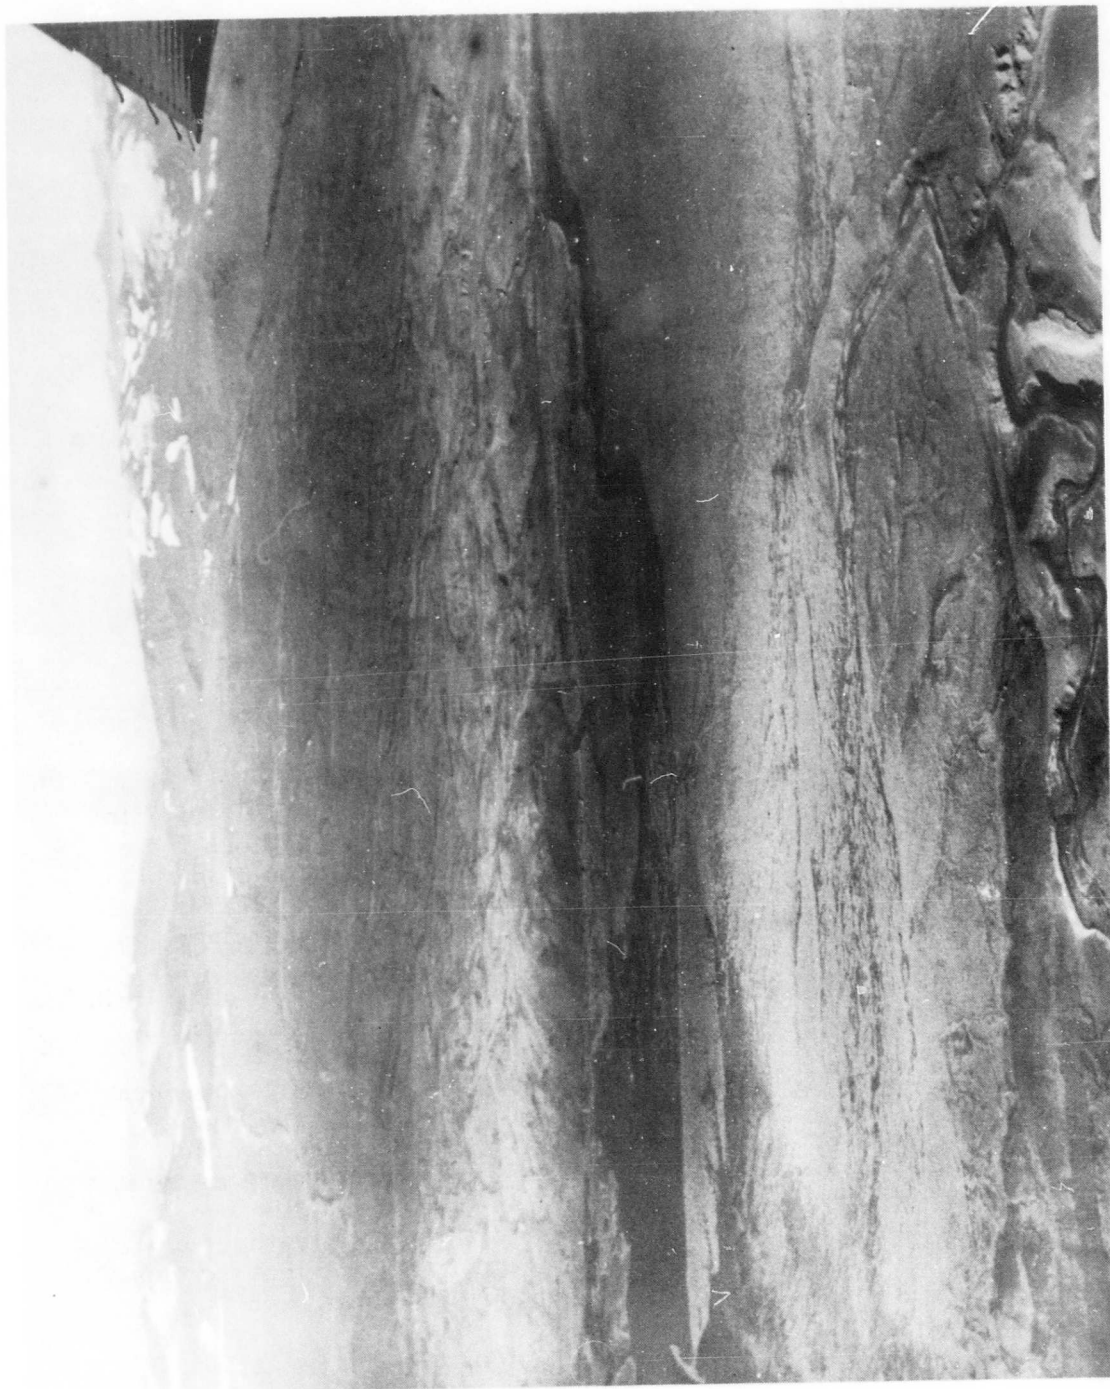
Photograph 7. View eastward across the broad lowland at the head of Loch Fyne. In the foreground is an emerged bottom-land that extends for a distance of several miles south of Loch Fyne, which can be seen on the left margin of the photograph. Elevation approximately 3000 feet. Date: 30 August 1959.

Broad extensive lowlands occupy the southeastern part of Hold With Hope and the area between MacKenzie Bugt and the heads of Loch Fyne and Moskusoksefjord. The lowland of southeastern Hold With Hope is known as Østersletten. Much of the lowland topography of this area is hummocky, characterized by scattered low hills and poorly drained boggy depressions. These areas are principally underlain by glacial moraine, consisting of an unconsolidated, unsorted mixture of silt, sand, and gravel, containing scattered cobbles and boulders. Areas of relatively flat-surfaced outwash and alluvium are also present. The highlands in this area, including those of Hold With Hope and eastern Gauss Halvø, are composed largely of basalt (of Tertiary age). The lower slopes of the basalt mountains are characterized by parallel bedrock terraces defended by successive flows of basalt. Terraces of this type are found along the west side of Hold With Hope, bordering the broad lowland at the head of Loch Fyne. One of the outstanding features of that lowland is an exceptionally flat, emerged bottom-land that extends for a distance of several miles south of Loch Fyne (Photograph 7).

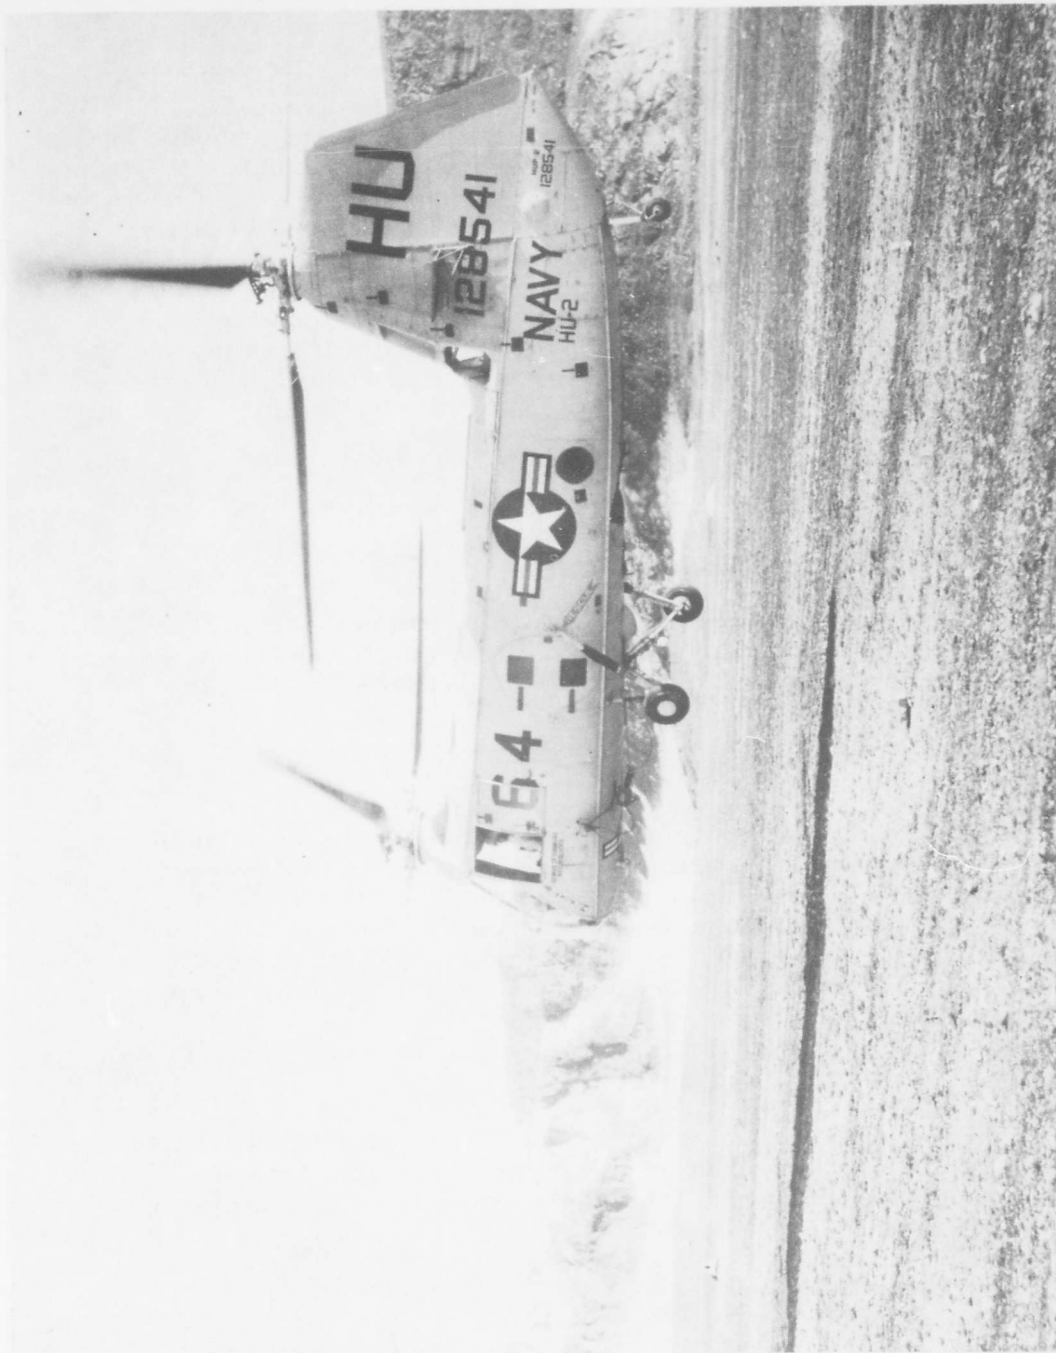
Photograph 8. HUP-2 helicopter at Hvalrosbugt Site. HUP-2 used for helicopter operations taking off from unprepared landing strip on outwash plain at Hvalrosbugt, one mile north of the village of Scoresbysund. Date: 18 August 1959.

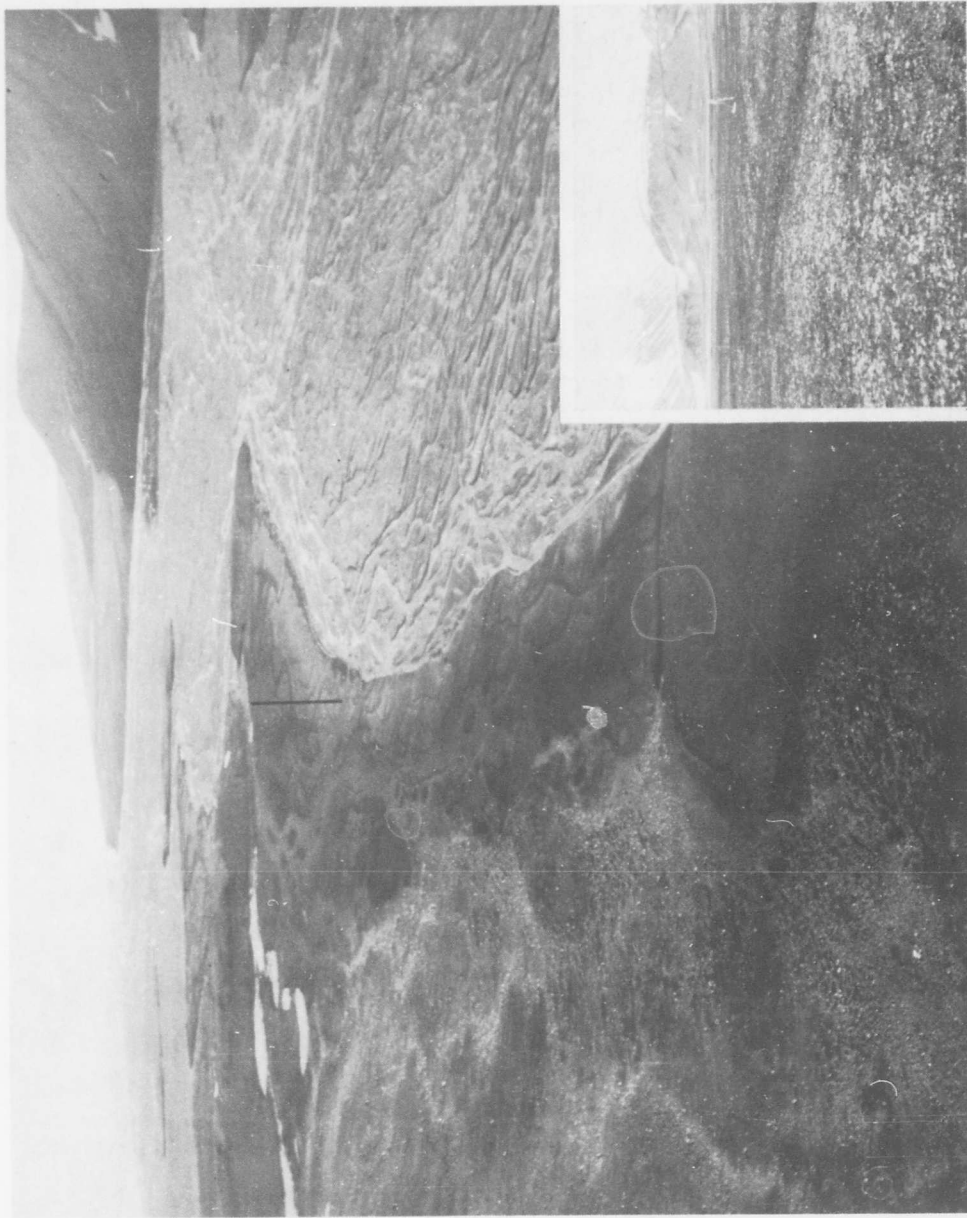
Photograph 9. Ground and aerial views of the Jaettedal airstrip (Site #2). Aerial view is southwest toward Rosenvinge Bugt, showing location of centerline. Ground view is along the centerline from near the south end. The range poles mark the centerline; the flags mark the edges. The site is smooth and free of microrelief features with the exception of shallow swales, such as the one shown in the foreground, about 6 inches lower than the predominant level of the landing strip. However these are nearly parallel to the runway and would not impede landings and takeoffs. View northeast. Date: 21 August 1959.

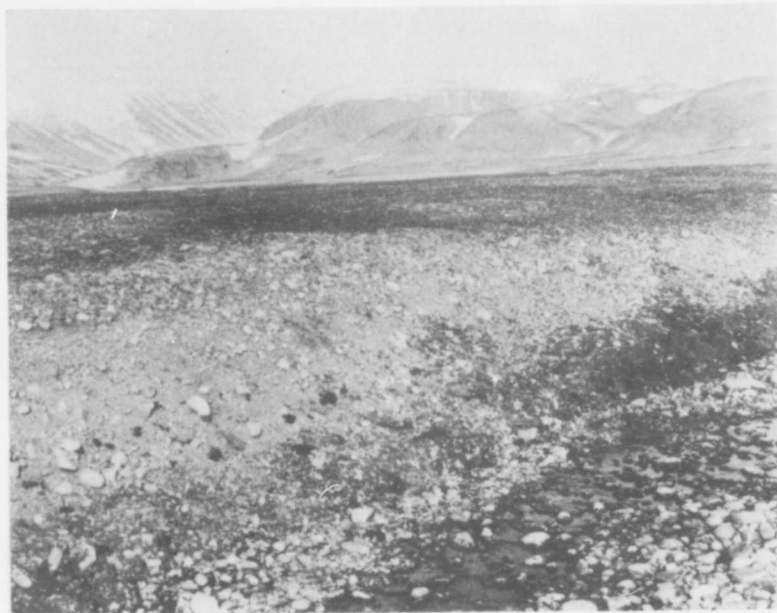
Photograph 10. Terrace of outwash gravel and sand on which the Jaettedal airstrip is situated, about 6 feet above the flood plain of the Jaette. Abundant sand and gravel can be obtained from the flood plain or from the edge of the terrace. A test landing by a Dornier (DO-27) demonstrated that the natural surface will safely support that aircraft and will probably support landings by an Otter (DHC-3) or a Caribou (DHC-4). View northeast. Date: 21 August 1959.

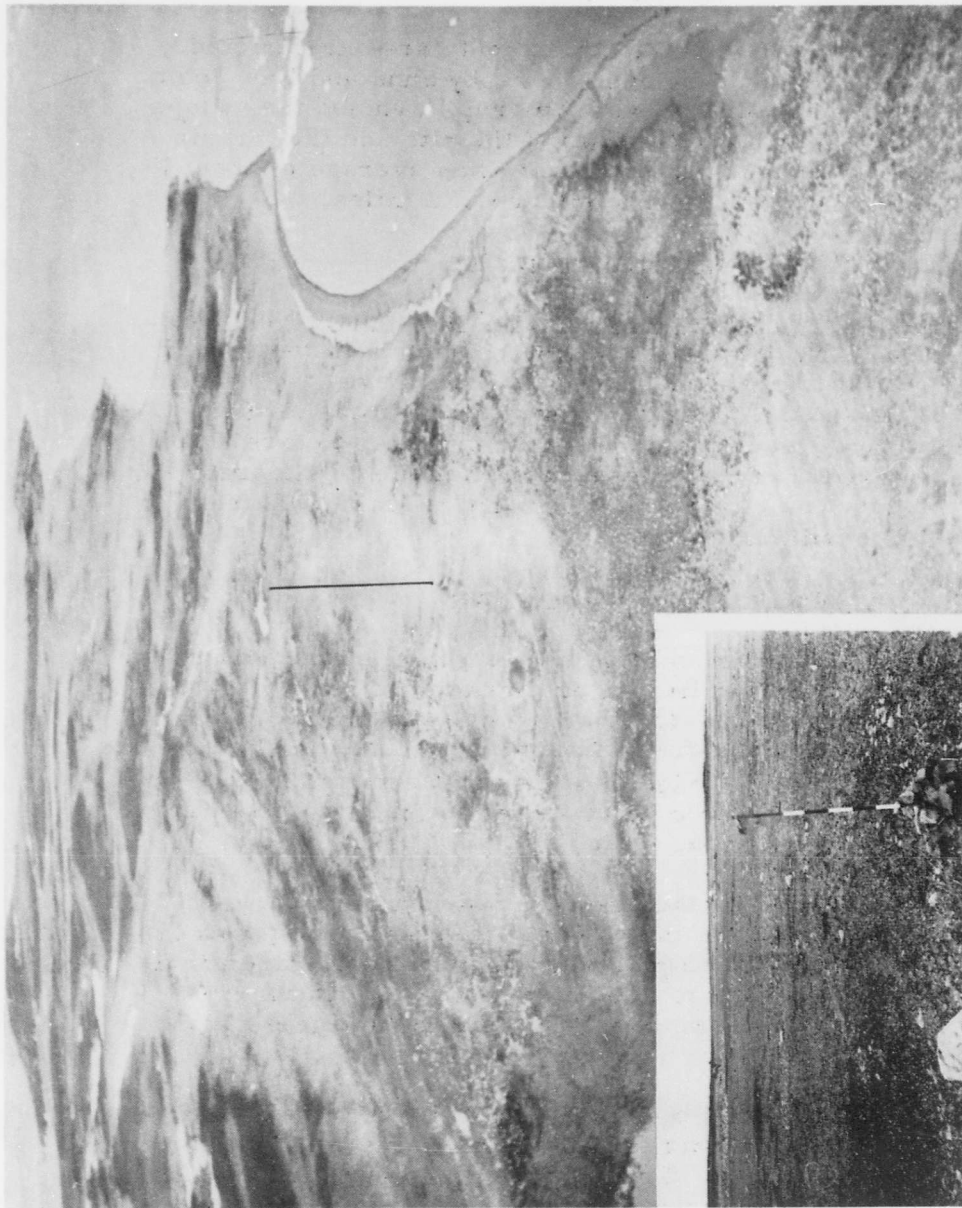
Photograph 11. Ground and aerial views of the Kap Tobin Site (#11). Aerial view is southward toward Kap Tobin (center background), showing location of centerline. Ground view is along the centerline from the north end. The range pole marks the centerline of the strip. If it is essential to have a short landing strip near Kap Tobin, this is considered to be the best available site for constructing a 710-foot x 100-foot strip with a minimum of effort. The site is at present unsuitable for aircraft landings because of scattered large cobbles and boulders. View south. Date: 17 August 1959.

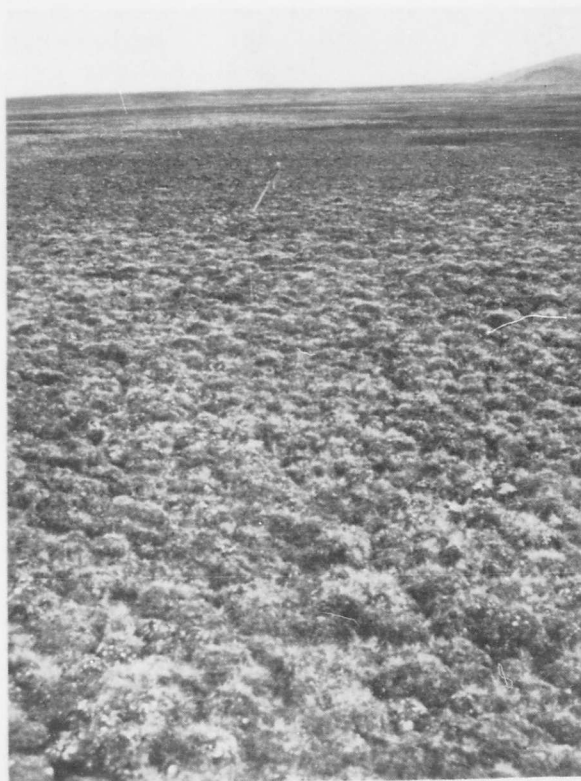
Photograph 12. Typical surface near center of 11,500-foot runway site near Storelv, showing typical size of hummocks that occur from 4000 to about 6500 feet from the northwest end of the strip. Typical dimensions of the hummocks shown are 6 to 12 inches in diameter and 2 to 6 inches high. Hummocks of this size would probably permit safe landings and takeoffs by planes of the C-130 type. View is S15°E, along the center-line, near its midpoint. Date: 1 September 1959.

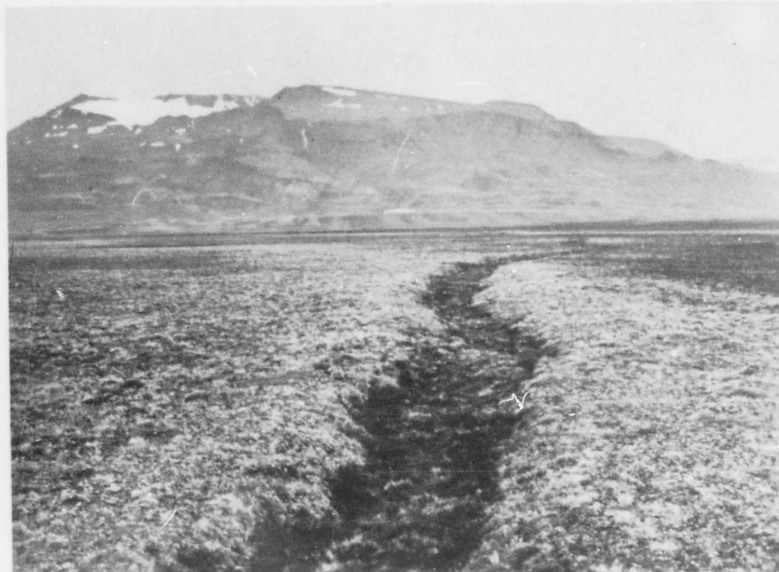
Photograph 13.
Frost crack that crosses center of surveyed runway site at Storely.

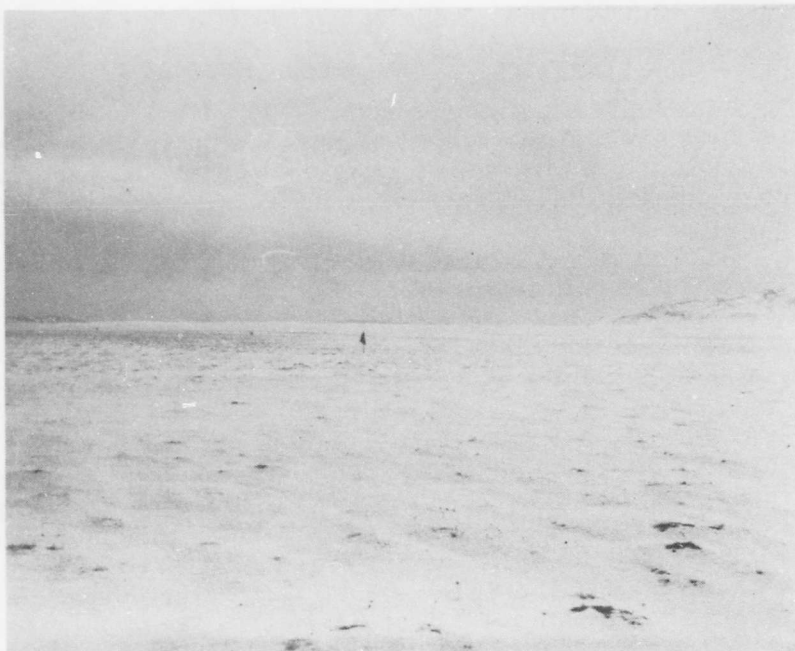
Photograph 14.
View along the surveyed runway at Storely after snowfall. View is from the northwest corner, looking southeast. The flag in the foreground marks the corner of the strip, which is 200 feet wide. The centerline extends into the background and to the right, marked by flags spaced 500 feet apart, at least two of which are visible near the corner-marker. Date: 5 September 1959.
