SNAP 2/10A GROUND TEST PROGRAM, PHASE I

TECHNICAL DOCUMENTARY REPORT NUMBER AFSWC-TDR-62-144

The purpose of the SNAP 2/10A Reactor Ground Test Program was to determine the structural behavior of the SNAP 2/10A reactor assemblies when subjected to thermochemical, fire, explosive and impact environments.

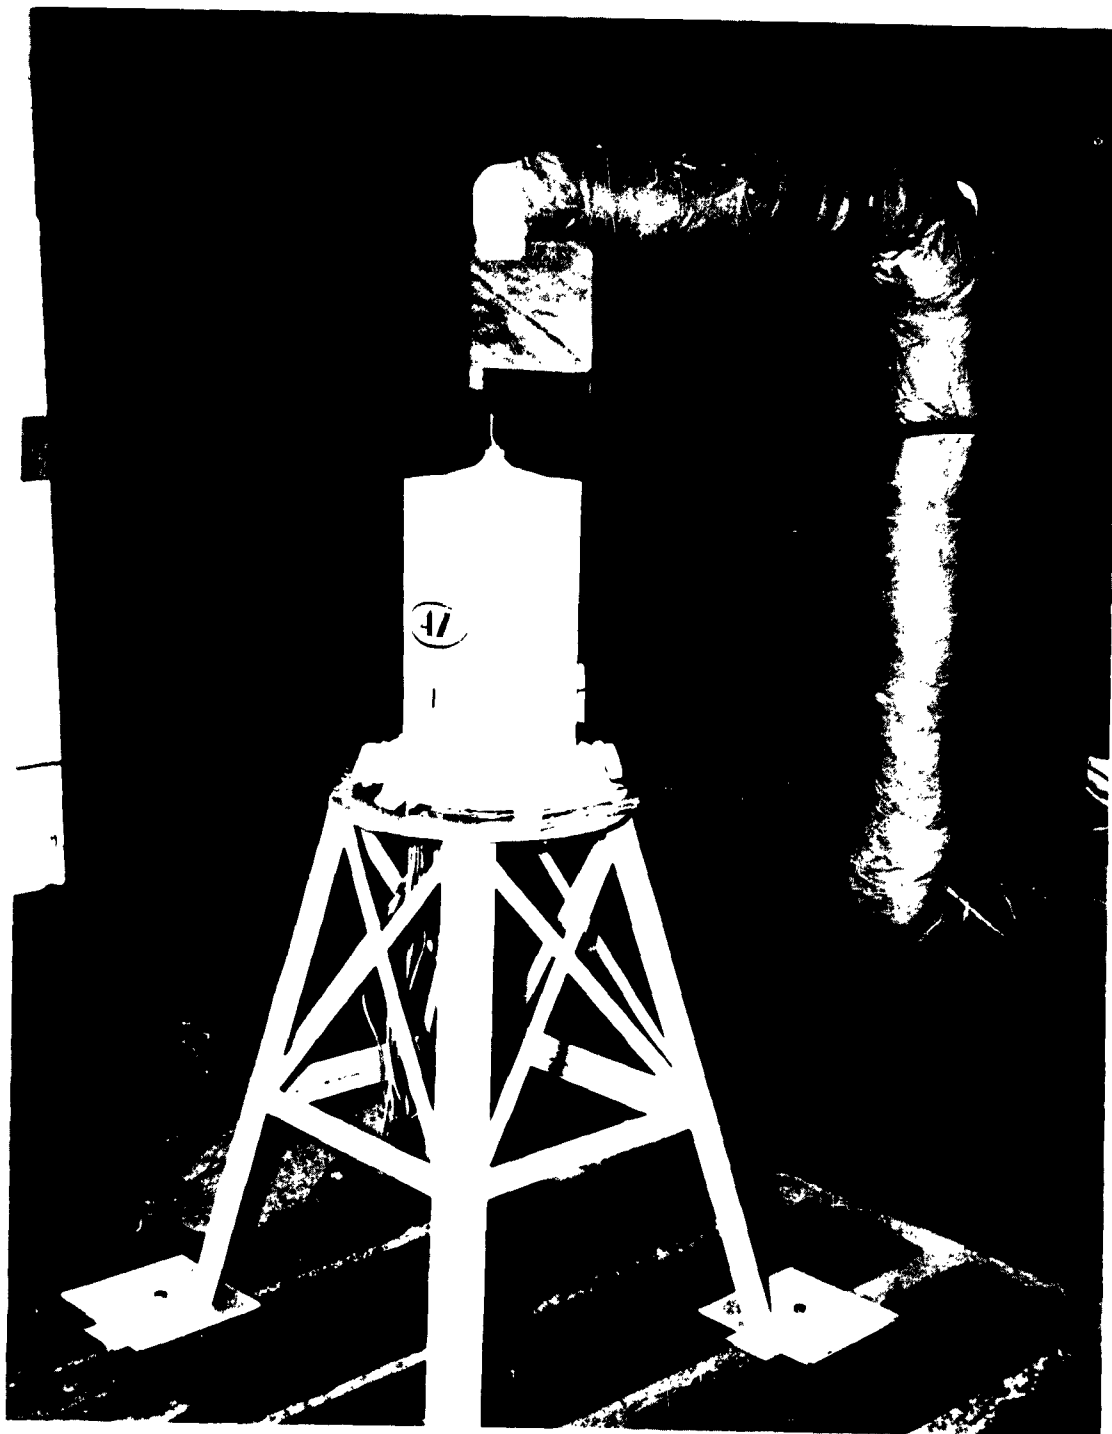
Figure 2. LOX Spray test setup

The reactor assembly, consisting of the reactor vessel, was mounted upright on a metal test stand (figure 2) which was located at the Holloman Horizontal Test Stand Complex. At 1300 hours, 9 May 1962, the reactor vessel was exposed to a spray of LOX for approximately 40 seconds.

The test item was exposed to a deluge rather than an evenly distributed spray of LOX for approximately 40 seconds. All recorders and cameras operated satisfactorily. Visual examination of the test item after the test revealed that no external damage had occurred to the core vessel. Oscillograph data were of little value since the responses from the strain gages and thermocouples were small in value. This could be explained by either the short duration of the test and/or the insensitivity of the strain gages and thermocouples that were used. Even though there was a lack of

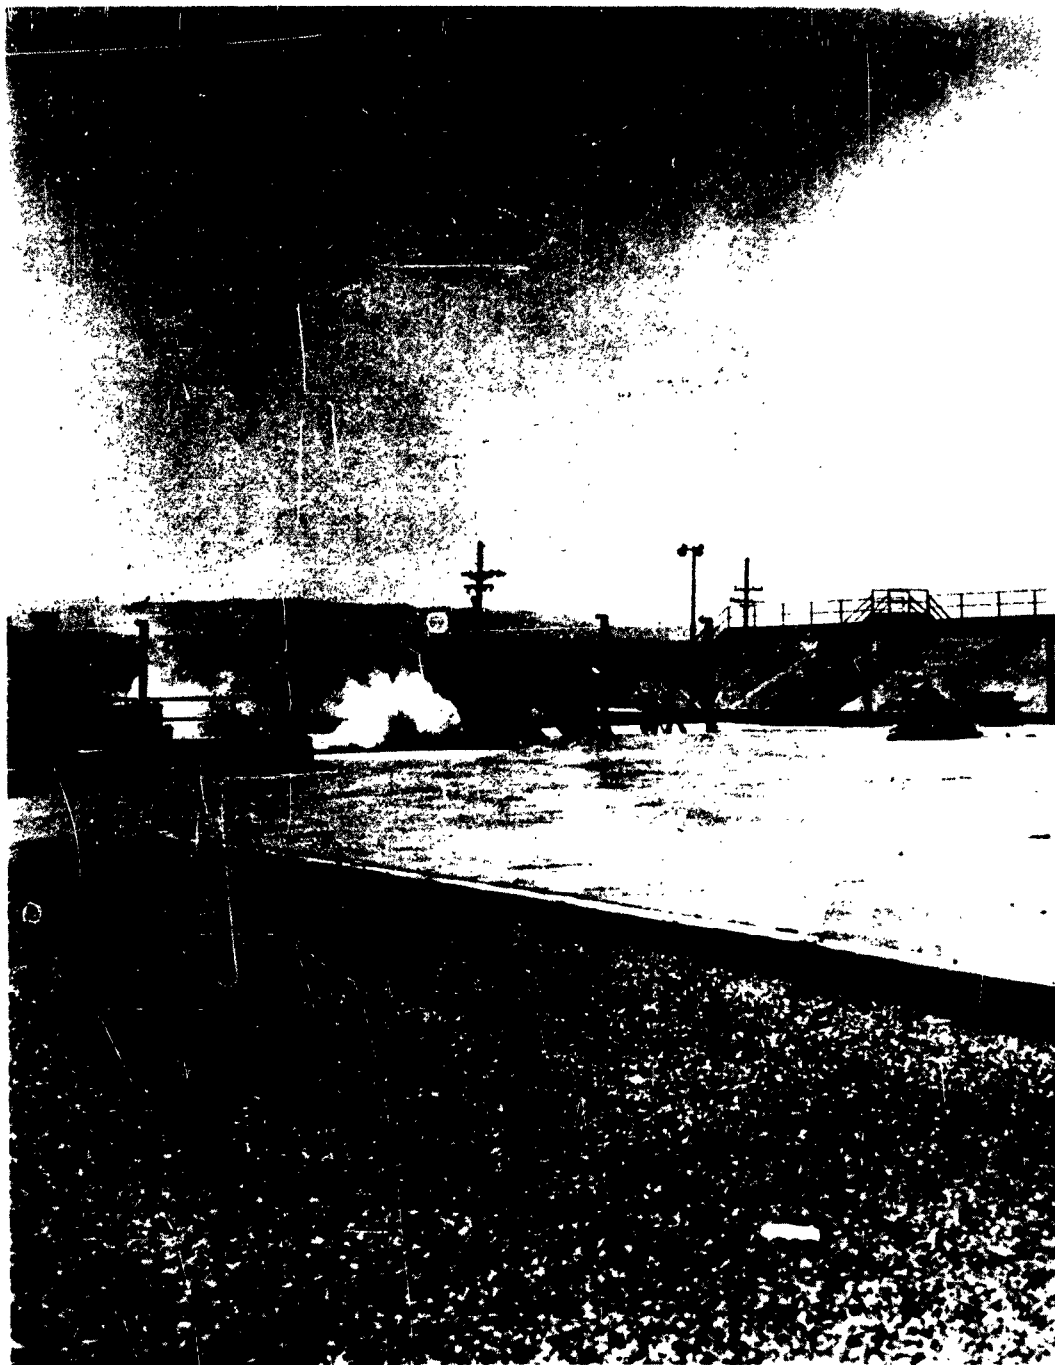
Figure 4. LOX-NaK test

Two seconds after the Squibs were fired to open the NaK lines, the LOX spray was initiated and was continued for approximately 40 seconds. Soon after the LOX spray was initiated, the NaK solidified, minimizing the initial reaction. Approximately 8 minutes after the LOX spray was terminated, the NaK began to liquify and flow from the core vessel. The NaK then reacted violently with water standing under the test stand (see figure 4).

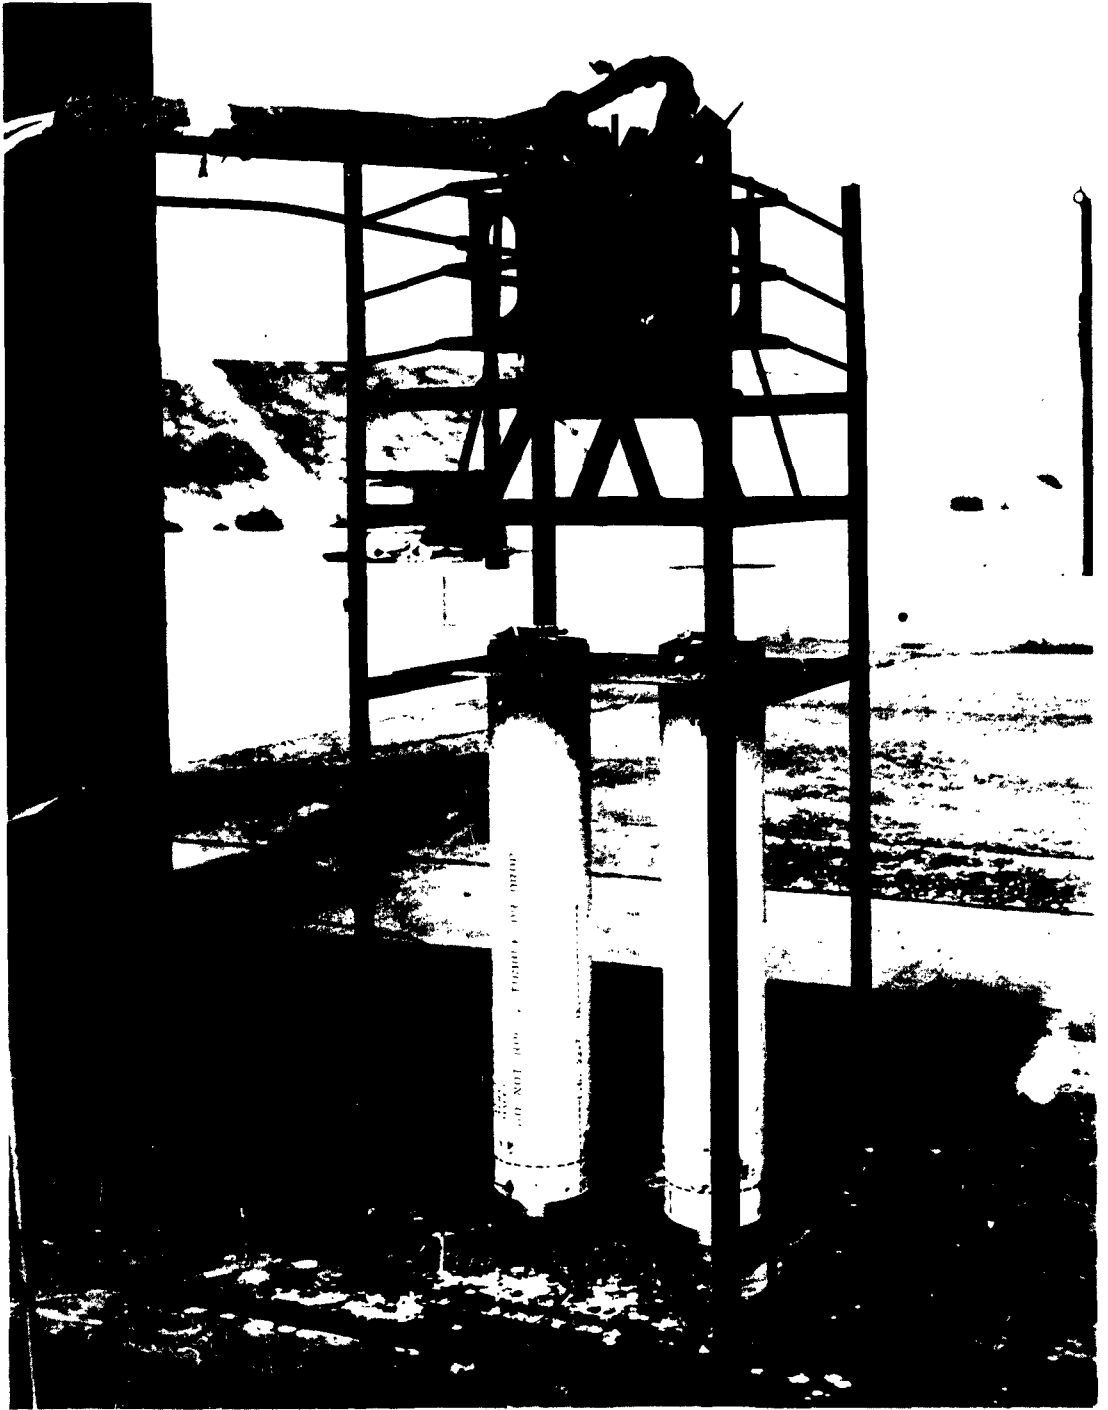
Figure 11. Reactor assembly -- post test

Upon completion of the 15-minute "cooking" period, the gauges were shut off and the test item inspected. The reflector retaining band had parted during the booster flame blast, but the reflector assembly was still in its original position; the reflector separation mechanism had been "locked" in place by the thermal expansion of two eye-bolts used for handling purposes. After the test item had cooled for approximately 20 minutes, the eye-bolts had contracted enough so that the reflector halves were released. Complete separation from the test item did not occur, since the reflector assembly was then retained by the three burner rings. Apparently, if the eye-bolts had been removed before the test, the reflector separation mechanism would have

functioned properly. The reactor vessel did not sustain any visual damage as a result of high temperatures (figure 11). Consequently, it appears from the preliminary analysis that the SNAP 2/10A core configuration would not be distorted sufficiently to prevent subsequent criticality.

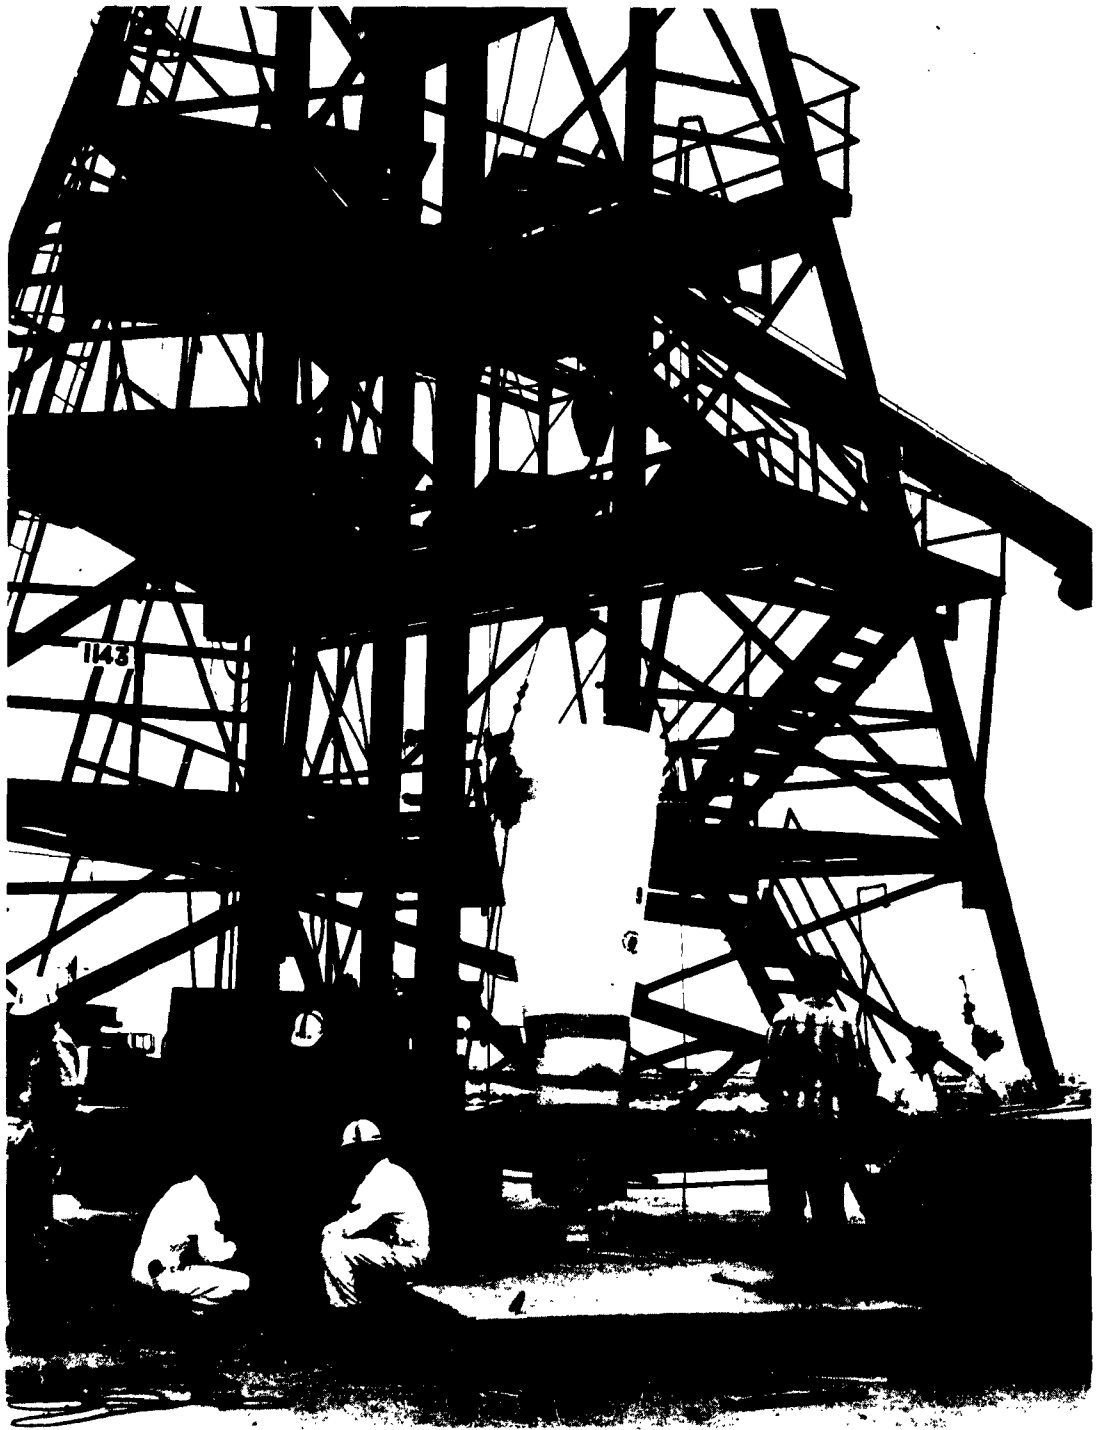
Figure 14. Low-velocity concrete impact: nose-on

The complete SNAP 2/10A system consisting of the reactor vessel with simulated fuel rods, reflector assembly, shield, and converter structure, was impacted on the pump end of the assembly at  $80 \pm 10$  fps (figure 14).

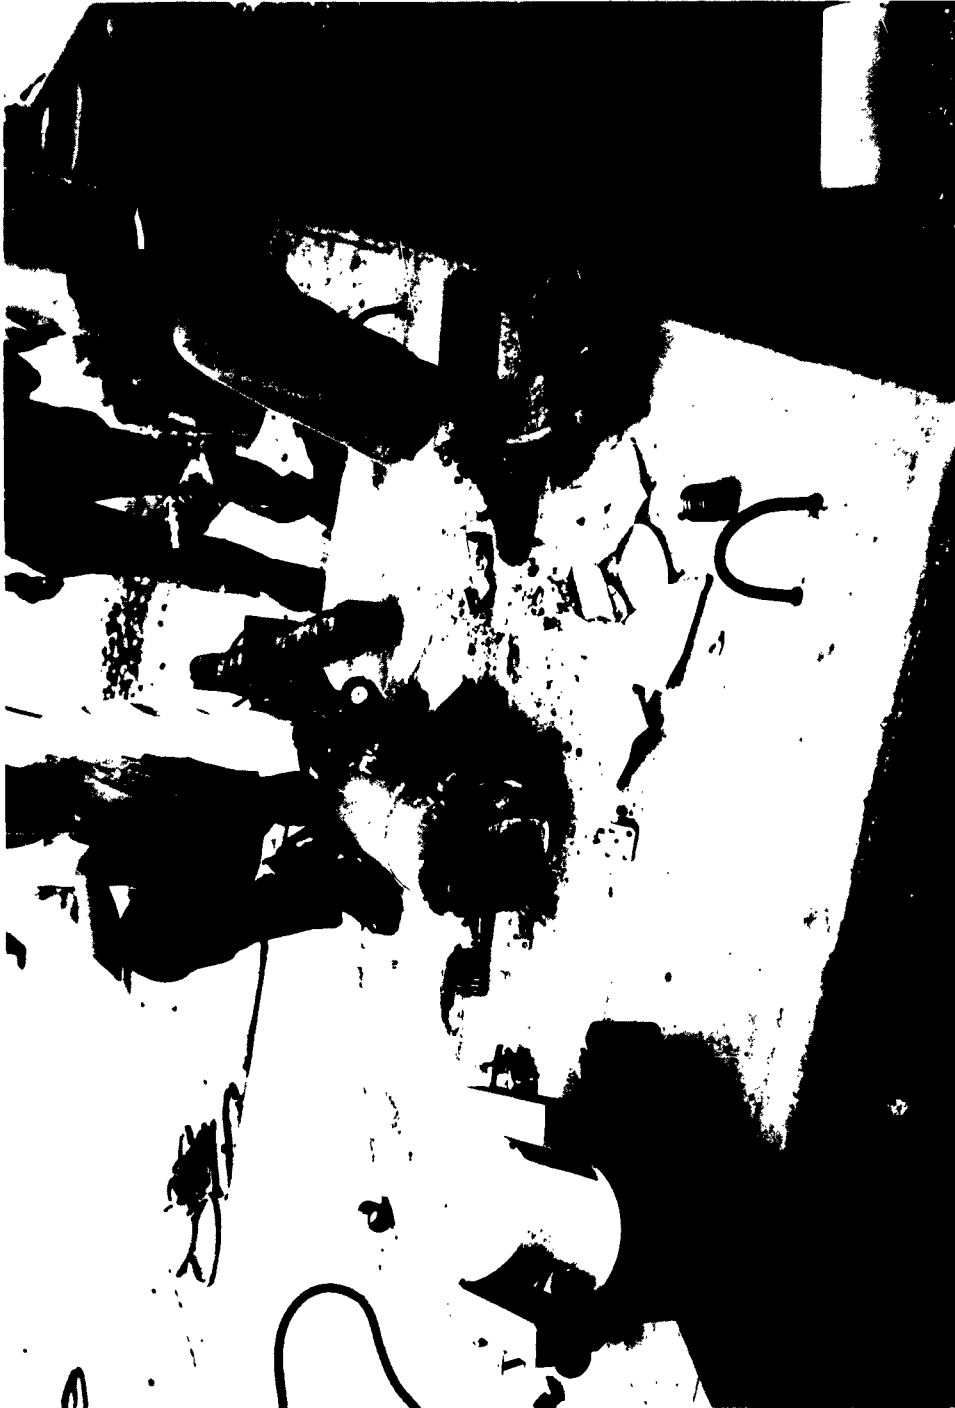
Figure 16. Reactor vessel -- post test

At impact, the pump assembly was driven back into the core vessel resulting in a cracked and dished core-can lid (figure 16). Motion of the rotatable reflector drums and concurrent motion of the reflector halves were not monitored. Preliminary post-test observations have indicated that the reactor reflector assembly did not attain a configuration capable of sustaining criticality; however, further analysis will be conducted by Atomics International to substantiate this fact. All cameras and recorders performed satisfactorily.

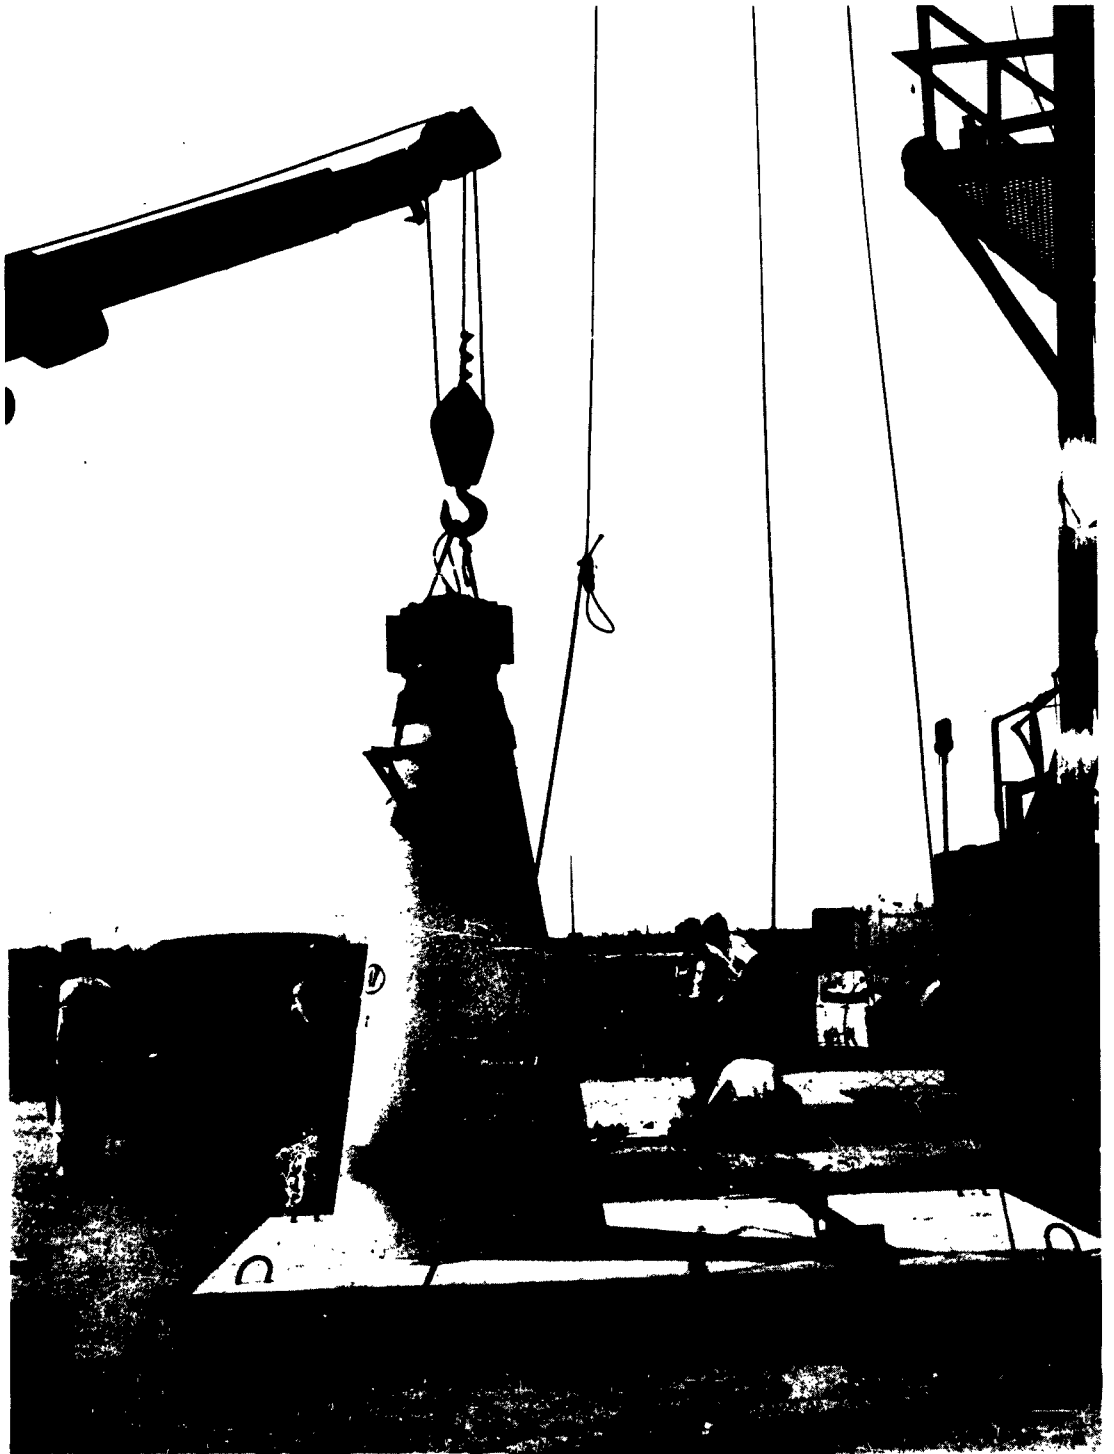
Figure 17. Low-velocity concrete impact: tail-on

The complete SNAP 2/10A system, consisting of the reactor vessel with simulated fuel rods, reflector assembly, shield, and converter structure, was impacted on the converter end of the assembly at  $80 \pm 10$  fps (figure 17). The test procedure was the same as in Test No. 6.

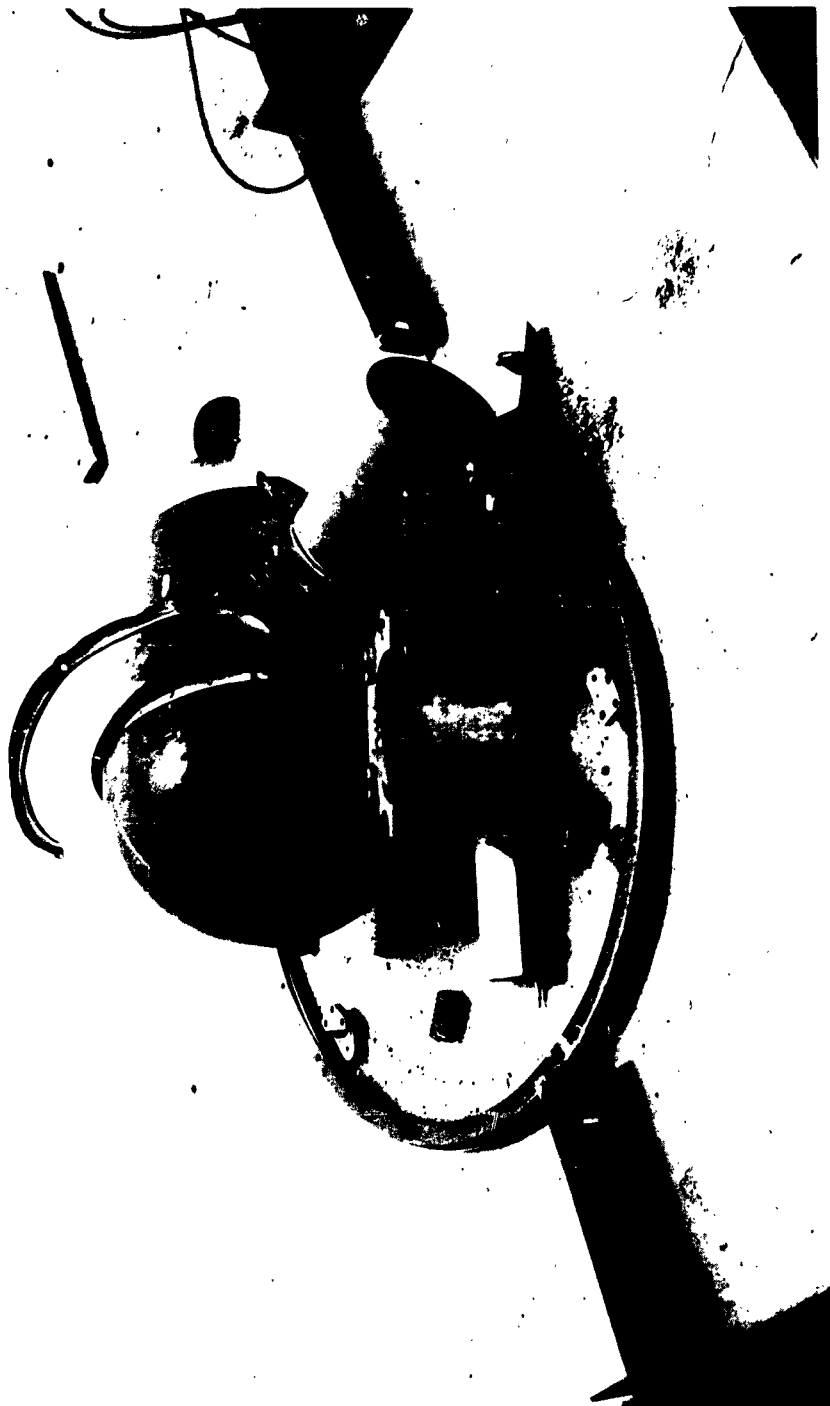
Figure 18. Reactor vessel -- post test

Figure 18 shows the reactor vessel, shield, and reflector assembly after the converter-radiator structure had been lifted from the concrete pad. Examination of the reactor vessel revealed no external damage. All cameras and recorders functioned. Further analysis will be made by Atomics International.

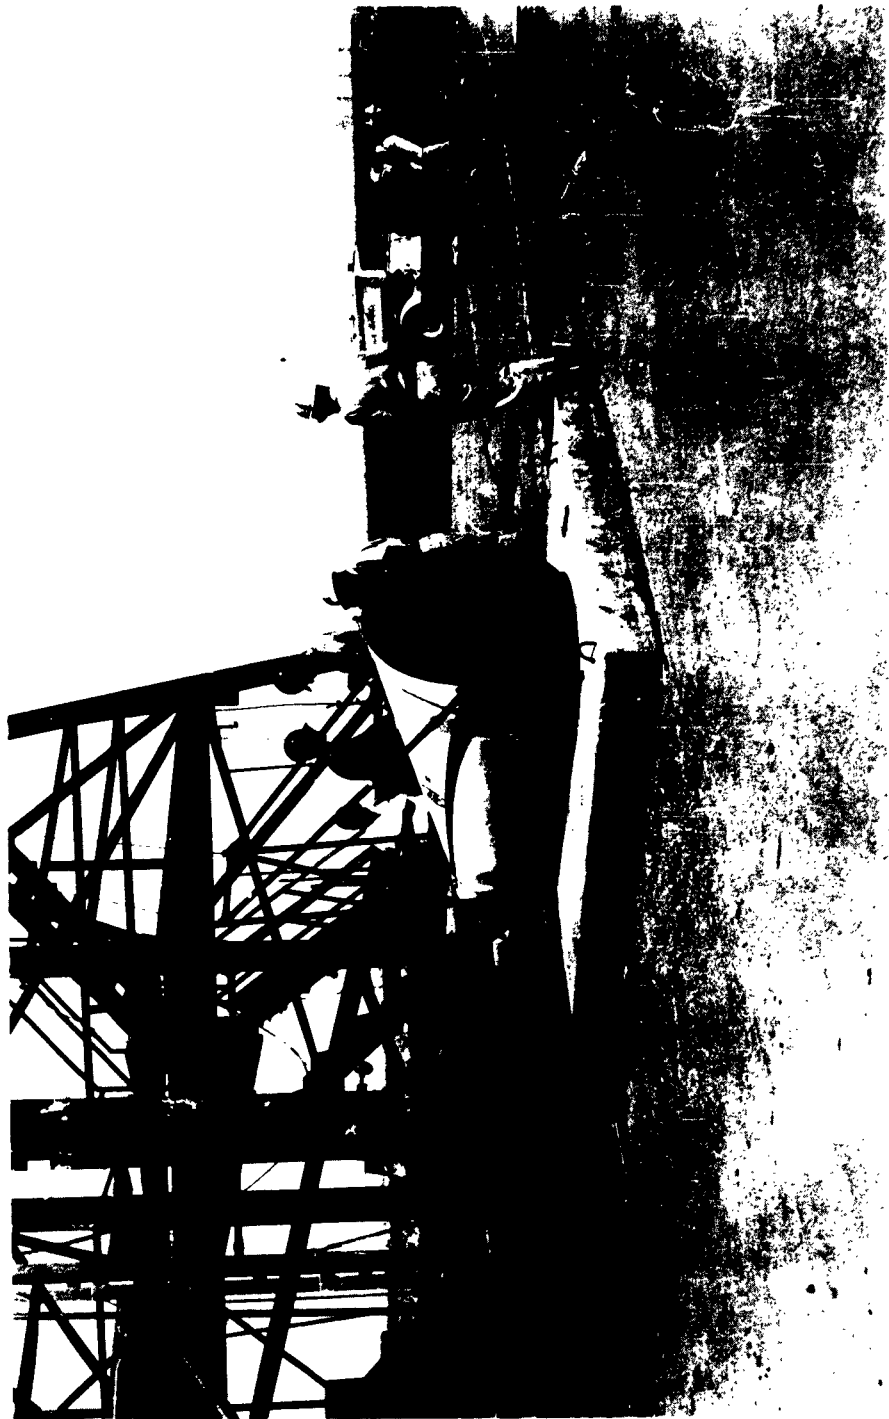
Figure 19. Low-velocity concrete impact: side-on

The complete SNAP 2/10A system consisting of the reactor vessel with simulated fuel rods, reflector assembly, shield, and converter-radiator structure was impacted side-on at  $80 \pm 10$  fps (figure 19). The test procedure was the same as in Test No. 6.

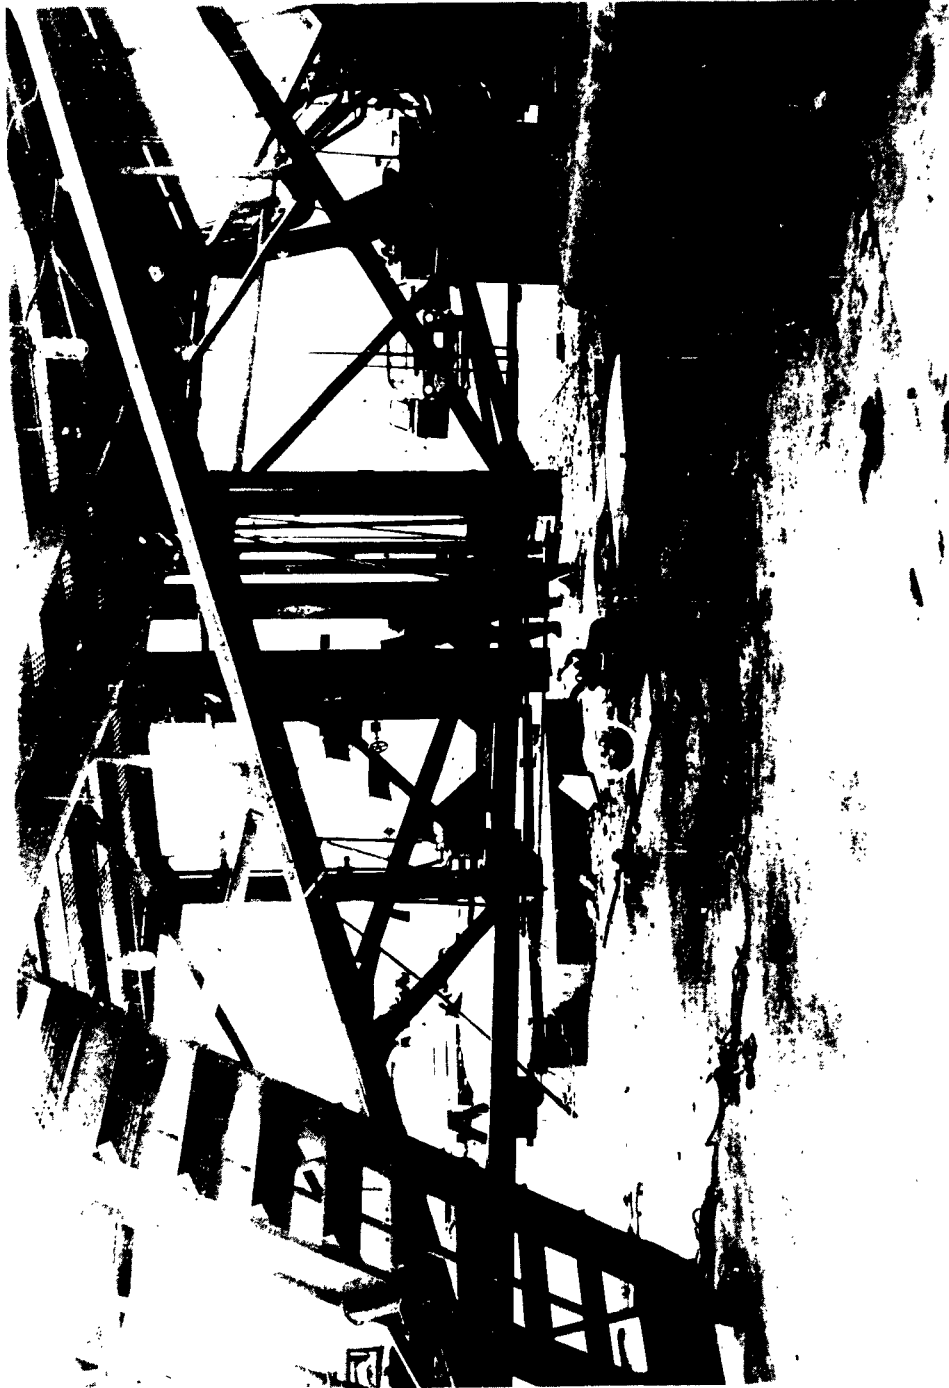
Figure 20. Reactor vessel -- post test. Circle shows reflector half with control drum.

At impact, the reactor vessel broke loose from its converter structure mountings (figure 20). Post-test examination of the reactor vessel showed no external damage. Located to the left of the reactor vessel is a portion of one of the reflector halves with rotatable control drum which had rotated to the "in" position. (See circled portion of photograph.)

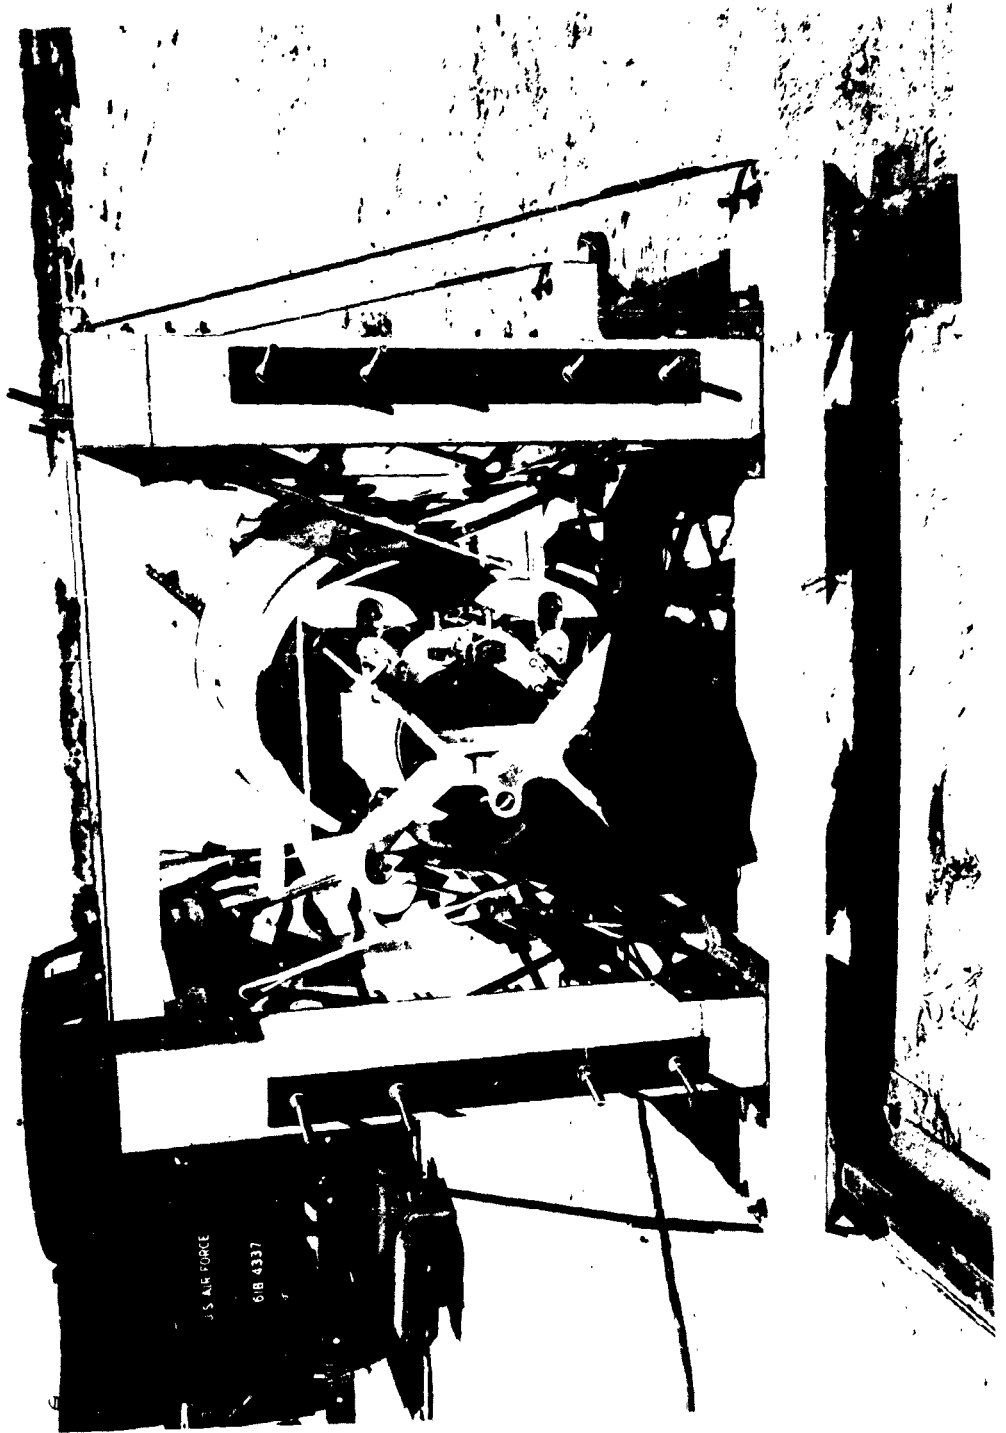
Figure 37. Sled-mounted test item -- fourth water impact test

The reactor assembly, consisting of the reactor vessel, reflector assembly, and shield with a portion of the radiator, was to be impacted head-on into an expendable water tank at a velocity of  $750 \pm 50$  fps (see figures 36, 37, 38, 39). Twelve HVAR boosters were used for propulsion and were staged 2 - 4 - 6. The sled-run distance to impact was 700 feet. Firing time was approximately 1400 hours on 10 October 1962.
