**BORG-WARNER CORPORATION**  
**INGERSOLL KALAMAZOO DIVISION**  
1810 North Pitcher Street, Kalamazoo, Michigan

ADHESIVE BONDING OF END CLOSURES  
FOR HIGH STRENGTH AND RELIABILITY  
IN ROCKET MOTOR CASES

Quarterly Report No. 3  
Contract NOrd 15719 Control 2937-62  
October 1, 1962 through March 30, 1963

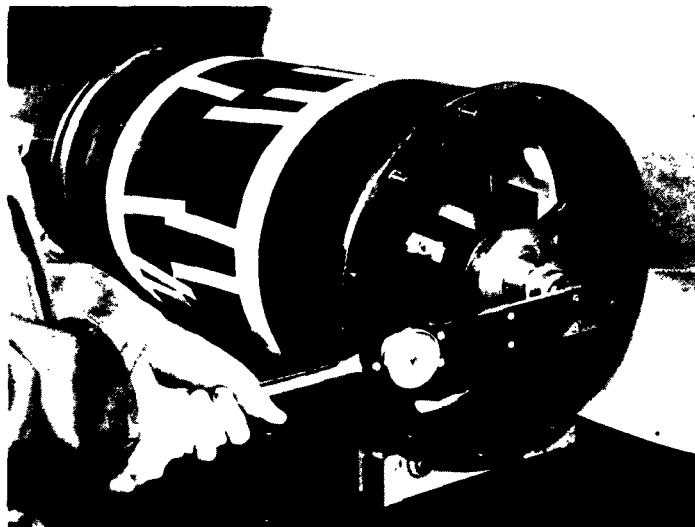
Figure 11. The End Rings Were Drawn onto the Tubular Section Using the Threaded Rod and End Plate Curing Fixture and Wrench.

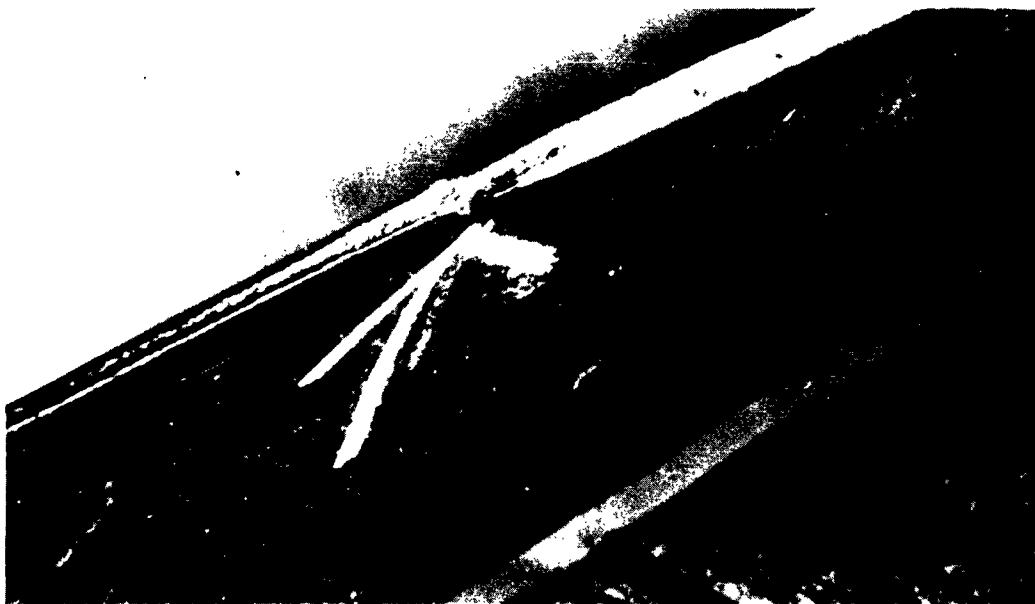
Figure 20. Super Tricent Case #3  
Plain stress originates from a  
crack at the inner wall surface
