**DEVELOPMENT OF GAS-ENTRAINED  
POWDER LUBRICANTS FOR HIGH SPEED-AND  
HIGH-TEMPERATURE OPERATION OF SPUR GEARS**

Technical Report AFAPL-TR-65-24  
May 1965

Air Force Aero Propulsion Laboratory  
Research and Technology Division  
Air Force Systems Command  
Wright-Patterson Air Force Base, Ohio

(Prepared under Contract No. AF33(657)-8625  
By the Stratos Division of the Fairchild  
Hiller Corporation, Bay Shore, New York;  
S. Wallerstein, Author)

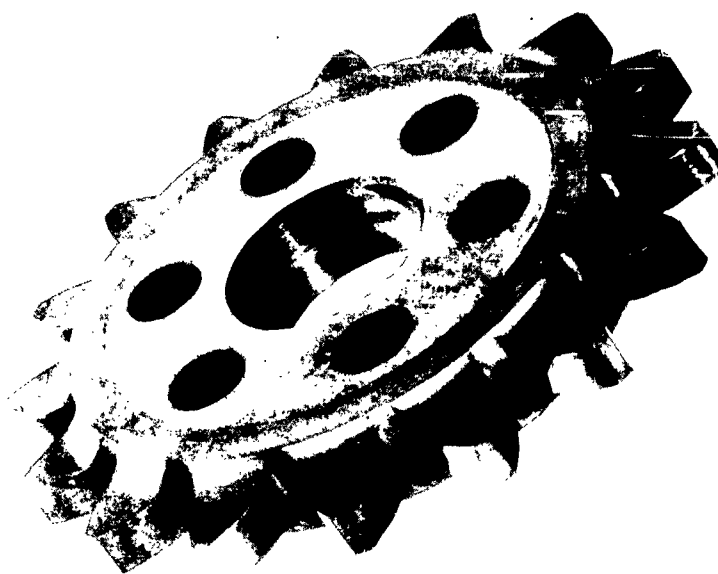
Figure 16. Sixteen-Tooth Test Gear Used in G-114

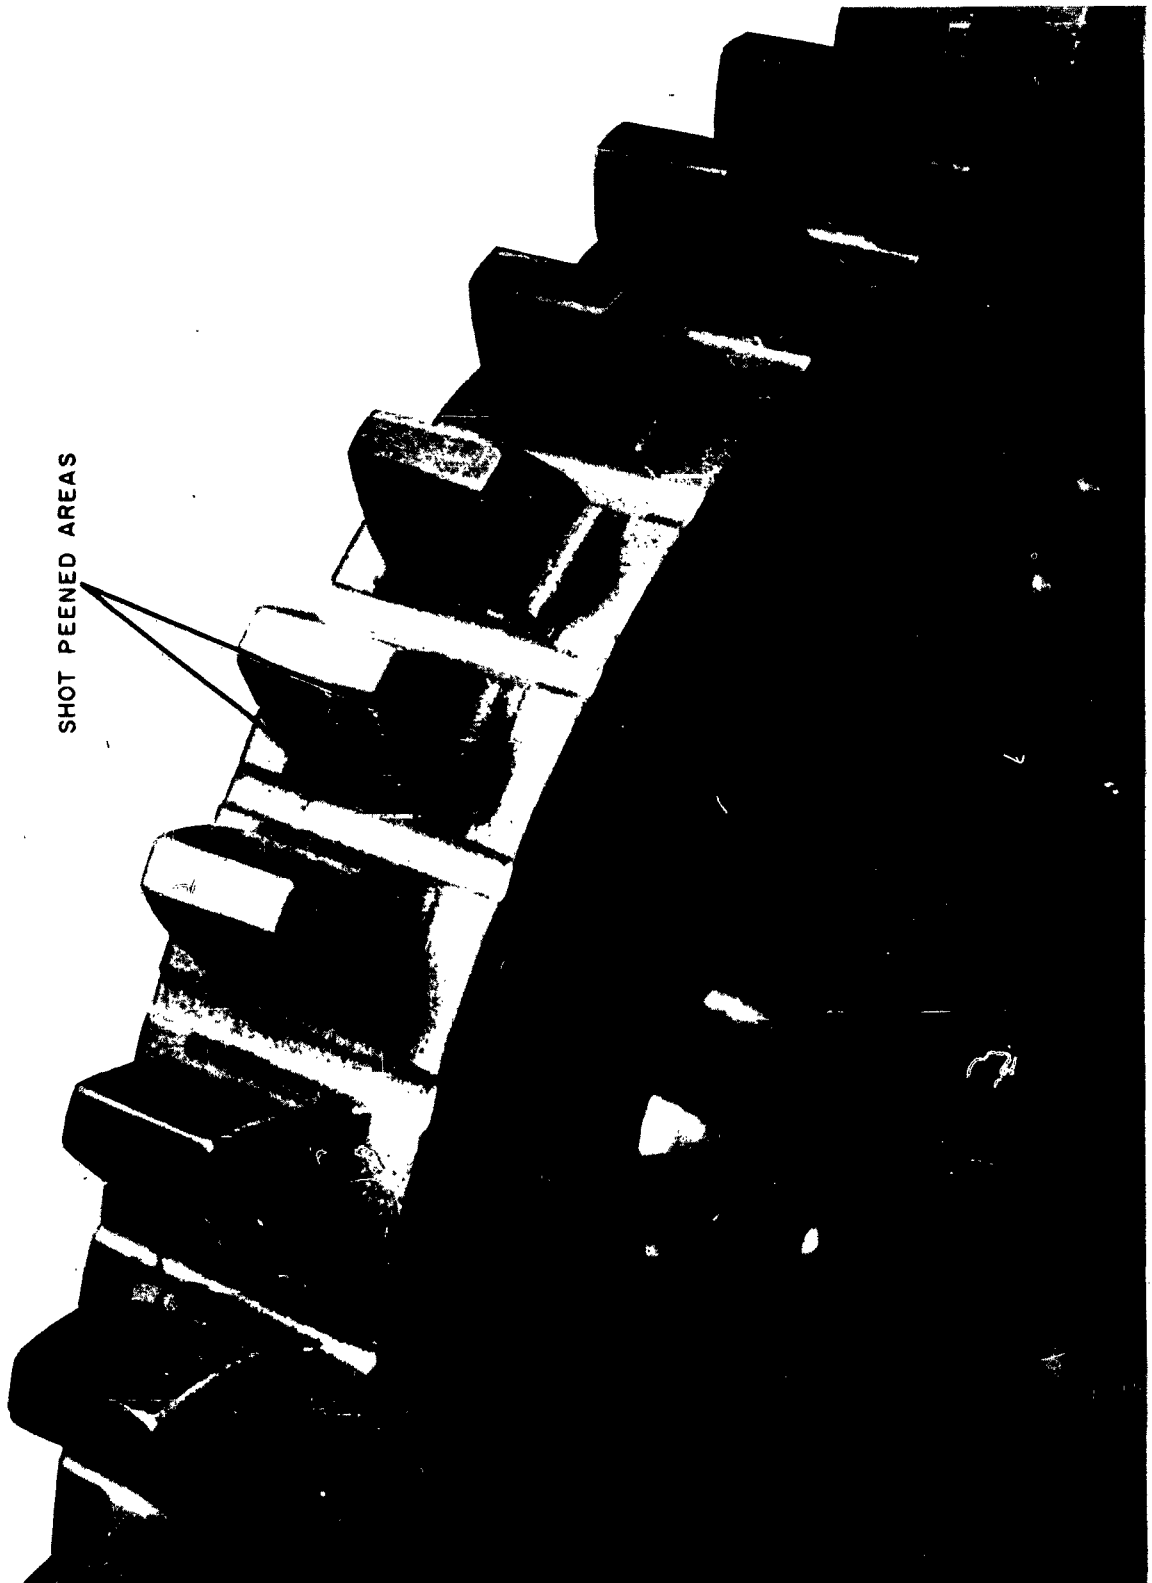
Figure 28. Shot-Peened Gear
