FINAL REPORT
DEMONSTRATION OF 156 INCH MOTOR WITH
SEGMENTED FIBERGLASS CASE AND ABLATIVE NOZZLE

VOLUME I--MOTOR DESIGN AND FABRICATION (U)

CONTRACT AF 04(611)-11603 ✓

THIOKOL CHEMICAL CORPORATION
WASATCH DIVISION
Brigham City, Utah

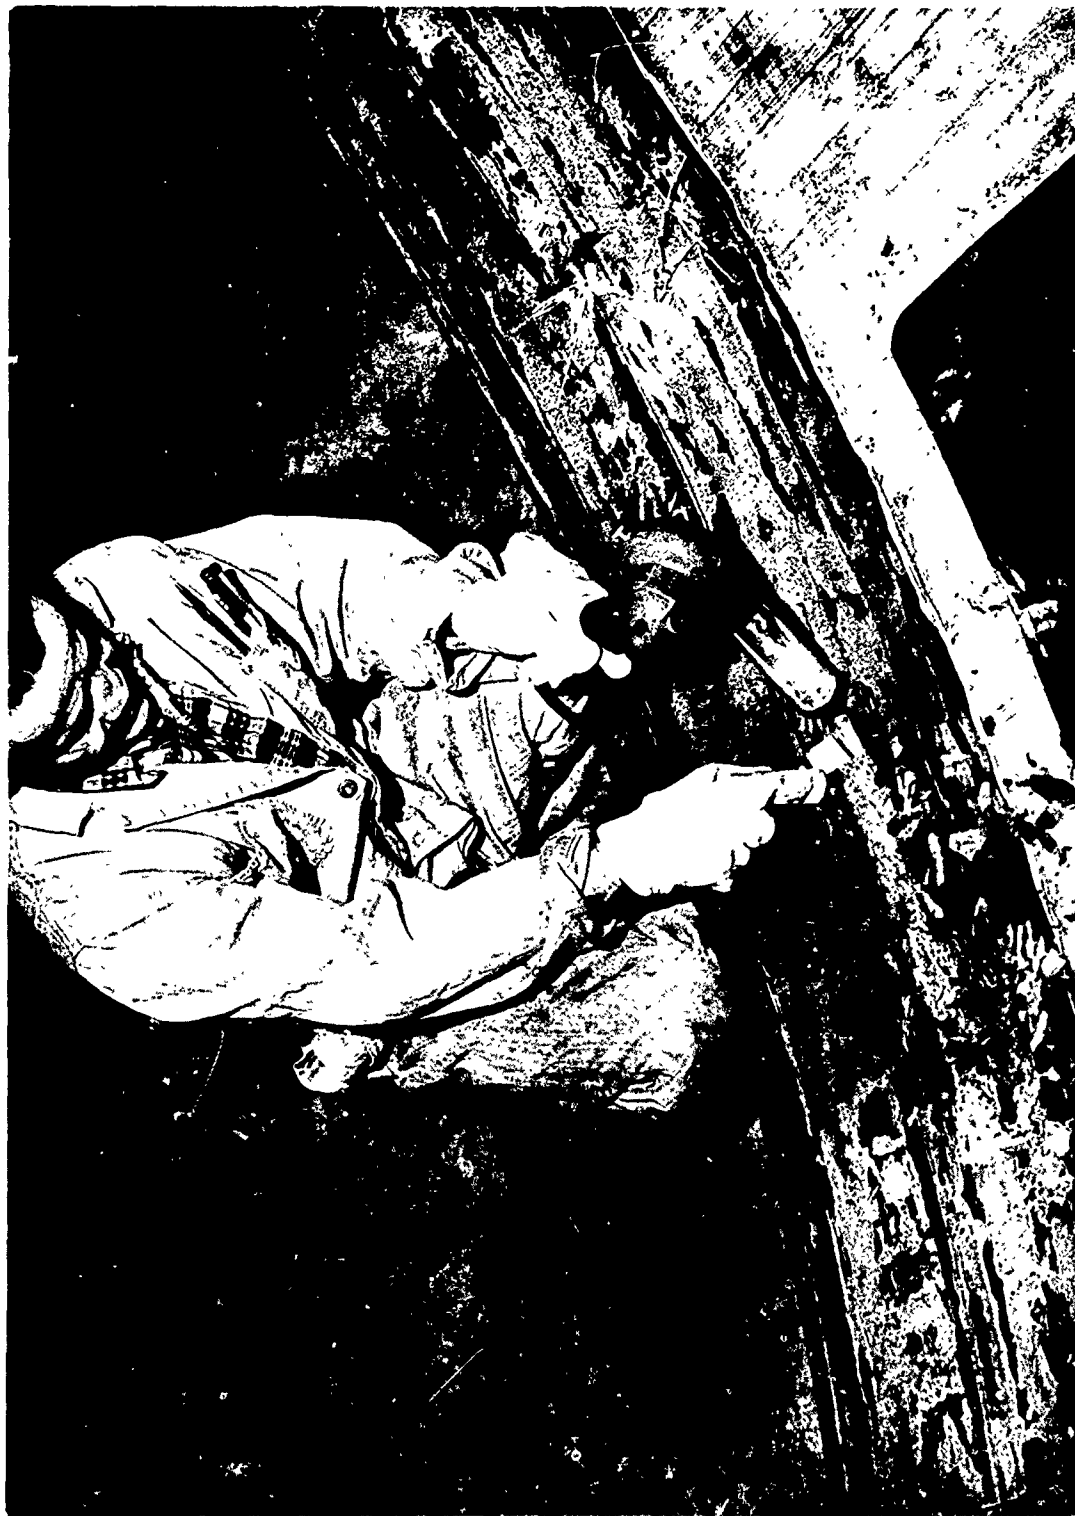
(U) Figure 14. Removal of Buna-N Strips from Joint Areas

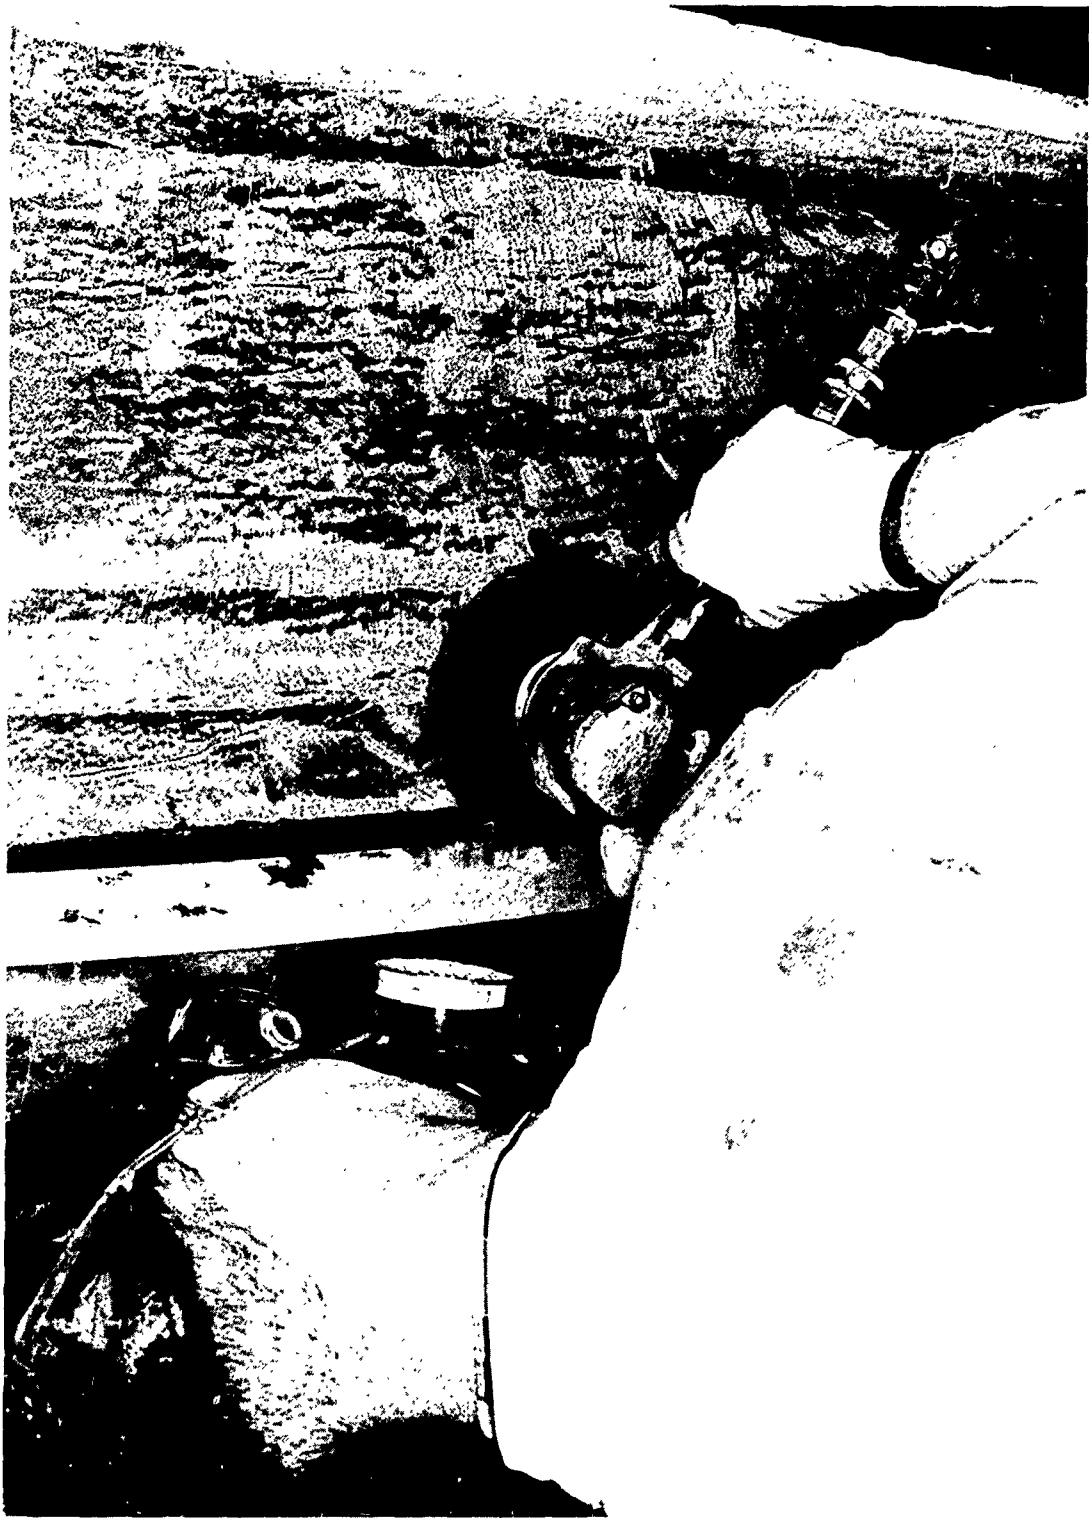
(U) Figure 26. Sanding of Case

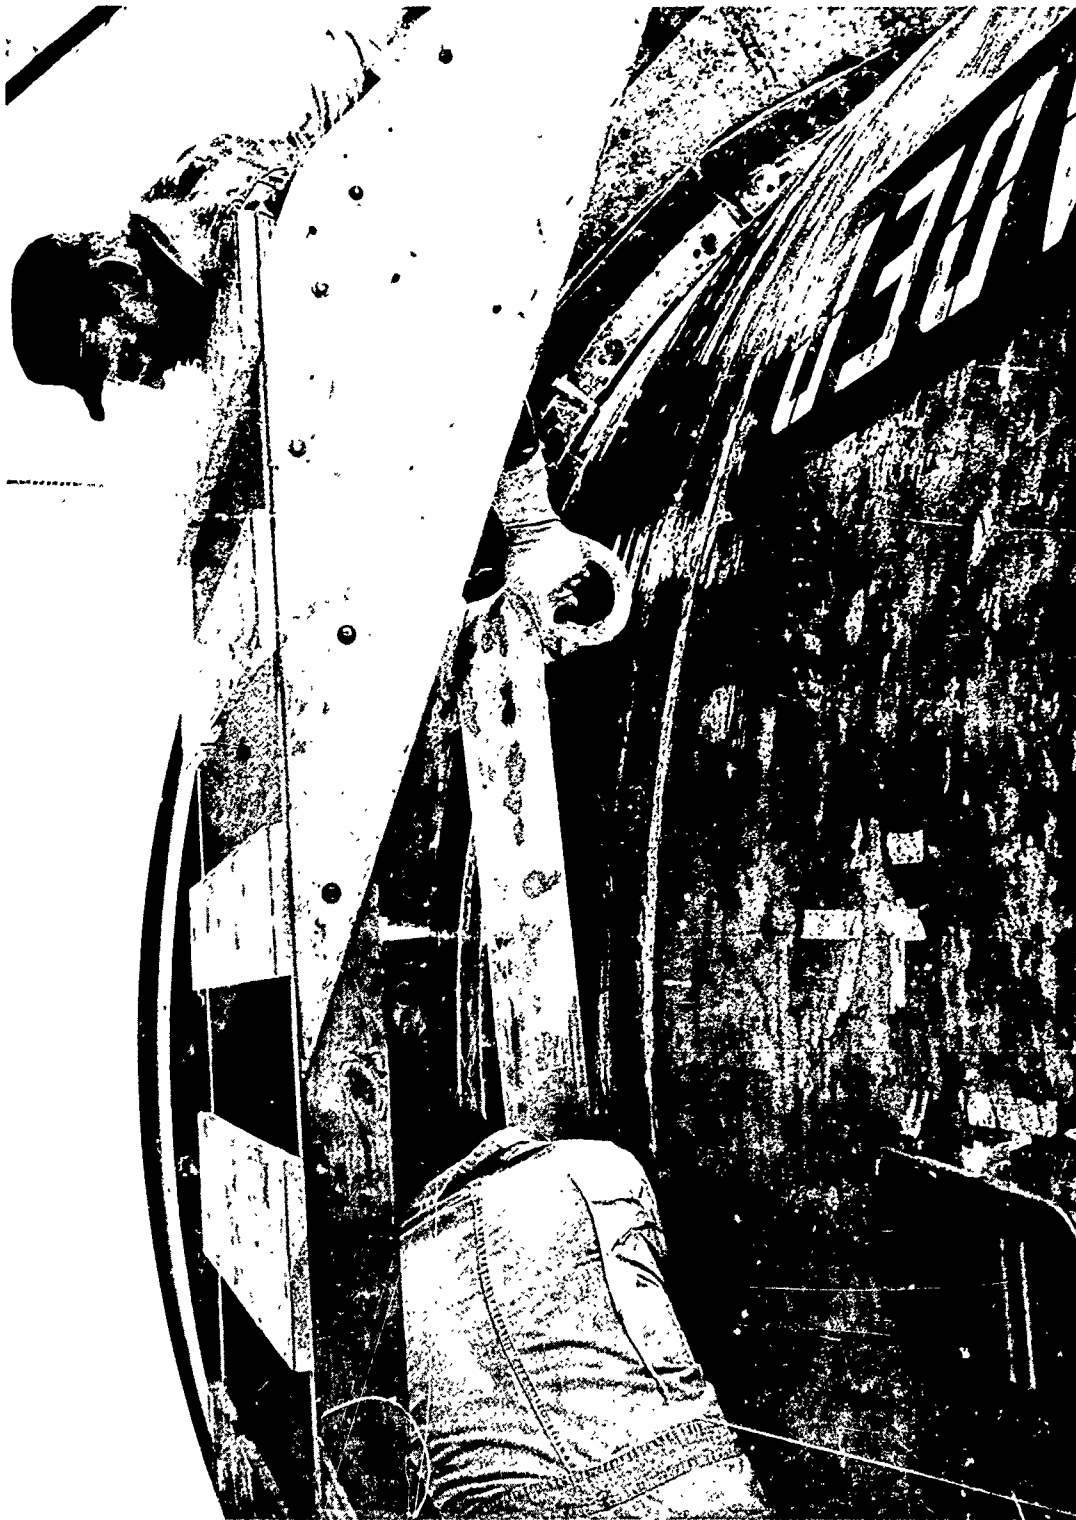
(U) Figure 27. Wrapping of Glass Cloth

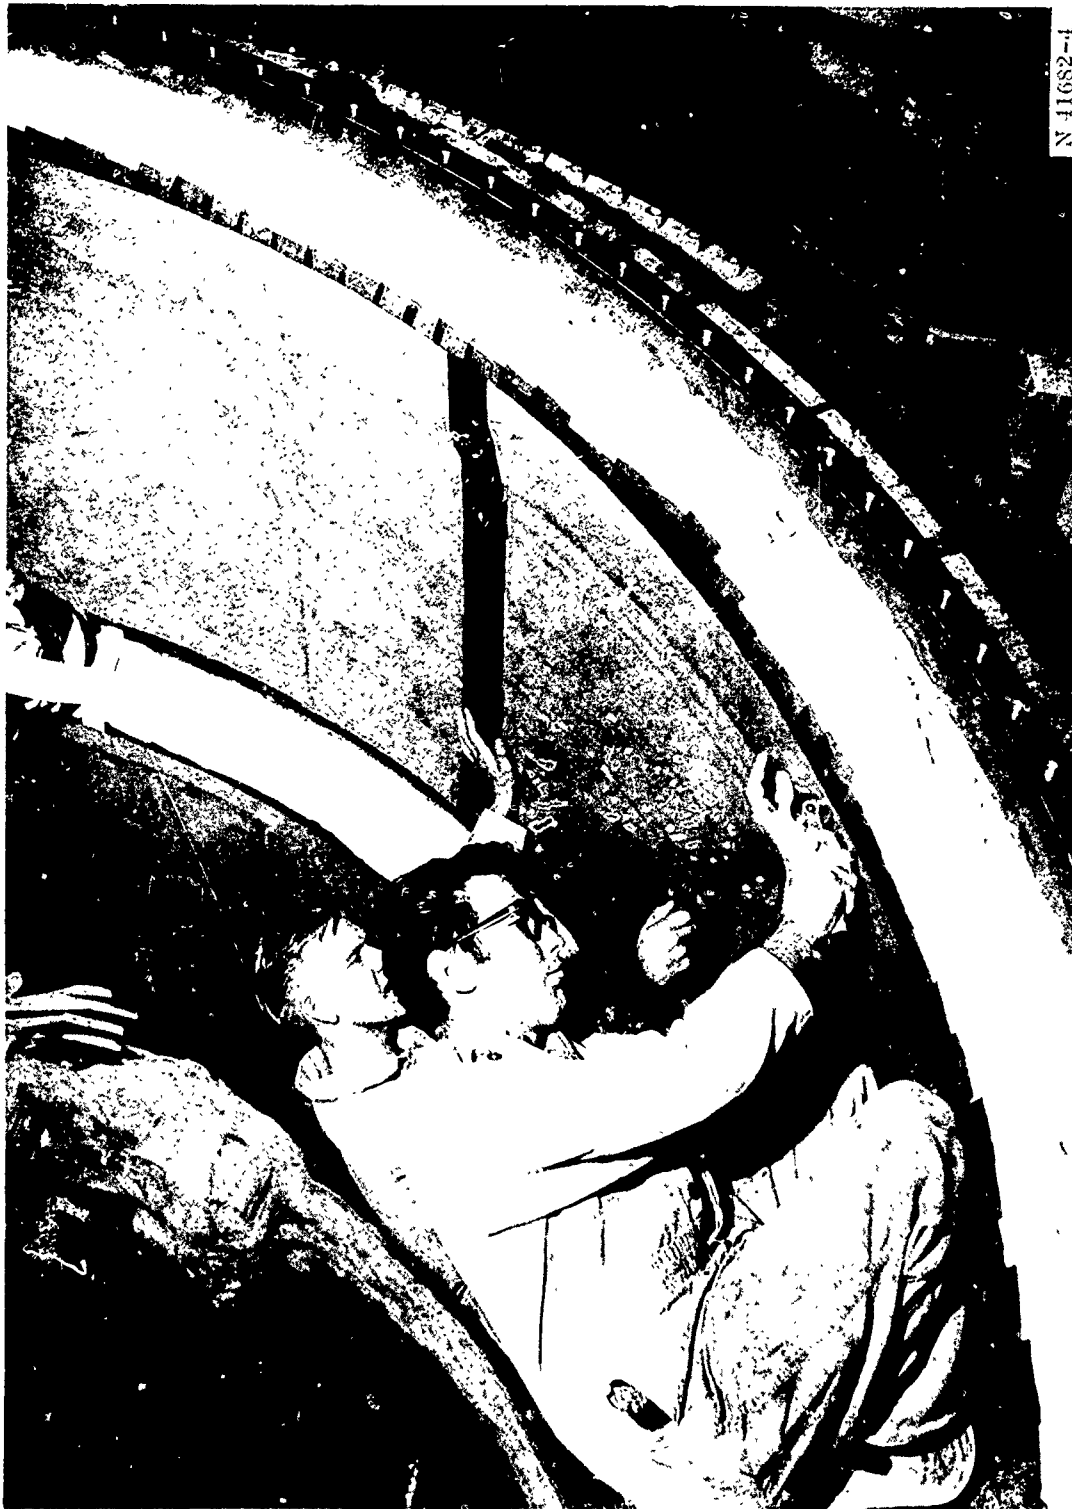
Figure 50. Rolling and Stitching V-44 Sheets for Laminate

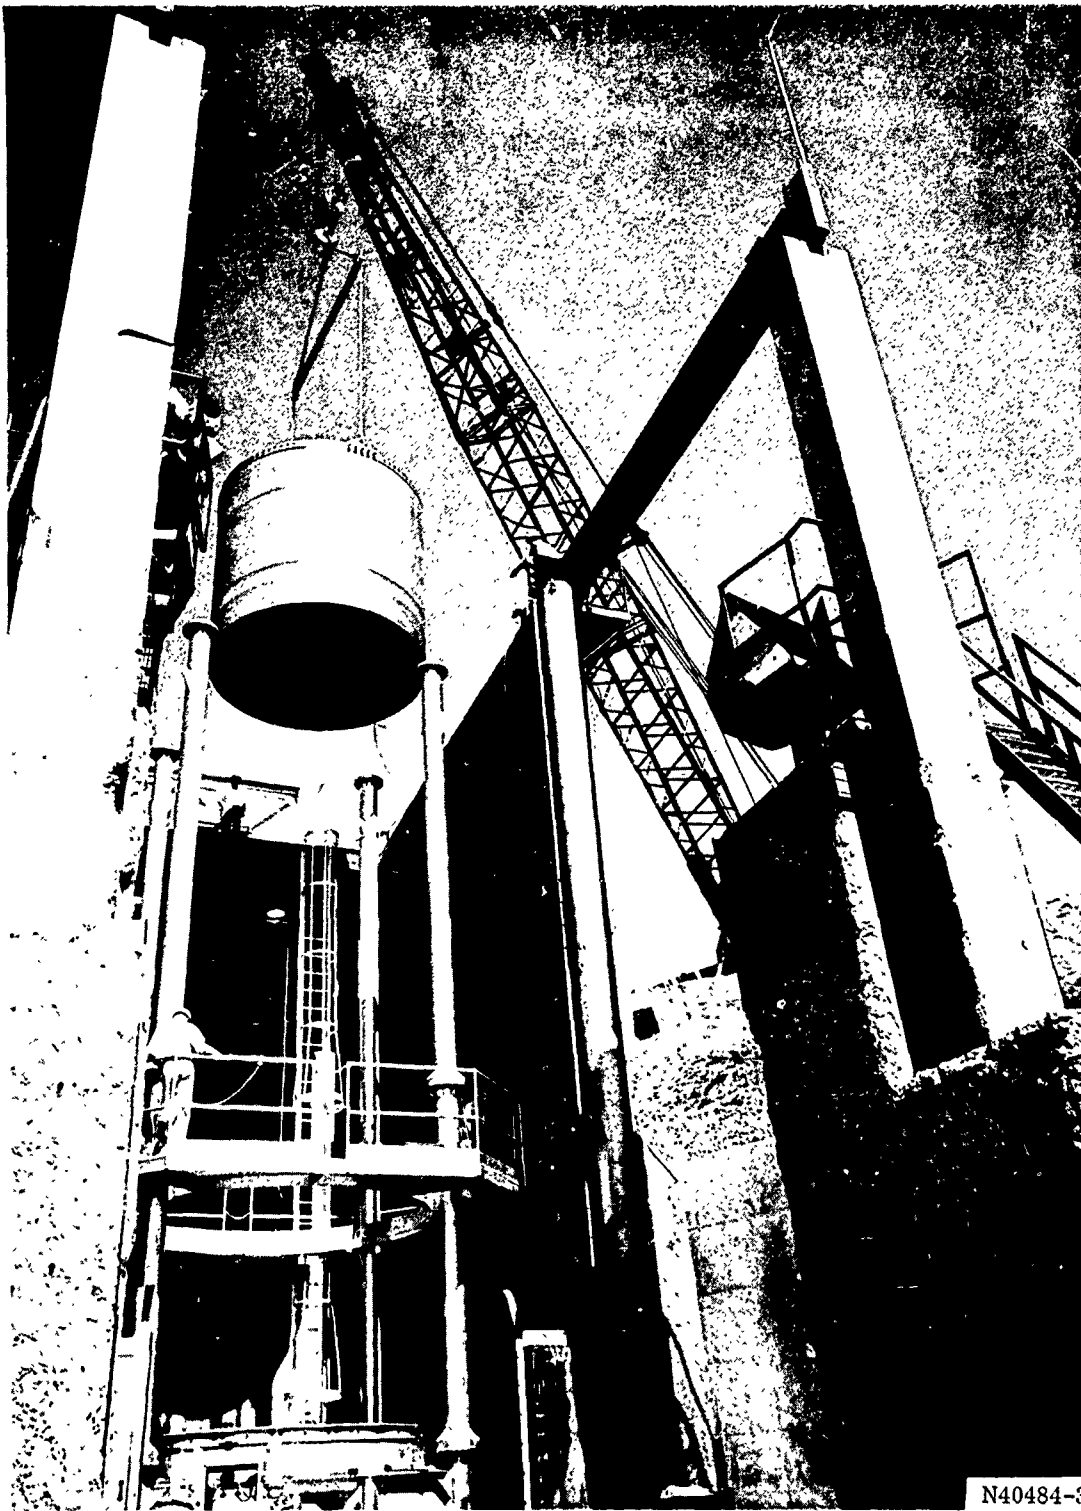
(U) Figure 70. Lowering Forward Segment into Place

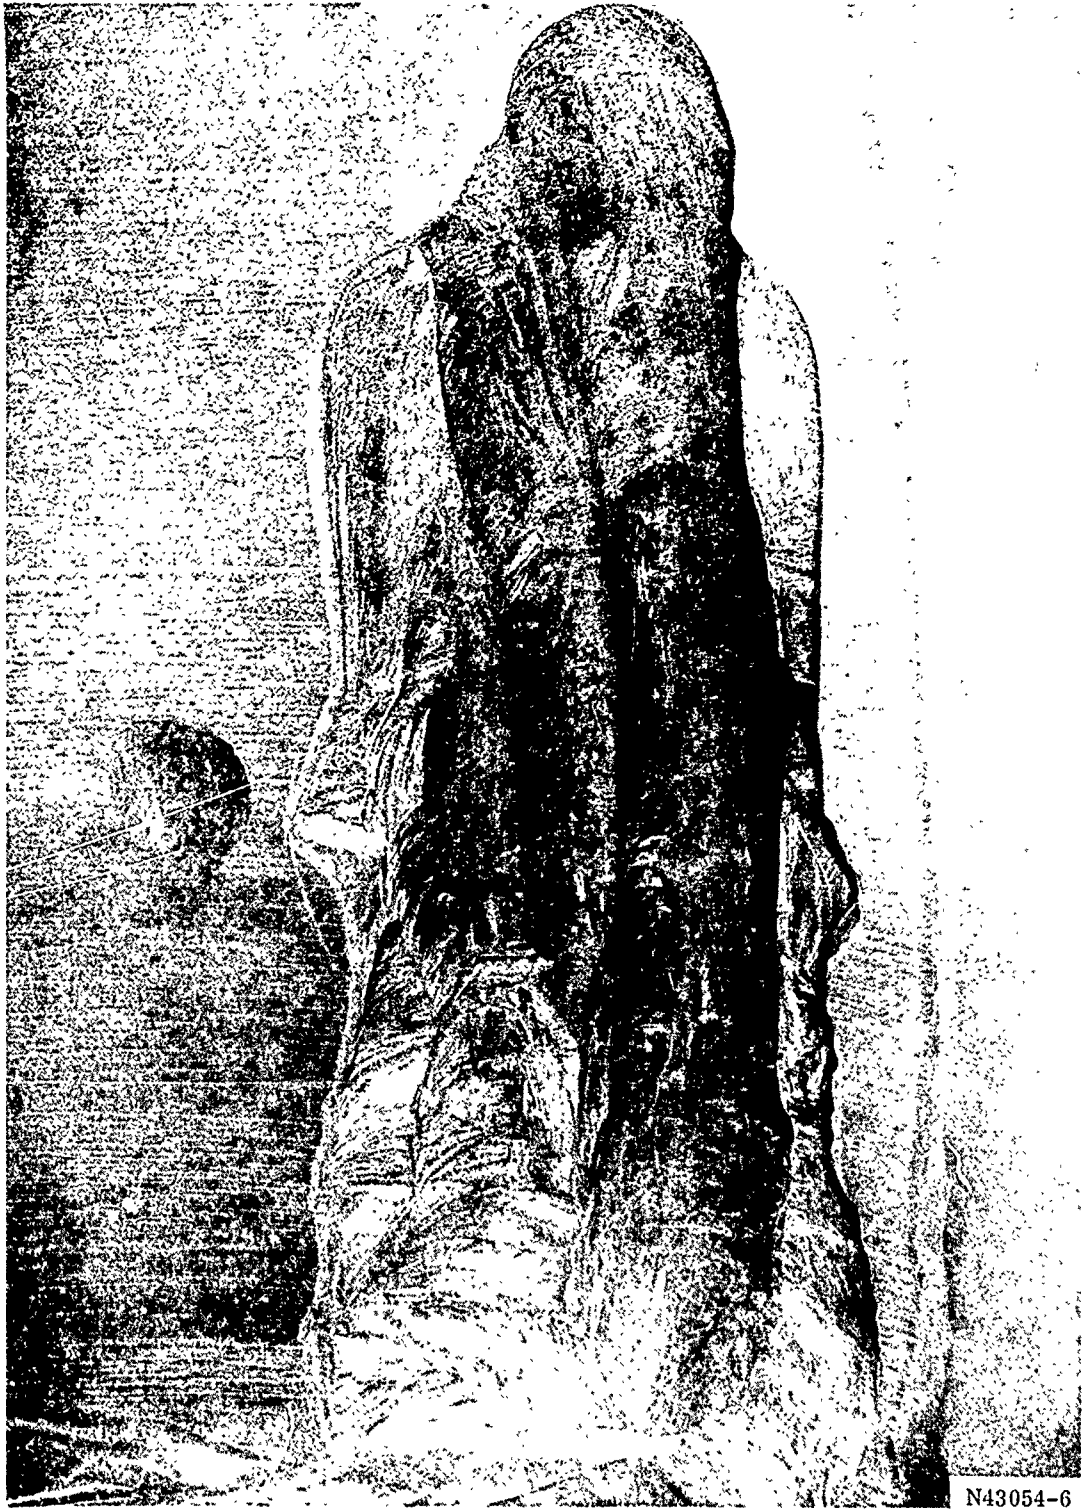
(U) Figure 121. Hand Trimmed Side Cavity
