## USAAML TECHNICAL REPORT 65-39

# POLYURETHANE AS EROSION RESISTANT MATERIAL FOR HELICOPTER ROTOR BLADES

U. S. ARMY AVIATION MATERIEL LABORATORIES

## ABSTRACT

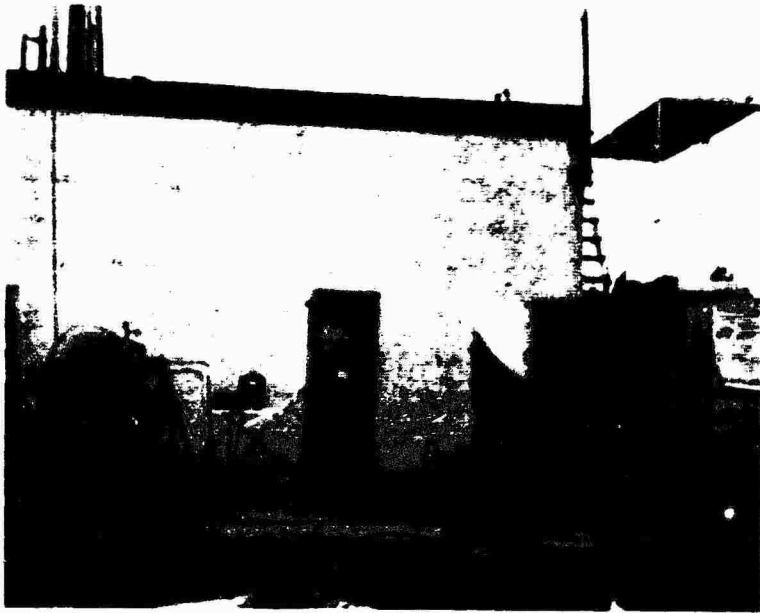
**Figure 1. Whirling-Arm  
Rig With Power Source  
and Controls.**

To determine the best material to protect the leading edge of helicopter main rotor blades, 184 materials were tested. The test conducted on the most promising materials was a whirling-arm test, which consisted of controlled release of sand from eight bins onto the specimens rotating at tip speeds of 600 and 750 feet per second. Control specimens of .010-inch-thick, full-hard, 301 stainless steel were used on each run for a comparison (see Figures 1, 2, and 3).

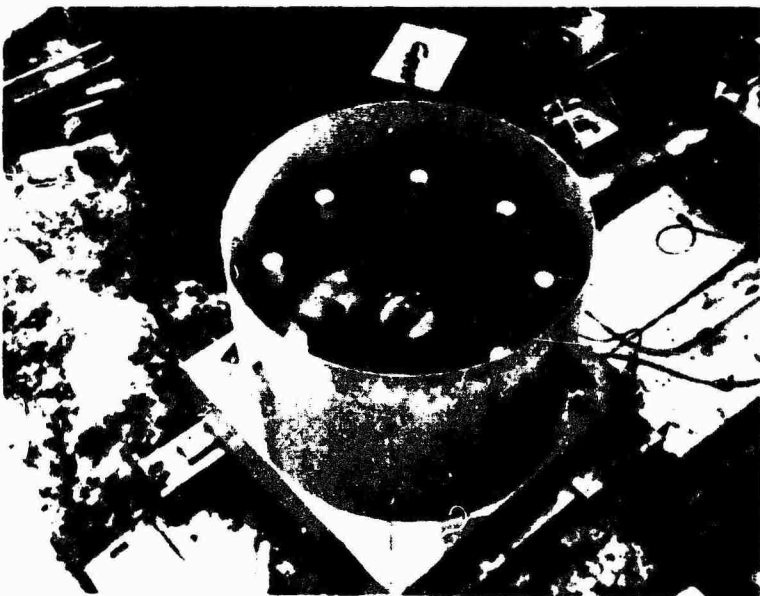
**Figure 3. Top View of  
Whirling-Arm Rig Showing  
Sand Hopper.**

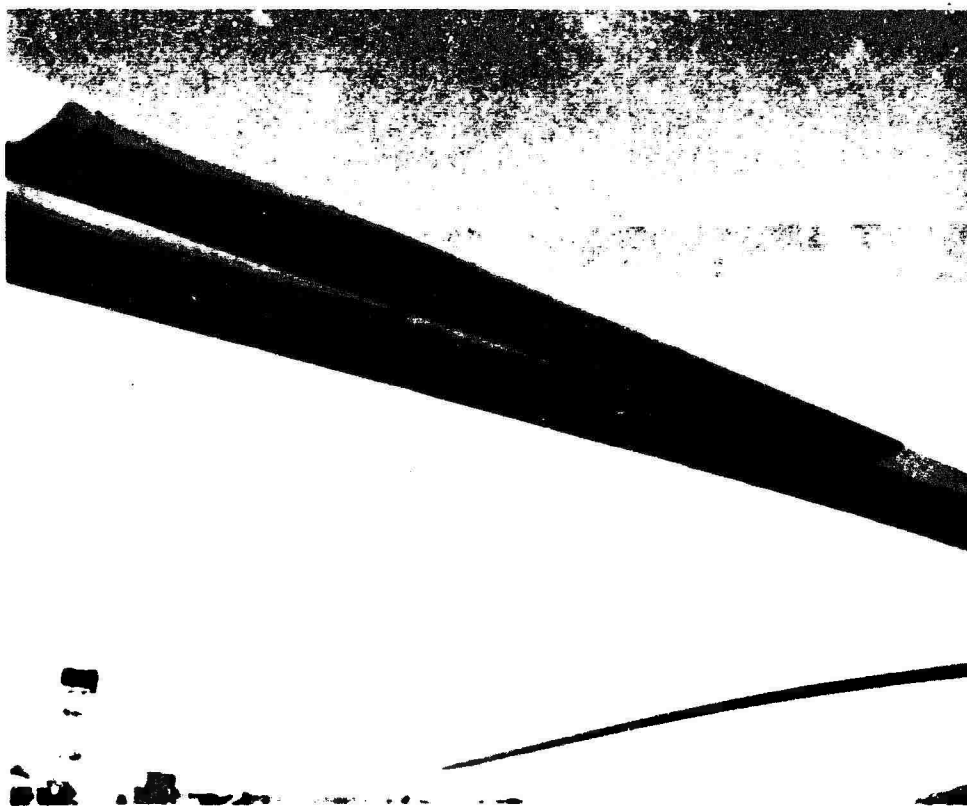
**Figure 6. Polyurethane Boot After 1 Year of Service.**

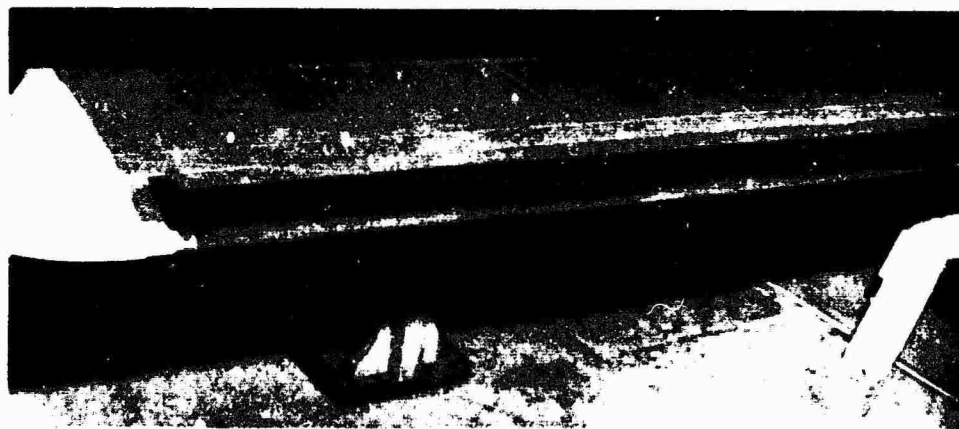
Figure 9. Polyurethane Boot at Time of Removal.

After the CH-34 helicopter left the desert environment, the boots were removed from the blades so that the polyurethane and the blades could be analyzed. The blades had had 339 flying hours, with an average of 10 landings per hour since the boot installation, and approximately 2 years of operation at Yuma Proving Grounds (see Figure 9).

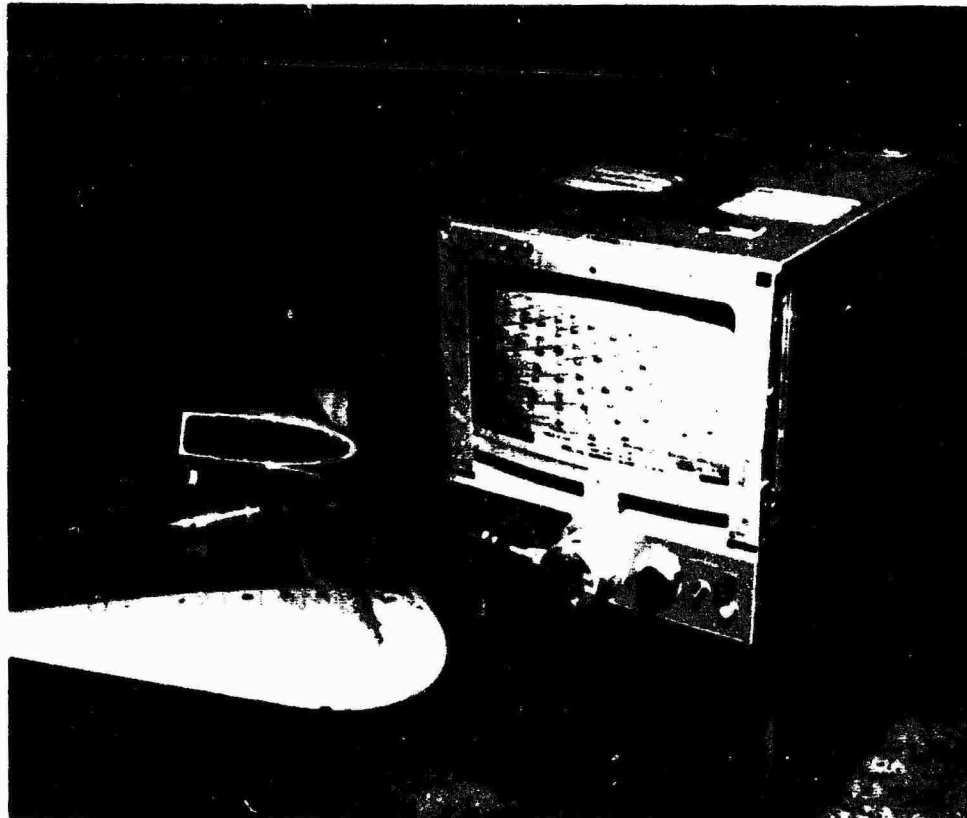
Figure 10. Vidigage Instrument, Typical CH-34 Spar, and CH-34 Main Rotor Blade.

The leading-edge spar thickness of two blades, one protected (58-M-3911) and one unprotected (58-M-4137), was measured (see Figures 10 and 11). The instrument used for these measurements was a Vidigage with a 4- to 8-megacycle-per-second oscillator and a 1/2-inch-diameter, type ZB, 9-megacycle-per-second transducer. Blade measurements are shown in Table II.

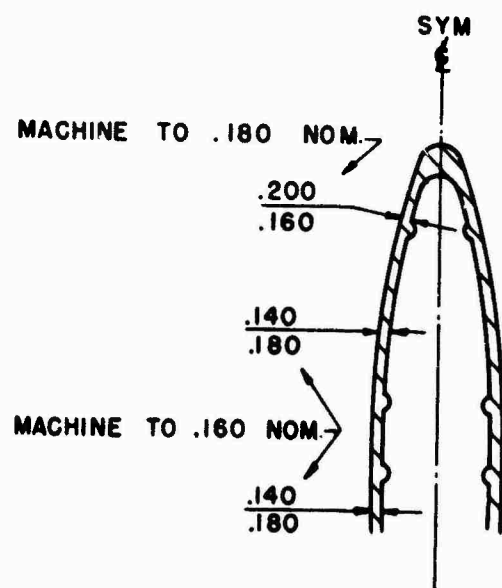
Figure 12. Outboard Section of CH-34 Main Rotor Blade Spar.

Since the blades were not measured at the beginning of the test and since the thickness tolerance is .040 inch (see Figure 12), a direct comparison cannot be made. However, from Figure 13 it can be seen that over .010 inch of metal was saved by the polyurethane boot on the bottom, or wear side, of the blade.

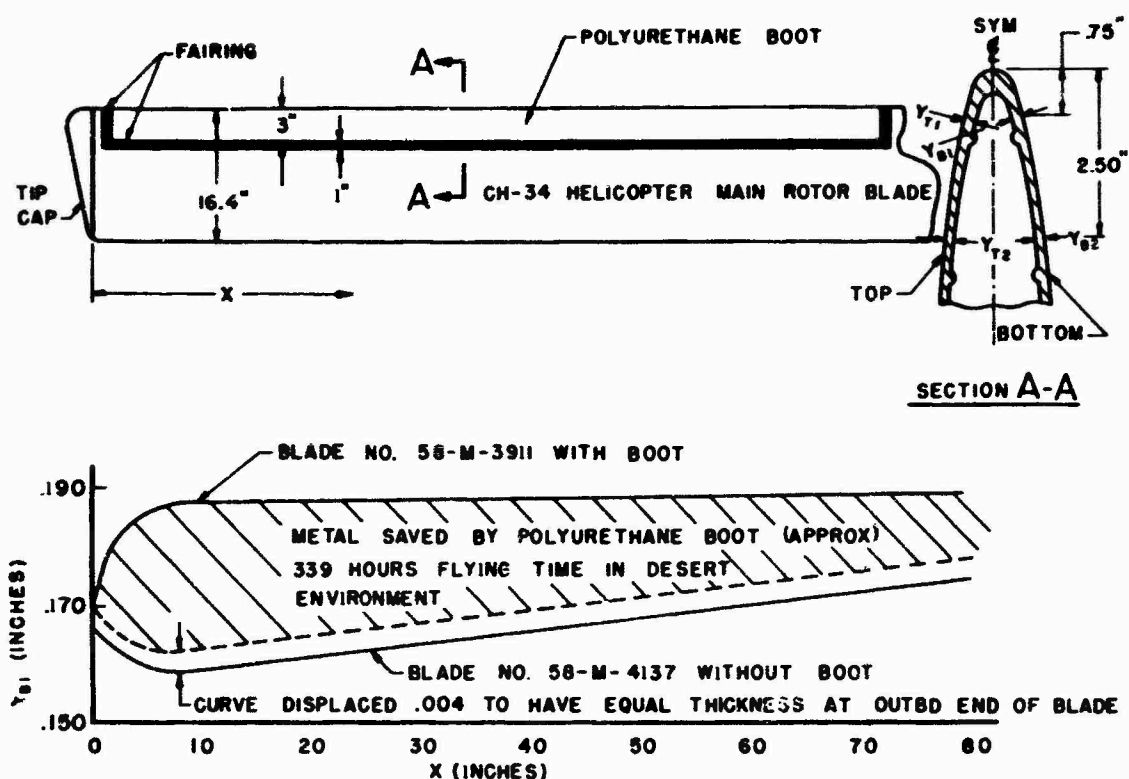
Figure 13. Protected and Unprotected Blade Comparison.

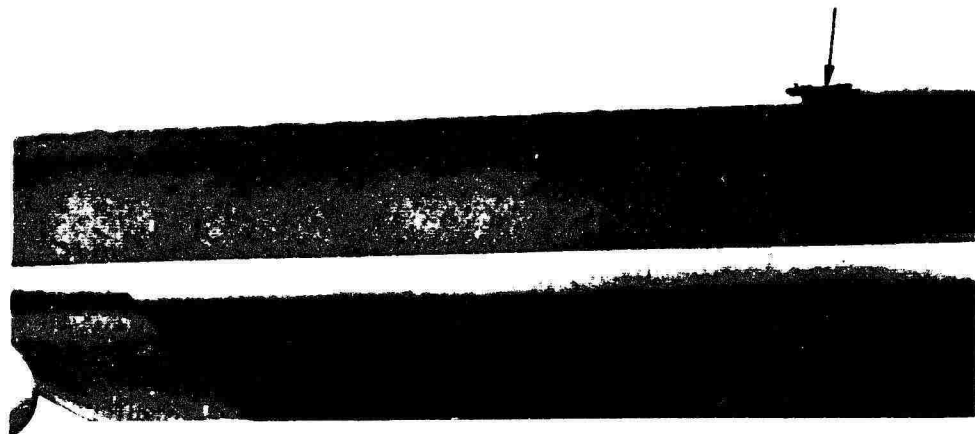
Figure 15. UH-1 Blade Showing Leading-Edge Deformation and Condition of Neoprene Fairing. (Arrow indicates neoprene fairing.)

The UH-1B helicopter was then flown to NATC to conduct the sand test from 19 to 24 June 1963. After hovering the helicopter over a sandy beach for 1.4 hours (see Figure 14), the test was discontinued, due to the turbine's excessive gas temperature. The unprotected 301 stainless steel (.020-inch-thick, 1/4-hard) had deformed (see Figure 15), and approximately .007 inch of metal had eroded from the blade tip. The polyurethane boots were extensively cut, and the neoprene fairing was eroded (see Figure 16); however, PO 655 polyurethane had protected the airfoil

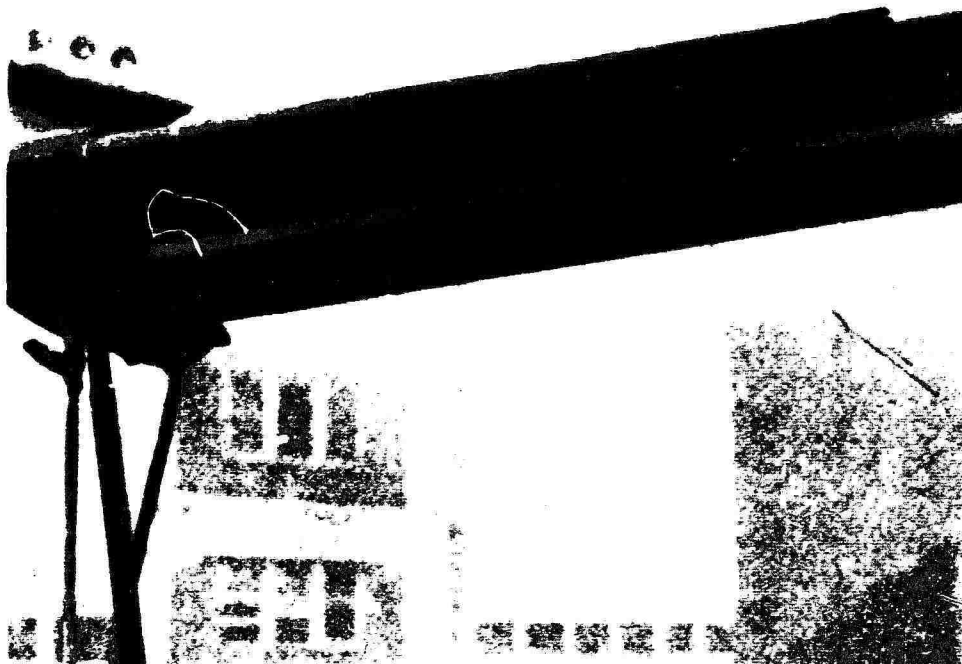
Figure 16. Outboard Polyurethane Boot on UH-1.

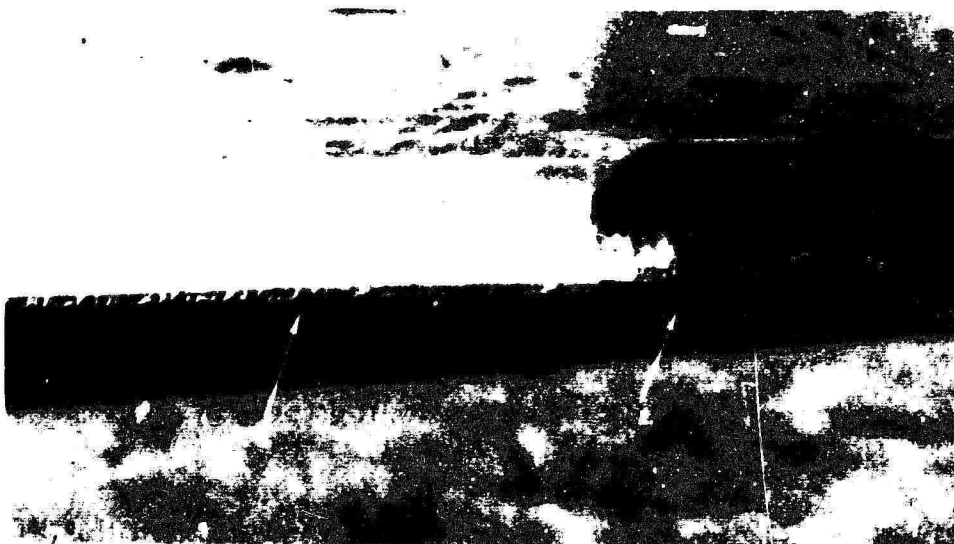
Figure 17. UH-1 Blade Comparison. (Arrow 1 indicates blade without boot; Arrow 2 indicates blade after boot removal.)

shape of the leading edge of the blade. Figure 17 shows a comparison of the blade without boots and the blade after the removal of the polyurethane boots.

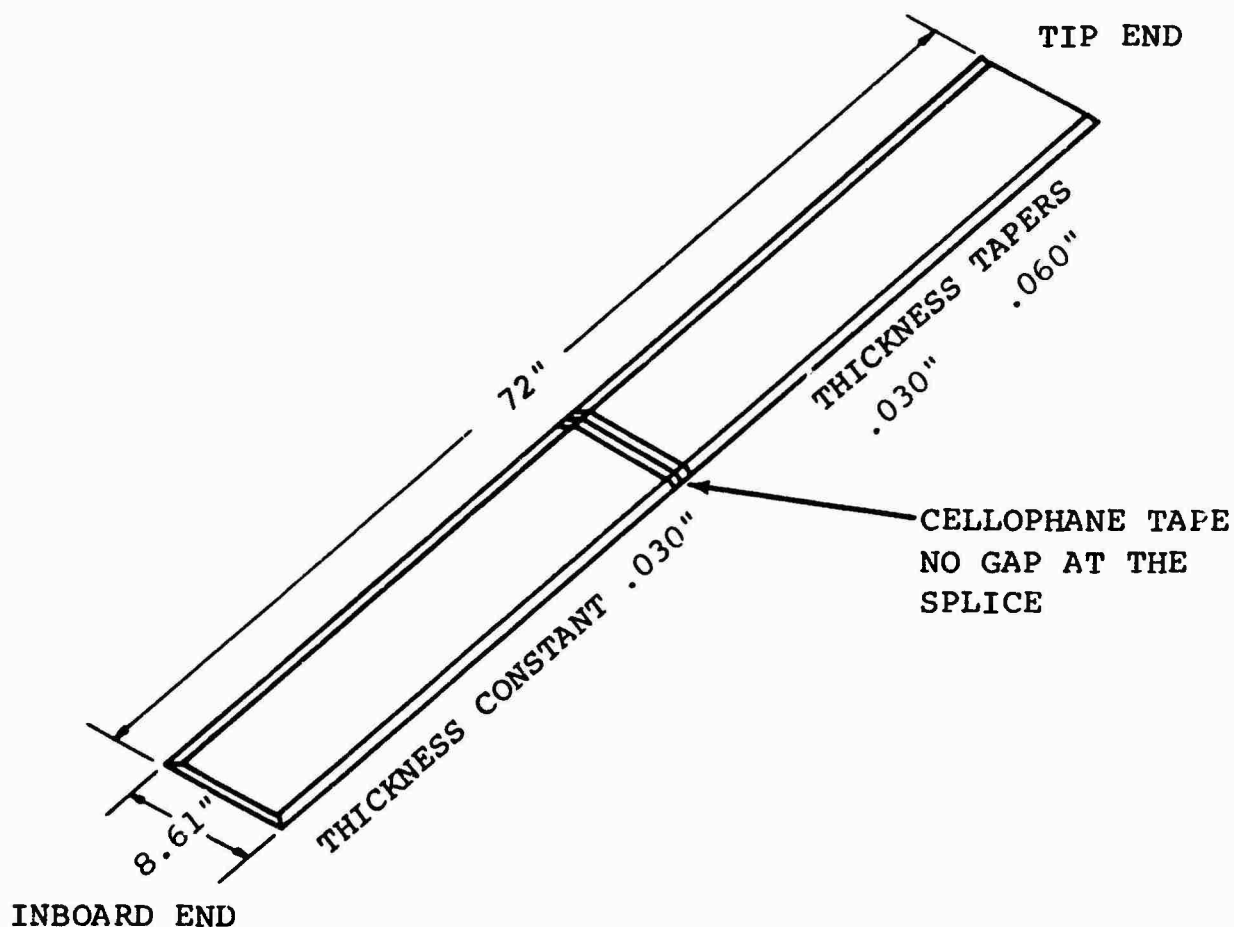
Figure 19. Polyurethane Erosion Protection System

###### A. Polyurethane erosion protection system shown in Figure 19

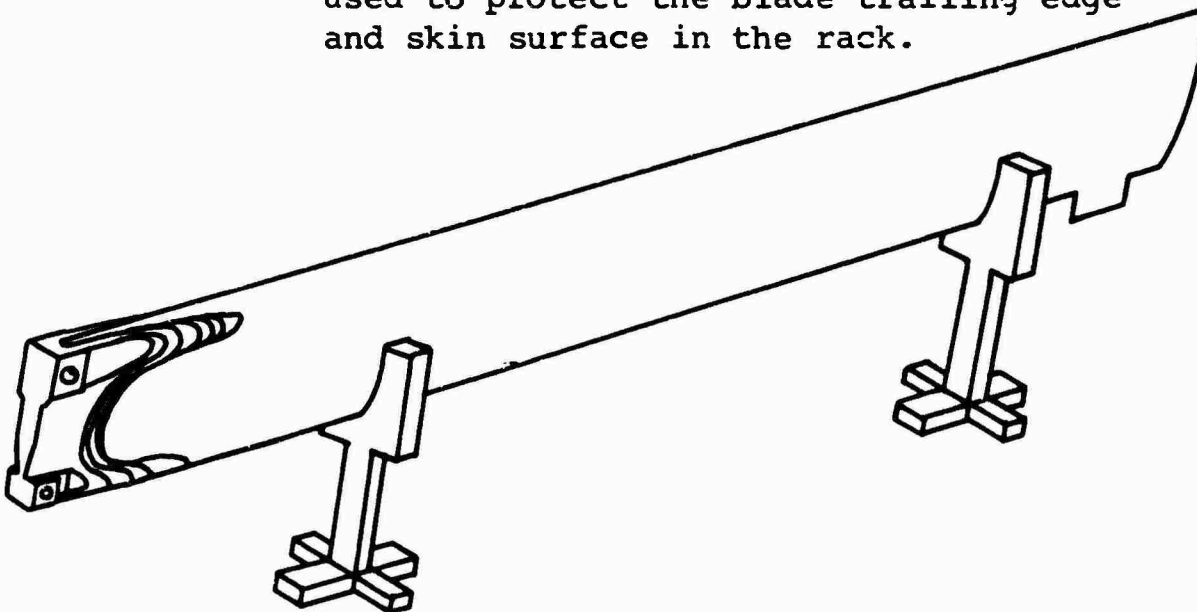
Figure 20. Positioning the Blade in Workstands

- A. It is best to install the erosion protection system indoors with the blades positioned with trailing edges down in suitable workstands, as shown in Figure 20. However, the system can be applied outdoors while the blades are on the helicopter. In the event the installation is made while the blades are on the helicopter, it is necessary to arrange for a suitable work platform in order to reach the rotor blades. In addition, it is necessary to support the blade 7 feet inboard of the tip end. If dust, rain, or fog should contaminate the cleaned surface or uncured adhesive, removal of the uncured adhesive with acetone and complete recleaning of the surface is required.

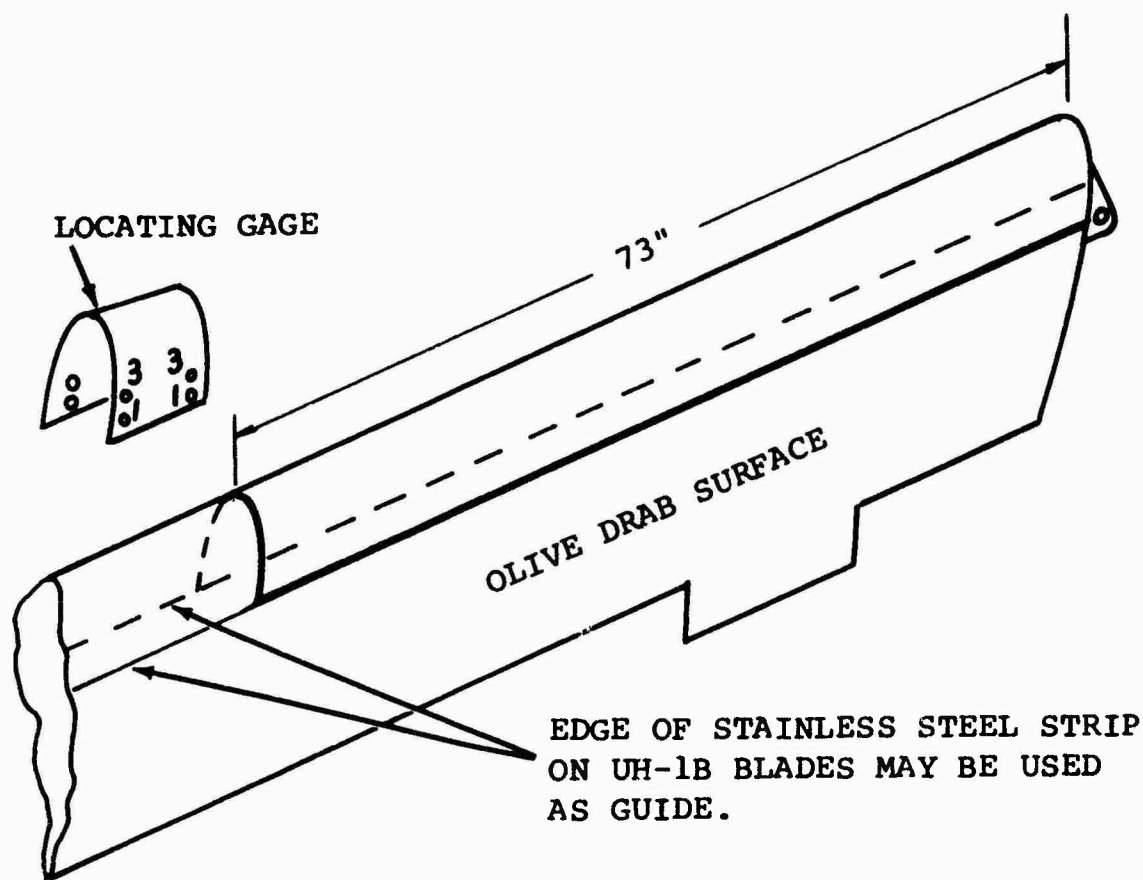
Figure 21. Installation Area

- B. Using a locating gage and a soft pencil, mark off the installation area on the blade as shown in Figure 21.

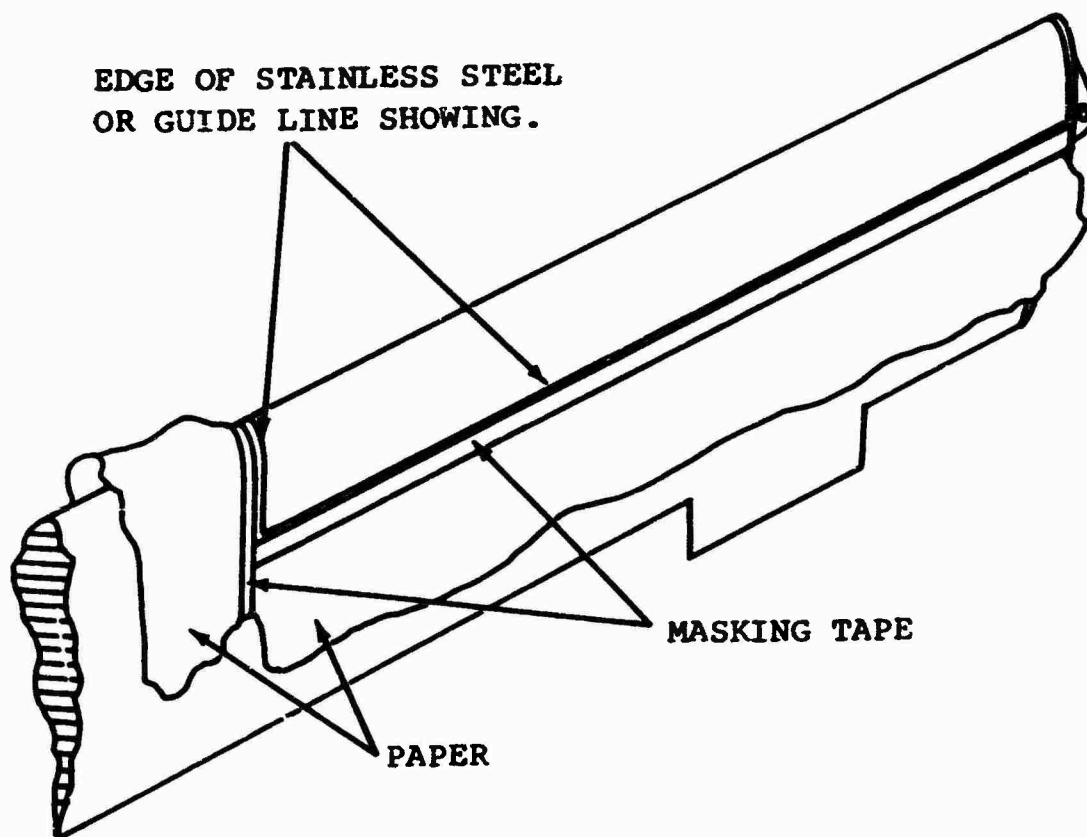
Figure 22. Masking the Installation Area

- C. Mask off the installation area as shown in Figure 22. Be sure to locate the masking tape inboard and on the trailing edge side of the guide lines.

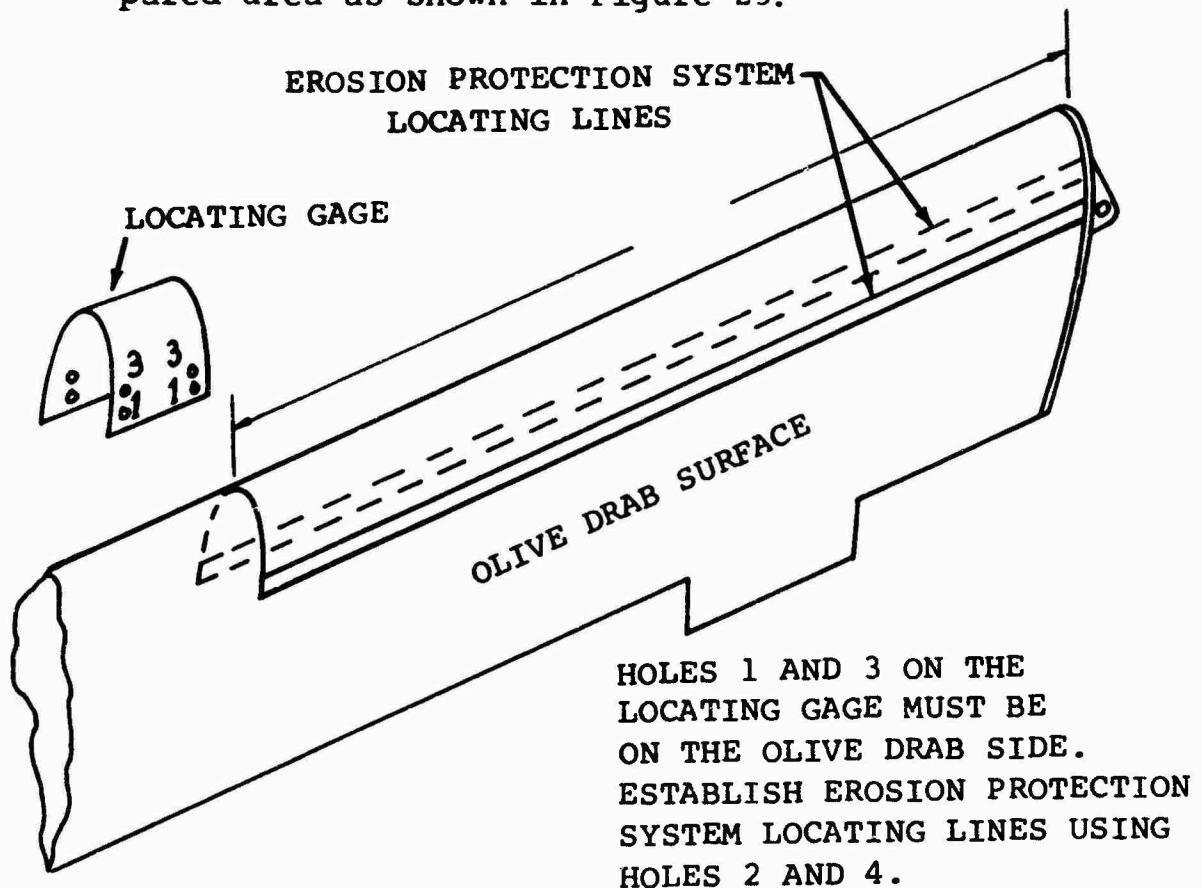
Figure 23. Erosion Protection System Location

- E. Remove the paper and masking tape.
- F. Using the locating gage, mark off the location of the erosion protection system within the prepared area as shown in Figure 23.

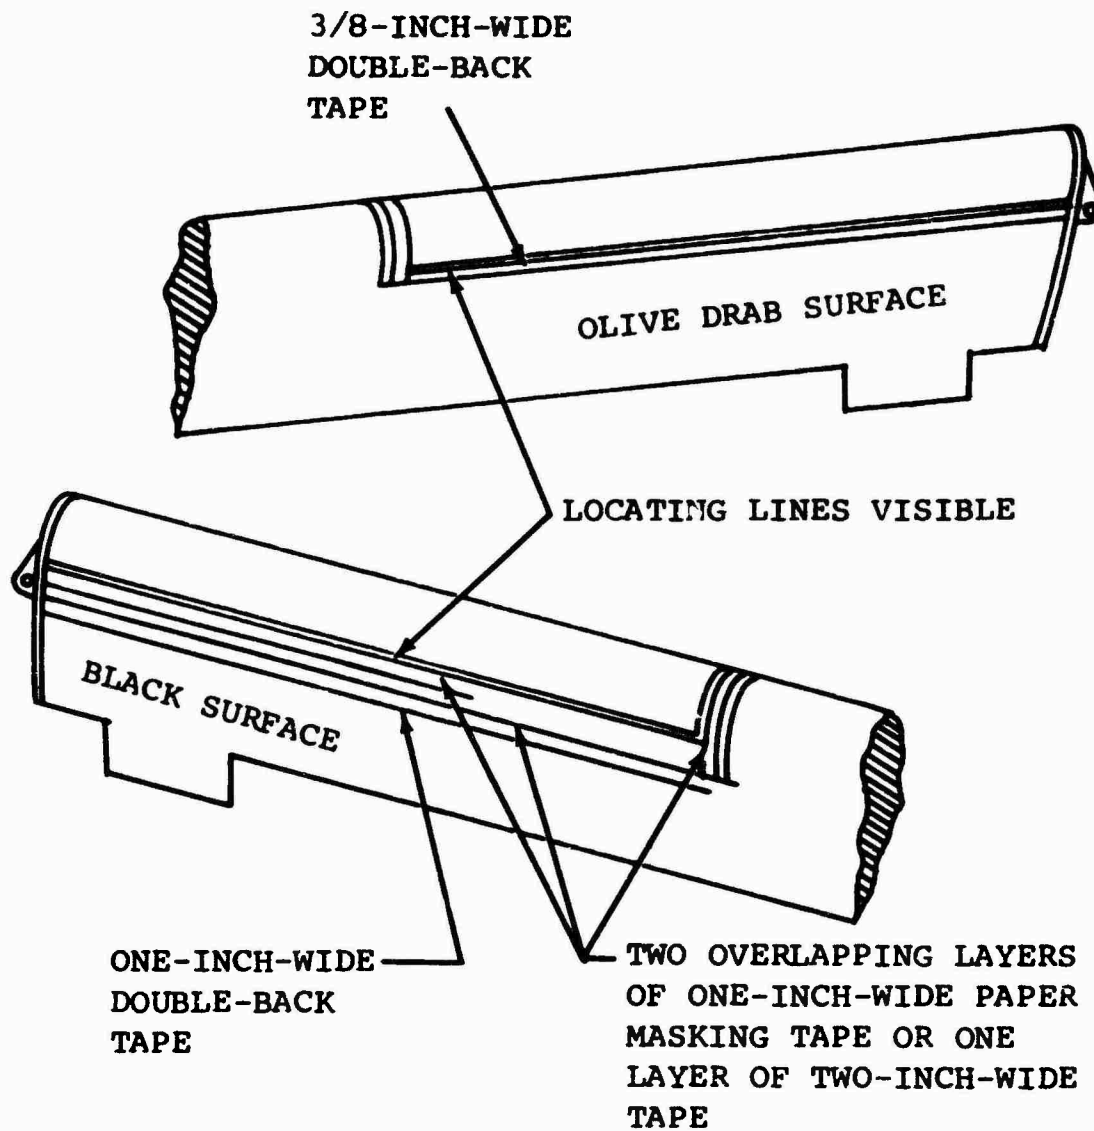
Figure 24. Masking the Erosion Protection Area

- G. Apply double-back and paper-back masking tapes to the blade as shown in Figure 24.

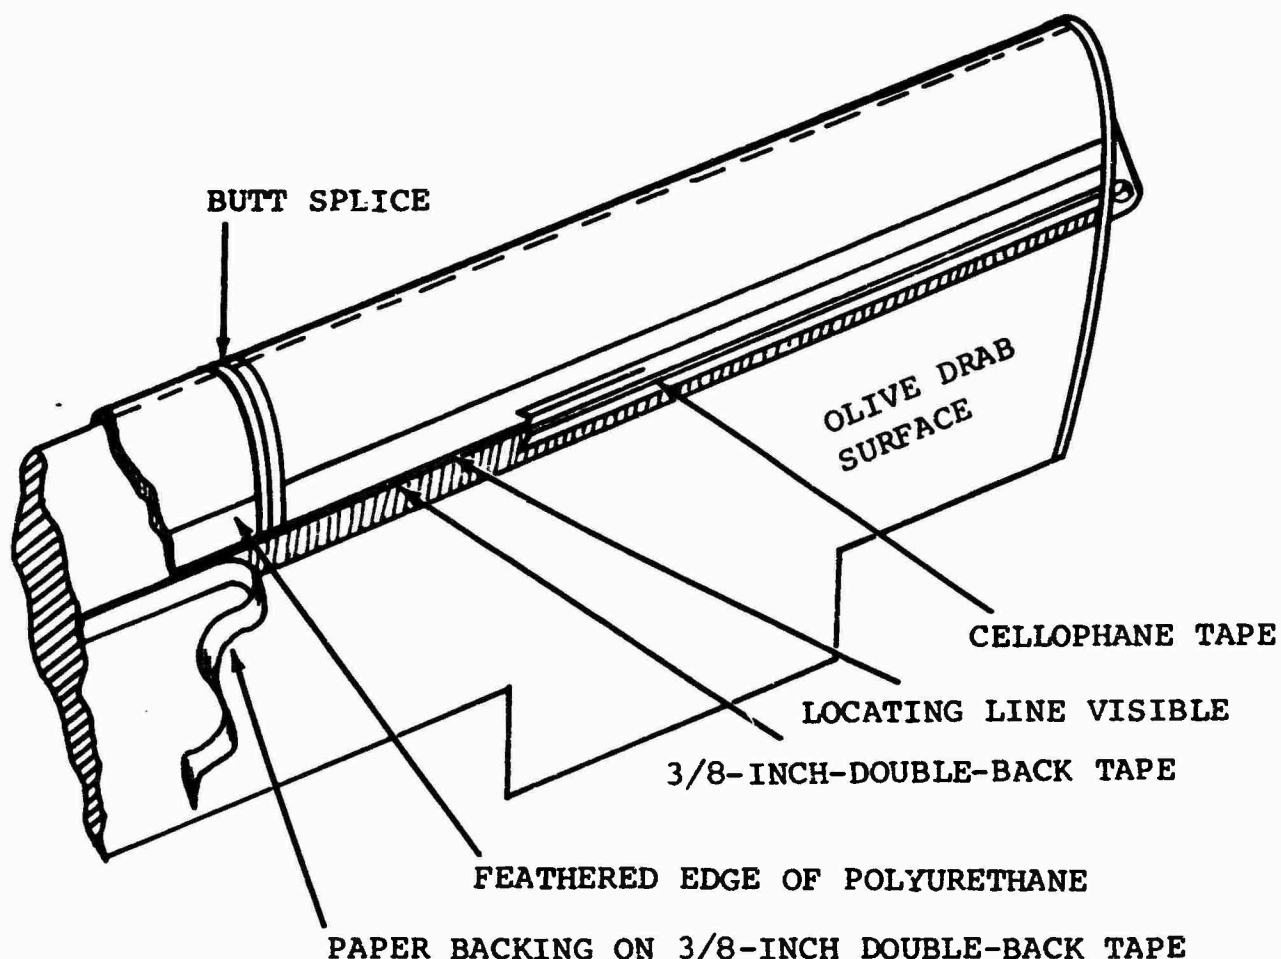
Figure 25. Taping the System in Place

- H. Position the erosion protection system on the blade with the shiny side out and the thick end butting against the edge of the tip cover. Remove the paper backing from the 3/8-inch double-back masking tape. Using clear cellophane tape, attach the erosion protection system to the 3/8-inch double-back tape as shown in Figure 25.

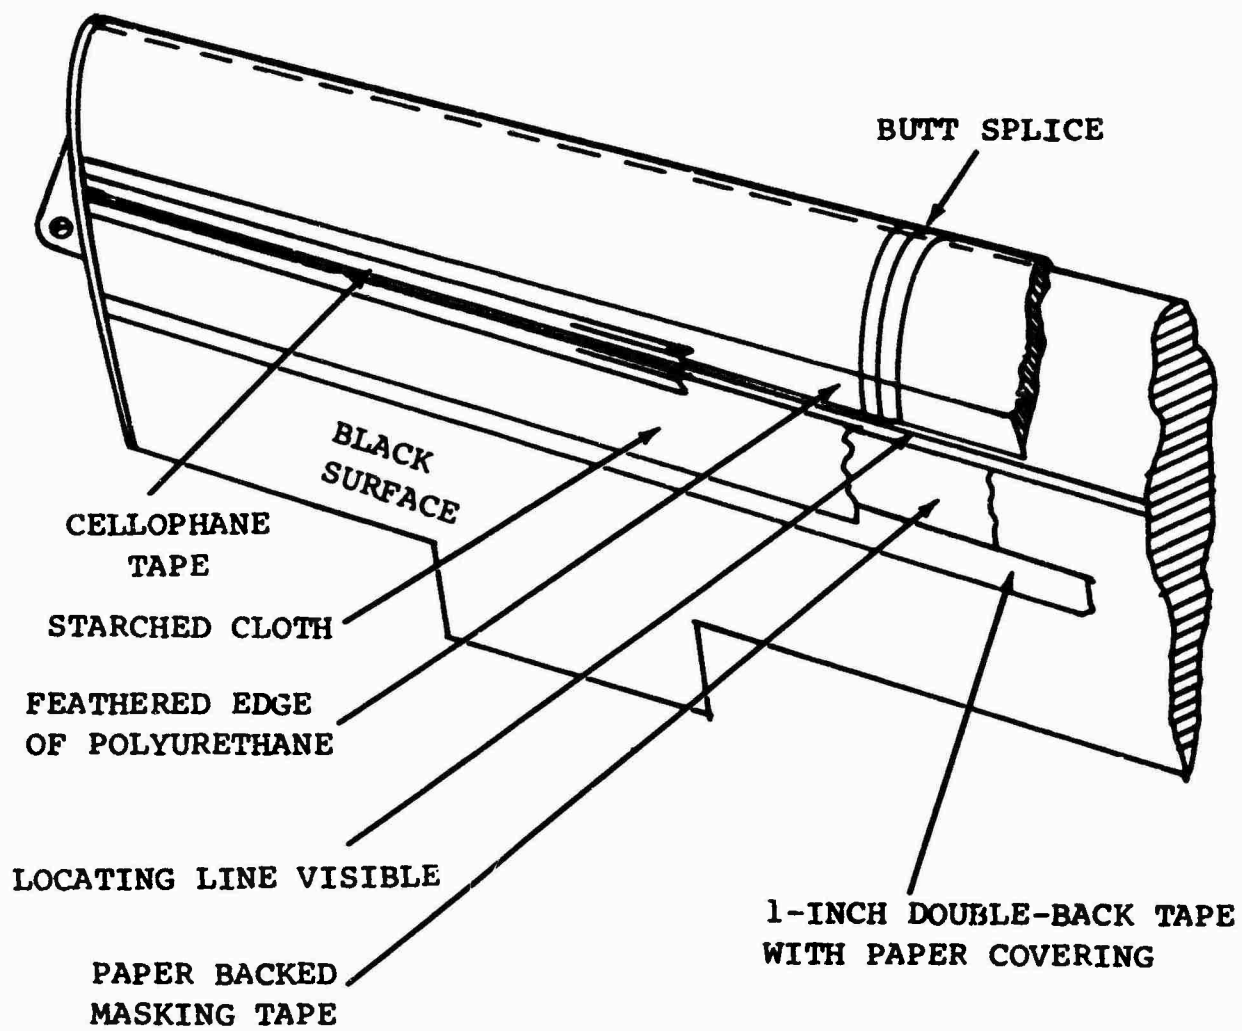
Figure 26. Taping the Starched Cloth in Place

- I. Attach the starched cloth to the polyurethane erosion protection system using clear cellophane tape as shown in Figure 26.
- J. From this operation until the polyurethane protection system is adhesive bonded in place, the white cotton gloves must be worn. Oil from the hands or any other source can destroy the strength of the adhesive.

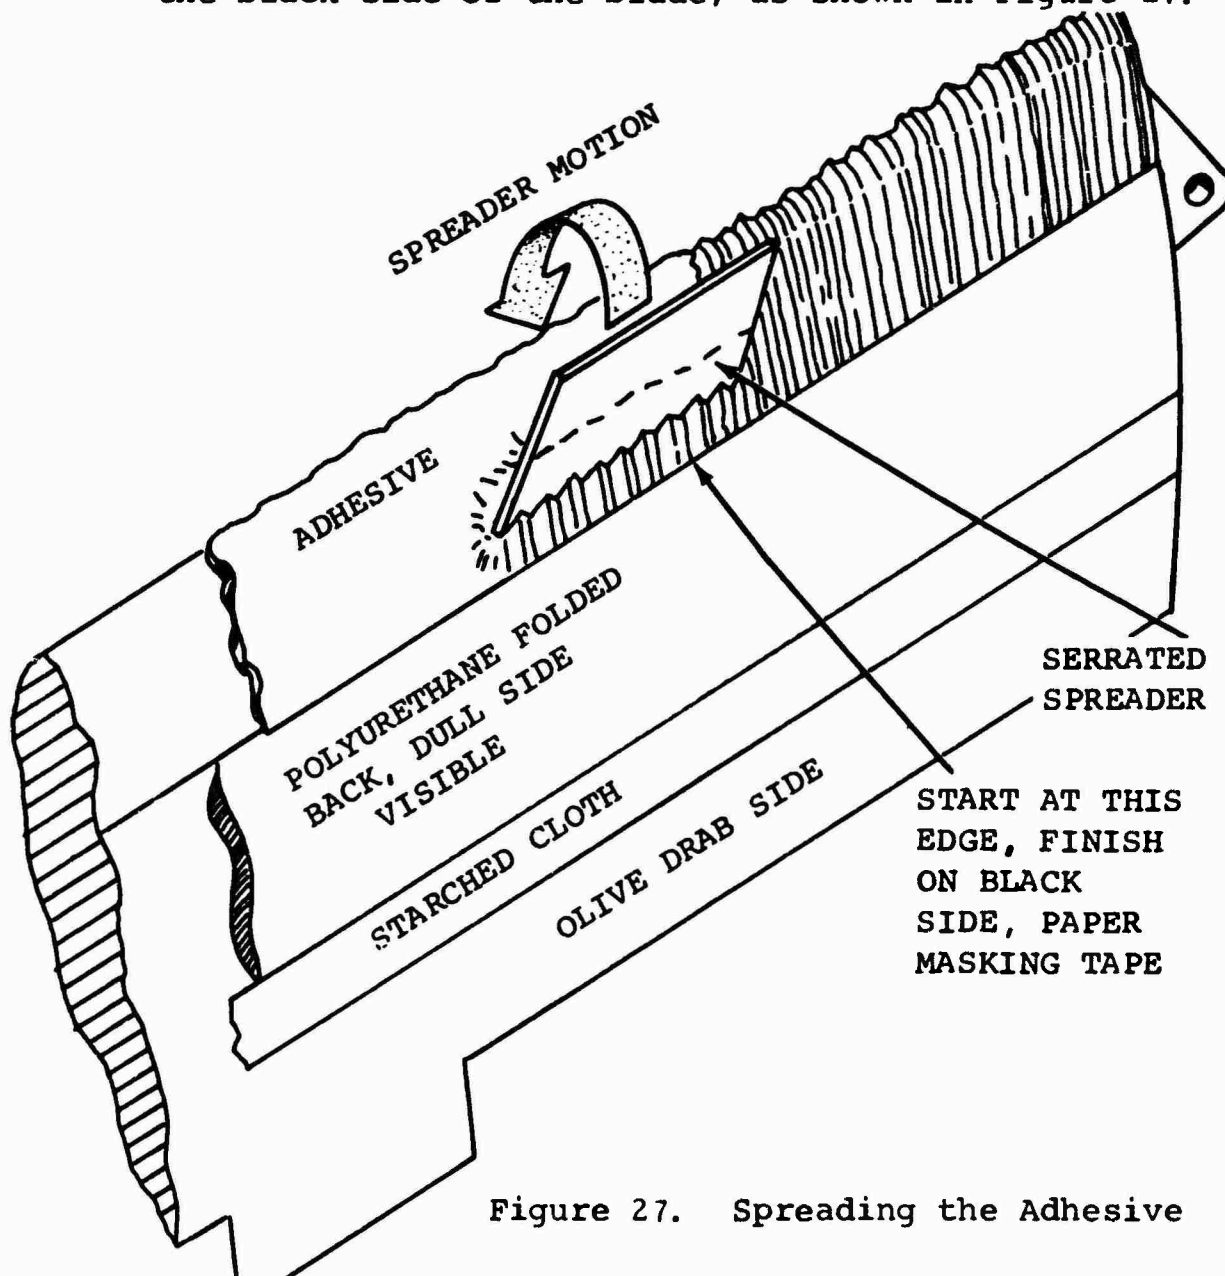
Figure 27. Spreading the Adhesive

2. Apply the mixed adhesive to the metal surface of the blade using the stirrer. If some adhesive falls on the dull side of the polyurethane it is not harmful, but the polyurethane surface should not be coated with adhesive.
- L. Score the adhesive using the saw-tooth serrated plastic spreader. Start the spreader at the protection system trailing edge on the olive-drab side of the rotor blade. Move the spreader over the leading edge, finishing on the paper masking tape on the black side of the blade, as shown in Figure 27.

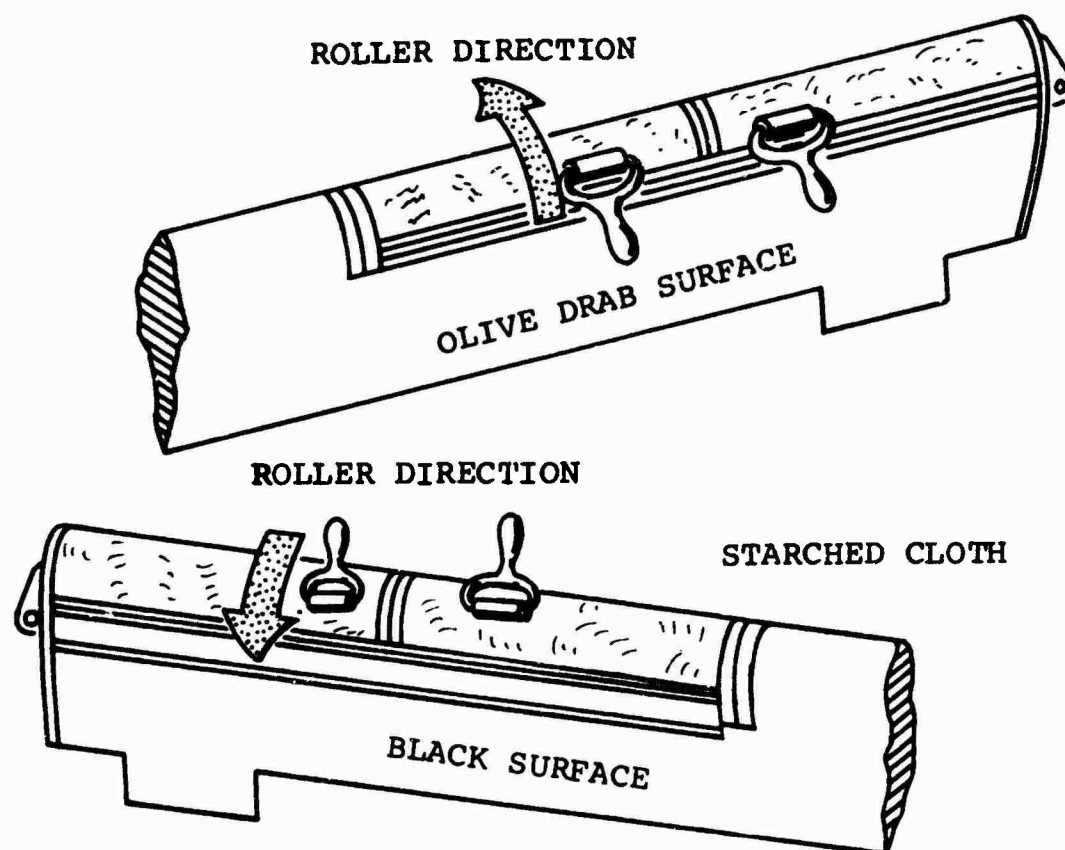
Figure 28. Rolling Out Entrapped Air and Excess Adhesive

M. Place the polyurethane erosion protection system over the leading edge. With both men starting on the olive-drab side of the rotor blade at the trailing edge of the polyurethane center splice, roll out the entrapped air. Push the roller from the trailing edge towards the leading edge. One man works from the center splice to the inboard end, the other man works to the tip end. After the olive-drab side is completed, continue the operation on the black side, pushing the roller from the leading edge towards the trailing edge. Force the excess adhesive under the starched cloth and over the masking tape. See Figure 28.

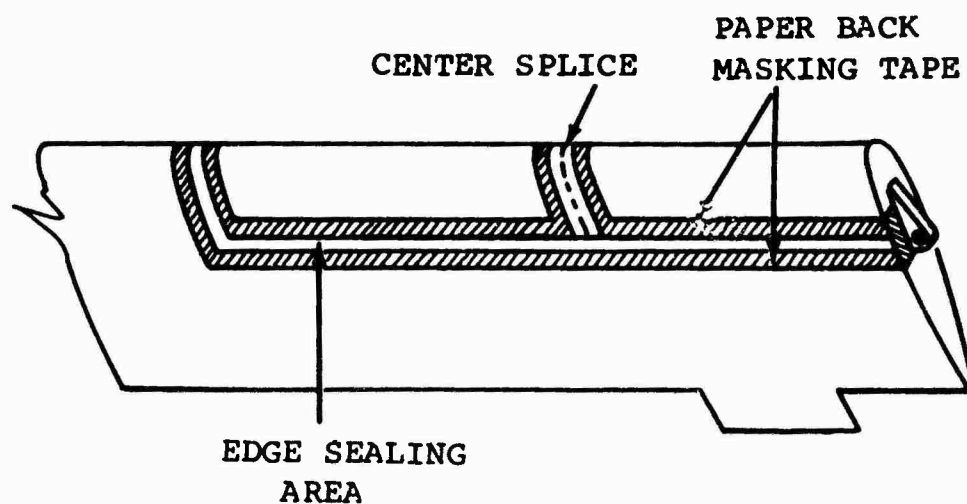
Figure 29. Masking the System for Edge Sealing

- P. There should be approximately one-half inch of exposed metal surface between the polyurethane and the paint. After the adhesive has hardened (in 3 to 4 hours) place one-inch-wide masking tape on the polyurethane and over the paint, letting the exposed metal show. Also, mask the splice (a one-half-inch gap is sufficient). Mask the in-board and tip ends, as shown in Figure 29.

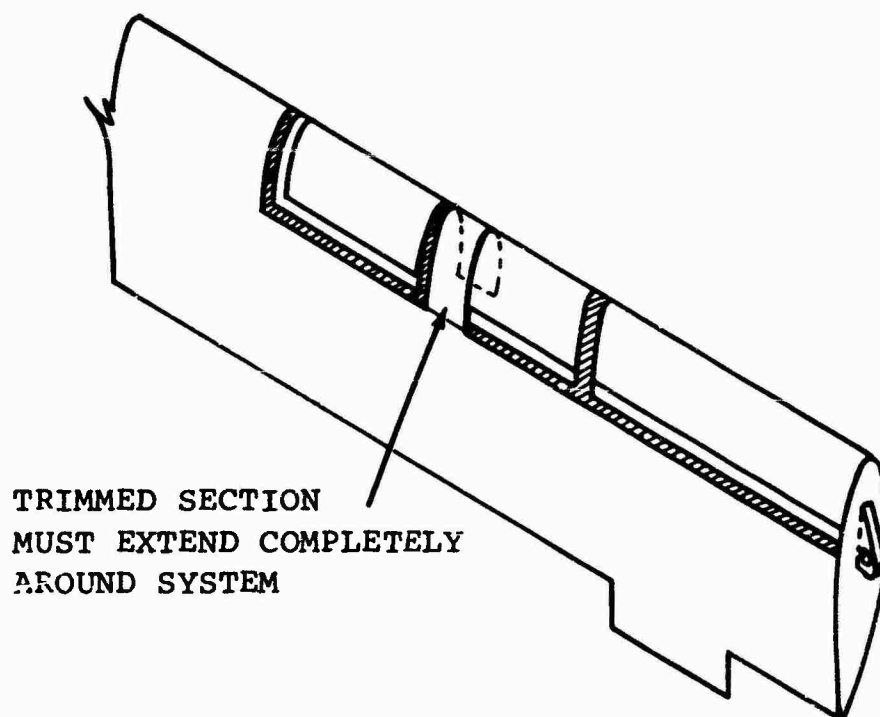
Figure 30. Removing Damaged Portion

1. Trim the damaged and loose polyurethane as shown in Figure 30.
2. Cut a replacement section of polyurethane the same size as the trimmed area.
3. Mask the paint and polyurethane around the trimmed area using one-inch-wide masking tape and paper. Remove excess adhesive and edge-sealer from the metal per paragraph IV A through IV G.
