MISCELLANEOUS PAPER NO. 4-804

# ROCKET - BLAST - RESISTANT MATERIALS

## ROCKET ENGINE BLAST TESTS ON EXPEDIENT SURFACING MATERIALS

April 1966

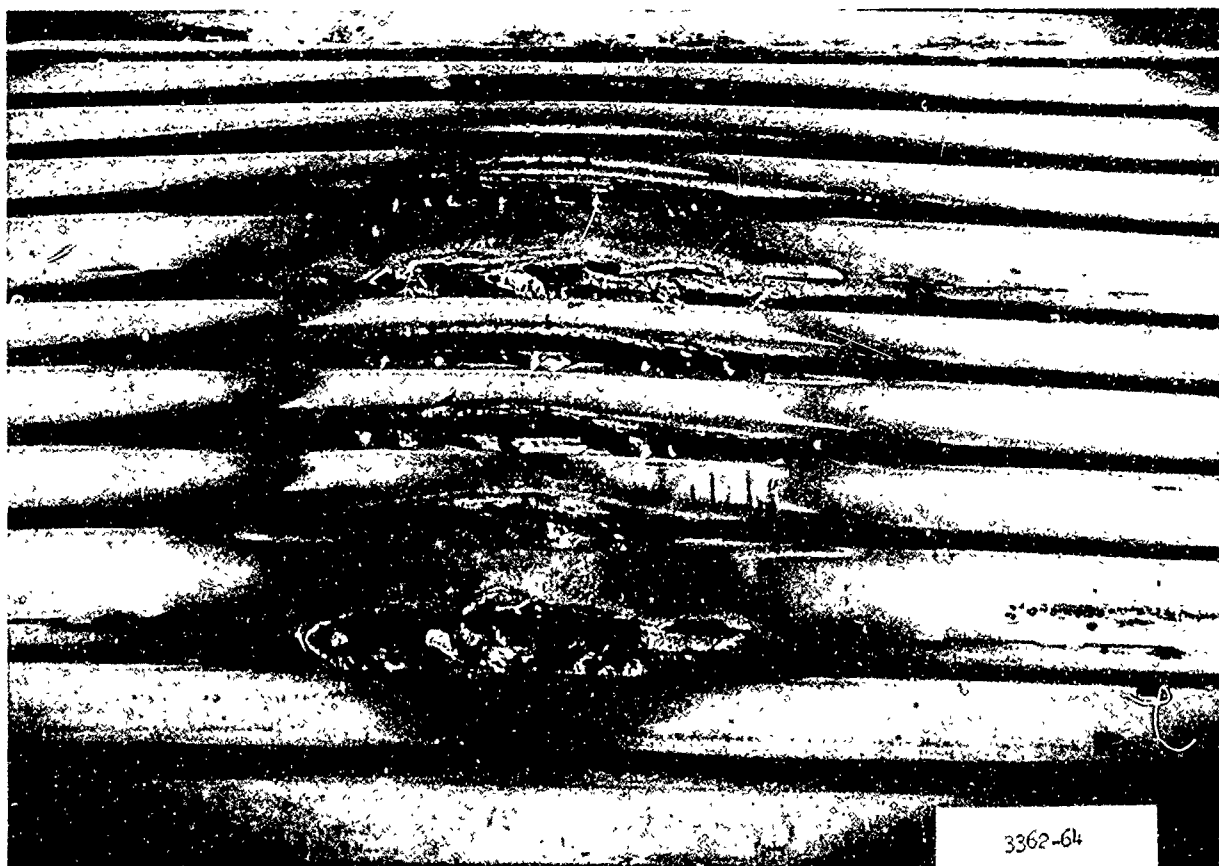
Photograph 12. Steel panel surface after third test

20. Photograph 12 shows the blast impingement area of the steel panels after the third test as viewed from the rocket engine exhaust nozzle. Considerable damage was done to the panel as the hot exhaust gases impinged against the rib sections. The abrupt change in surface at the edge of each rib of the panel apparently caused concentration of heat which in turn burned the steel at these points. A comparison of photographs 9 and 12 shows that the blast along the panel ribs caused less panel damage than that across the ribs.
