# K EWEENAW R ESEARCH C ENTER

EVALUATION OF  
DIESEL ENGINED JEEP (JAPAN)

Job Order No. 318  
Contract No. DA-20-113-AMC-08571(T)

January, 1967

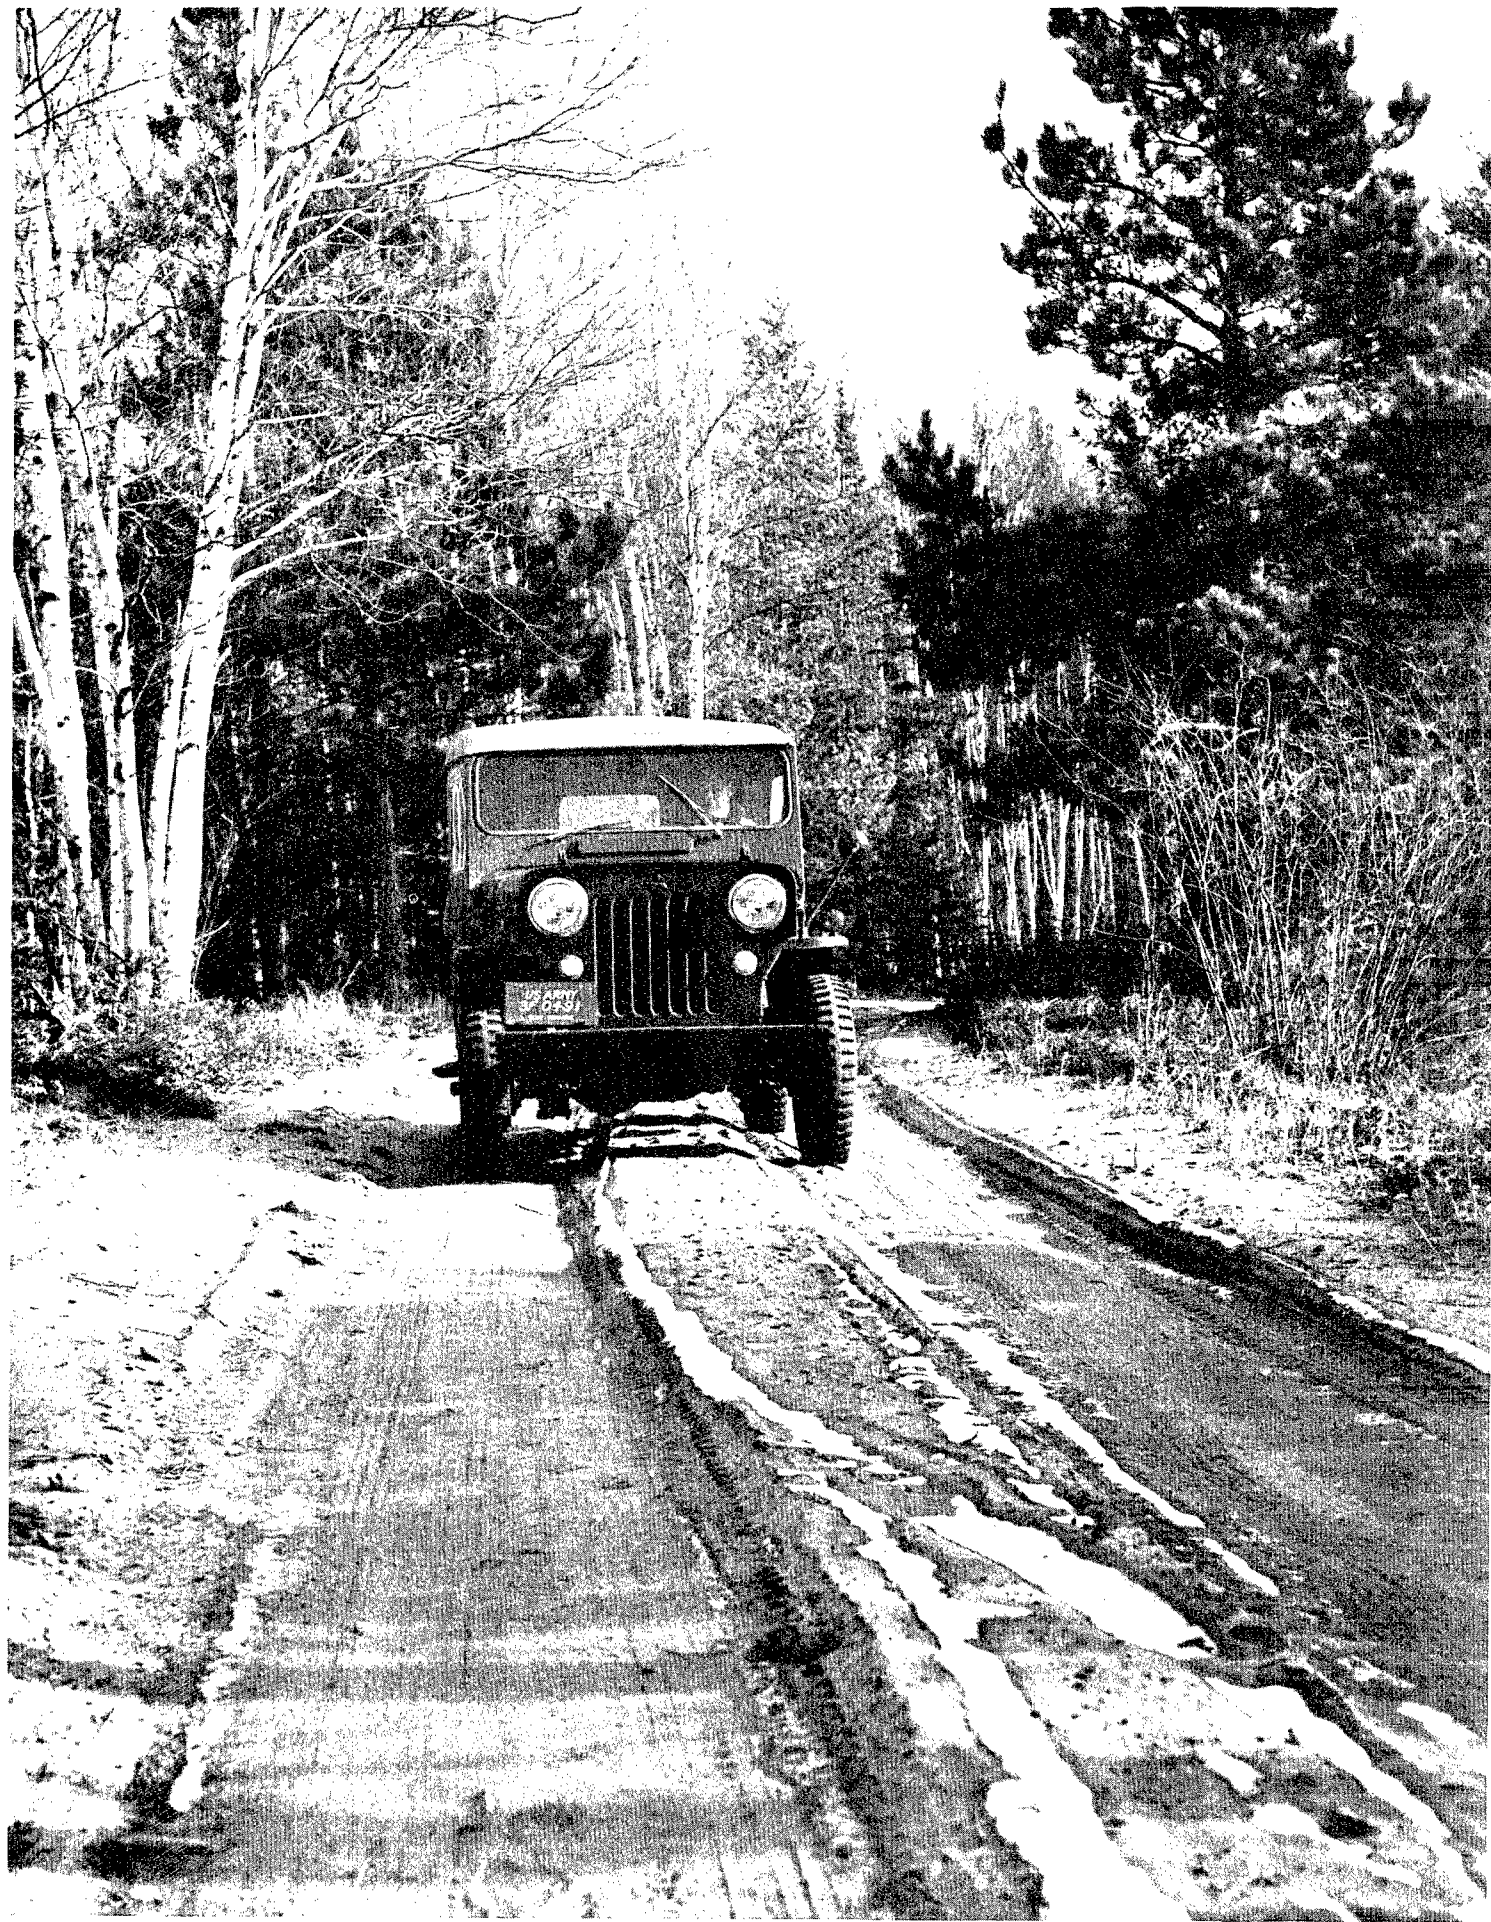
Figure 2  
Japanese Jeep - Secondary Road  
- 2 -

The vehicle is shown in several views in Figures 1 to 4, (detailed specifications are listed in Table I). The vehicle, as tested, had a total weight of 3,750 pounds, including the driver and one passenger plus 550 pounds of payload; a rated engine horsepower of 61 at 3,600 rpm; and a maximum governed vehicle speed of 55 mph.

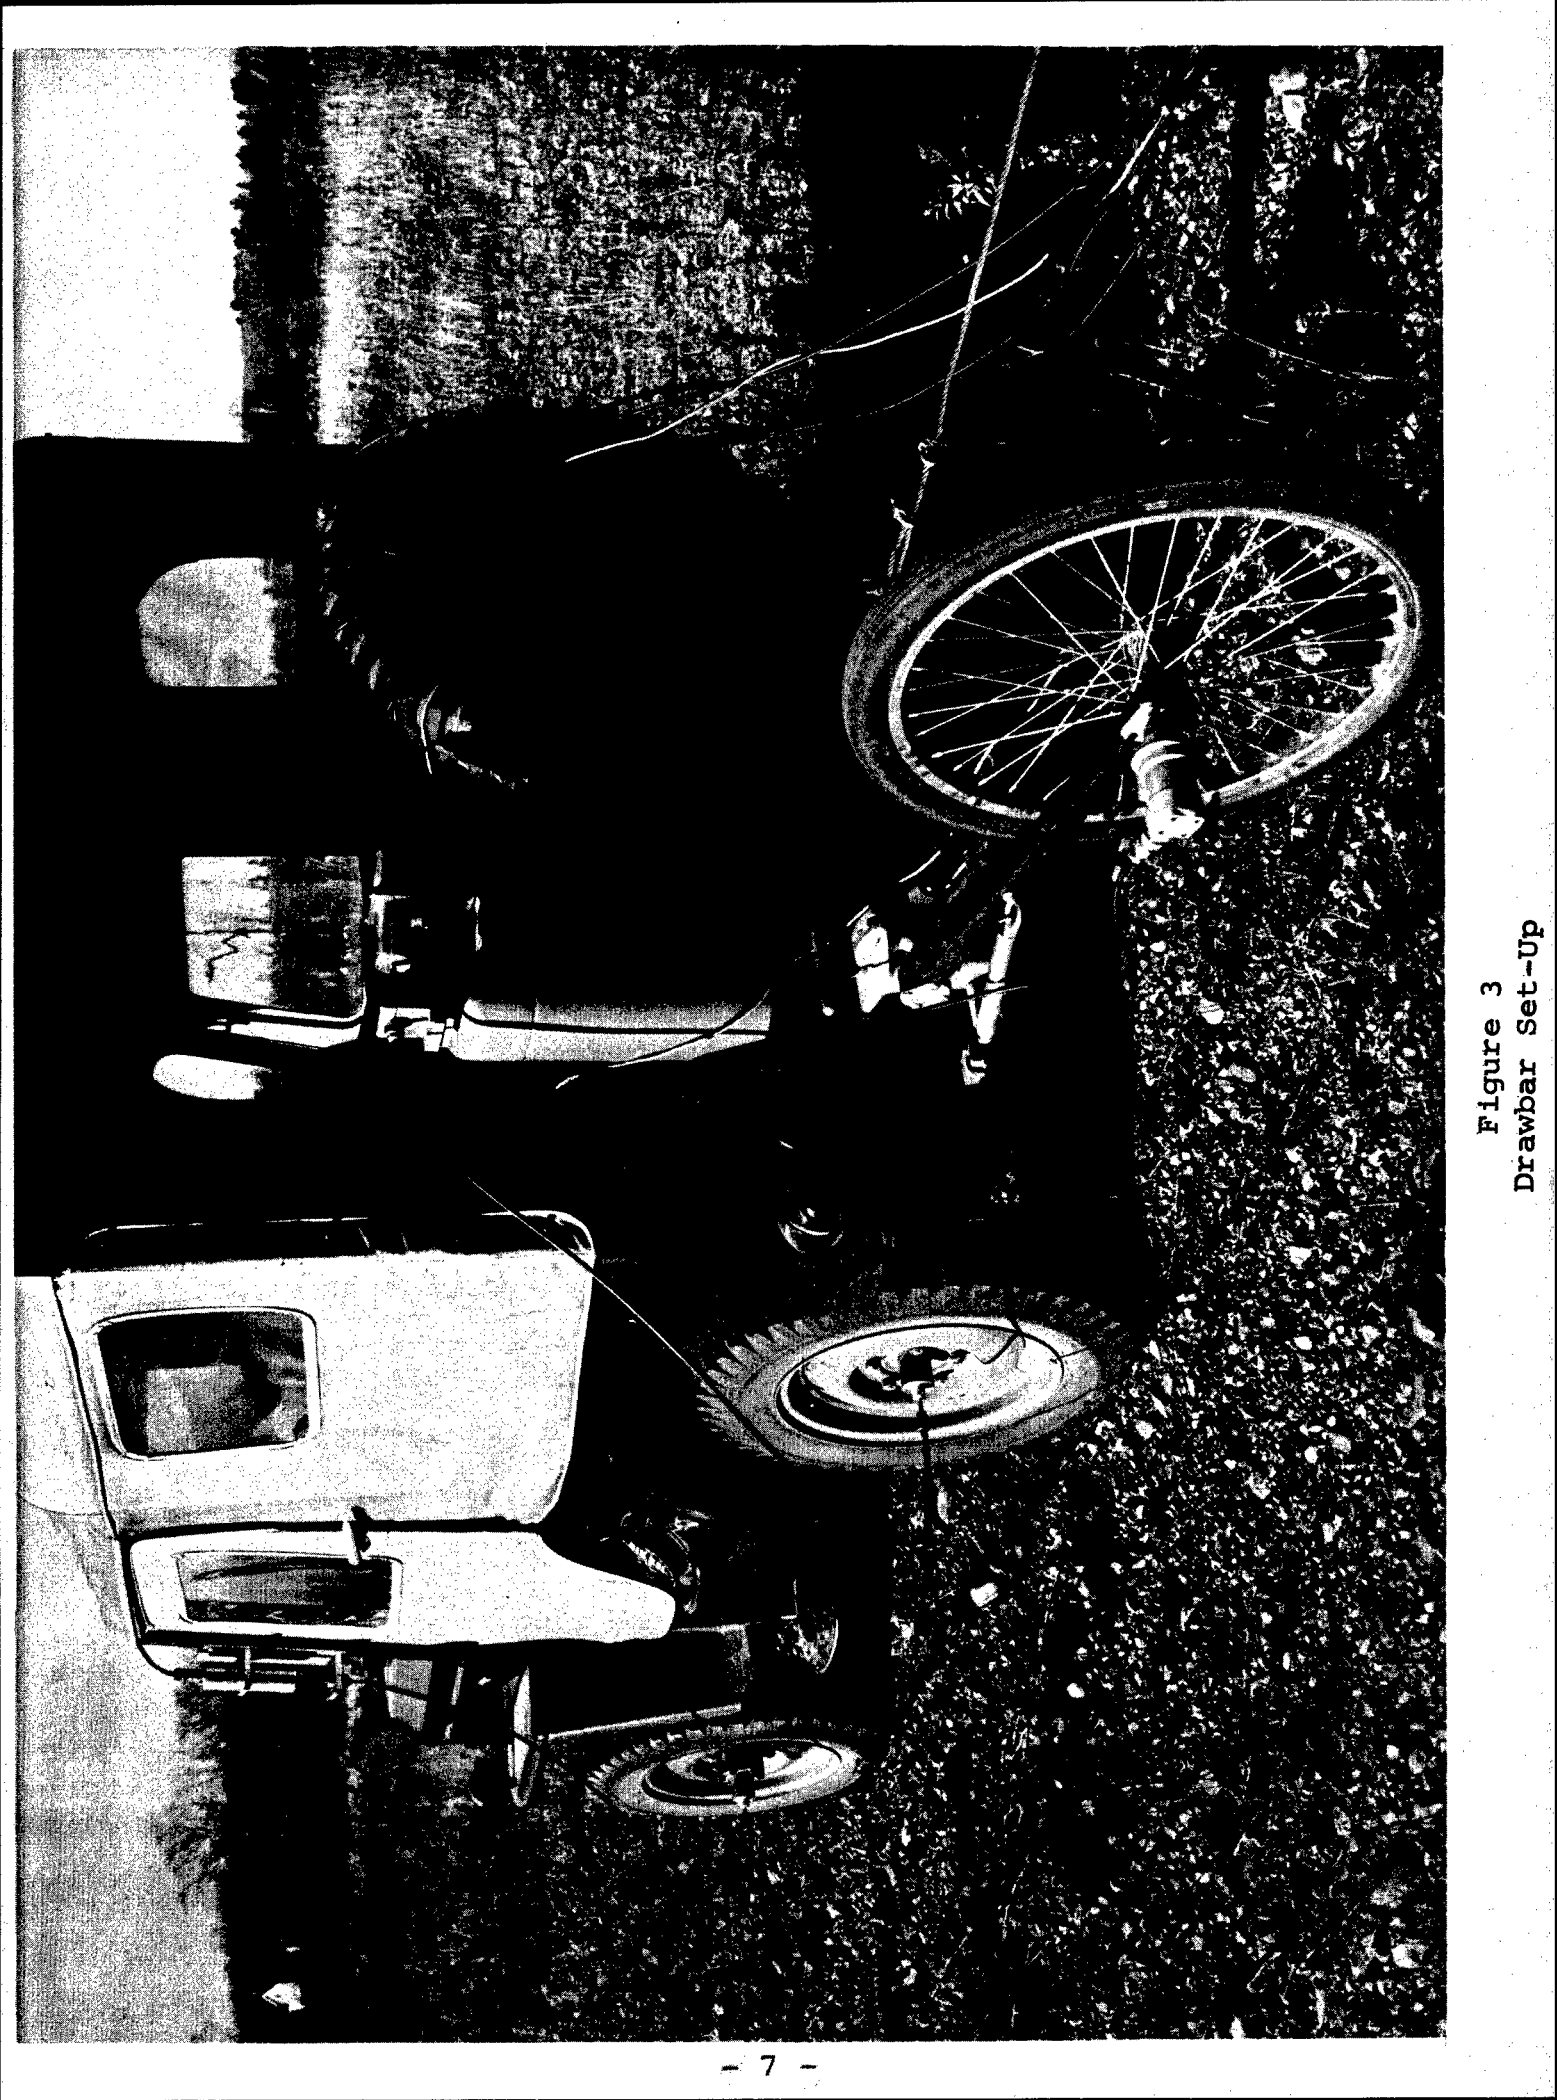
Figure 3  
Drawbar Set-Up

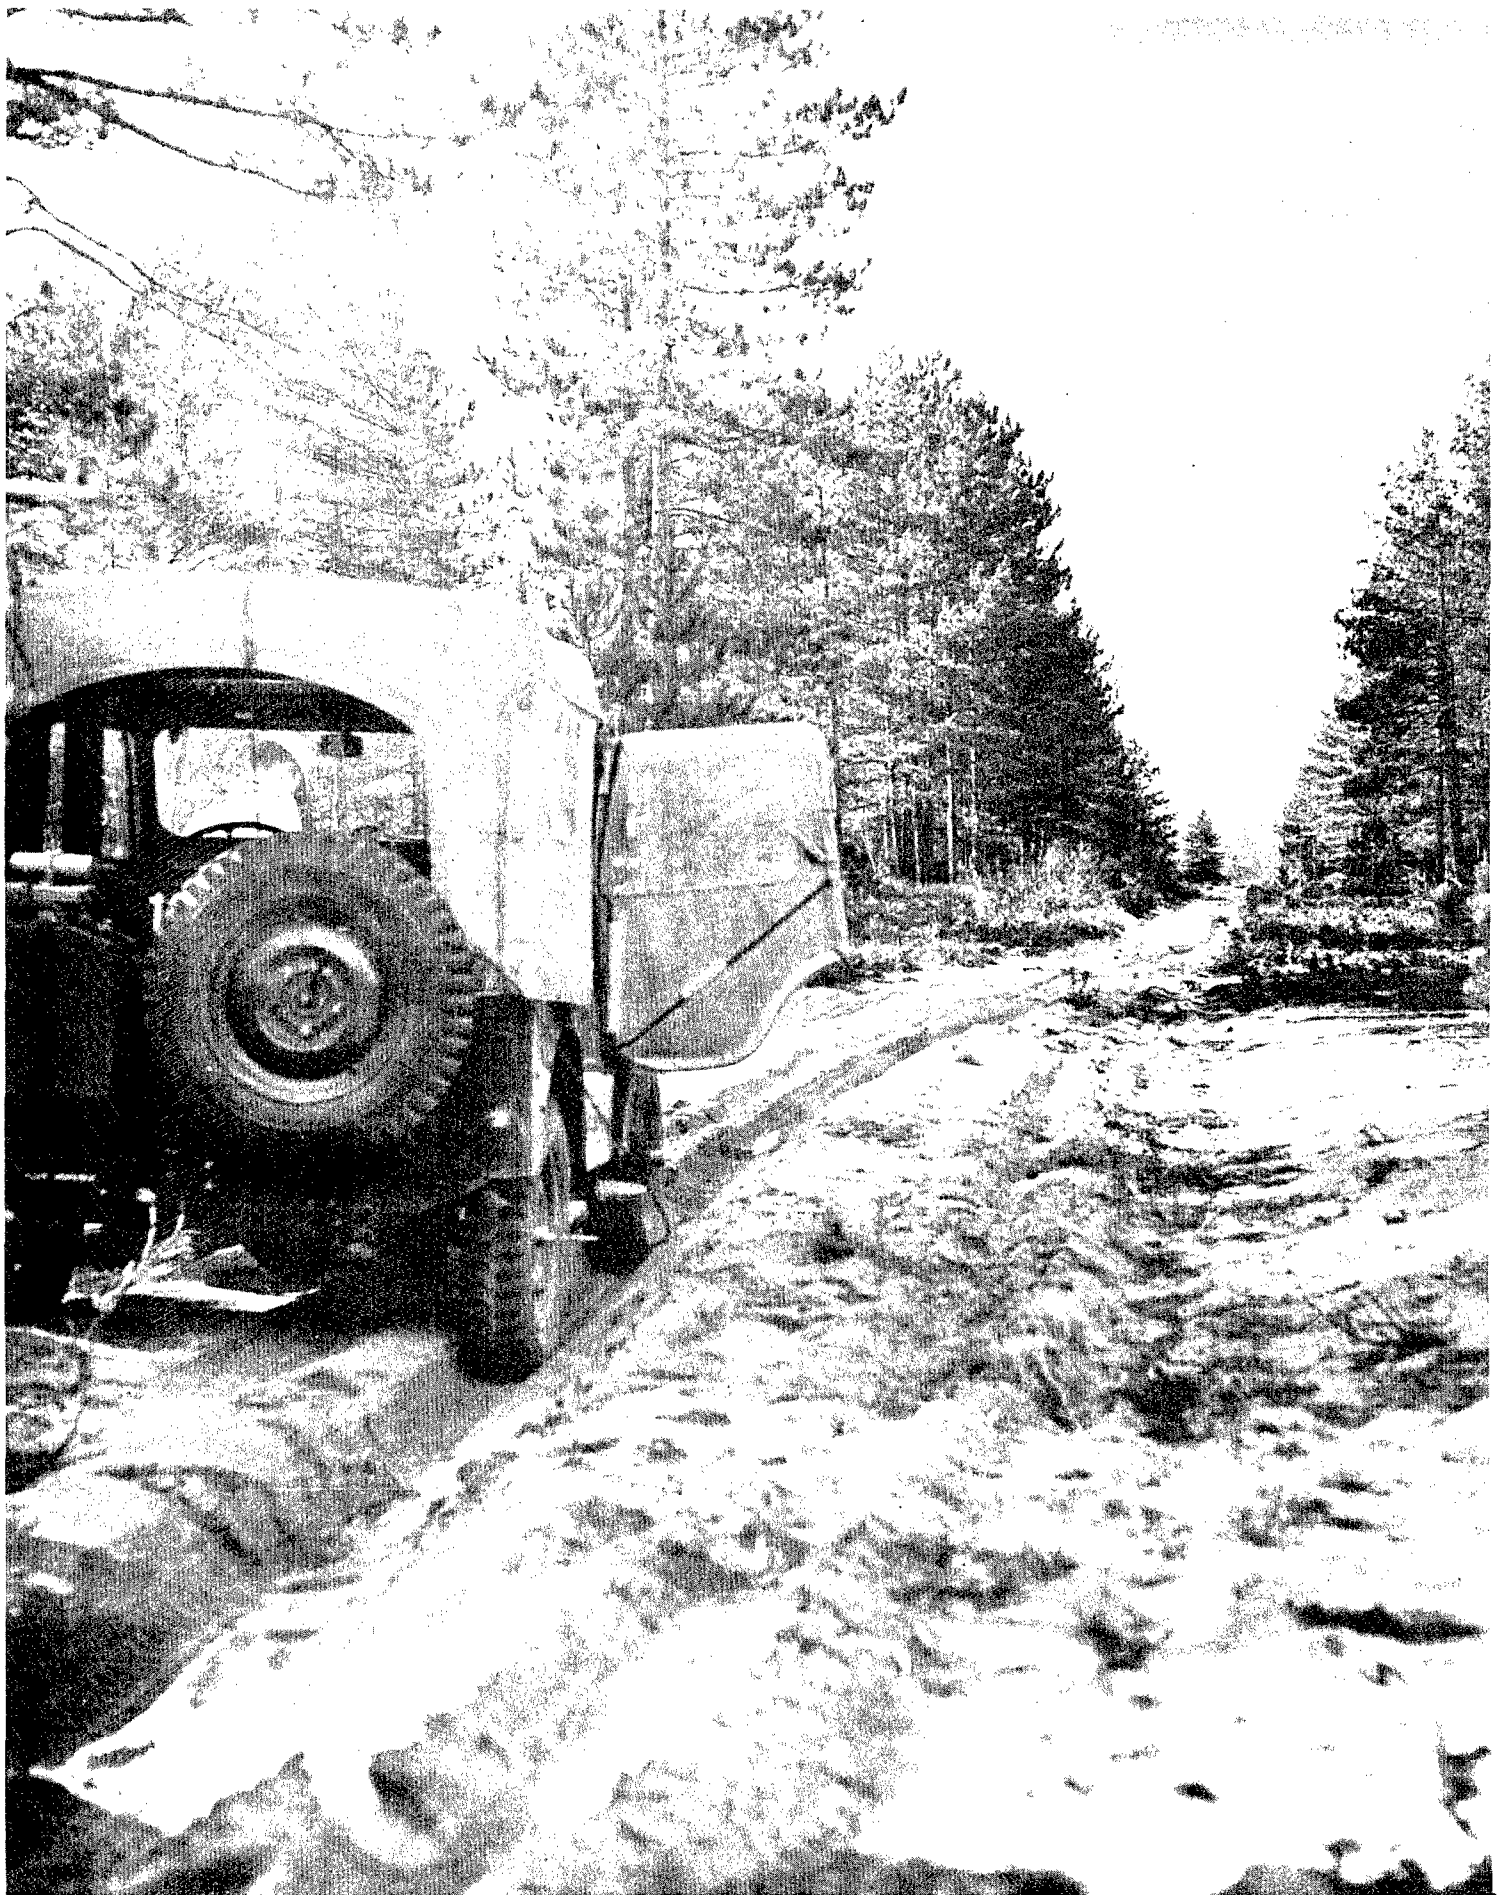
Figure 1A  
Drawbar Test in Sand

Jeep to the Military M38 Jeep. On no occasion was power limitation a cause of immobilization. A series of photographs, Figures 1A to 12A, inclusive, shows the vehicle on various test courses, both on summer and winter terrain.

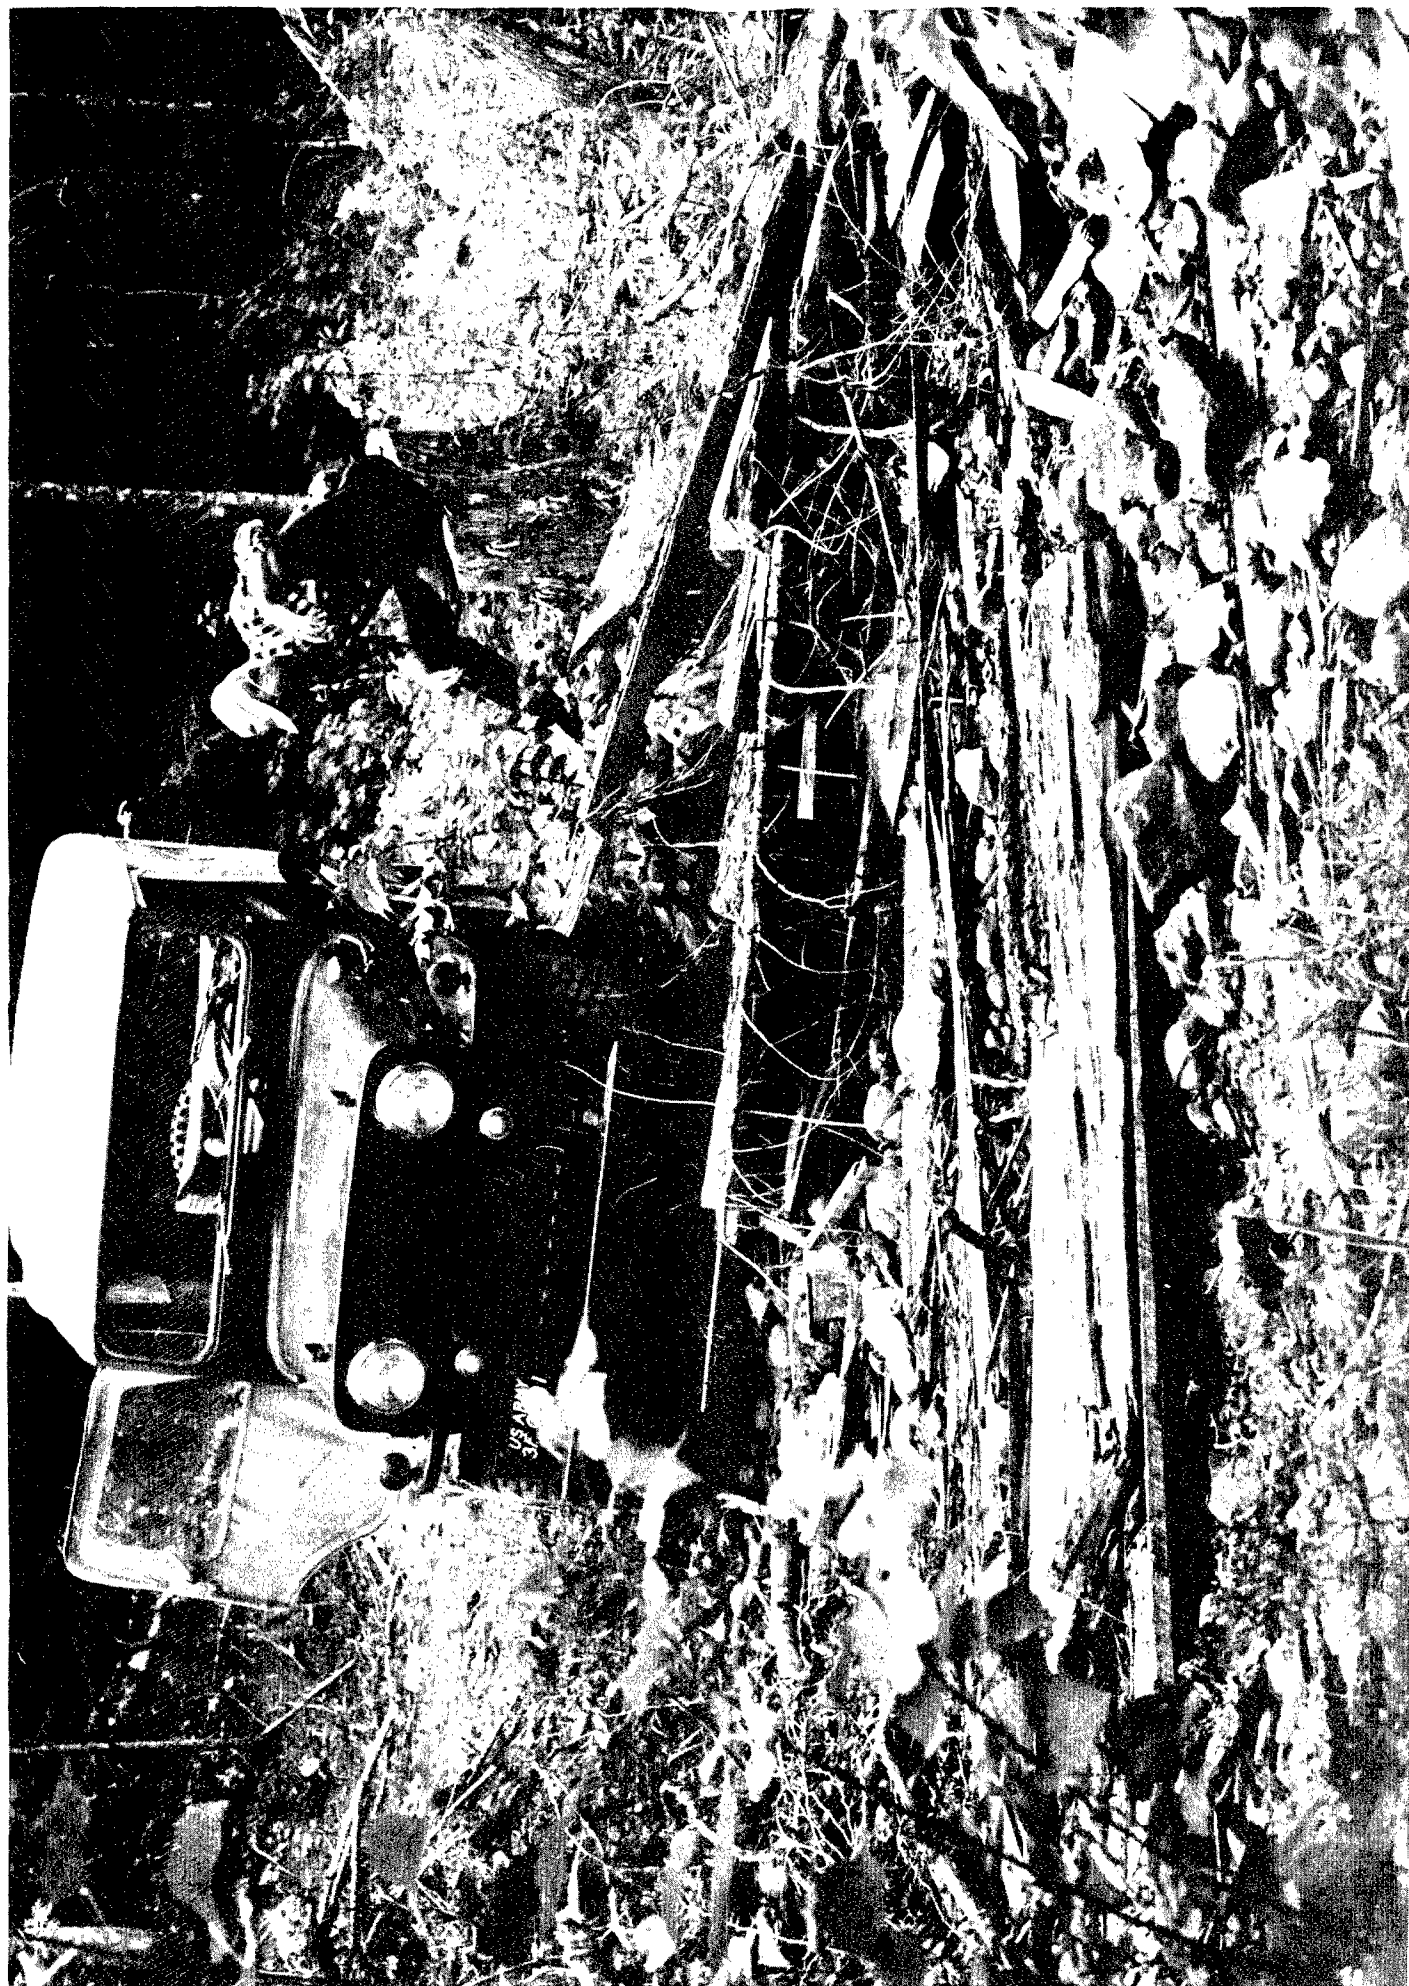
Figure 4A  
Hung-Up on Rough Cross Country Course

Vehicle mobility limits usually involved getting "hung-up" on the under carriage. This occurred in soft soil and also in snow which was encountered at the end of the vehicle test. In several instances the vehicle became hung-up on protruding obstacles; and in other cases, on ordinary soft soil surfaces, after the wheels dug themselves into soft ruts. A similar problem was encountered when snow accumulation caused decreased traction and high resistance to motion, and finally hanging-up on the underbelly. Mobility limiting snow conditions finally required sending in a track-laying tractor into the test area to retrieve the vehicle when it became immobilized in snow.

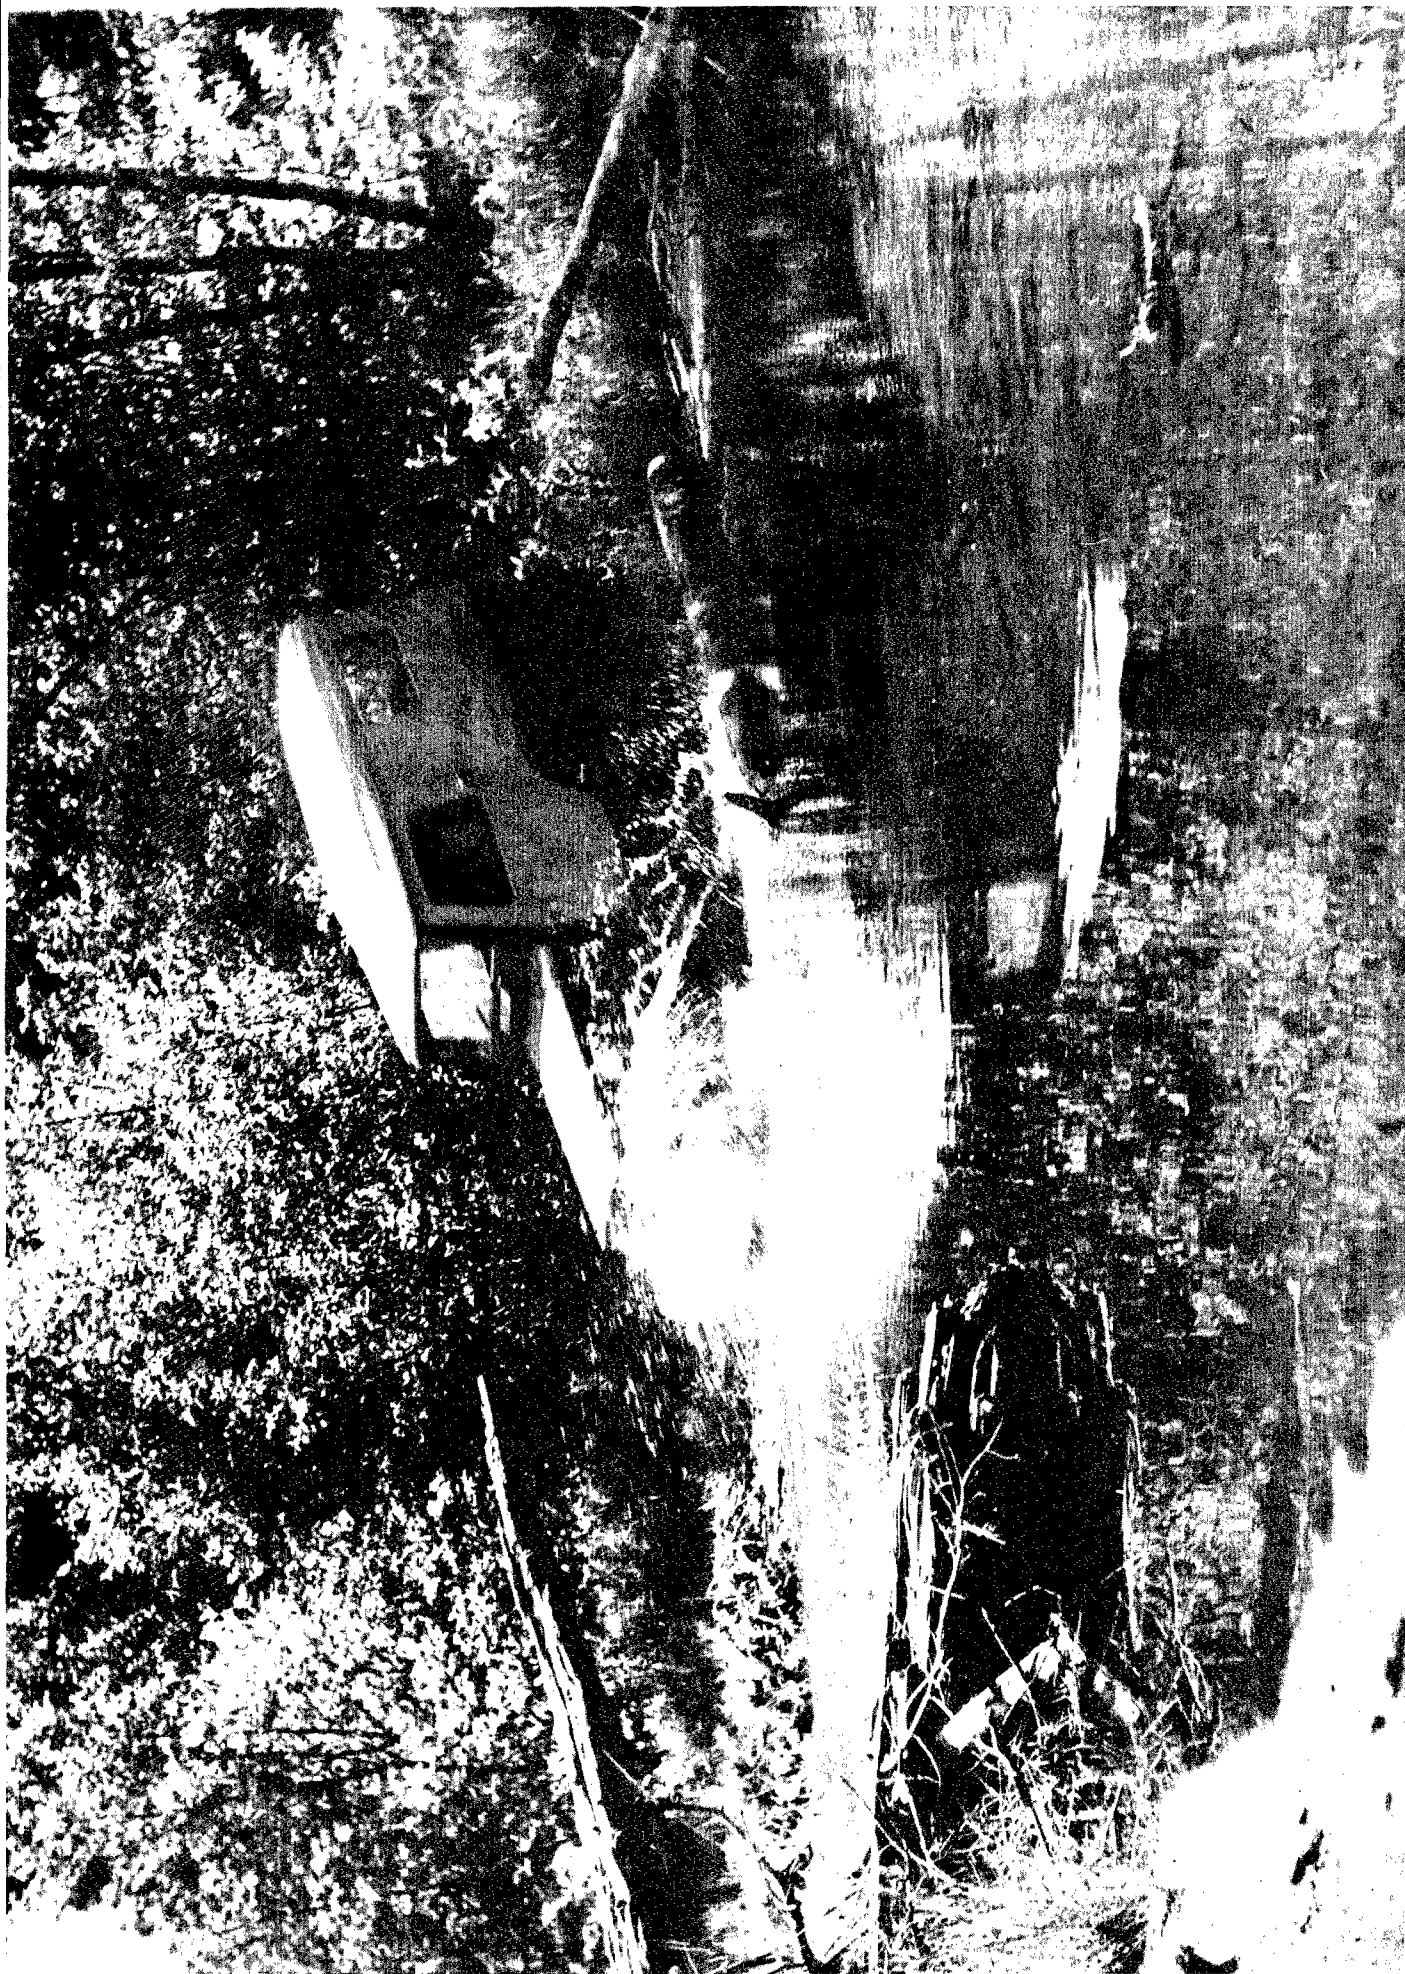
Figure 6A  
Creek Crossing on Cross Country Course

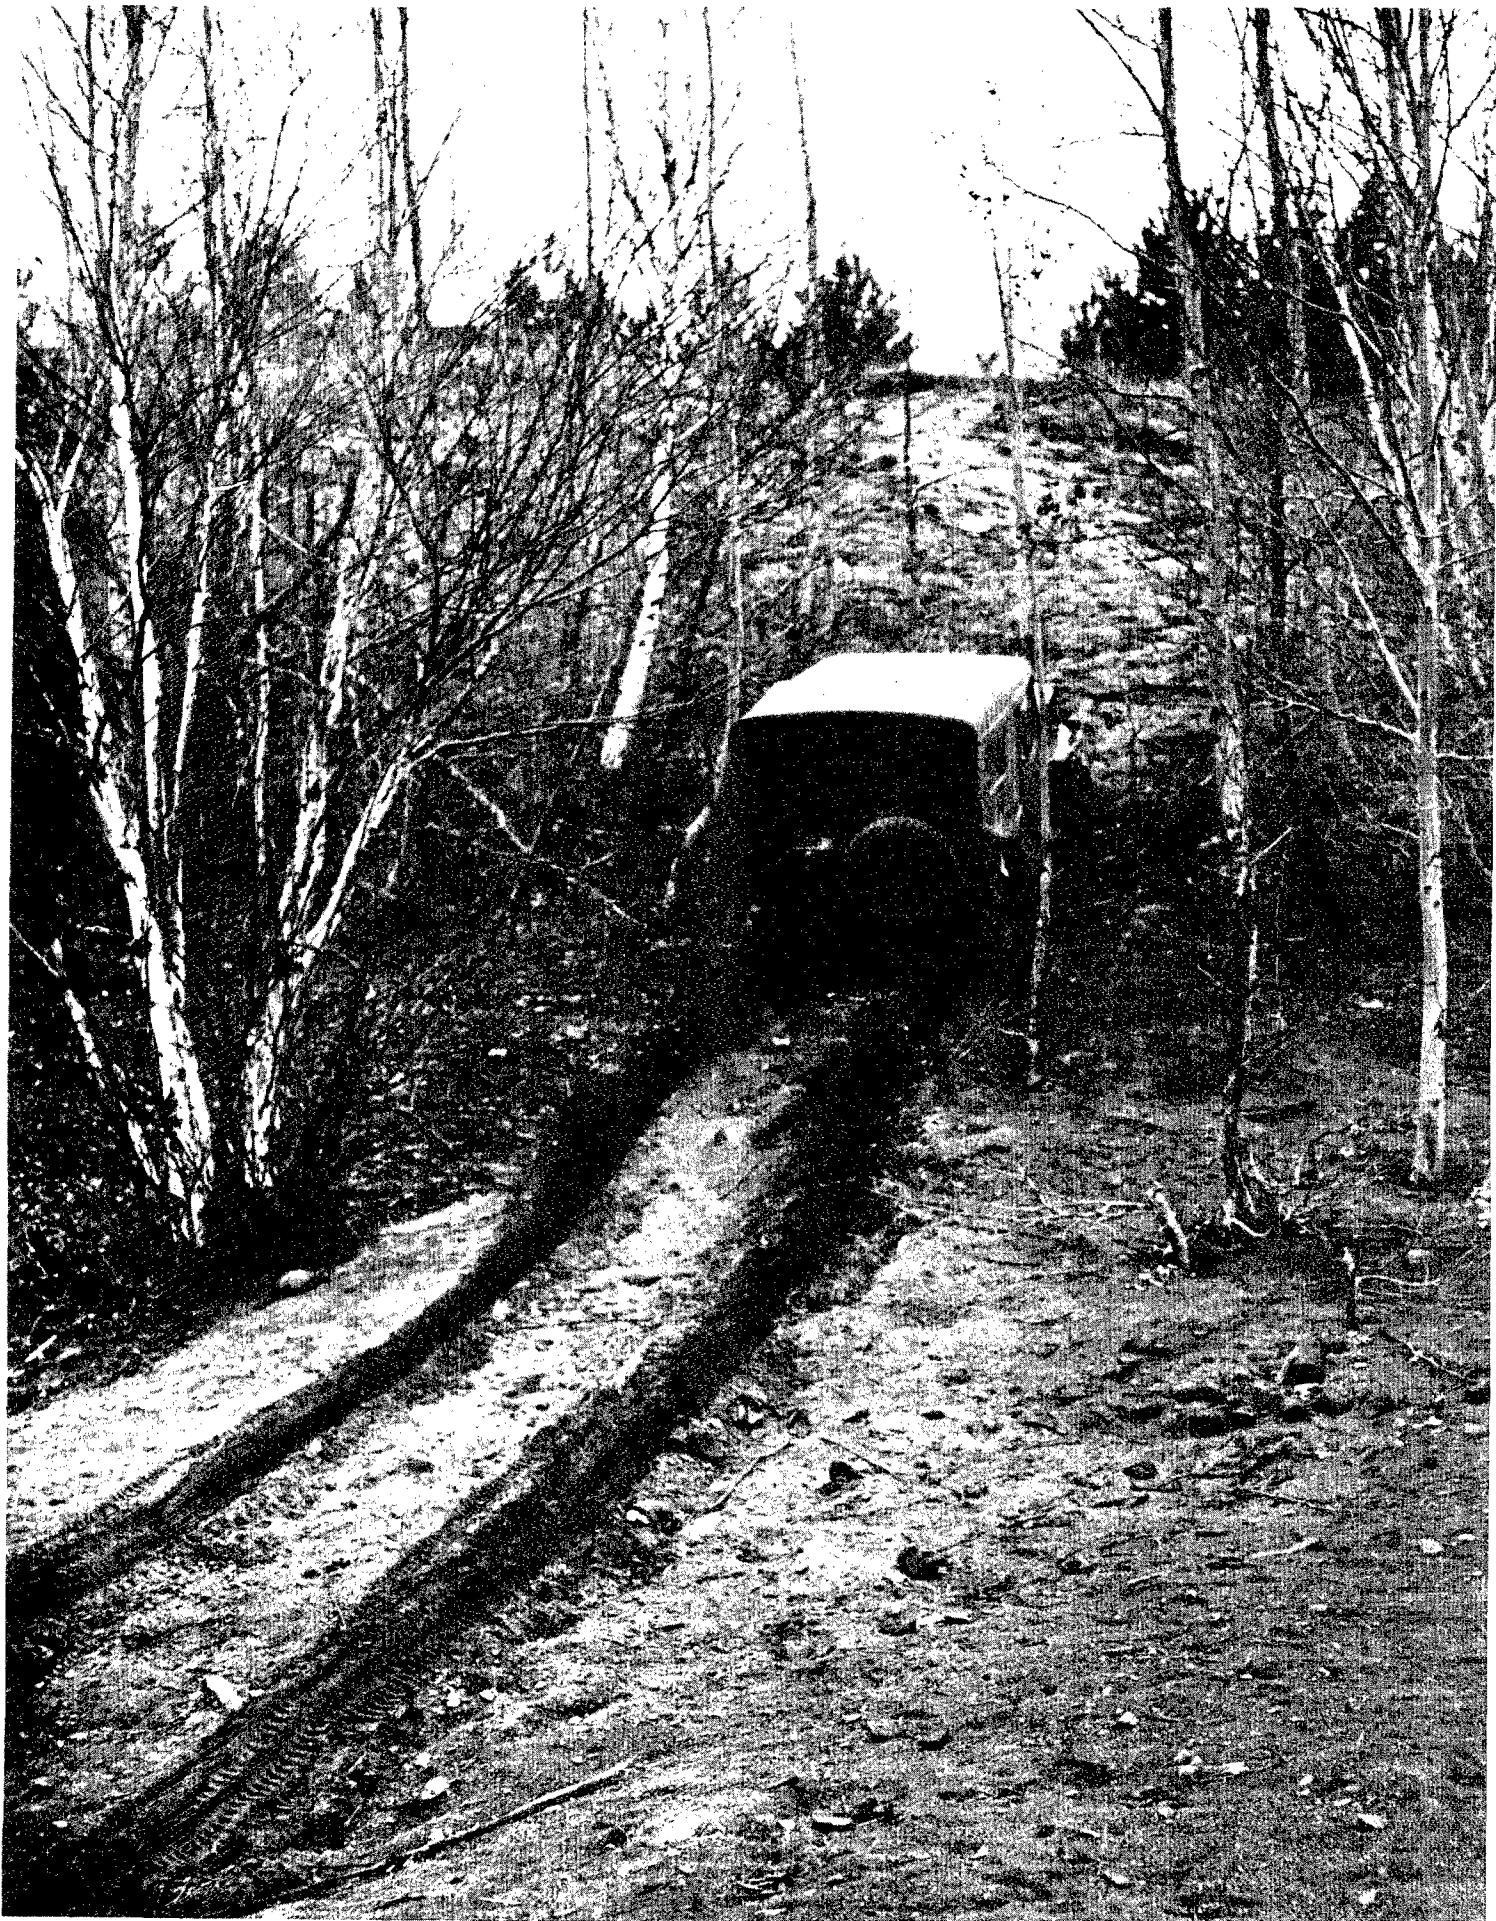
Figure 10A  
Gradeability Test on Packed Dirt

Table II lists the actual Vehicle Performance Factors as measured under test conditions in the Keweenaw Field Station area. Gradeability ranged from 35% on soft sand up to 60% on hard sand, 55% on loose soil, and 65-70% on packed dirt.

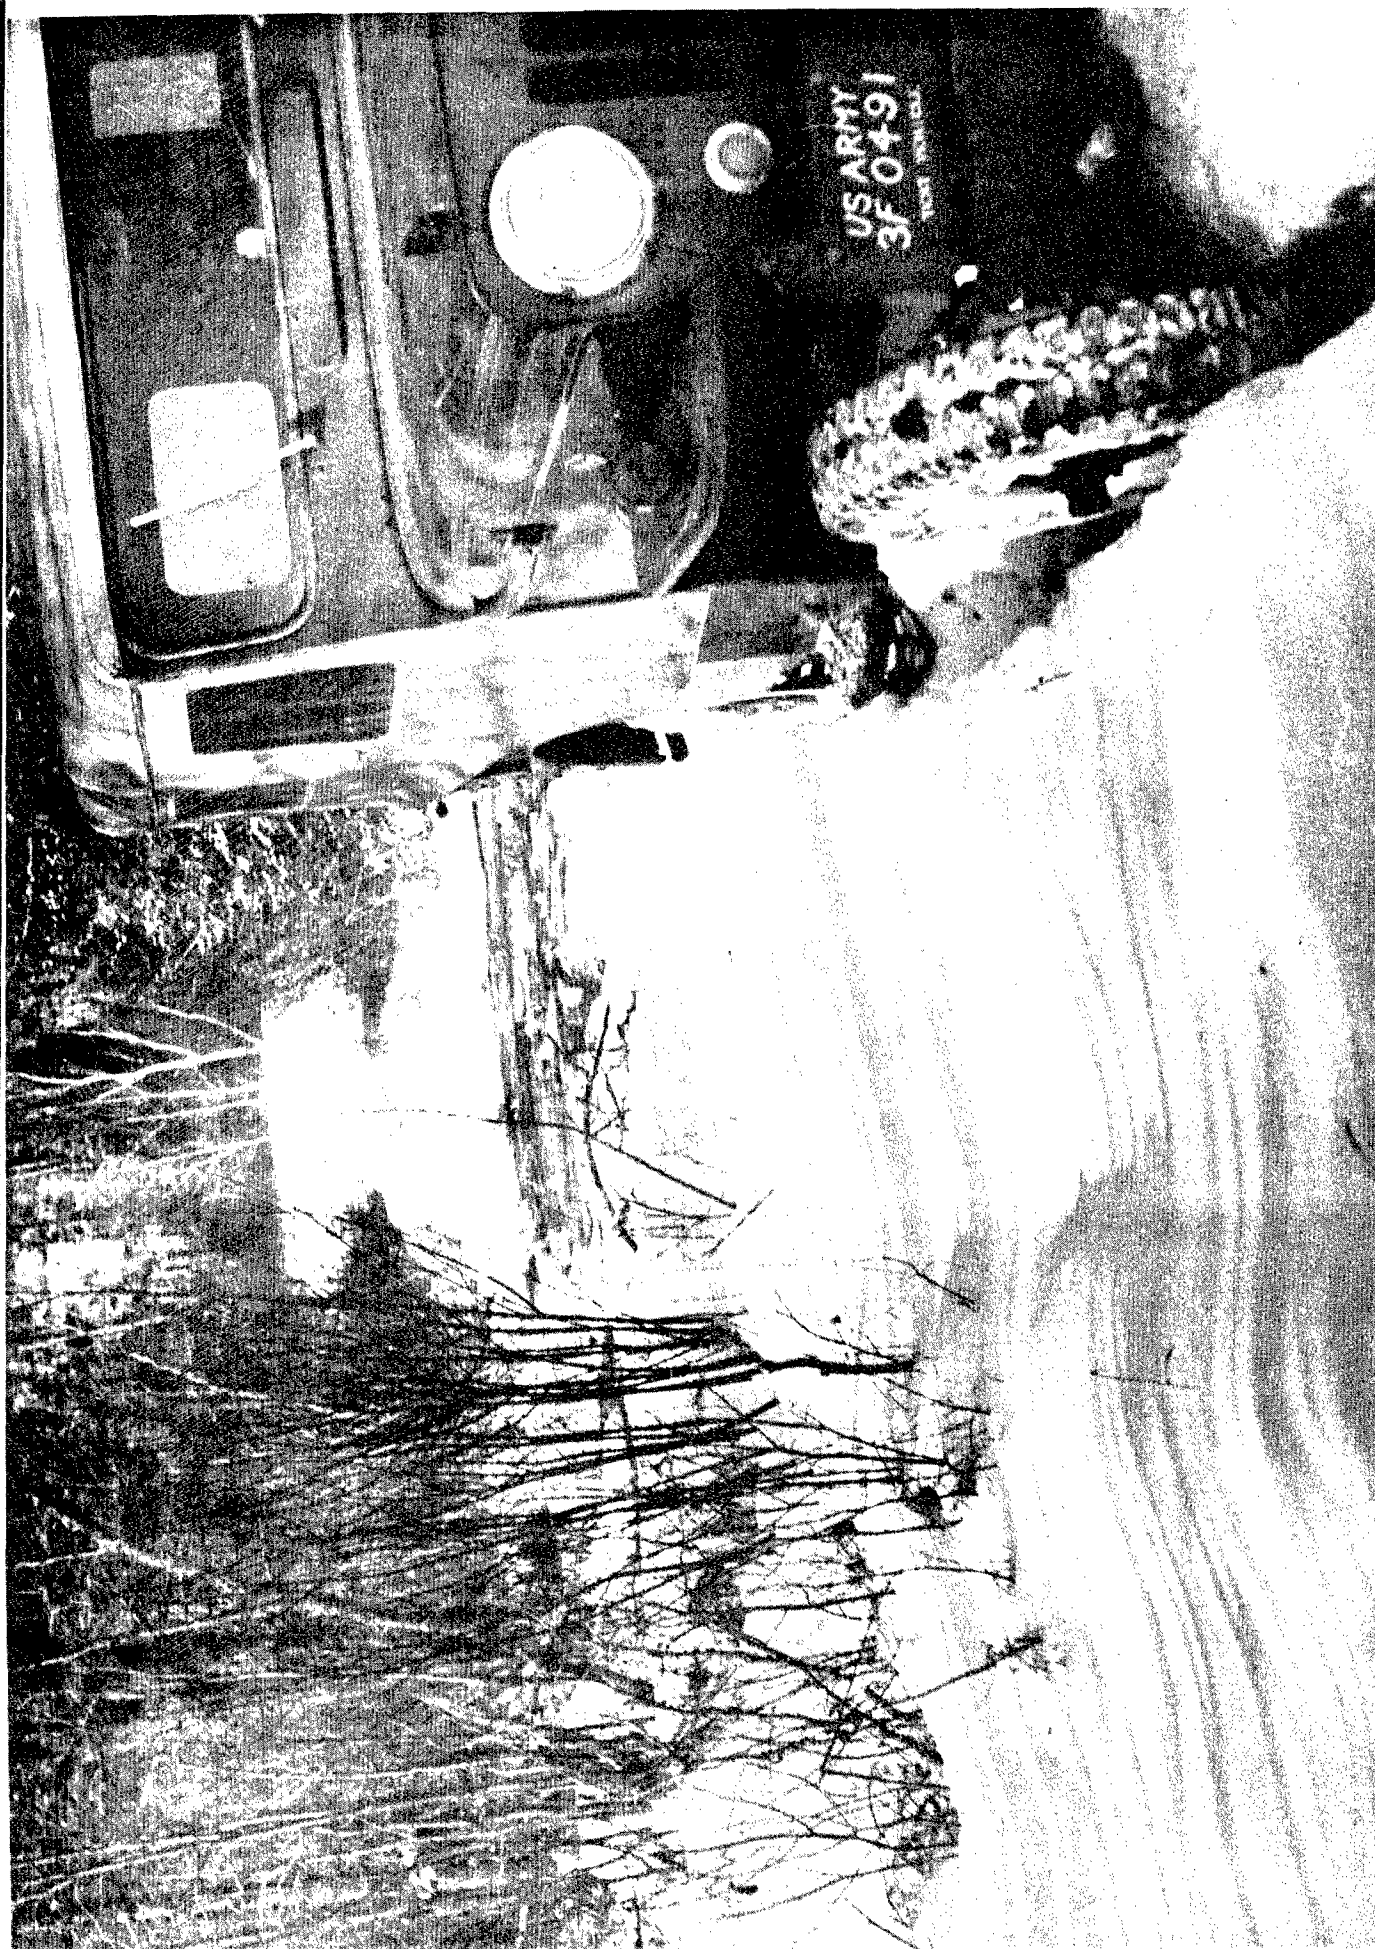
Figure 11A  
Mobility Test in Snow
