MISCELLANEOUS PAPER NO. 4-788

**EVALUATION OF AM2 LANDING MAT  
REPLACEMENT PANELS AND  
KEYLOCK ASSEMBLIES**

January 1966

U. S. Army Engineer Waterways Experiment Station  
CORPS OF ENGINEERS  
Vicksburg, Mississippi

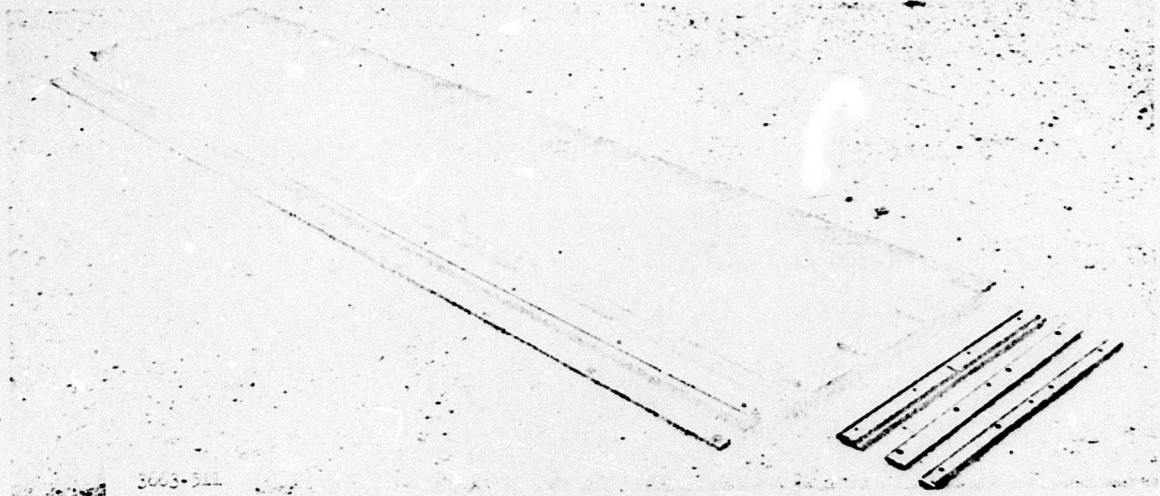
Fig. 1. Unassembled AM2 landing mat replacement panel

5. The replacement panels, fabricated by Harvey Aluminum Company, Torrance, Calif., are 10 ft long, 2 ft wide, about 1-1/2 in. thick, and average about 145 lb in weight. Figs. 1 and 2 show a replacement panel

with the side and end connectors disassembled and assembled, respectively. The side connector consists of two pieces which are held in place on the panel by ten 3/8-in. Allen screws and the end connector consists of three pieces which are held together and in place on the panel by four Allen screws. The four screws for the end connector are recessed in vertical-walled counterbores and the 10 screws for the side connector are countersunk.

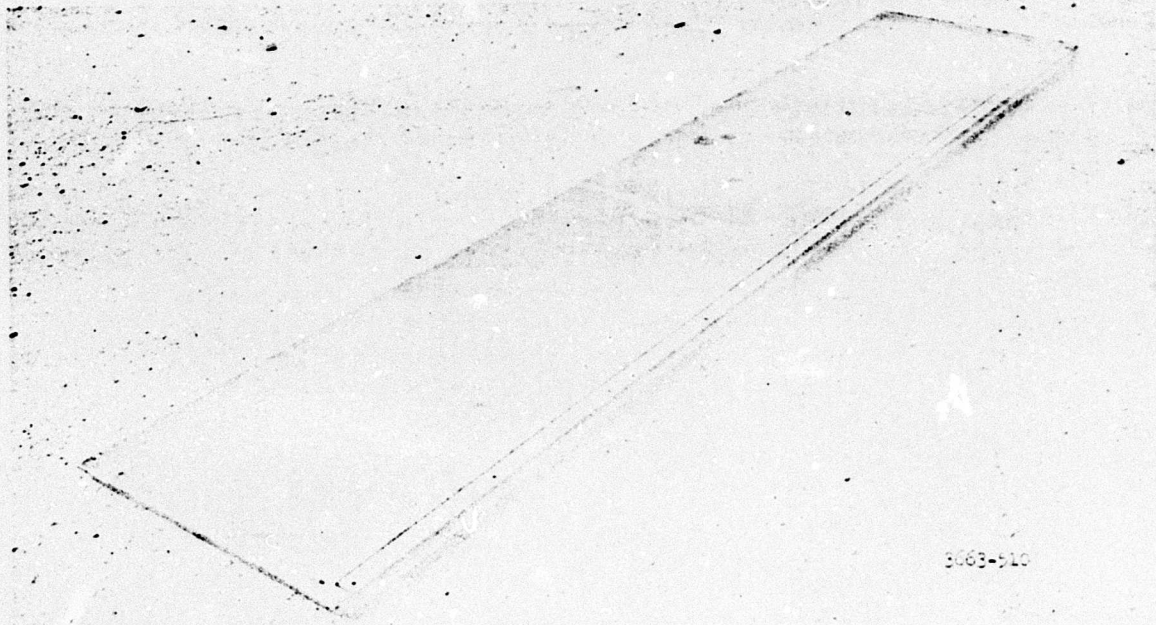
Fig. 2. Assembled AM2 landing mat replacement panel

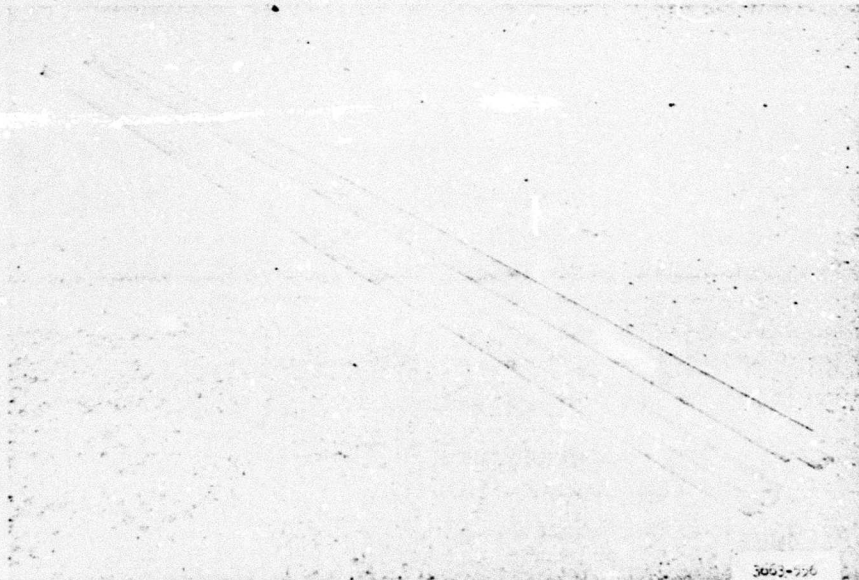
a. Standard

**Fig. 3. Keylock assembly**

6. The keylock assemblies were also fabricated by Harvey. They are 12 ft long, 4 in. wide, and weigh about 22 lb. The standard keylock assemblies (fig. 3a) have the same side connectors as the AM2 mat. Also tested were modified keylock assemblies (fig. 3b) which had male connectors on both sides, enabling the mat to be placed on both sides. The modified keylocks were about the same size as the standard keylocks and weighed 28 lb each. All of the keylocks were 12 ft long originally, but some were sawed into other lengths to accommodate the unusual mat size combinations. An Allen screw located at the end of the keylocks was used to lock them together.

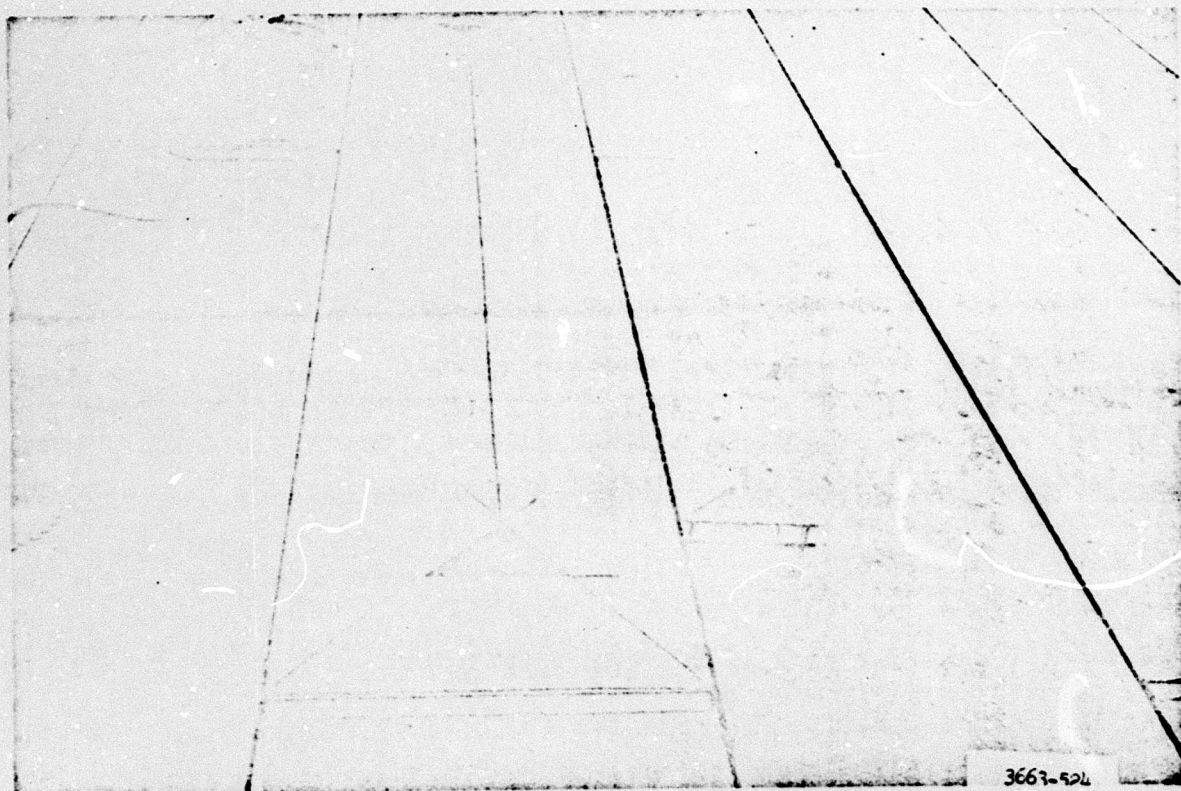
Fig. 6. Small triangles removed from damaged panel.

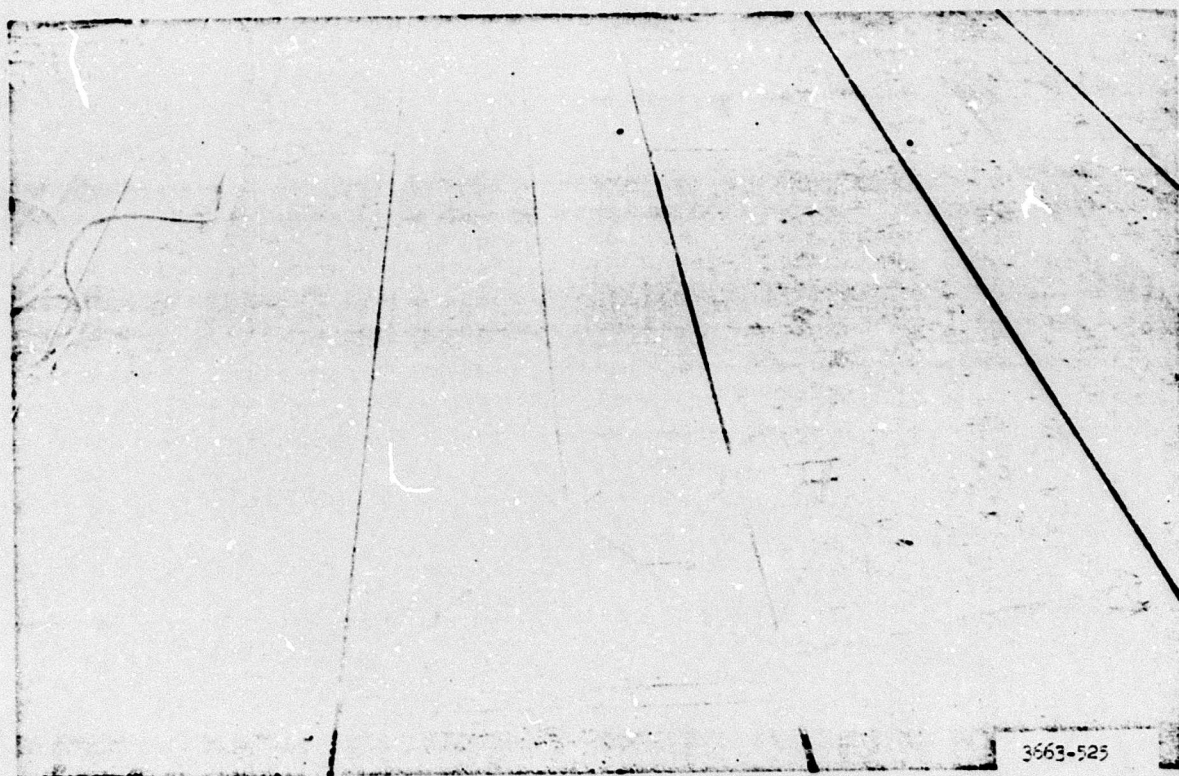
Fig. 7. Ends removed from damaged panel

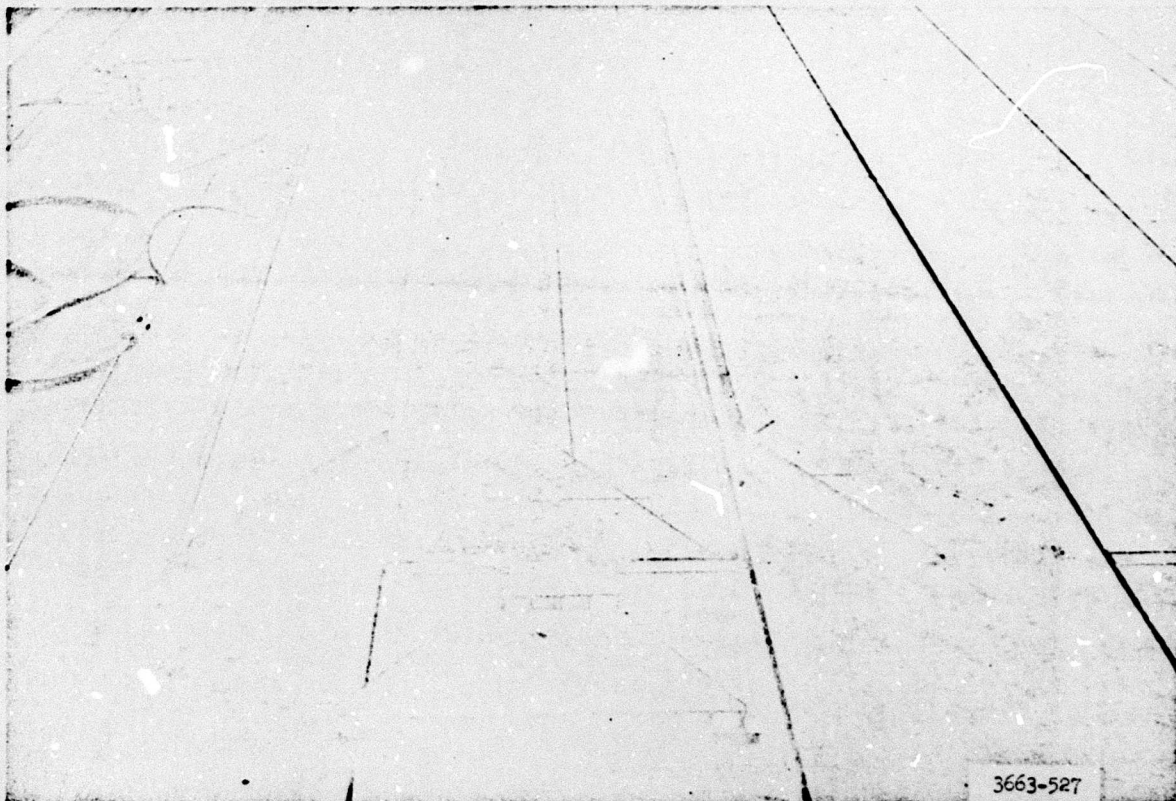
Fig. 8. Entire damaged panel removed

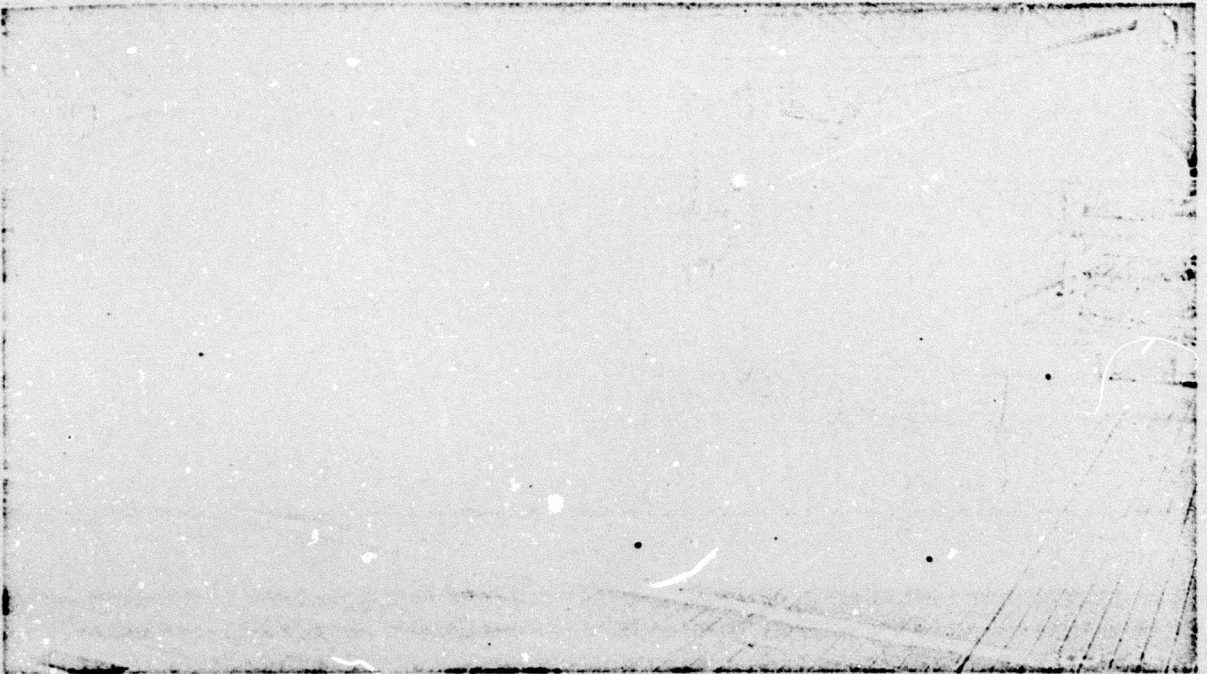
**Fig. 9. Test cart with 27,000-lb single-wheel load and tire inflated to 400 psi**

14. A specially designed single-wheel-load test cart (fig. 9) loaded to 27,000 lb was used in the traffic tests. It was fitted with an outrigger wheel (not visible in fig. 9) to prevent overturning and was powered by the front half of a four-wheel-drive truck. The load-cart wheel was equipped with a 30.00-7.7, 18-ply tire inflated to 400 psi. The tire contact area was about 82 sq in., and the average contact pressure was 330 psi.

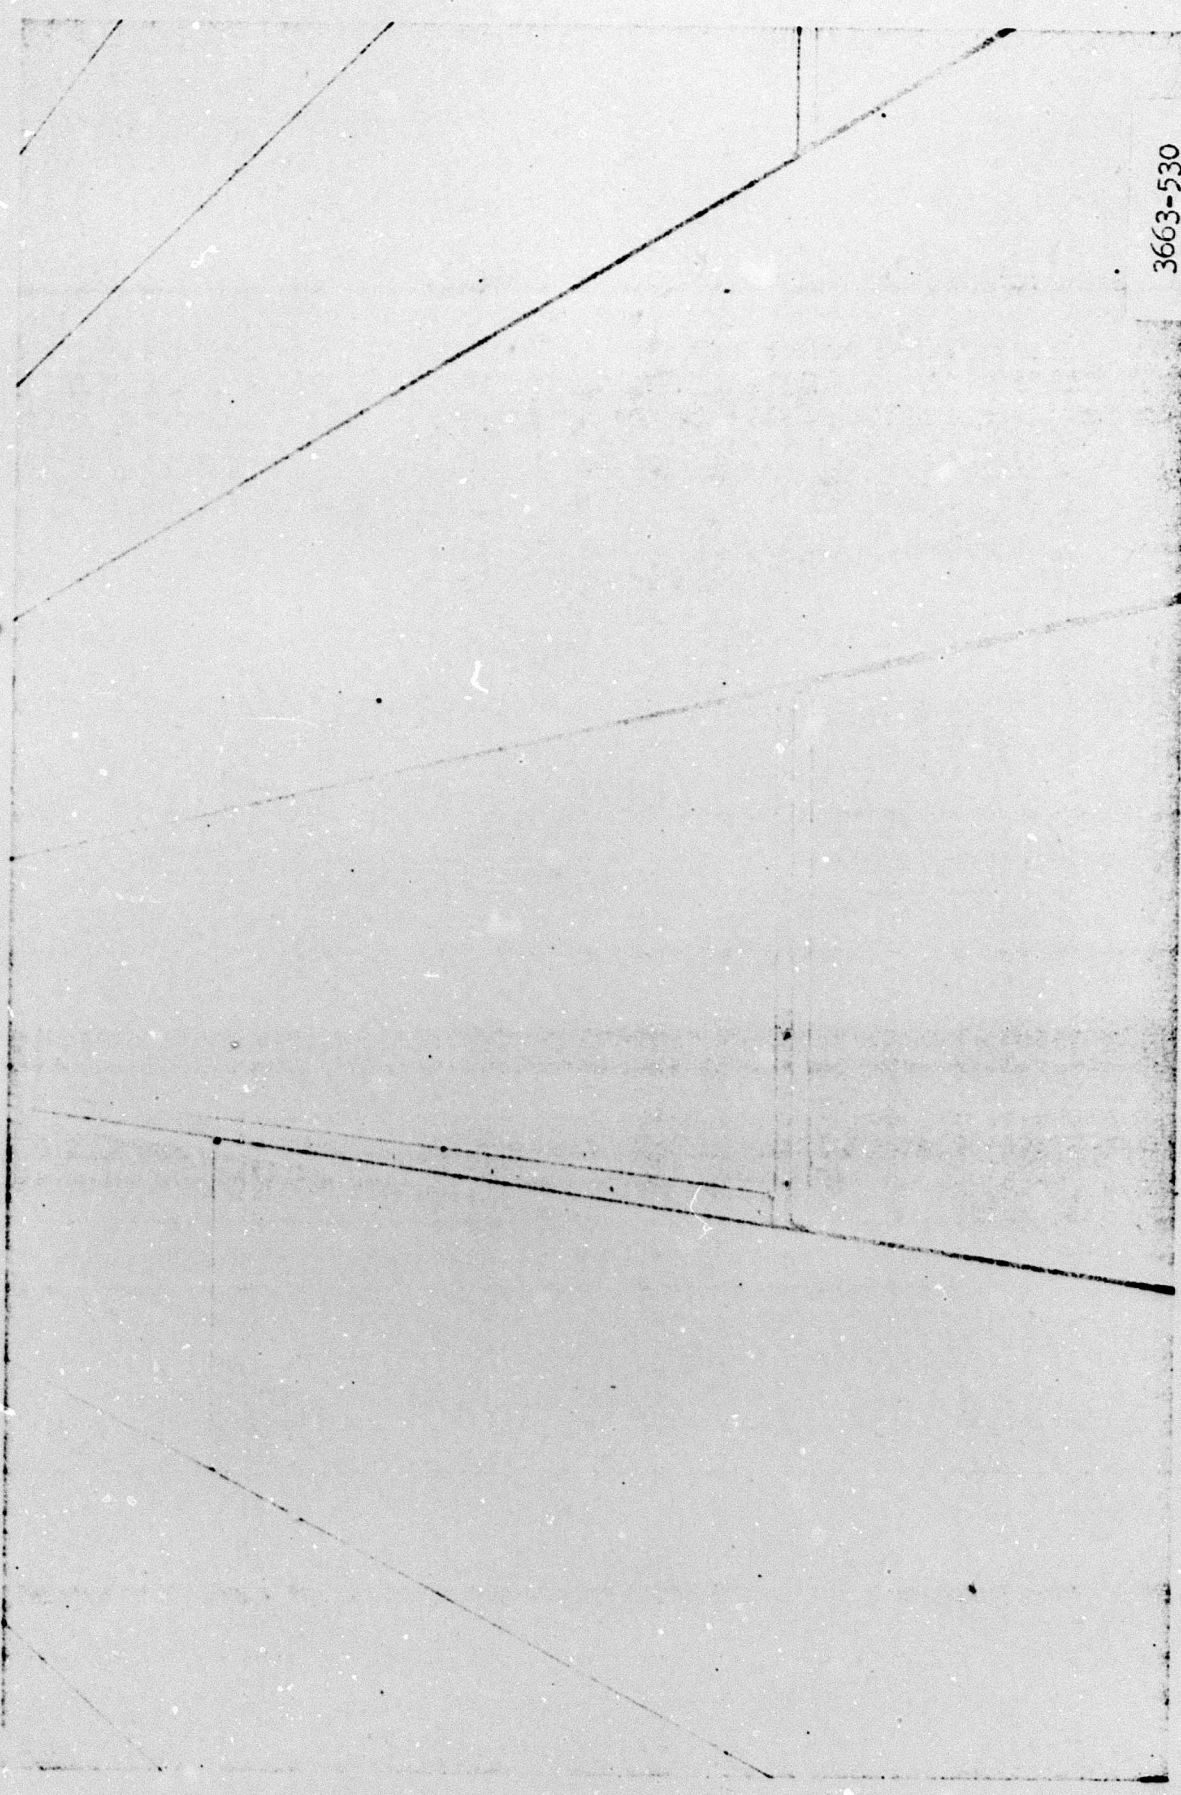
3663-530

Photograph 2. Replacement panel installed

The replacement panel was then laid in place and the screws were tightened to lock the panel in place. Approximately 35 min was required to remove and replace a panel, with the majority of this time being consumed by the sawing operation. Photograph 2 shows a replacement panel with installation complete.

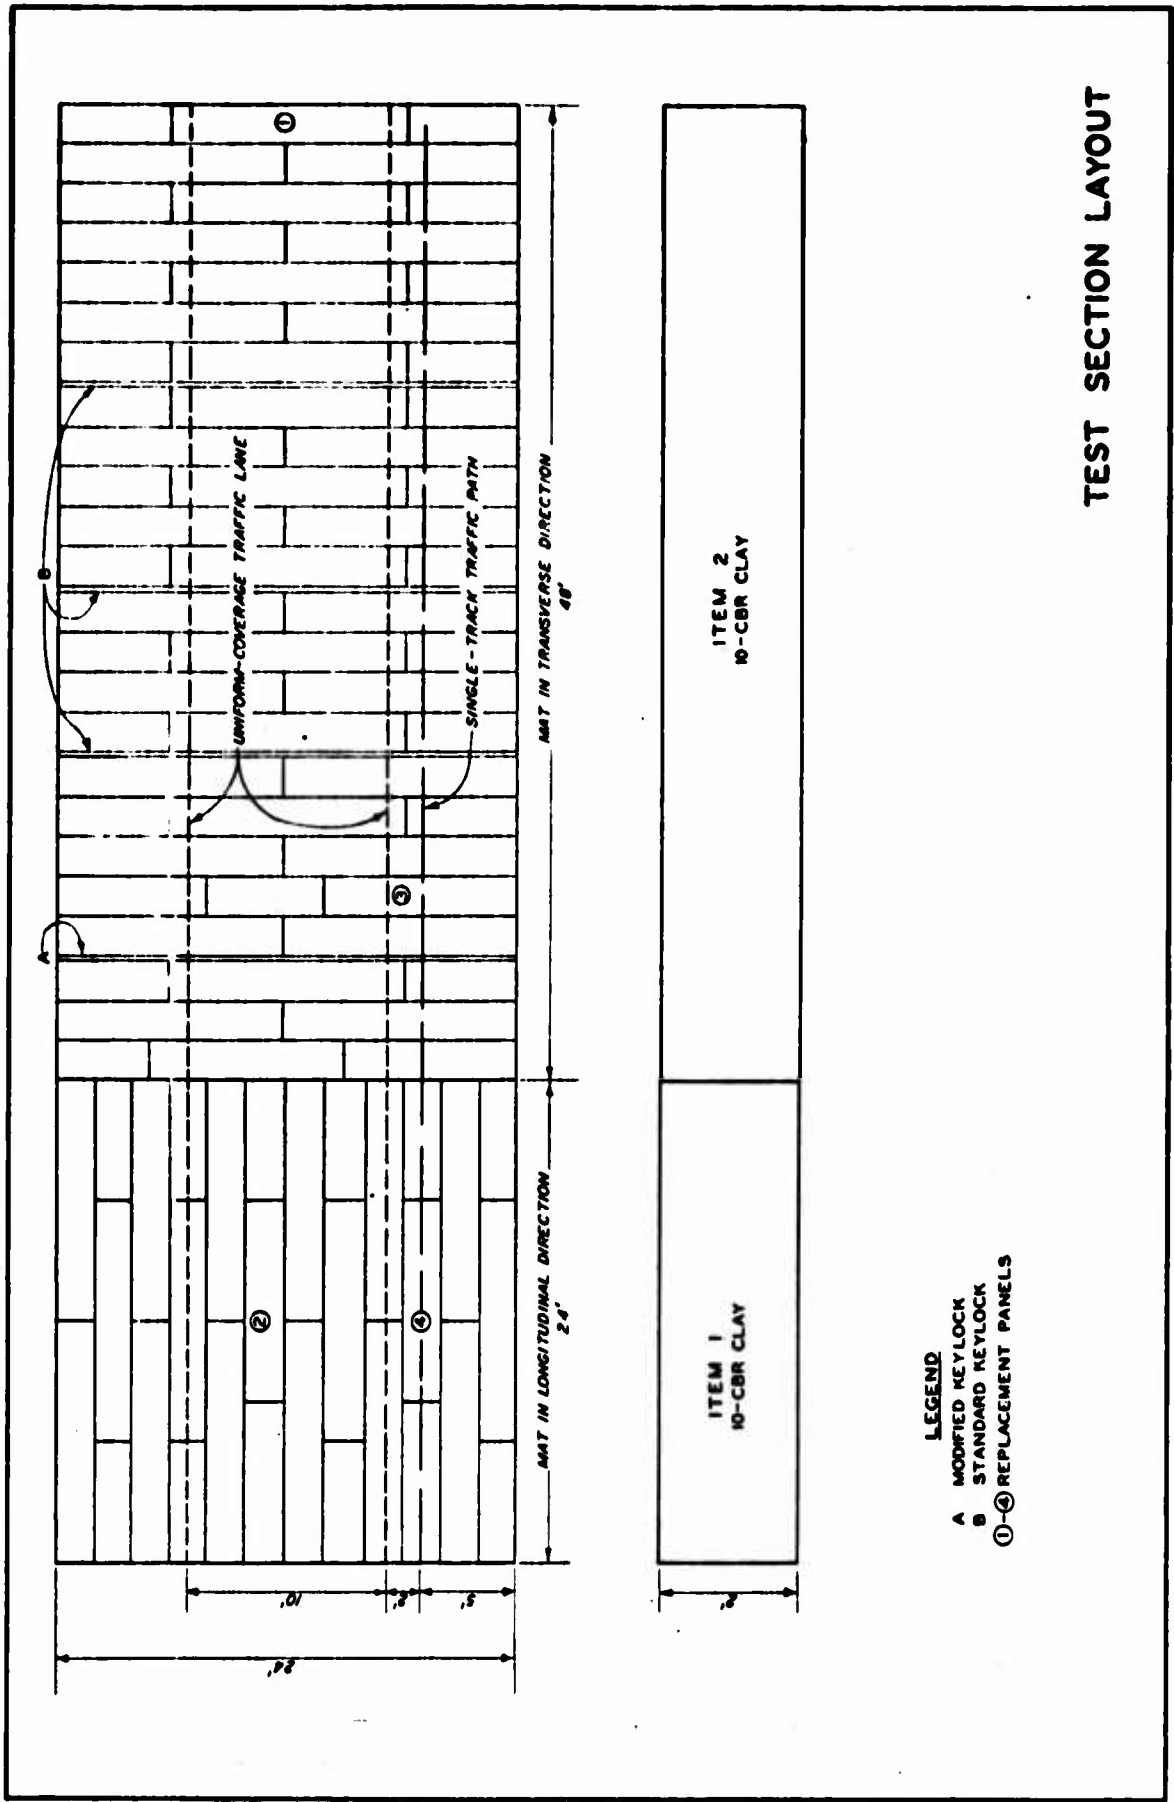
PLATE 1

8. The test section (plate 1) consisted of two test items, each approximately 24 ft wide. Item 1 was about 24 ft long and item 2 was about 48 ft long. Classification data for the subgrade, a heavy clay soil, are shown in plate 2. The locations of the replacement panels and keylock assemblies are shown in plate 1.

15. To simulate normal landing, takeoff, and taxi operations on a runway, uniform-coverage traffic was applied over a 10-ft-wide traffic lane down the center of the test section (plate 1). Traffic was applied by driving the load cart first forward and then backward the length of the test section. The path of the cart was shifted laterally about 7.3 in. (one tire-print width) on each successive forward pass. This procedure resulted in two complete coverages each time the load cart was maneuvered from one side of the traffic lane to the other. Traffic was continued to 188 coverages, which has been established as being equivalent to 1600 cycles of operations of an aircraft having a 27,000-lb single-wheel load and 400-psi tire inflation pressure (see WES MP 4-615\*).

16. As explained in paragraph 1, if a catapult system is used for launching an aircraft on the mat-surfaced runway, the main-gear wheels of a given type of aircraft will run in the same path during each takeoff. For 1600 cycles of aircraft operations, 1600 launchings would be required. Therefore, to simulate these operations, the load cart was driven forward and backward in the same track for 1600 passes. The center line of the traffic path was located 2 ft outside the uniform-coverage traffic lane and 5 ft from the outside edge of the section, as shown in plate 1.

19. Item 1. In item 1, with mat laid parallel to the direction of traffic, one replacement panel was placed near the center of the uniform-coverage traffic lane and one was placed at the center of the single-track traffic path (plate 1); therefore, neither panel received both the uniform-coverage and the single-track traffic.

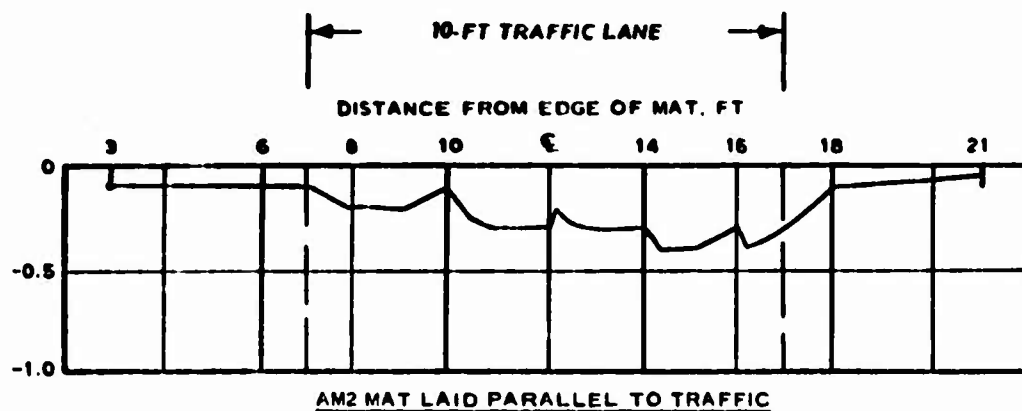
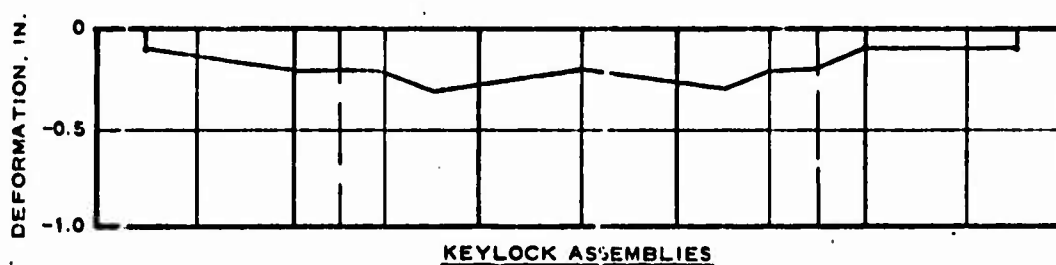
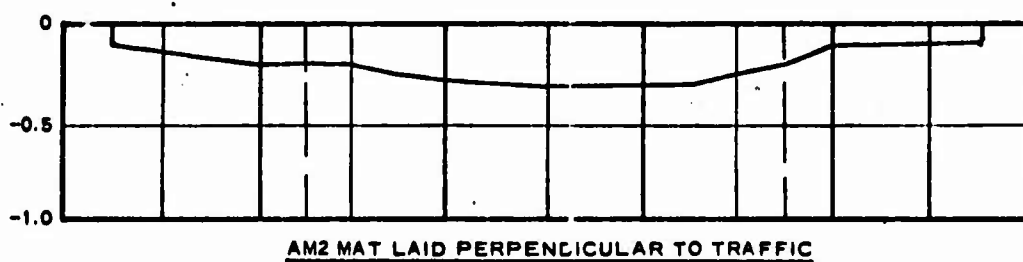
PERMANENT MAT DEFORMATION  
 27,000-LB SINGLE-WHEEL LOAD  
 400-PSI TIRE INFLATION PRESSURE  
 UNIFORM-COVERAGE TRAFFIC  
 188 COVERAGES

28. Permanent deformation. Level readings taken to show permanent deformation of the mat during traffic are shown in plates 3 and 4. The data in plate 3 show average cross sections after the uniform-coverage traffic for the AM2 mat (laid longitudinally and transversely) and for the keylock assemblies in item 2. These data indicate that a relatively uniform deformation of about  $1/4$  in. occurred over the entire test section under the uniform-coverage traffic. Plate 4 shows a profile of the single-track traffic path after 1600 passes of the load wheel. These data show that the maximum permanent deformation was about the same in item 1 and item 2. However, more variation in the surface elevation developed in item 2 than in item 1.

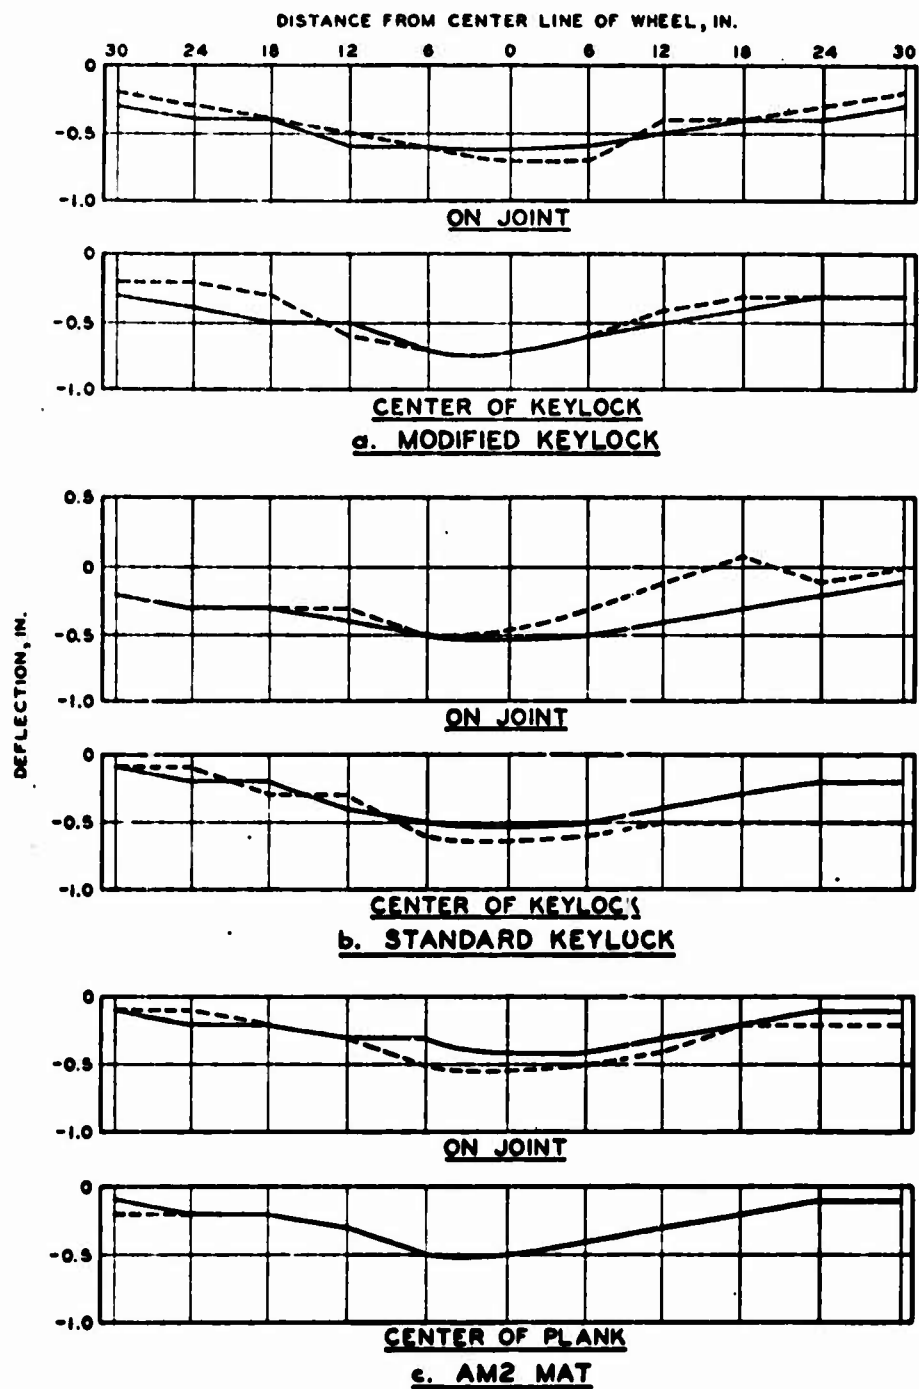
**MAT DEFLECTIONS  
ITEM 2  
27,000-LB SINGLE-WHEEL LOAD**

29. Mat deflection. Level readings taken to show the mat deflection in item 1 are shown in plate 5. These data indicate the elastic deflection, or rebound, of the mat as the load wheel moved over the surface. Plate 6 shows data from item 2 on the AM2 mat and for standard and modified keylocks in item 2 at an end joint and at a center point of a panel. These data show that deflections of about  $1/4$  to  $3/4$  in. occurred throughout the test period.
