Institute of Ocean Science and Engineering  
School of Engineering and Architecture  
The Catholic University of America  
Washington, D.C. 20017

| 3. REPORT TITLE<br>AXIAL FATIGUE OF WIRE ROPE IN SEA WATER | | | |
| 4. DESCRIPTIVE NOTES (Type of report and inclusive dates)<br>Final Report | | | |
| 6. REPORT DATE<br>June 15, 1972 | | 7a. TOTAL NO. OF PAGES<br>65 | 7b. NO. OF REFS<br>27 |

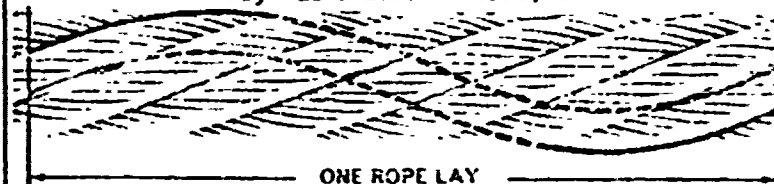
"Lay" as a unit of measure

Showing how "one rope lay" is the lengthwise distance in which a strand makes one complete turn around the rope.

In its second meaning, as a unit of measure, rope *lay* means the lengthwise distance a single strand covers in making one complete turn around the rope. Lay length is measured in a straight line parallel to the center line of the rope, *not* by following the strand as it spirals around the rope. Lay length is directly related to rope diameter, providing a convenient basis for rope inspection. An example of the use of this would be in the requirement that a rope be removed from service after a certain number of wires are broken in one rope lay. Such a requirement would be more dependable than one requiring removal on the basis of broken wires per foot.
