AFFDL-TR-71-127

## ANNEALED FOIL FATIGUE SENSOR DEVELOPMENT

*LOCKHEED-GEORGIA COMPANY*

TECHNICAL REPORT AFFDL-TR-71-127

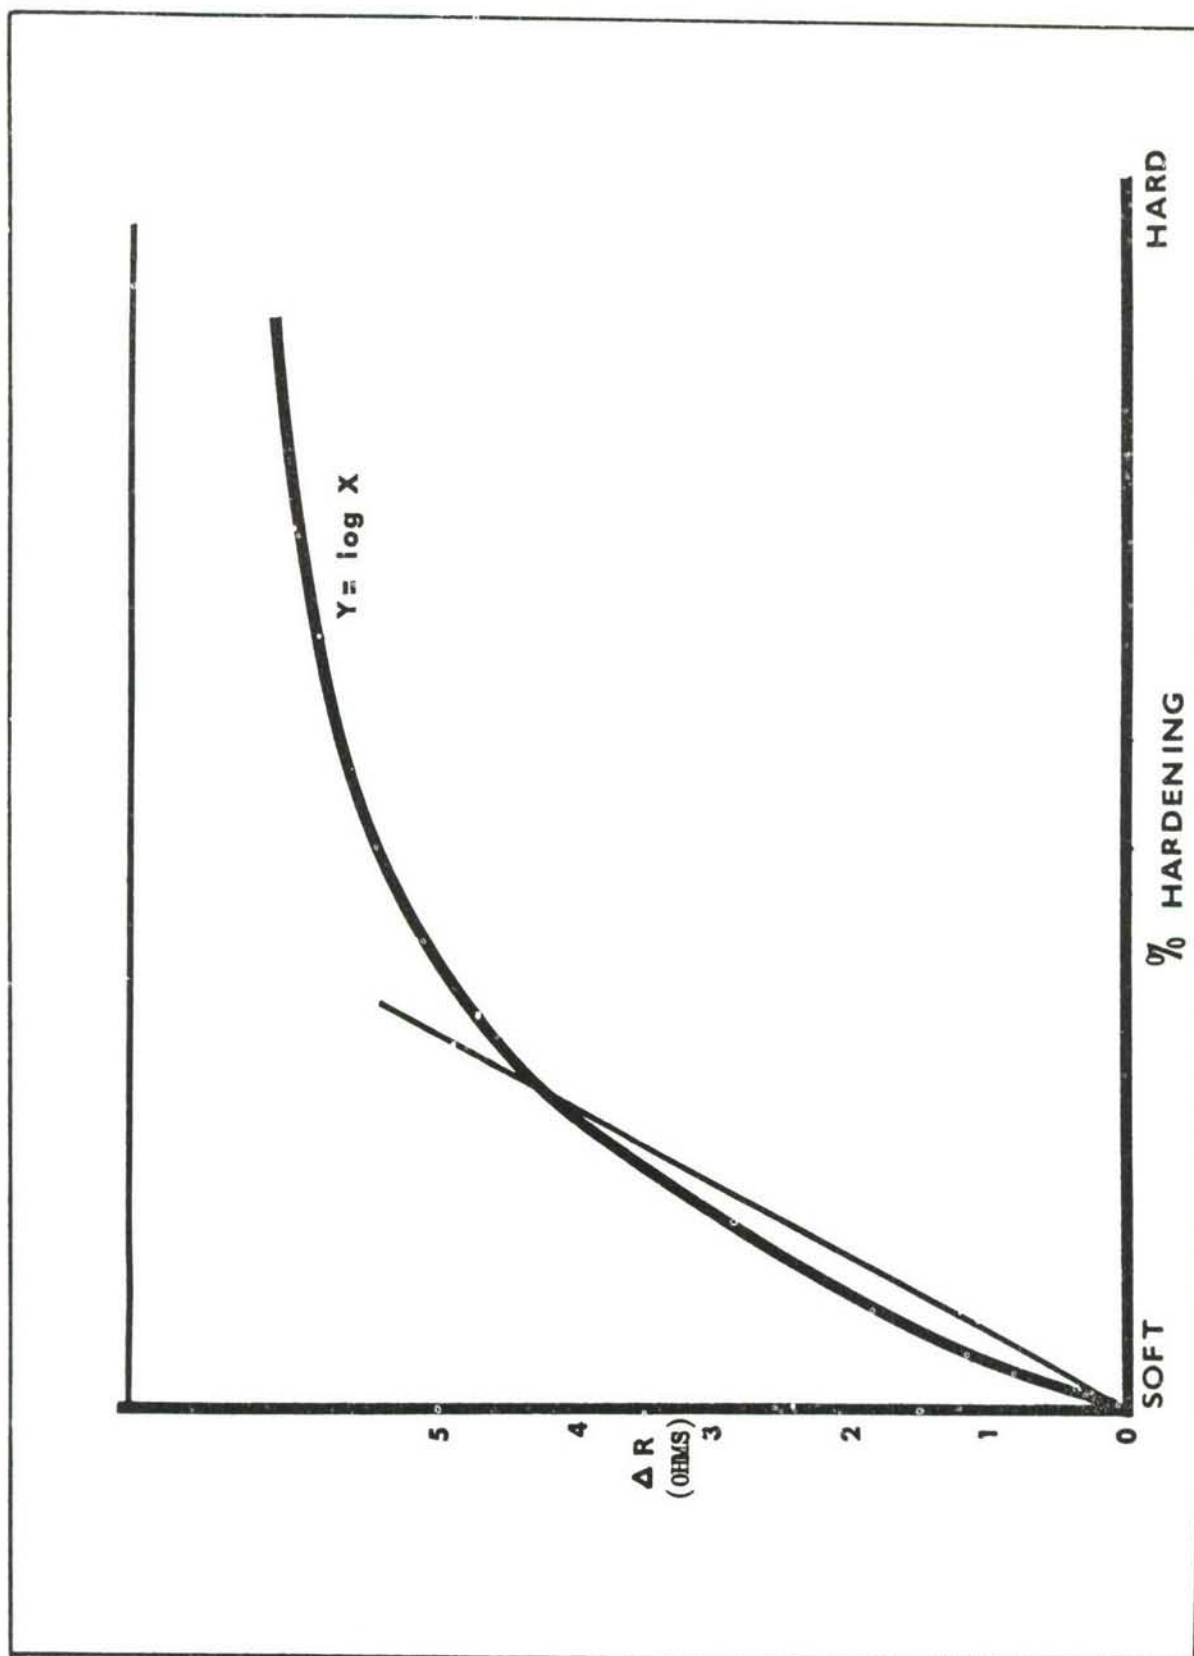
FIGURE 3. RELATIONSHIP OF SENSOR RESISTANCE CHANGE TO STRAIN HARDENING

Metallurgical handbooks (Refs. 11 and 12) indicate that the relationship between electrical resistance change and material hardening is a logarithmic function as shown in Figure 3 and follows the general form of  $y = \log X$ . It can be observed that up to a value of about five ohms the sensor resistance change with respect to work hardening shows maximum linearity and sensitivity. Further electrical resistance change of the sensor approaches the full hard metallurgical condition asymptotically and with corresponding minute resistance changes.

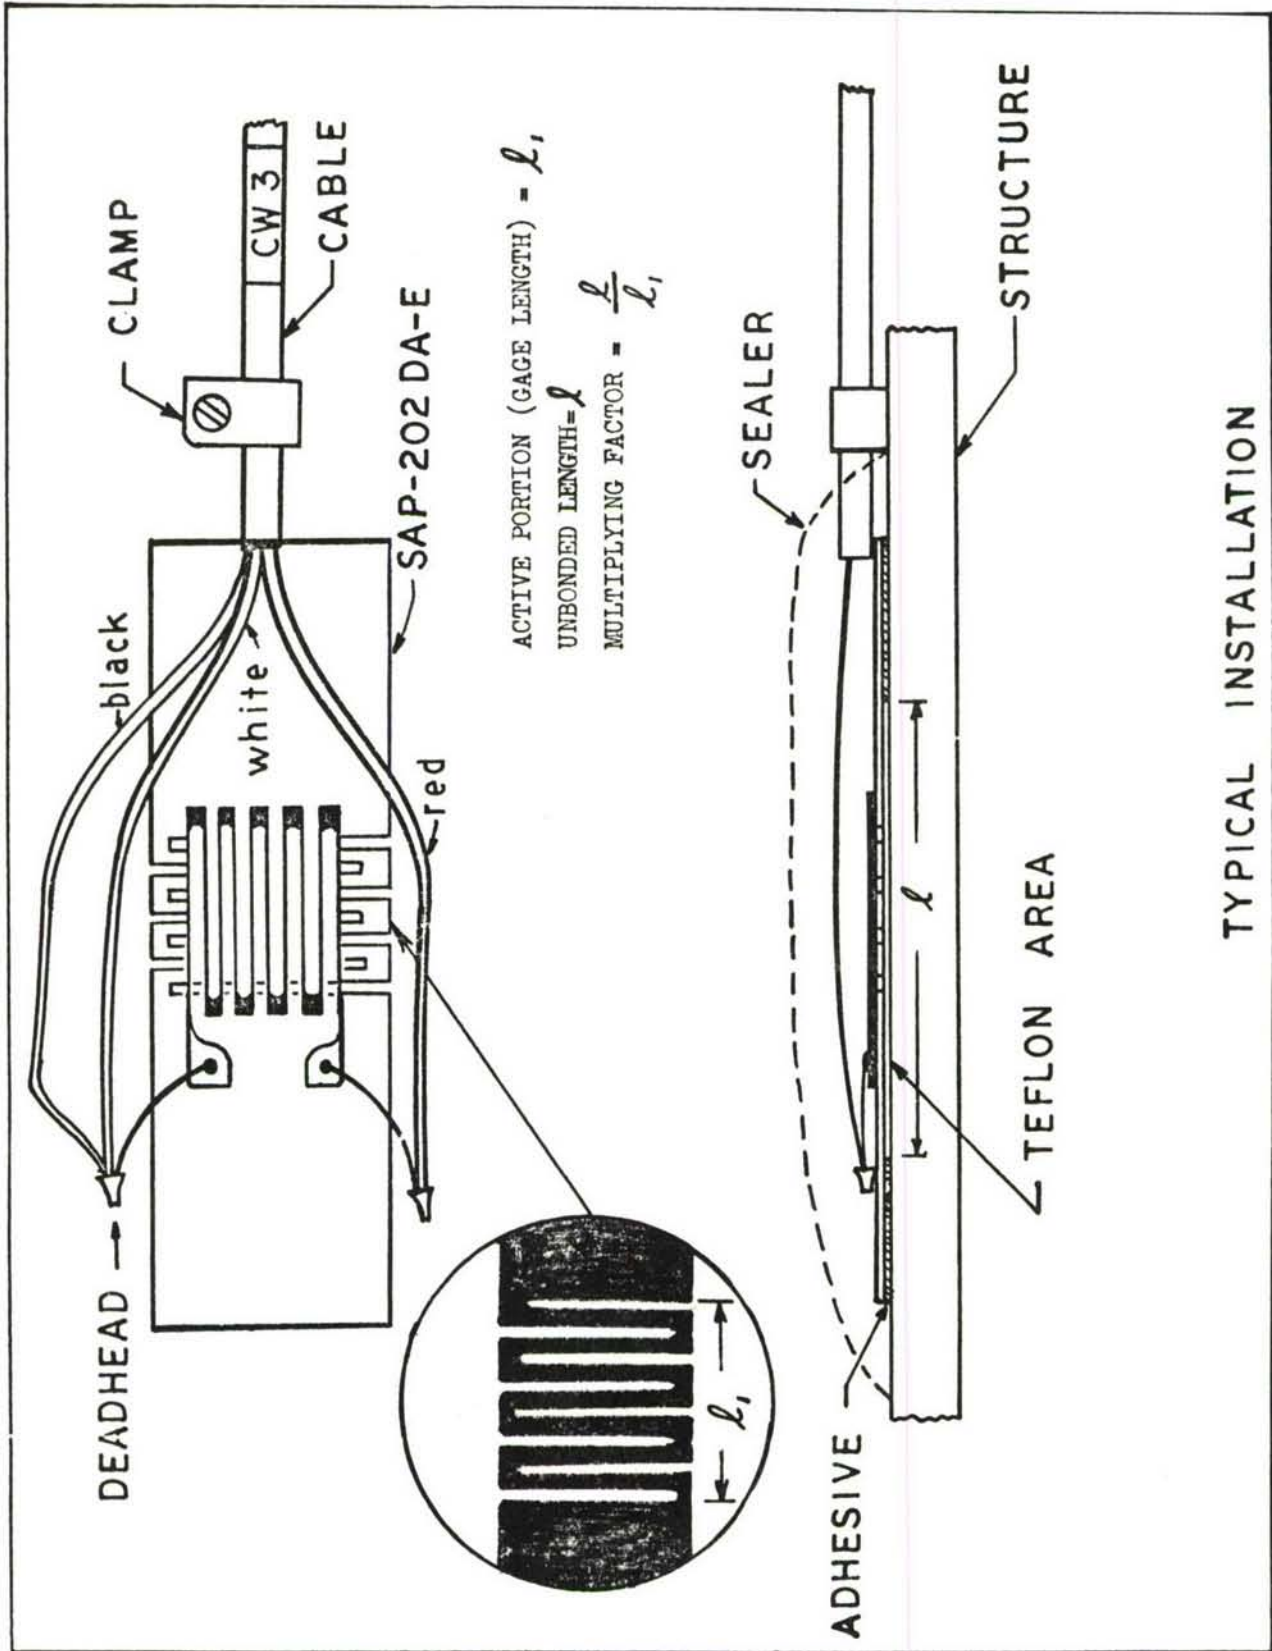
FIGURE 6. TYPICAL SENSOR INSTALLATION (SAP 202DA-E)

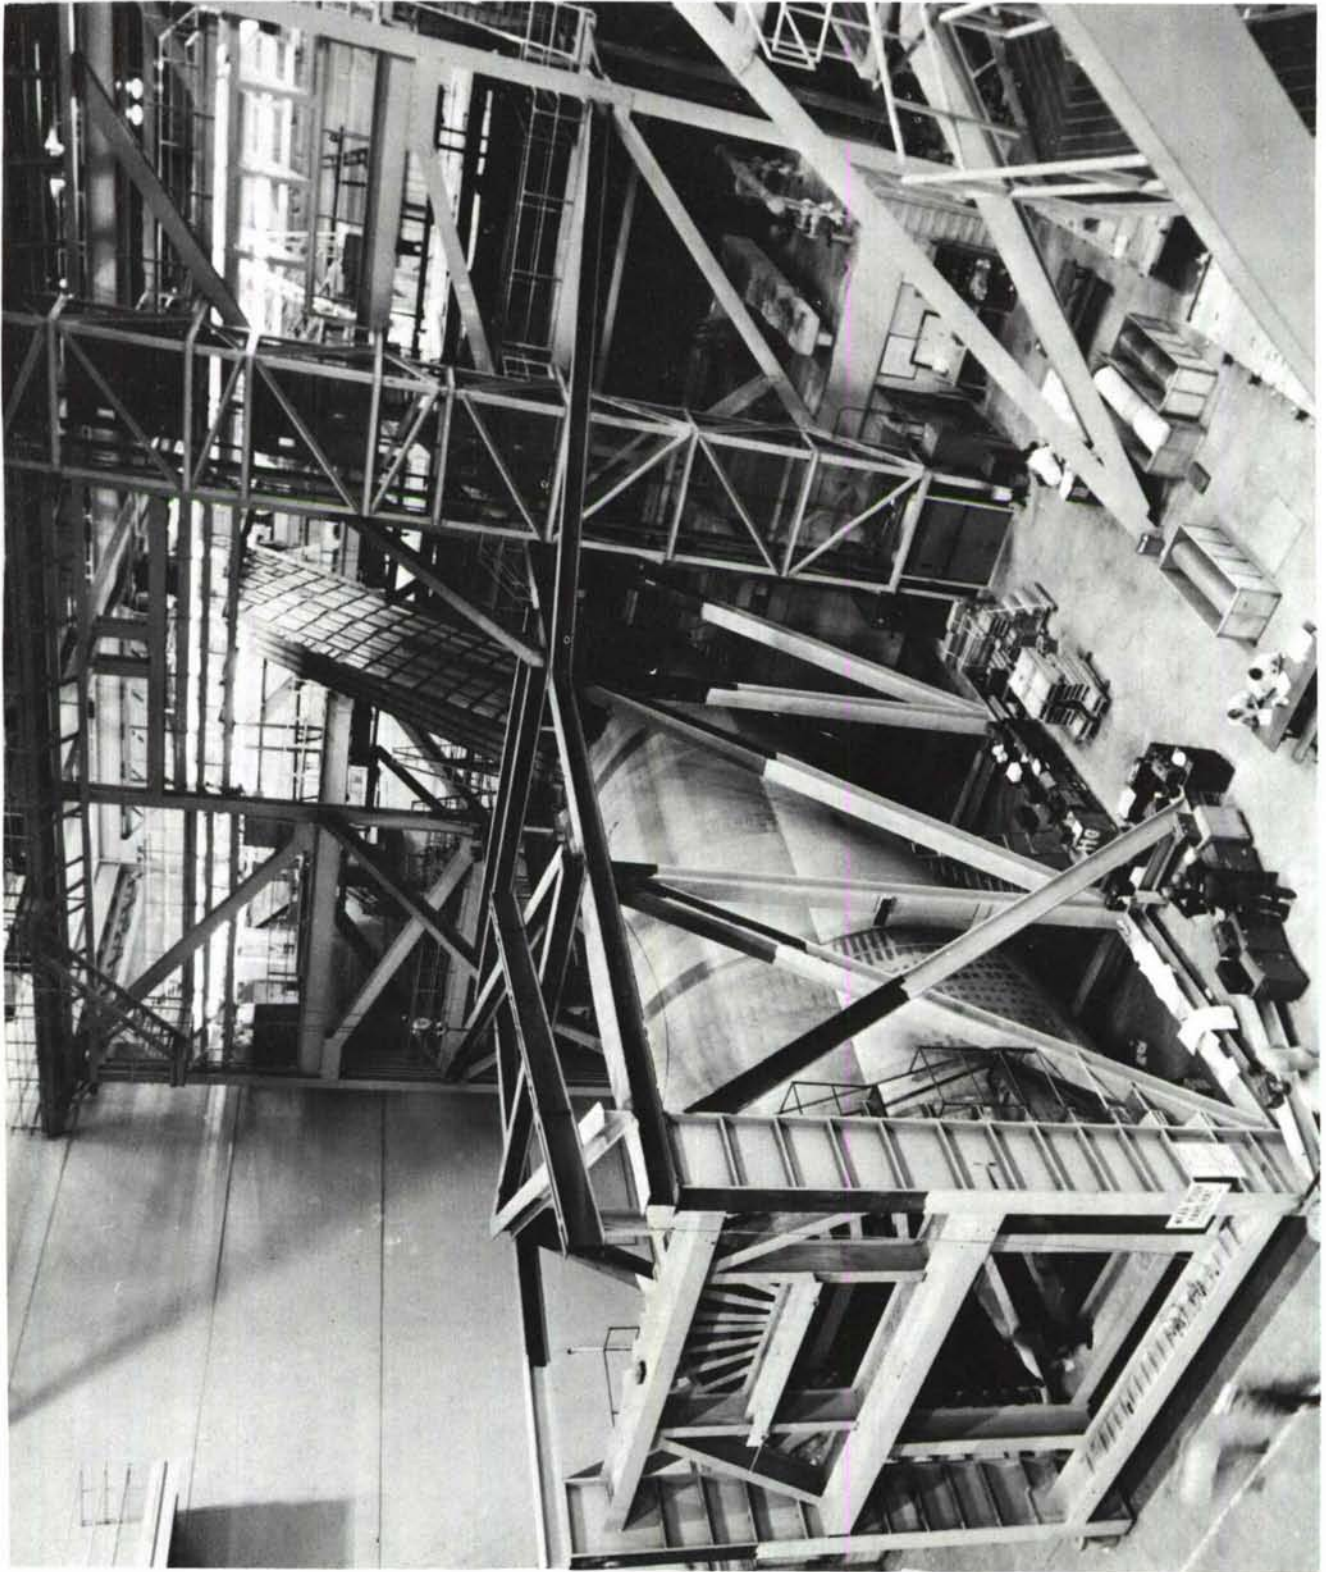
FIGURE 33. C-5A AFT FUSELAGE-EMPENNAGE IN TEST FIXTURE PRIOR TO INSTALLATION OF JACKS AND LINKAGE

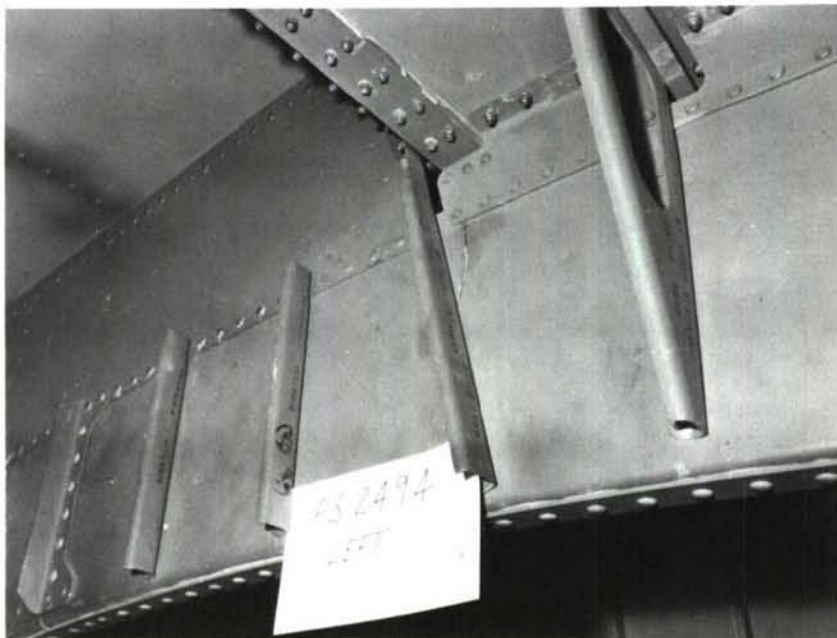
FIGURE 67. FATIGUE DAMAGE AT FUSELAGE FRAME STATION F.S. 2494.  
LOOKING AFT.
