DEVELOPMENT OF CBR DESIGN CURVES FOR AM1 LANDING MAT

MISCELLANEOUS PAPER NO. 4-599

September 1963

U. S. Army Engineer Waterways Experiment Station
CORPS OF ENGINEERS
Vicksburg, Mississippi

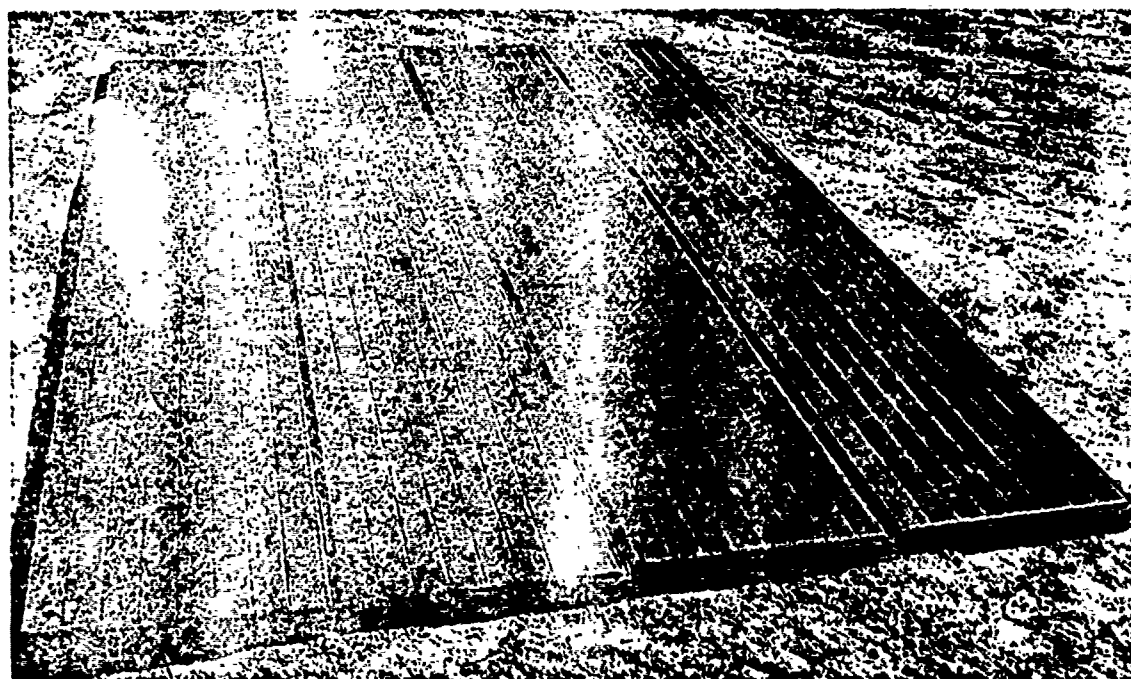
Fig. 1. The four types of Fenestra mat

5. The landing mats used in this investigation were fabricated from nine aluminum extrusions which were mechanically interlocked and usually welded to form a mat plank approximately 2 by 12 ft. Aluminum end connectors were welded across the ends of the 2-ft planks. The variation in the experimental mats was primarily in the degree of welding along the longitudinal joints of the individual extrusions. A top view of the four experimental mat types studied is shown in fig. 1. A brief description of the mats is given below:

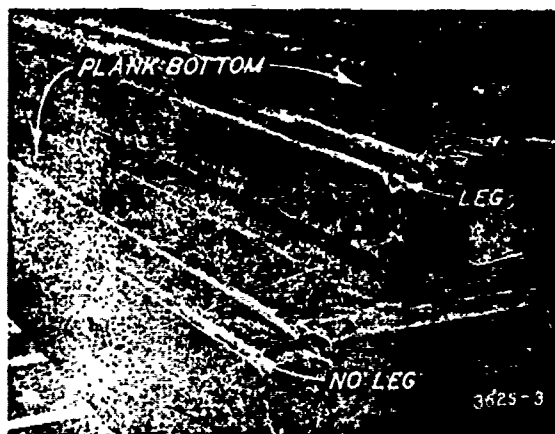
Fig. 2. Bottom view of type 1-a mat with leg and 1-d mat without leg

The leg is a small extension of the underlapping plank edge (fig. 2) on the bottom of the mat. When the mat is in place, the leg rests on the bottom extension of the overlapping plank, thus furnishing vertical support to the underlapping plank. A total of 15 bundles of mat, each consisting of 9 full planks and 6 half planks, were received for surfacing the test section.

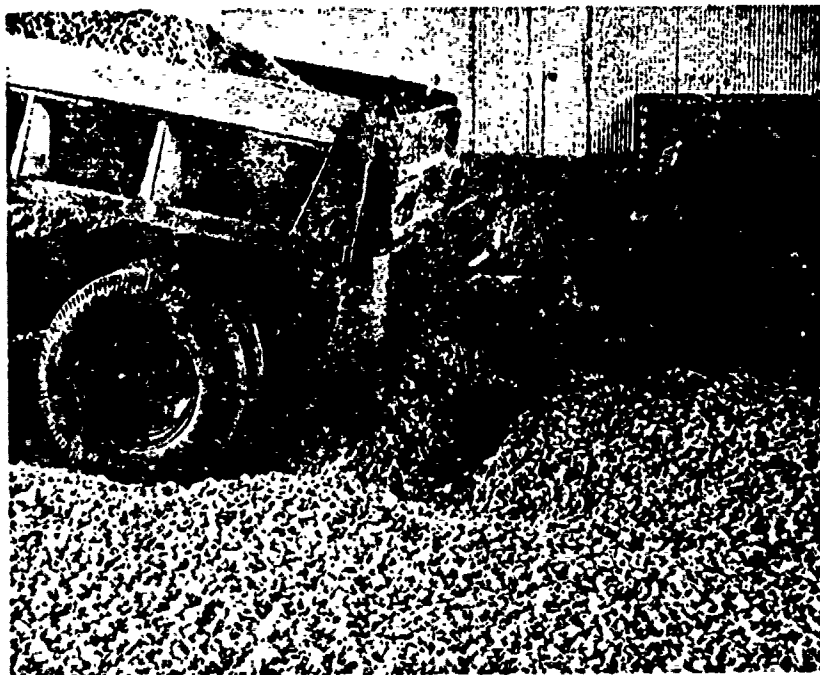
Fig. 3. End-dumping of rock in item 3'

10. Items 3 and 4. Item 3 of the test section consisted of 12 in. of uncompacted, loose rock that had been end-dumped (fig. 3) and spread by hand. Item 4 consisted of 24 in. of uncompacted sand that had been end-dumped (fig. 4) and spread with a D4 tractor. A CBR of about 3 was measured in the sand item prior to placement of the mat. A CBR of 3 for a

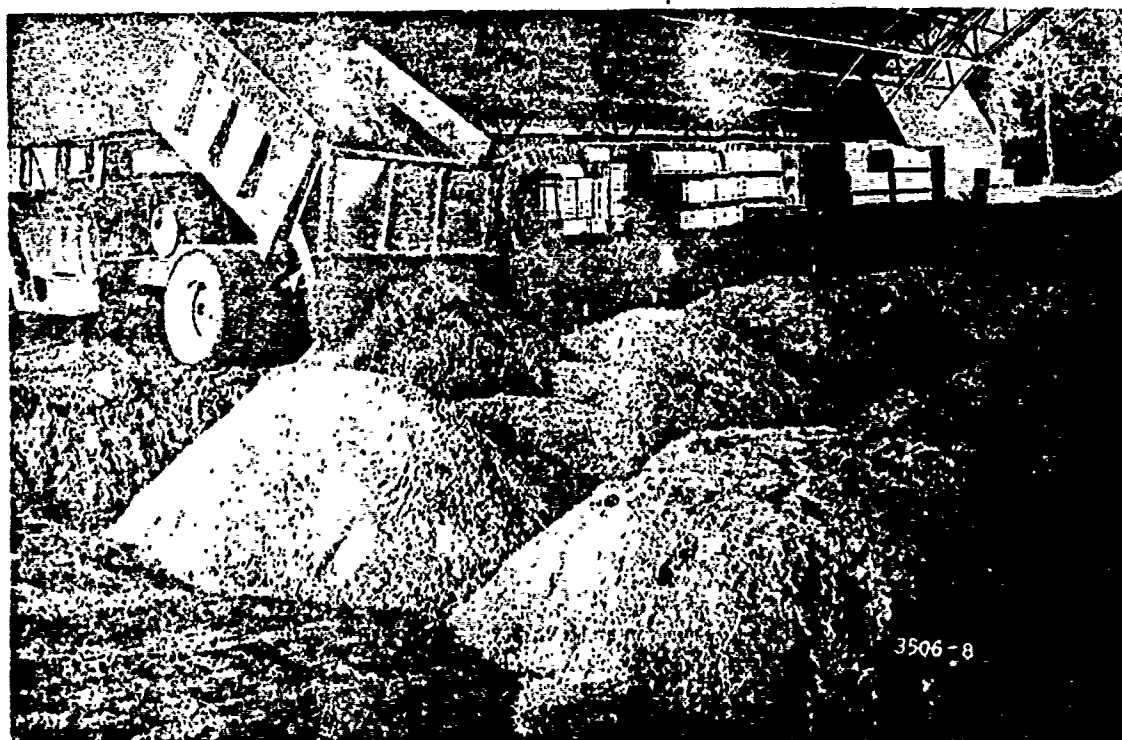
Fig. 4. End-dumping of sand in item 4

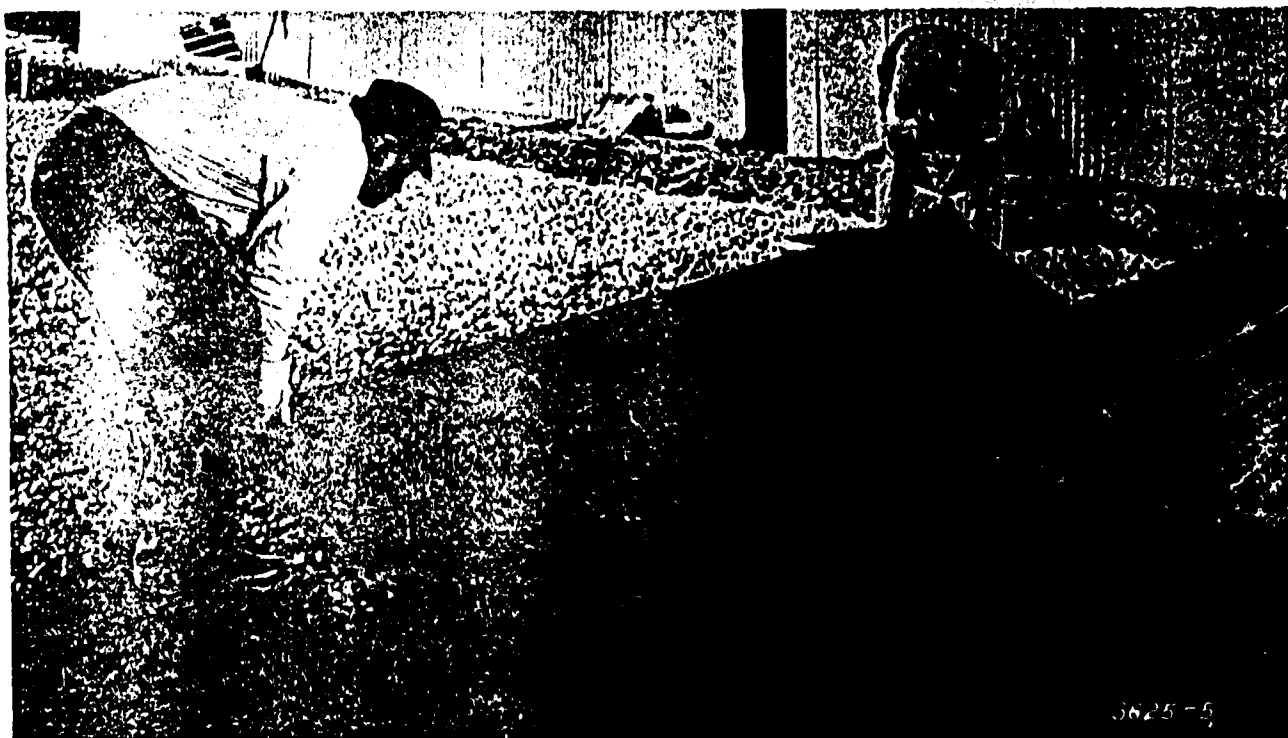
Fig. 5. Placement of Fenestra mat on test section

11. The Fenestra mat was placed on the test section by a crew of six experienced laborers working under the supervision of a foreman. The mat bundles were placed alongside the test section by crane, and individual planks were carried about 30 ft into place (fig. 5). Approximately 250 sq

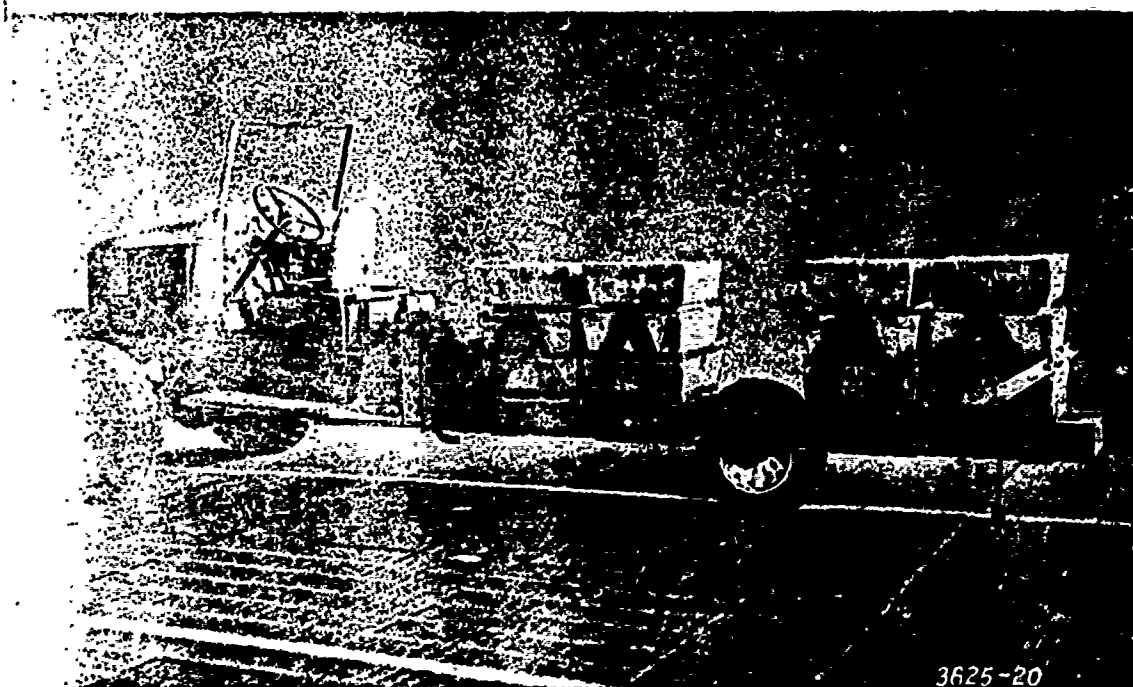
Fig. 6. Test load cart with 27,000-lb single-wheel load with tire inflated to 400 psi

13. A specially designed single-wheel test cart (fig. 6) was used for traffic tests with 17,000- and 27,000-lb single-wheel loads. This test cart was fitted with an outrigger wheel (not visible in fig. 6) to prevent

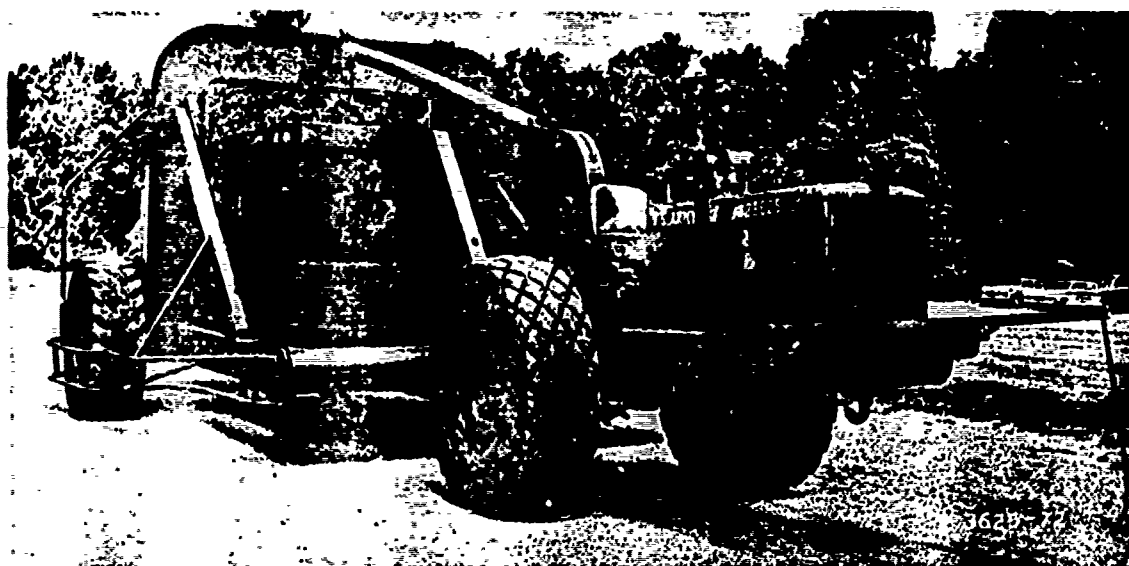
Fig. 7. Test load cart with 39,000-lb single-wheel load with tire inflated to 400 psi

contact area of 82 sq in. with a tire-print width of 7.3 in. The average contact pressure was about 330 psi. A large runway test cart (fig. 7) was used with the 30-7.7 tire for the 39,000-lb, single-wheel-load traffic. A close-up of the load wheel mounted under the load box is shown in fig. 8. The 39,000-lb load on this tire resulted in a contact area of 103 sq in. and an average contact pressure of 378 psi.

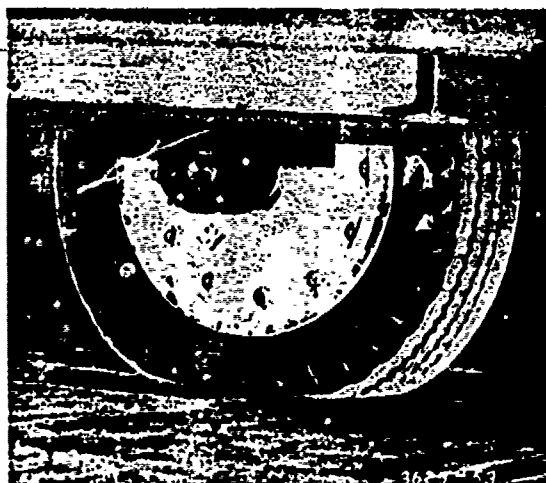
Fig. 8. Close-up of 39,000-lb single-wheel assembly

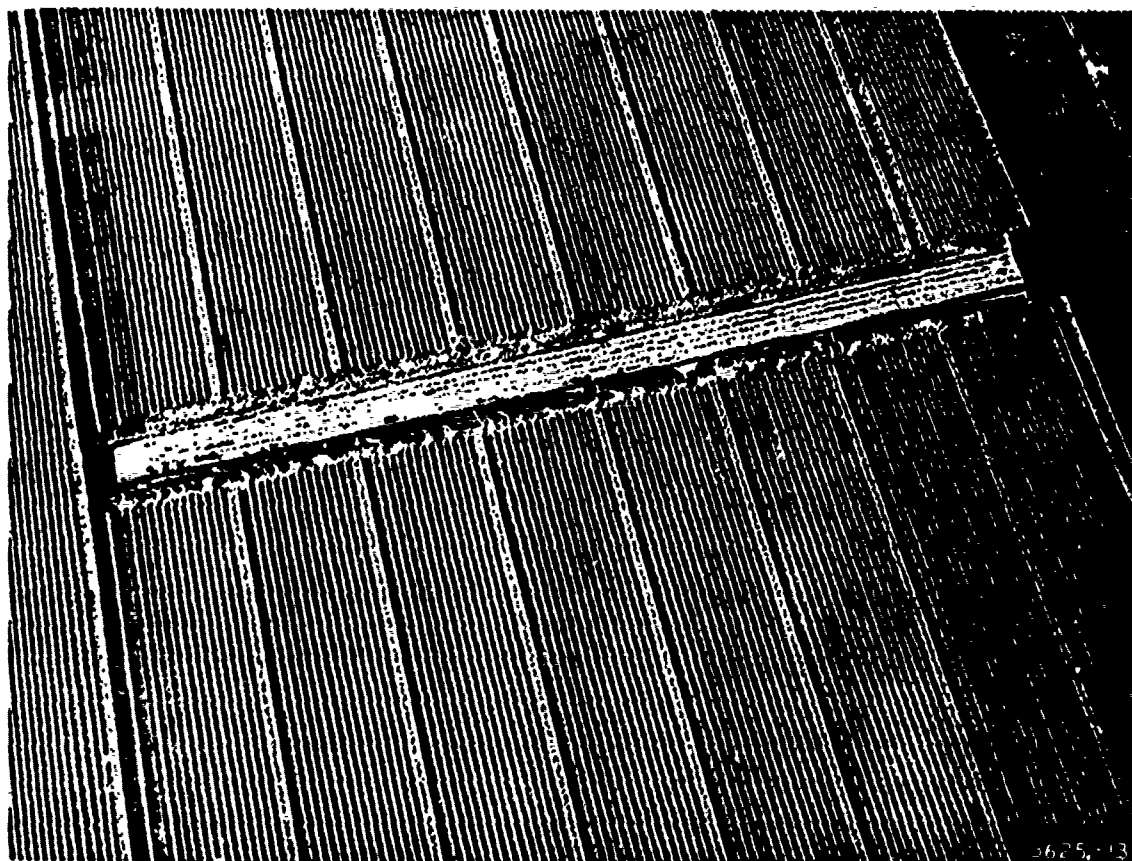
Fig. 10. Cracks at end joint and overlapping corner break in item 1 after 20 coverages of traffic

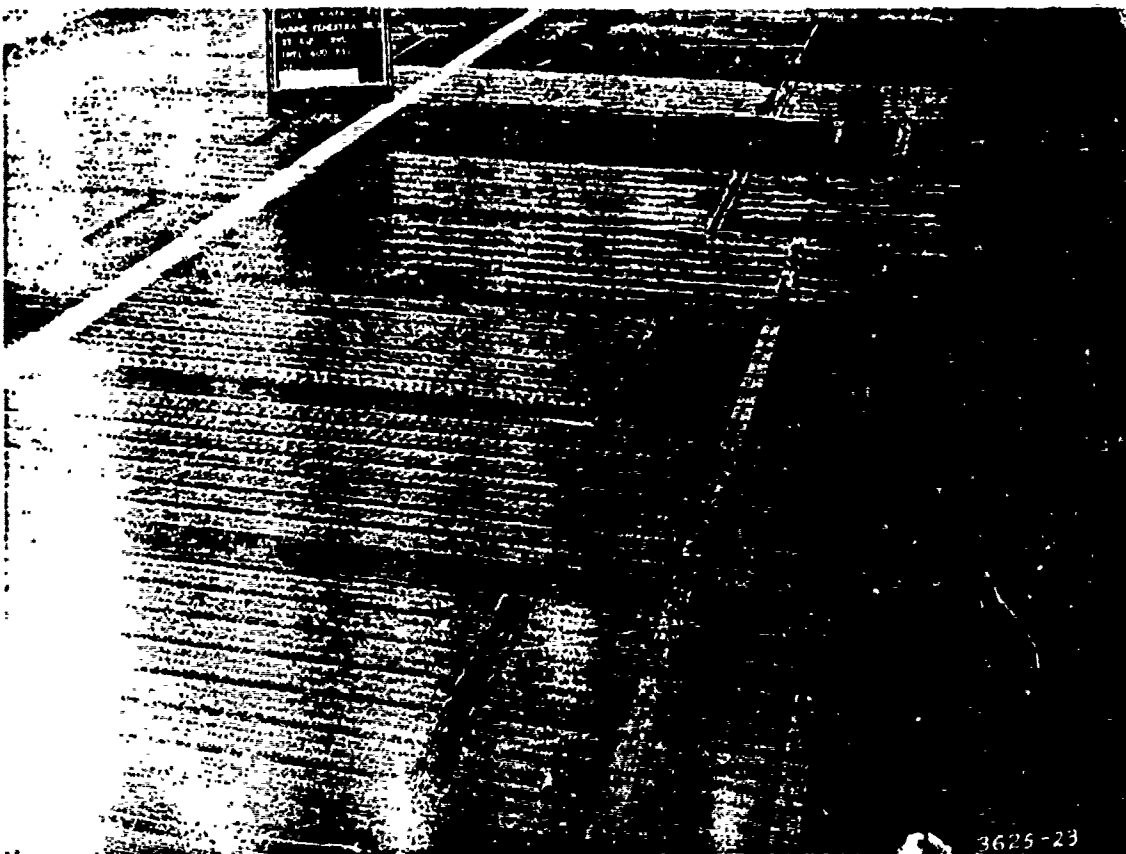
Fig. 13. Overlapping corner breaks in item 1 after 29 coverages of traffic with 27,000-lb single-wheel load

Number of overlapping corner breaks had developed, as shown in fig. 13. The loose projecting ends from these breaks were cut off to prevent tire damage, as shown in fig. 14. The breaks continued to progress as traffic

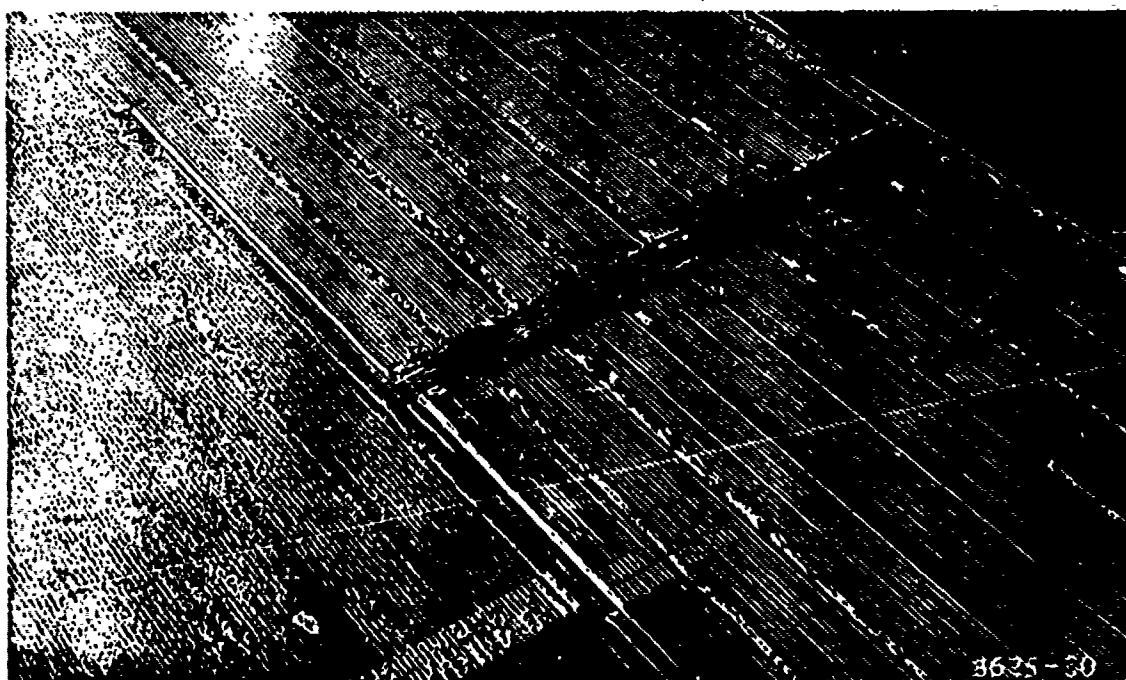
Fig. 14. Area where loose projecting ends of overlapping edge of mat were cut off

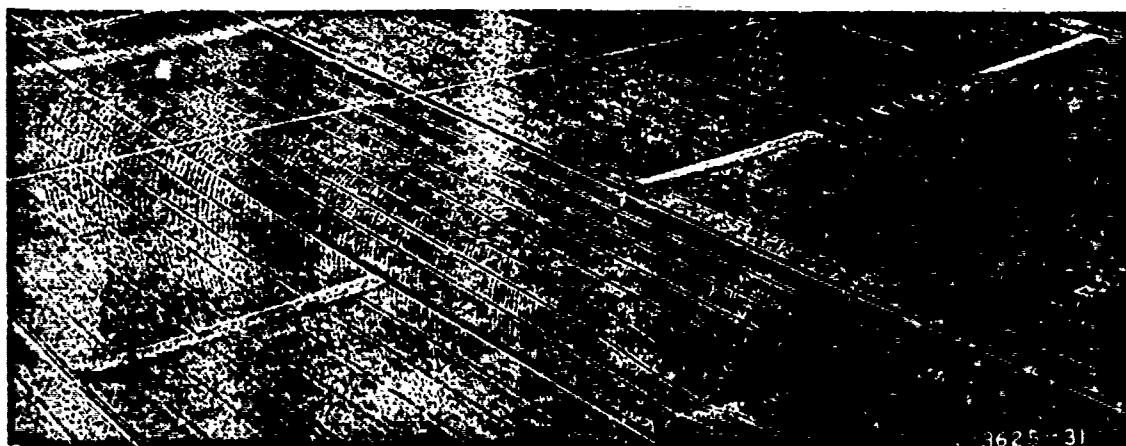
Fig. 15. Failed end joints in item 4 after 73 coverages with 27,000-lb single-wheel load

27. Item 4. Considerable breakage occurred in types 1-b and 1-c mats. These breaks were similar to those discussed for item 1, and started during the early stages of traffic. By 73 coverages, three end joints had completely failed, as shown in fig. 15, and types 1-b and 1-c mats were removed from the item. Types 1-a and 1-d mats performed satisfactorily for the full period of traffic (188 coverages).

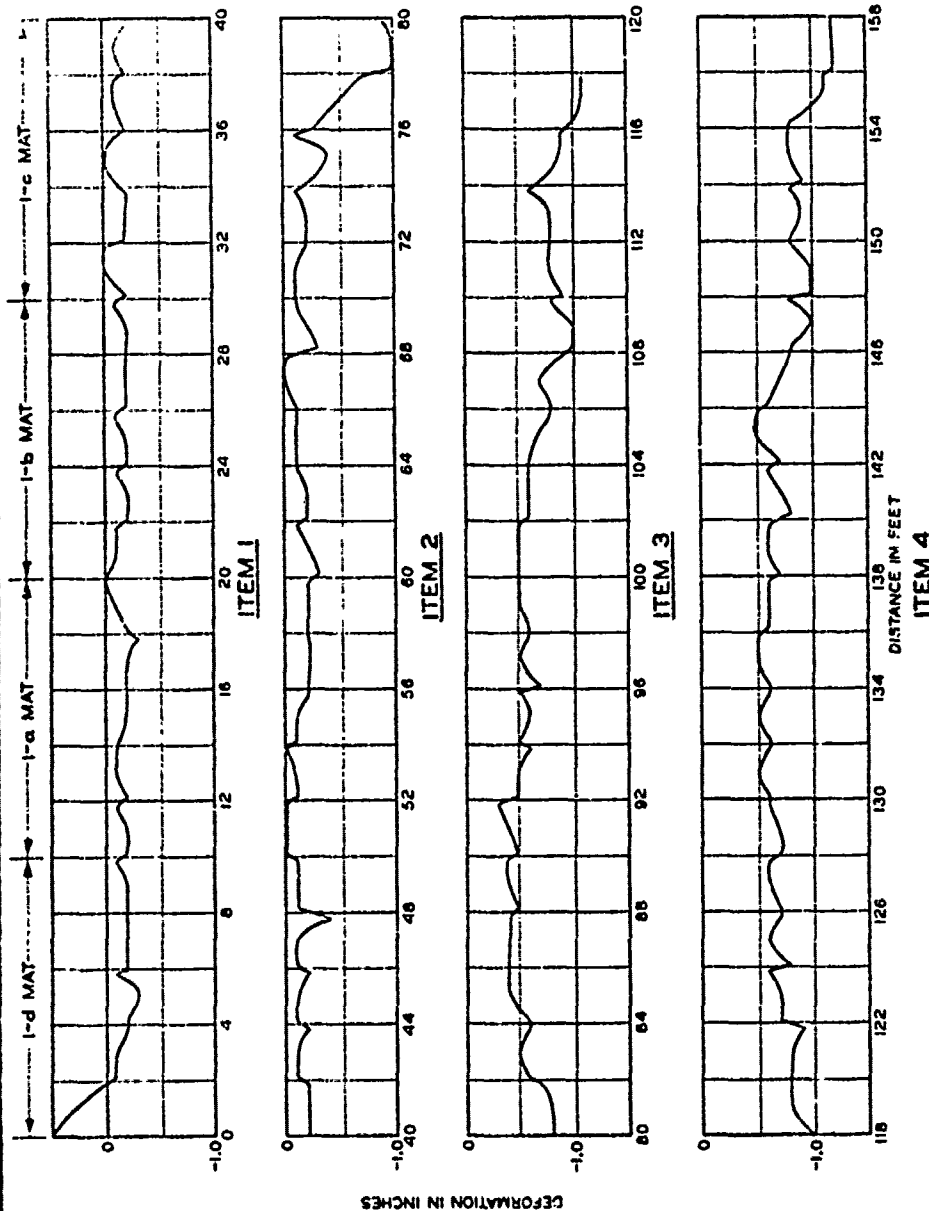
FENESTRA MARK III MAT
 CENTER-LINE PROFILES
 17,000-LB SINGLE-WHEEL LOAD
 50 COVERAGES

21. Center-line profiles showing deformation of the mat in each test item down the center line of the test lane are shown in plate 5. These profiles show slight deviations in deformation within the various test items, but no consistent difference due to mat type. In general, the surface grade remained smooth throughout the 50 coverages of traffic, as can be noted in photograph 2.

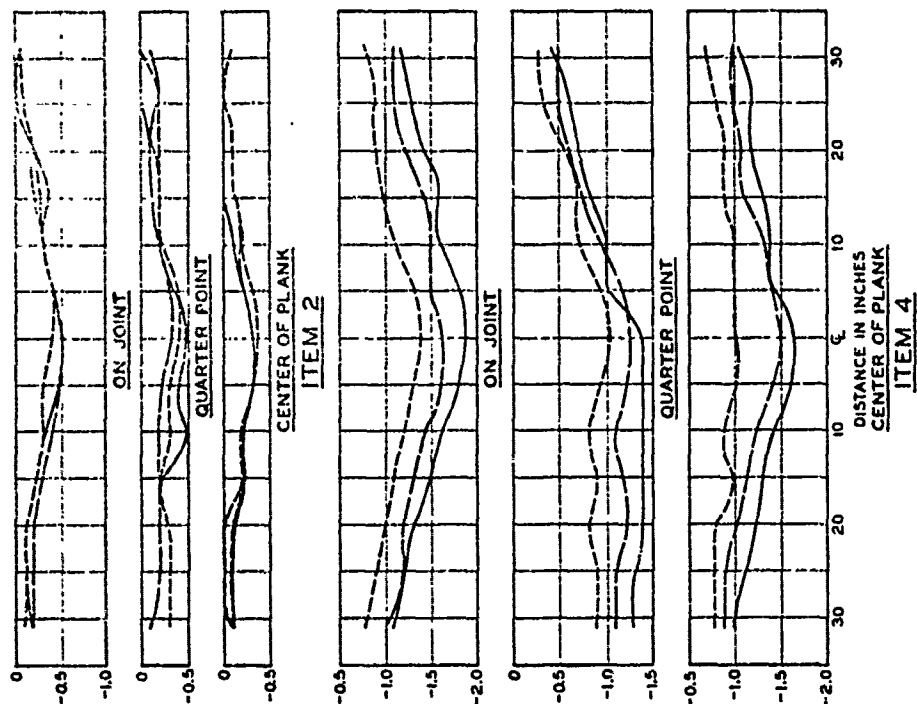
FENESTRA MARK III MAT

MAT DEFLECTIONS

29. Mat deflection. Plots presenting elastic deflection of the 1-a and 1-d mats under load for the various intervals of traffic are shown in plate 9. The mat deflection in item 4 was severe, exceeding 1.5 in. As discussed in paragraph 22, this severe deflection was due to the mat bridging the subgrade, as the mat did not conform to the subgrade after densification of the sand occurred under traffic. As can be noted in table 1, the density of the sand increased from about 91 lb per cu ft prior to traffic to about 106 to 111 lb per cu ft after traffic.

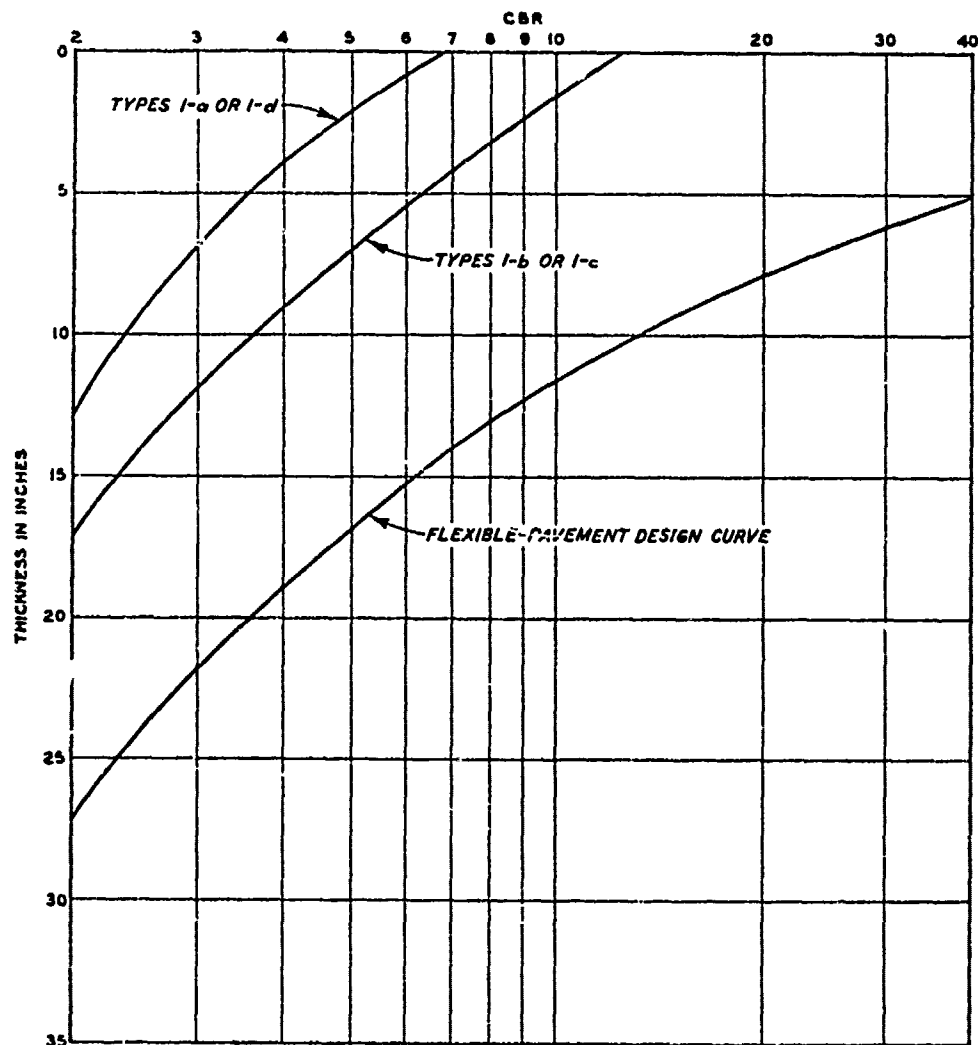
FENESTRA MARK III MAT
 CBR DESIGN CURVES
 27,000-LB SINGLE-WHEEL LOAD
 400-PSI TIRE PRESSURE
 188 COVERAGES

45. The data obtained from the loose rock and sand test items were not used in developing the design curves shown in plate 11. However, the data indicated that a loose sand or rock subgrade with an initial CBR of 4 or better, surfaced with type 1-a or 1-d mat, would perform satisfactorily for 188 coverages of the 27,000-lb wheel load provided that the severe mat deflections caused by the mat bridging the subgrade were not detrimental to aircraft performance. A slightly higher initial subgrade strength would be required for type 1-b or 1-c mat.

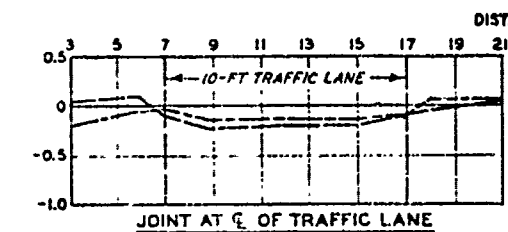
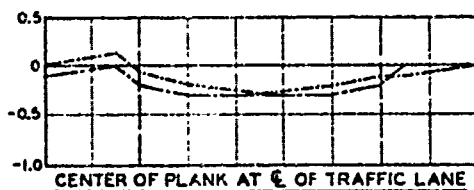
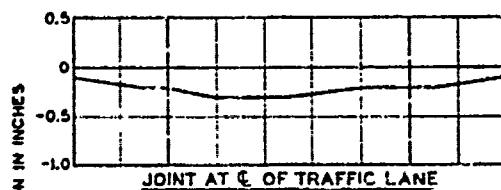
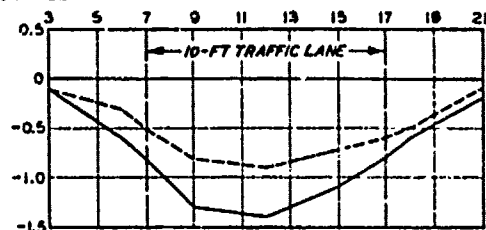
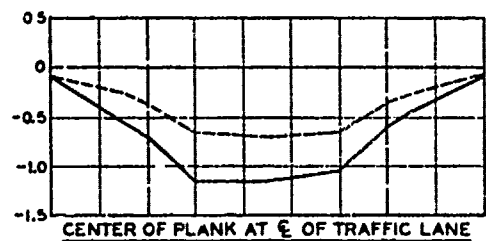
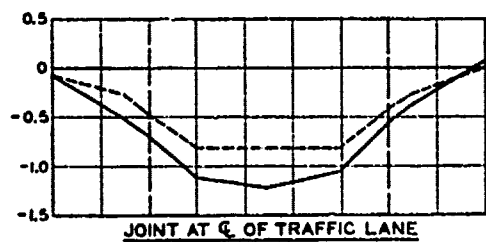
BUTLER AMI MAT
 PERMANENT DEFORMATION
 27,000-LB SINGLE-WHEEL LOAD

65. Permanent deformation. Level readings taken to show permanent deformation of the mat during traffic are shown in plate 13 for all test items. From these data it can be noted that little settlement occurred in any of the clay subgrades, items 1 through 3. However, considerable deformation occurred in items 4 and 5, rock and sand subgrade items, respectively. This deformation was due to densification of the rock and sand under traffic, as was the case for the Fenestra mat discussed previously.

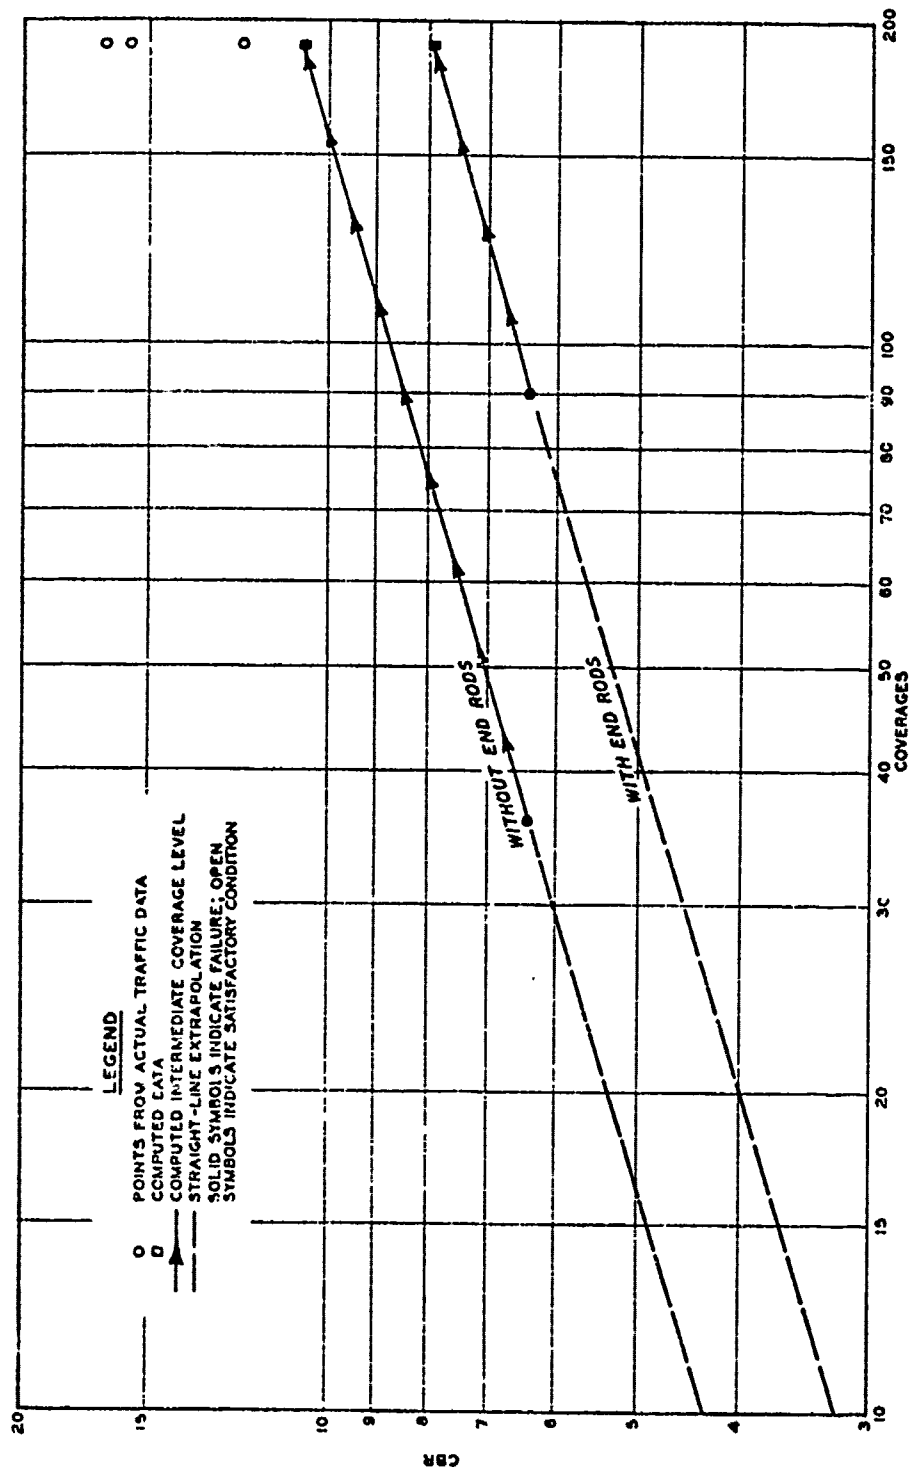
BUTLEN AMI MAT
CBR VS COVERAGES
27,000-LB SINGLE-WHEEL LOAD
400-PSI TIRE PRESSURE

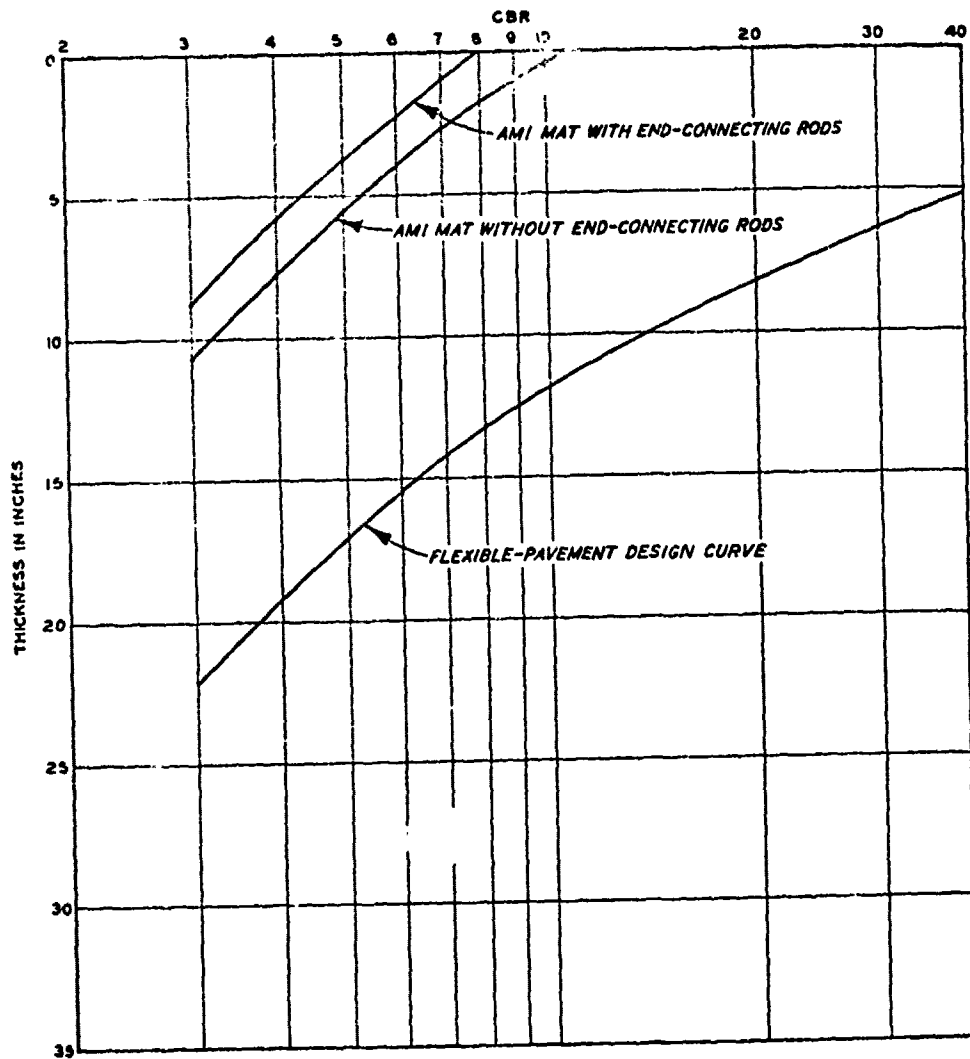
BUTLER AMI MAT
 CBR DESIGN CURVES
 27,000-LB SINGLE-WHEEL LOAD
 400-PSI TIRE PRESSURE
 188 COVERAGES

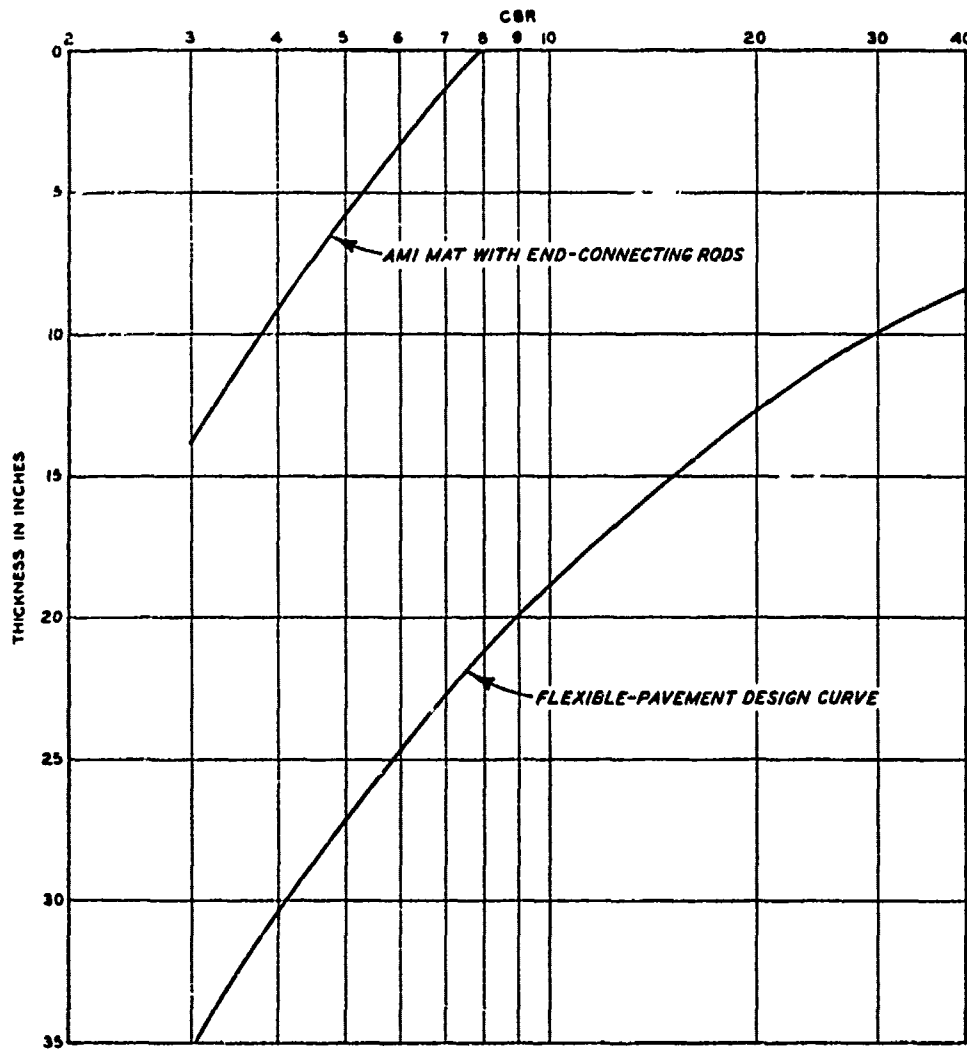
PLATE 18

BUTLER AMI MAT
CBR DESIGN CURVES
39,000-LB SINGLE-WHEEL LOAD
400-PSI TIRE PRESSURE
1600 PASSES
