EVALUATION OF BALLISTIC DAMAGE RESISTANCE  
AND FAILURE MECHANISMS OF COMPOSITE MA-  
TERIALS

Avco Corporation

Air Force Materials Laboratory

Technical Report AFML-TR-72-79  
AVSD-0311-72-CR

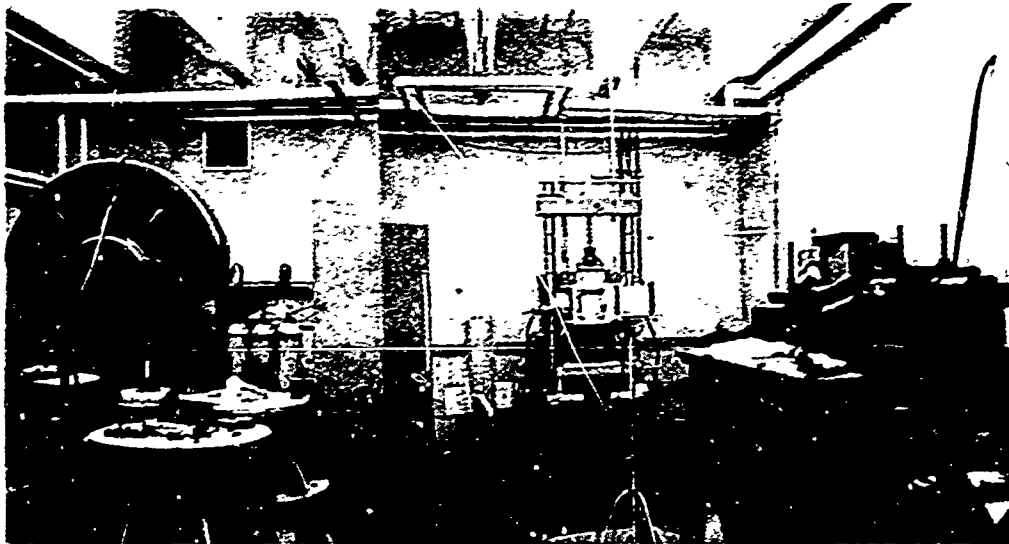
Figure 10 PHOTOGRAPH OF BALLISTIC TEST SETUP

AT THE LEFT IS THE BECKMAN WHITLEY CAMERA, IN THE CENTER IS A SPECIMEN LOADED BY THE BALDWIN TEST MACHINE, AND IN RIGHT (FOREGROUND) IS THE RIFLE.

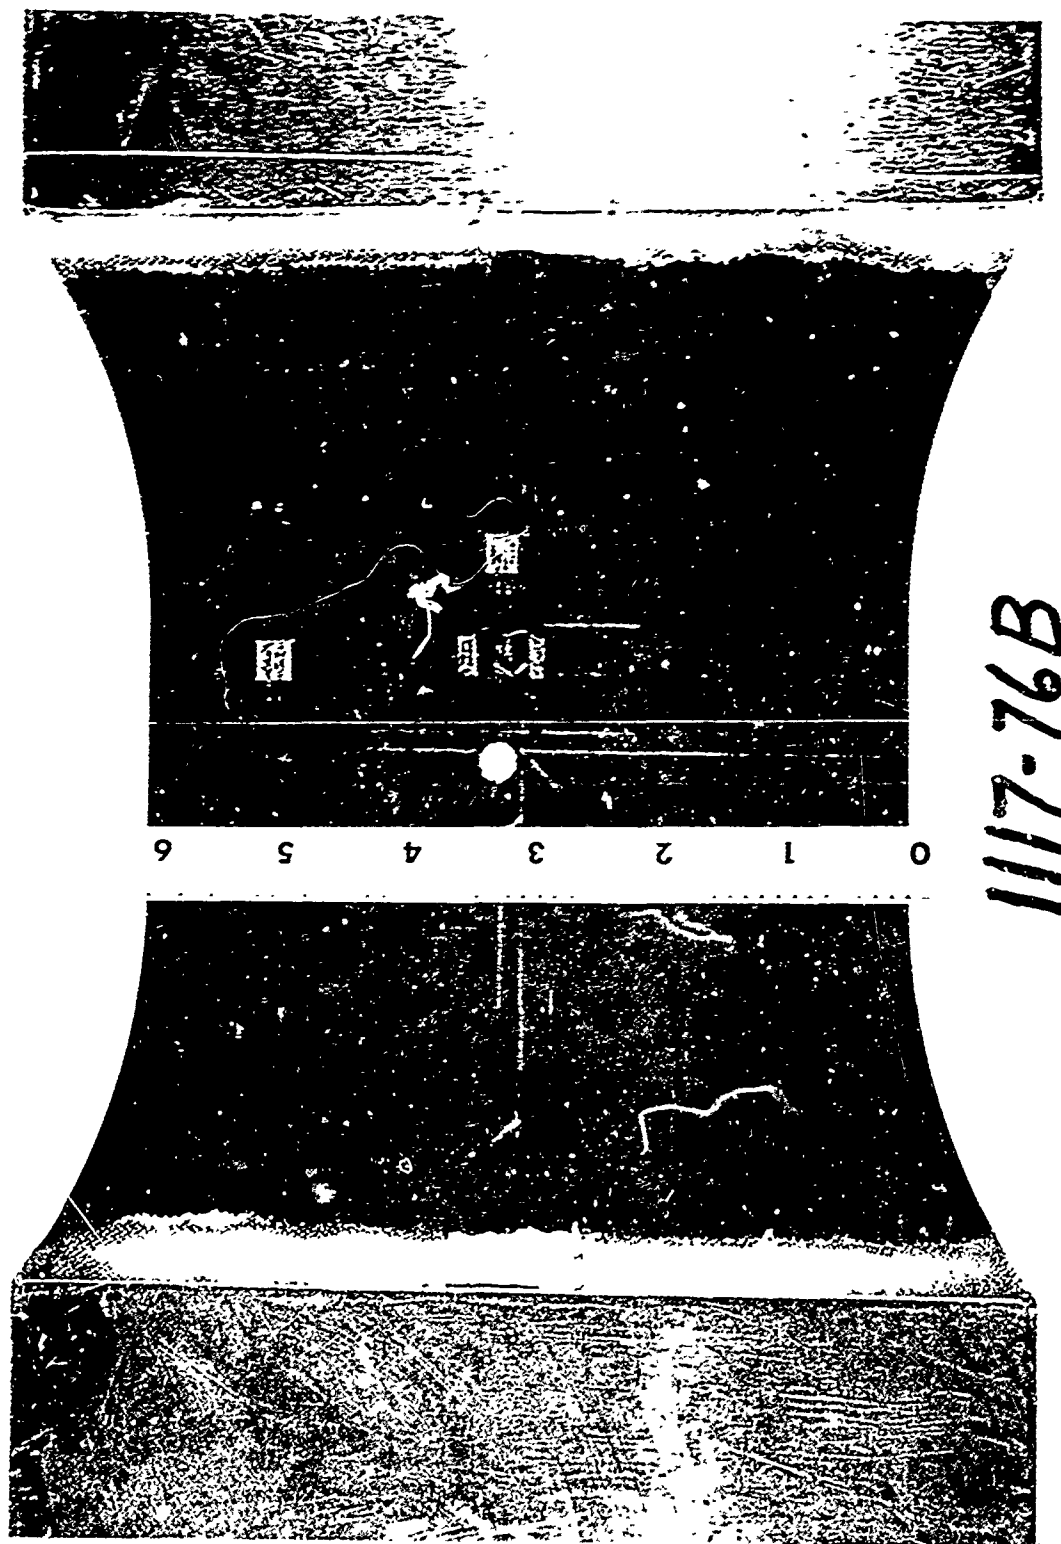
Figure 21 EFFECTS OF PROJECTILE ON GRAPHITE/EPOXY

PANEL 1117 76B WAS PRESTRESSED TO 63% OF ITS UTS AND SHOT WITH A 30 CALIBER AP PROJECTILE. NOTE THE RELATIVELY CLEAN HOLE AND ABSENCE OF DELAMINATION ON BOTH THE ENTRANCE SIDE (a) AND EXIT SIDE (b).

Figure 21 Continued EFFECTS OF PROJECTILE ON GRAPHITE/EPOXY  
(b) EXIT SIDE

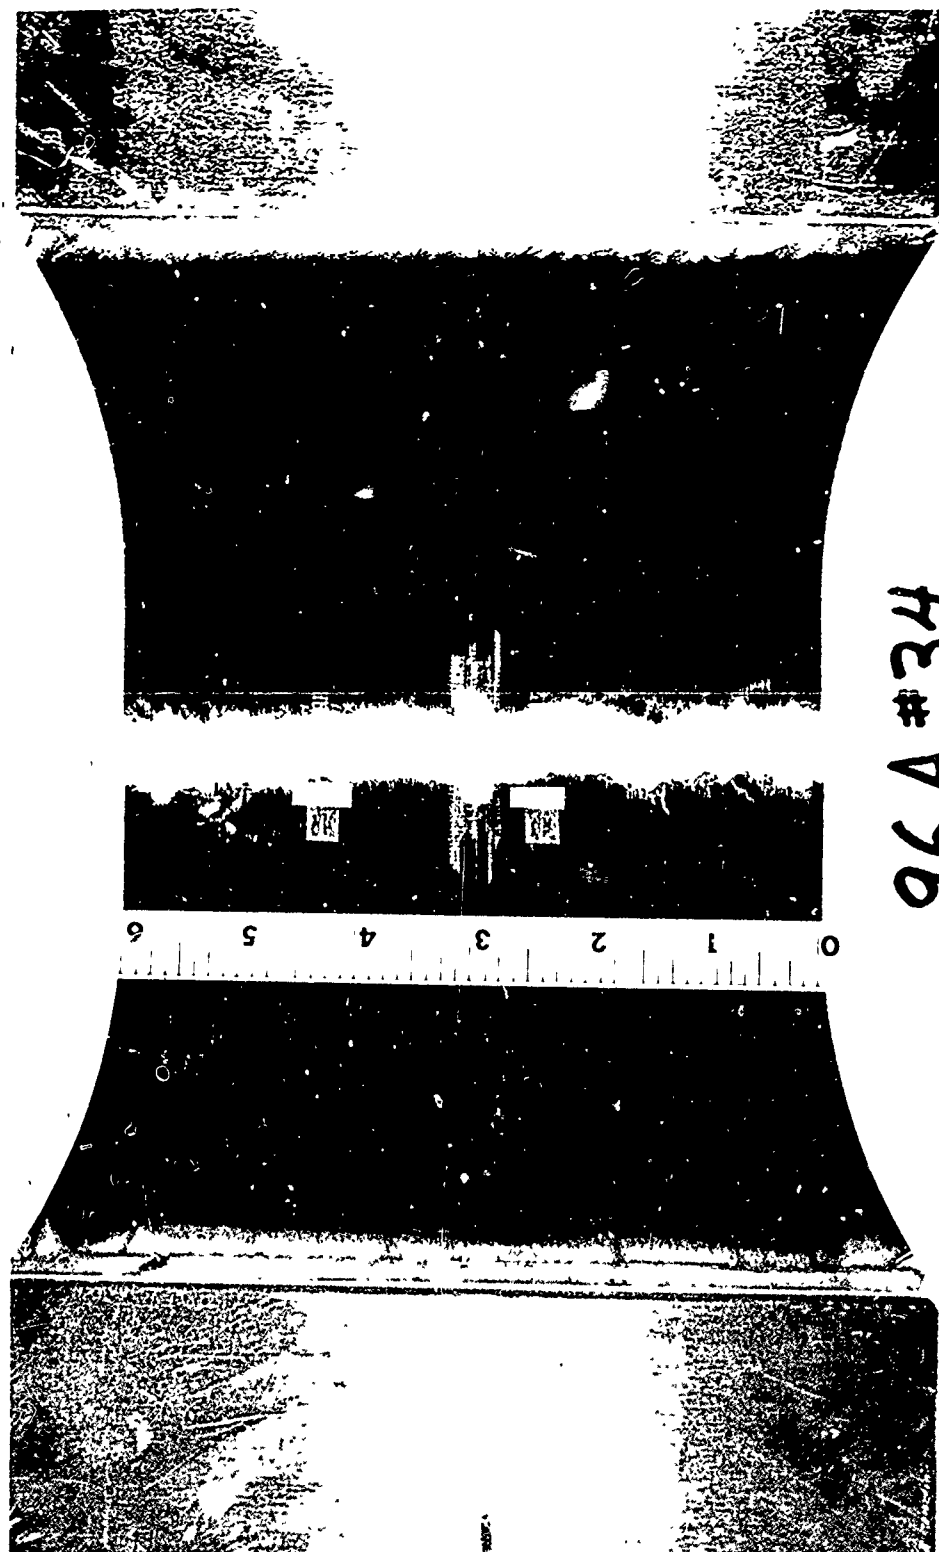
Figure 25 CLOSEUP SHOWING THE SLIGHT DAMAGE THAT OCCURS ON THE  
EXIT SIDE OF BORON/EPOXY SPECIMENS
