LIGHTWEIGHT GEARBOX DEVELOPMENT FOR  
PROPELLER GEARBOX SYSTEMS APPLICATIONS  
POTENTIAL COATINGS FOR TITANIUM ALLOY  
GEARS

**Detroit Diesel Allison Division  
General Motors Corporation  
Indianapolis Operations**

**TECHNICAL REPORT AFAPL-TR-72-90**

**December 1972**

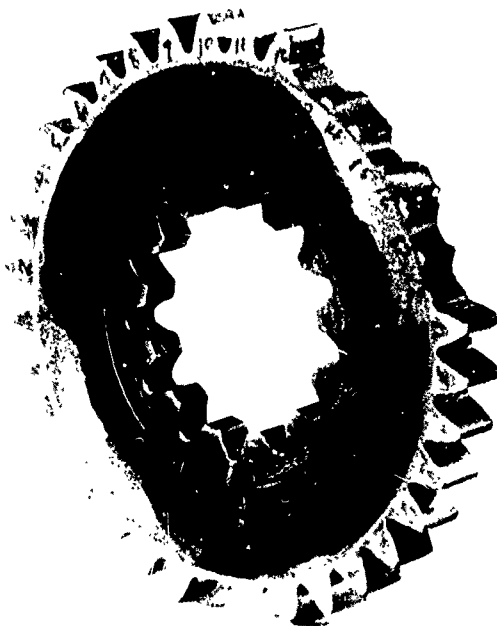
7326-57

Figure 57. Fractured gear teeth induced by fatigue failure.

Test I. 3—Fracture of narrow gear teeth resulted from multiple indications of fatigue failure in the area of high nickel concentration in the tooth root fillet area. Figure 57 shows the fractured tooth failures.
