LIGHTWEIGHT GEARBOX COMPOSITE CASE.
PHASE II.

**PHASE II
LIGHTWEIGHT GEARBOX
COMPOSITE CASE**

**FINAL REPORT
(18 MARCH 1970 TO 18 JANUARY 1971)**

**Detroit Diesel Allison Division • General Motors
Indianapolis, Indiana**

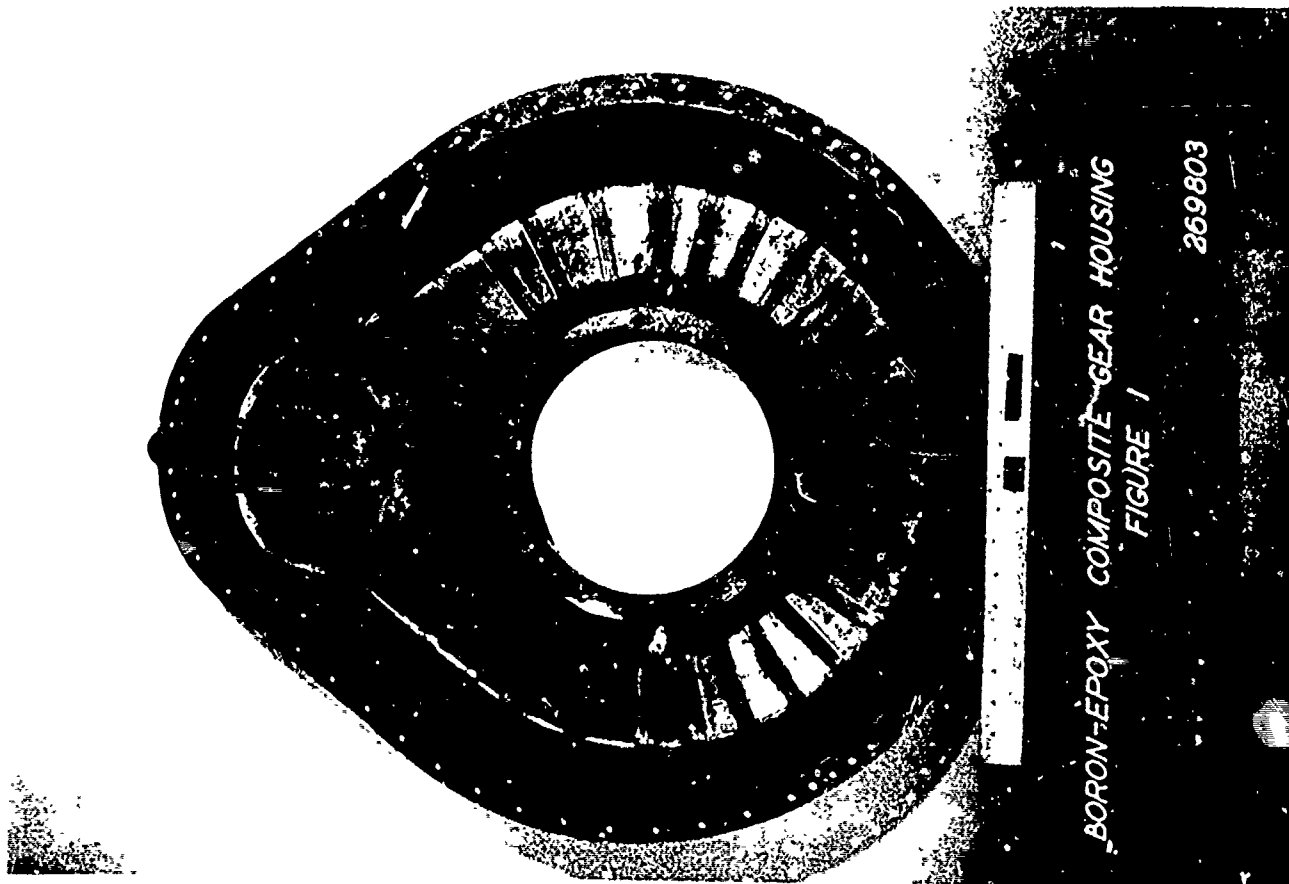
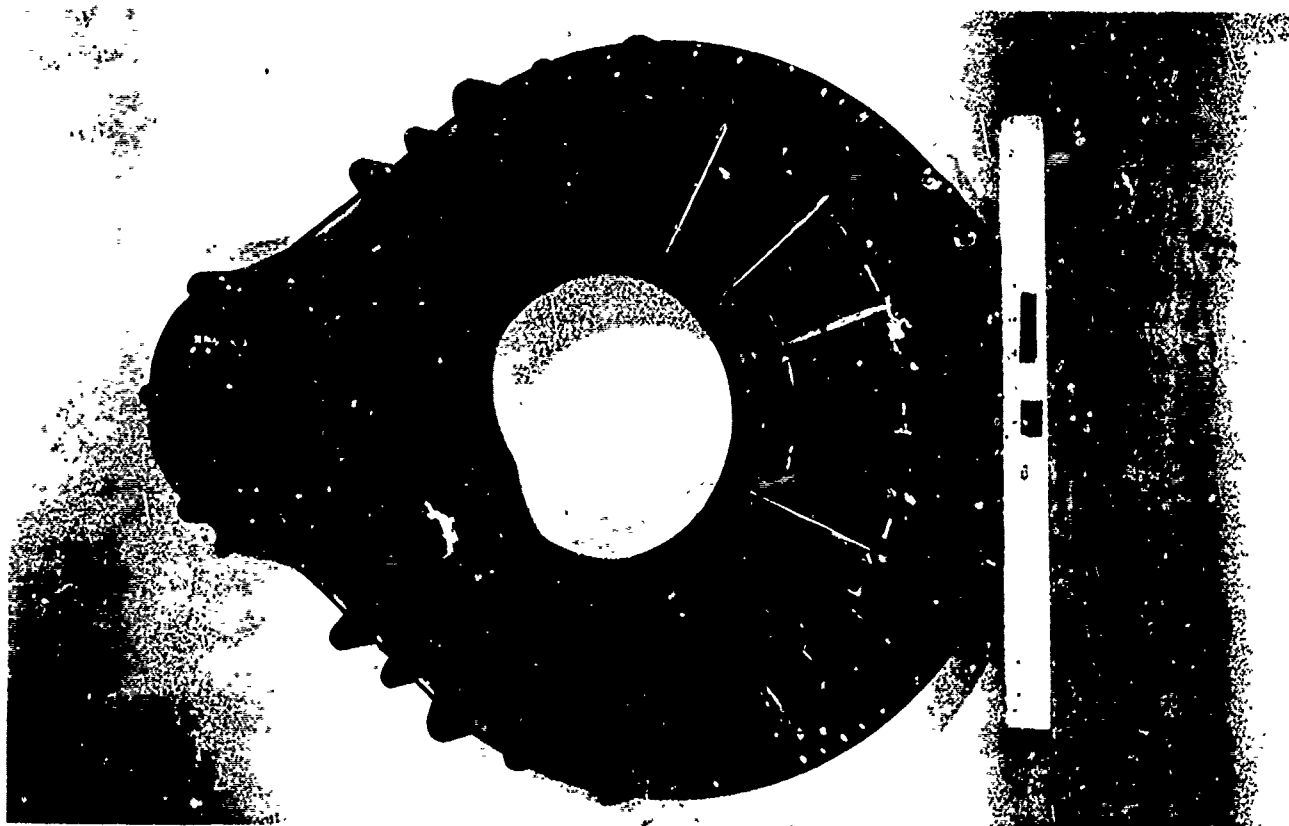
A general view of the finished case is given in Figure 1.

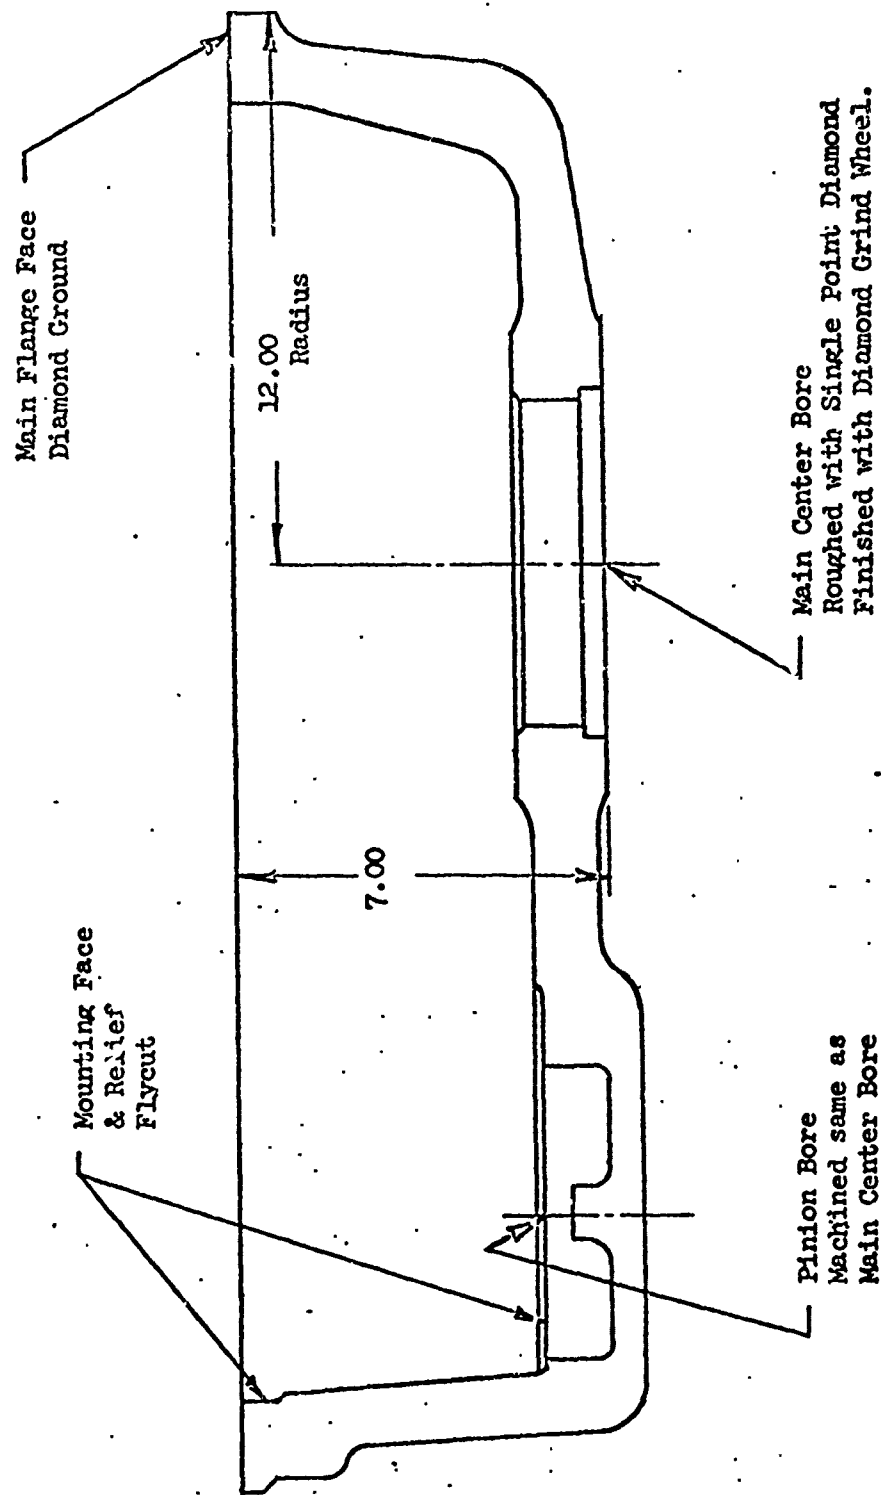
Figure 2
Front Reduction Gear Housing

Single Point Diamond Tools - Initial attempts at finishing the main center bore and pinion bore (see figure 2) were made with single point diamond tools. The housing was set up on a 66 in. vertical lathe for these trials. Enough wear on the diamonds was encountered to make design tolerances of $\pm .0005$ over a 1.40 bore length impossible to hold. (See figure 5 for photographs of a diamond tool after use). This, again, is not a total evaluation of diamond tool life. The machine used limited the cutting speed to 550 surface feet per minute (SFM) whereas diamond tools are most efficient at speeds of 1000 SFM or above. Tool configuration was also not ideal. As indicated in further development, a high negative rake tool provides better tool life. The tools used on the lathe were zero degree rake.

Additional single point tool usage involved machining a mounting face adjacent to the pinion bore and a clearance cut near the main flange face (see figure 2). Because these areas were contoured, the housing was set up on a 2-dimensional vertical spindle contour mill with templates. A single point diamond tool with 20° negative rake was set at .70 radius in a fly cutter. The necessary machining was done with one tool and very little diamond wear was experienced. The machined surfaces met design tolerances with flatness held within .001 total indicator reading on the pinion bore mounting face. The best surface finish obtained was 150 RMS and this was deemed acceptable.

Diamond Grinding - A 5 in. OD - 180 grit diamond cup wheel was used to finish machine the main flange face, center bores and pinion bore (see Figure 2). This wheel was mounted on an Ex-Cell-O tool post grinder set up on the ram of a vertical lathe. Machining was done at the parameters specified in Table I.

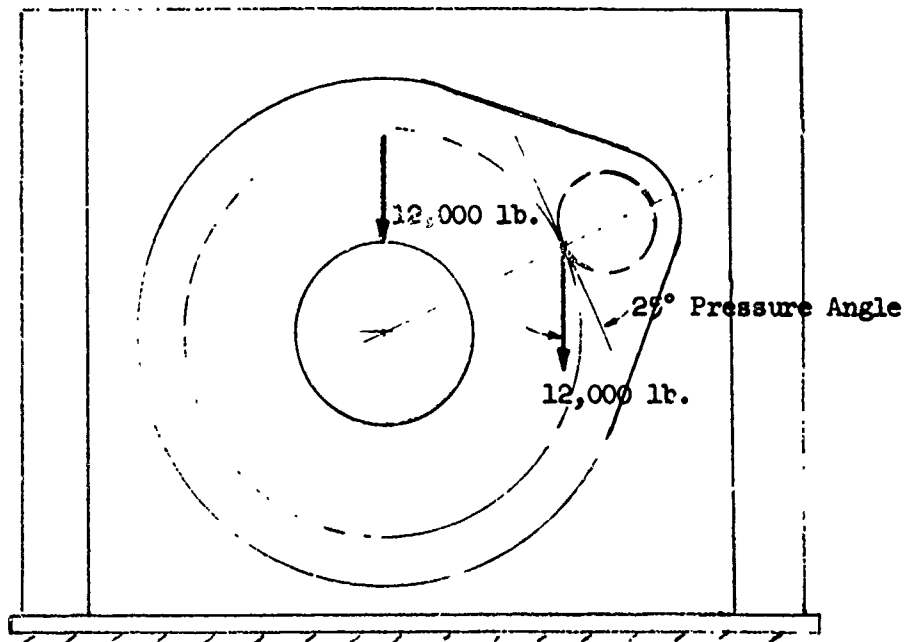
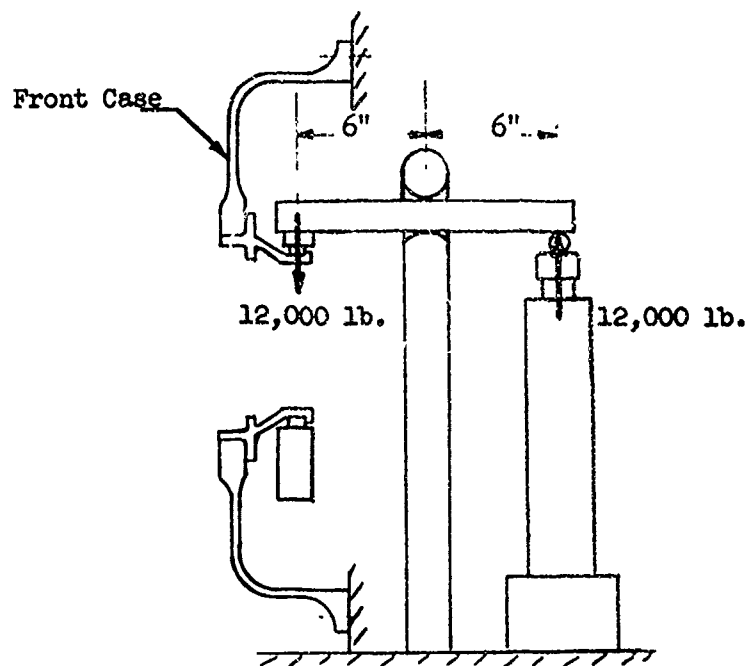
Figure 9 - Static Deflection Test Set-Up

The case was mounted to a steel plate which was supported by ram stands. A hydraulic ram supplied the force from outside the case by means of a fulcrum bar loading into a steel ring. The load was transferred from the ring through the bearing rollers to the bearing support. Figure 9 shows a sketch of the test set-up. A photograph of the loading method is shown in Figure 10.

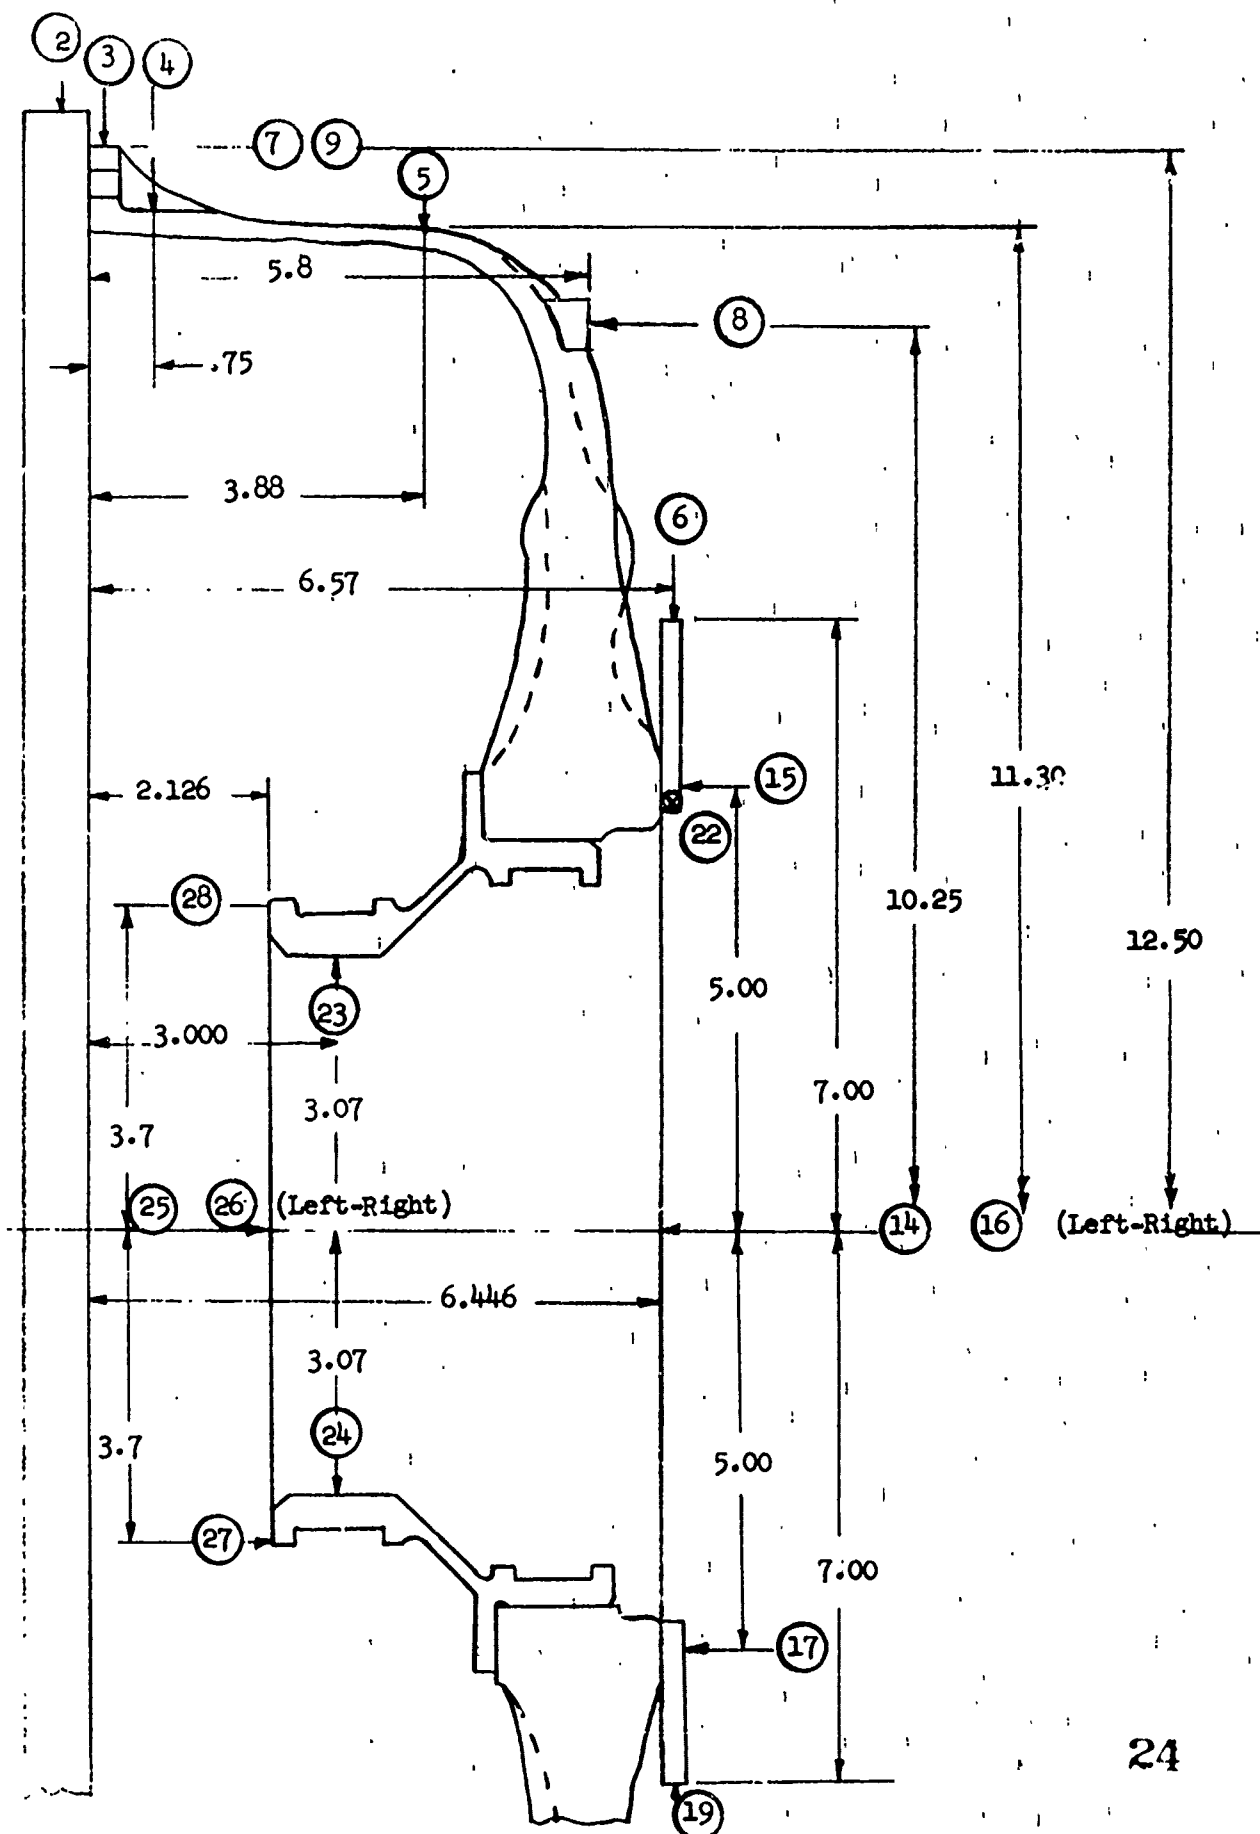
Figure 11 - Dial Indicator Locations

Dial indicators were installed to obtain front face deflection at the center bore, front face deflection at the pinion bearing pad, main drive gear bearing support deflections and other deflections on the outside of the case. The locations of the indicators are shown in Figure 11. A photograph of the instrumentation is presented in Figure 12.

* This slope measured by indicators #10 & 12 (Figure 11)

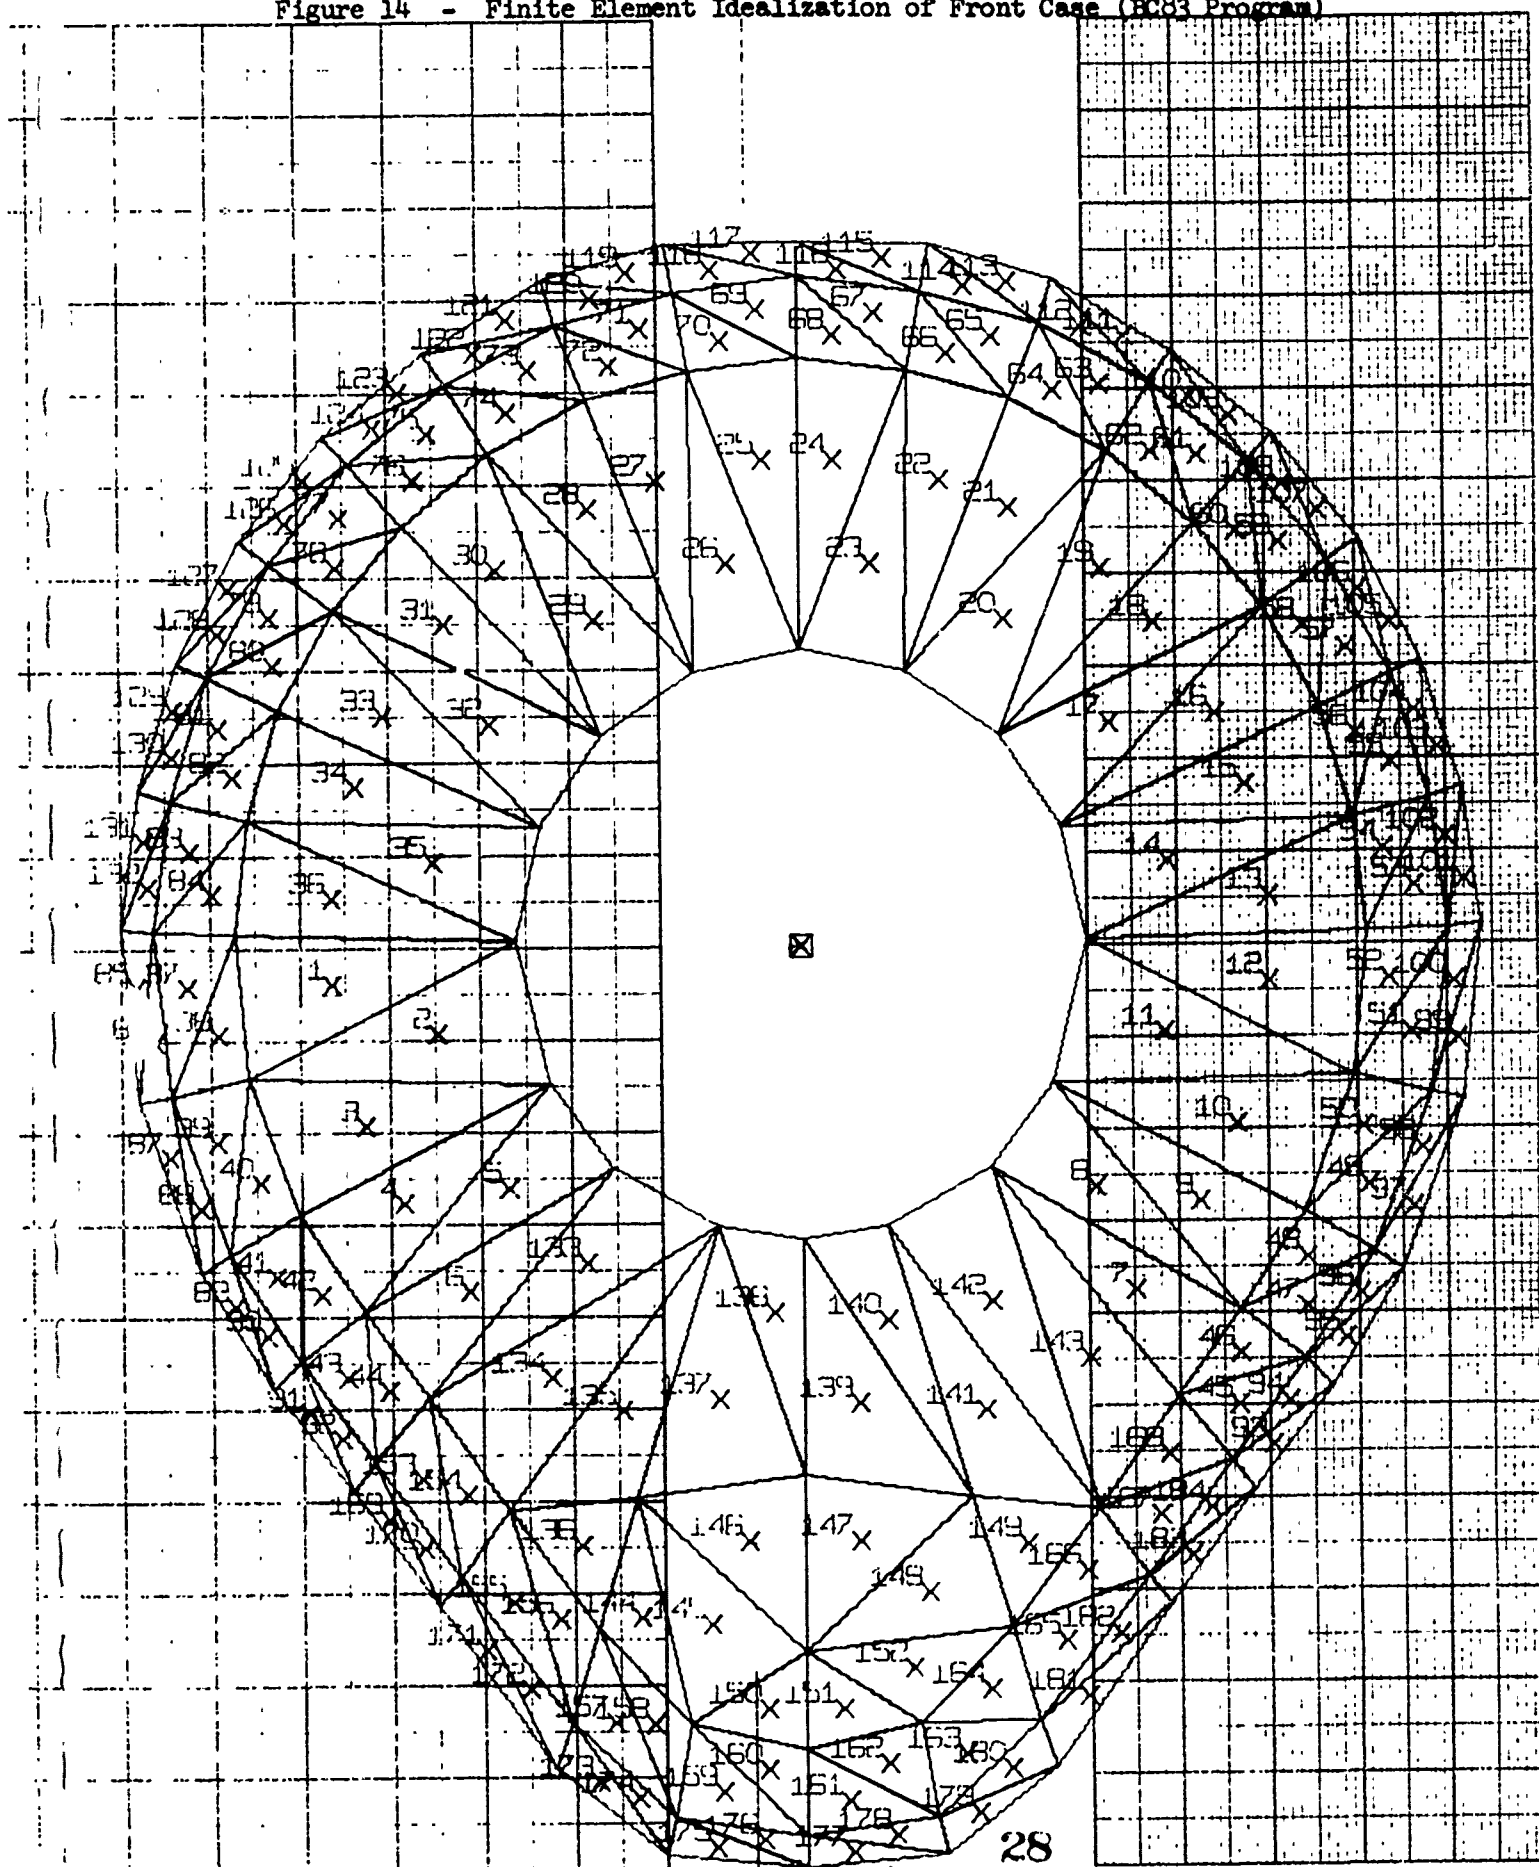
Figure 14 - Finite Element Idealization of Front Case (BC83 Program)

An 1130 computer plot of the front projection of the finite element idealization of the composite case for program BC83 is given in Figure 14.

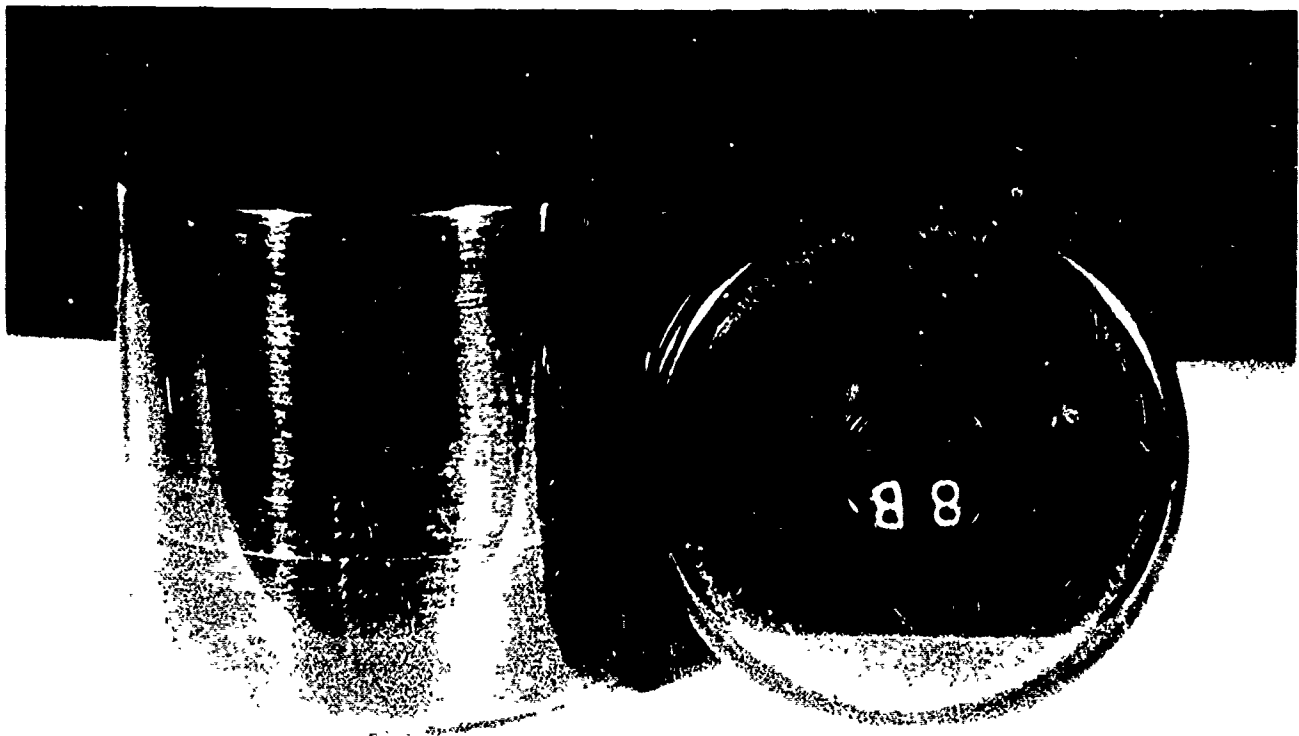
FIGURE 18 MAIN DRIVE GEAR BEARING SUPPORT - INNER RACEWAY AND ROLLERS
(AFTER TEST)

Photographs of these same components after the testing indicated that their condition was unchanged. This fact leads to the conclusion that the stiffness of the composite material front gear case was adequate in reacting the imposed loads to maintain proper gear and bearing alignment.

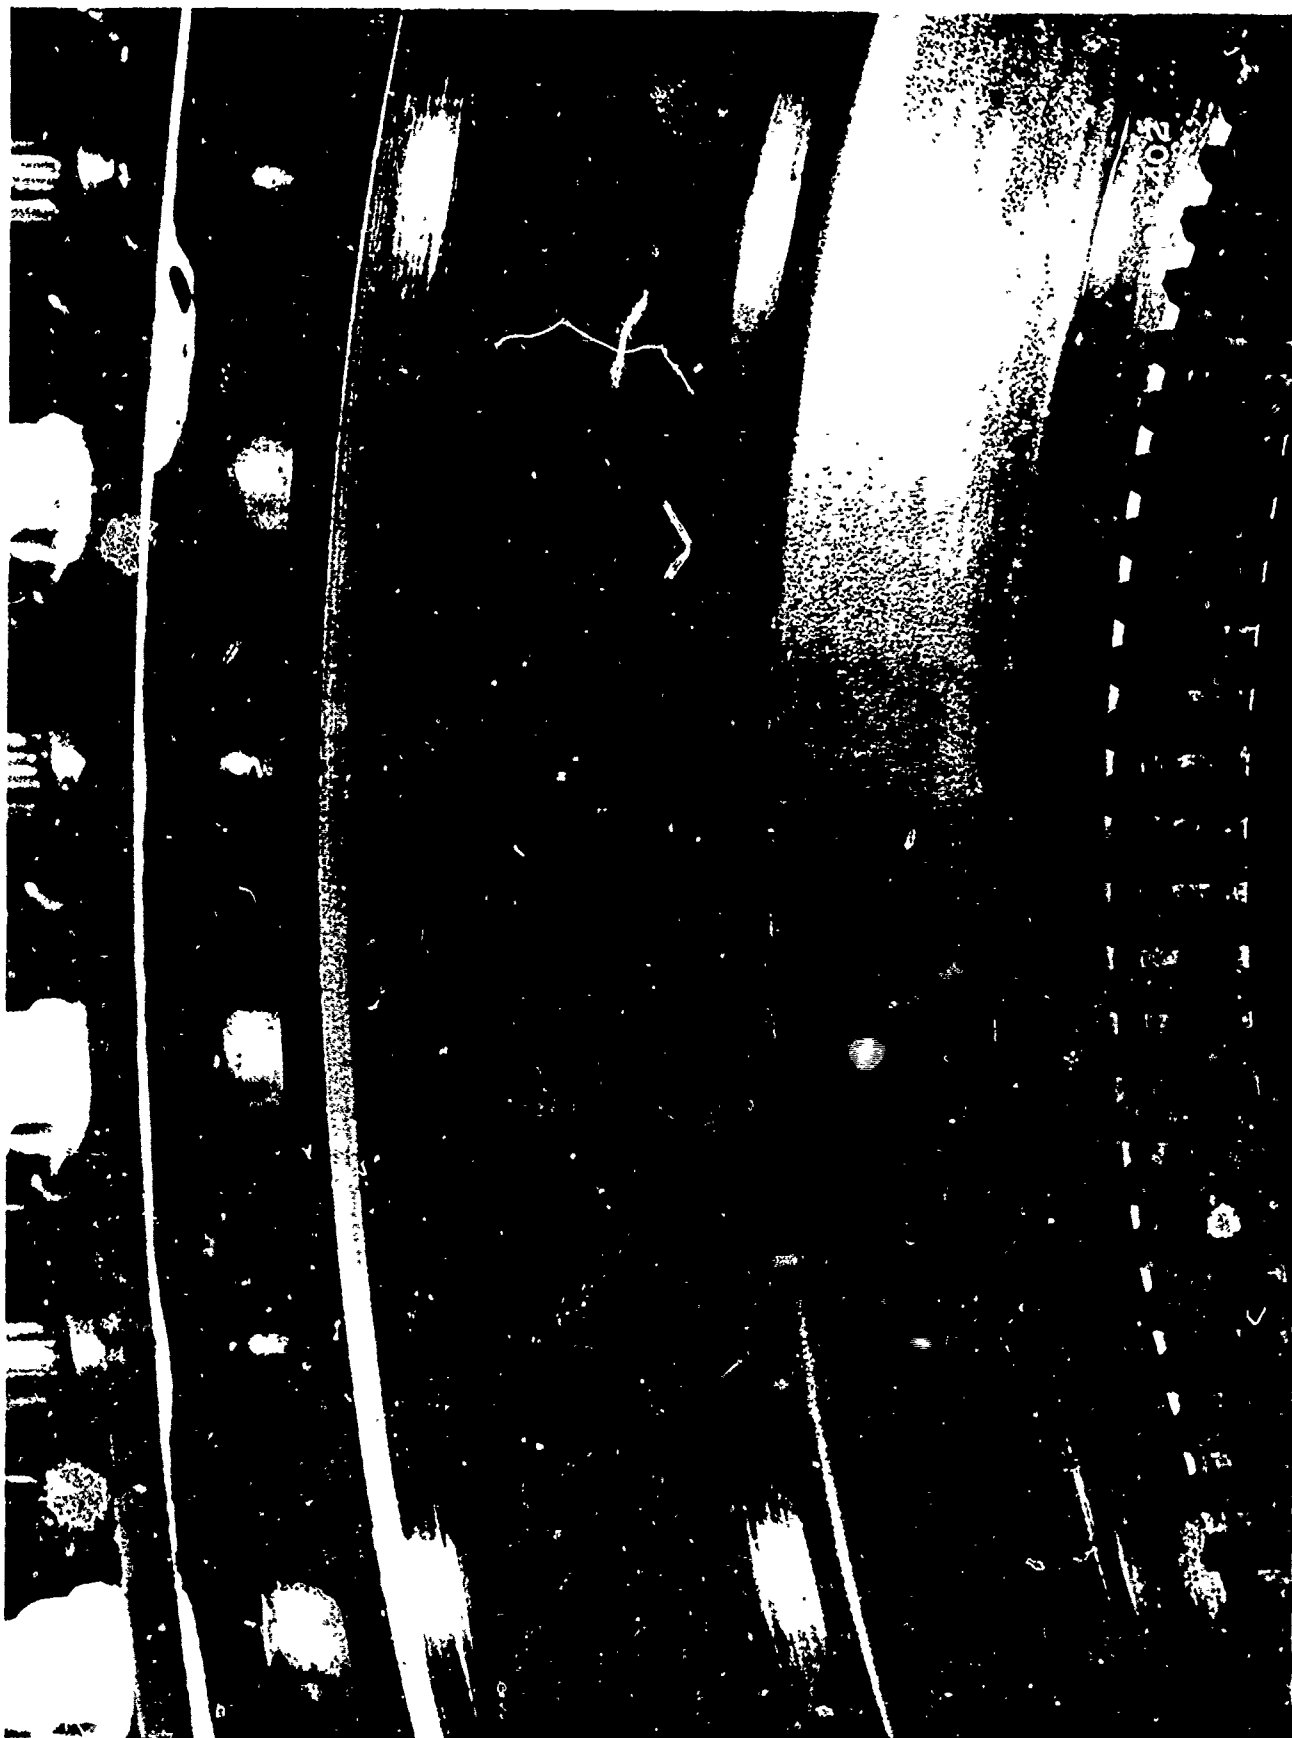
FIGURE 19 MAIN DRIVE GEAR BEARING-OUTER RACEWAY (BEFORE TEST)

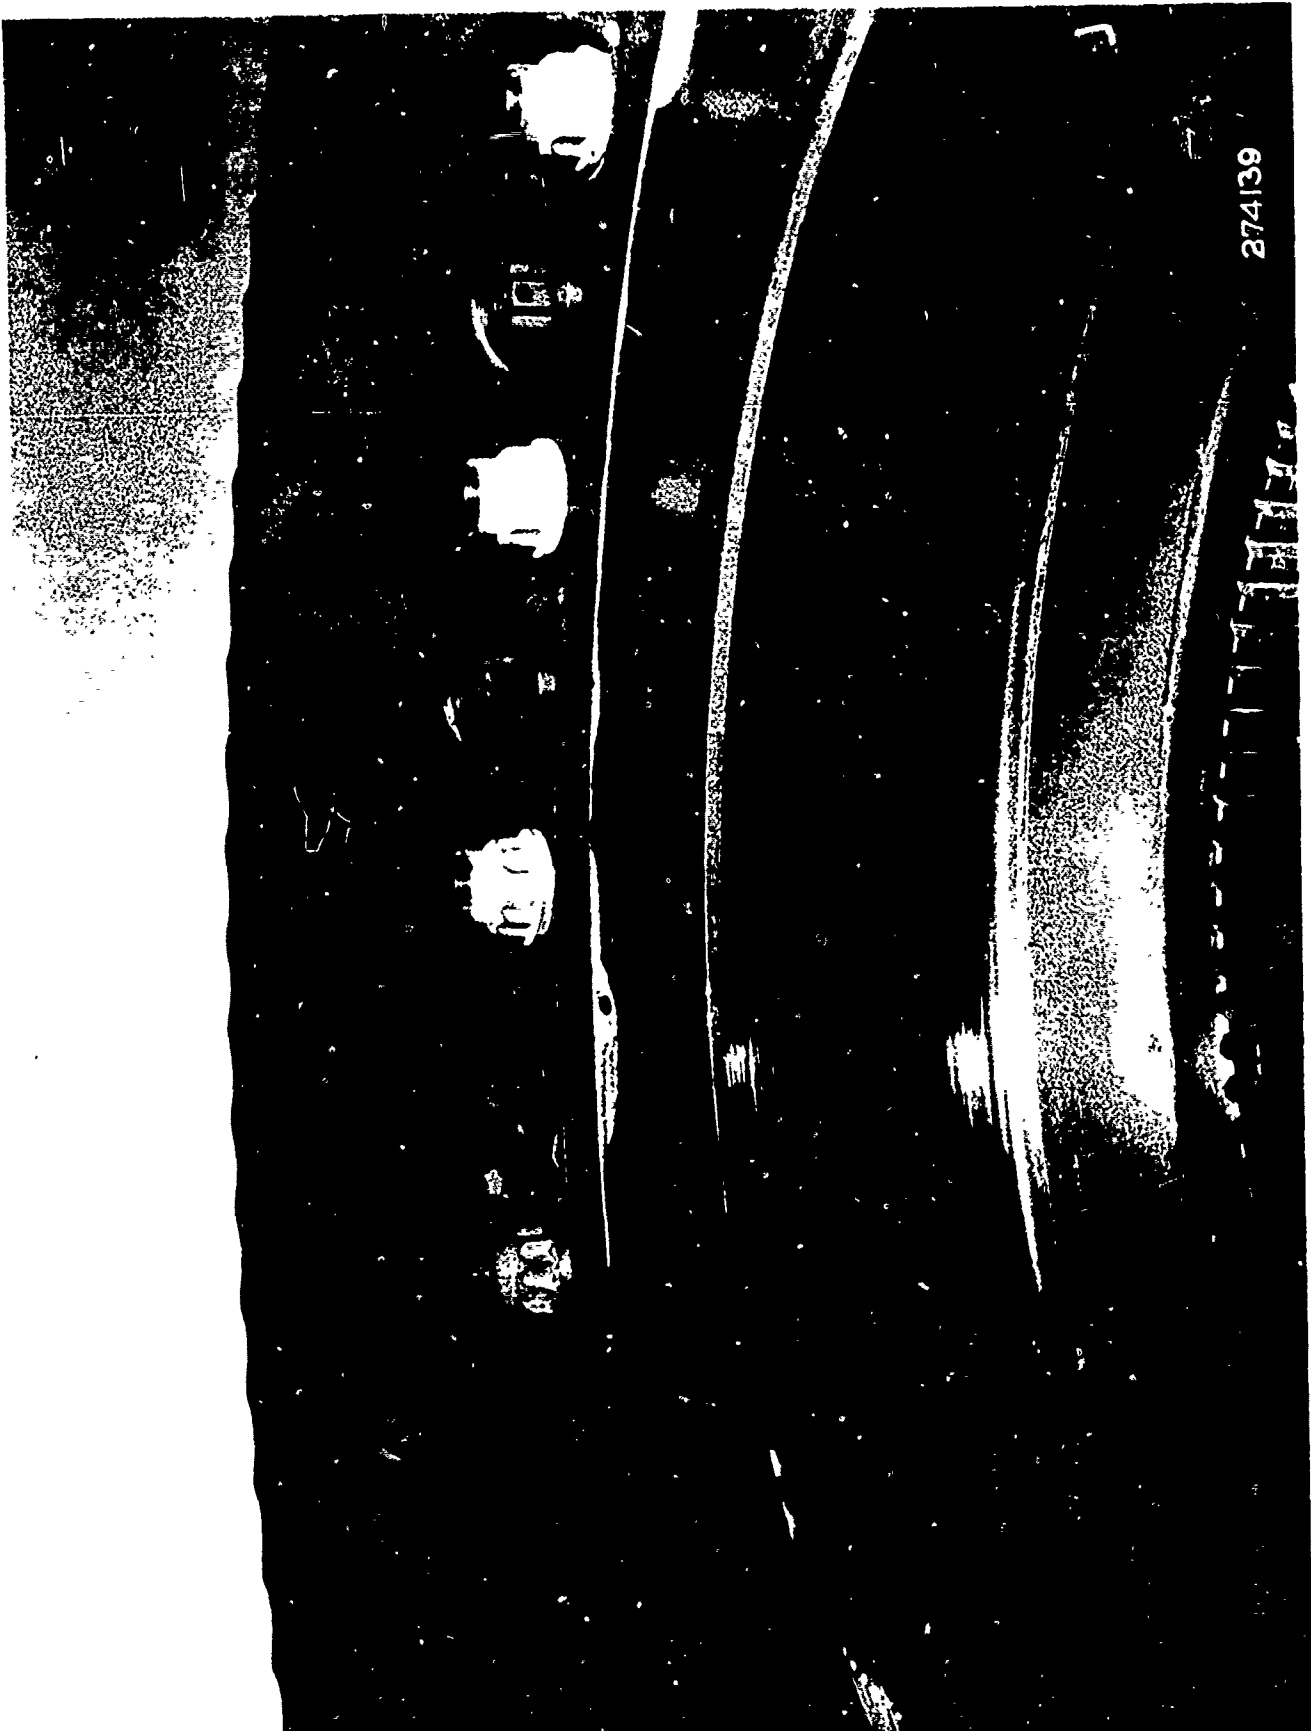
FIGURE 20 MAIN DRIVE GEAR BEARING-OUTER RACEWAY (AFTER TEST)

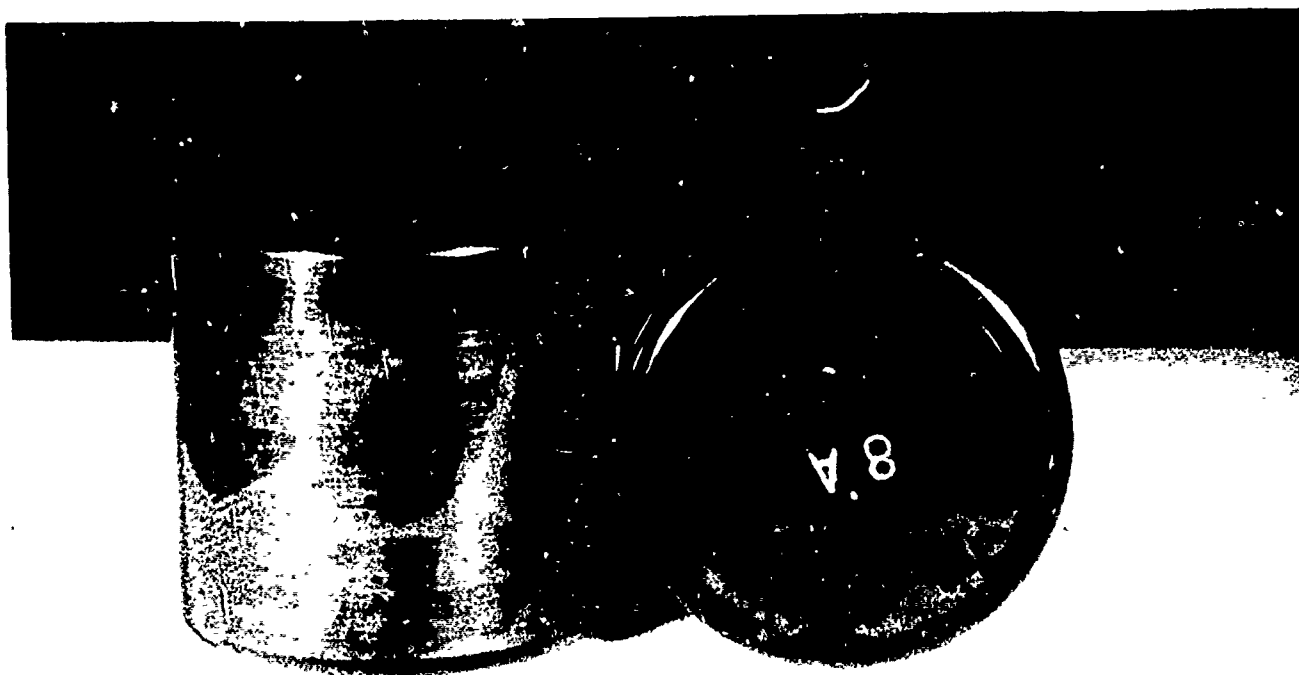
FIGURE 22 MAIN DRIVE GEAR SUPPORT-PROPELLER BEARING OUTER RACEWAY AND ROLLERS (AFTER TEST)

These photos are grouped in pairs (before and after condition) and are given in Figures 21 through 24 and Figures 27 through 32.

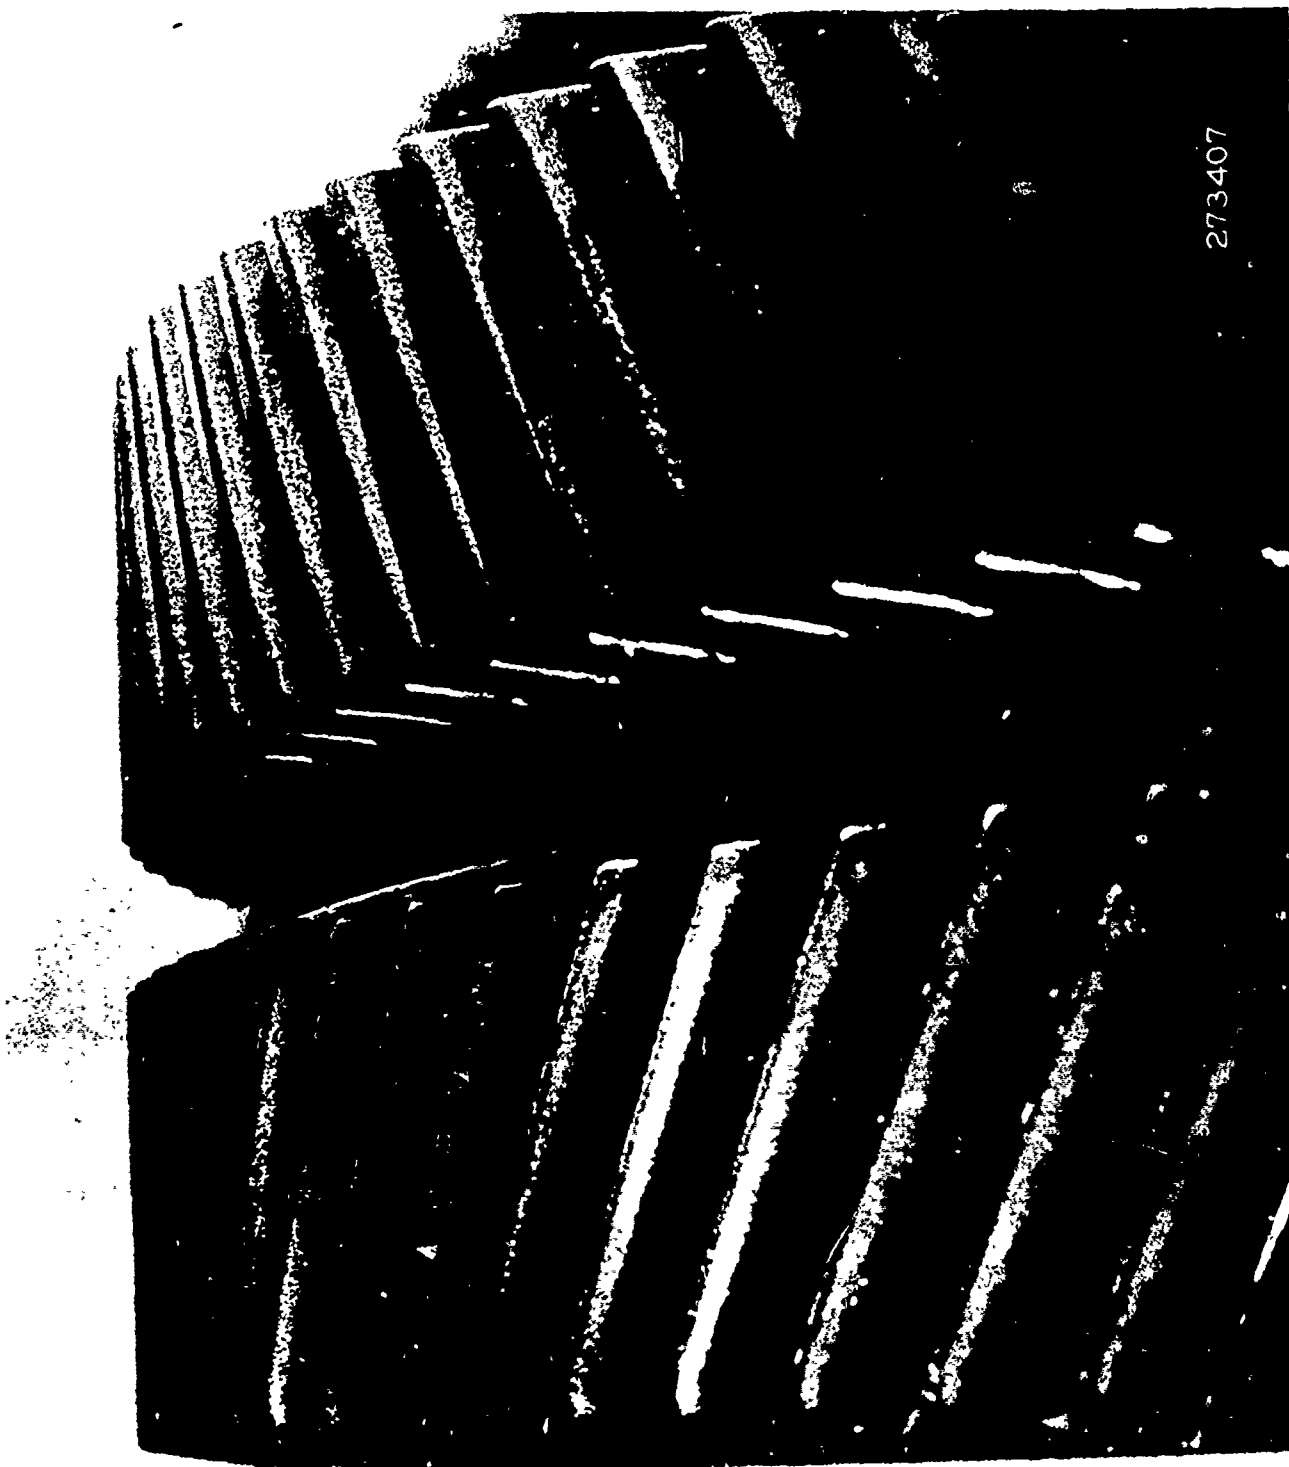
FIGURE 25 MAIN DRIVE GEAR TEETH-LOAD SIDE (BEFORE TEST)

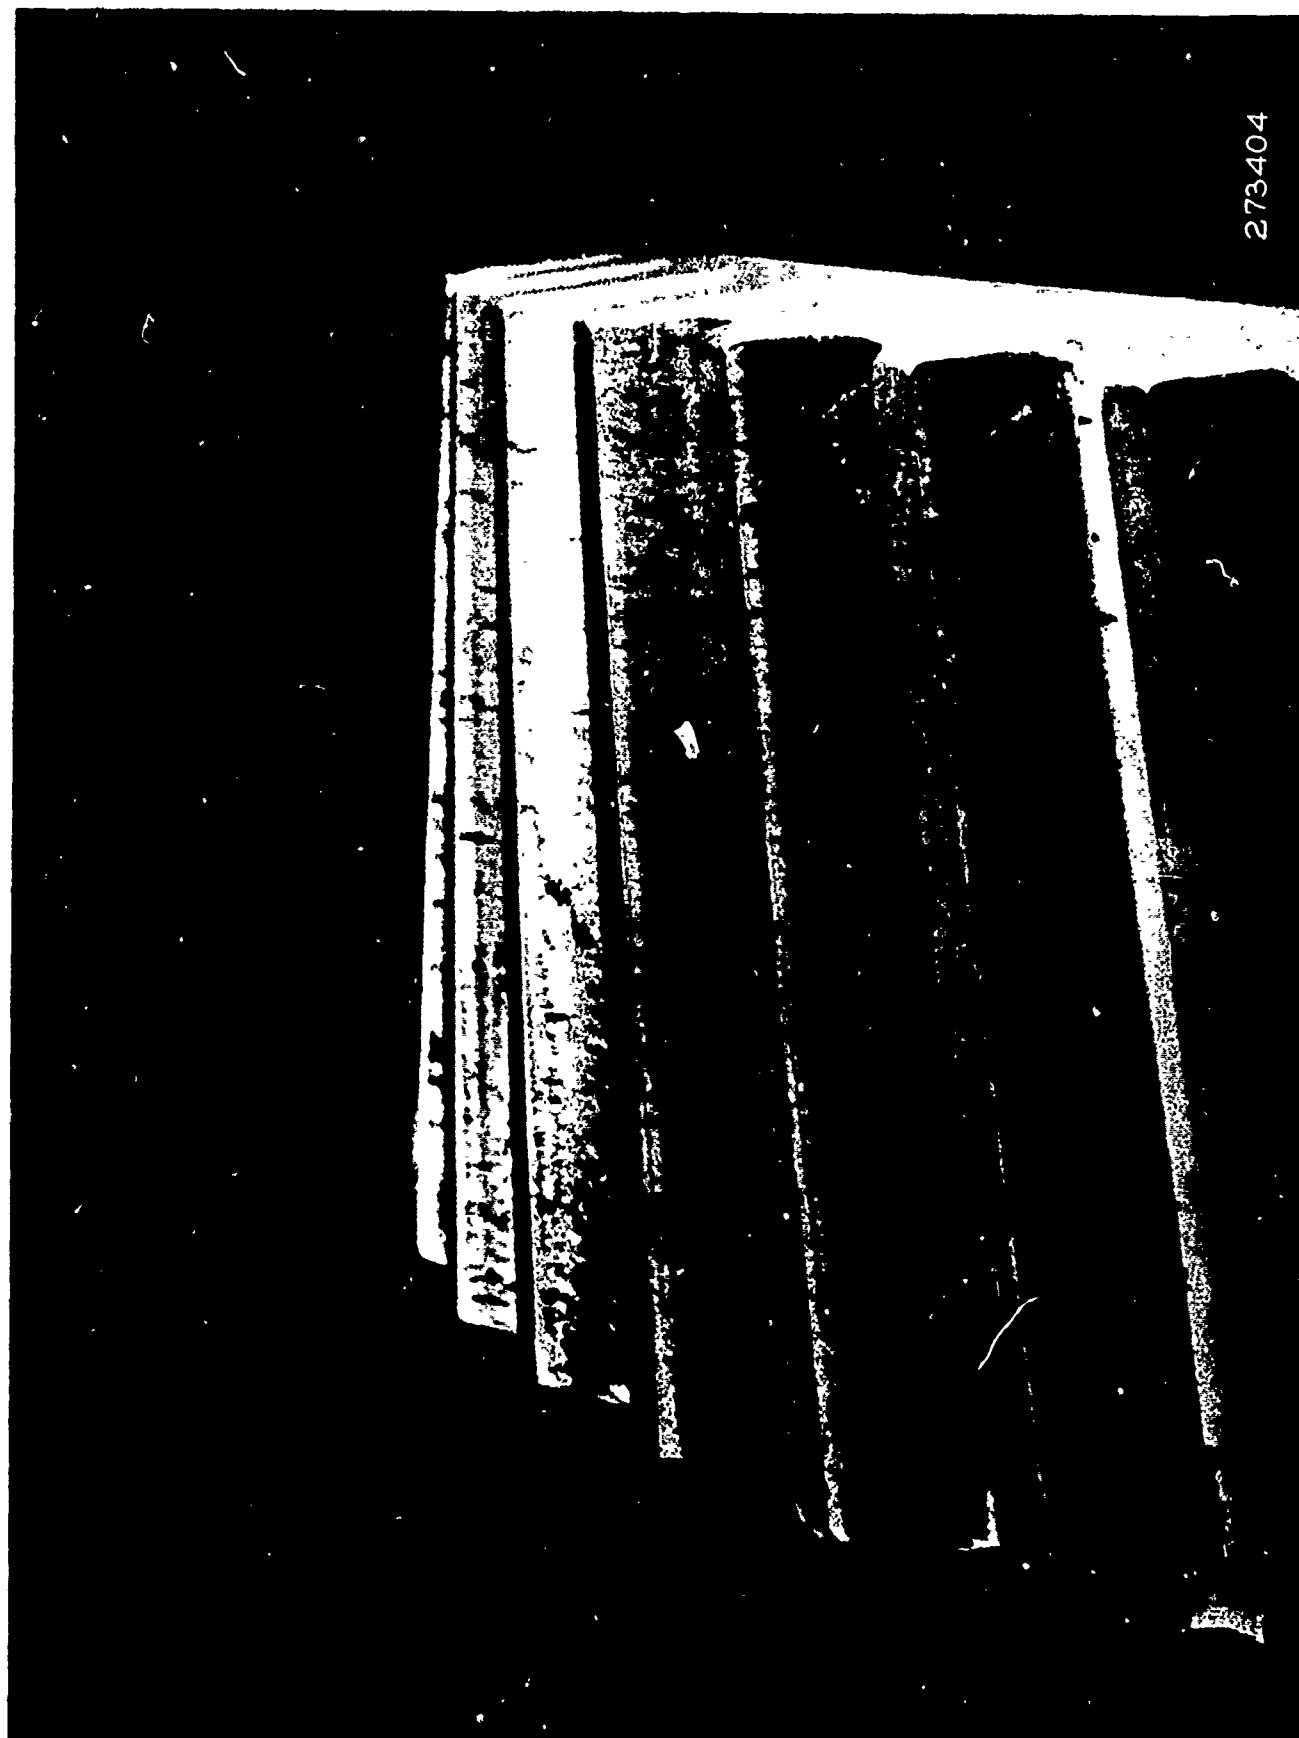
FIGURE 27 SUN GEAR TEETH-LOAD SIDE (BEFORE TEST)
