LIGHTWEIGHT GEARBOX COMPOSITE CASE.
PHASE II.

**PHASE II
LIGHTWEIGHT GEARBOX
COMPOSITE CASE**

**FINAL REPORT
(18 MARCH 1970 TO 18 JANUARY 1971)**

**Detroit Diesel Allison Division • General Motors
Indianapolis, Indiana**

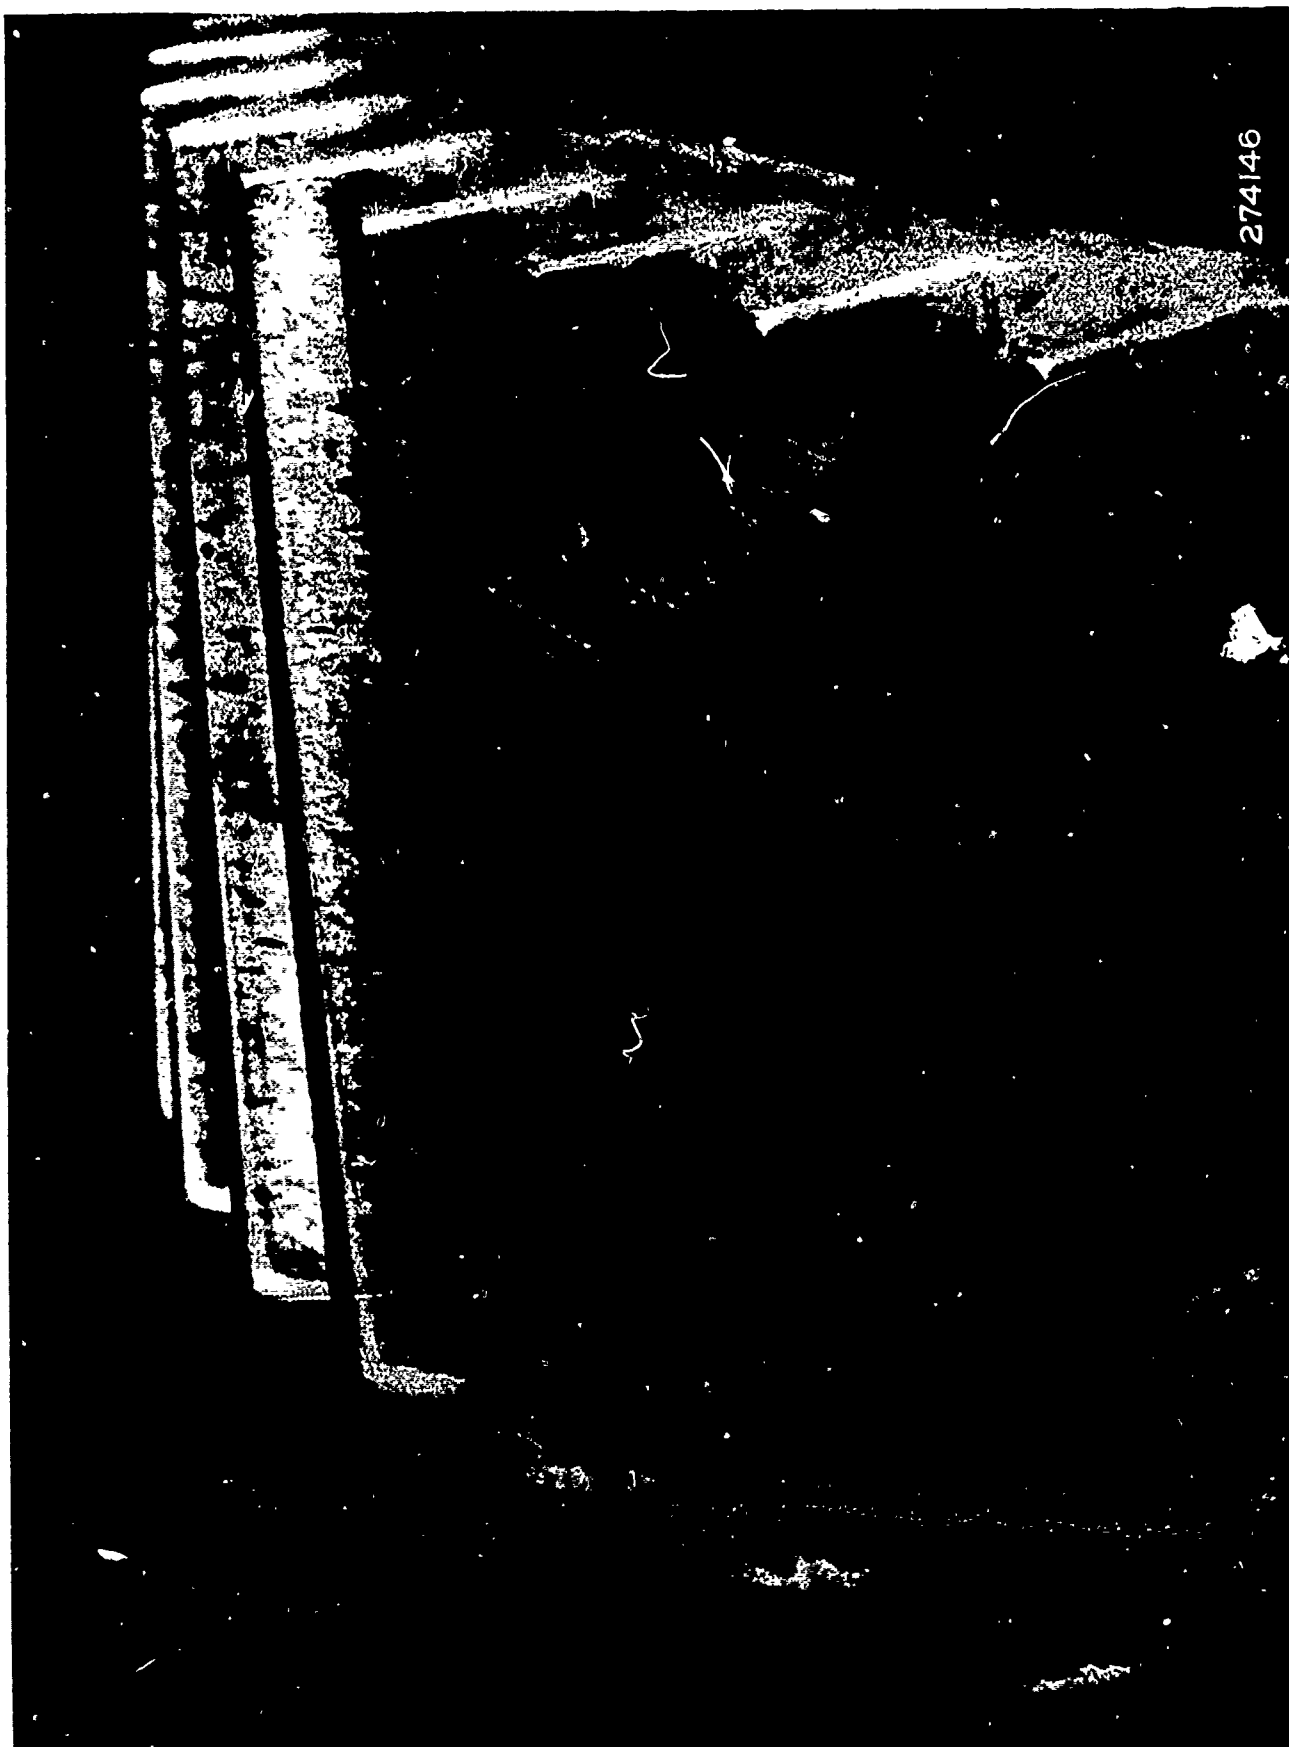
FIG. 28 SUN GEAR TEETH-LOAD SIDE (AFTER TEST)

These photos are grouped in pairs (before and after condition) and are given in Figures 21 through 24 and Figures 27 through 32.

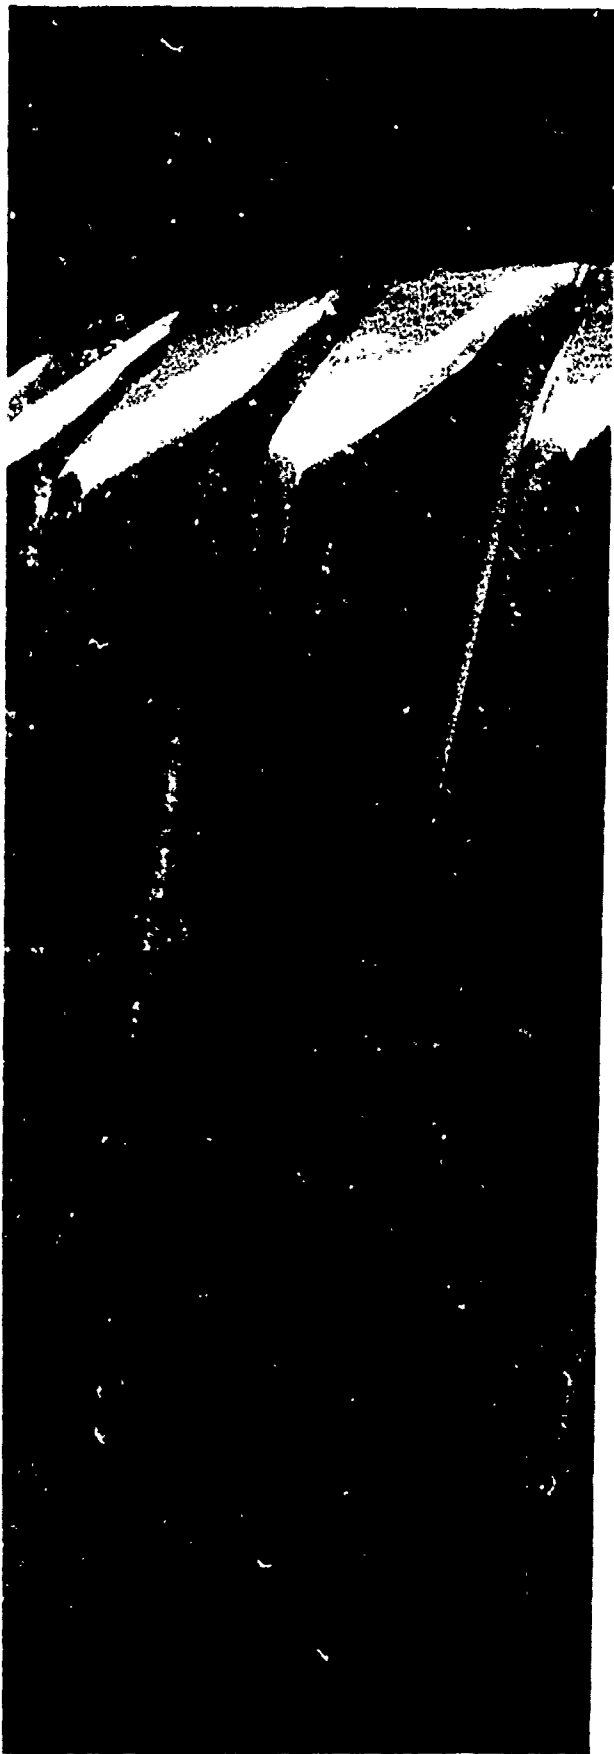
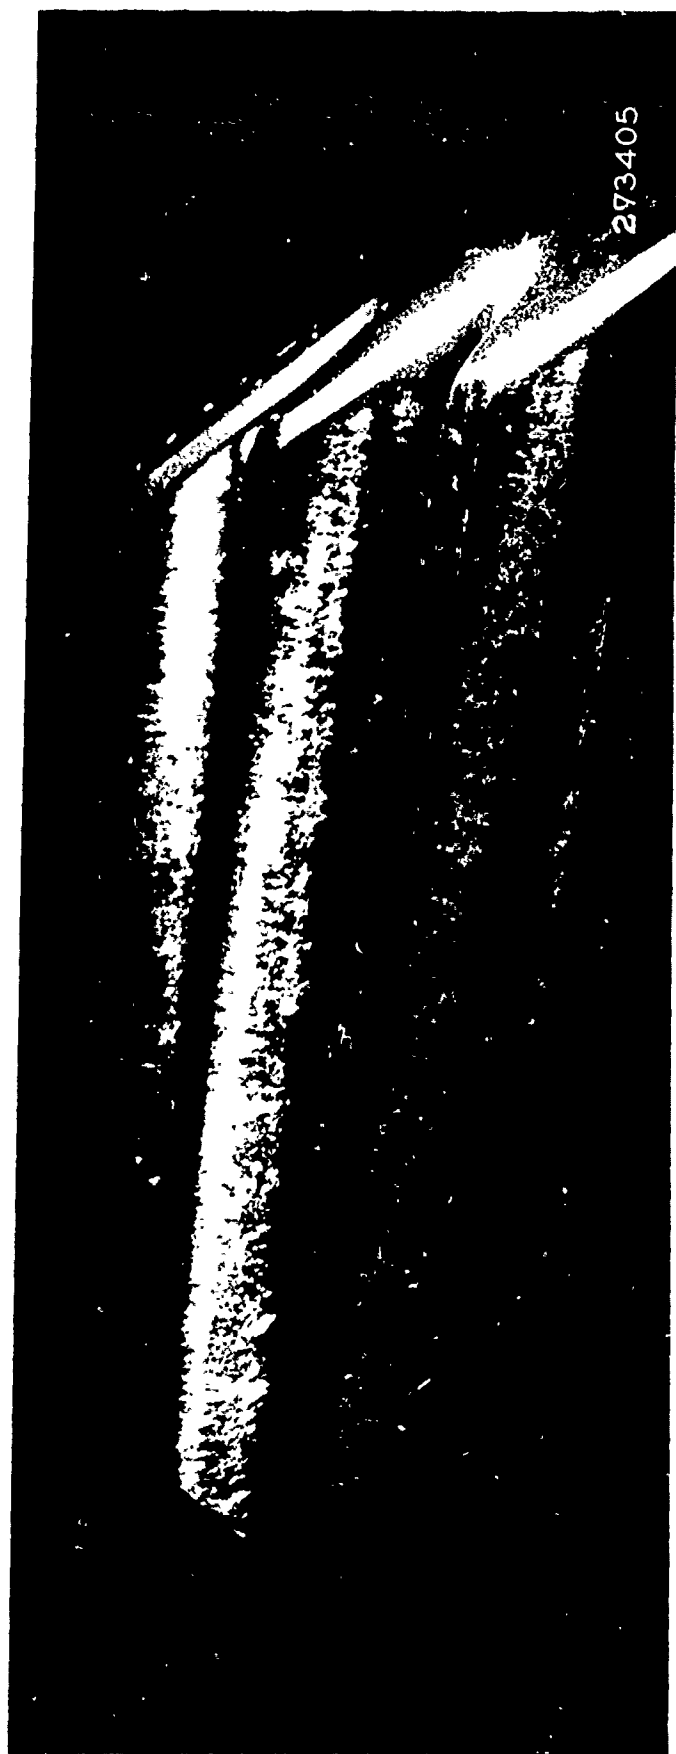
FIGURE 29 PLANET GEAR TEETH (BEFORE TEST)

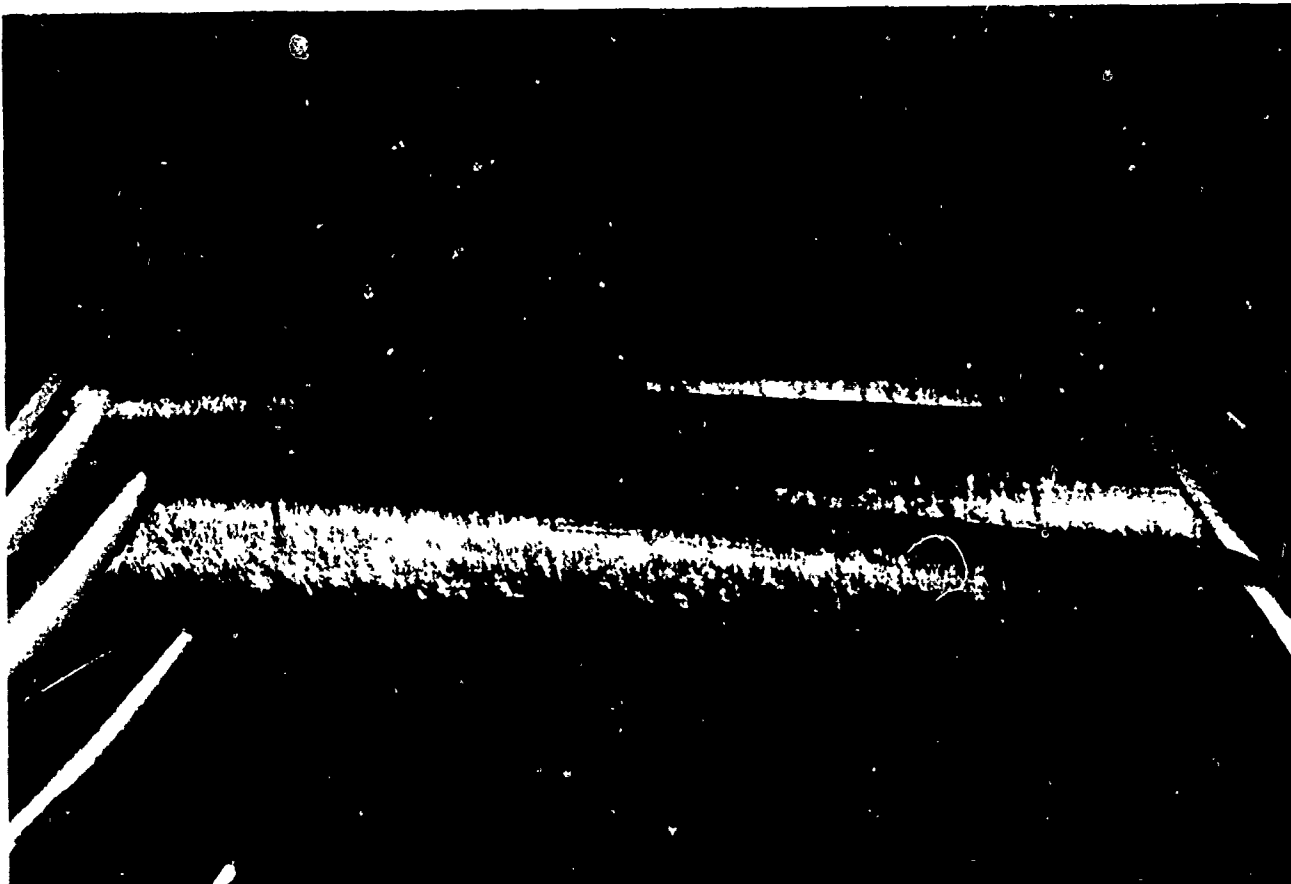
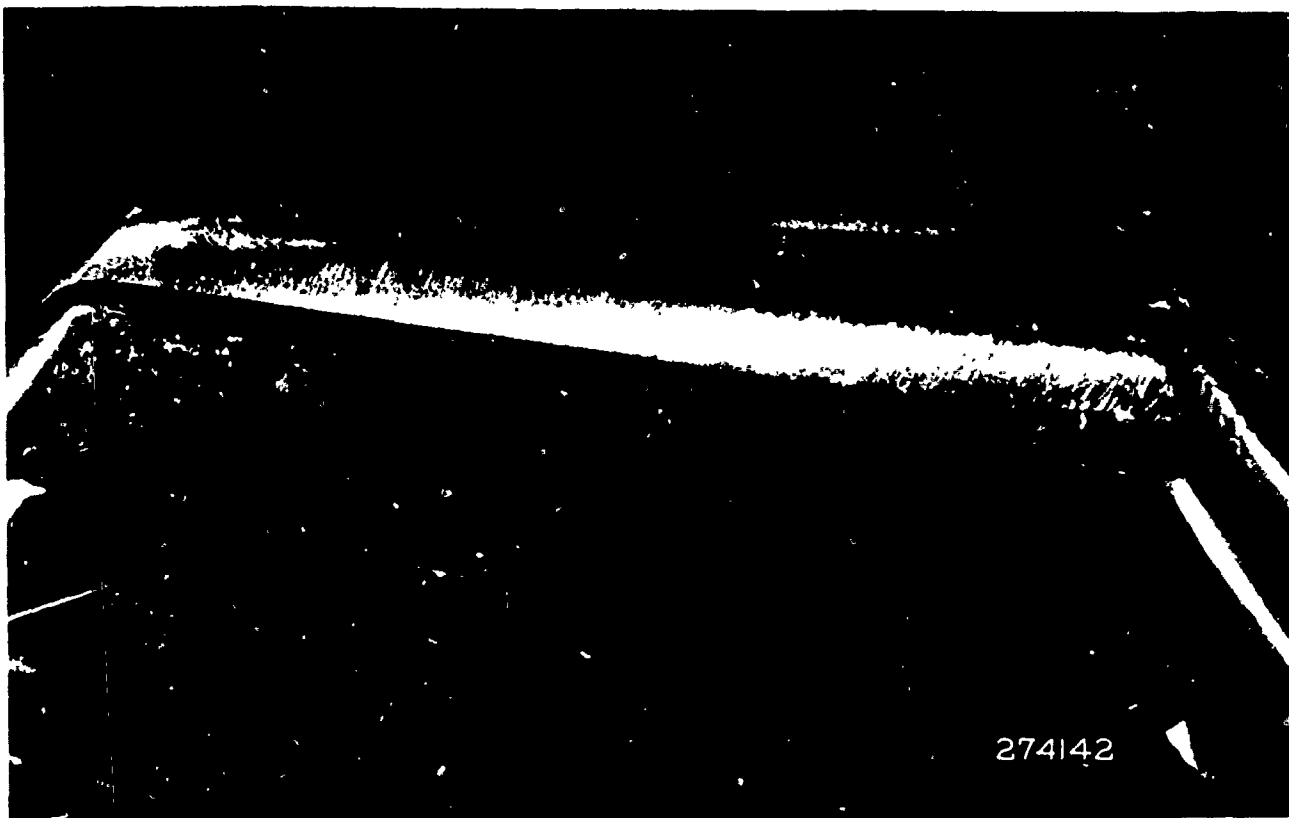
FIGURE 30 PLANET GEAR TEETH (AFTER TEST)

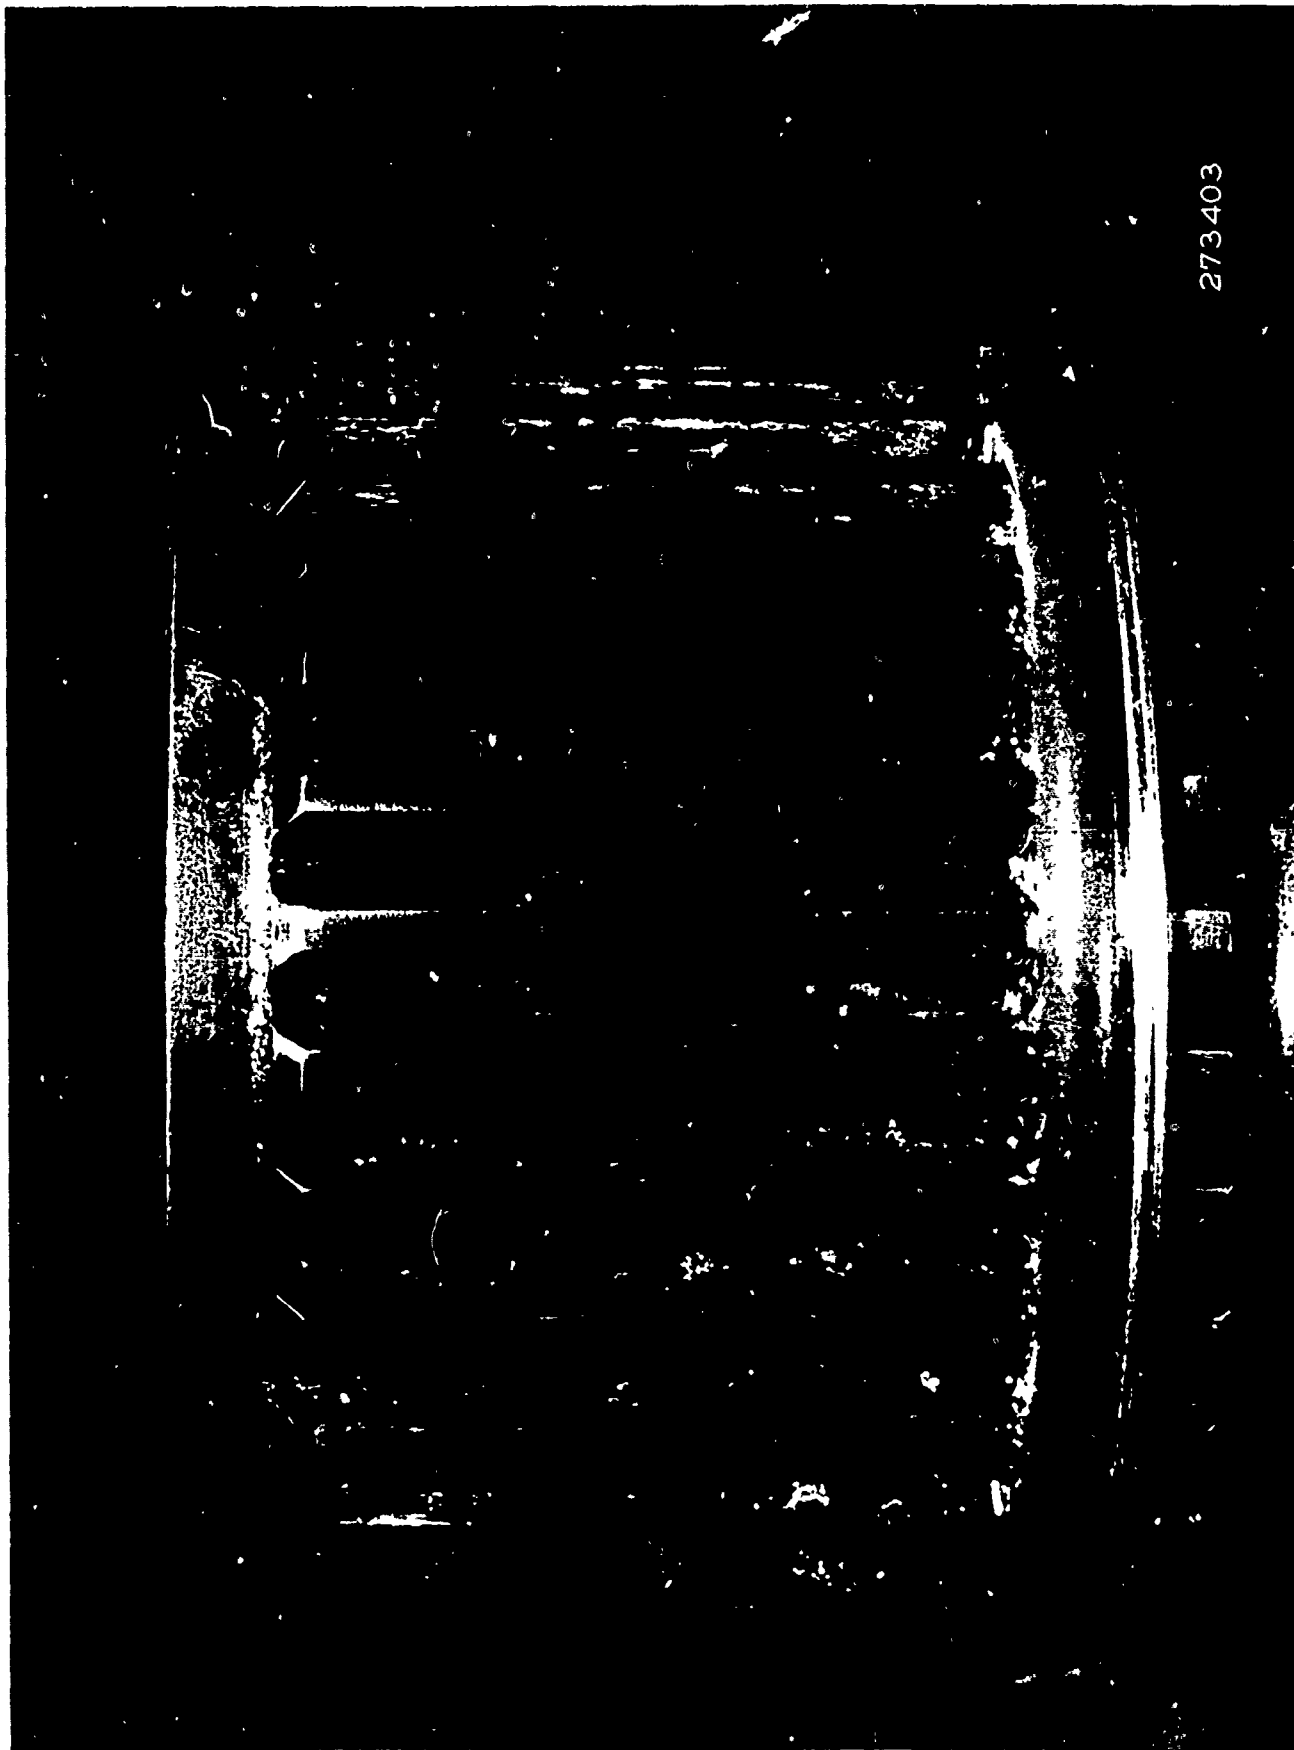
FIGURE 31 PINION DRIVE SHAFT SPLINE (BEFORE TEST)

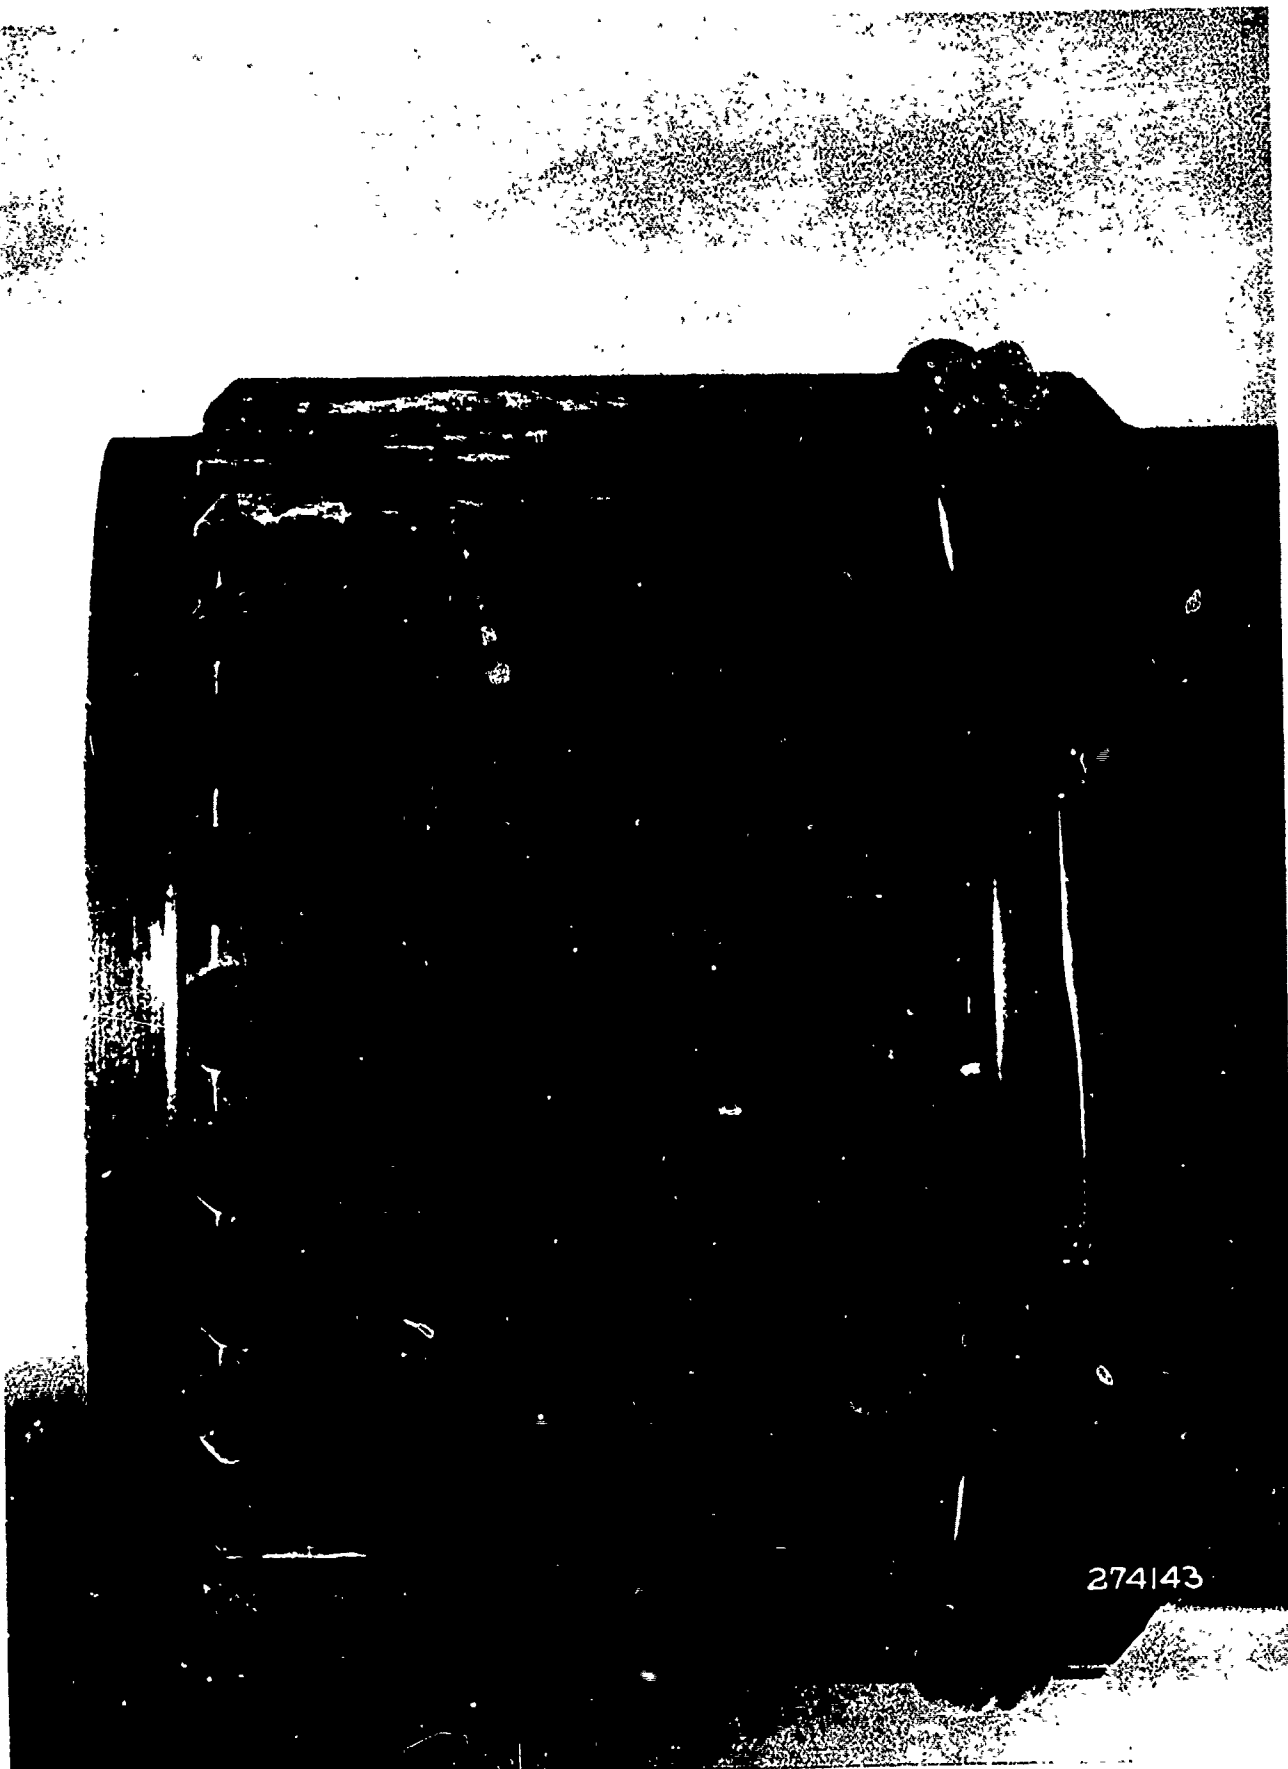
FIGURE 32 PINION DRIVE SHAFT SPLINE (AFTER TEST)

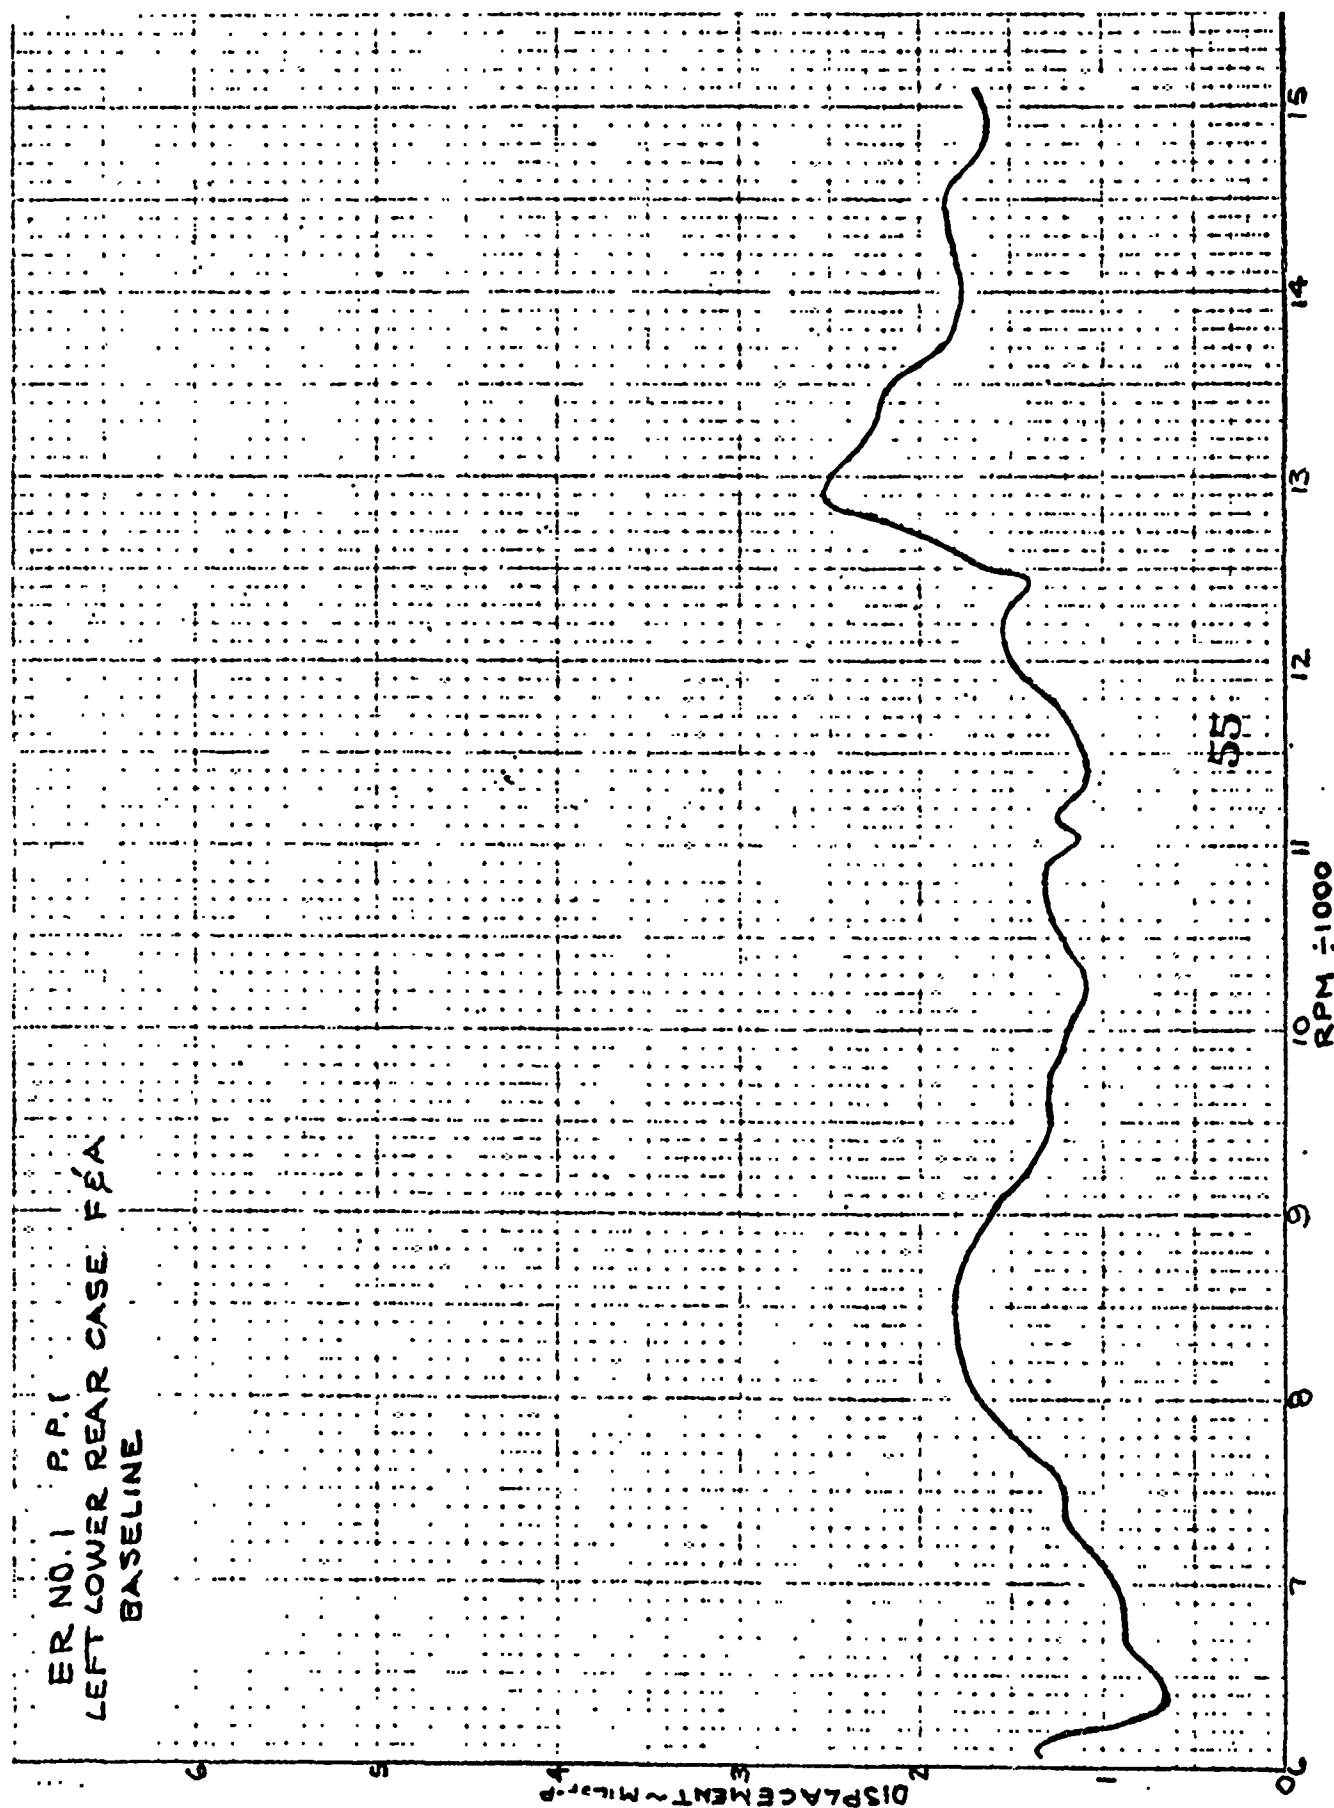
CURVE NO. 1

BASELINE
G/B REAR CASE LOWER LEFT F&A
12,900 RPM = 215 Hz
PROP ROTATIONAL = 16 Hz

Analysis of the 1/3 octave data indicates that the primary vibration occurs at prop rotational, twice prop rotational, and engine rotational frequencies. The high vibration at 8,000 and 13,000 RPM appears to be a stand resonance occurring in the 31.5 Hz 1/3 octave band. The vibration levels at engine rotational frequency showed little variation at the RPM points checked.

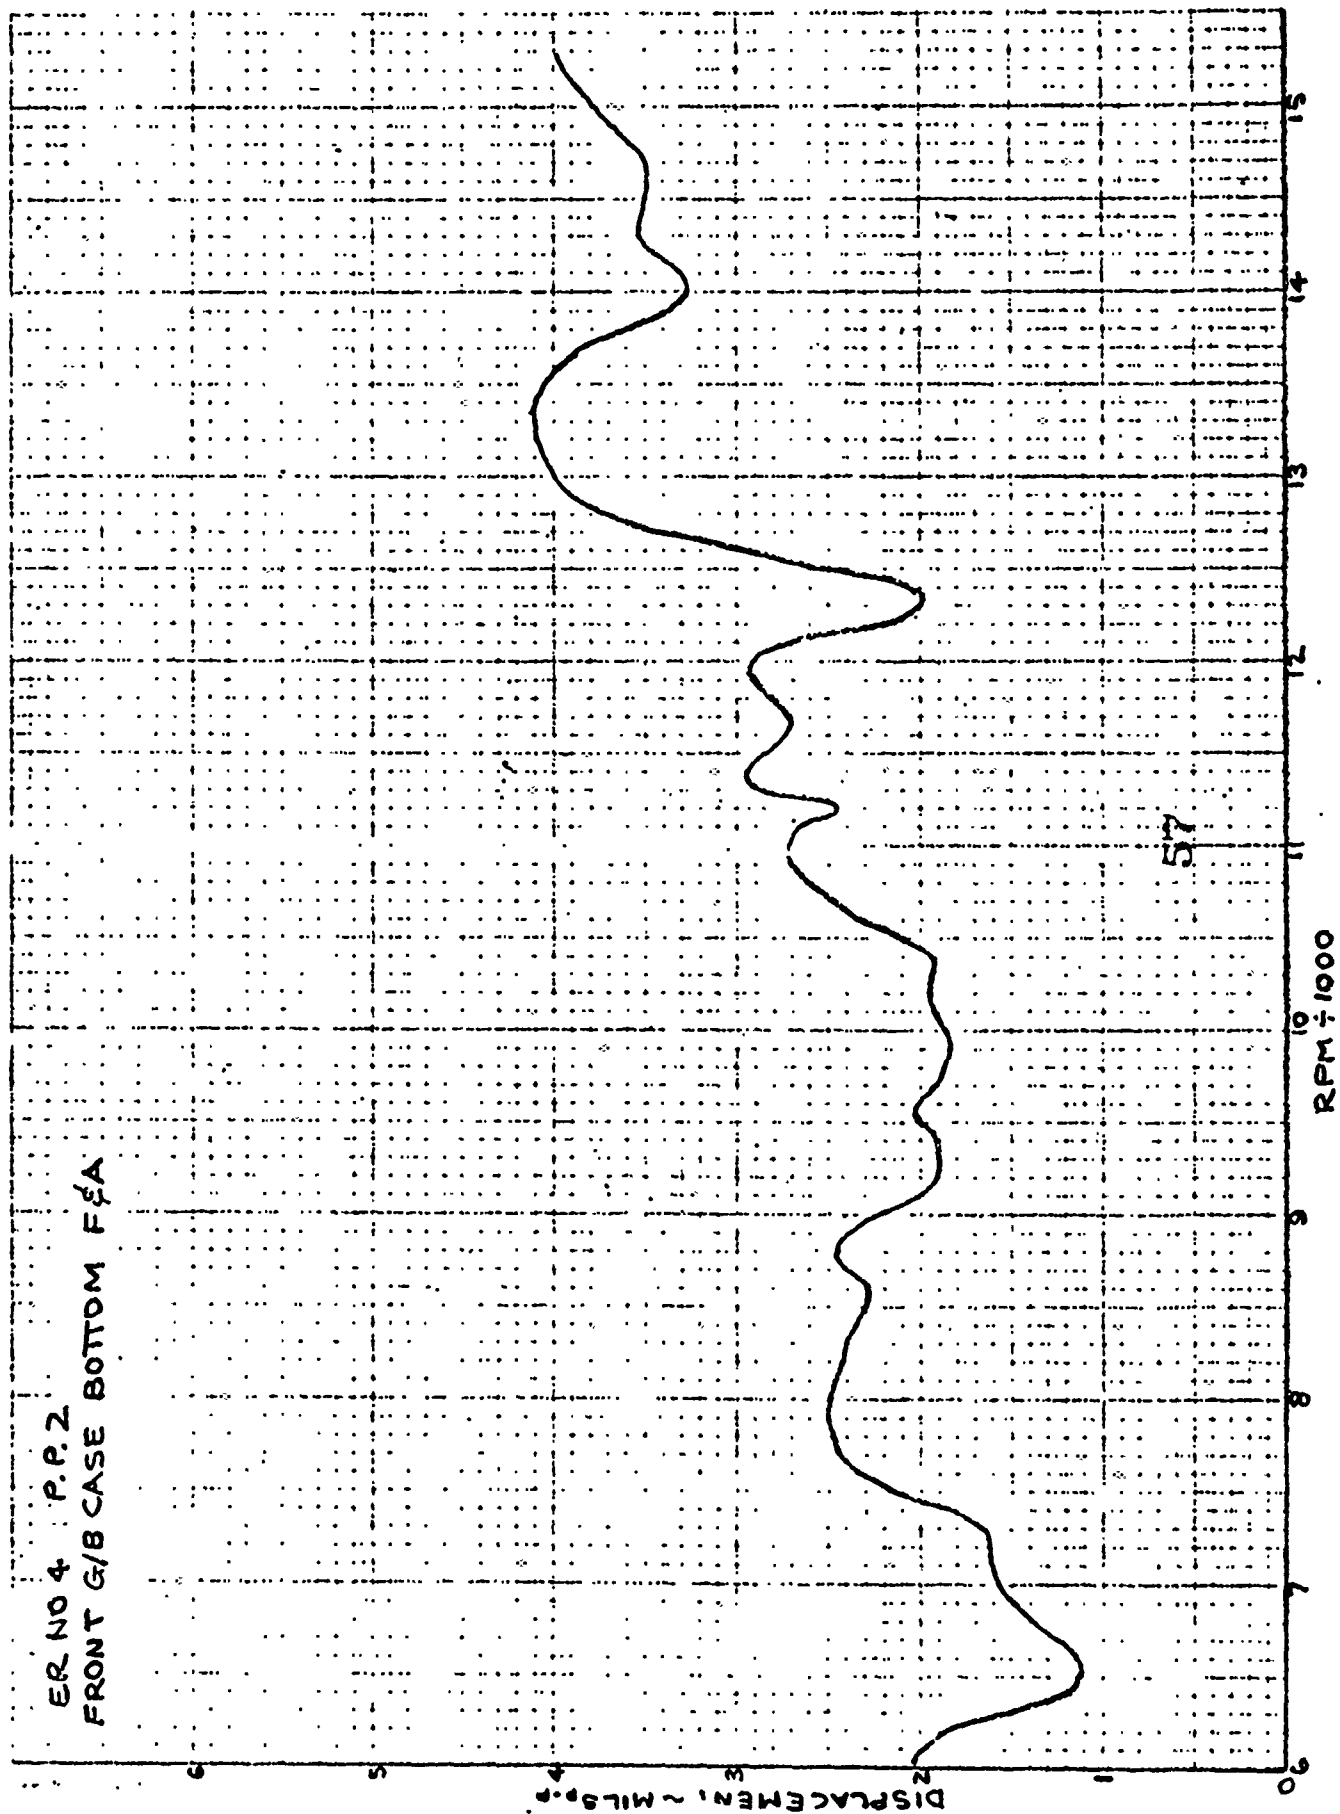
G/E FRONT CASE BOT. M. = 8A
12,900 RPM = 215 Hz
PROP ROTATIONAL = 16 Hz

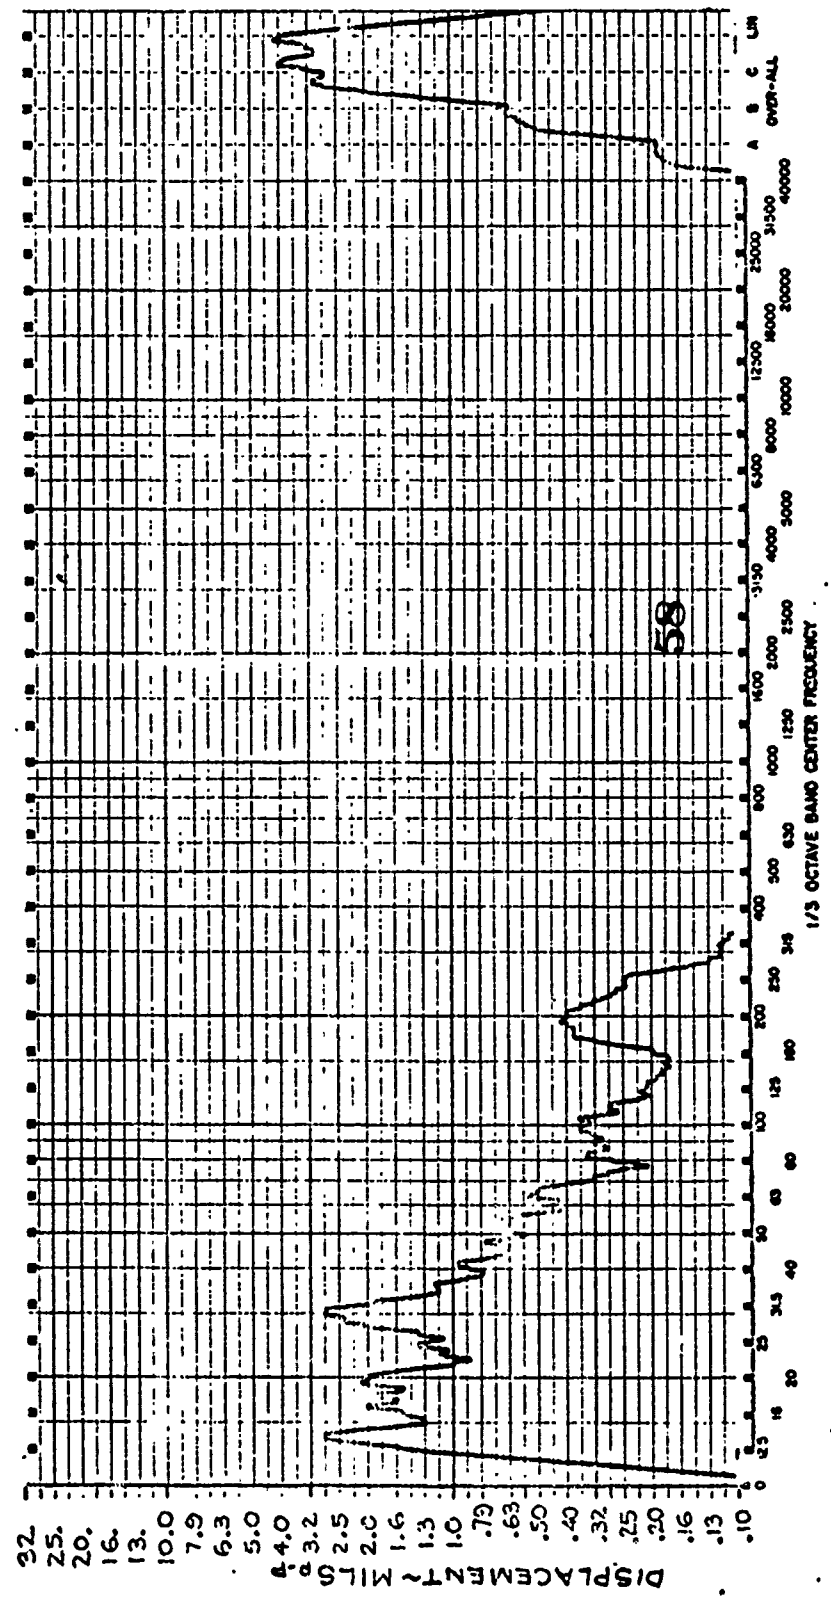
E/B FRONT CASE BOTTOM FEA
15,000 RPM = 250 HZ
PROP ROTATIONAL = 18 HZ
