AN INVESTIGATION OF METALLURGICAL  
FACTORS WHICH AFFECT FRACTURE  
TOUGHNESS OF ULTRA-HIGH STRENGTH  
STEELS

WILLIAM E. WOOD, EARL R. PARKER,  
and VICTOR F. ZACKAY

Lawrence Berkeley Laboratory  
University of California  
Berkeley, California 94720

Final Report      Contract Number DAAG46-72-C-0220  
LBL-1474

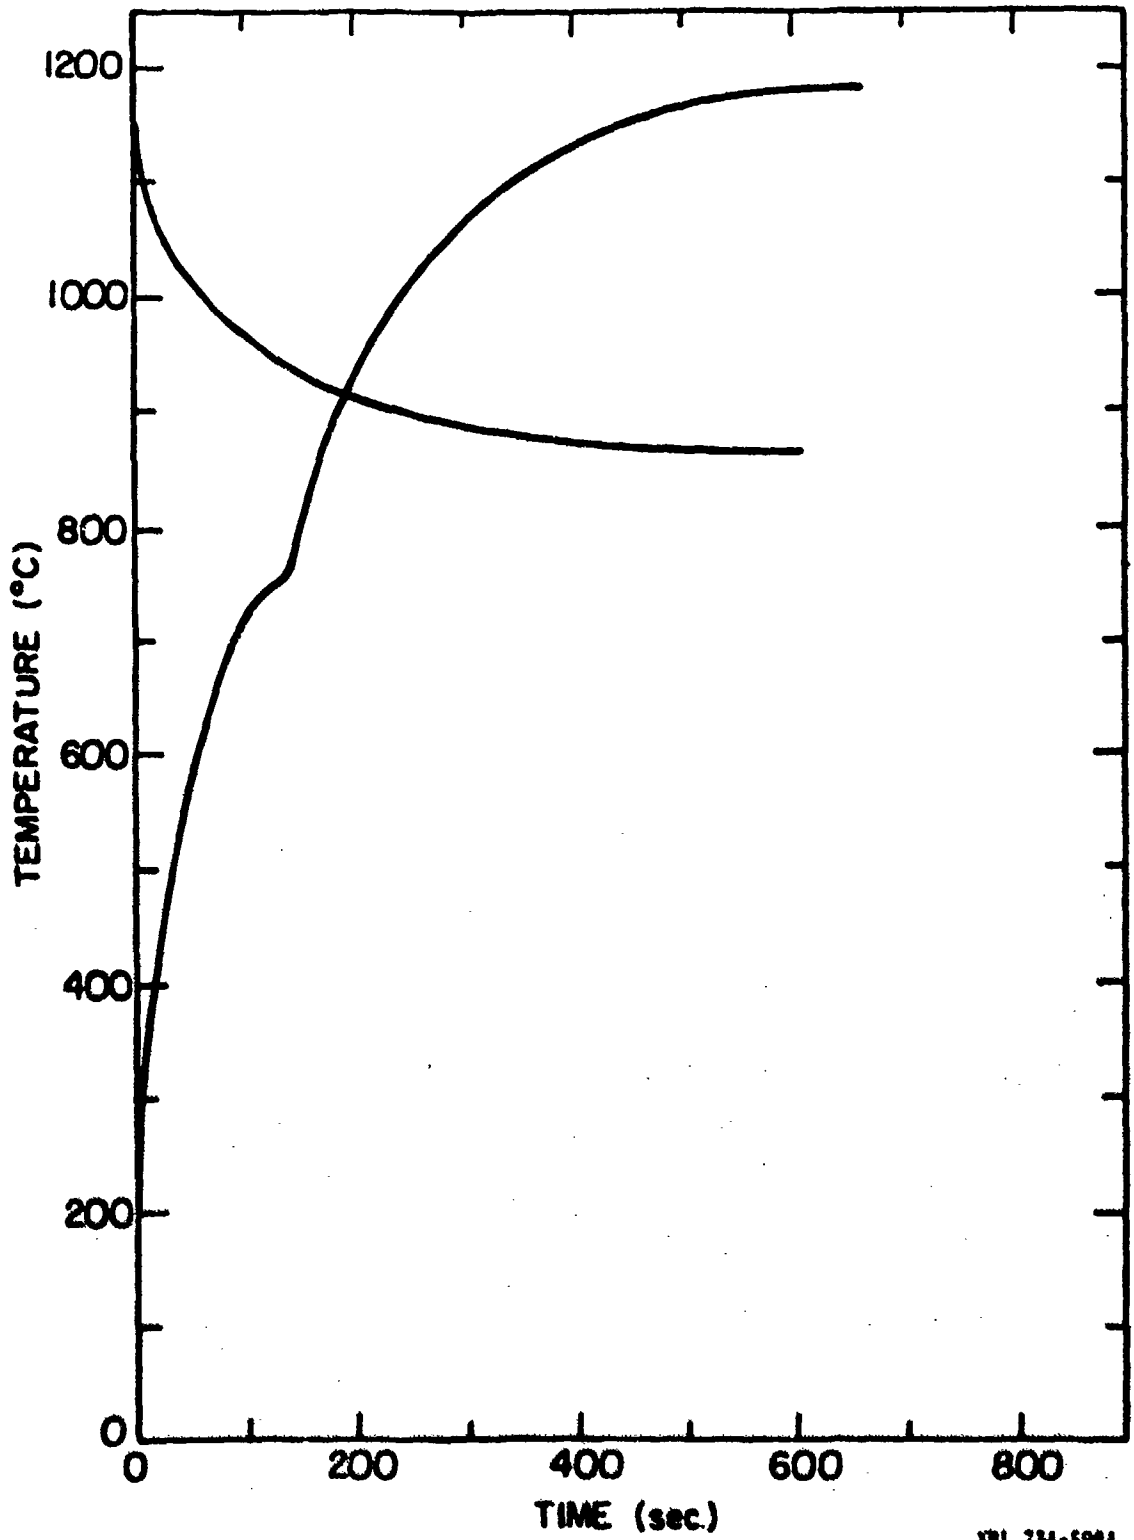
Fig. 12

Heating and cooling curves corresponding to the temperature profiles in the center of a fracture toughness specimen were determined for the different heat treatment schedules used in this investigation. Table II shows the temperature profile during heating from room temperature in an argon atmosphere. The temperature profile was monitored two times and appears in Table II as run 1 and run 2. Also shown in Table II is data corresponding to furnace cooling from about 1200°C to 870°C. Figure 12 shows these results graphically.

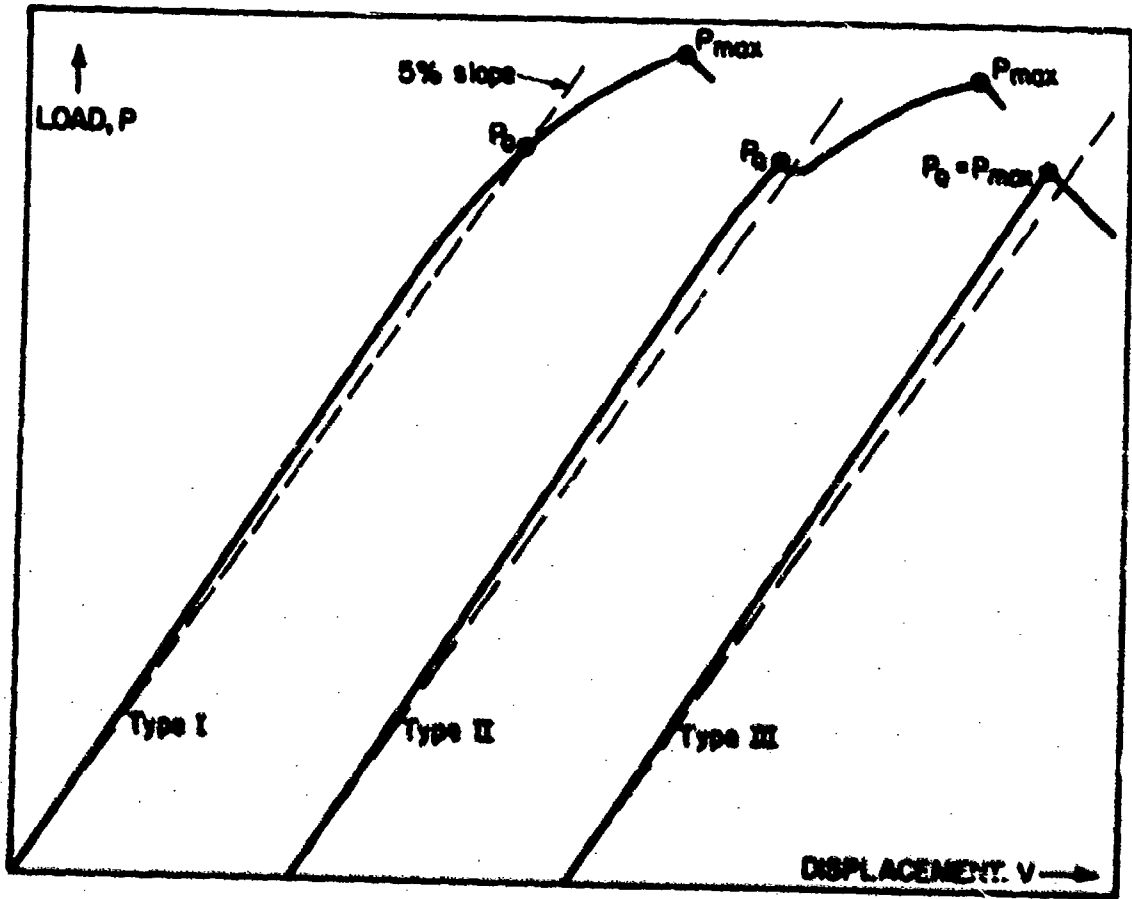
Fig. 15

The plane strain fracture toughness,  $K_{Ic}$ , is calculated using the load  $P_Q$  and the associated crack opening displacement (Fig. 15). The value calculated is the valid plane strain fracture toughness if the following two conditions are met:

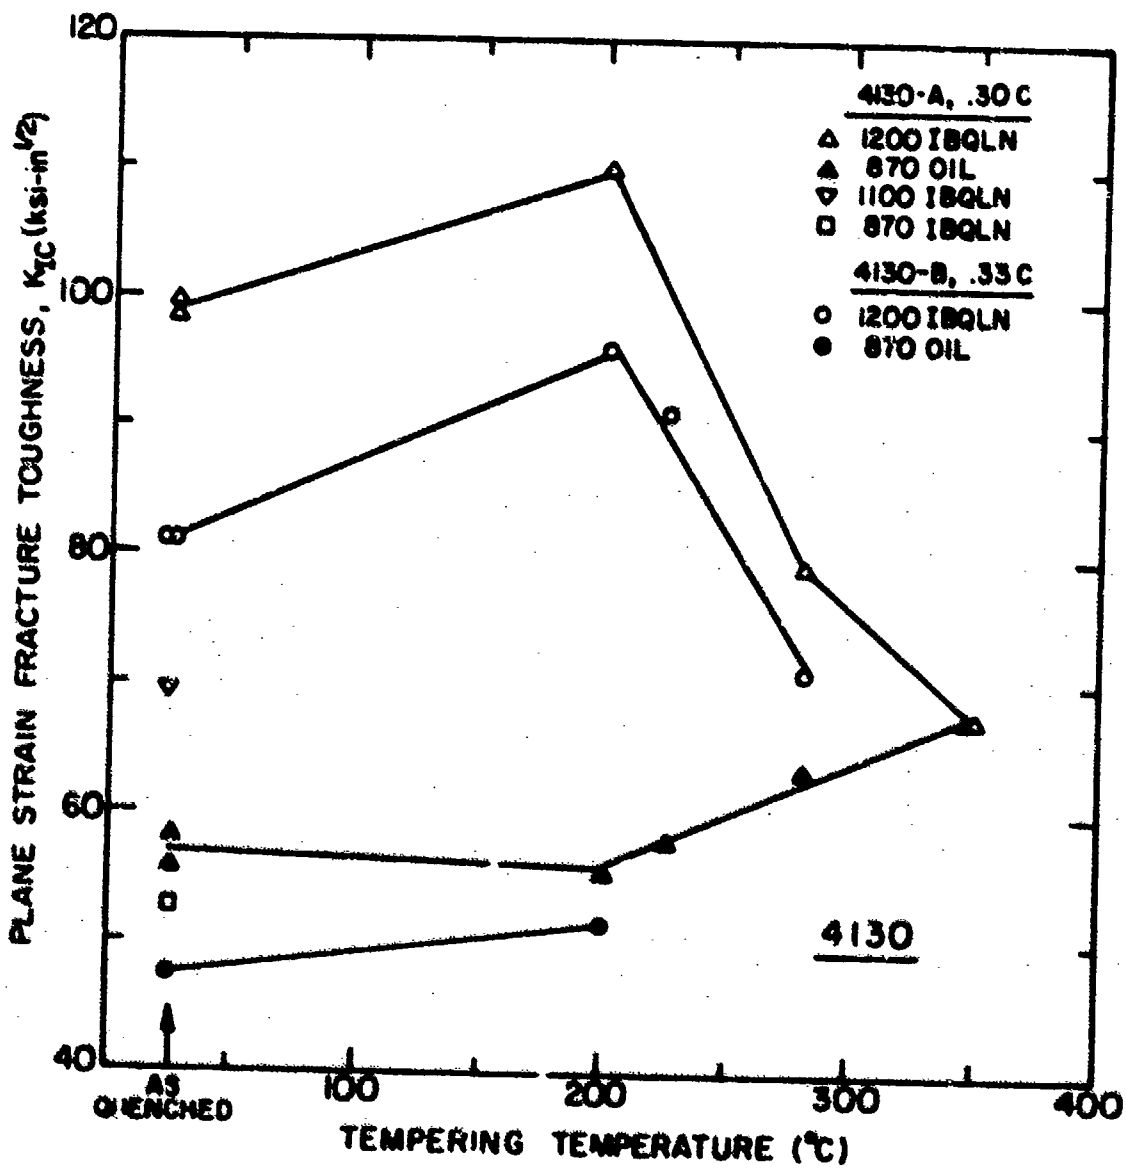
Fig. 16

The fracture toughness results for all conditions tested are given in Table VI, and some of these are plotted in Fig. 16. For this alloy the normal commercial heat treatment is to austenitize at 870°C followed by oil quenching, (870, Oil). This results in a fracture toughness of 57 ksi-in.<sup>1/2</sup> for the as-quenched condition. If the specimen is ice brine quenched and refrigerated in liquid nitrogen (L.N.) after austenitizing at 870°C, (870, IBQLN) there is no increase in toughness. However, by raising the austenitizing temperature from 870°C to 1200°C, followed by oil quenching, the toughness abruptly increases to 85 ksi-in.<sup>1/2</sup> in the as-quench condition. From Fig. 16, it is seen that the maximum toughness is obtained by austenitizing at 1200°C followed by an ice brine quench and L.N. refrigeration (1200, IBQLN). If the austenitizing temperature is lowered to 1100°C, the toughness again drops from 99 ksi-in.<sup>1/2</sup> to 69 ksi-in.<sup>1/2</sup>. The response to tempering for the commercial heat treatment (870, Oil) and the best heat treatment (1200, IBQLN) are exactly opposite. The (870, Oil) heat treatment shows no response until tempered at a high enough level to cause a drop in strength and hence an increase in toughness. On the other hand, the (1200, IBQLN) treatment does exhibit a response to a low 200°C temper but then drops catastrophically at higher temperatures down to the level of the commercial heat treatment. This is a common phenomenon in high strength steels and is referred to as "500°F embrittlement". Finally, the value of the fracture toughness

achieved for any heat treatment condition is very sensitive to the amount of carbon. Figure 16 illustrates how changing the carbon content from 0.30 to 0.33 shifts the fracture toughness of both the commercial heat treatment and the (1200, IBQLN) heat treatment lower. Summarizing then, in order to obtain the best possible fracture toughness, both a 1200°C austenitizing temperature and a very severe quench are required.

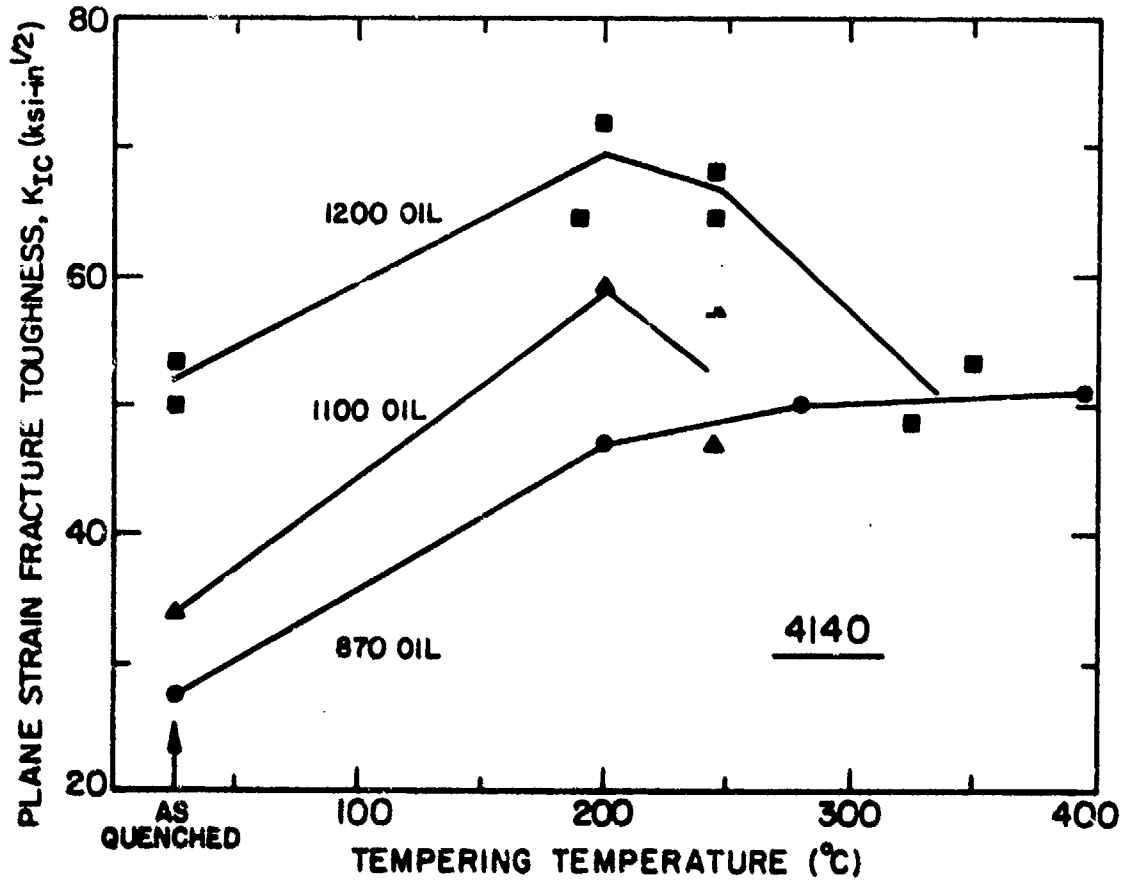
Fig. 17

The response of the fracture toughness to tempering for three heat treatments is shown in Fig. 17. It can be seen that the increase in fracture toughness associated with an increasing austenitizing temperature is maintained during tempering until the "500°F embrittlement" range is reached. Then both the higher austenitizing heat treatments have an abrupt drop in toughness similar to that of alloy 4130. Also, as in the case of the alloy 4130, the higher the maximum toughness achieved, the greater the loss in toughness when tempered in the 200 to 350°C range. As in the alloy 4130, when the drop in toughness occurs, it reduces the toughness to that of the commercial heat treatment at the tempering temperature of 350°C.

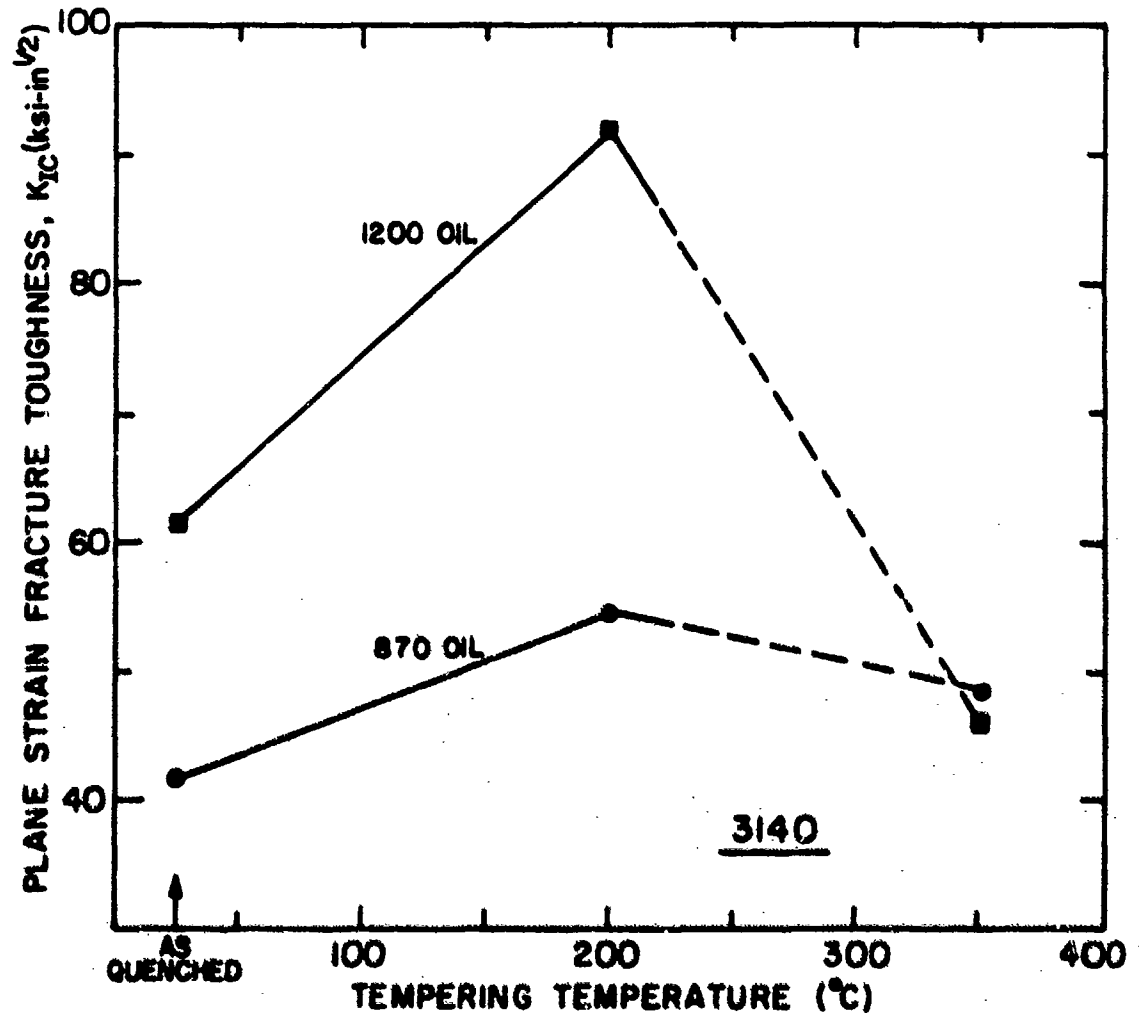
A limited amount of data has been obtained for alloy 3140 and is given in Table XII. The fracture toughness for both the (1200, Oil) and (870, Oil) heat treatments are graphed as a function of tempering temperature in Fig. 21. While the information is not complete, the results in Table XII and Fig. 21 show that this alloy does respond significantly to the (1200, Oil) heat treatment and that as for several other alloys the step quench heat treatment does not result in as high a fracture toughness as the direct (1200, Oil) heat treatment. Finally, this alloy does show an abrupt drop in toughness when the direct (1200, Oil) heat treatment is tempered above 200°C.

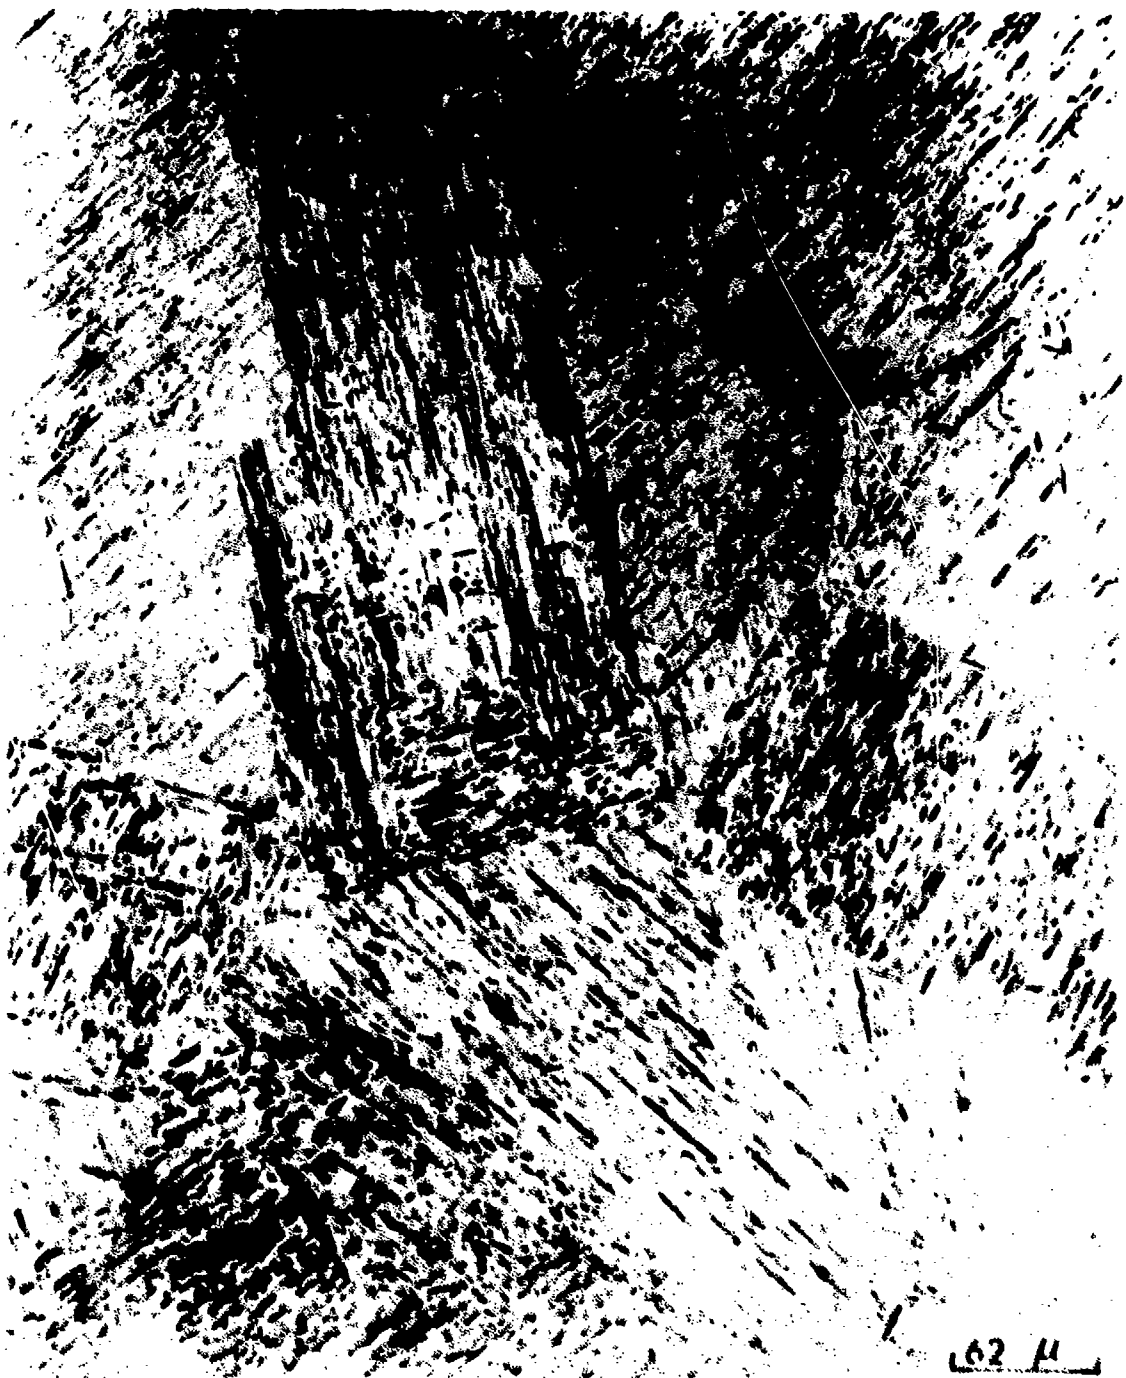
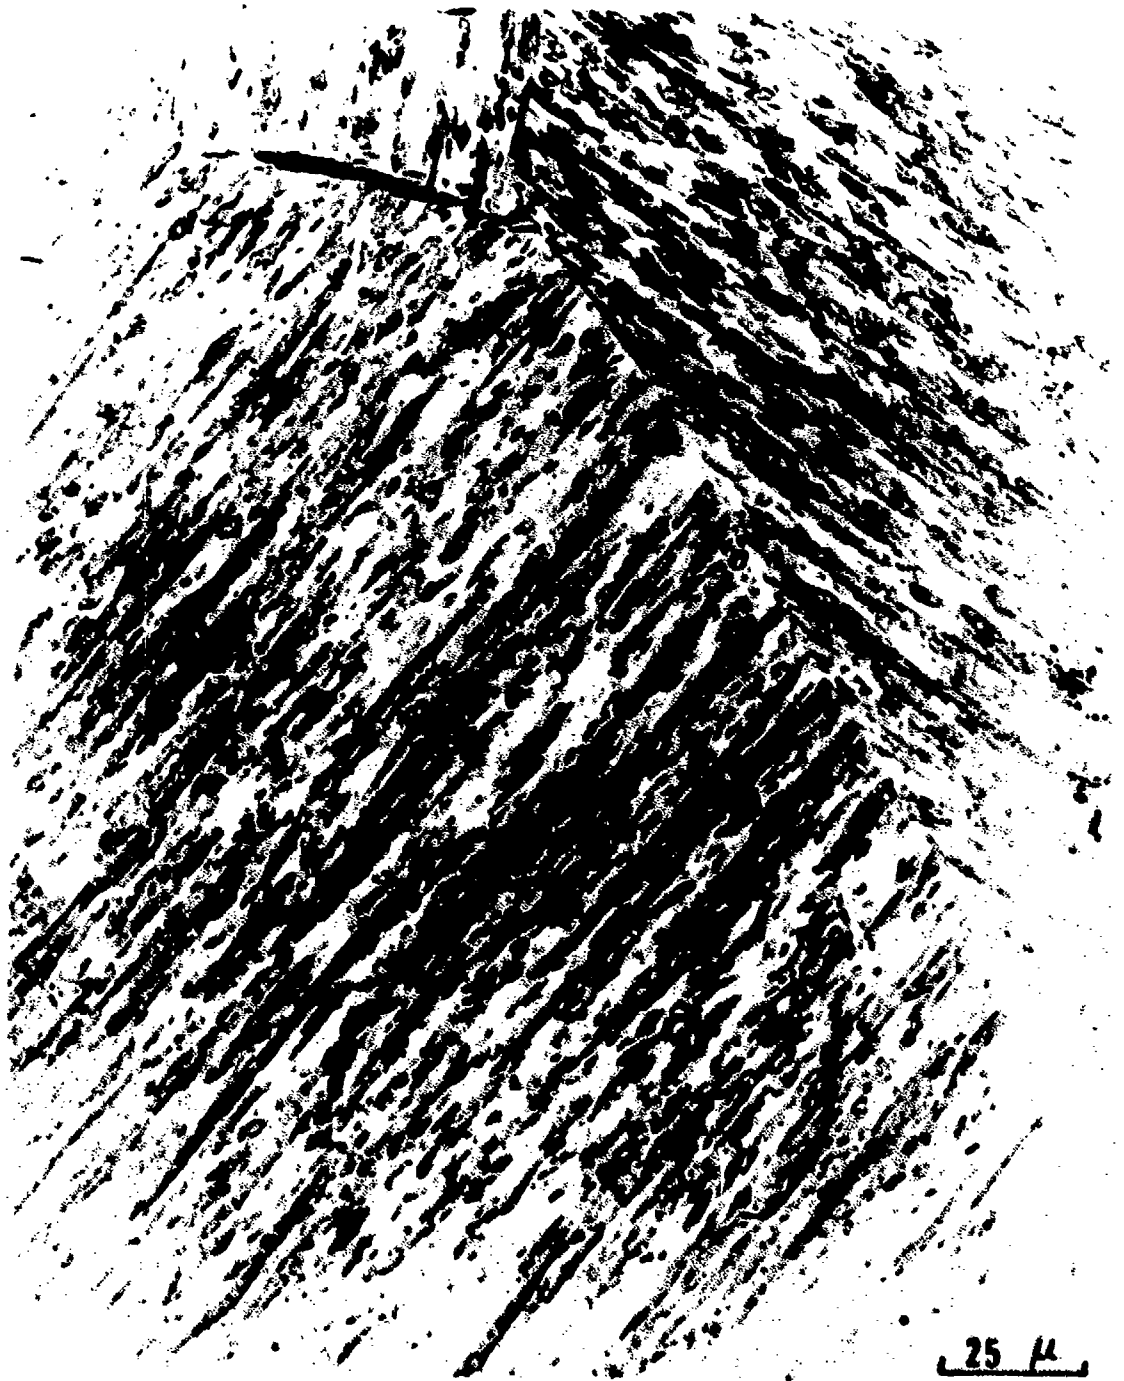
The as-quenched microstructure after austenitizing at 1200°C and ice brine quenching followed by liquid nitrogen refrigeration is shown in Figs. 34, 35 and 36. The large grain size of the specimens austenitized at 1200°C is revealed in these figures. The microstructure is comprised of martensite and bainite which has nucleated along prior austenite grain boundaries (Fig. 35). Figure 36 clearly shows how these plates grow out from the grain boundaries. Small particles can be seen in Fig. 35 and are about 1 micron in diameter. These have been identified as MnS particles by a microprobe analysis.

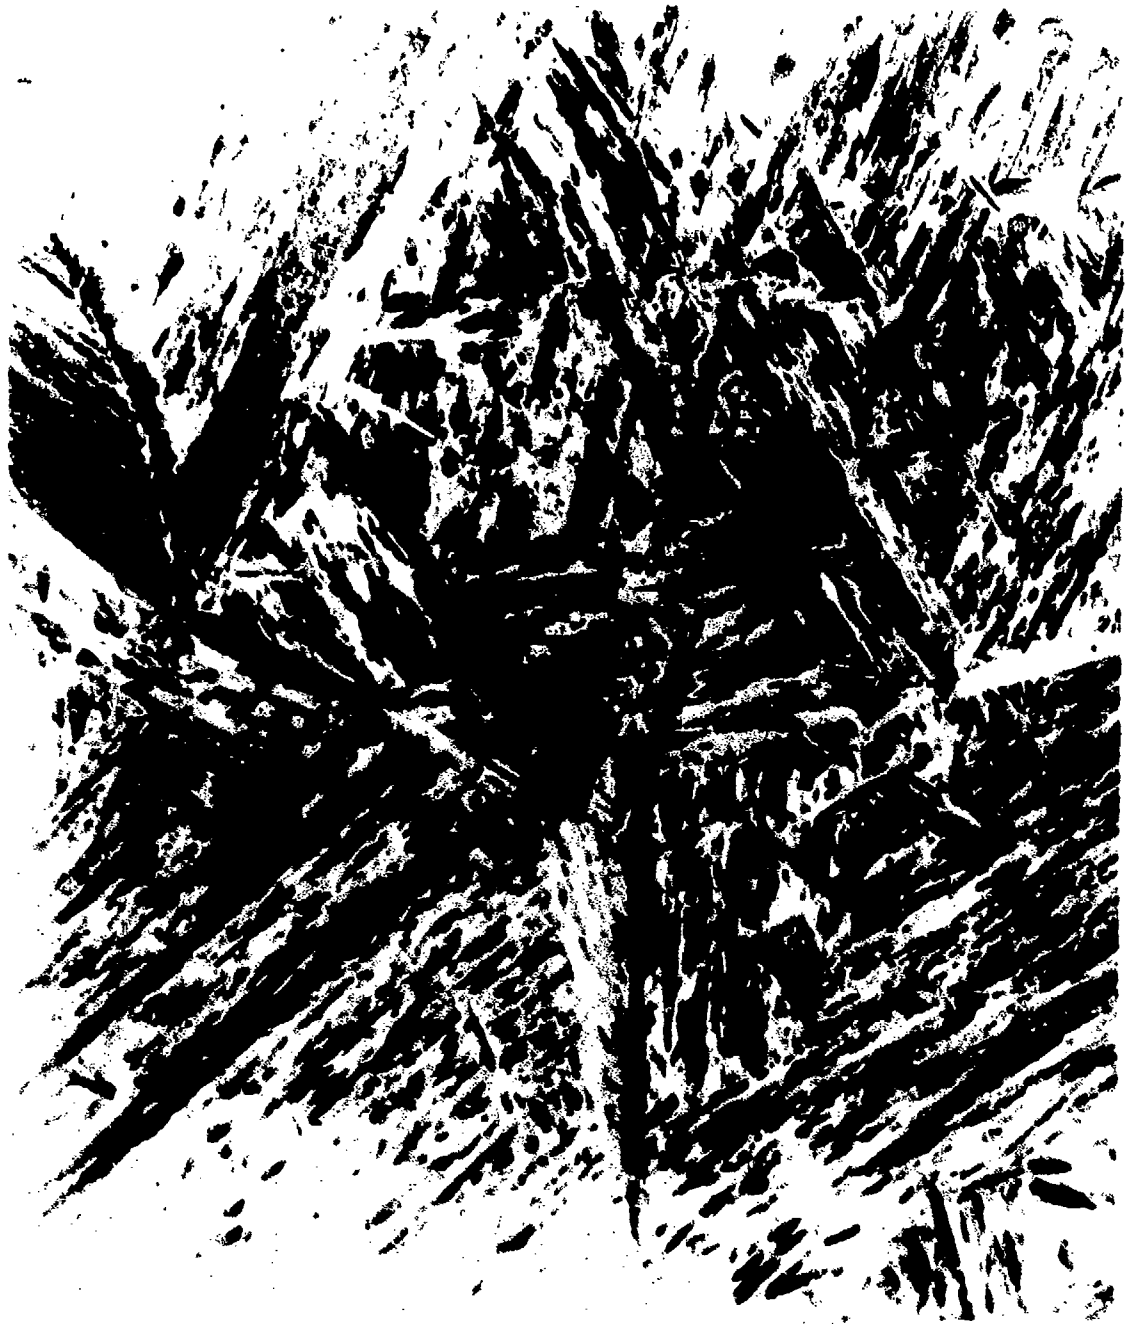
Fig. 38

4130 (1200, 011) AQ

If an oil quench is used from 1200°C rather than an ice brine quench, then a significant change occurs in the resulting microstructure. The (1200, Oil) heat treatment results in extensive formation of upper bainite through nucleation along prior austenite grain boundaries, Figs. 37 through 42 (bainite is indicated by arrows in Fig. 37, 38 and 39). The alternating parallel sheaths of ferrite and iron carbide are clearly visible and characteristic of upper bainite.<sup>4,5</sup>

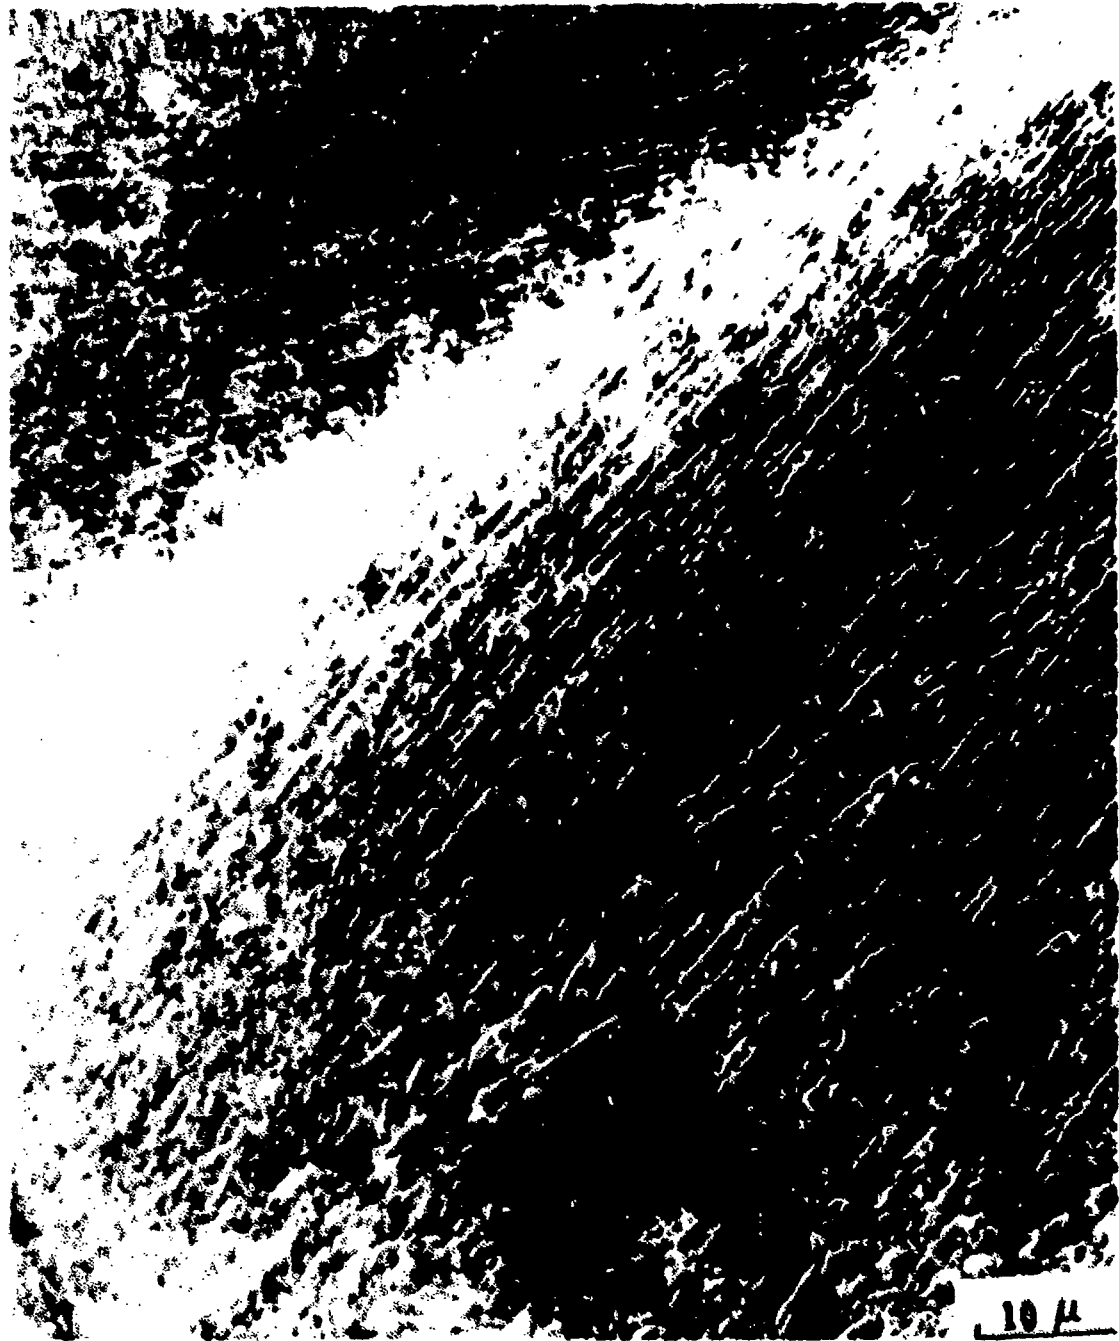
Fig. 40

4130 (1200, 011) A0

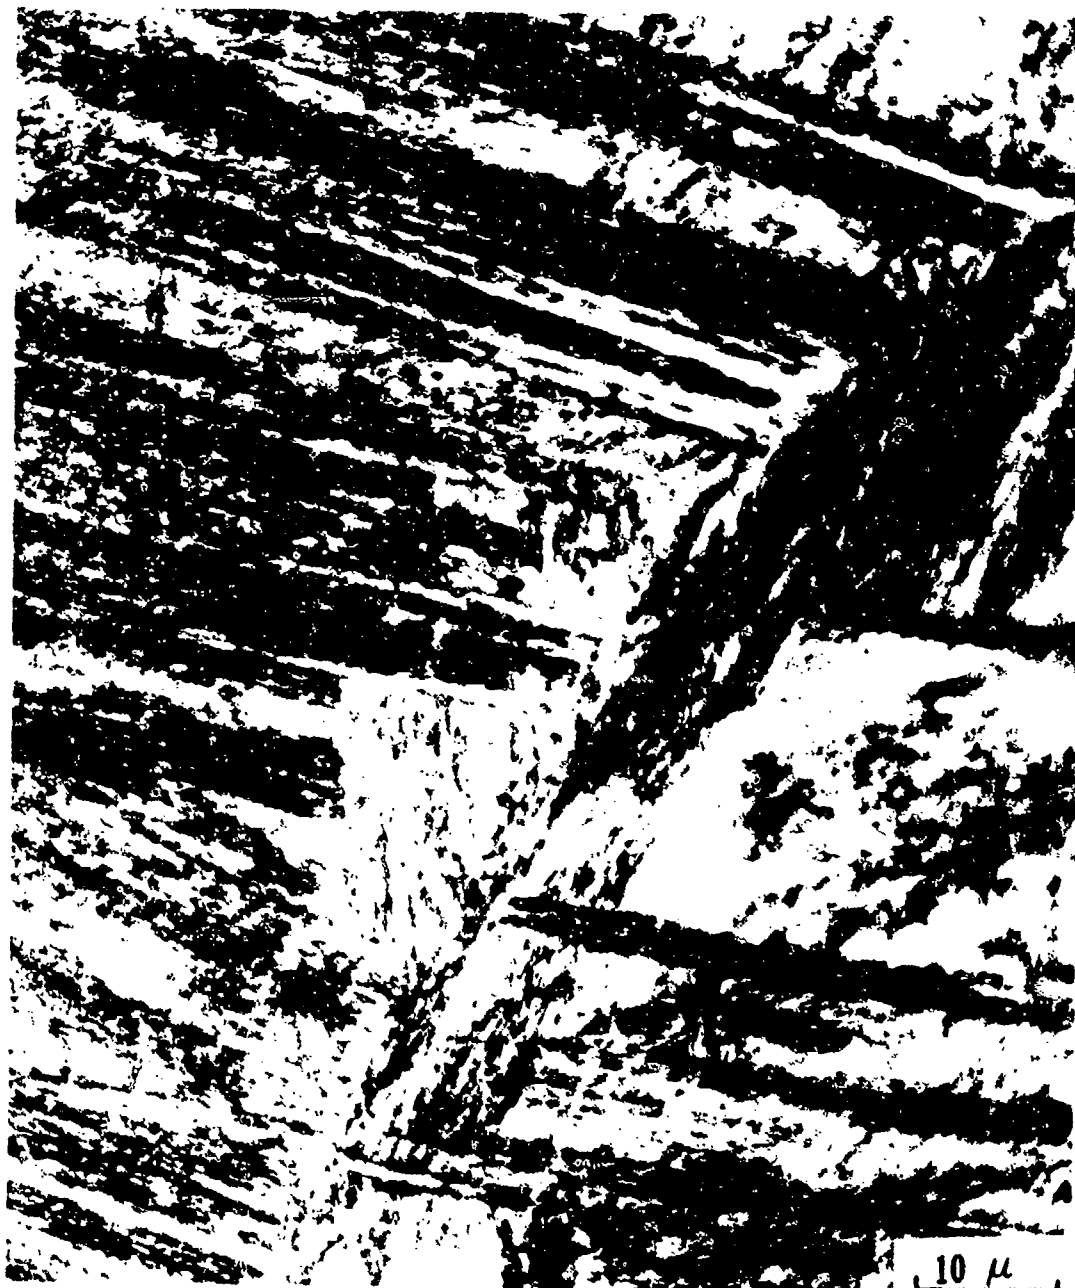
Using a step quench into oil, (1200-870, Oil) does not produce a change in the microstructure. Upper bainite is visible again originating from grain boundaries (Figs. 43 and 44).

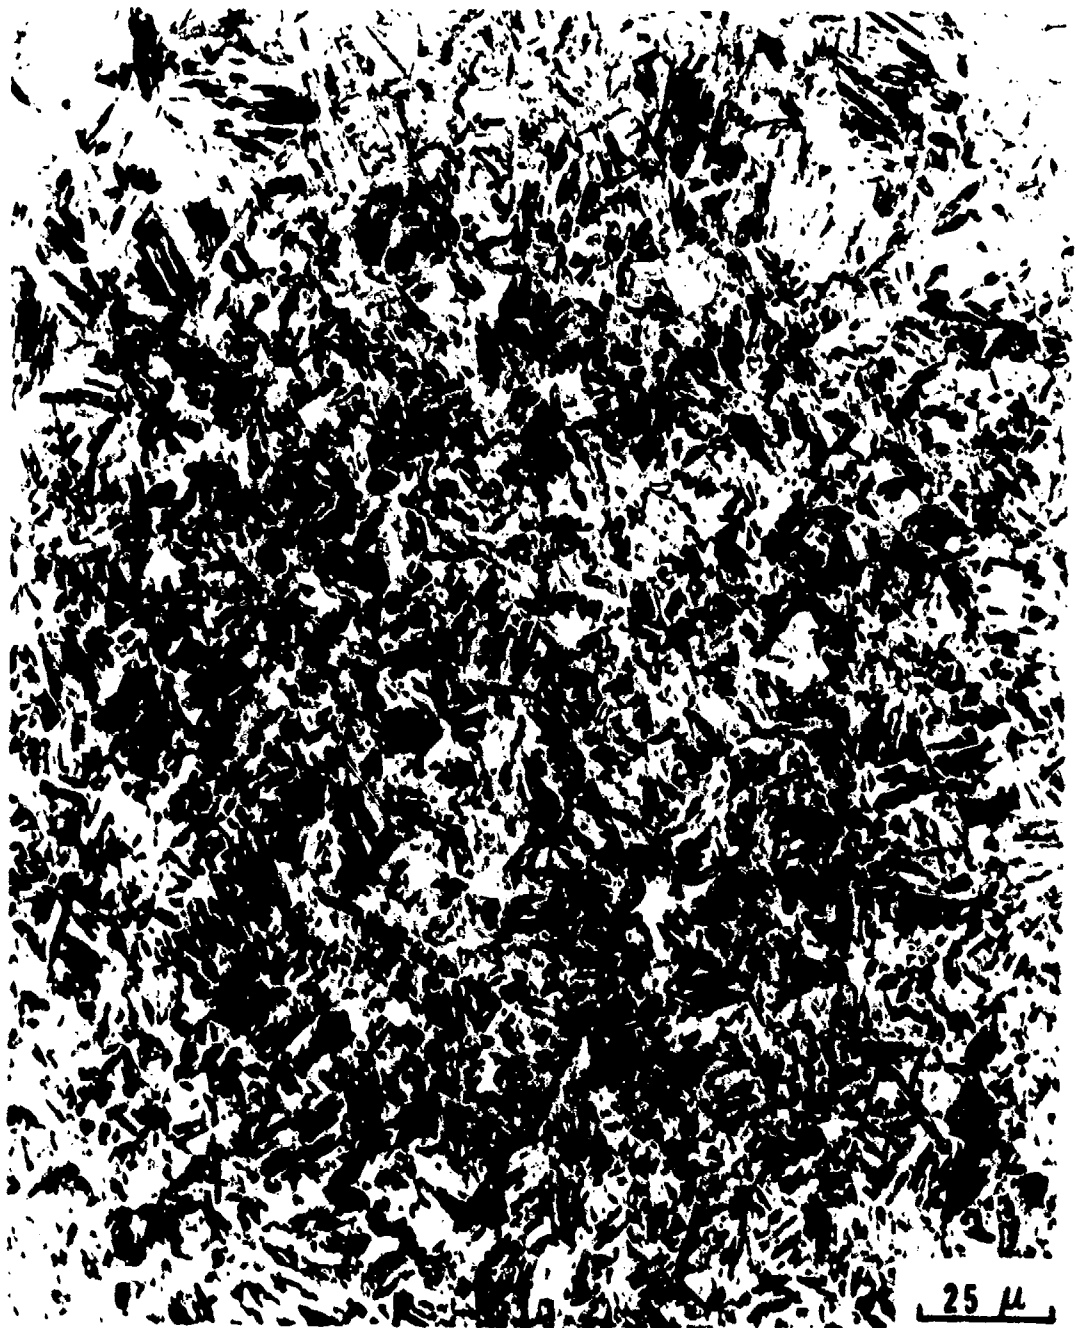
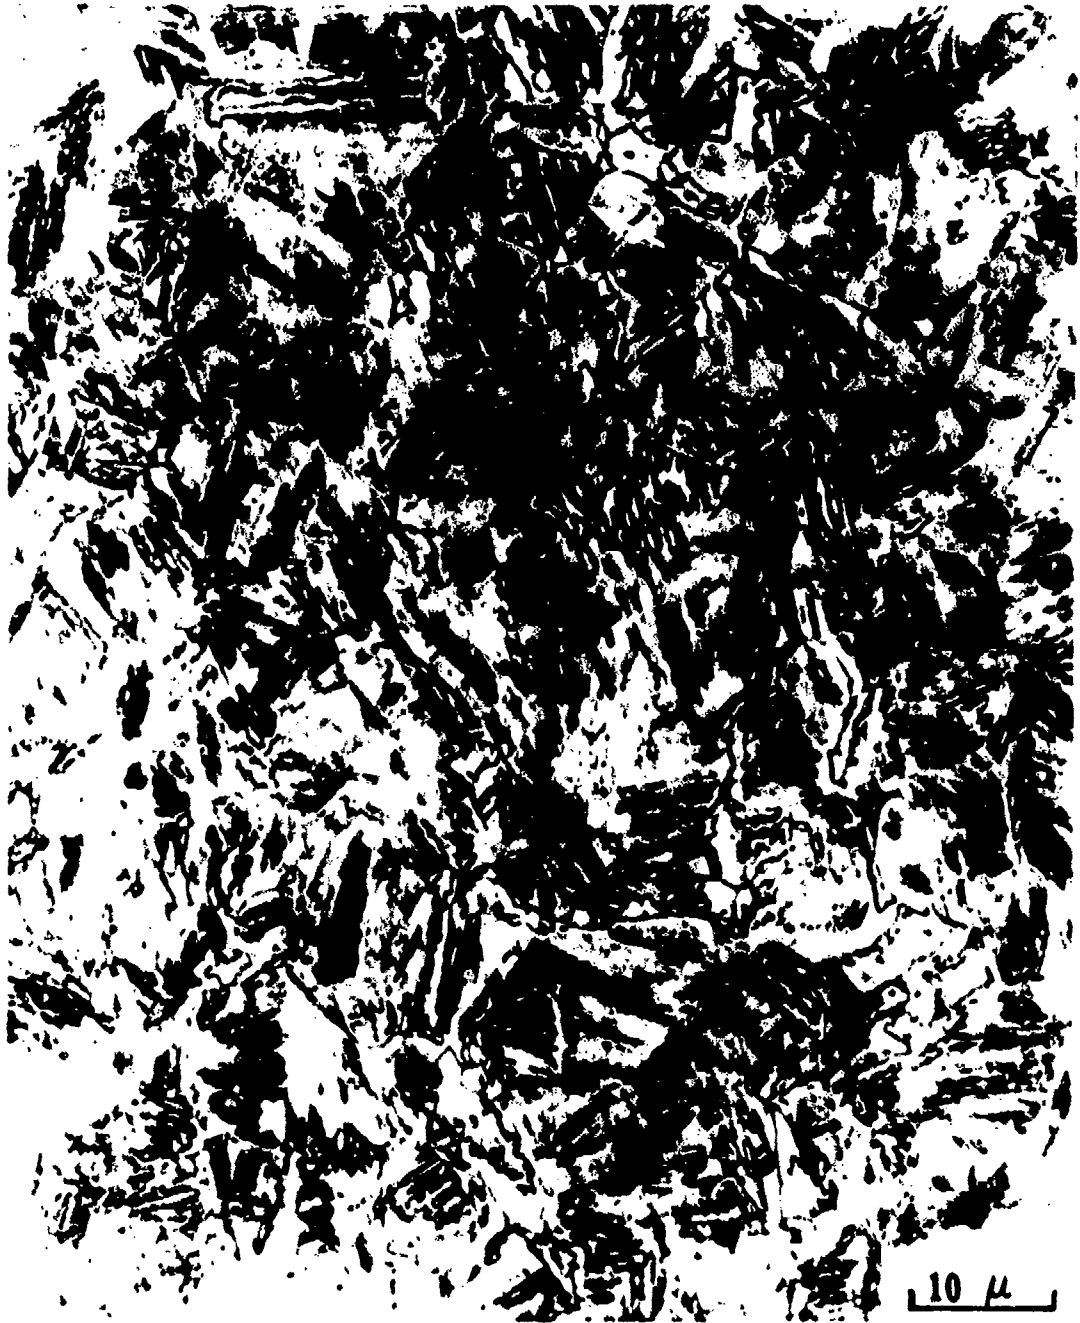
The microstructure which results from the commercial 870°C austenitization followed by an oil quench is shown in Figs. 49 and 50. Figure 50 reveals that this heat treatment results in the formation of ferrite and very coarse upper bainite in which the ferrite laths

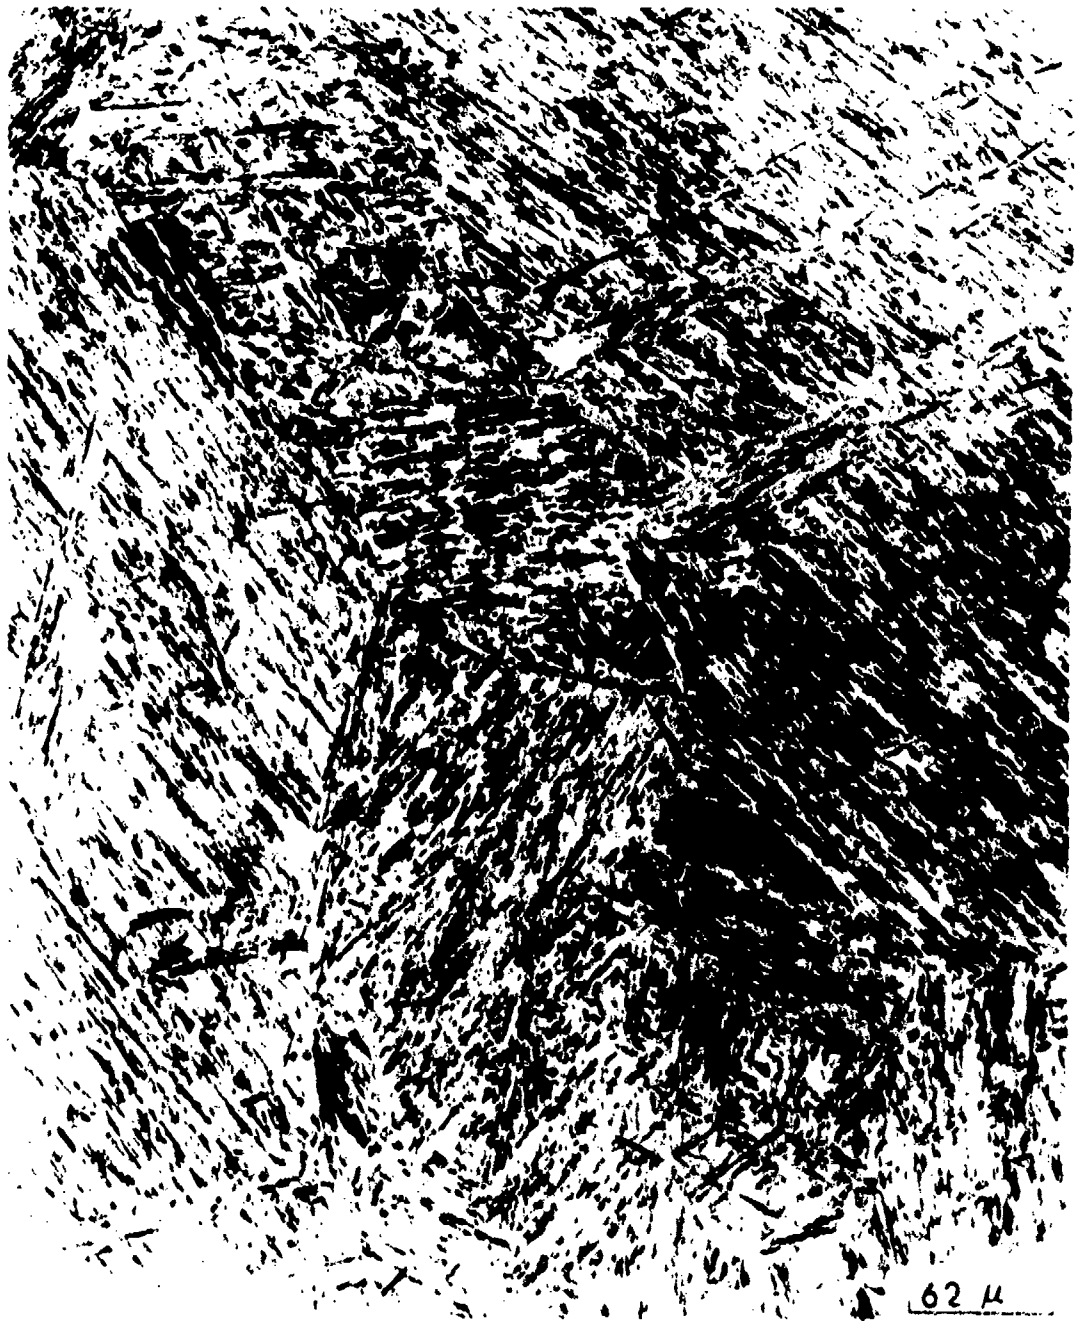
Fig. 51

The microstructure of the (1200, IBQLN) heat treated fracture toughness specimen is very similar to that of alloy 4130. The general appearance of the microstructure of this alloy for this heat treatment is shown in Fig. 51. It is difficult to identify without transmission electron microscopy whether this heat treatment results in a fully martensitic or mixed martensitic and bainitic structure. However, a decomposition product can be seen along the sites of prior austenite grain boundaries. For the (1200, Oil) heat treatment though, there are small regions of upper bainite found occasionally along prior austenite grain boundaries. An interference contrast micrograph (Fig. 52) in which the dark etching region, marked by arrows, can actually be seen to consist of many very finely spaced parallel plates originating from the grain boundary. The long dark etching plates radiating outward from the grain boundaries in the (1200, Oil) heat treatment (Fig. 53) are actually made up of several parallel units characteristic of bainite. Finally, a very fine film of ferrite outlines the grain boundary in Fig. 54 for the (1200, Oil) heat treatment. All the features identified in Figs. 52 through 54 for the (1200, Oil) heat treatment can also be found in the specimen given a (1200-870, Oil) heat treatment (Fig. 55).

4330 (1200, IBQLN) AQ

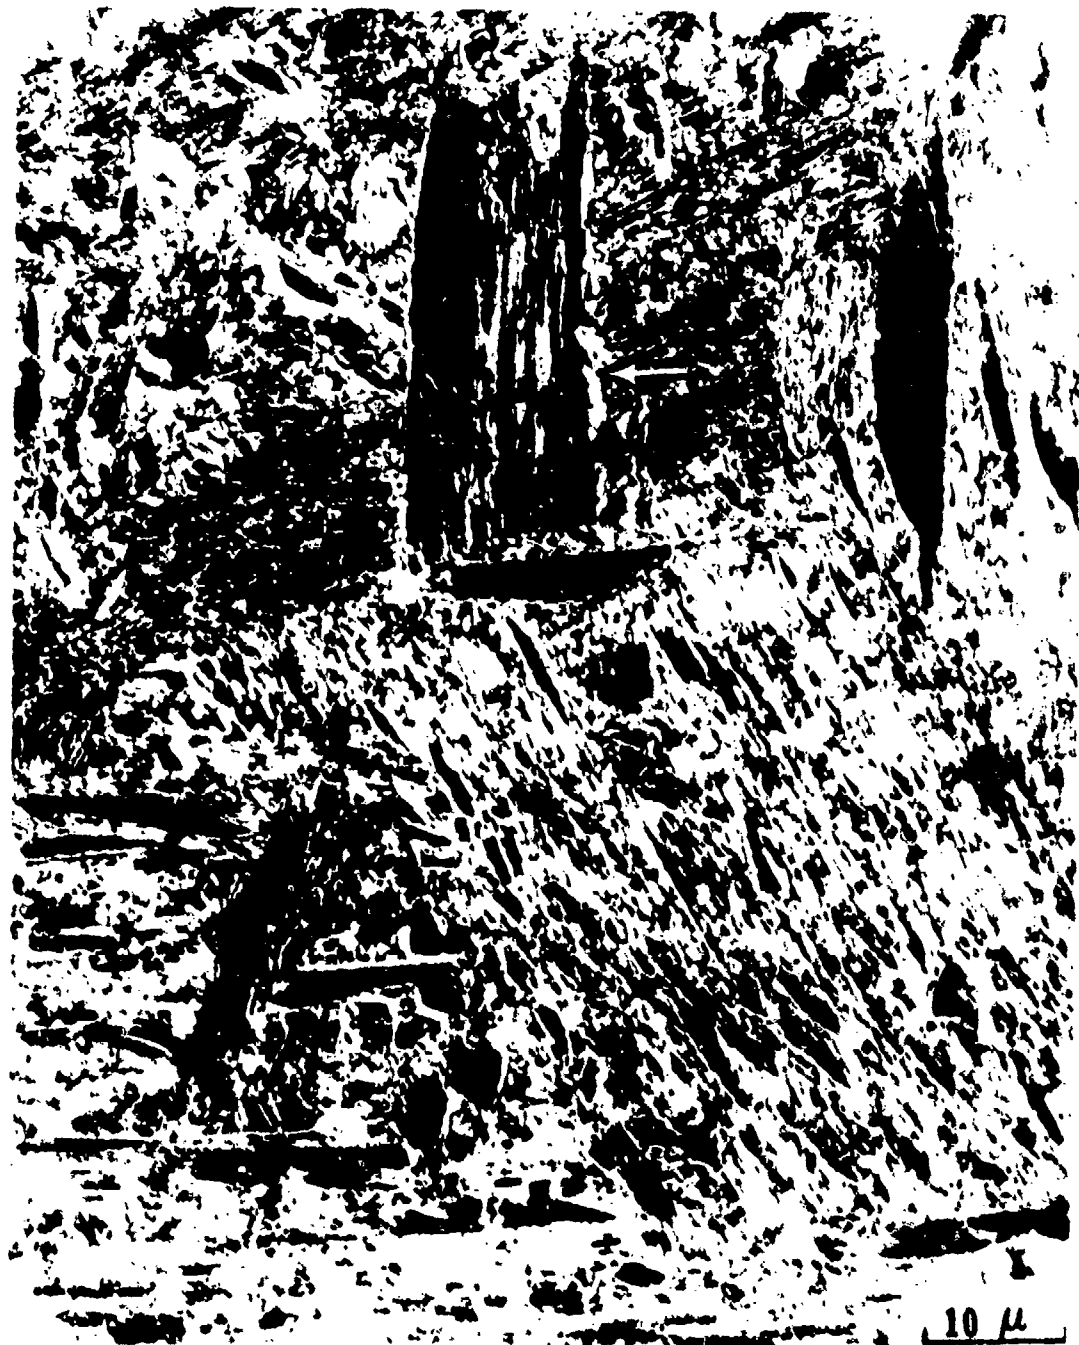
Fig. 52

4330 (1200, 011) A0
