AN INVESTIGATION OF METALLURGICAL  
FACTORS WHICH AFFECT FRACTURE  
TOUGHNESS OF ULTRA-HIGH STRENGTH  
STEELS

WILLIAM E. WOOD, EARL R. PARKER,  
and VICTOR F. ZACKAY

Lawrence Berkeley Laboratory  
University of California  
Berkeley, California 94720

Final Report      Contract Number DAAG46-72-C-0220  
LBL-1474

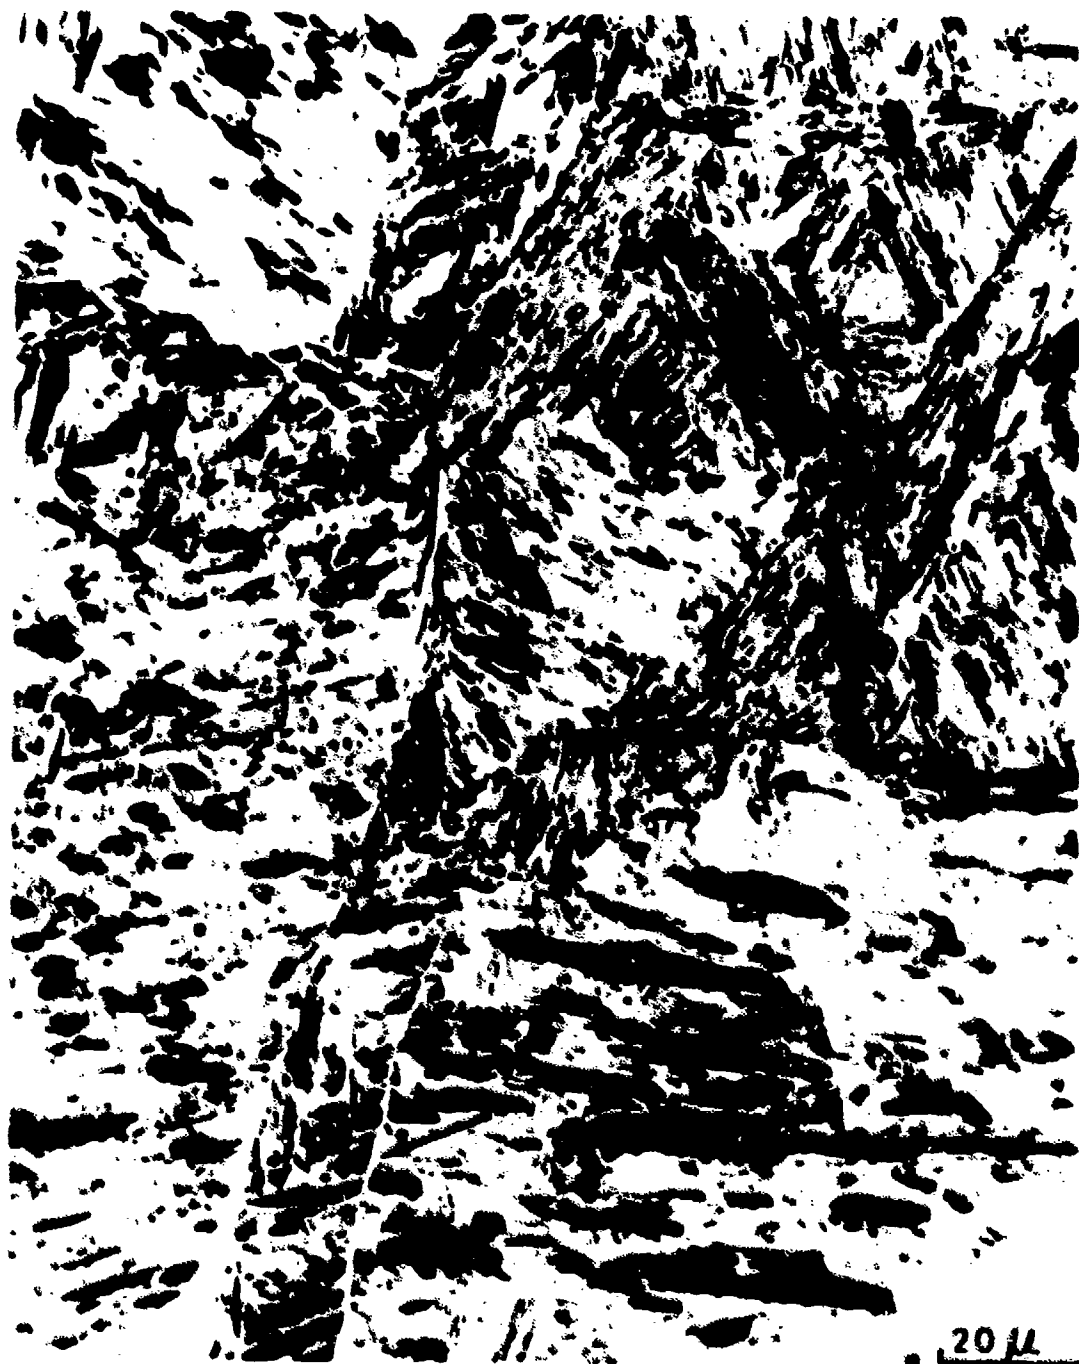
Fig. 55

The microstructure of the (1200, IBQLN) heat treated fracture toughness specimen is very similar to that of alloy 4130. The general appearance of the microstructure of this alloy for this heat treatment is shown in Fig. 51. It is difficult to identify without transmission electron microscopy whether this heat treatment results in a fully martensitic or mixed martensitic and bainitic structure. However, a decomposition product can be seen along the sites of prior austenite grain boundaries. For the (1200, Oil) heat treatment though, there are small regions of upper bainite found occasionally along prior austenite grain boundaries. An interference contrast micrograph (Fig. 52) in which the dark etching region, marked by arrows, can actually be seen to consist of many very finely spaced parallel plates originating from the grain boundary. The long dark etching plates radiating outward from the grain boundaries in the (1200, Oil) heat treatment (Fig. 53) are actually made up of several parallel units characteristic of bainite. Finally, a very fine film of ferrite outlines the grain boundary in Fig. 54 for the (1200, Oil) heat treatment. All the features identified in Figs. 52 through 54 for the (1200, Oil) heat treatment can also be found in the specimen given a (1200-870, Oil) heat treatment (Fig. 55).

4330 (1200+870, 011) AQ

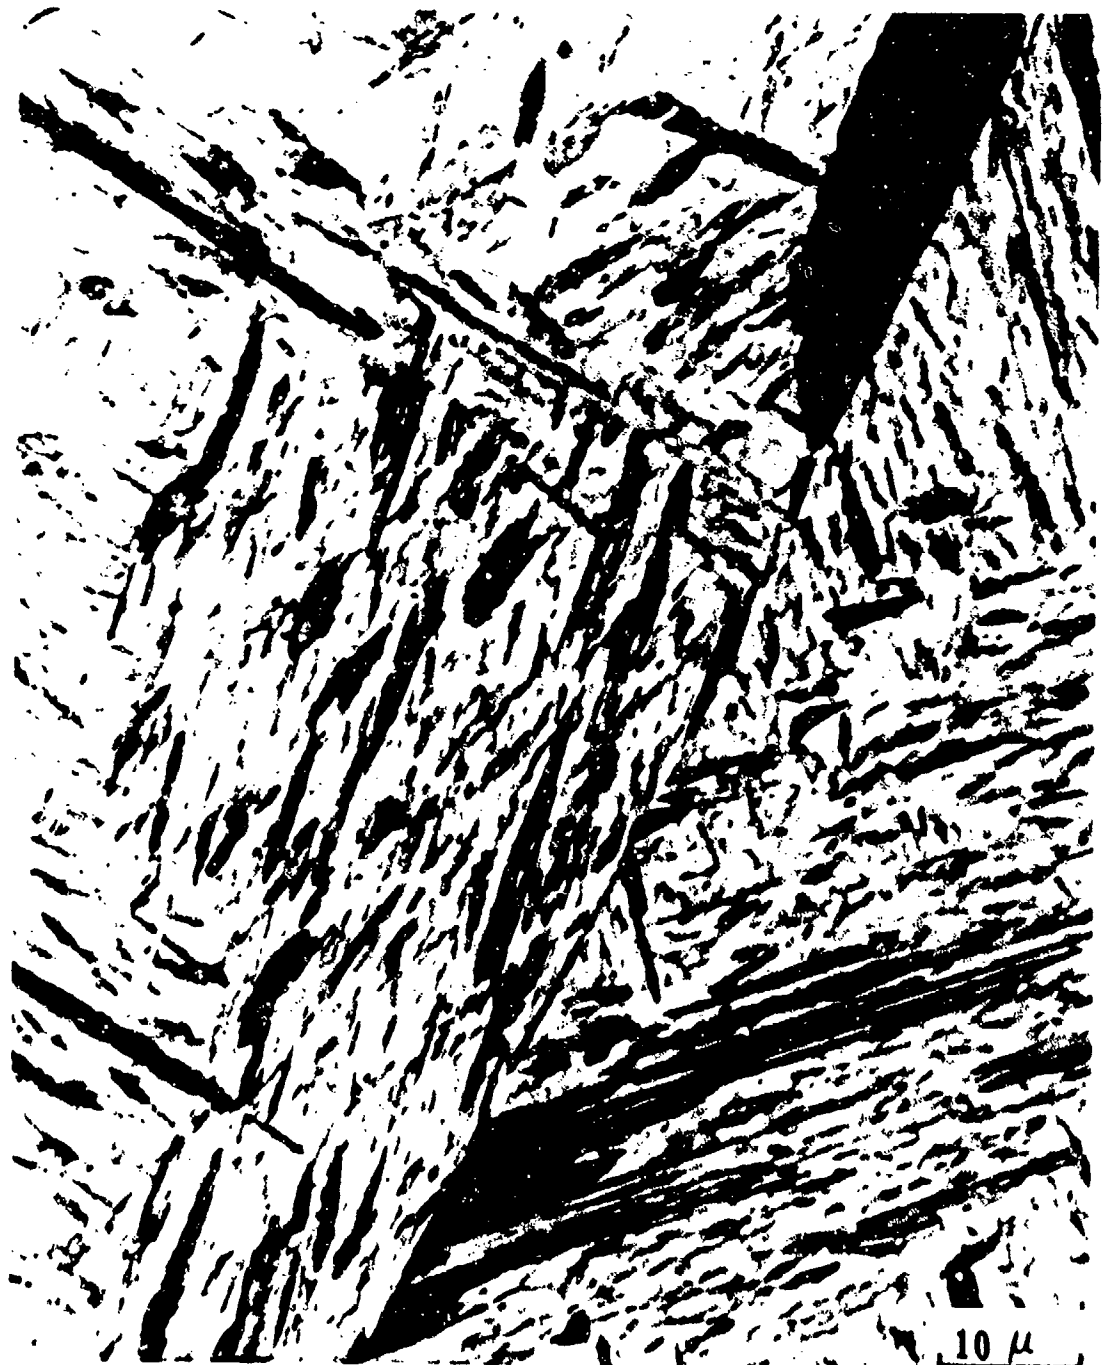
The microstructure of this alloy is shown in Figs. 56 through 62. As with the previously examined alloys, the (870, Oil) heat treatment resulted in the formation of extensive amounts of upper bainite (Figs. 57A and 57B). The large grained (1200, Oil) heat treatment eliminated almost all of the coarse upper bainite features found in the fine grained material. Occasionally a finger like or feathery type of decomposition product was observed. Examples of this are marked by arrows in Figs. 58 and 59, and also in Fig. 60, an interference contrast micrograph.

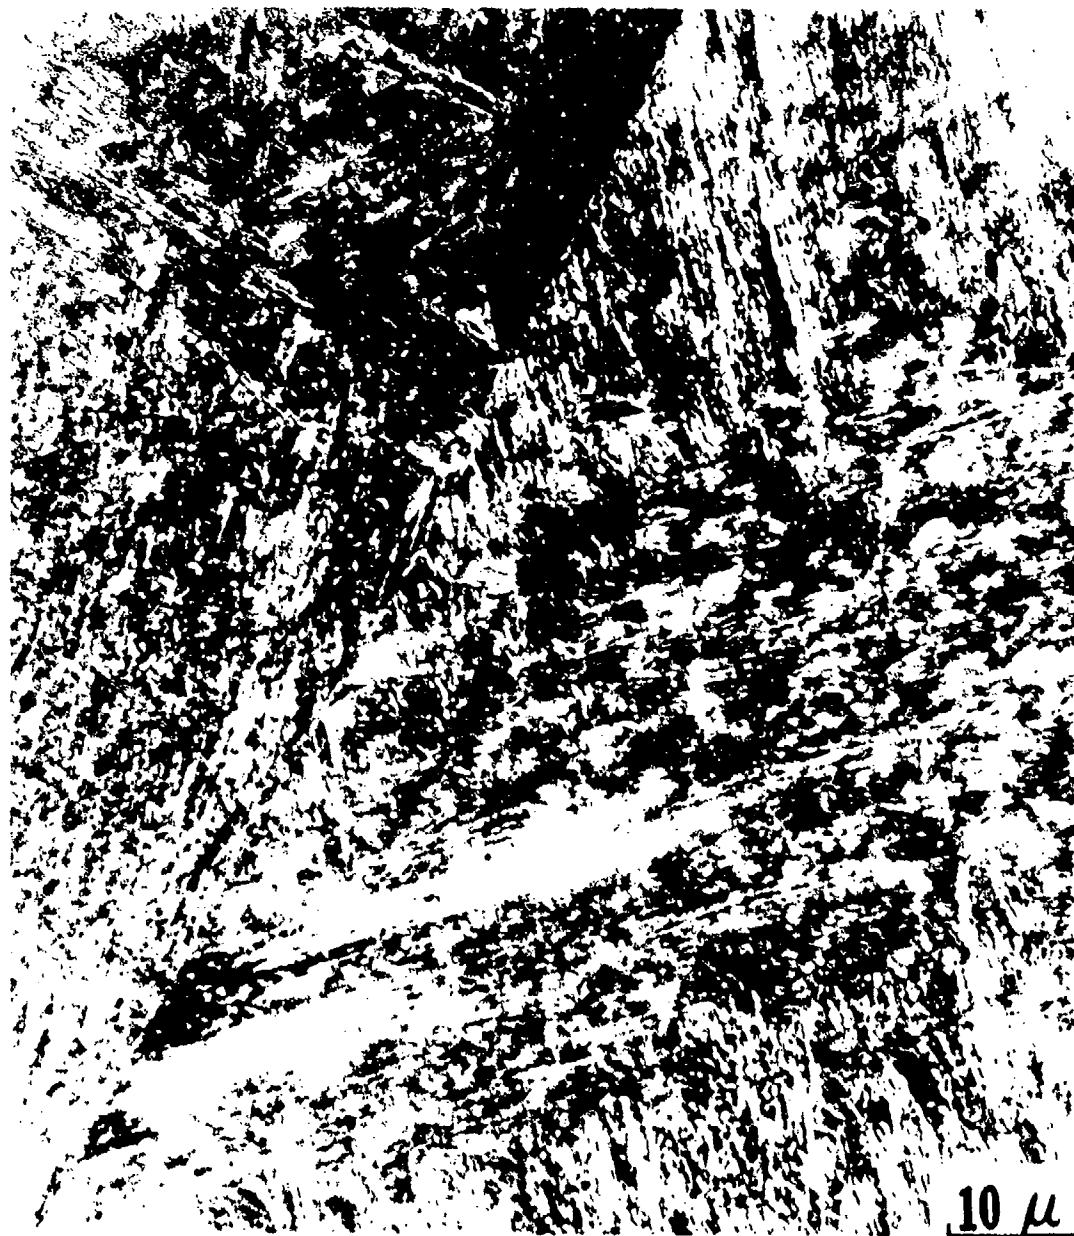
Fig. 60

4140 (1200, 011) A0

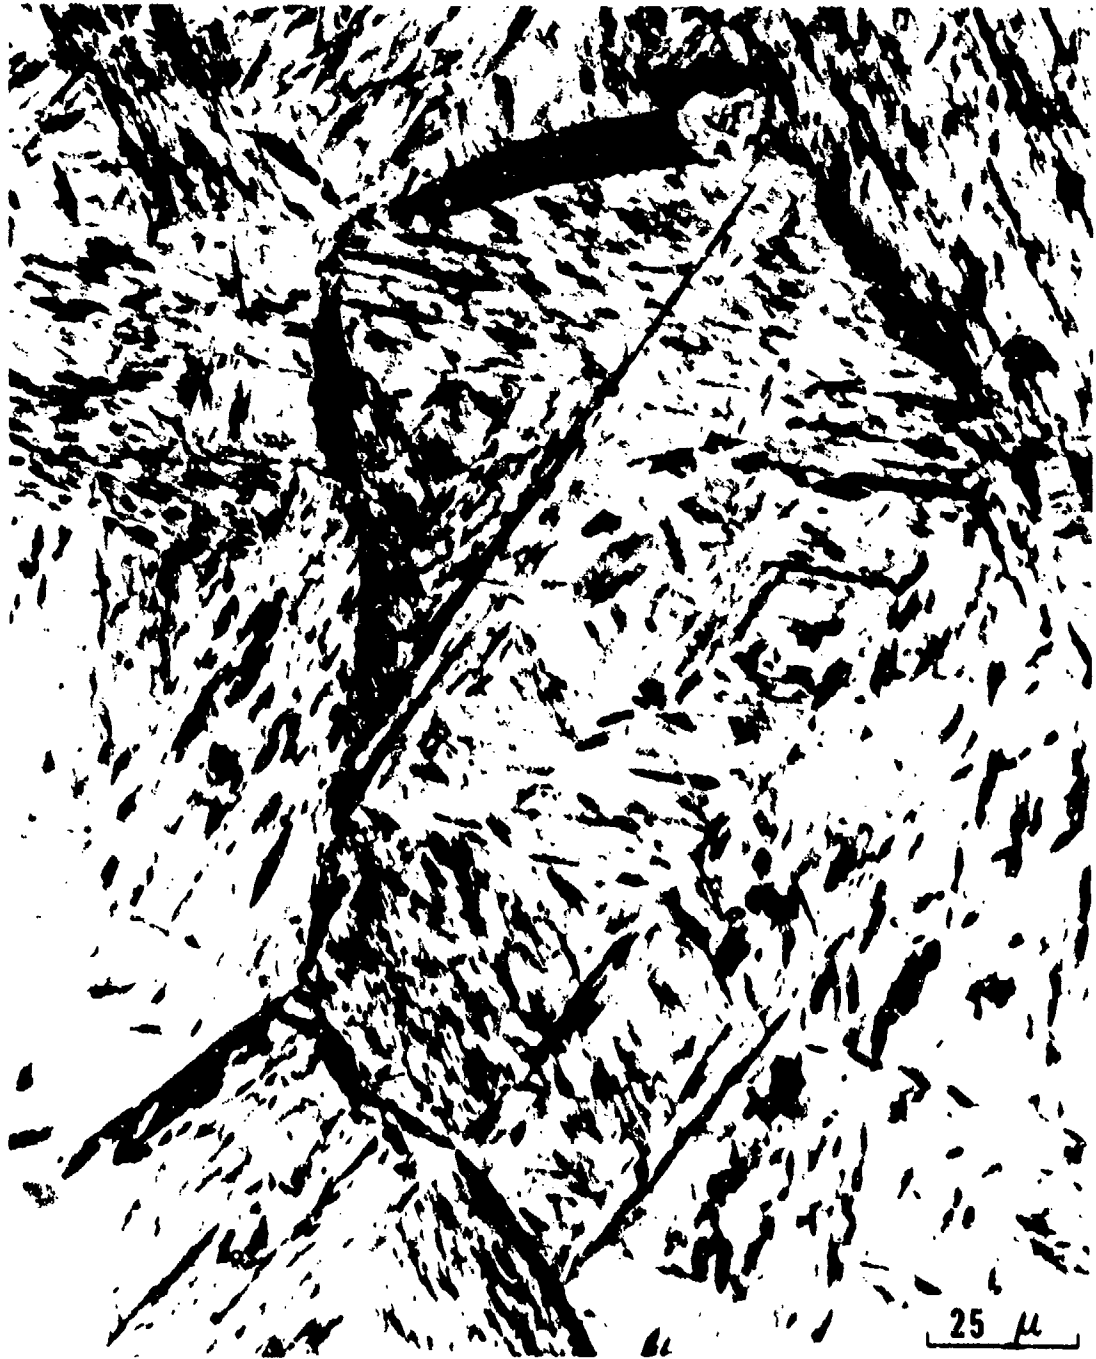
Fig. 61

4140 (1200, 011) AQ

While there is not an extensive amount of dark etching constituent with a resolvable feathery type of morphology, there is a rather extensive network of black etching plate-like decomposition product visible in Figs. 61 and 62. Figure 61, a bright field micrograph, shows this network very clearly and also shows some very long needle like dark etching constituents running completely across the grain. The surface relief effect of the same area using the interference contrast technique is shown in Fig. 62. In this figure, the two areas marked by the arrows are heavily etched and mottled due to the etching of the carbide by the nital and picral etch. Also, a close examination reveals that the area marked by the lower arrow actually has spikes growing

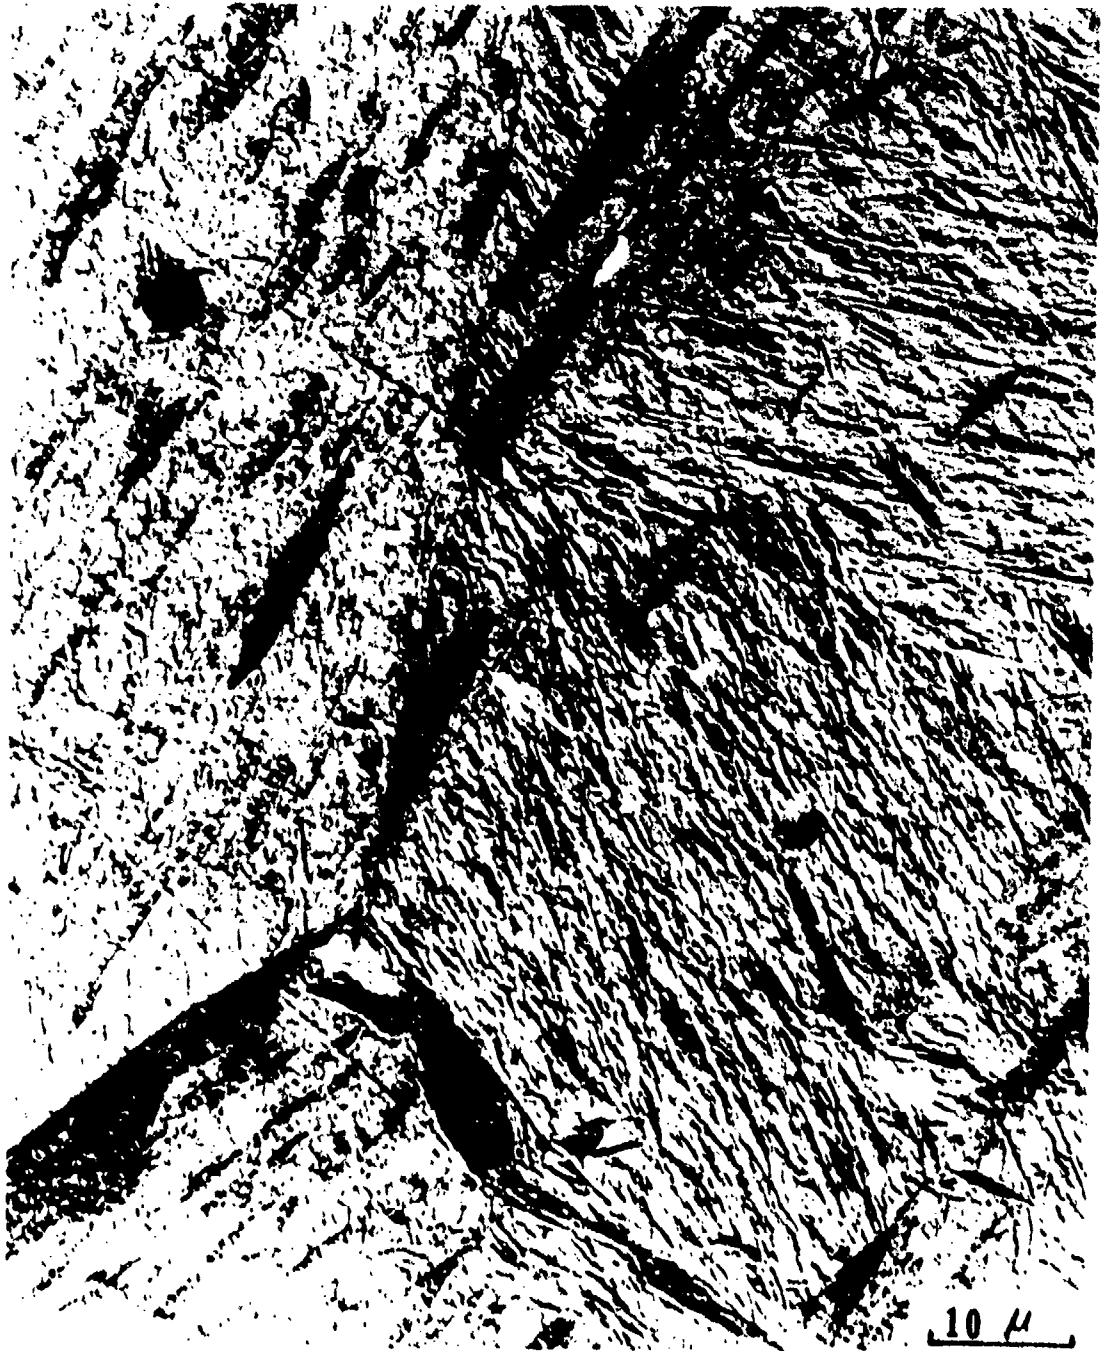
Fig. 62

4140 (1200, 011) AQ

out from it, while the area marked by the upper arrow has several steps or ledges associated with it. Both these features are characteristic of the bainite reaction.<sup>4,5,6</sup> The beginnings of the long needle like rods that extend all the way across the grain are visible at the top of Fig. 62. These too have a feathery type of appearance which can just barely be resolved.

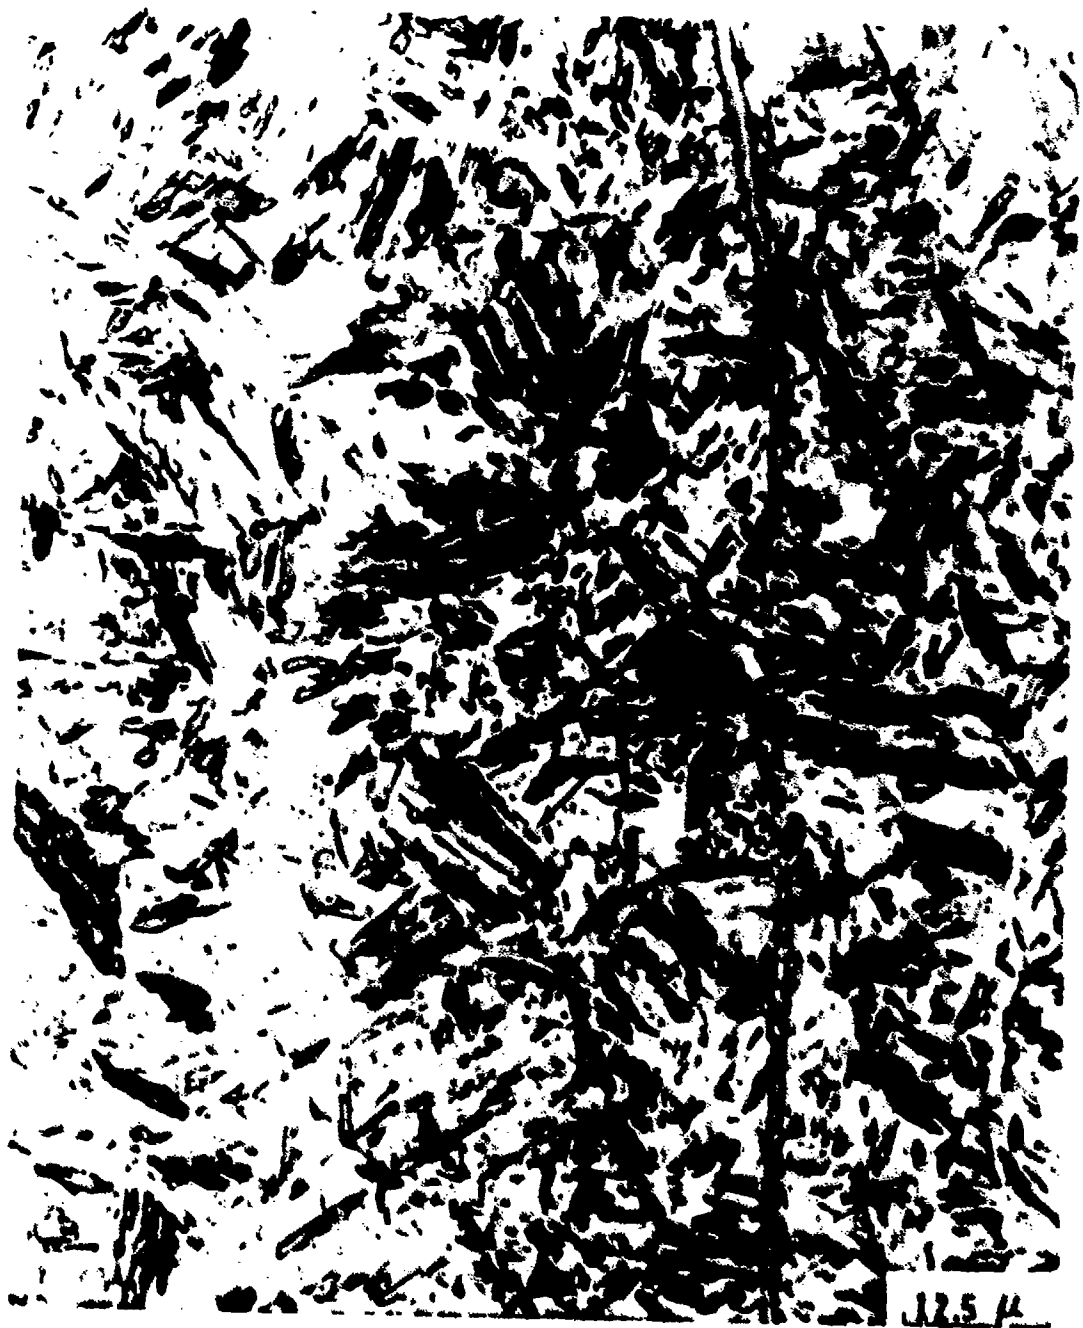
Finally, Fig. 69 was taken from a section cut parallel to the rolling direction for the (870, 011) heat treated fracture toughness specimen. Again, bainitic plates are distinguishable throughout the microstructure and are marked by arrows. Also, and most noticeable, are the two rod-like stringers running nearly the entire length of the micrograph.

4340 (870, 011) AQ
