# PREPRODUCTION TESTING OF THE BDU-38/B PRACTICE BOMB

TECHNICAL REPORT NO. AFSWC-TR-67-16

AIR FORCE SPECIAL WEAPONS CENTER  
Air Force Systems Command  
Kirtland Air Force Base  
New Mexico

July 1967

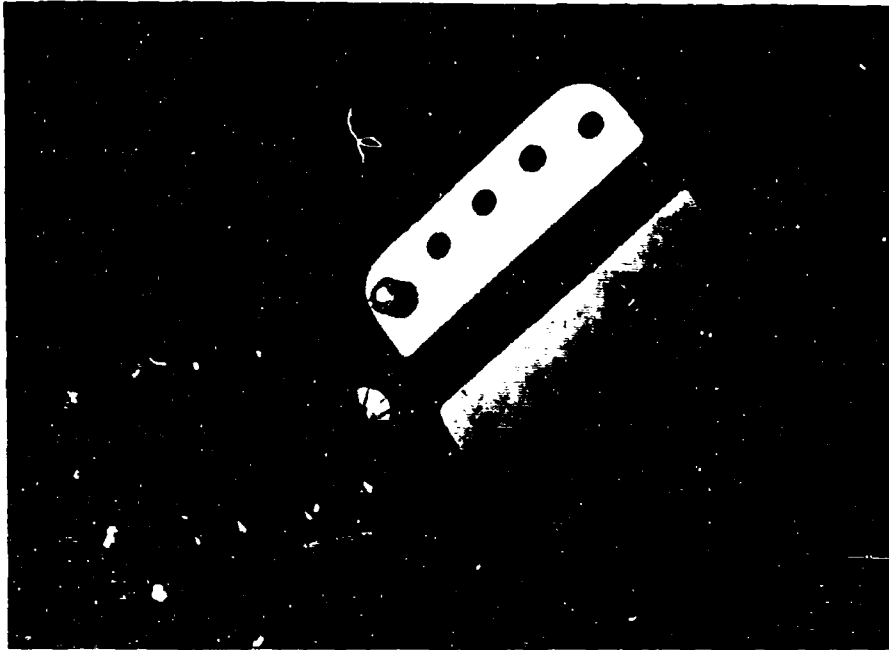
Figure 30. 14-inch Lug Failure at 43,700 Pound Vertical Load.

The 14-inch lug withstood the 150-percent value of condition 3 loads. The lug was subjected to a vertical load test (no axial and side loads) and failure occurred at a load of 43,700 pounds. The failure is illustrated in Figure 30. Once again initial failure at the inserts caused subsequent tensile failure in the cap screws.
