TECHNICAL REPORT AFRPL-TR-68-141

STUDY OF LONG TERM EFFECTS OF HIGH
ENERGY PROPELLANTS ON FINE MICRONIC
STAINLESS STEEL WIRE CLOTH USED IN
SURFACE TENSION DEVICES

AIR FORCE CONTRACT F04611-68-C-0064
WESTERN FILTER COMPANY, INCORPORATED
CHATSWORTH, CALIFORNIA

FINAL REPORT

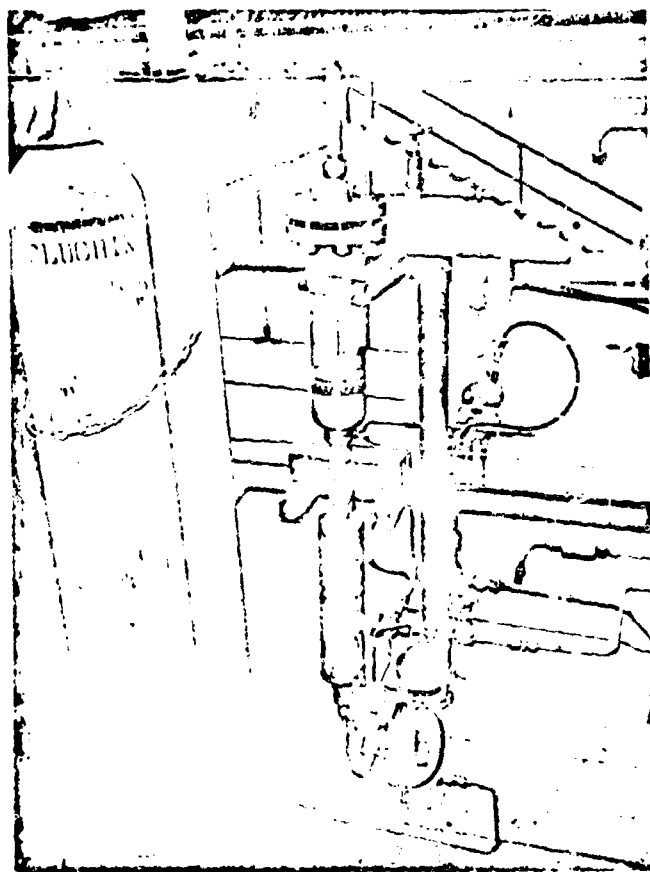
FIGURE 20
PAGE 45

Filter assembly P/N 10270 was designed and manufactured by Capitol Westward for use in CLF₃ and was installed at TRW Test Systems, San Juan Capistrano, in the HEPS (High Energy Propellant Stand) area.

The filter assembly, an inline configuration, has MS 33656-16 ports at each end. The filter element, P/N 5561, is Heli-arc welded using 304 stainless steel wire cloth.

The first element used in this system, when taken out and cleaned, reacted and burned up because of over temperature in passivation. It was then replaced with a new element which has remained in service for 1-1/2 years unharmed.

*Element burned up because of hot passivation, caused it to react; replaced and remained in service unharmed 1-1/2 years.

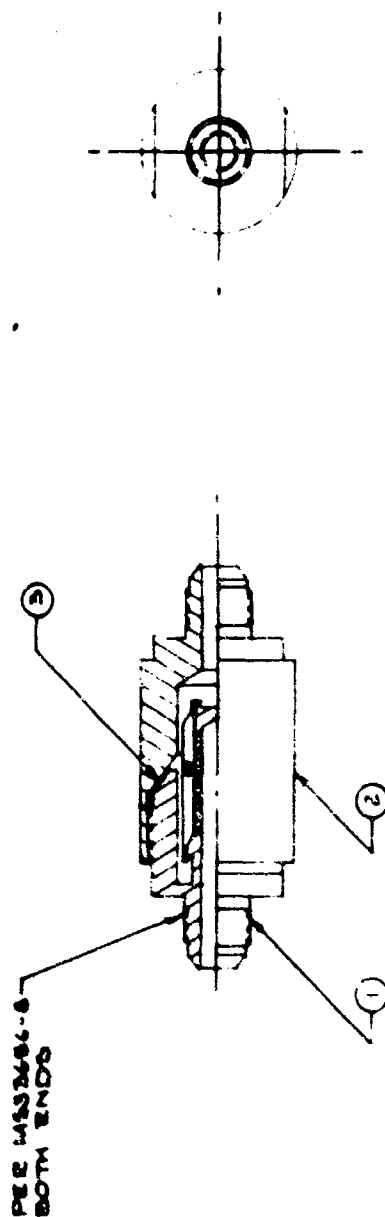
FIGURE 35
PAGE 96

After the test, the LF_2 was disposed, the filter was removed and examined for significant corrosion attack. None was observed.

2-2-67 Wesley F. 16
After second test with
LF2

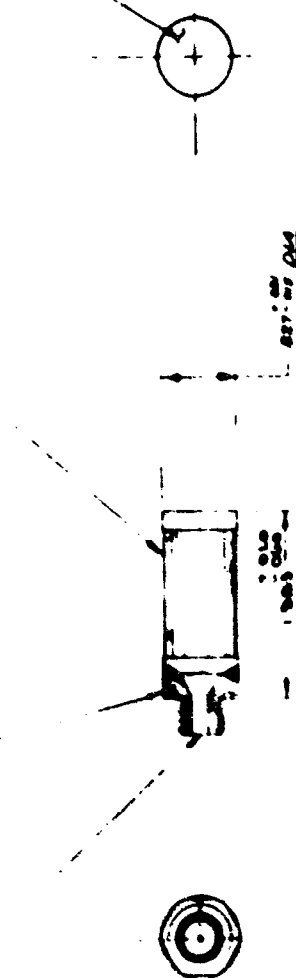
FIGURE 39
PAGE 107

PERMANENT MARK
WESTERN FILTER CO. INC.
P/N 9-1-500-V
