# DEVELOPMENT OF FUSED SLURRY SILICIDE COATINGS FOR THE ELEVATED-TEMPERATURE OXIDATION PROTECTION OF COLUMBIUM AND TANTALUM ALLOYS

S. Priceman  
L. Sama  
Sylvania Electric Products Inc.  
Hicksville, New York

Technical Report AFML-TR-68-210  
December 1968

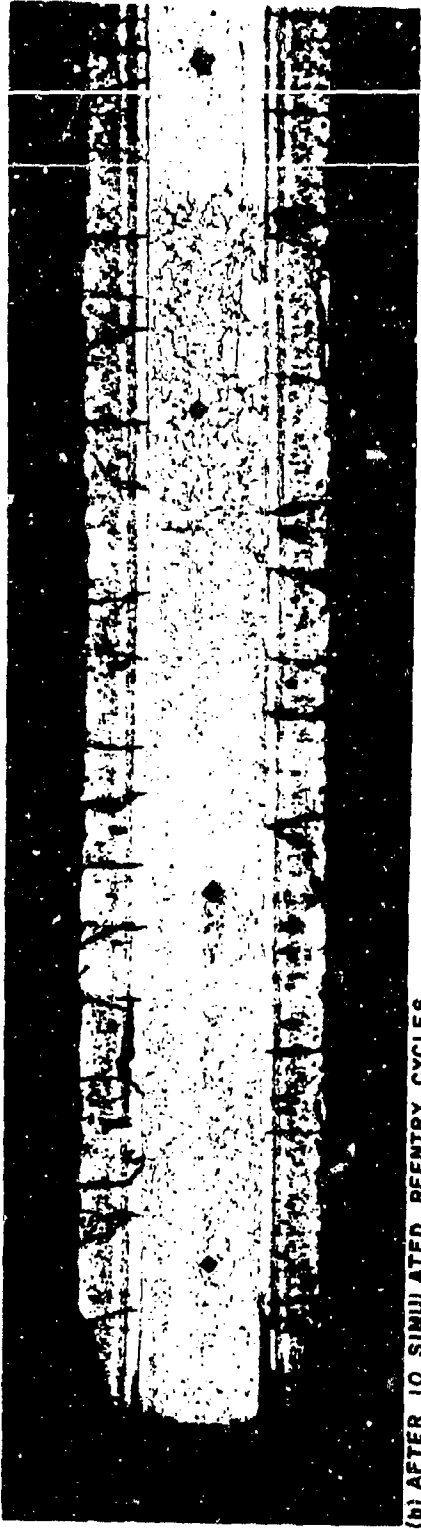
(a) AS DEFECTED (edge of 0.032 hole is at left)

Figure 53 Sections Through Reentry Simulation Exposed Defected Coated Specimens (100X).  
(Reduced 10 Percent in Reproduction)

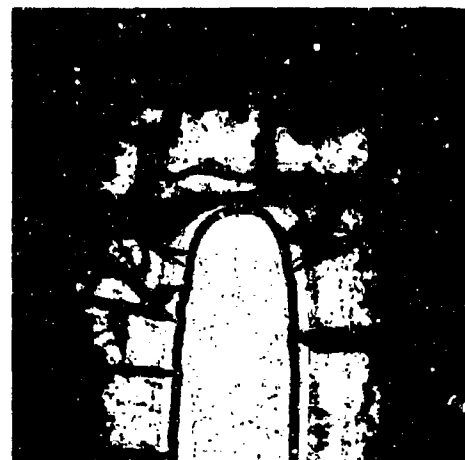
(a) COATED AND DRILLED (28599-4)

(b) COATED AND DRILLED (28579-3)  
+ 3 SLOW CYCLES

(c) COATED, DRILLED  
AND REPAIR COATED (28579-1)

(d) COATED, DRILLED, REPAIR  
COATED + 43 SLOW CYCLES (28579-2)

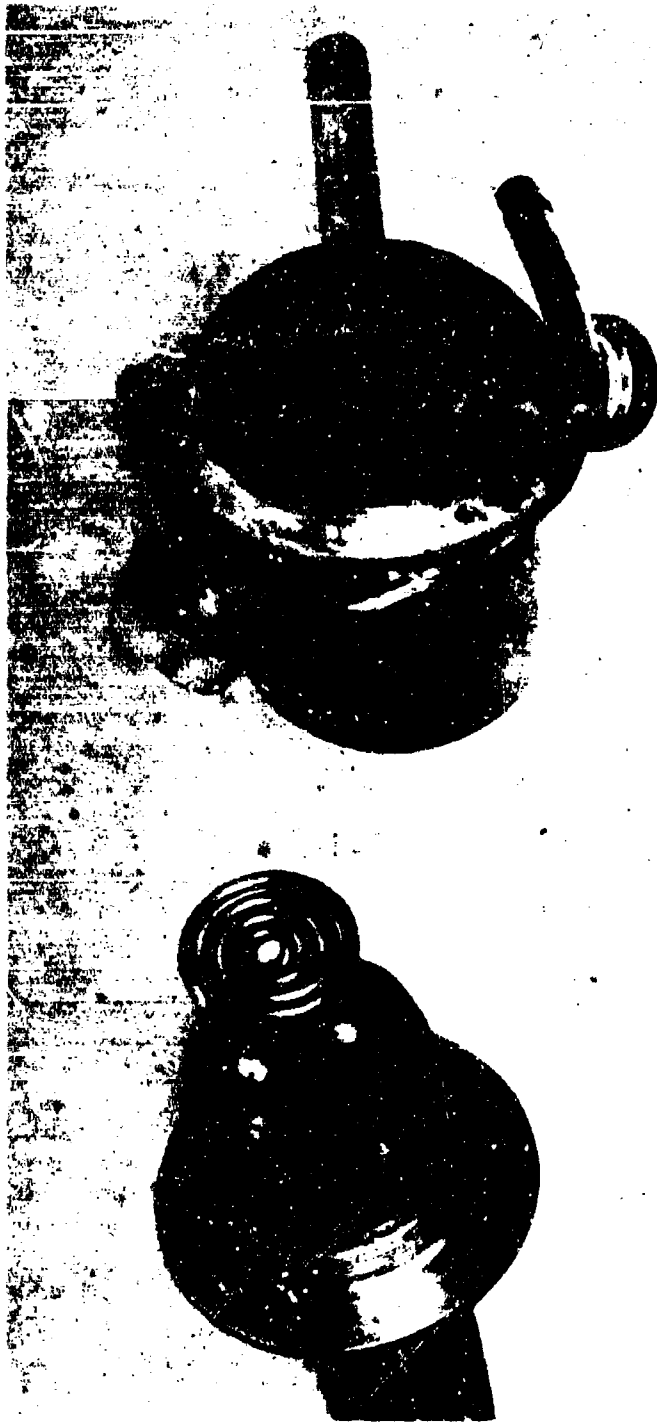
Figure 94 Disassembled View of Coating Repair Unit

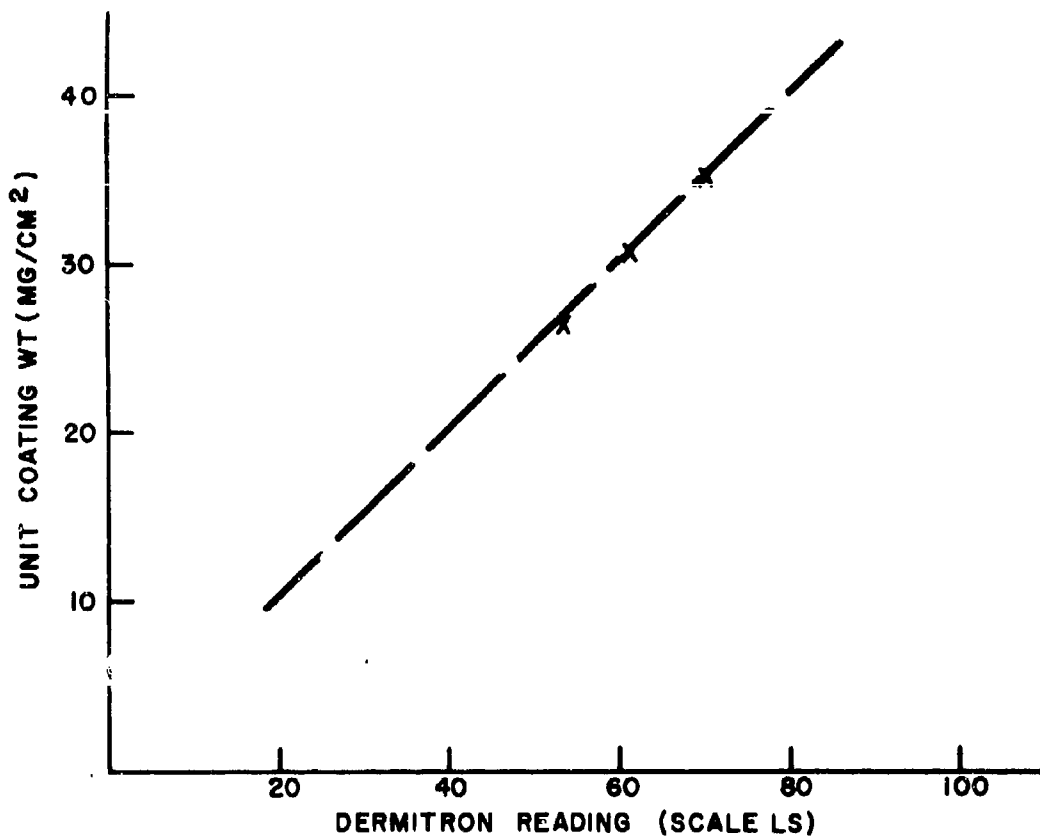
Figure 118 Green Coating Weight vs Dermatron Response  
(Si-20Cr-20Fe Coating on D43 Alloy)
