**CR 69.008**

NAVAL CIVIL ENGINEERING LABORATORY  
Port Hueneme, California

FERRO CEMENT PANELS  
VOLUME I

Experimental Evaluation  
and Protective Potential

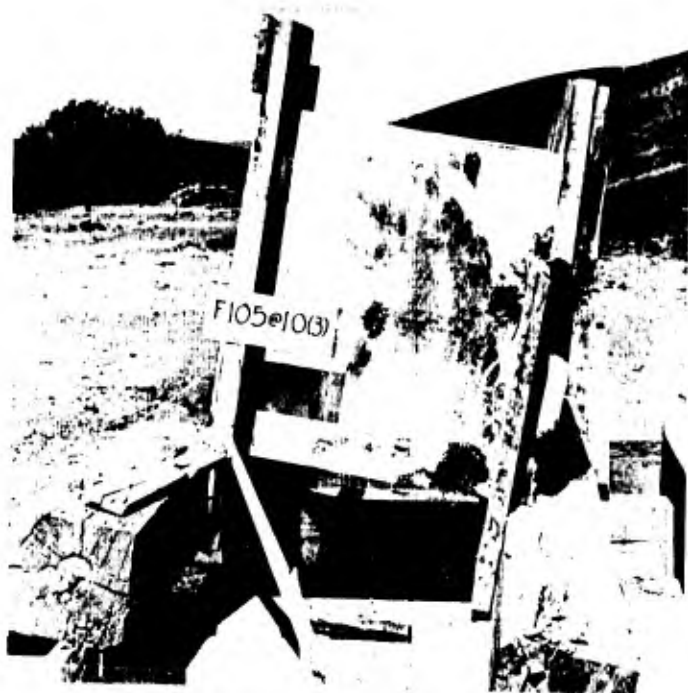
Figure 4-4.307

There was one penetration of the intermediate panel, one embedment creating slight spall on the back face and one hit that cut a large notch in the edge of the panel. The rear panel was undamaged. This indicated that the penetration of the intermediate panel extracted virtually all of the energy of the fragment. The support was pushed backward 11" and considerably damaged. (Fig. 4-4.307)

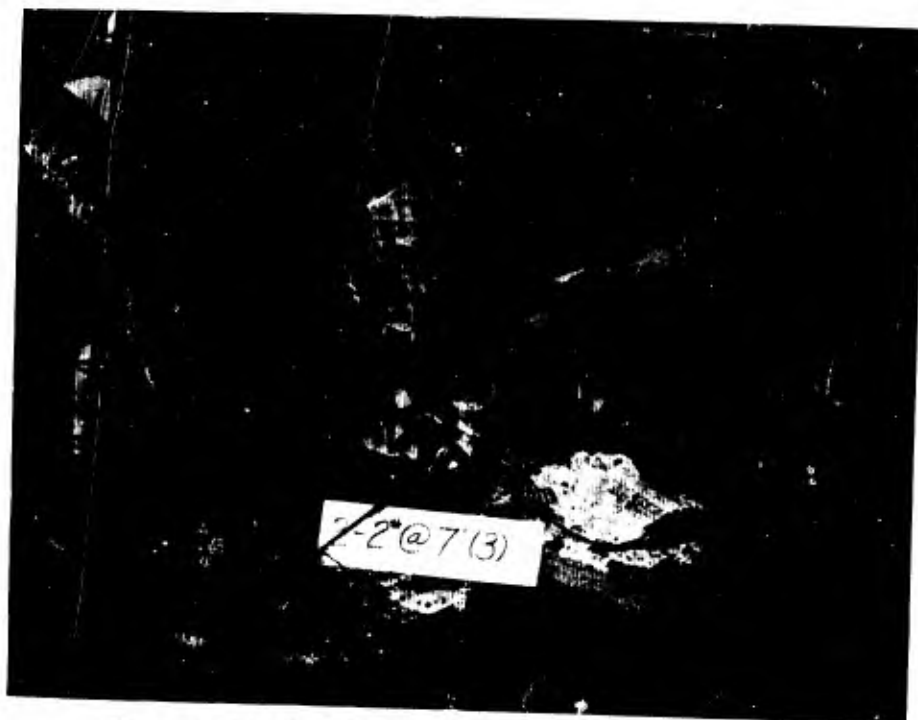
Figure 4-7.301 Support and Panels  
as Hoisted Aboard

The damage was the same in all respects as in the first experiment but located 3 ft. nearer the pier simulator (Figure 4-7.301).

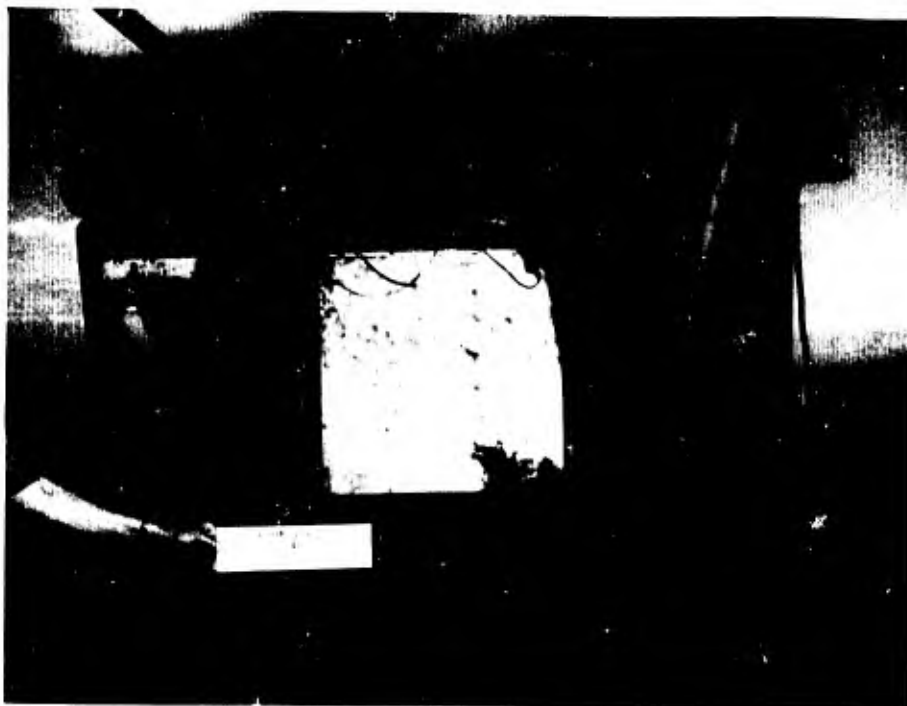
Figure 4-7.802 Damage to Rear Panel

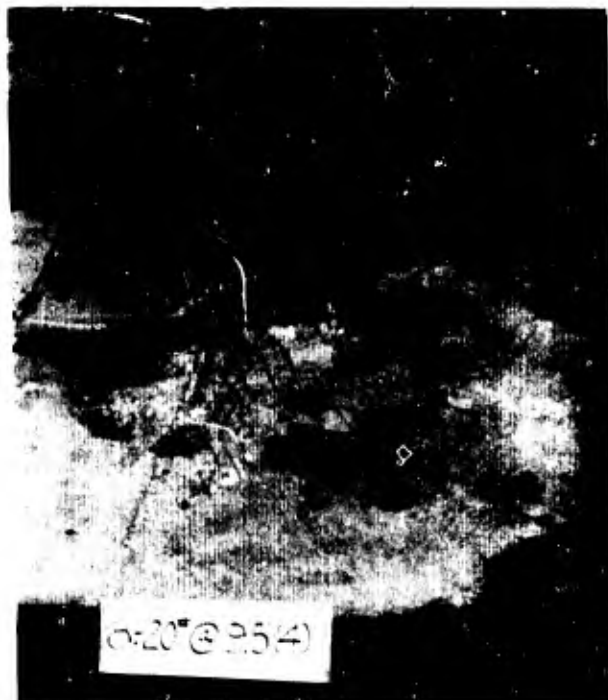
Figure 4-7.903 Damage to the Two Intermediate Panels
