## USAAVLABS TECHNICAL NOTE 1

# A METHOD FOR PREVENTING CATASTROPHIC FAILURE IN ALUMINUM STRESSED SKIN PANELS

December 1969

**U. S. ARMY AVIATION MATERIEL LABORATORIES  
FORT EUSTIS, VIRGINIA**

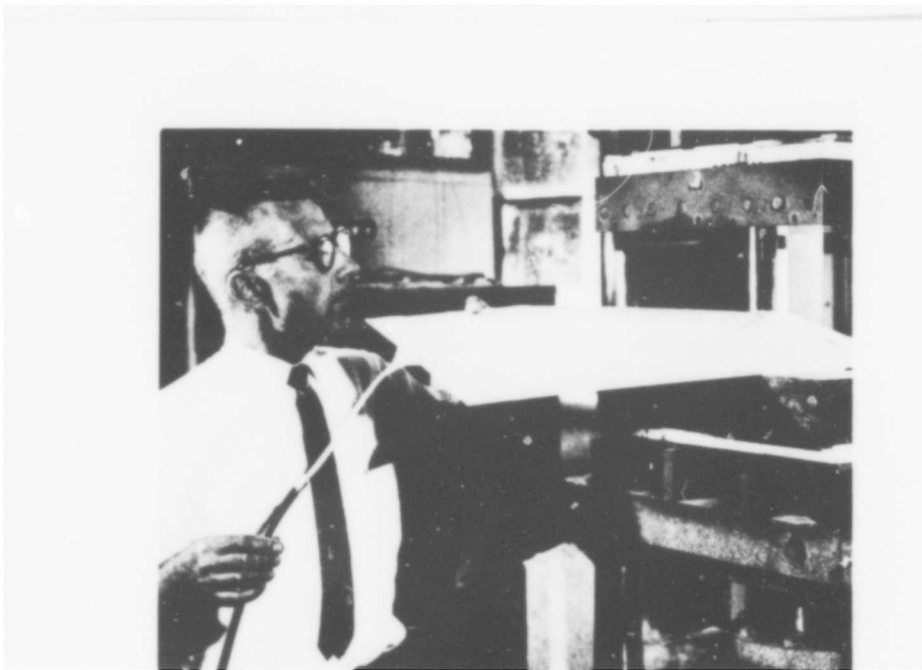
e. Pressing Operation.

8. An 8- to 10-mil thickness of Epon 828 resin with Z curing agent was applied to the bond area.
9. A single layer of 1002-S unidirectional prepreg tape was placed parallel to the direction of loading (see Figure 1d).
10. The tape was rolled with a roller to remove entrapped air.
11. The specimen was vacuum-bagged (specimens 1 through 24).
12. Vacuum was applied (specimens 1 through 24).
13. The specimen was placed in a press at 30 psi, 330°F, for 1 hour (see Figure 1e).
14. The specimen was postcured in an air circulating oven at 280°F for 1 hour (see Figure 1f for finished specimen).

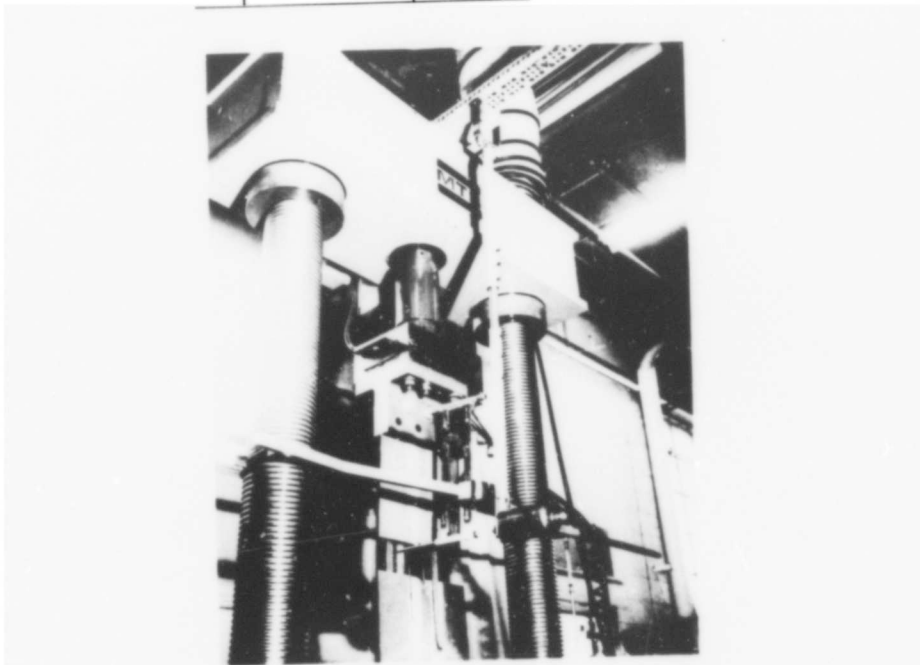
Figure 2. Test Setup.

A 100,000-pound-capacity close-loop hydraulic test machine was used to perform the static tests. Loads were monitored with a Brush recorder, a recording oscilloscope, and an X-Y plotter. The specimens were loaded to predetermined values, and a pointed 0.375-inch-diameter steel rod was driven through the specimen midpoint with the pendulum device shown in Figure 2. A point was ground on the rod simulating that of a .38 caliber bullet (see Figure 3). Projectile impact velocities of 15.1 feet per second were obtained from measurements taken from motion picture film shot at 720 frames per second. The pendulum stayed in contact with the pointed rod during the time that the rod was being driven through the specimen.

An 8mm camera operating at 10,000 frames per second was used to obtain crack growth data. In cases where failure did not occur on impact, the load was removed, the crack length was measured, and the specimen was reloaded to failure at a load rate of 1000 pounds per second.
