# Evaluation Of The Fused Slurry Silicide Coating Considering Component Design And Reuse

*MCDONNELL DOUGLAS ASTRONAUTICS COMPANY - EAST*

TECHNICAL REPORT AFML-TR-70-154

December 1970

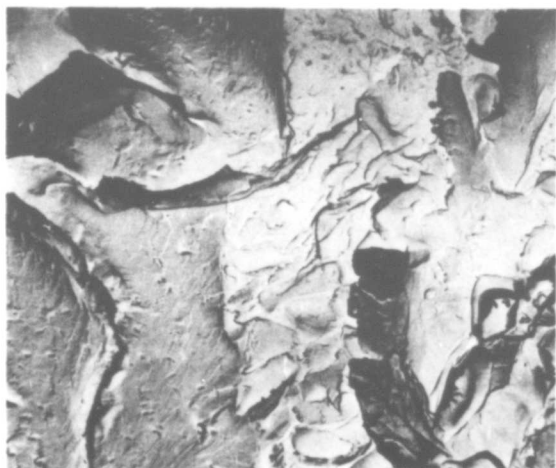
Area A

Figure 57 Replicated Fracture Surface Areas Of Specimen 1

The microscopic features of the fracture surfaces as observed in the light microscope indicate fracture origin at both edges of Specimen 1 and at one edge of Specimen 2. The remaining areas of both specimens consisted of shear fracture. Electron fractographic examination of Specimen 1 revealed a duplex structure at the origin, Figure 57 Area A. The duplex structure consisted of a mixture of brittle cleavage rupture and ductile dimple rupture. The shear region exhibited elongated dimples typical of a ductile shear rupture, Area B of Figure 57. Both the origin and shear region on Specimen 2 revealed ductile features typical of an overload failure, Figure 58.
