## **The Influences of Geologic Depositional Environments on Sand Boil Development, Tara Wildlife Lodge Area in Mississippi**

Ryan C. Strange, Maureen K. Corcoran, Joseph B. Dunbar,  
and Darrel Schmitz

March 2016

Final report

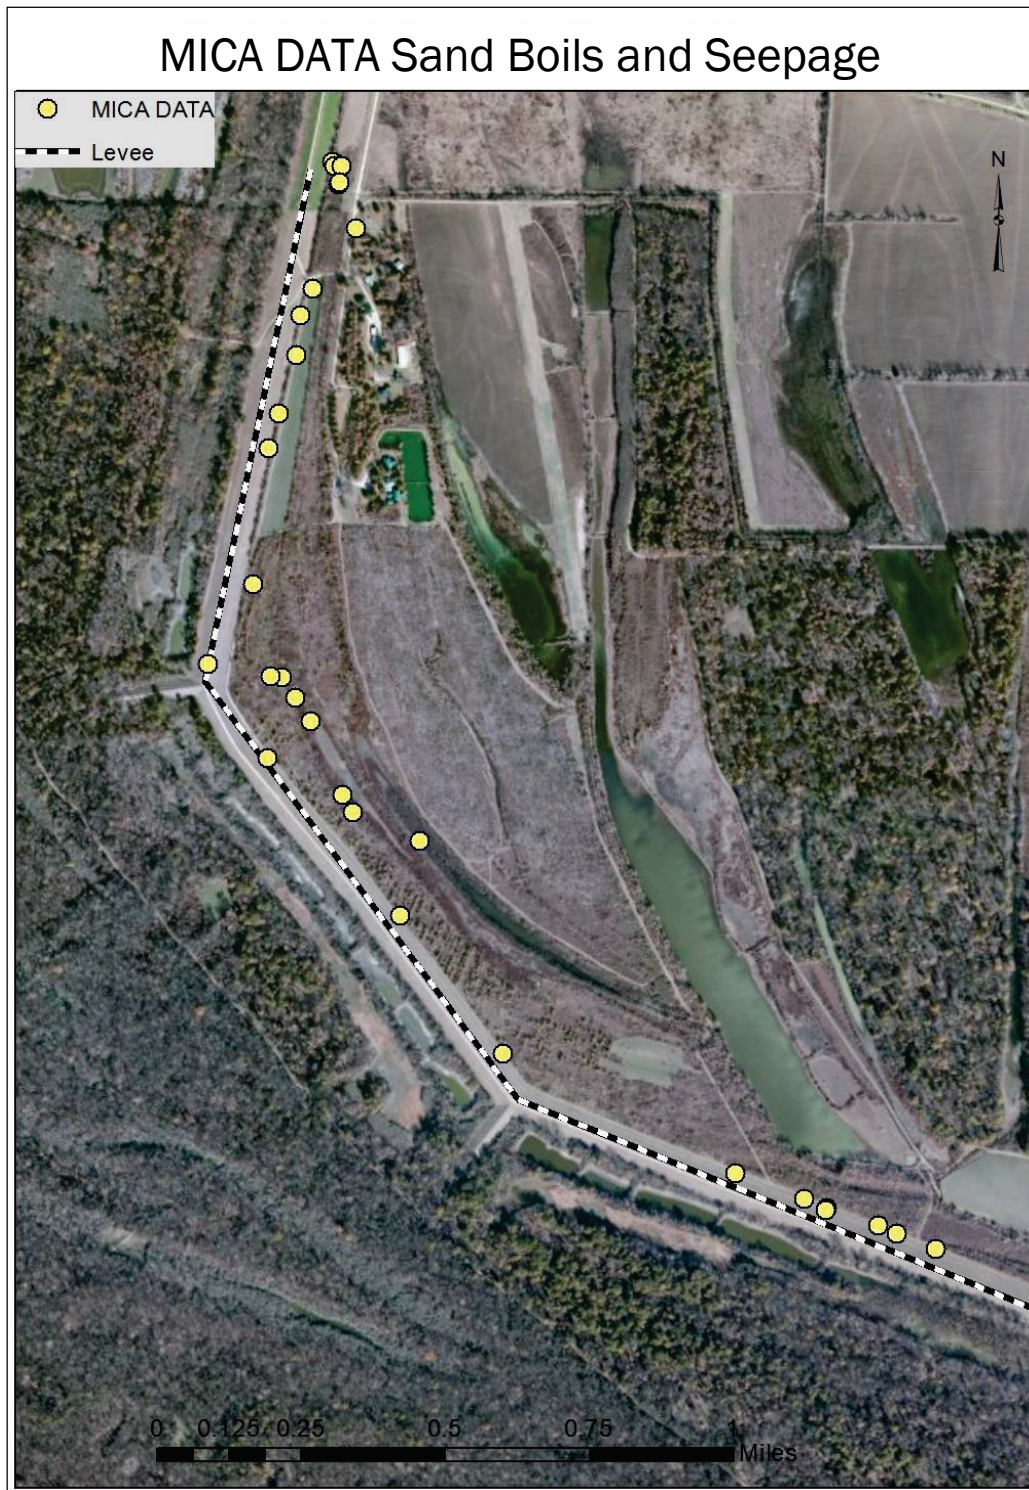
Figure 15. Map showing MICA data collected during the 2011 flood (ESRI 2014).

During the 2011 flood, moderate to heavy underseepage and numerous active sand boils and pin boils were observed within 50 ft of the landside toe in front of Tara Wildlife Lodge. Sand boil and seepage data, obtained in locations shown in Figure 15, were collected using the Mobile Information Collection Application (MICA) that is described in Chapter 6. Three high-energy sand boils with 12- to 16-in. throats were identified (USACE 2012a). These boils cumulatively flowed 100+ gal/min, transported 5+ cu yd of fine sand/silt before and during remedial action, and were located between 10 and 20 ft from the levee toe (USACE 2012b.)

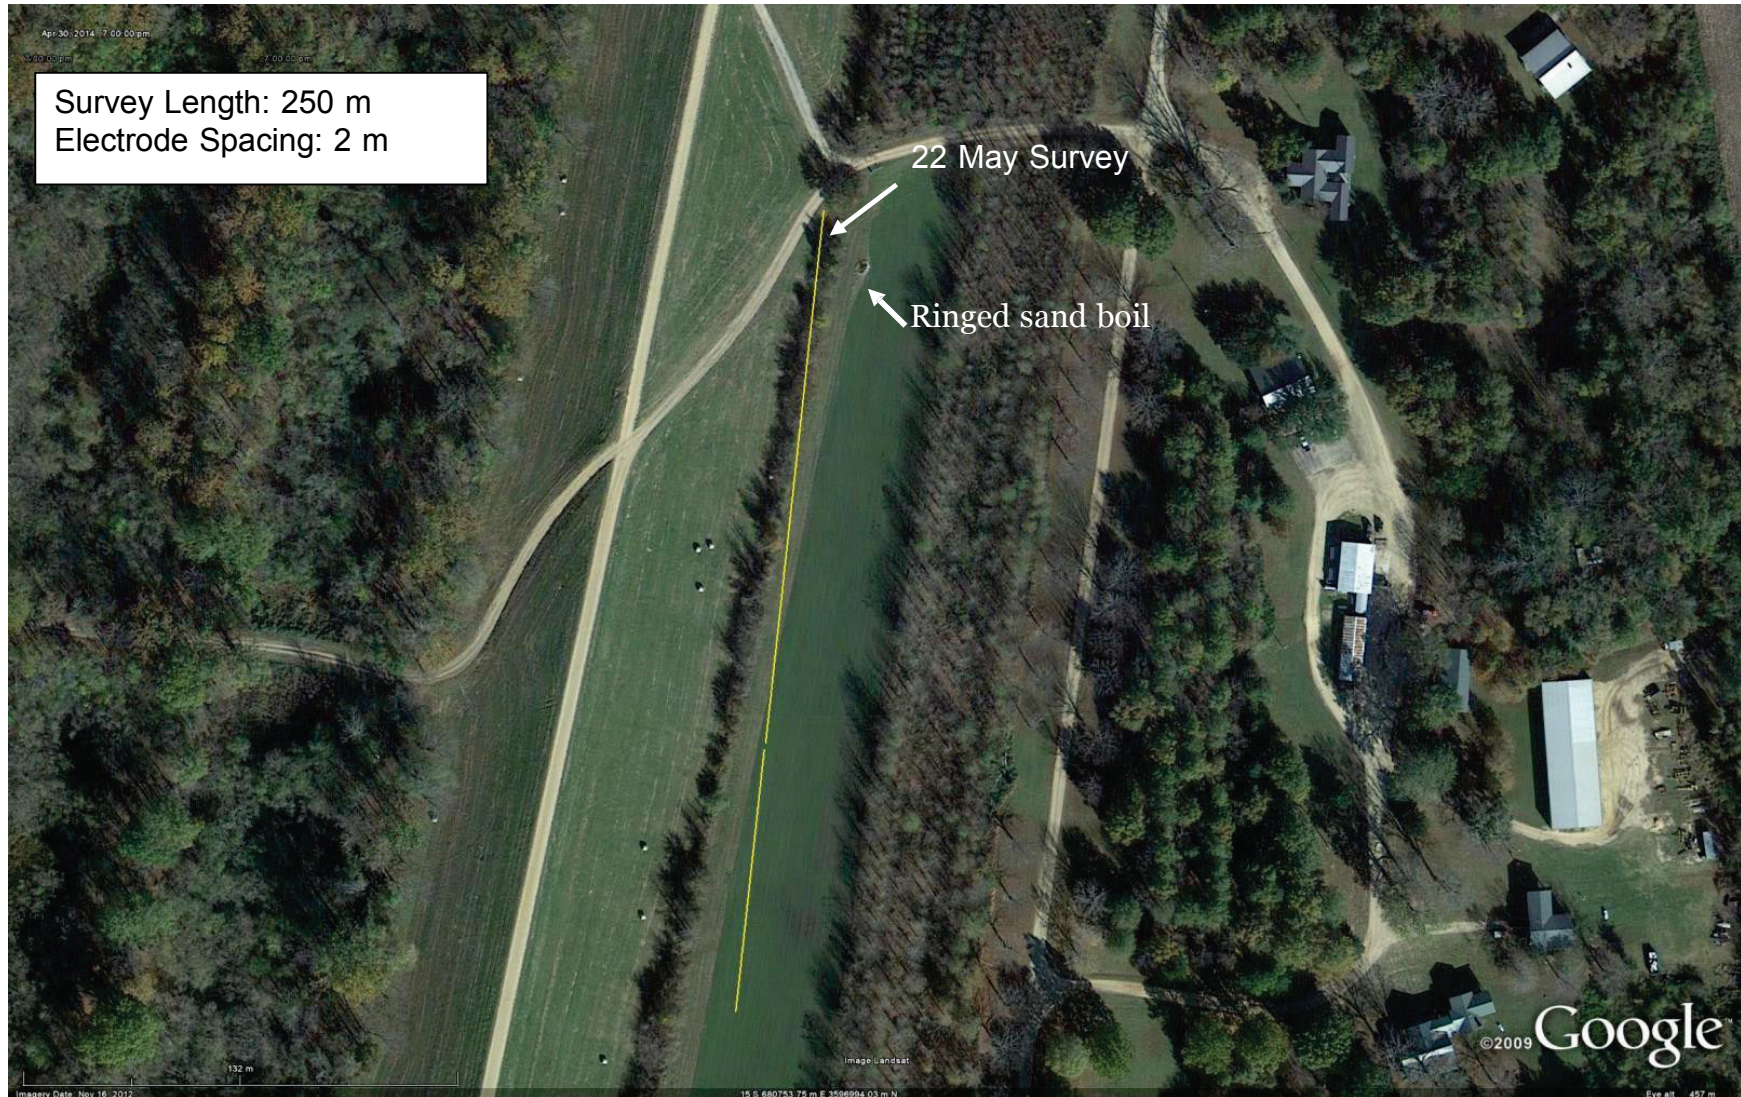
Figure 20. Northern ERT survey transecting areas of seepage. Notice ringed sand boil (Google 2009).

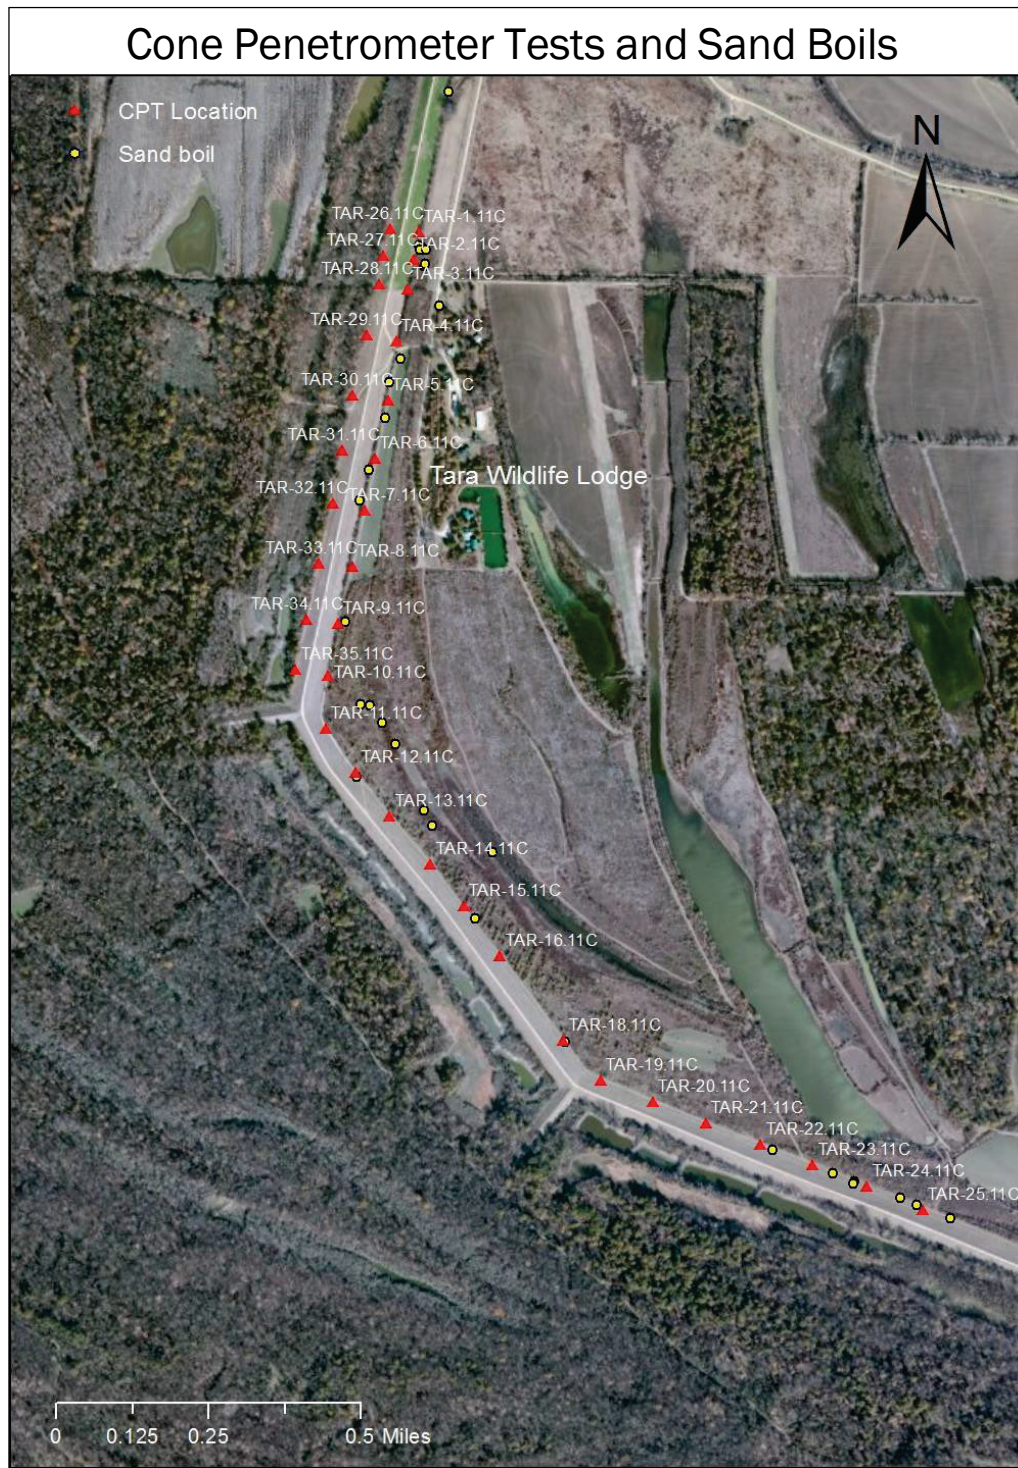
Figure 34. Map of cone penetrometer tests and location of sand boils from MICA data from the 2011 flood (ESRI 2014).
